3.1.2.6 Rietvlei:

i) **General description of the wetland site.**

ii) Rehabilitation information.

vi) Wetland Rehabilitation site details.

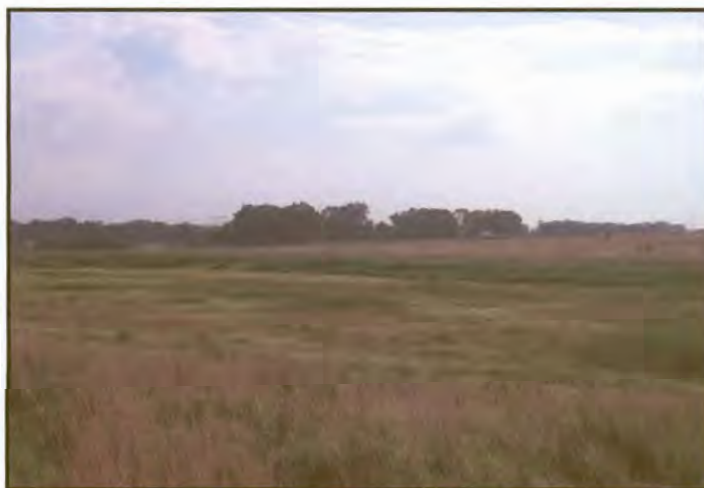
Figure 66: The Rietvlei wetland. Previous peat mining activities can be seen in the foreground of the wetland.

Grundling and Marneweck (2000) documented that *Phragmites australis* and *Carex cernua* are the dominant vegetation species on the southern peatland, and reflect the permanent wet conditions of the peatland. Furthermore they explained that mixed grass / sedge meadows occur on the edges of the peatland and on some of the abandoned peat working surfaces and indicate seasonal to semi-permanent wet conditions (Figure 66).

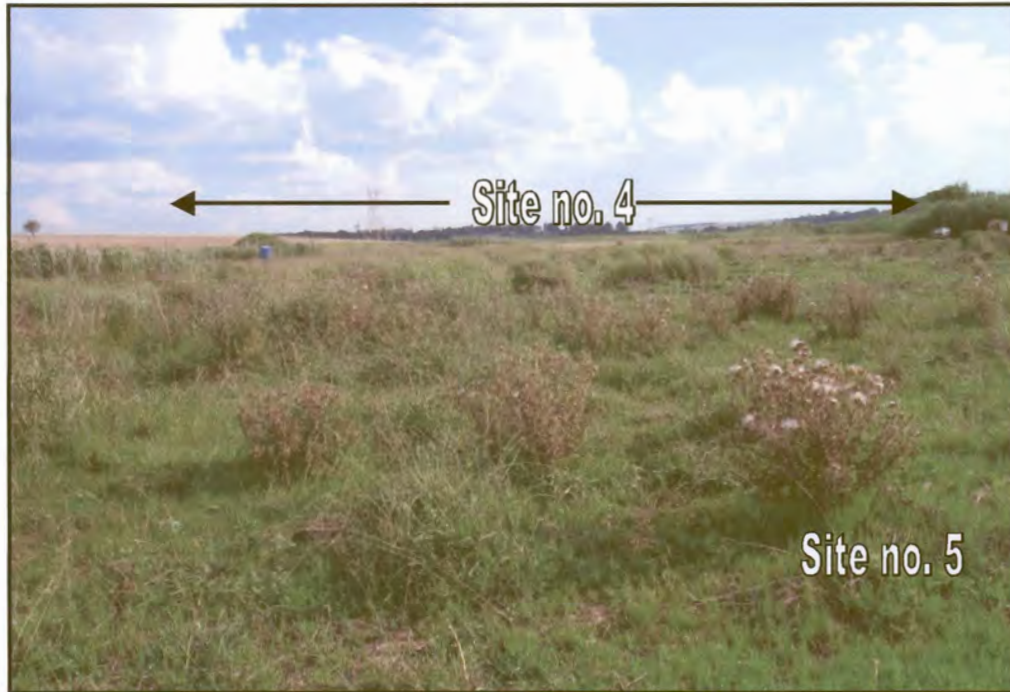
Figure 68: The area between site no. 4 and site no. 5.

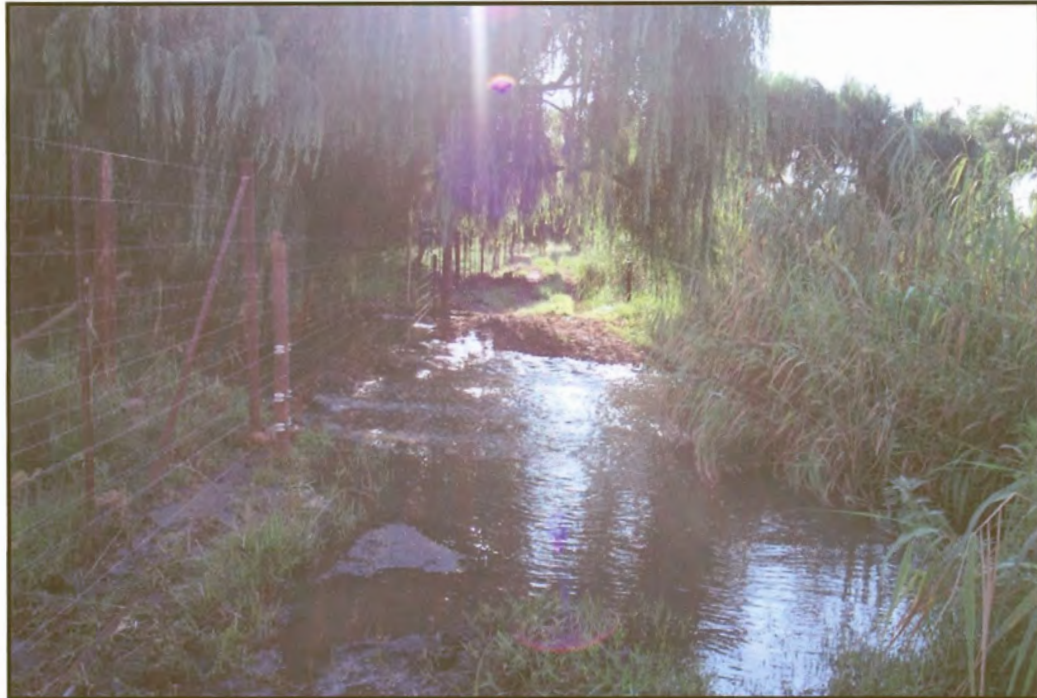
Figure 71: Site no. 1. A man-made drift was built across the entry point into the Rietvlei Nature Reserve. Due to this the flow of water has been concentrated.

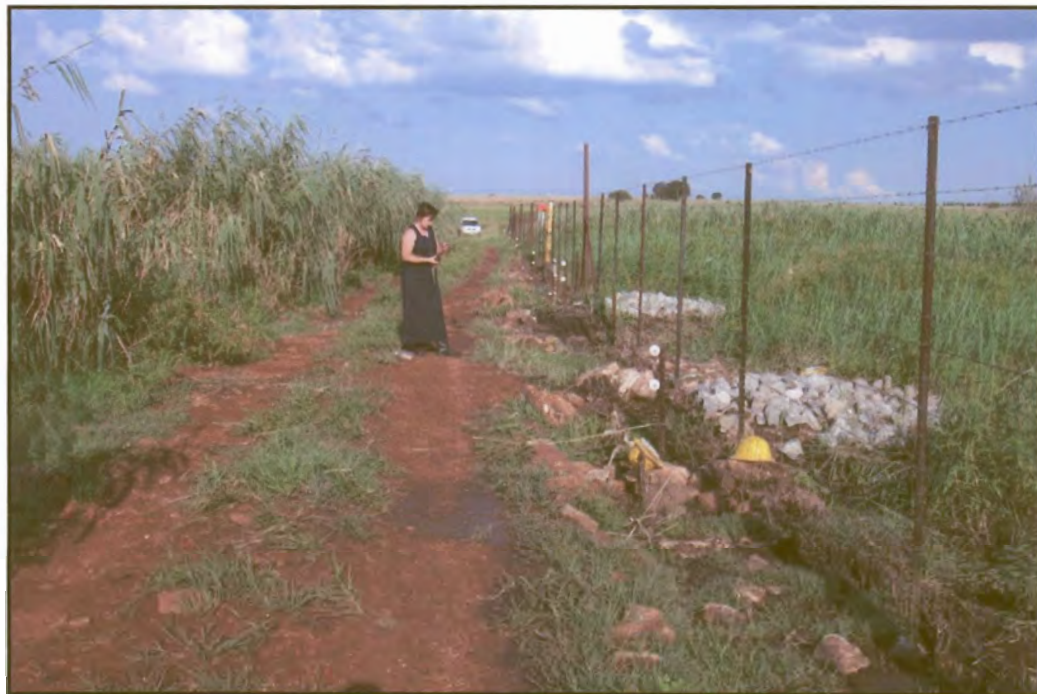
Figure 72: Site no. 1. Energy dissipaters were constructed along the drift to spread the flow and dissipate the energy.

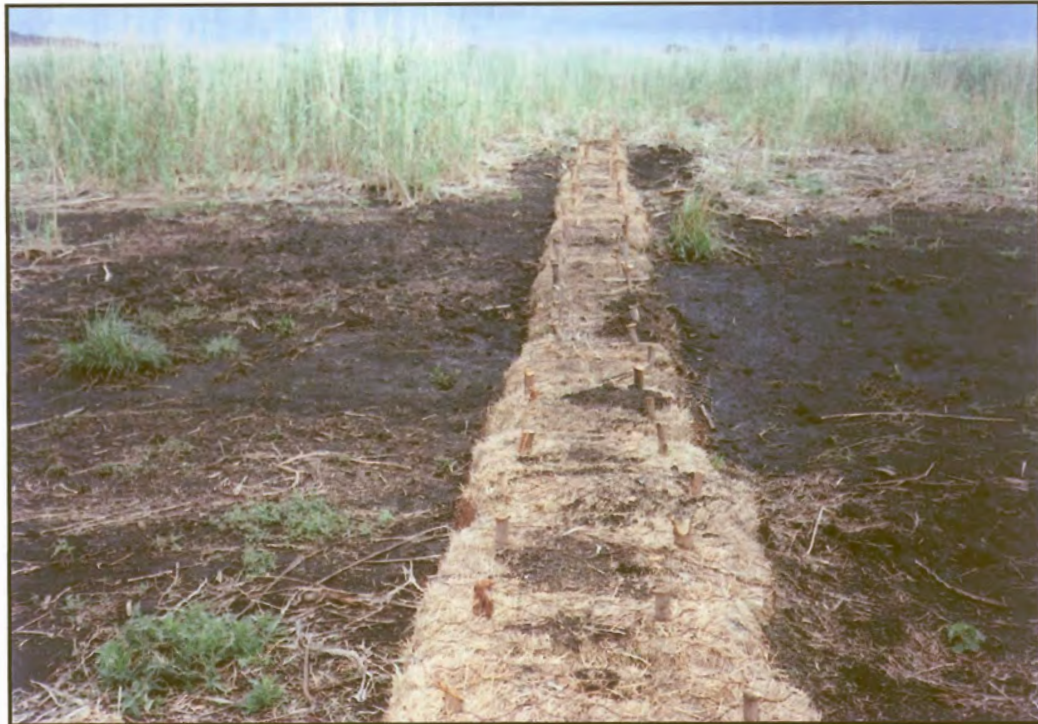
Figure 73: At site no. 2.1 the shallow erosion gully was stabilized with grass bales.

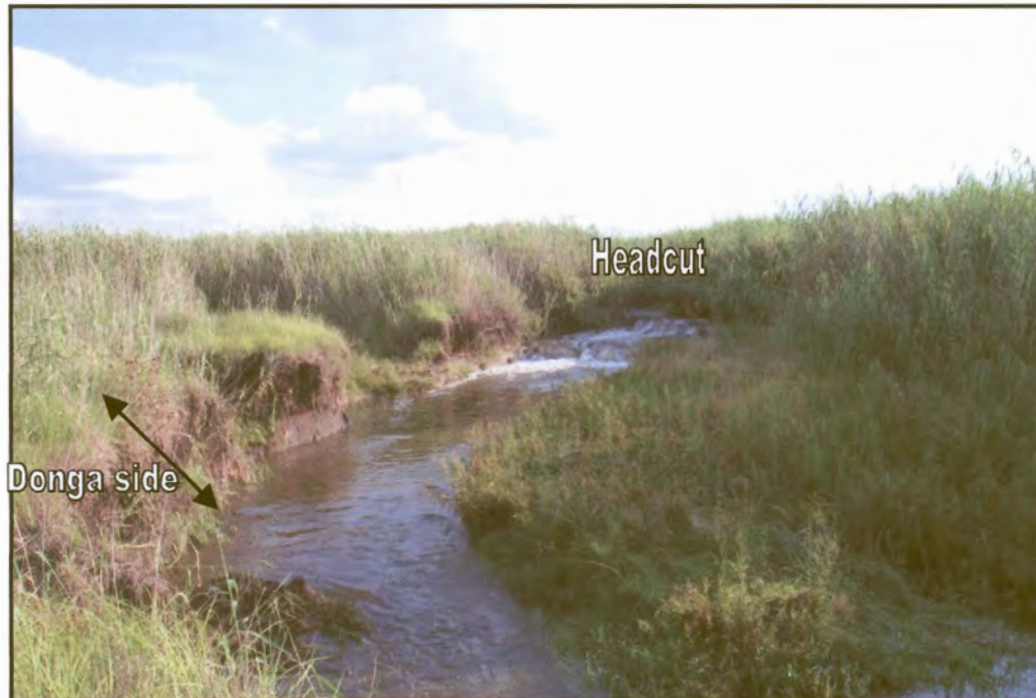
**Figure 75: Headcut and donga (incised drainage channel) at site no. 3.1.
The donga sides need to be sloped and re-vegetated.**

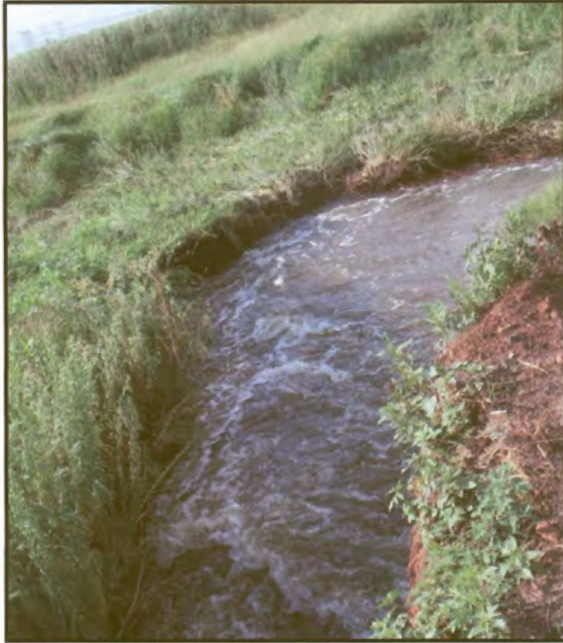
Figure 77: Site no. 4. A bypass furrow used during the construction of a concrete weir in the causeway was blocked to prevent channel erosion.

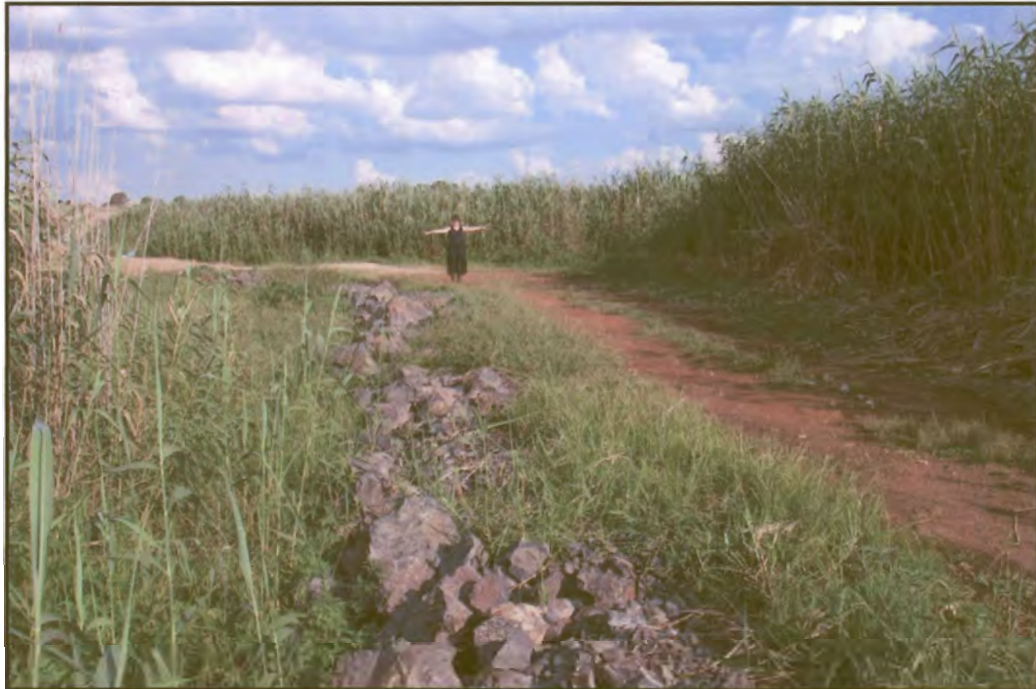
Figure 78: Site no. 4. A causeway was applied as a structure to disperse water and to raise the water level in the wetland. Downstream of the structure the erosion was stabilised by using rock packs.

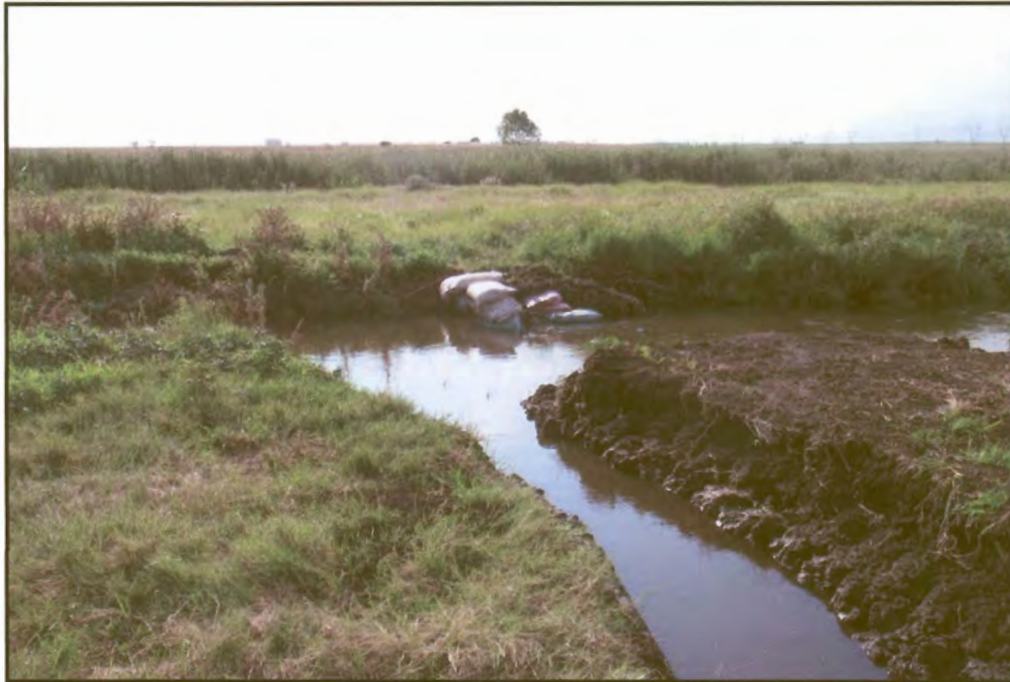
Figure 79: Site no. 5.1. A bypass furrow has been constructed to allow the construction of a gabion weir to facilitate the raising of the water table and to disperse the water.

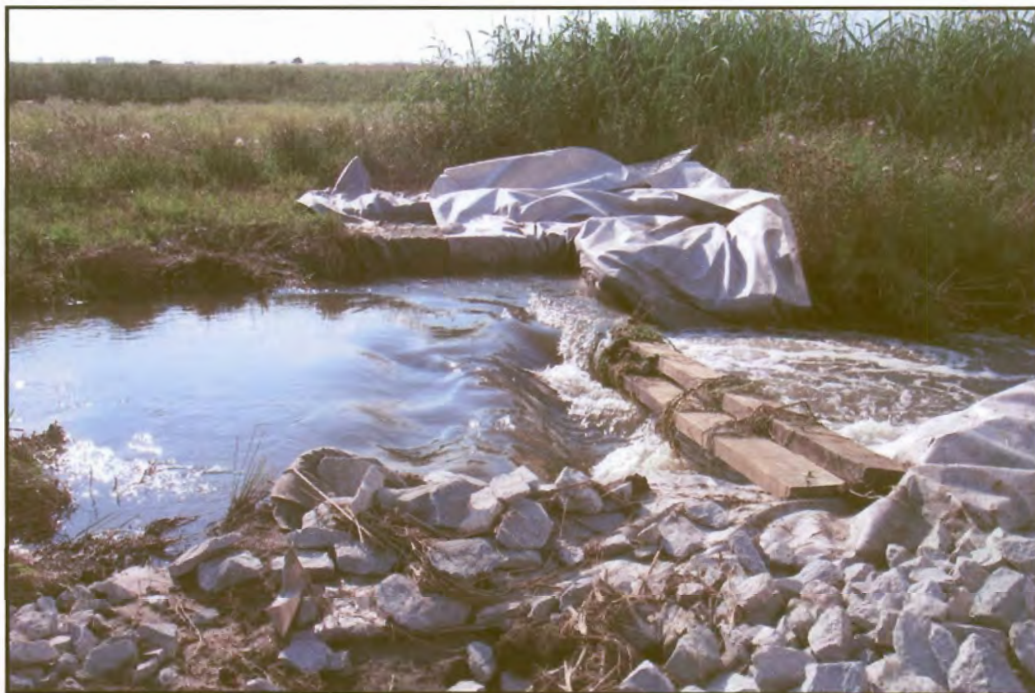
Figure 80: Construction of a gabion in progress at site. no. 5.1.1. Flooding is taking place.

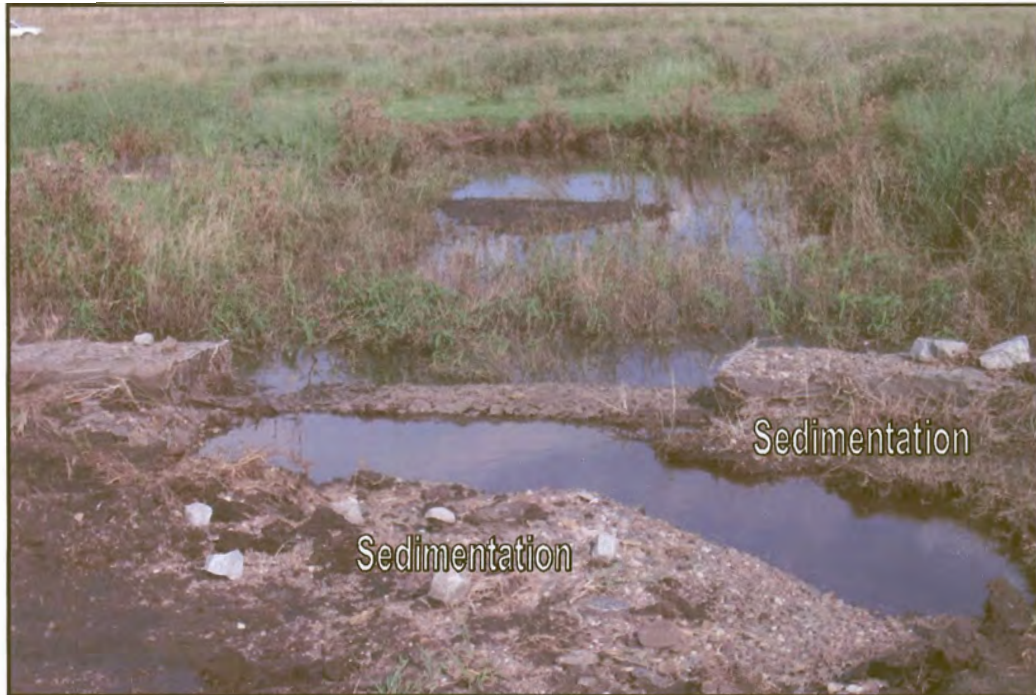
Figure 81: Site no. 5.1.2. Sedimentation taking place behind the structure.

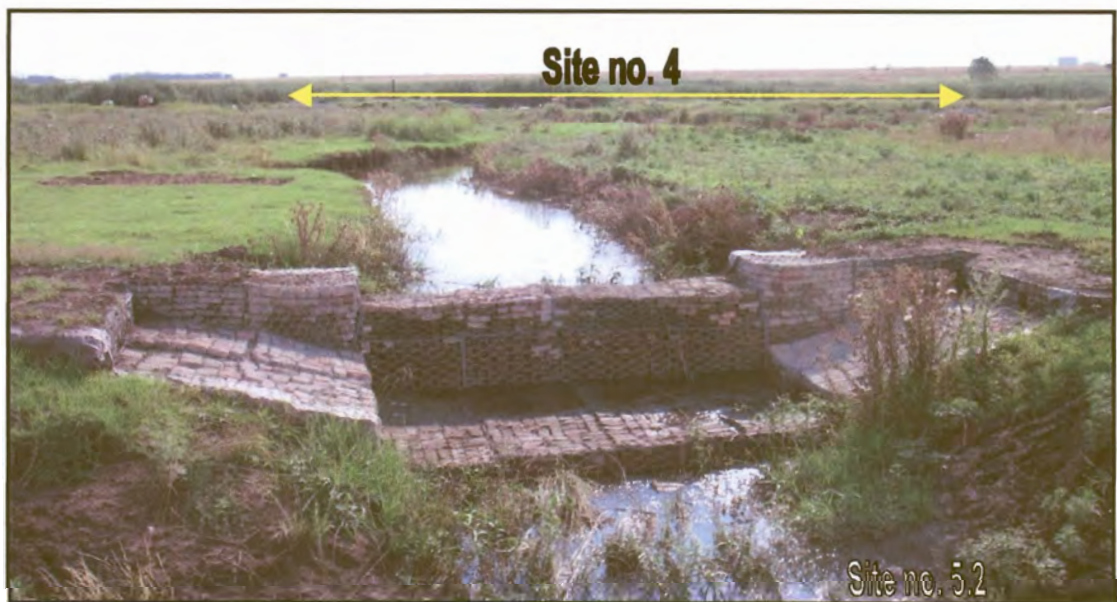
Figure 82: Gabion structure at site no. 5.2. Note the difference in the water table upstream and downstream of the structure.

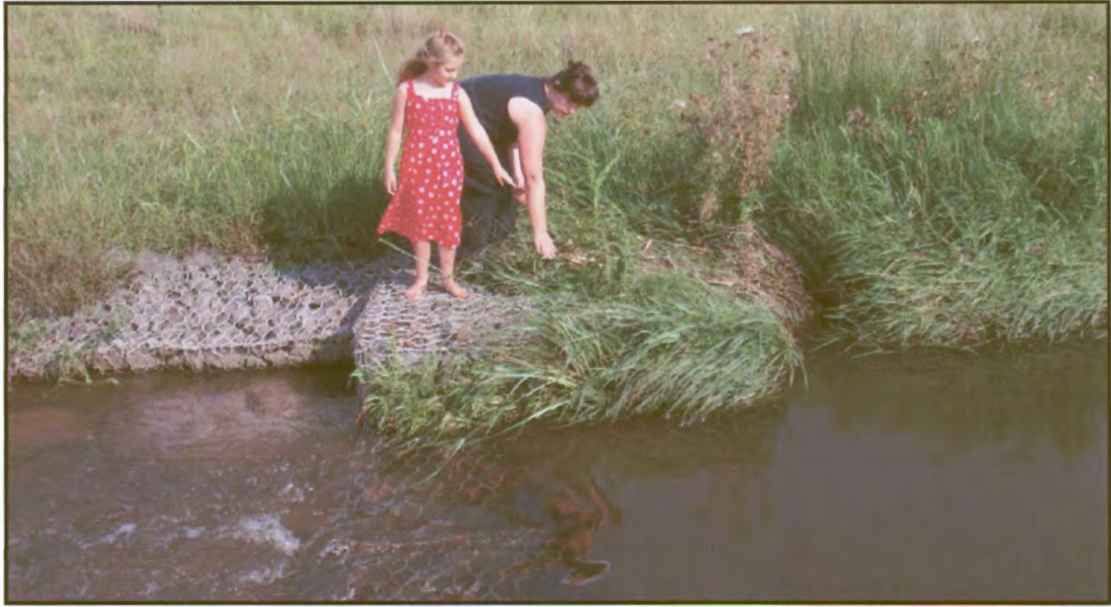
Figure 83: Site no. 6.1. Note the higher water table behind the structure. The bent grass on the bank of the channel indicates a previous flooding event.

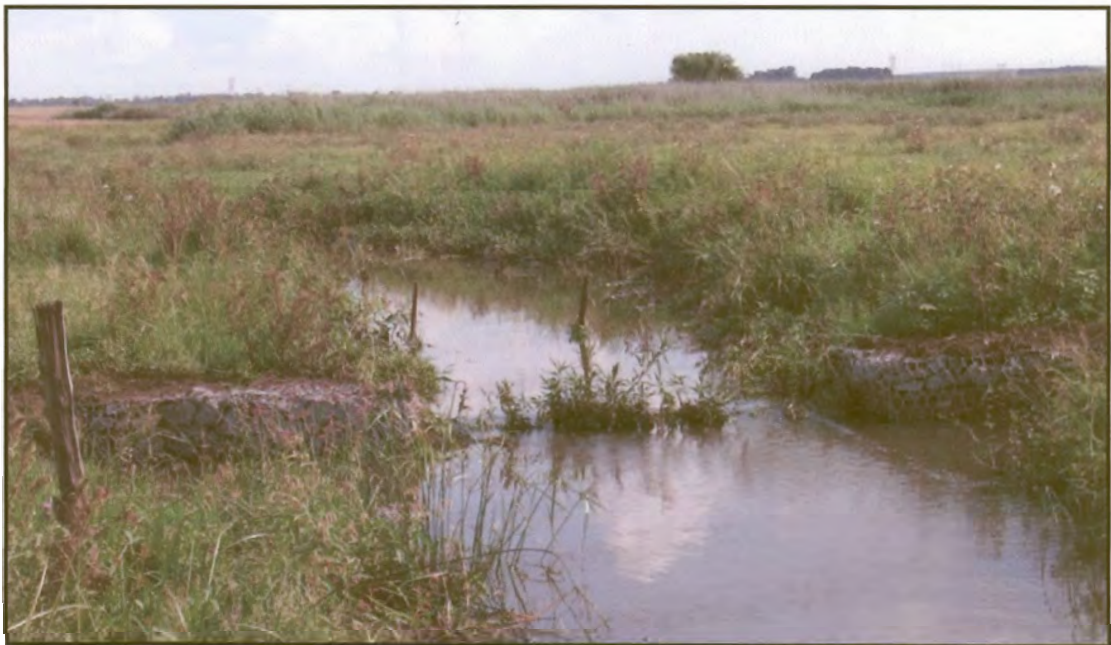
Figure 84: A drowned gabion structure between sites no. 6.1 and 6.2 due to an increase in back flooding from the structure at site no. 6.3.

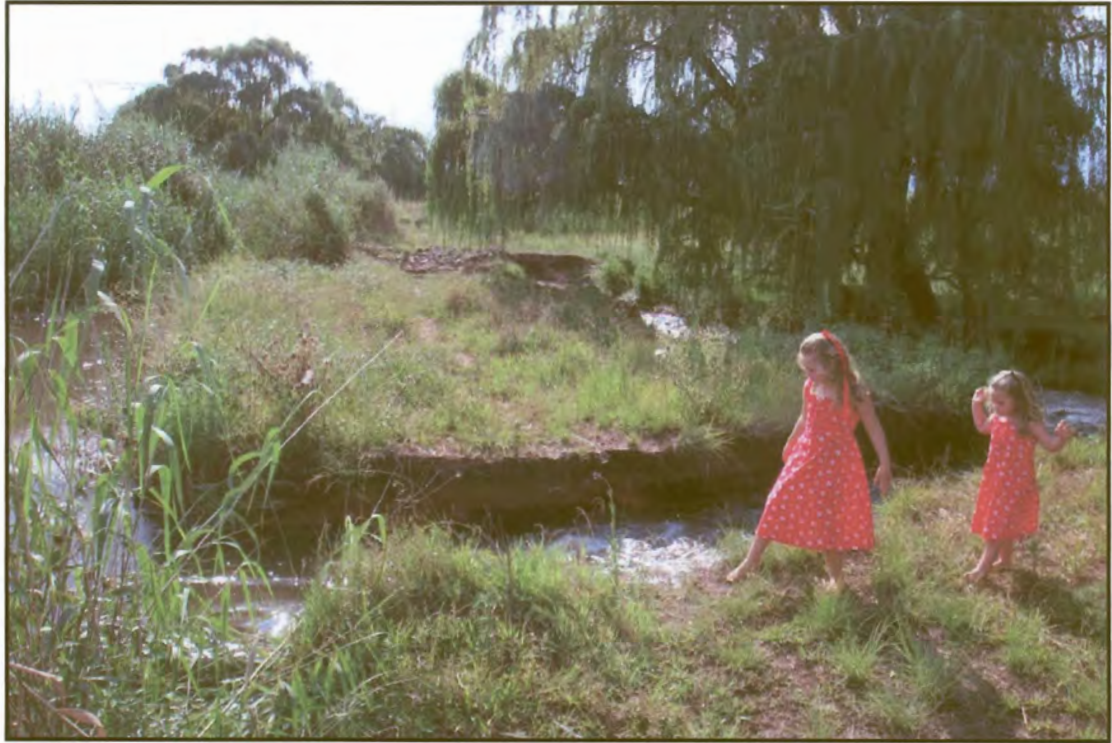
Figure 85: Site no. 6.3. The bypass furrow must be closed and the energy must be dissipated to prevent the concentration of water resulting in channel erosion.
