Evaluation of remote sensing sensors for monitoring of rehabilitated wetlands

Althea Theresa Grundling

Submitted in partial fulfillment of the requirements for the degree
MAGISTER SCIENTIAE
In the Faculty of Natural & Agricultural Science
African Vegetation and Plant Diversity Research Center
Department of Botany
University of Pretoria
Pretoria

March 2004

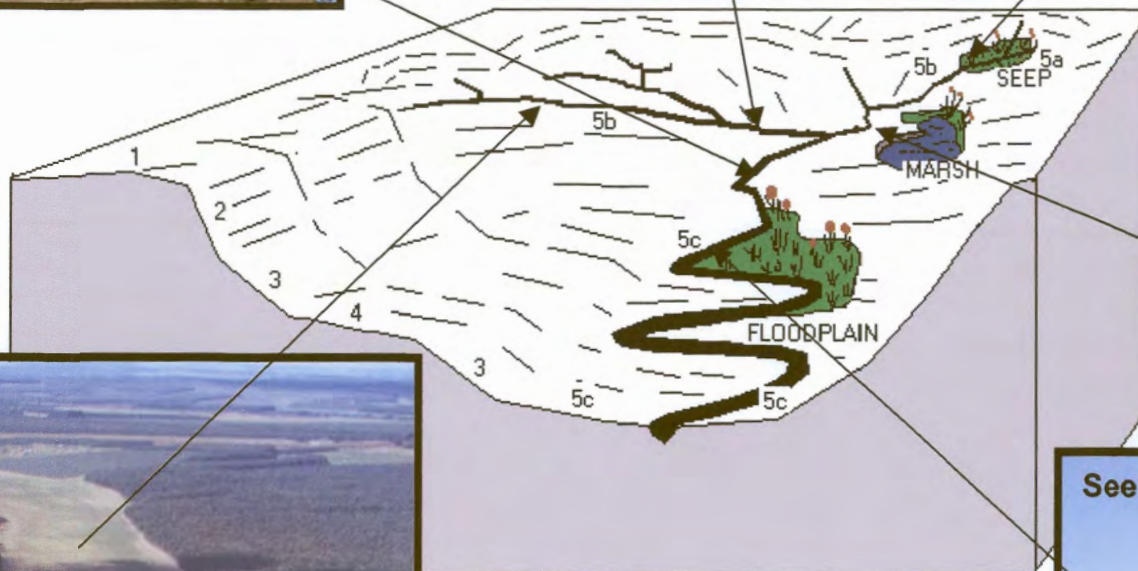
- KEY:**
- 1 = Crest
 - 2 = Scarp
 - 3 = Midslope
 - 4 = Foothlope
 - 5 = Valley bottom
 - 5a= Valley head
 - 5b= Young valley
 - 5c= Mature valley

Figure 3: The location of the selected rehabilitated wetlands within the different terrain units and wetland types (Adapted from Kotze *et al.*, 1994).

Figure 3 (page 37) describes the location of the selected rehabilitated wetlands within the different terrain units and wetland types and Table 5 (page 38, 39) gives a summary of the site description of the rehabilitated wetlands that were selected.

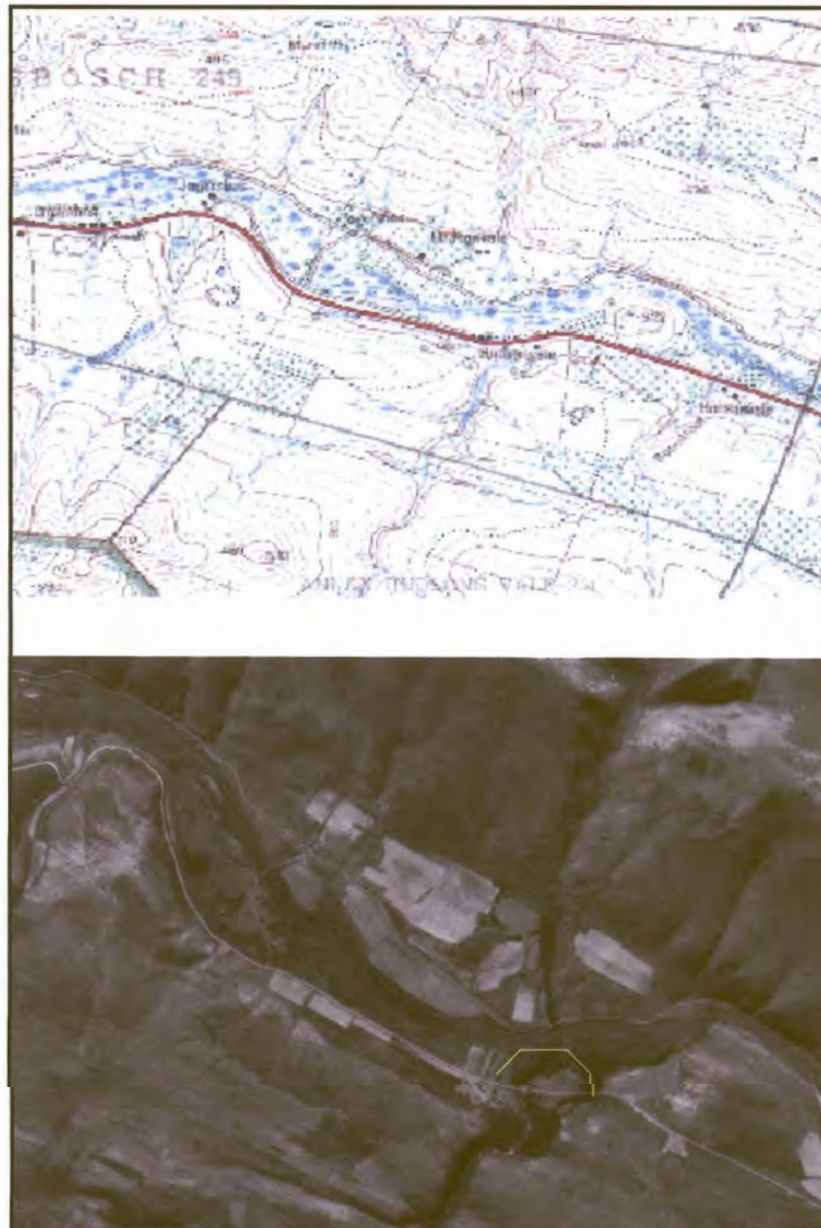
Figure 5: Topographical map section of the Kromme valley with 1954 aerial photograph showing an alluvial fan at Hudsonvale.

Parallel ridges of the Cape Fold mountain range to the north and south define the Kromme River valley. Numerous tributaries drain into the Kromme River from these steep slopes (25% - 40%). The river flows in an East-Southeast direction. Incised alluvial fans have developed at a number of places where tributaries entered the main axis between Kromdraai, Kompanijsdrif and at Hendrikskraal, Jagersbos and Hudsonvale (Figure 5) (Haigh *et al.*, 2002).

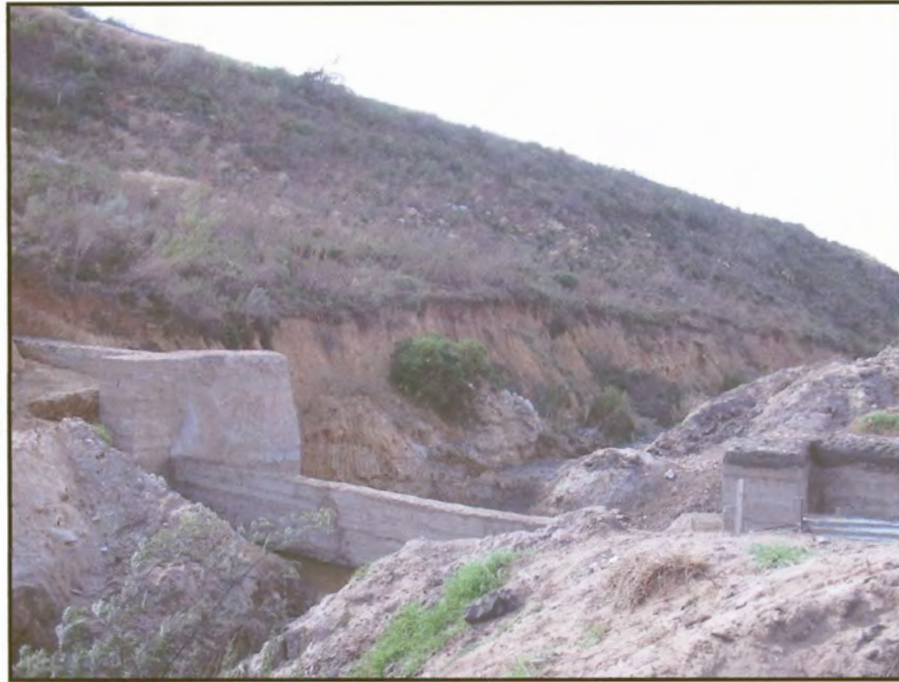
Figure 14: Rehabilitation structure 3: Concrete Weir being constructed.

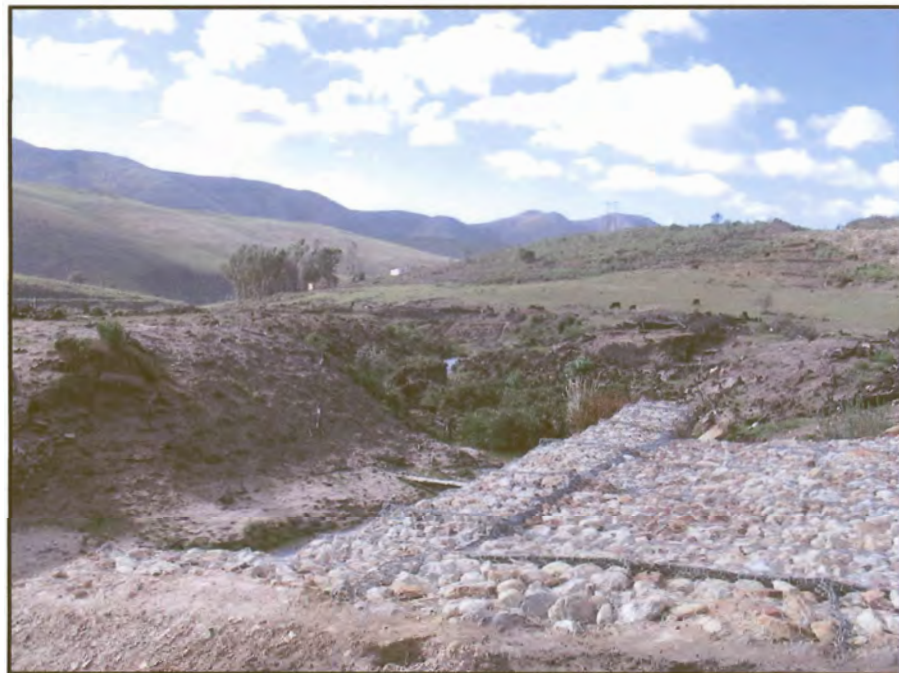
Figure 15: Rehabilitation structure 4: Gabion weir at Kompanjiesdrif.

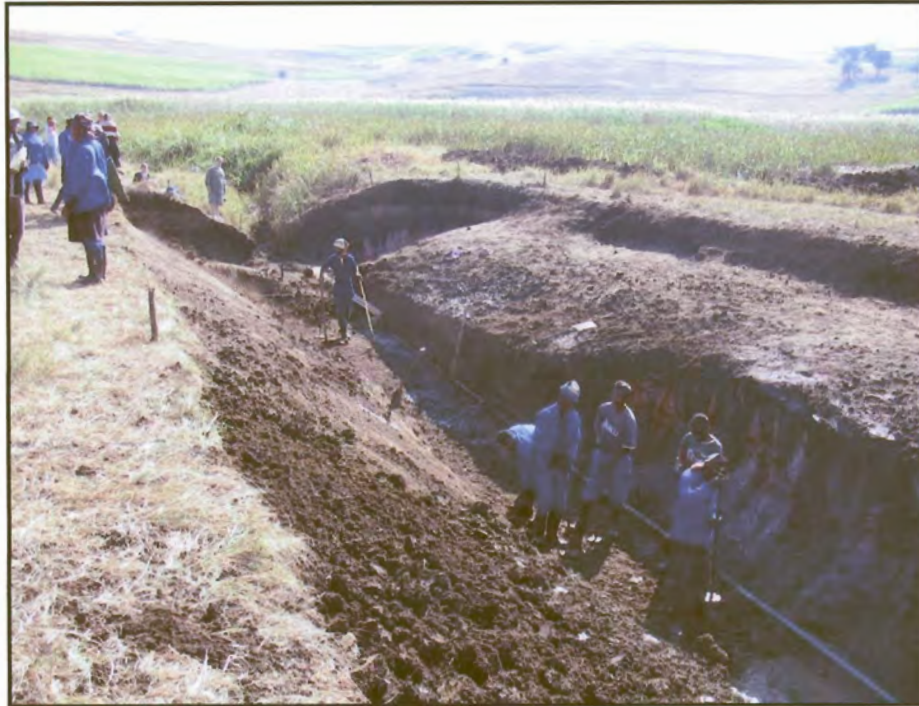
Figure 27: Before flooding. Photo taken up stream on 4 July 2002 at the Amatigulu site.

Astrup (2002) commented that all the preparatory work at both the sites was totally destroyed (Figure 24). Flood waters gushed through the sites and caused serious erosion on the chute preparation (Figure 25, 26, 27, 28, 29 and 30). Astrup (2002) explained further that it was impossible to start again with chute preparation due to water flow and the loss of precious work time. The risk of spring rains would threaten chute preparation work started at this stage. Large volumes of water flowed through the Amatigulu site right up until August. A decision was taken to re-plan a structure for the winter of 2003 (M. Astrup, *pers. comm.*).

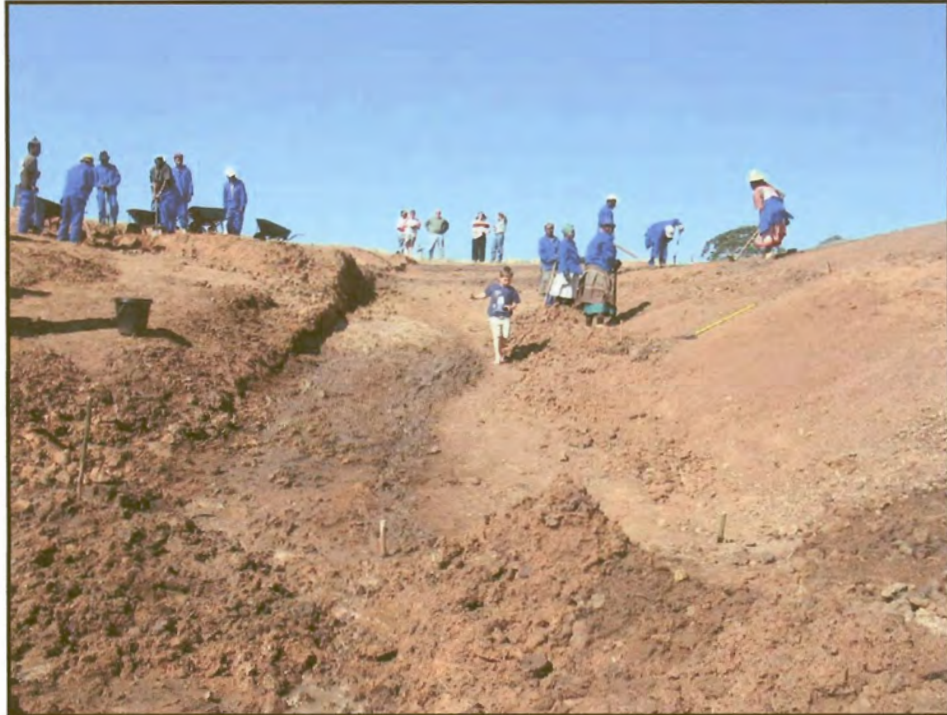
Figure 29: Before flooding. Photo taken on 4 July 2002 at the Uvova site.

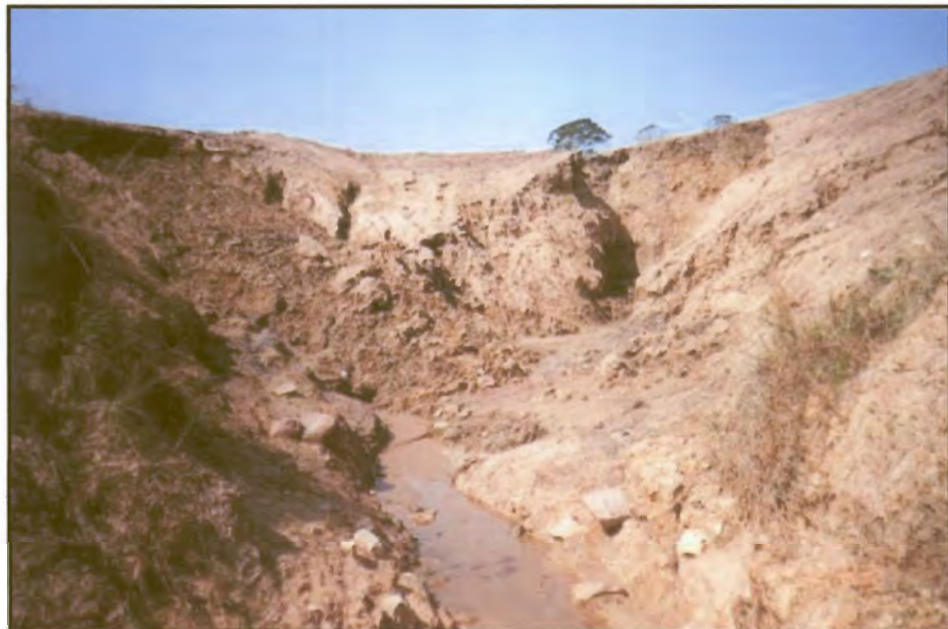
Figure 30: Uvova site damage to chute preparation after July 2002 floods (Photo: M. Astrup).

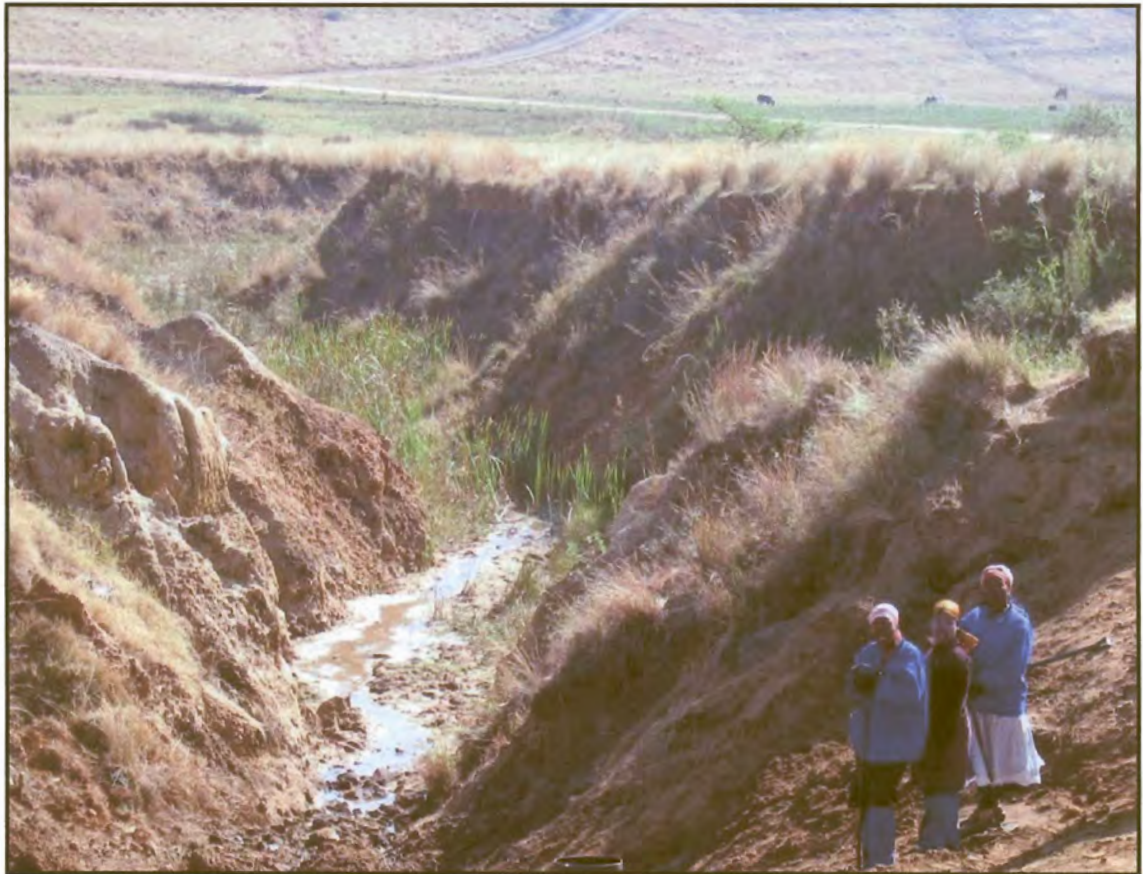
Figure 32: An eroding headcut situated on the Uvova stream. The stream enters the Mbongolwane wetland. Photo taken on 4 July 2002.

A concrete chute is planned for where the stream flow enters the drainage line (Figure 32). The position will be about 400 m below the headcut.

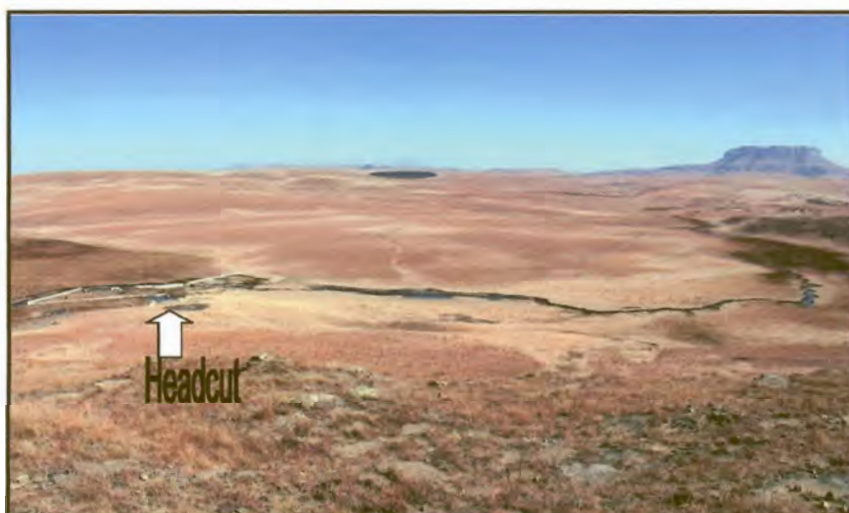
Figure 33: The Wilge River Wetland and rehabilitation structure at the headcut.

An aerial survey of the Wilge catchment by Rand Water revealed a headcut at the outlet of a wetland on the farm Wilge River 319 (hereafter referred to as the Wilge River wetland). The wetland rehabilitation has been performed on this portion of wetland in the upper catchment of the Wilge River (N. Collins, *pers. comm.*) (Figure 33).

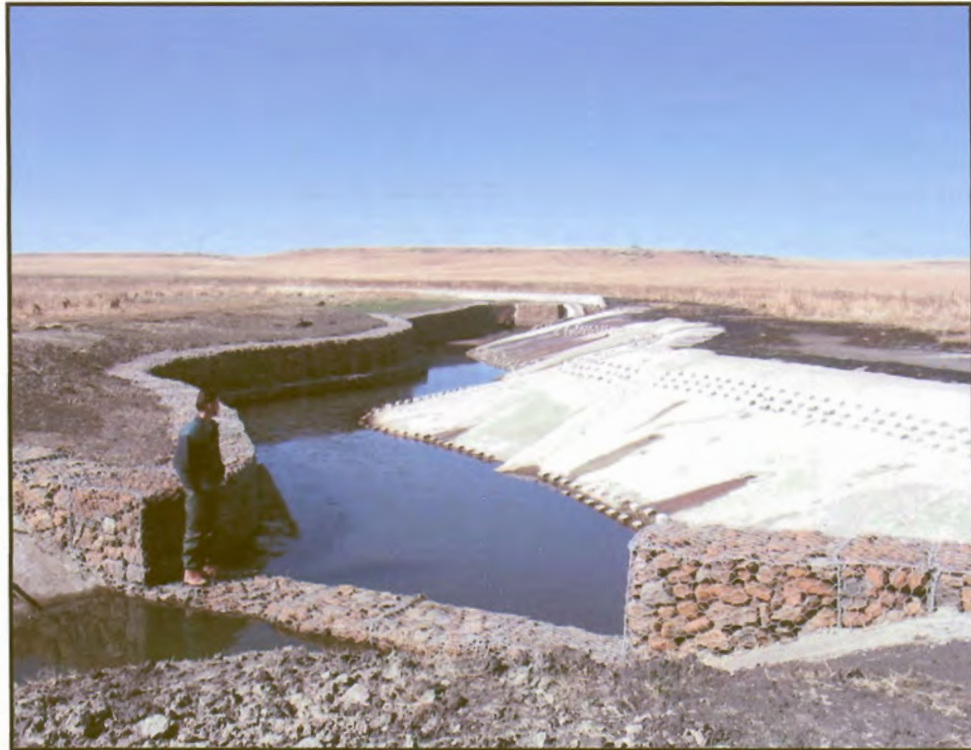
Figure 38: Close up of the headcut rehabilitation structure.

Site no.	Problems	Rehabilitation action	Desired results
<p>1</p> <p>28°13'38" 29°33'31"</p>	<p>Headcut (45 m) and channel (95 m donga) erosion (Figure 38)</p>	<p>Structural erosion control is needed.</p> <p>Headcut:</p> <ul style="list-style-type: none"> - 30 m sloping: hyson cells (1:4), 15 m concrete basin, 100 m soil berm, 300 m fencing and revegetation (Figure 39). <p>Donga:</p> <ul style="list-style-type: none"> - 95 m sloping: hyson cells, 10 m concrete basin, channel plugs: gabions filled with rock. 	<ul style="list-style-type: none"> • Stabilise the headcut • Stabilise headcuts developing on the banks of the channel • Dissipate the energy of floods. • To prevent further erosion of the wetland causing the affected wetland area to be drained.

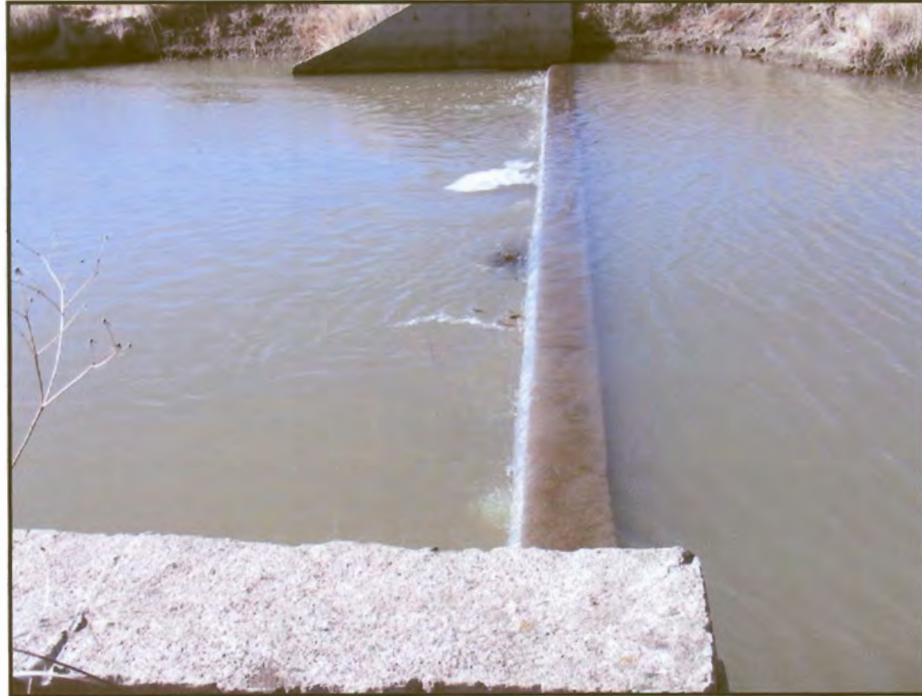
Figure 45: Site no. 2. Concrete weir.

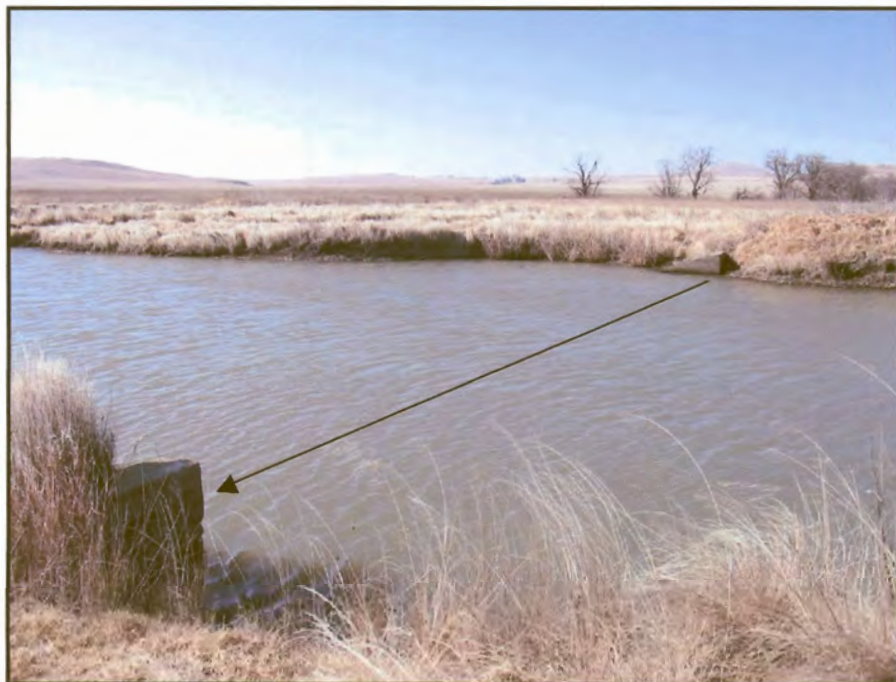
Figure 48: Site no. 4. Merel's vlei. A small weir drowned below the water surface.

4 29° 35' 04" 27° 34' 59"	Merel's vlei. Channel erosion and bank erosion.	Concrete weir has been constructed and features below the water surface (Figure 48).	<ul style="list-style-type: none"> • Stabilise bank erosion. • Structure must act as a silt trap. • Lift the water table. • Dissipate the energy of the floods. • Prevent further erosion of the wetland.

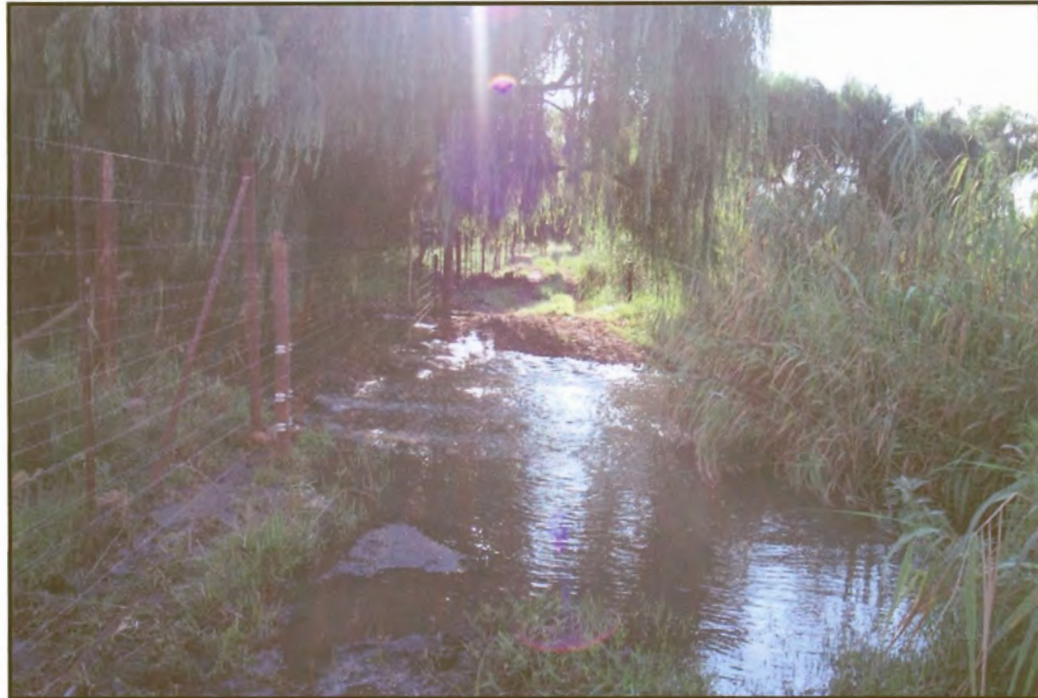
Figure 71: Site no. 1. A man-made drift was built across the entry point into the Rietvlei Nature Reserve. Due to this the flow of water has been concentrated.

Headcut erosion began as a result of an unattended drainage furrow that was used to drain the peat during the peat mining operation. A causeway was constructed to access the peat mining operation. This compounded the erosion in the furrow by concentrating the water flowing through it.

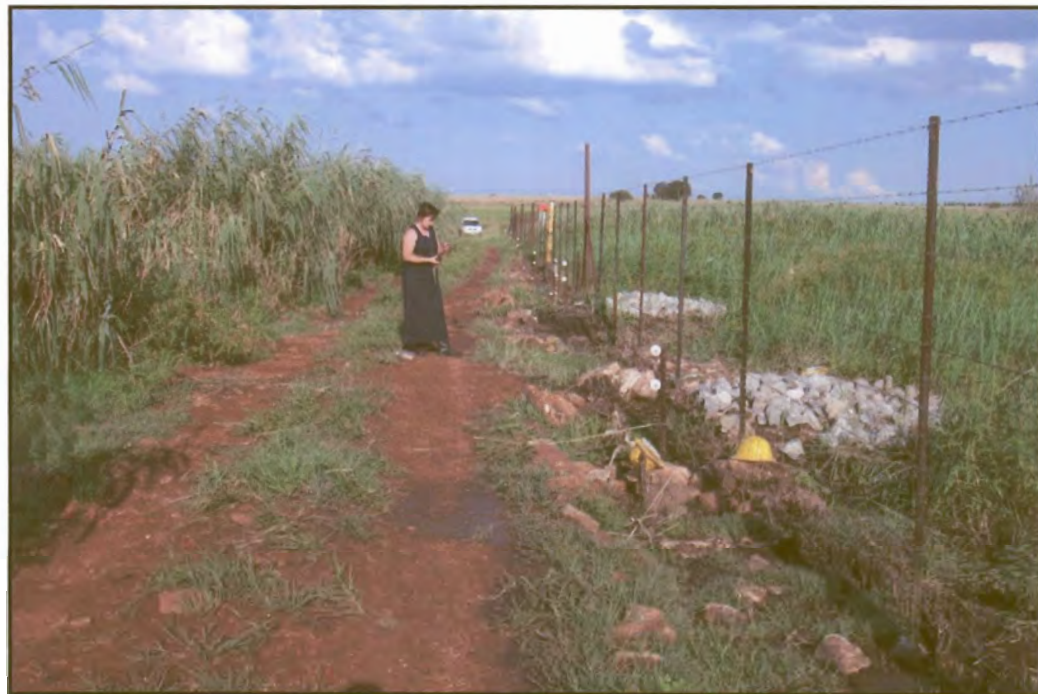
Figure 72: Site no. 1. Energy dissipaters were constructed along the drift to spread the flow and dissipate the energy.

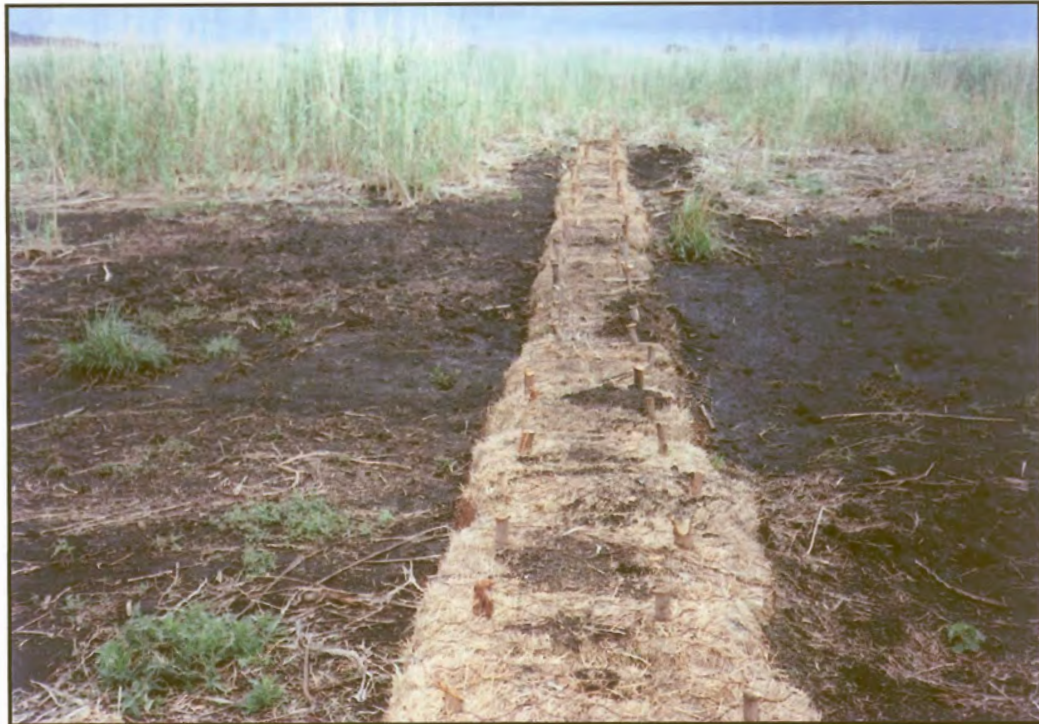
Figure 73: At site no. 2.1 the shallow erosion gully was stabilized with grass bales.

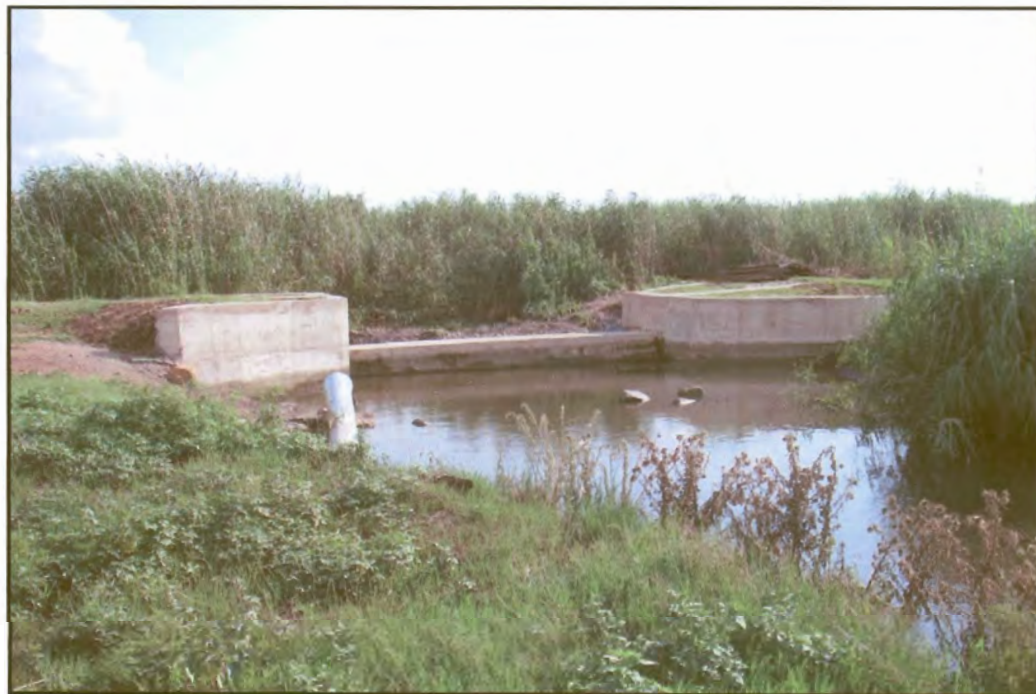
Figure 76: Site no. 4. Eroded culverts on the road crossing were replaced by a concrete weir.

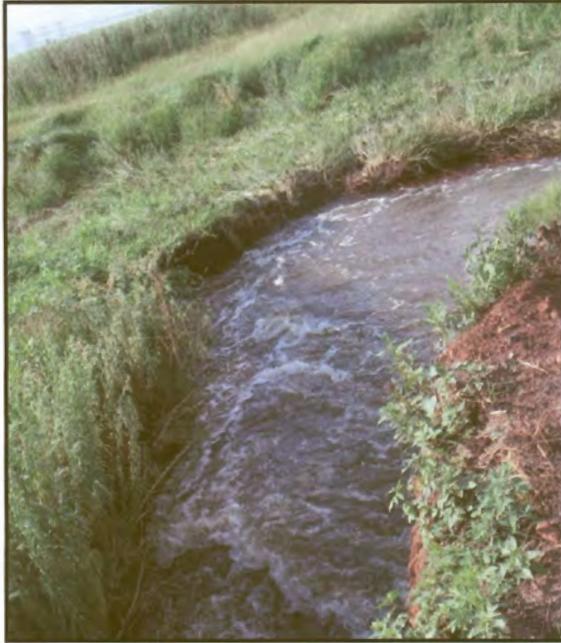
Figure 77: Site no. 4. A bypass furrow used during the construction of a concrete weir in the causeway was blocked to prevent channel erosion.

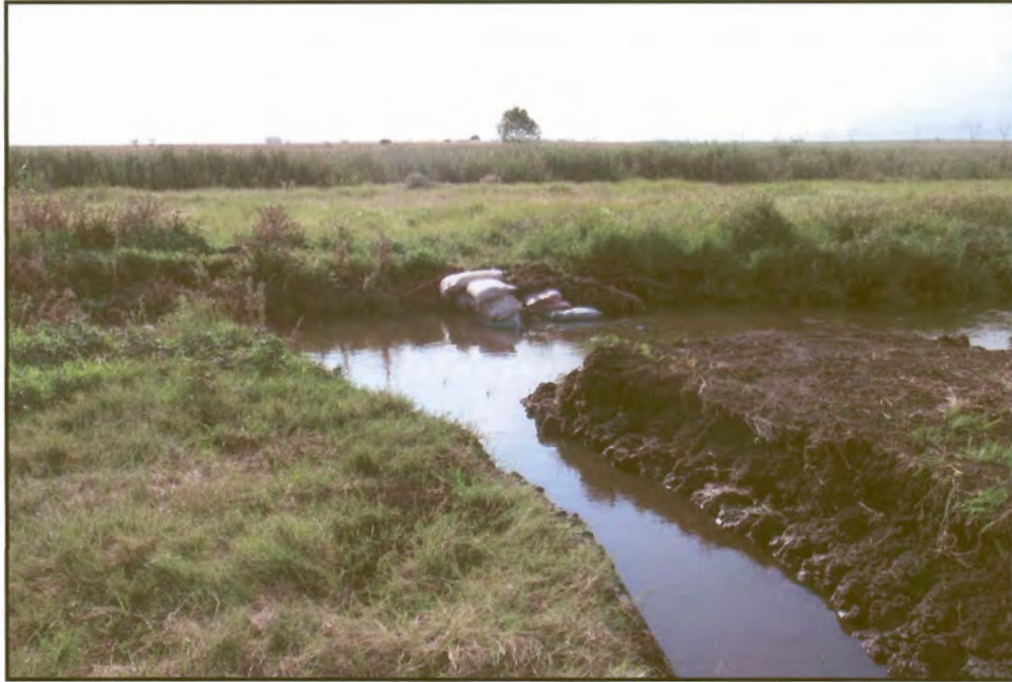
Figure 79: Site no. 5.1. A bypass furrow has been constructed to allow the construction of a gabion weir to facilitate the raising of the water table and to disperse the water.

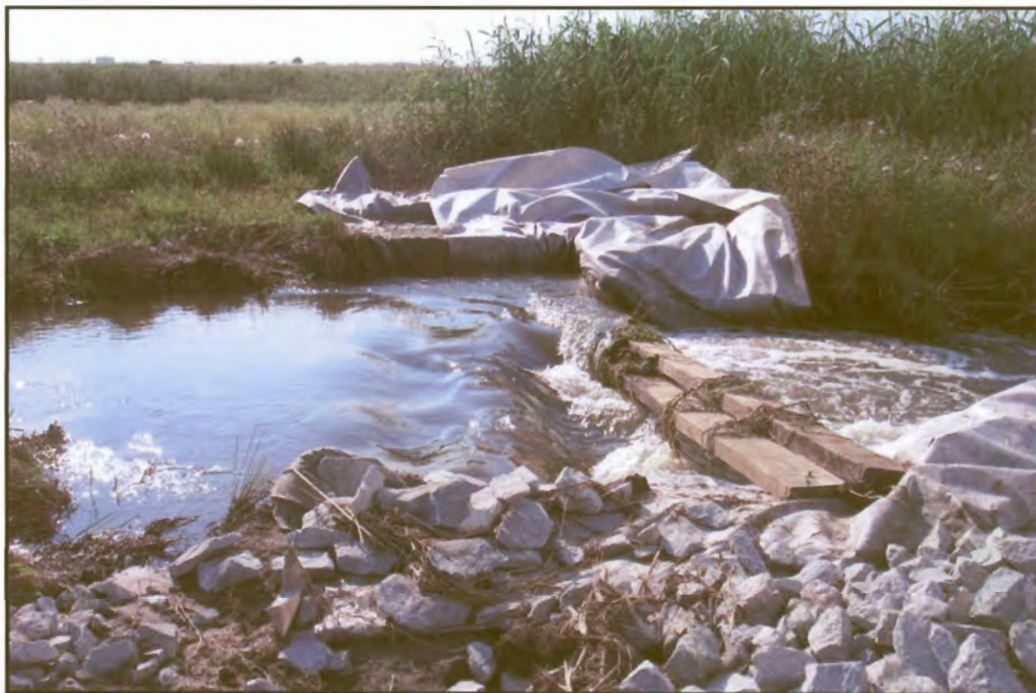
Figure 80: Construction of a gabion in progress at site. no. 5.1.1. Flooding is taking place.

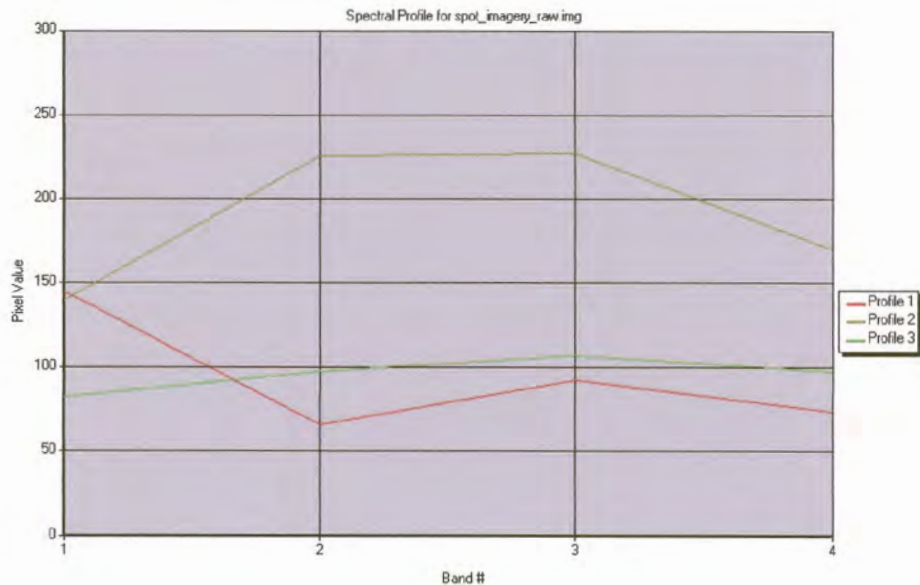
Figure 86: Spectral profile for SPOT 5 Imagery.

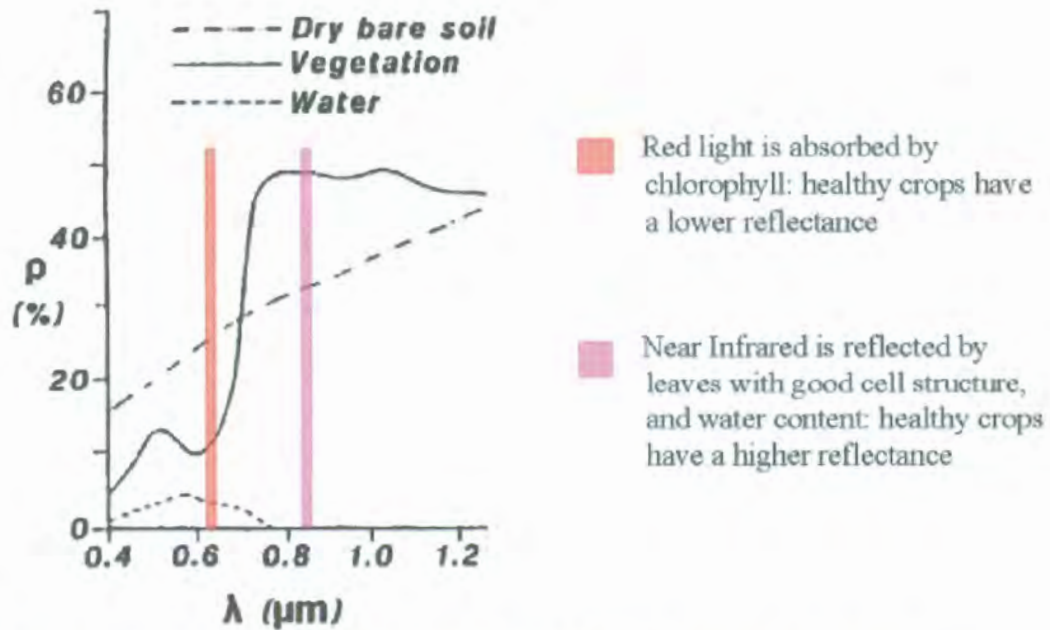
Figure 108: Reflectance values of KODAK240 (Near infrared).

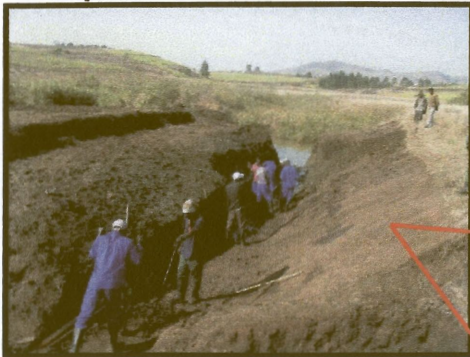
Figure 140: Headcut erosion feature. Geocell chute preparations.

A comparison between EROS and DuncanTech CIR images of the Amatigulu site at the Mbongolwane Wetland shows the extent of the difference in detail. Various wetland rehabilitation indicators and structures (headcut erosion - Figure 140; subsistence farming – Figure 142; harvesting of reeds – Figure 143 and diversion furrow - Figure 146) are vague in Figure 141 (EROS), but clear and evident in Figure 145 (DuncanTech). It gives a good indication of the level of detail these sensors are capable of.

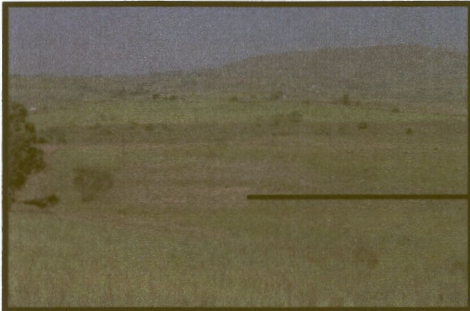
Figure 143: Harvesting (*Phragmites australis*).

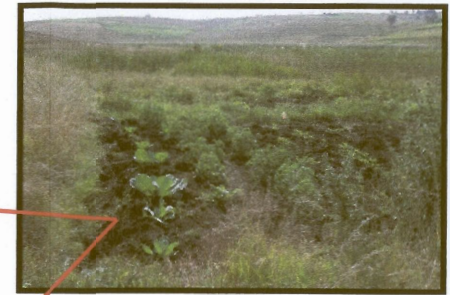
Figure 142: Subsistence farming.

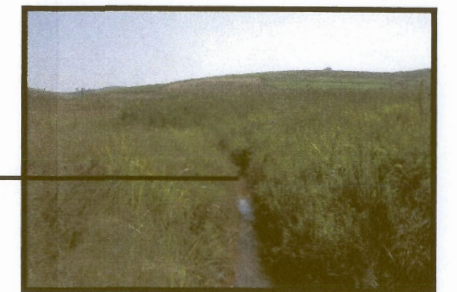
Figure 146: Furrow diverting water away from the erosion feature for construction purposes.

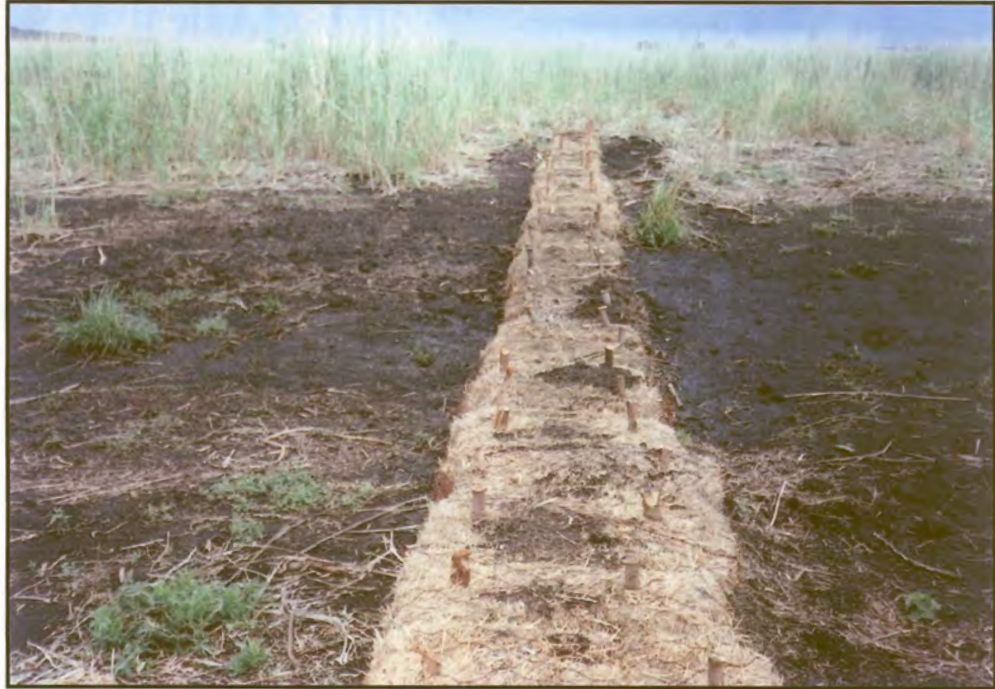
Cheap and effective way to stop erosion at low energy levels.

Figure 2: Grass bales used at the Rietvlei wetland.

- **Grass bales (Figure 2).**

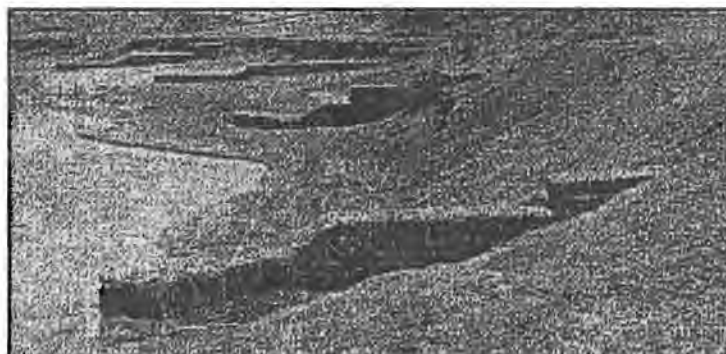
Stabilizing river and gully side-walls. Material that can be used:

1. Sandbags
2. Concrete

Figure 9: Groynes (Haigh, 2002).

- **Groyne (Figure 9).**

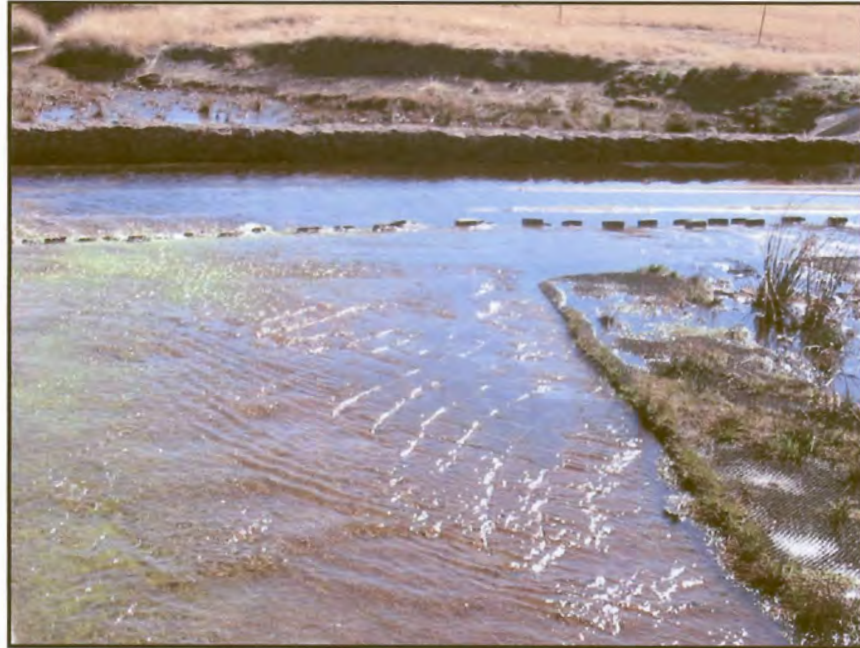
Lining materials such as rubber compound tyres, rock-filled wire mattresses, gabion baskets or concrete cellular mattresses such as Geocell (Hyson cell), Armalite or interlocking blocks could be considered if there is a concern that the topsoil and plantings will be washed away (Haigh, 2002).

Figure 10: Geocell lining at the Wilge wetland structure.

- **Geo-cell (Figure 10 and 11).**

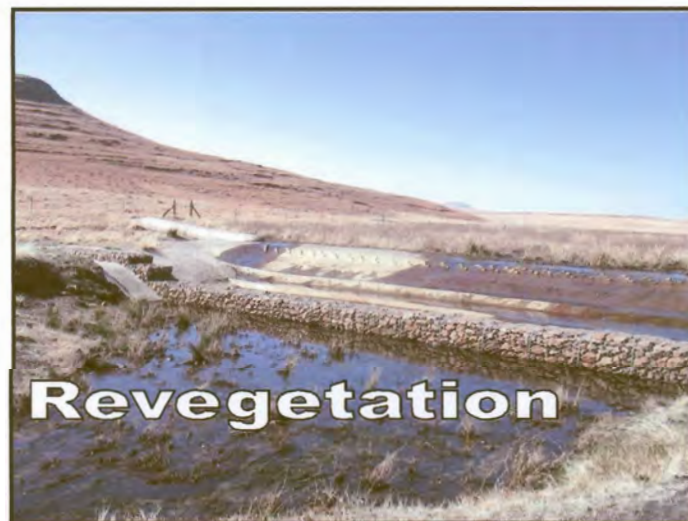
Figure 14: Bioengineering at the Wilge wetland structure.

4. Revegetation of desiccated areas (Figure 13 & 14).

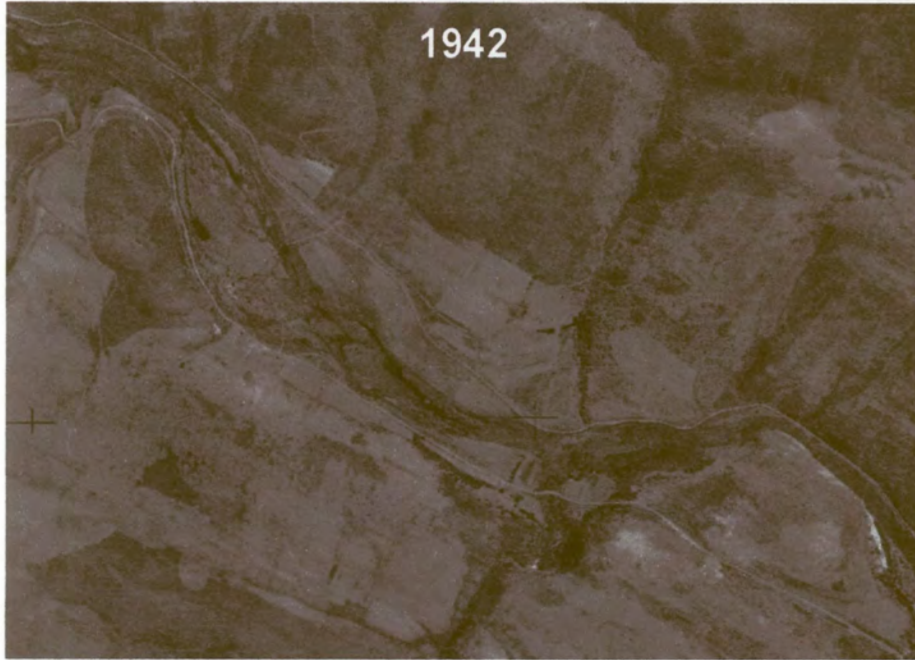
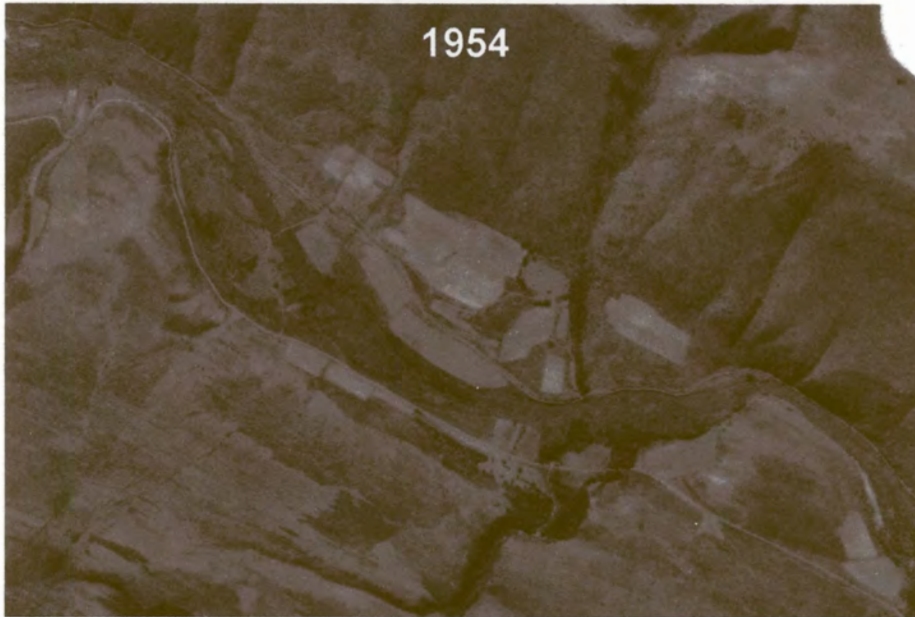
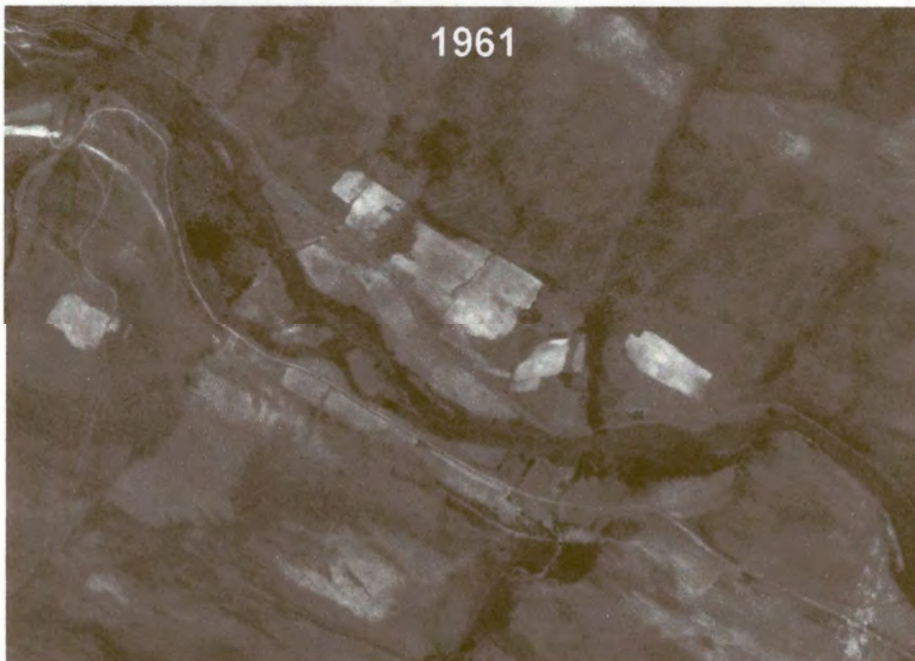
Figure 1: Landscape changes in the peat basin on the farm Hudsonvale is described from aerial photographs (1942 - 1961)(Haigh et al. 2002).

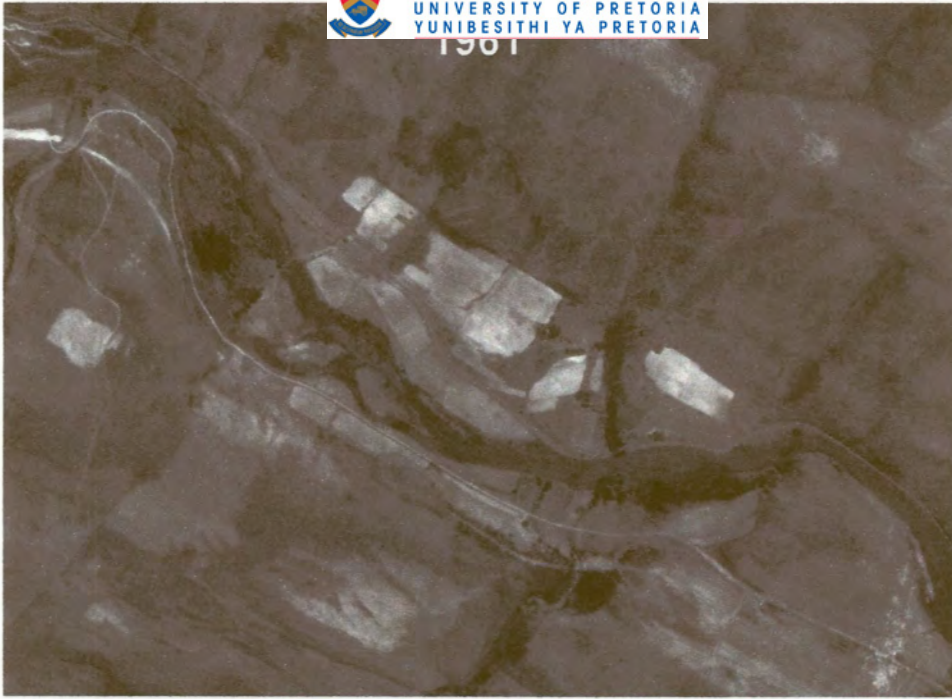
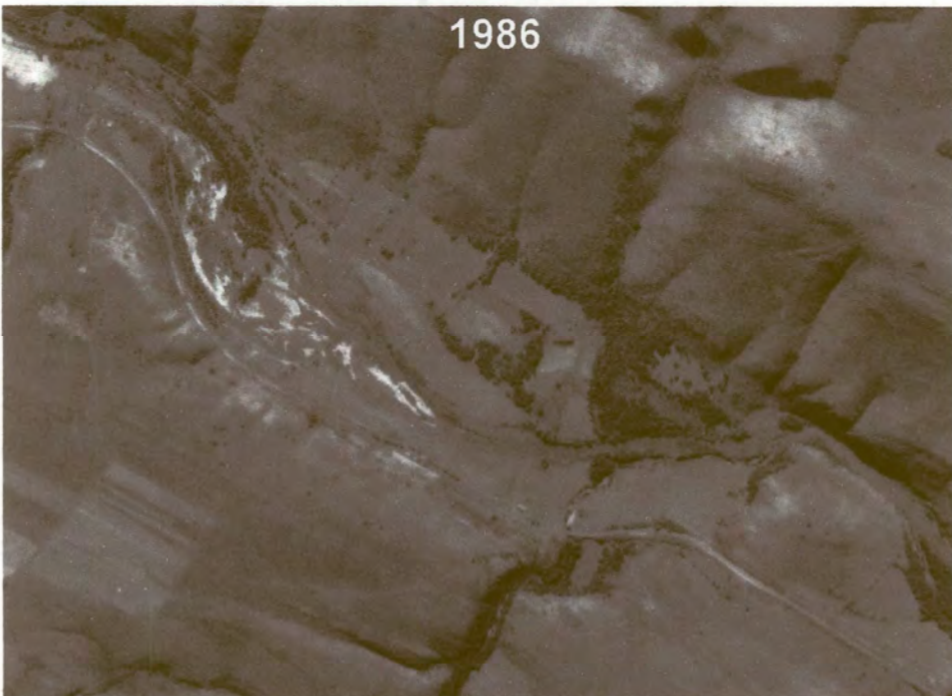
Figure 2: Landscape changes in the peat basin on the farm Hudsonvale is described from aerial photographs (1961 - 1986)(Haigh et al. 2002).
