Evaluation of remote sensing sensors for monitoring of rehabilitated wetlands

Althea Theresa Grundling

Submitted in partial fulfillment of the requirements for the degree
MAGISTER SCIENTIAE
In the Faculty of Natural & Agricultural Science
African Vegetation and Plant Diversity Research Center
Department of Botany
University of Pretoria
Pretoria

March 2004

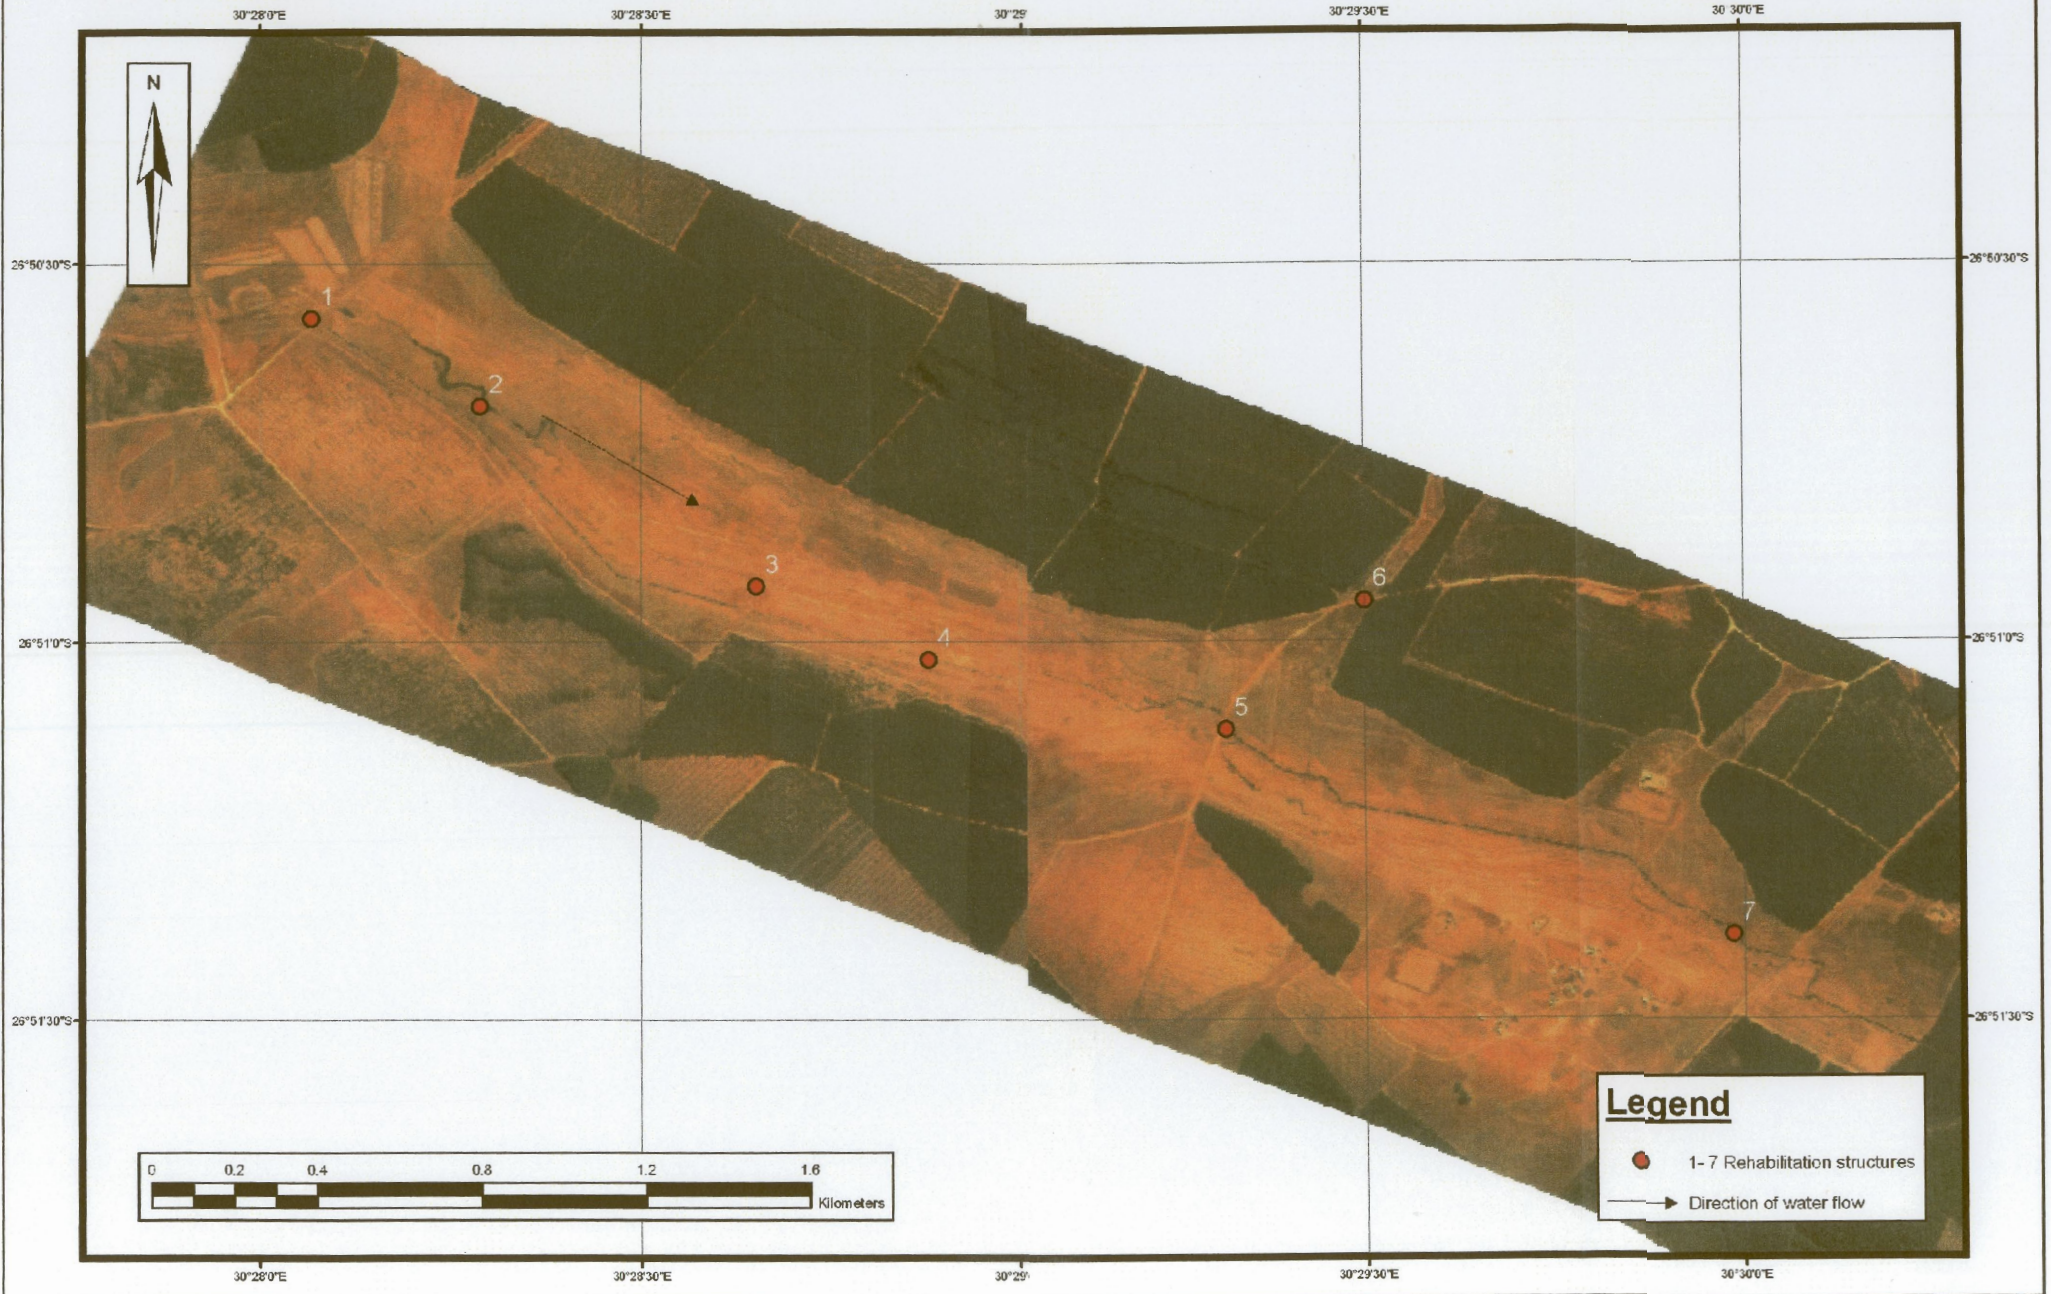
Zoar Wetland - DuncanTech (1e colour) Imagery

Image acquisition date: 09/06/2003
Resolution: 0.25 m

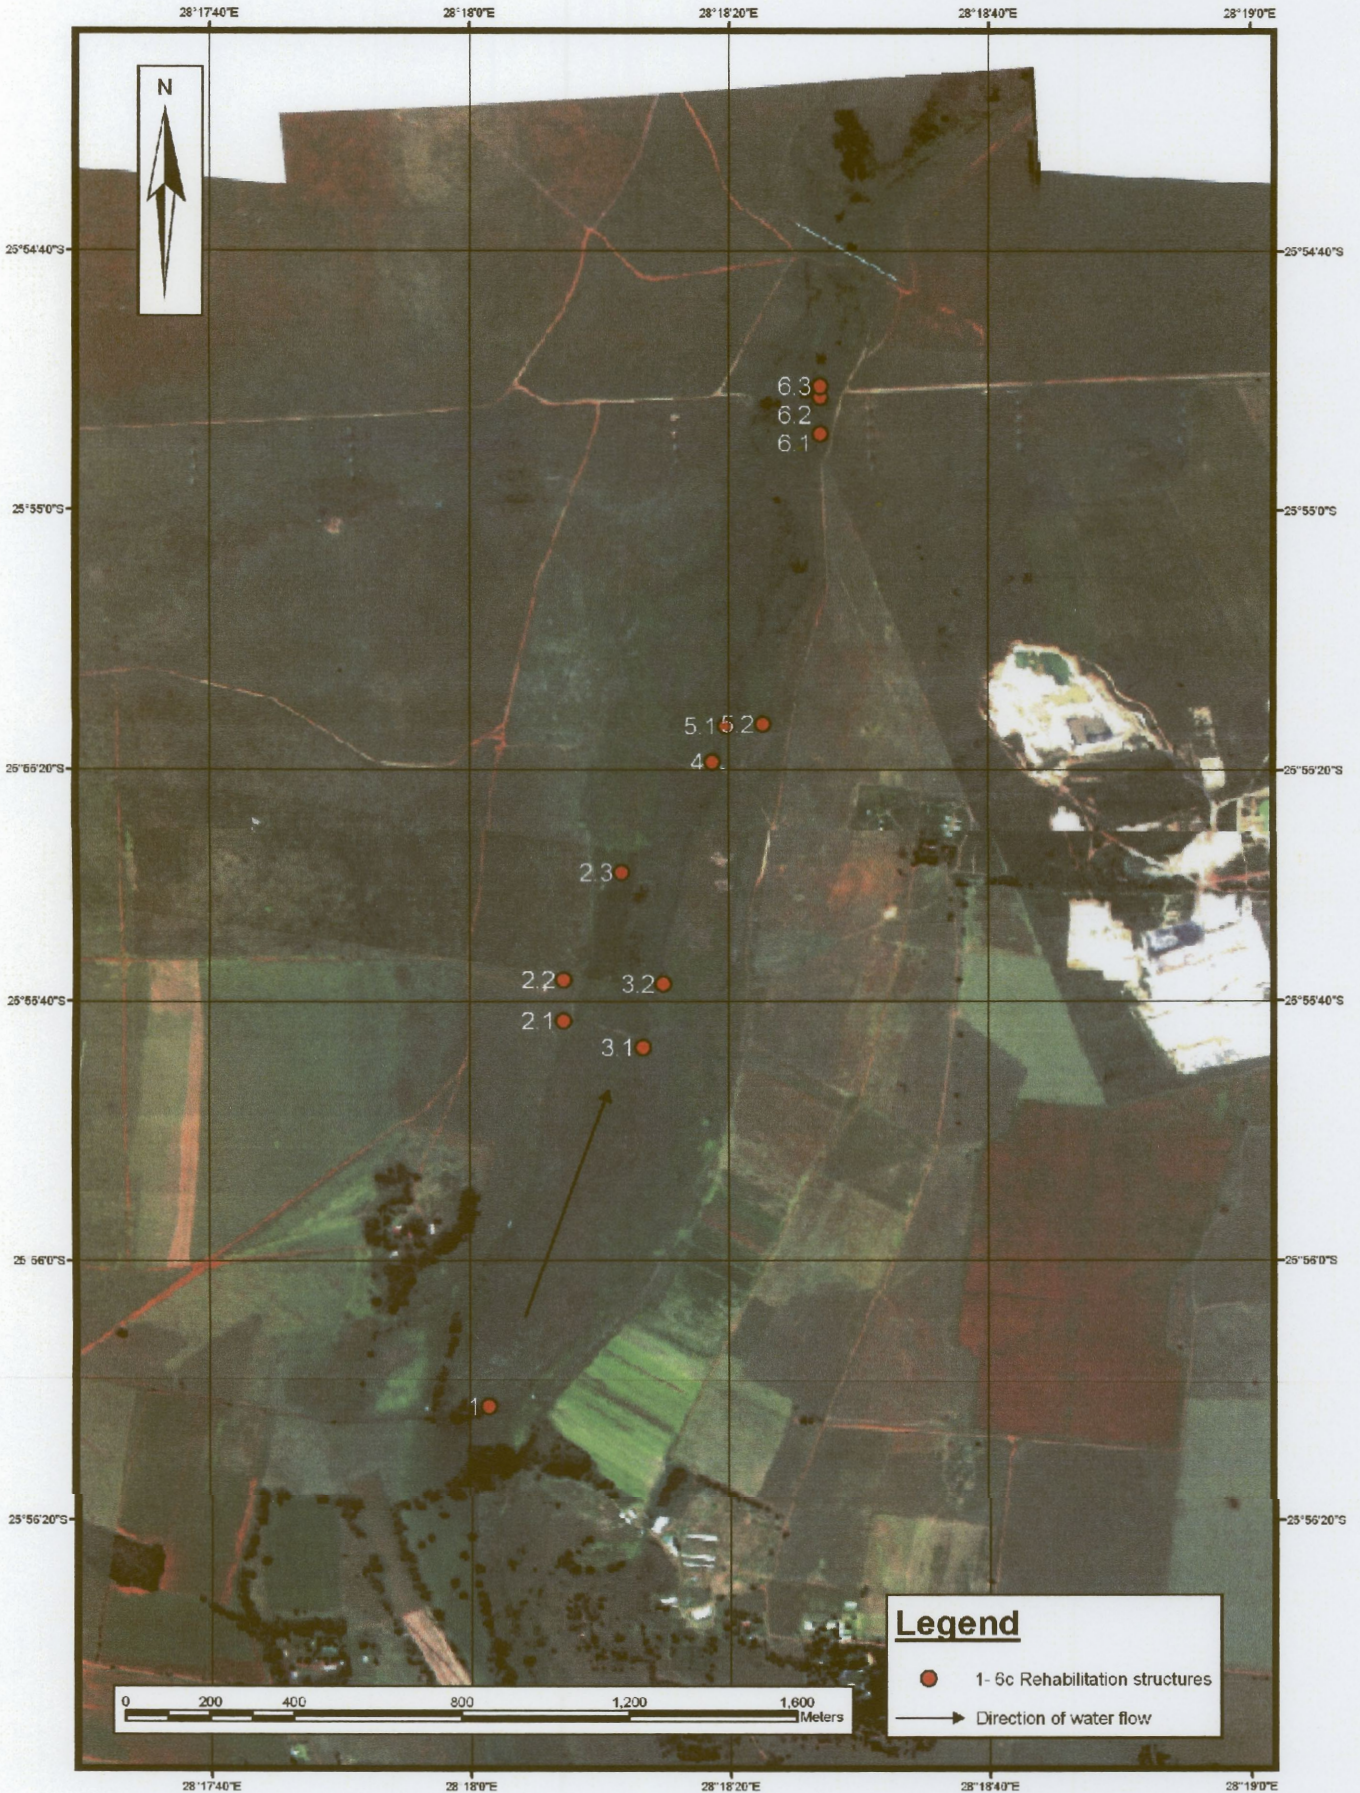
Rietvlei Wetland - DuncanTech (True colour) Imagery

Image acquisition date: 09/06/2003
Resolution: 0.5 m
