A New Understanding of the Early Behaviour of
Roller Compacted Concrete in Large Dams

QUENTIN HENRY WENHAM SHAW

Submitted in partial fulfilment of the requirements for the degree of Philosophiae Doctor (Civil Engineering) in the Faculty of Engineering, Built Environment and Information Technology, University of Pretoria, Pretoria.

Submitted: **10th August 2010**

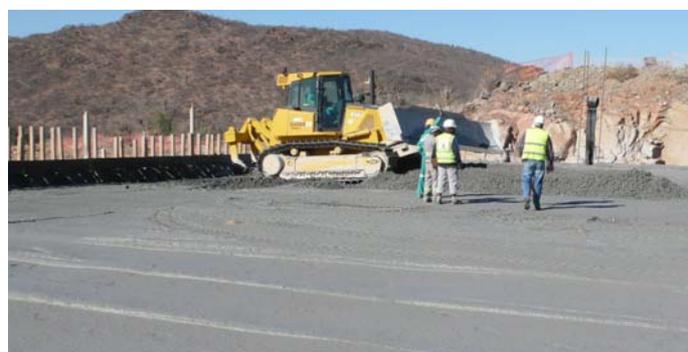
Plate 2.3: High Workability RCC

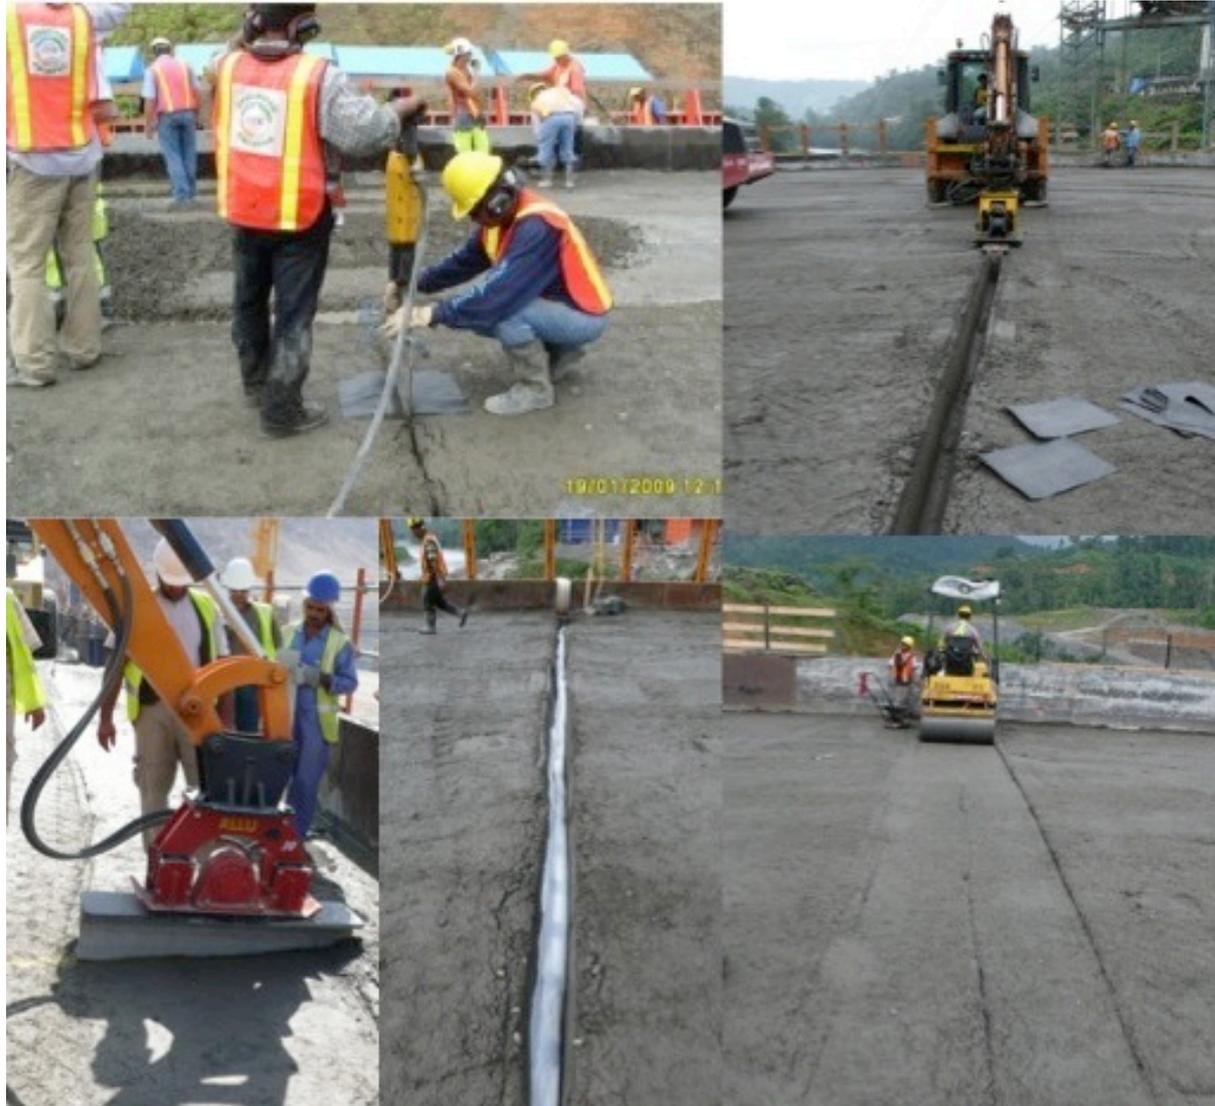
Plate 2.5: Induced Joint Inserted into Compacted RCC

Joints are induced in RCC at specific cross-sections by de-bonding placement by between 25 and 100% and thereby creating a localized weakness that will concentrate cracking consequential to long term temperature drop shrinkage at a pre-determined location, where it can be isolated with a waterstop. While South African practice has to date inserted a de-bonding mechanism in every fourth layer (see **Figure 2.1**), international practice generally applies de-bonding in every layer. The early practice of inserting de-bonding systems into the RCC during placement (see **Plate 2.4** and **Figure 2.2**), but before compaction, has almost universally been replaced by driving de-bonding systems into compacted RCC (see **Figure 2.3** and **Plate 2.5**).

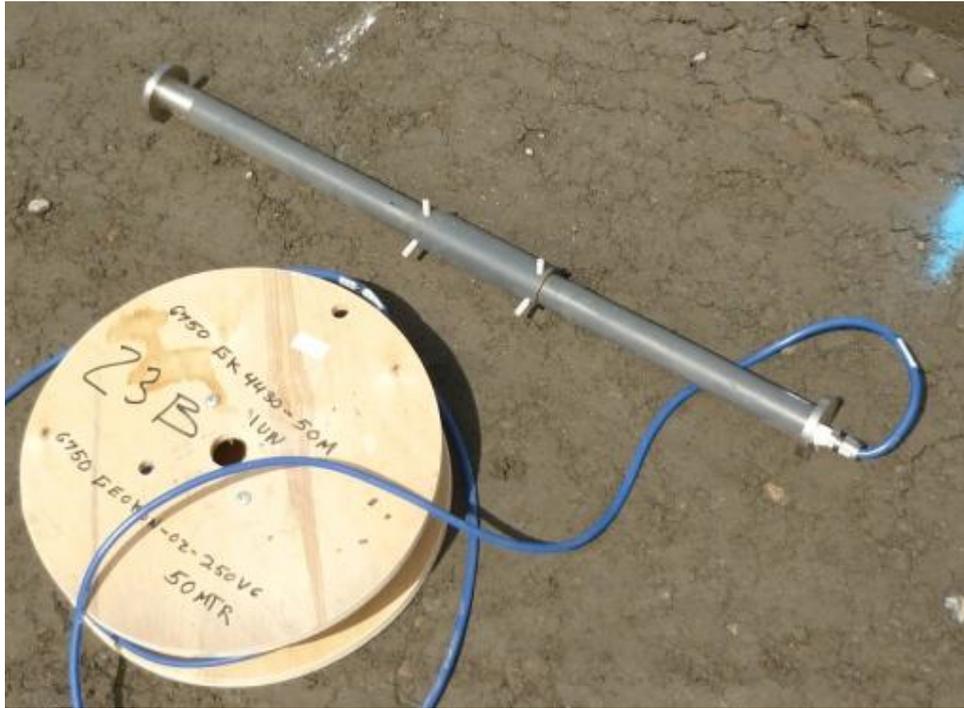
Plate 2.6: Long-Base-Strain-Gauge- Temperature-Meter (LGSGTM)

A long-base-strain-gauge-temperature-meter is essentially a long strain, or deformation gauge that is installed across (perpendicular to) the alignment of an induced joint. These instruments are correspondingly aligned parallel to the axis of the dam structure. The LBSGTM was developed by Geokon for use in RCC dam construction on the request of the South African Department of Water Affairs (DWA). The gauge is a vibrating wire meter that measures deformation across a distance of between 600 mm and 1 m. The long-base was considered necessary to ensure that the crack on the induced joint passes between the flanged end plates of the gauge. Initially, a gauge length of 1 m was considered necessary, but it has since become evident that 600 – 700 mm is quite adequate. The Geokon Model 4430 gauge is specified for a measurement sensitivity of 0.01 mm and an accuracy of ± 0.05 mm. The gauge measures temperature, as well as deformation, and the indicated deformations must be adjusted for temperature.

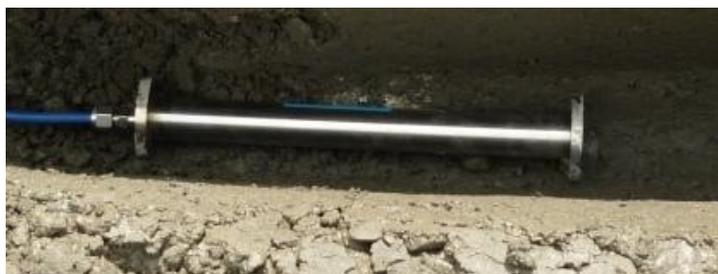
Plate 2.7: Strain Gauge

The Geokon Model 4210 gauge used for measuring strain is a particularly robust, all-stainless steel-cased instrument that is designed for direct installation into concrete with large aggregate and indicates a measurement sensitivity of 0.4 microstrain and an accuracy of $\pm 1\%$. The gauge also measures temperature and the gauge readings must be adjusted to indicate actual concrete strain.

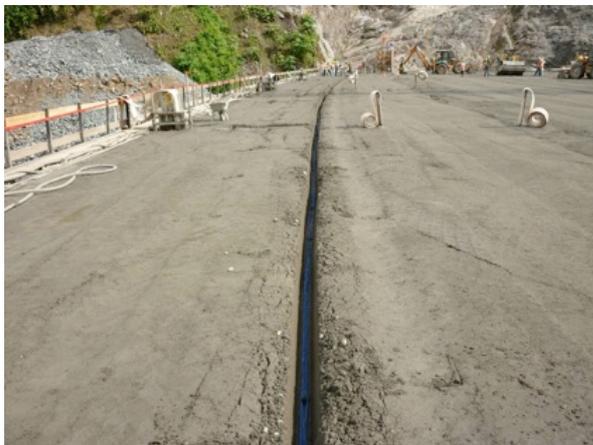
Plate 2.9: Instrumentation Cable Trench

times by cutting slots with a vibrating blade during the process of completing the layer surface. In either case, the cabling is laid out, the instruments are installed and the trenches and slots are backfilled with a structural concrete. Resumption of RCC placement above can often be delayed for a further number of days, but critical data collection starts as soon as the respective gauge is covered with a layer of RCC.

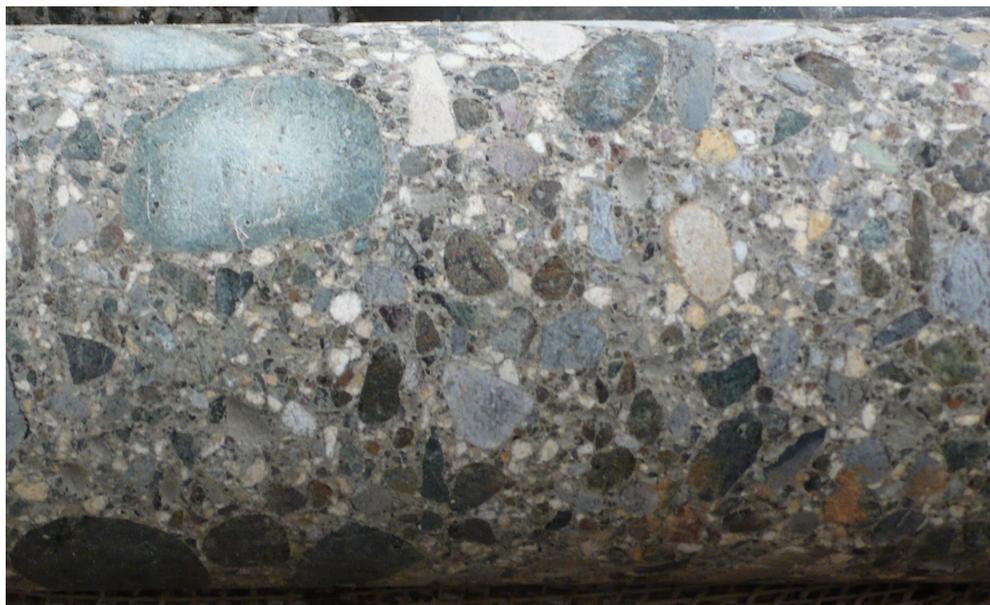
Plate 6.3: Typical Modern High-Paste RCC

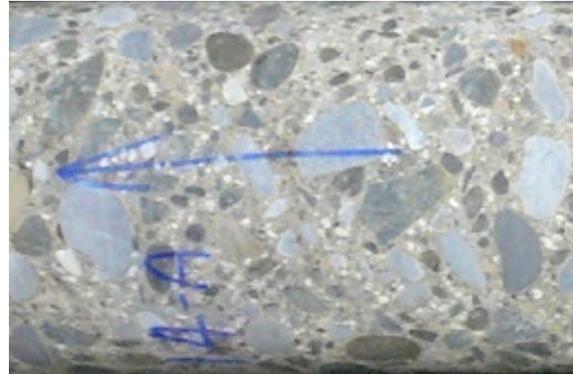
Plate 8.2: Typical RCC Core
