### 3. case studies

### WARWICK JUNCTION, DURBAN, SOUTH AFRICA Herb traders' stalls by OMM Design Workshop

### BARAGWANATH PUBLIC TRANSPORT INTERCHANGE AND TRADERS MARKET SOWETO, GAUTENG, SOUTH AFRICA.

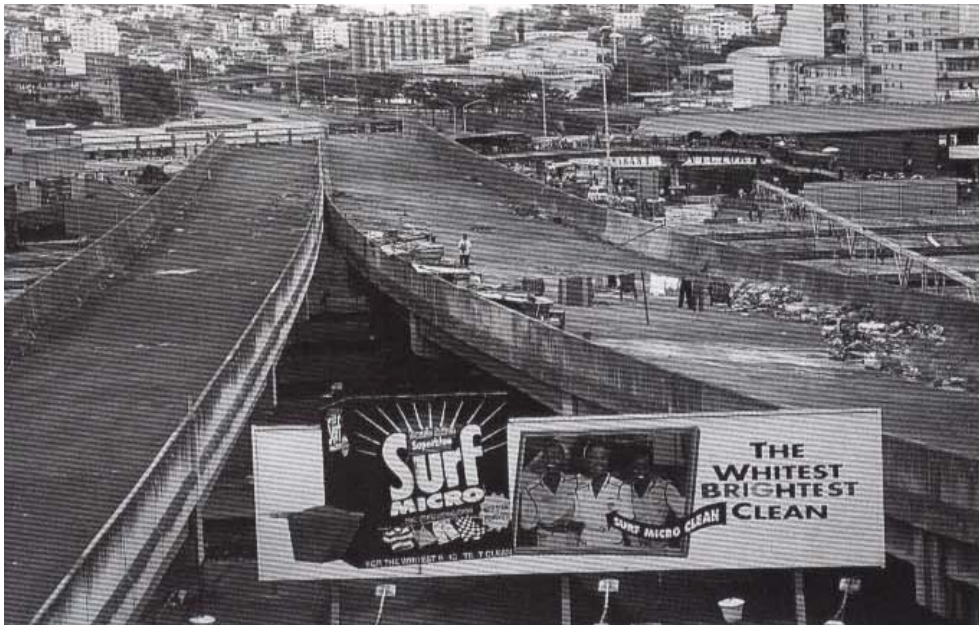
Fig. 3.1 Condition of bridge before herb traders started using it (Dobson, 2001)

The principle of accepting and using the existing layout of the traders is the principle in consideration. As stated in the theory, the everyday users of an area have the best understanding of how a place functions. In the case study the architects recognised the traders' ability to spot potential selling space. Their intervention was a direct response to where the traders were sitting and the stalls that were designed were not pre-designed but customised to fit on the bridge. Provision of infrastructure was kept to a minimum (Dobson, 2001:9).

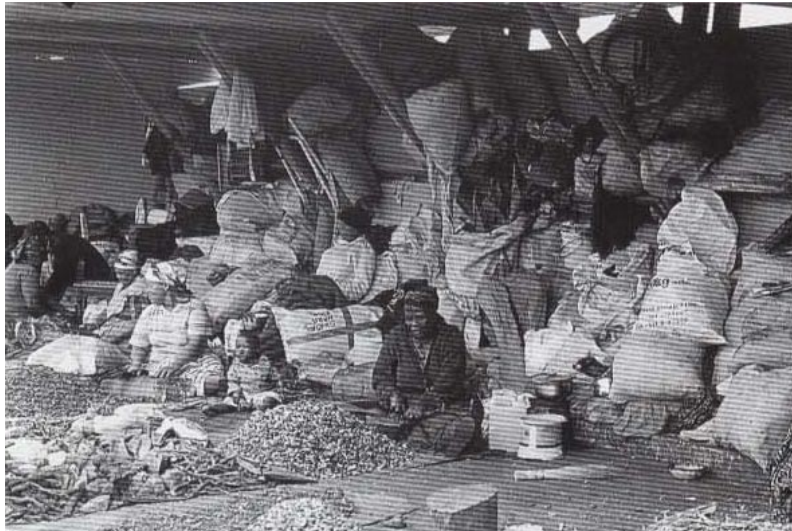
Fig. 3.2 Herb traders under roof structure erected on bridge (Dobson, 2001)

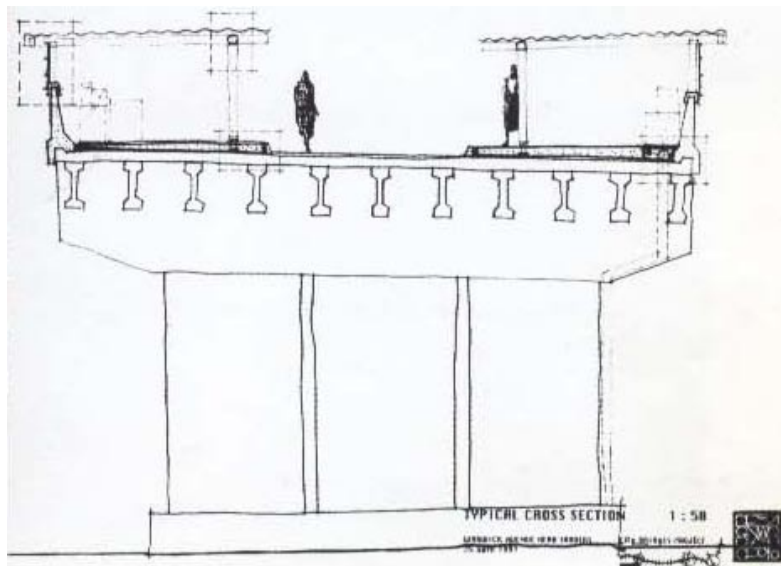
Fig. 3.3 Technical drawing of roof structure erected on bridge (Dobson, 2001)

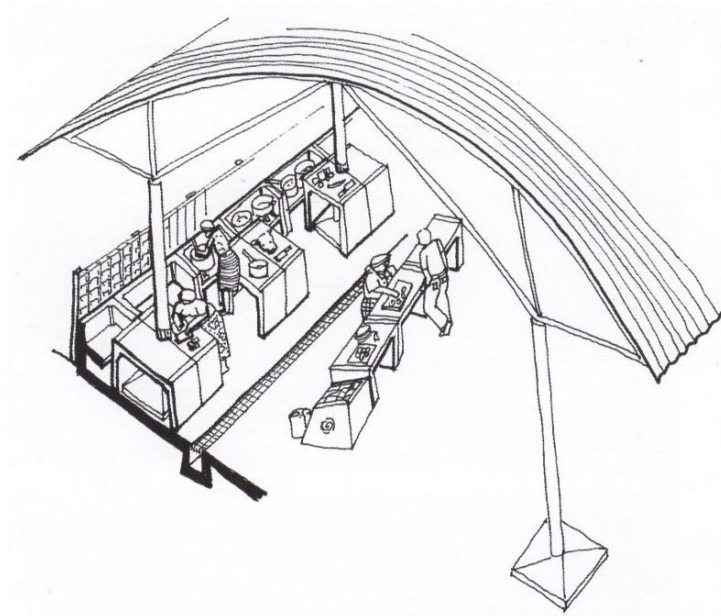
Fig. 3.5 Perspective drawing of bovine head cooking facilities (Dobson, 2001)

The case study shows that with the provision of simple but accurate facilities, individuals' businesses can expand for the betterment of their economic situation. Most of the traders in communities such as Warwick Junction and Marabastad are women, who are mostly the breadwinners of a family in South Africa's African society today. The far reaching implication of providing a substantial income for the breadwinner of a family, is that the children of that family are not forced to work, giving them the opportunity to receive an education (Dobson, 2001:12).

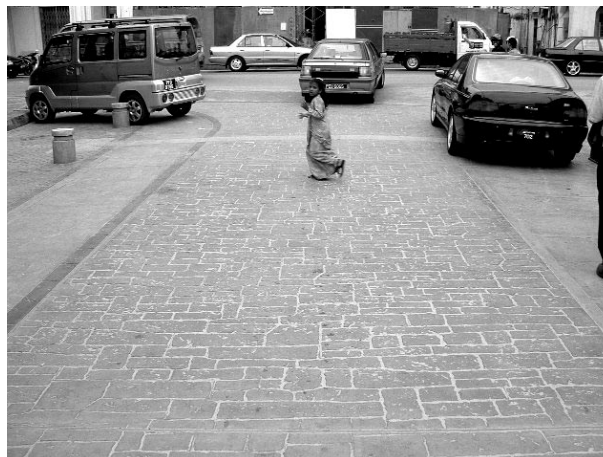
Fig. 3.7 Street upgrading in Penang, Malaysia (Bakker, 2004)

The case study is another example of how a simple and small intervention, such as the upgrading of a road, can add to not only the physical quality of an area, but also to economic growth as well as pride in the owners of property along the road. With the improvement of the street, the businesses along it were made more accessible to customers and tourism, allowing them to prosper economically.

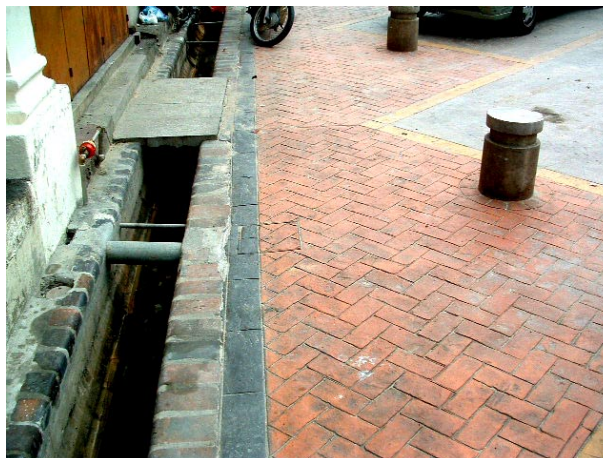
Fig. 3.8 Detail of street upgrading (Bakker, 2004)

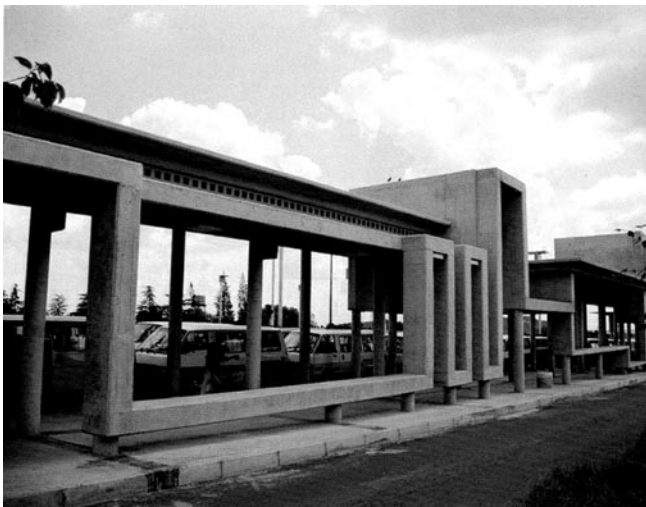
Fig. 3.9 Sculptural structure of transport interchange (Deckler, 2006)

As with the study area in discussion in the thesis, the Baragwanath case study is a very busy transport node in Soweto. The project consists of a 1.3 km long, 0.5 km wide concrete sculptural structure that serves as a core into and onto which different facilities are placed. The facilities support the needs associated with buses, taxis and hawkers that use the area. The fact that the needed shelter required by the different activities the structure supports was not met by just another conventional roof structure, is found to be successful because it gives the area a unique character.

Structural aspects in consideration are the materials used and the handling of the edges of structures. Concrete was used for the structure, intending to give it a robust and permanent nature. In transport nodes, with constant traffic and friction, robustness of materials is an important quality. Although concrete is a very suitable material for the context, it tends to be cold; the brick used sporadically gives needed warmth between the concrete. The details included in the development also give the high, concrete structure a more human scale. The round columns used make for a pedestrian friendly environment (Deckler et al., 2006: 64-67).

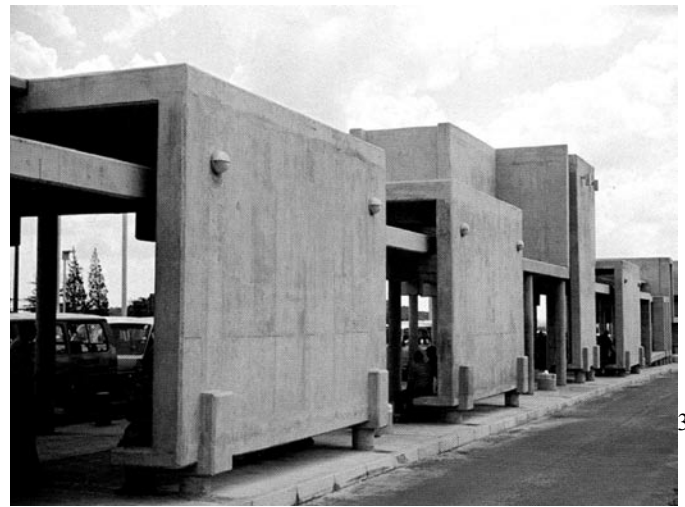
Fig. 3.10 Sculptural structure of transport interchange (Deckler, 2006)

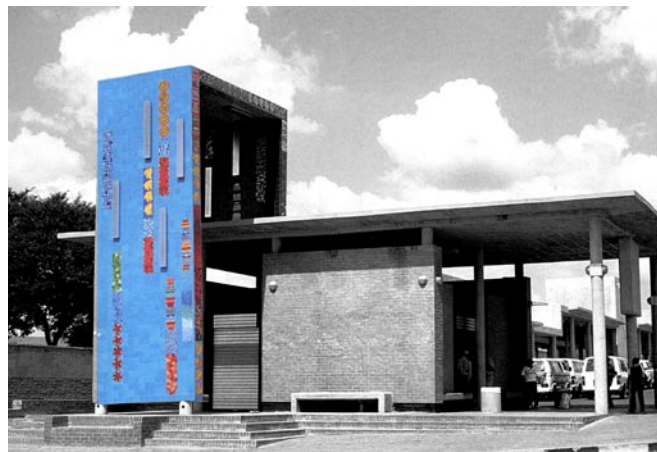
Fig. 3.11 Landmark structure with mosaic detail by community artists (Deckler, 2006)

Involving the community (i.e. local artists) in covering the landmark elements of the structure with artworks and the fact that the structure the people now use every day, was 'designed' for them, was a means of instilling a sense of ownership and pride in the project.

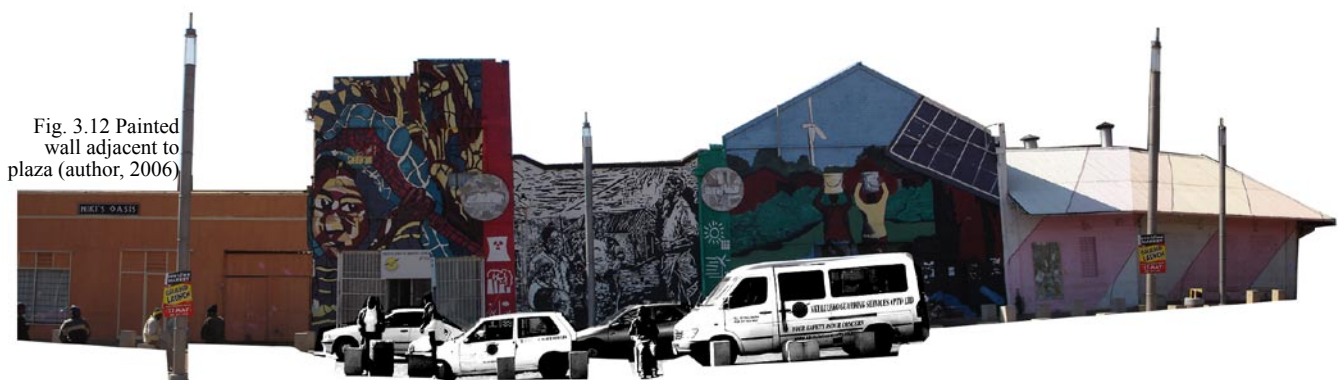
Fig. 3.12 Painted wall adjacent to plaza (author, 2006)

Walls bordering the plaza that would otherwise be harsh were decorated with themes applicable to the plaza's context. Making the walls available to paint upon, allows people a chance to communicate thoughts and ideas.

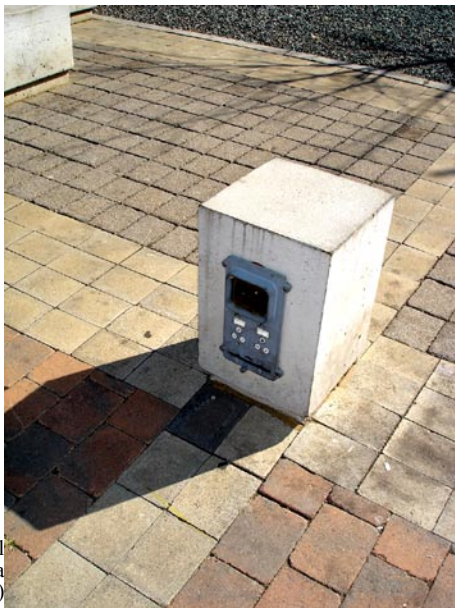
Fig. 3.13 Electrical points on the plaza (author, 2006)

The trading component of the Mary Fitzgerald Plaza consists of markers on the ground and paving details that demarcate stalls on the plaza. Provided alongside the demarcated stalls are electrical points traders can make use of. The stalls are rented per month and the monthly payment of R1400 covers the use of electricity. The stalls' dimensions are 2,5 x 3 metres.

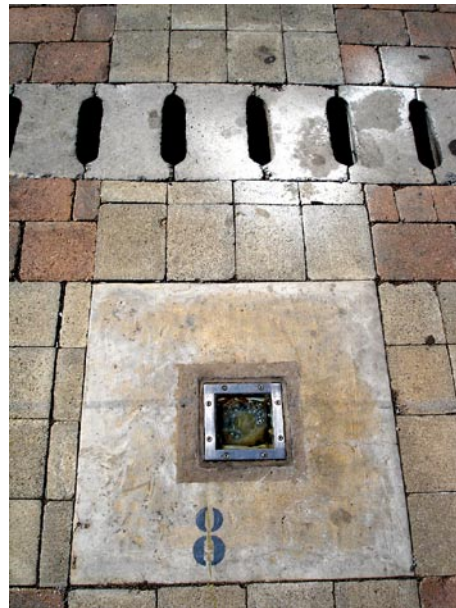
Fig. 3.14 Marking on plaza floor surface indicating stall positioning (author, 2006)

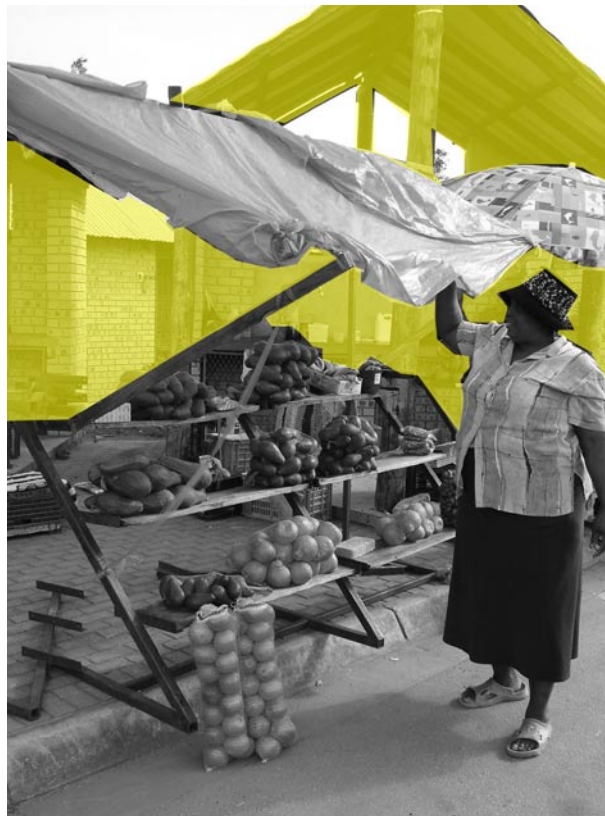
Fig. 3.15 Built structures shown in yellow in the background; display structures in the foreground (author, 2006)

Simple structures were erected next to the main road at the southern entrance road into Komatipoort to accommodate informal traders of fruit, vegetables and other products. The structures serve as storage with lock-up areas, counters and minimal shelter. They were erected approximately ten metres from the road. The structures themselves do not serve as the place from which they sell, but rather stepped steel shelves on which they display their goods. The traders sell their goods right against the road where passing traffic can easily spot them.

The case study serves as an example that very often markets are built without considering the pattern in which traders usually organise themselves. The storage space is of use, but the roofs over the counter and storage below would better have worked as shelter for the traders closer to the road where the traders position their stalls.

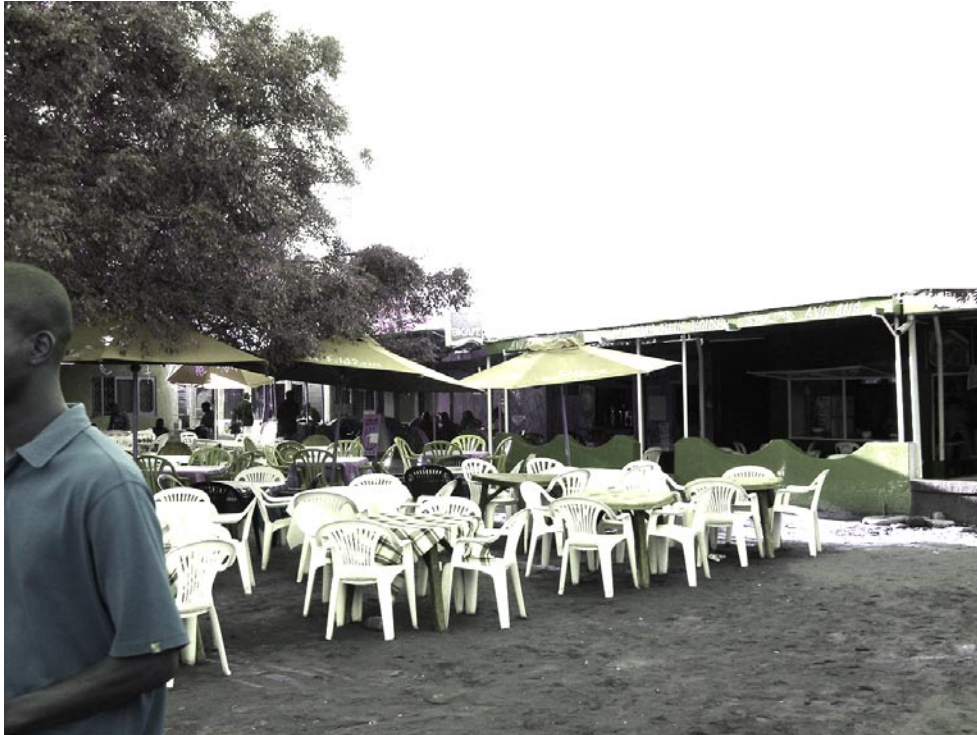
Fig. 3.16 Central part of market with scattered tables and chairs (author, 2006)

The central part of the market serves as an area where a number of small restaurants surrounding it can communally serve their respective customers. Simple, portable tables and chairs are placed on loose sand below a spreading and shade-giving tree, creating a protected atmosphere that many people can enjoy.

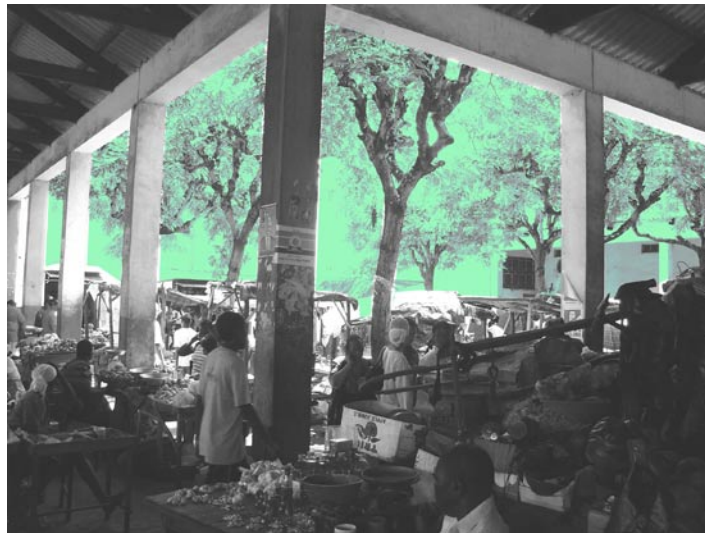
Fig. 3.17 Market at Inhambane with treed courtyard (White, 2006)

This market area in Inhambane has similarities to the proposed market design. Both have small surface areas which accommodate a large number of hawkers. The high roof and the open sides of the structure invites business in and allows a small space to appear larger; the type of structure also suits the hot climate of Mocambique. The treed open courtyard adds to the positive feel of the market.

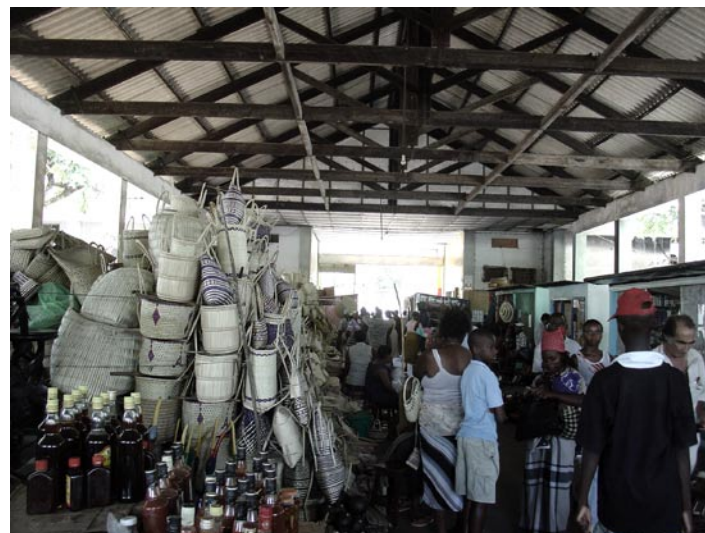
Fig. 3.18 Inhambane market's high roof structure (White, 2006)
