5. PRECEDENTS

One can learn from visiting institutions of the same or similar nature of the project one wants to design. For this purpose the following precedents will be reviewed for both positive and negative aspects:

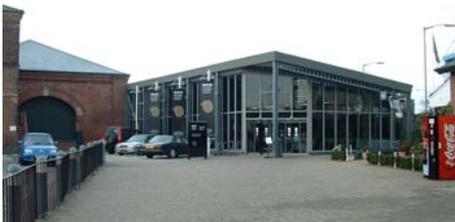
Fig. 5.2 Entrance

The new steel and glass entrances proclaim the functional nature of what is represented inside. The Great Hall is a historic masonry structure, now painted. The original roof has been replaced by a structure of triangular space-frame steel trusses, supported on the walls and new space-frame columns. Natural light is admitted through a very large window in the head wall. A mezzanine floor has been introduced in the Great Hall for the library and for smaller displays on e.g. signalling material and the history of ticketing and tickets. The Station Hall, too, is a Victorian red brick structure, but unpainted. Part of this hall's roof has been glazed to admit more natural light.

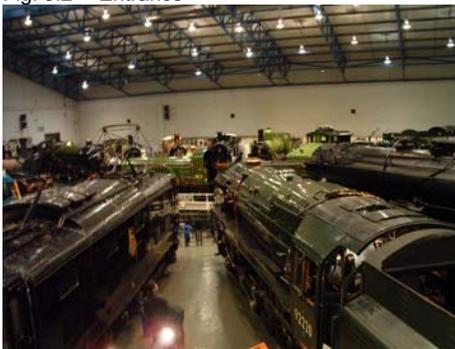
Fig. 5.3 Display around the turntable

In the Great Hall the display of a wide and comprehensive variety of locomotives is centred on a working turntable. However, the display is very dense and feels cluttered – one does not get an overview easily. As I did not buy a guide (otherwise superfluous due to the excellent information boards provided with each display), I never realized that the entrance to The Works was hidden in a corner by this panoply of locomotives, and thus never saw the displays there: this makes one question the clarity of the lay-out with regard to finding one's way about unguided. The clutter is less of a problem than the inadequately marked routes. – The displays were placed on tracks embedded in an easy-to-clean, smooth, polished concrete. However, the reflection of light on this material made the display look unrealistic, more like model train locomotives standing on a kitchen table: the authenticity was compromised.

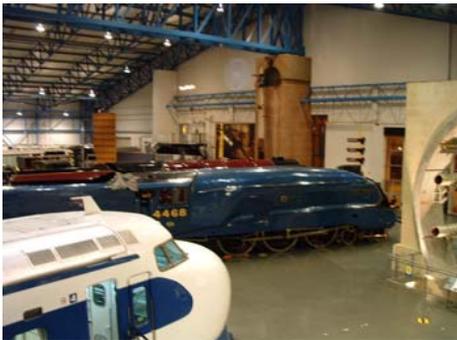
Fig. 5.4 The smooth, reflecting floor

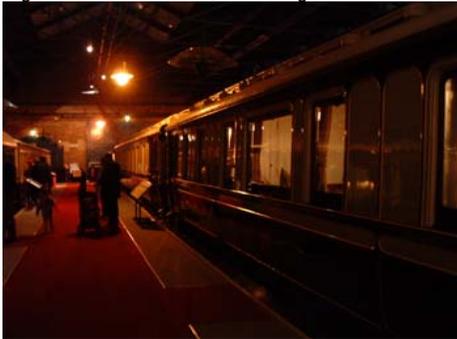
Fig. 5.5 The 'Royal Trains' section

Dimmed artificial lighting renders both the atmosphere of a station in the evening and enhances the opulence of royal splendour. It also helps in preserving these carriages and their furnishings, as exposure to natural or even too bright artificial light is reduced. This is a very successful part of the museum. The other three tracks display various passenger carriages and freight vans.

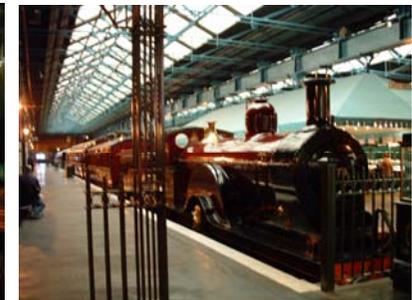
Fig. 5.7 Replica of oldest passenger train Fig. 5.8 Exhibits arranged as train ensembles Fig. 5.9 Glazed roof of Station Hall
5.2 Rail Transport Gallery, Cultra, Hollywood, Northern Ireland

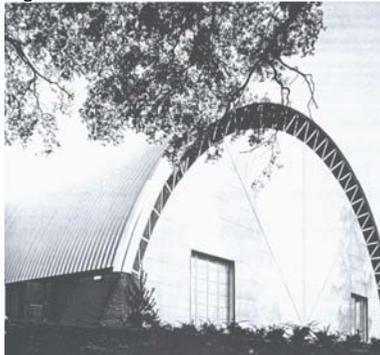
Fig. 5.11 Exterior view

This museum was reviewed by S. Greenberg in *The Architect's Journal* of 14 July 1993. – Designed by Ian Campbell and Associates and built in 1993, a large barrel vault shed reminiscent of Victorian times marks this museum, which centres its display on a turntable. The aluminium shed roof is supported on curved triangular space-frame trusses. The nine trusses were assembled in four sections on the ground and then hoisted into place. Due to the fitting of the turntable in the floor, it was impossible to counter the thrust forces of the arches with reinforcement ties embedded in the floor slab – a solution applied at London's St. Pancras station. The solution was found in the design of inclined reinforced concrete buttresses, surrounding the base of the museum, on which the trusses are anchored. These buttresses also accommodate the air-conditioning system's ducting. The walls of the shed are of blue engineering bricks. Limited natural light is admitted through a window seam touching and following the curve of the roof. The museum's area is 3,298 m² (including that of the separate entrance block), its cost of construction was £ 1,895,000, including preliminaries (£535.58/m²). Its tracks link to the rail network.

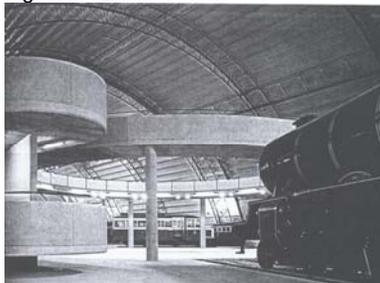
Fig. 5.12 Exhibition shed with foot-bridge and ramp

Further facilities provided are a 40-seater auditorium, lavatories and a staff room, located in the entrance building. The visitor passes through the entrance building, and crosses over a bridge, which accommodates the sloping terrain, enters the shed on a level above the display of the locomotives and rolling stock. This is supposed to recall an experience similar to that of standing on a foot-bridge, although I consider a first encounter with the exhibited locomotives on the same level more realistic to have. The bridge splits in the shed and encircles the turntable, before rejoining and leading down by means of a long ramp. However, the heavy reinforced concrete bridge structure impairs both the view of the display and the experience of the large vaulted space.

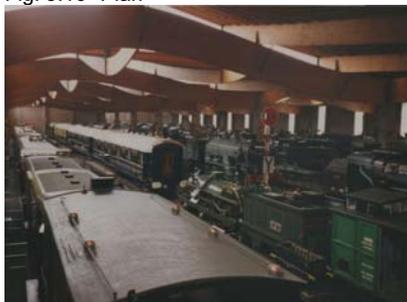
Fig. 5.17 Exhibition hall

The main hall of the museum is constructed of off-shutter reinforced concrete, whereas the roof is supported on laminated timber beams. It is not a clear span, but has three bays, the spans being supported on two rows of columns. The roof is a stylized version of a saw-tooth shed: the beams are bent in shallow curves, giving a wave-like appearance, on which rest bent joists, curving upwards to form a glazed vertical opening between the upper and lower roof pitch, admitting natural light. The ceiling is very busy for a building displaying functional machines, and appears to be rather low, resulting from the combined optical effect of the downward swing of the beams and joists and their darker timber colour. Tall windows in the long walls admit more natural light. This saves on the electricity bill and is more sustainable. A mezzanine is used for the display of other railway related items.

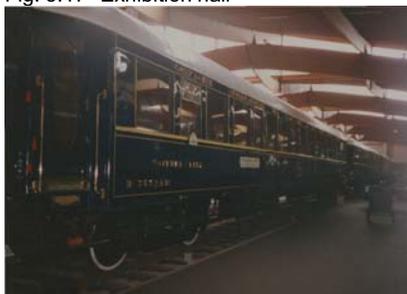
Fig. 5.18 Naturally lit and stylized saw-tooth shed

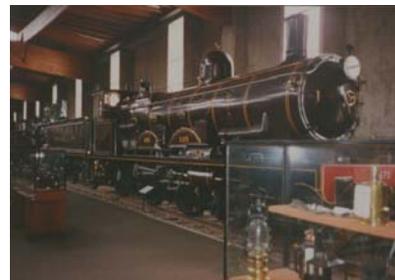
Fig. 5.19 Windows for natural light

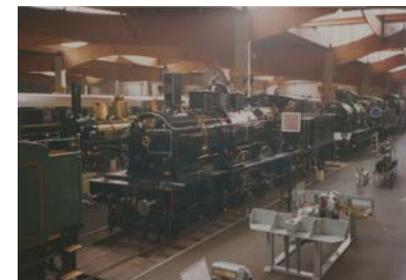
Fig. 5.21 Display on gravel-embedded rails

A very good variety of French locomotives and rolling stock, including luxuriously appointed carriages of the *Compagnie Internationale des Wagons-Lits*, is displayed on tracks embedded in gravel, with rails fixed to cross-ties, giving a more authentic effect than that discussed under the York museum.

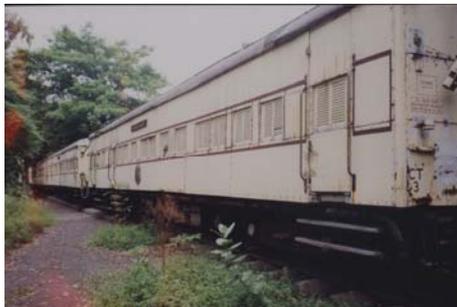
Fig. 5.24 Deterioration evident on exhibits

The large outdoor area would require garden maintenance, but with low labour costs in India this would presumably be cheaper than building maintenance. However, due to the outside storage, many of the exhibits are deteriorating, showing peeling paint and rusting metal: what is being saved on building costs necessitates it being spent on increased exhibit maintenance – if this is performed at all. The brass piping and tubing on the locomotives has also disappeared, as the area cannot be effectively secured 24 hours a day. (This problem is also encountered in South Africa, where 'free-lance wealth redistributors' are as eager to help themselves to items commanding a good scrap metal price.) The steam locomotives are therefore of a rather depleted appearance.

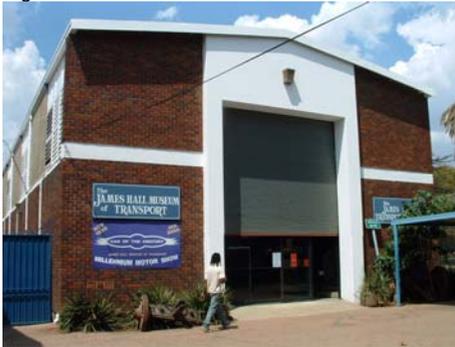
Fig. 5.29 Entrance

The entrance as such is ill-defined, using the roller-shutter door by which the exhibits are brought into the

shed and looking very much the same as the exit. The entrance and exit being separate necessitates that an additional person must be employed to control that nobody enters or exists the museum uncontrolled, resulting in higher staff costs. The entrance area, once one has entered the museum, is ill-defined, and basically non-existent. There is no information stand or counter; post-cards for sale are displayed at the back of the shed far away from the staff member controlling the entrance; the old office desk for this staff member is tucked under the staircase leading to the mezzanine. Providing a simple, yet elegant counter would provide a more professional feel to the museum.

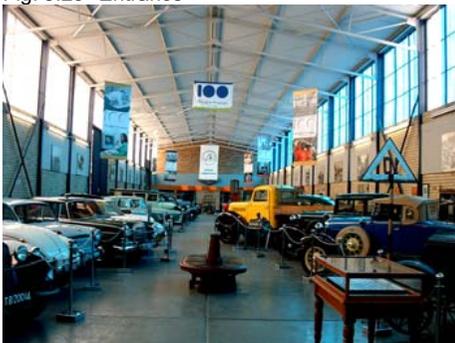
Fig. 5.30 Naturally lit northern shed

This museum consists of four enclosed sheds placed around an inner courtyard. They abut on each other to permit passage from the one to the other, except at one corner where access to the courtyard is provided. Here, too, entrance and exit are located separately, the visitor progressing through the museum in an anti-clockwise direction. The southern shed contains a mezzanine floor surrounding a central well. Stairs lead up to this, but ramps for the disabled are lacking. An open shed placed next to the northern enclosed shed displays items of a larger nature, such as locomotives. The structure is very straight-forward and simple, consisting of steel columns supporting steel roof trusses, with infill walls of face brick to a height of about four metres. Above this, filling the space between the masonry and the ceiling, are panels of opaque polycarbonate, admitting filtered natural light to such an extent that only minimal artificial light sources are required on a clear day. This reduces operating costs, whilst not allowing the entrance of too intensive direct to cause damage to the exhibits. (On the northern side these panels have been painted blue, to reduce the quantity of light infall; possibly the panels should have been limited to the southern side only.) Due to the dry Highveld climate not necessitating the removal of display-damaging excessive humidity, no air-conditioning units have been installed. Louvre panels have been provided for ventilation on the mezzanine level of the southern shed, where smaller and light-weight exhibits and the administrative offices are located. The building finishes demand little maintenance which, together with the mentioned low artificial lighting requirements, assists in significantly reducing operating costs.

The proportions of the sheds, the lofty height matching their width and length, coupled with the quality of light within, make for a pleasing space and atmosphere, and ample space for the displays. The exception is the shed containing the historic double-decker trams and buses, which are parked so densely that they can not be seen in full. The area of the open shed, surrounded by palisades (evidently only added since the crime epidemic commenced in South Africa) displays agricultural implements and locomotives, trucked in as the museum has no link to the rail network. However, the overhang of the shed roof is insufficient, as bleaching and other damage to the exhibits is evident where the sun reaches them. All brassware has been stolen off the locomotives, proving that the palisade fence does not adequately protect them against theft (unless the theft occurred before the erection of the fence). An old boat hulk placed in the open beyond the palisade seems to be totally ignored now and is rotting away. - The inside exhibits are in mint condition.

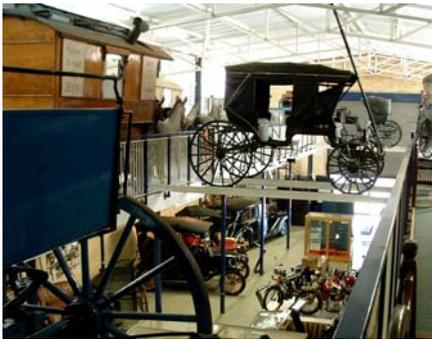
Fig. 5.31 Mezzanine with central well

An innovative approach to exhibiting items is used for some old coaches and horse carriages: they are displayed over the central well of the mezzanine level, their wheels being fastened to two beams spaced apart to a corresponding width and laid across the central well. Also on the mezzanine level are the club facilities of the Johannesburg Model Tramway Club, their tram lay-out visible within a glass enclosure.

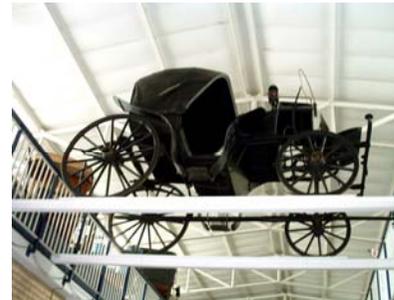
Fig. 5.35 Suspended carriage
