The 'Healing Activities Centre' serves as a design catalyst to enhance the harmony of South African society by tracking back to their inner roots. The design proposal allowed the building to regain life and enjoy greater interaction between inside and outside, the street scape and building interior. The once deserted building has again become open to everyone. Positive marks will be left on every person experiencing the 'Healing Activities Centre'.

APPENDIX

Image Gallery

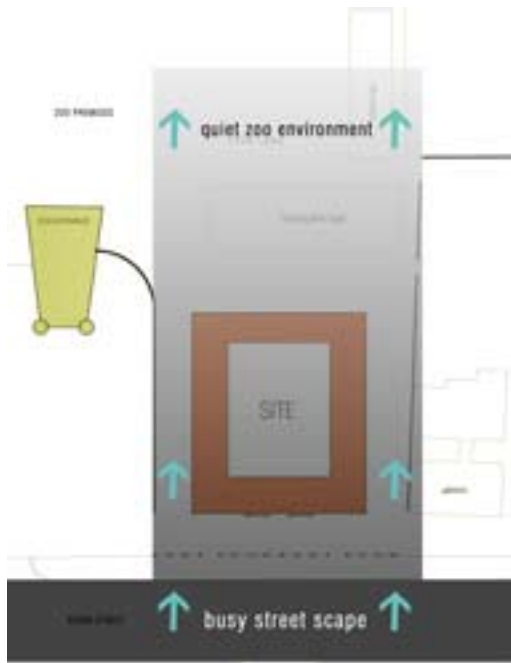
Image 1: The change from busy street scape (south) to the peaceful zoo (north).

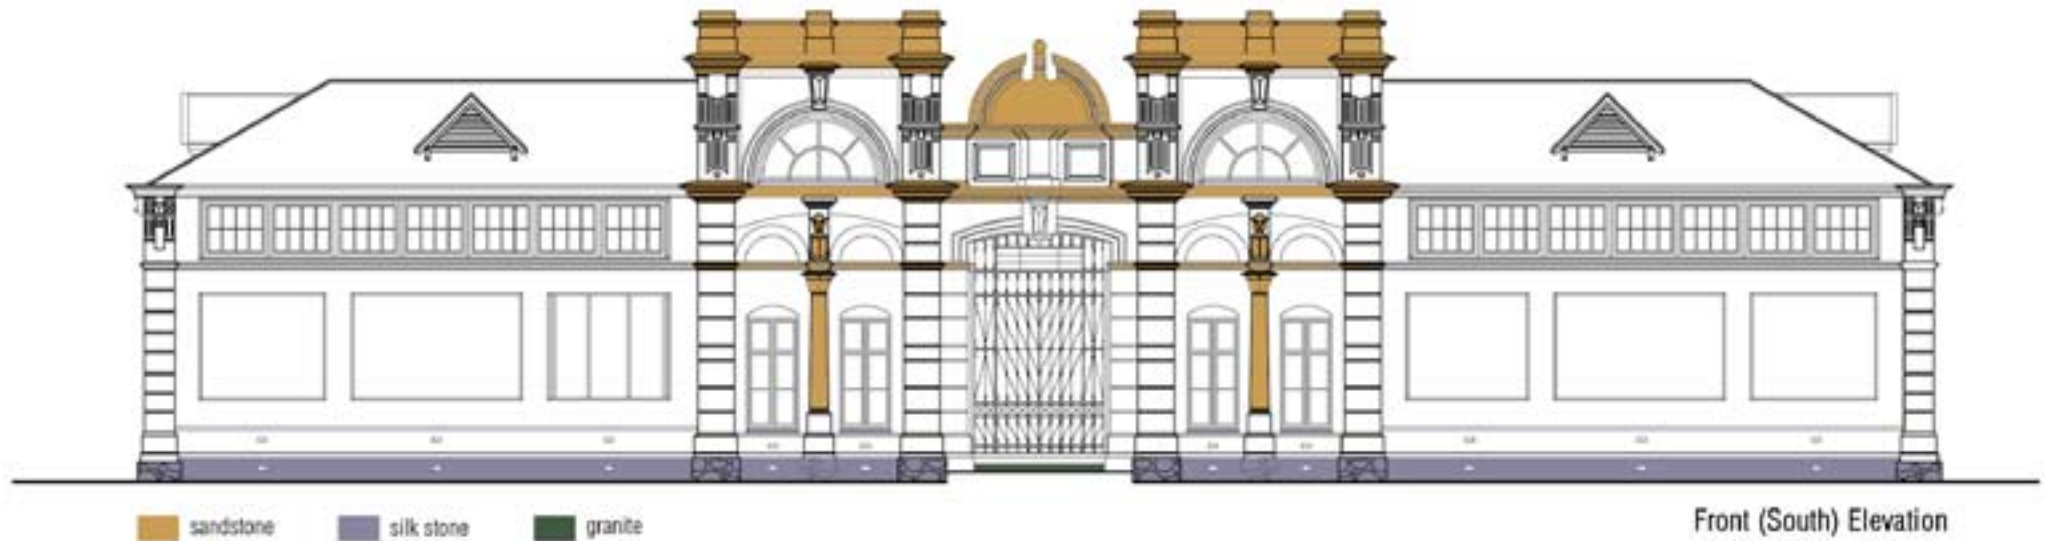
Front (South) Elevation

Image 2: The facade is made up of different building materials.

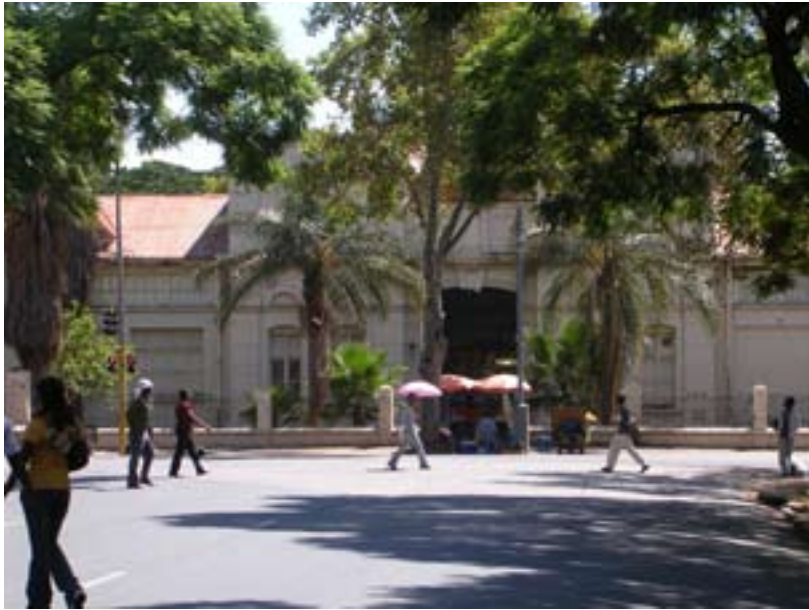
Image 3: The front facade is obscured by the trees in front of it.

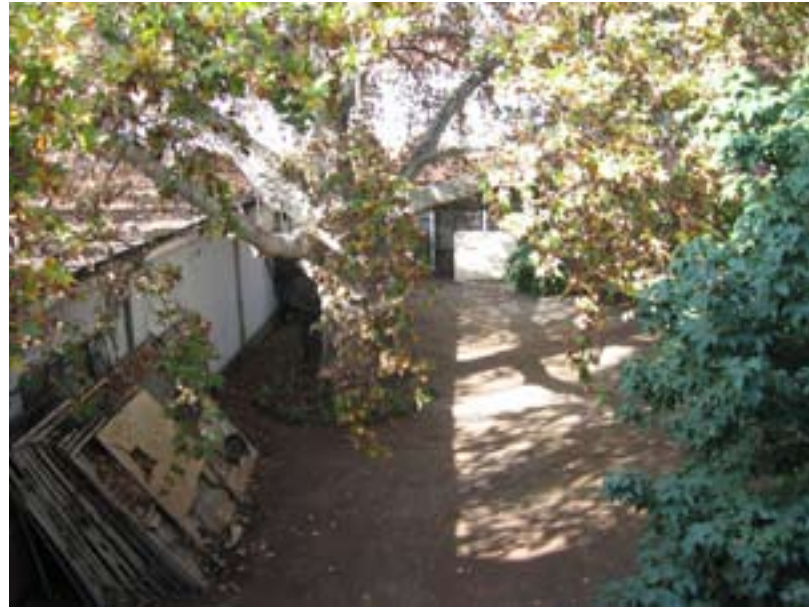
Image 4: The courtyard addition (left wing in photo) ruins the courtyard symmetry and atmosphere

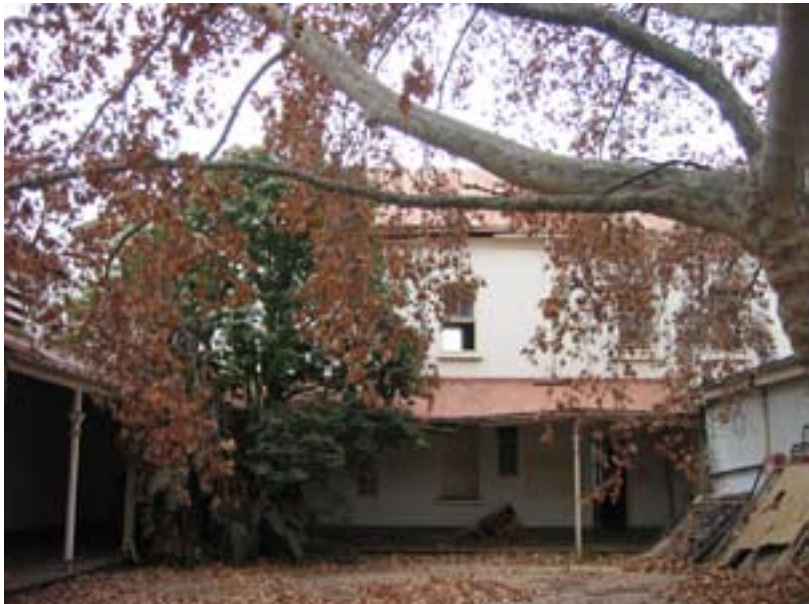
Image 4: The courtyard addition (right wing in photo) ruins the courtyard space

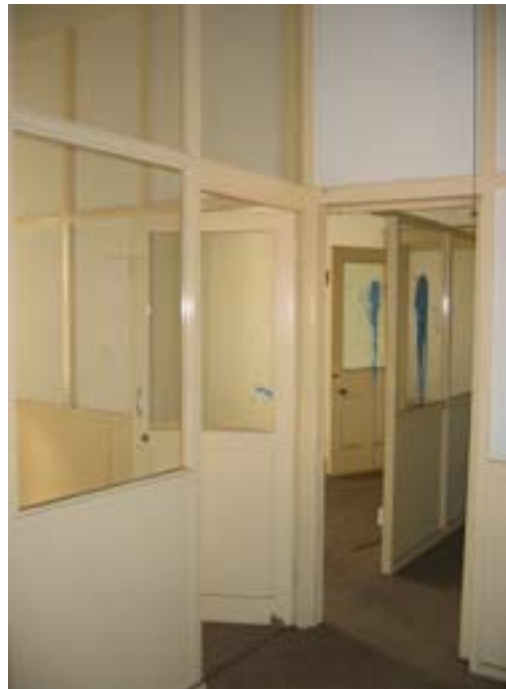
Image 5: Illogical partitions in the upper northern wing

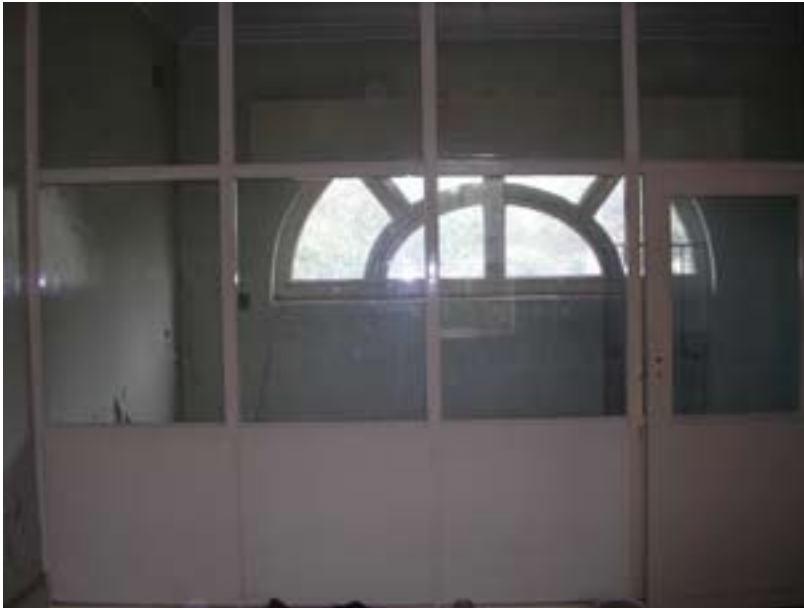
Image 6: 'Tower' partitions

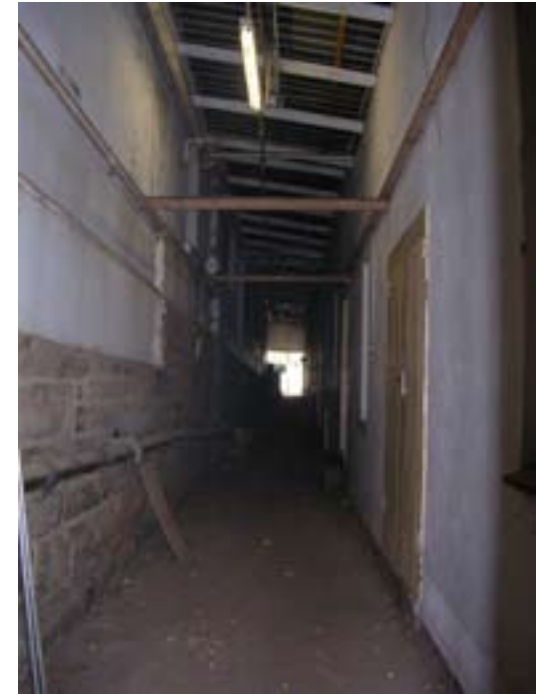
Image 7: The addition can be seen to the right of the building

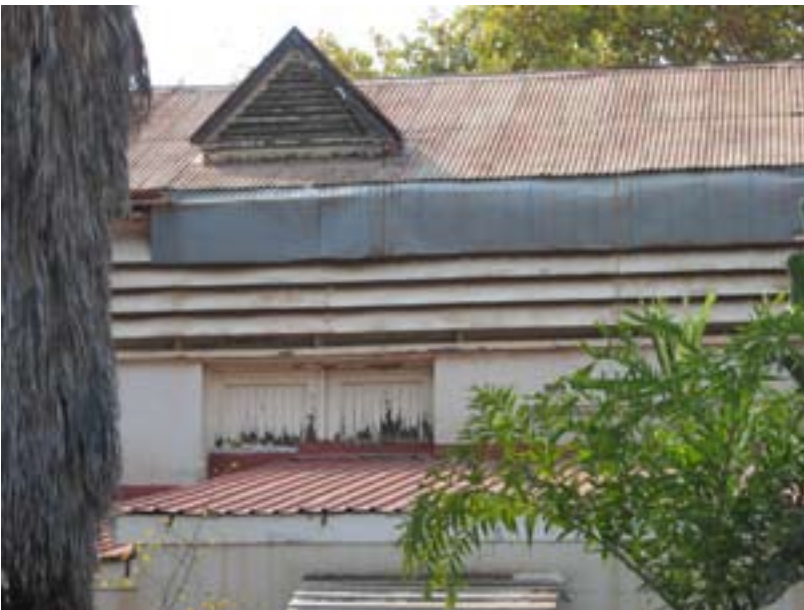
Image 8: The roof of the late addition stretches right across the 'wagon doors', blocking them

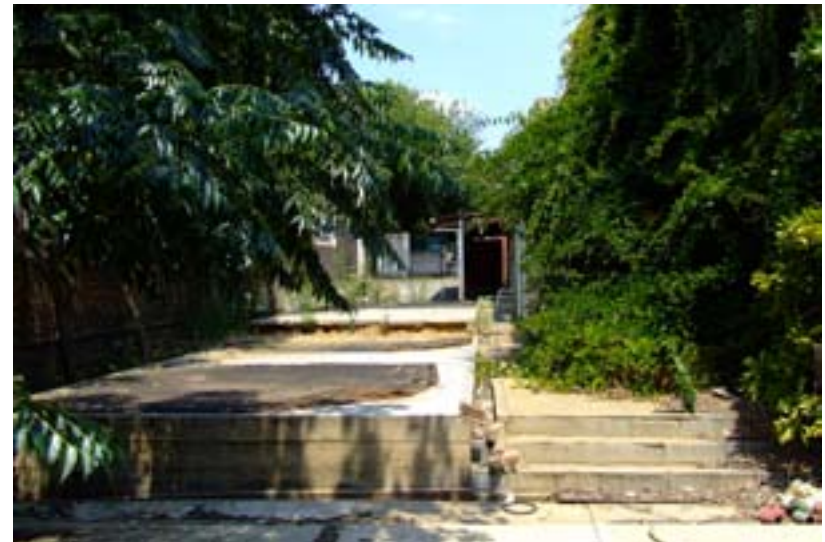
Image 9: Uneven blocks protrude from the ground level on the eastern side of the building

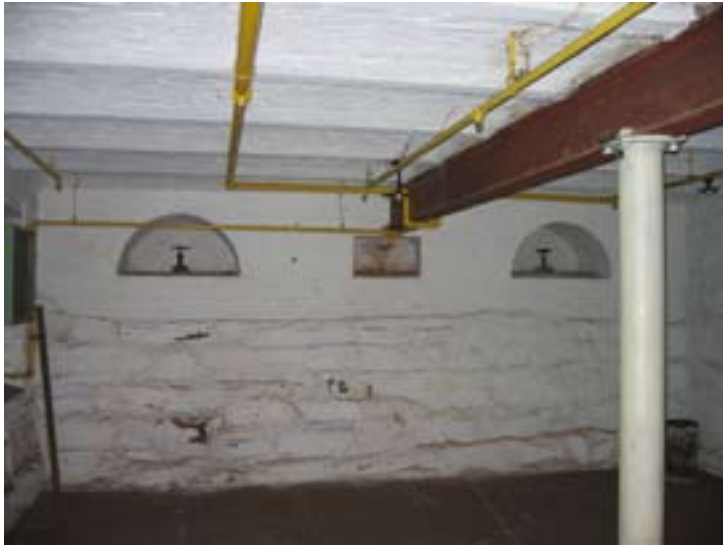
Image 10: Open area in basement

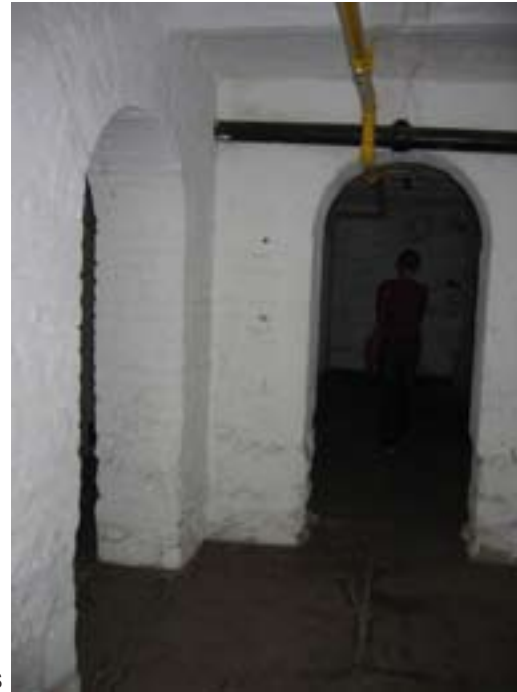
Image 11: The other half of the basement is subdivided by arches

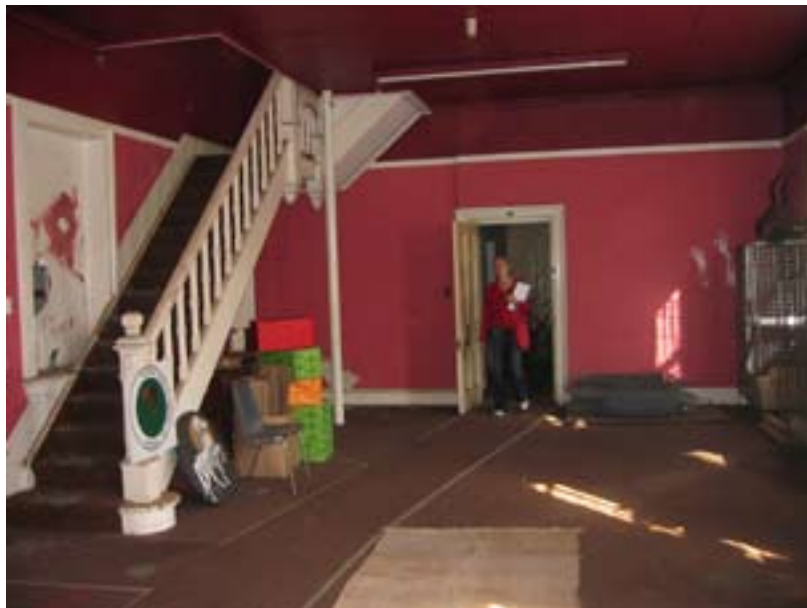
Image 12: An eye-catching staircase in the north wing, leading up to the first floor

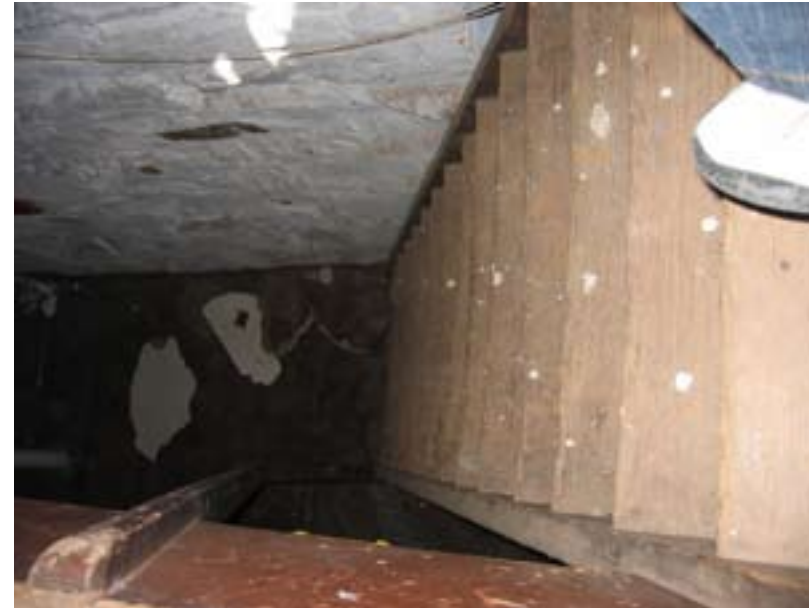
Image 13: A steep staircase leads down into the basement

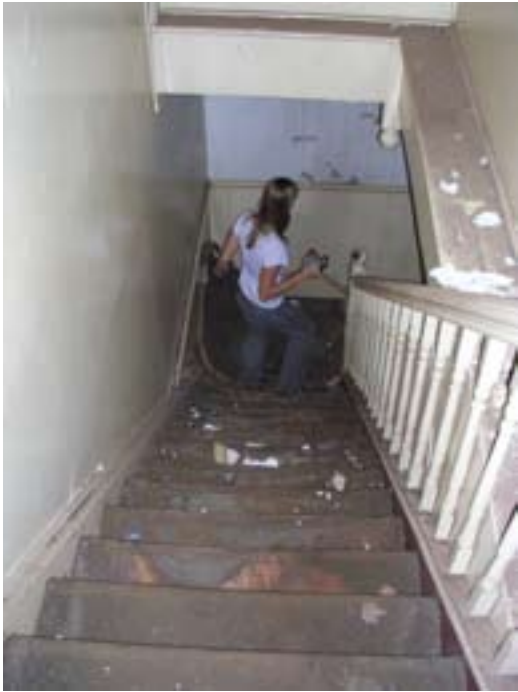
Image 14: Staircase leading up to the 'tower' first floor

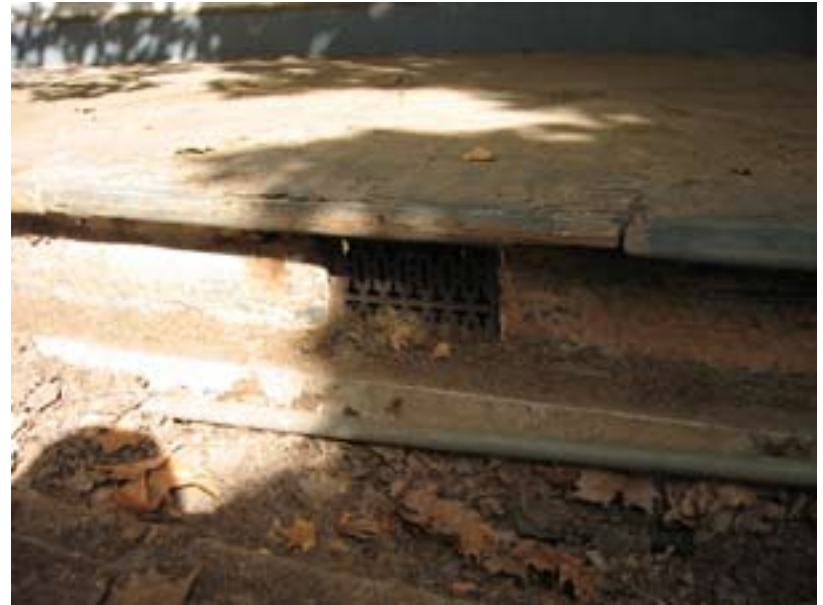
Image 15: Cast iron air vents are found all along the building exterior

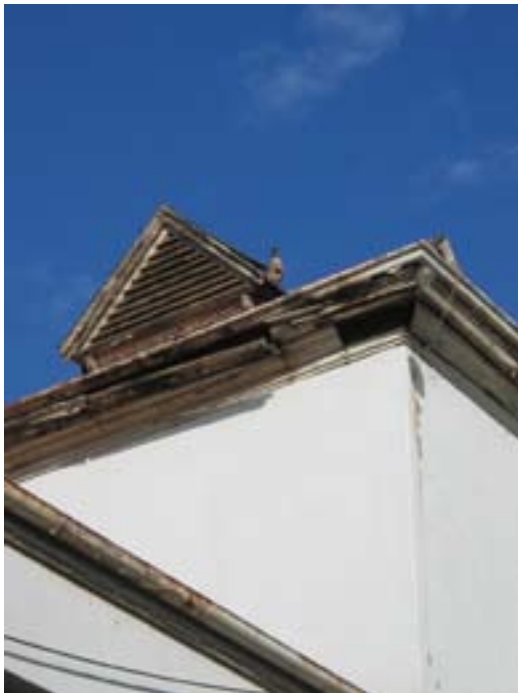
Image 16: Roof vents are placed on all roofs of the building

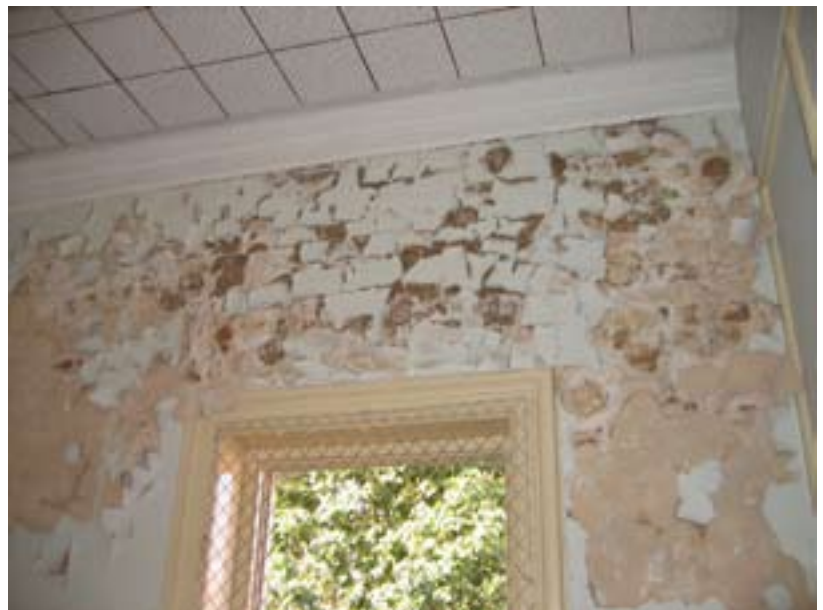
Image 17: The PVA paint layer is peeling off the lime-based paint. (This photo was taken in the northern upper wing, but also applies to the 'tower' first floor.)

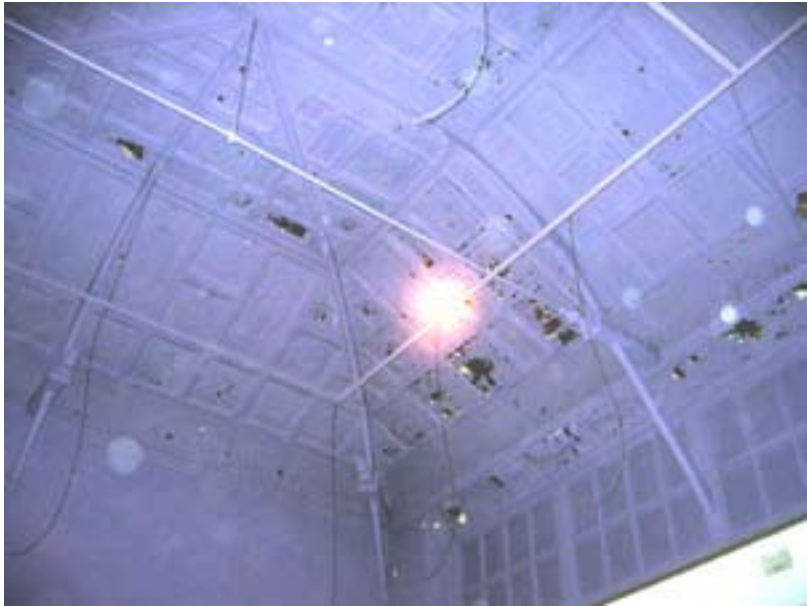
Image 18: The only vaulted pressed steel ceiling in the building, painted purple

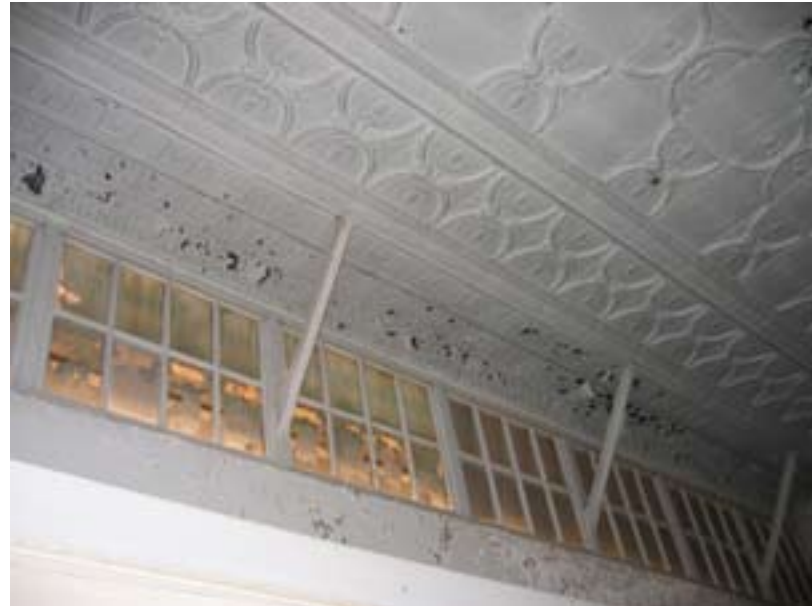
Image 19: The most expensive pressed steel ceiling found in the east wing

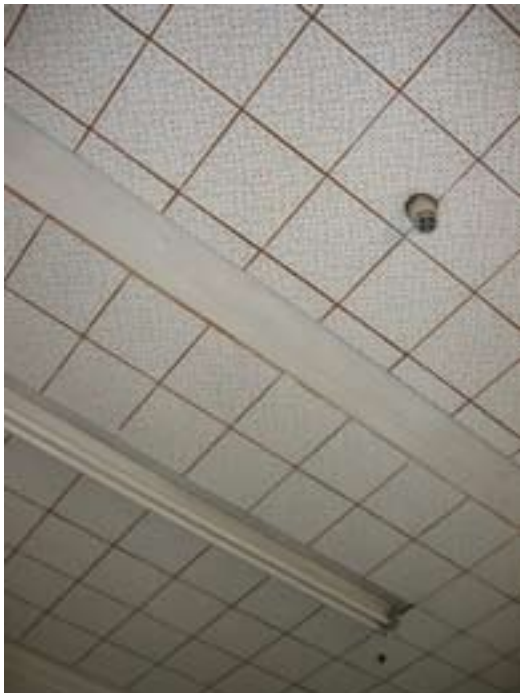
Image 20: The original 'Baltic Deal' timber ceiling is concealed by the later added acoustic panels

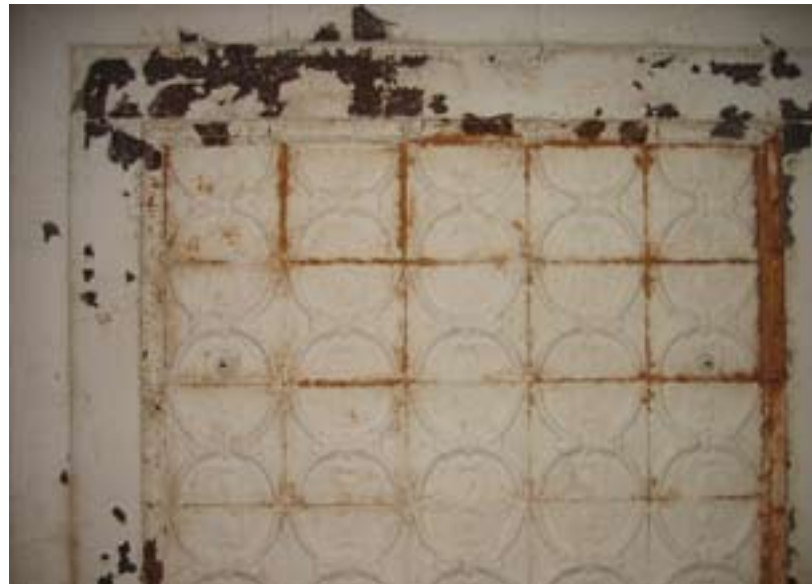
Image 21: The pressed steel ceiling in the foyer

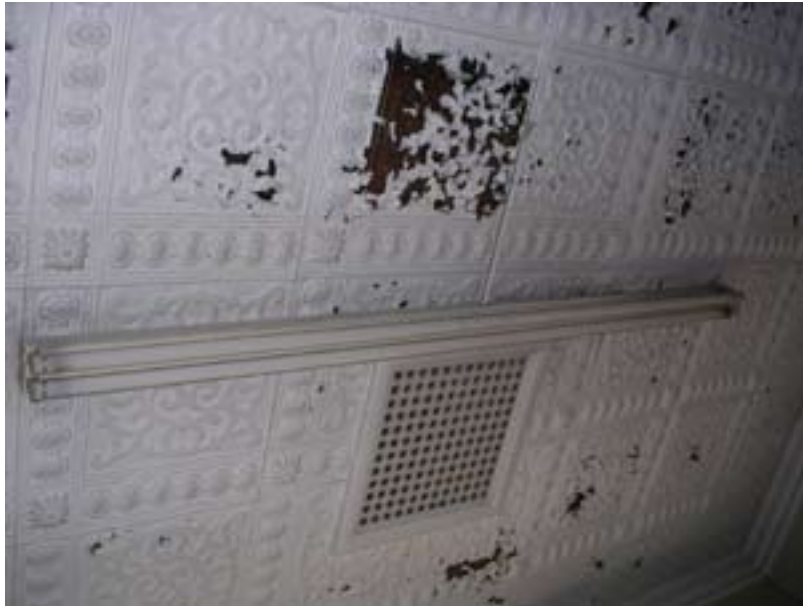
Image 22: Pressed steel ceiling in the 'tower' first floor

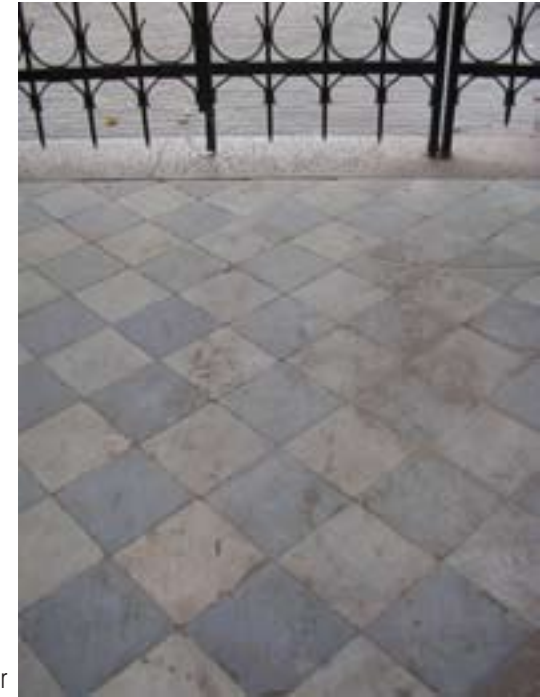
Image 23: The imported chequered marble floor in the foyer

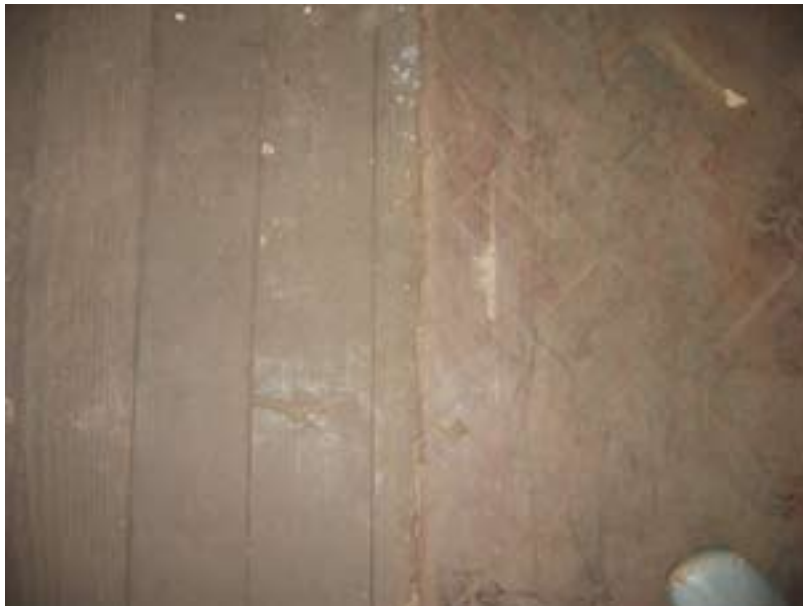
Image 24: The original 'Oregon Pine' timber floor was later covered with a layer of parquet flooring

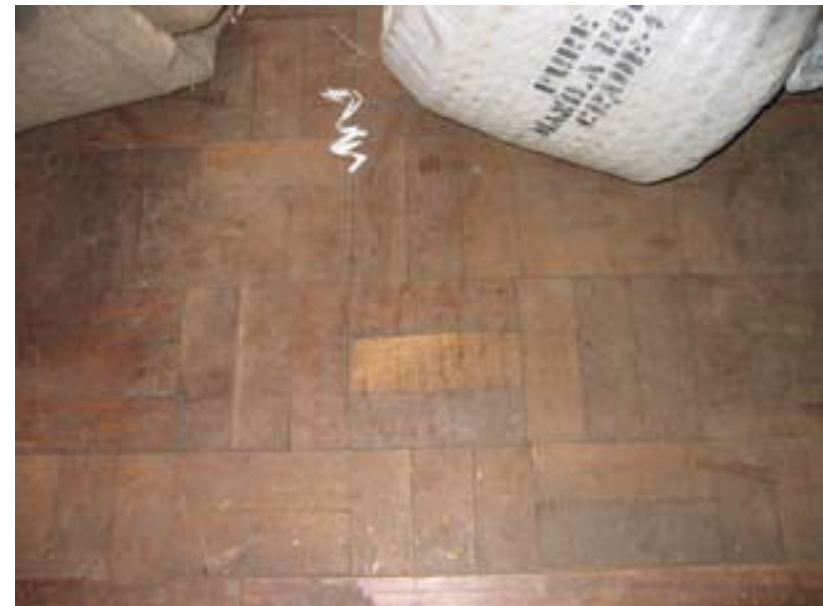
Image 25: A newer version of parquet flooring is to be found on ground floor in the outer ends of the northern wing

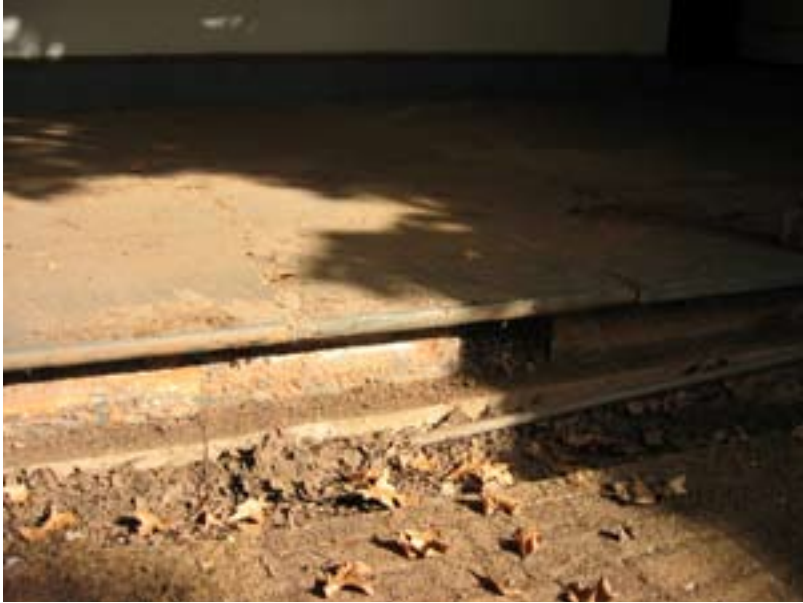
Image 26: Local blue slate covers what is left of the veranda floor

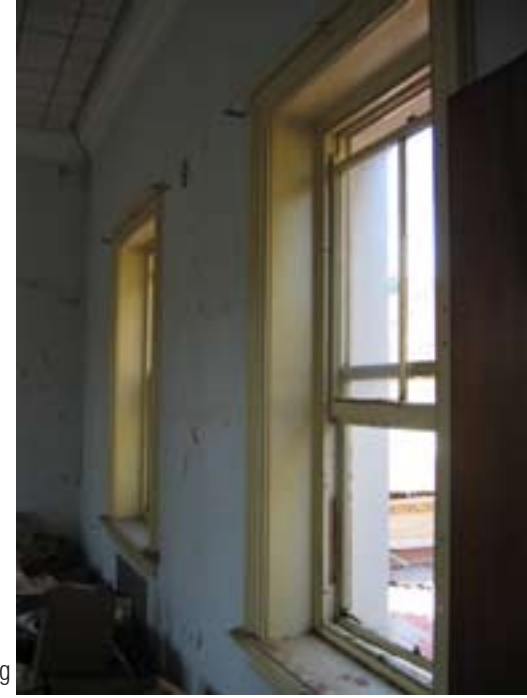
Image 27: Standard sliding sash windows are found through most of the building

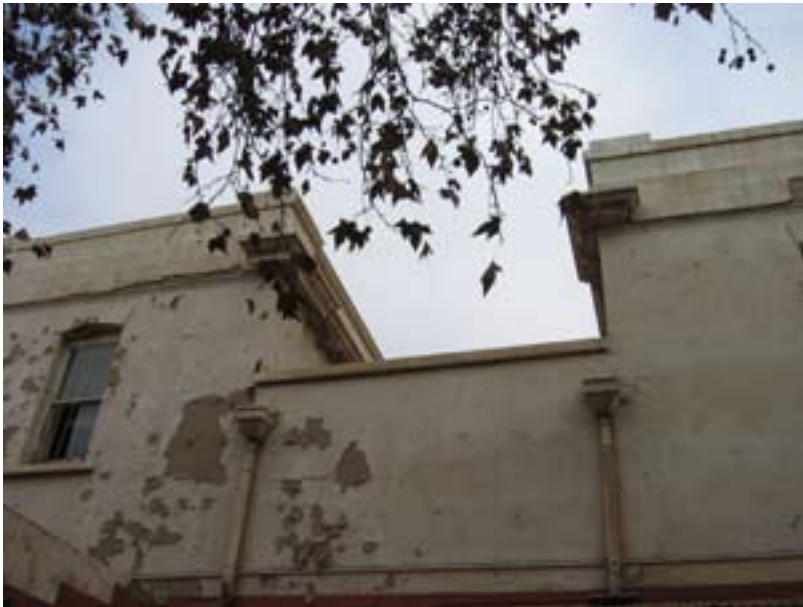
Image 28: One standard sash window is placed on each floor in the 'towers'

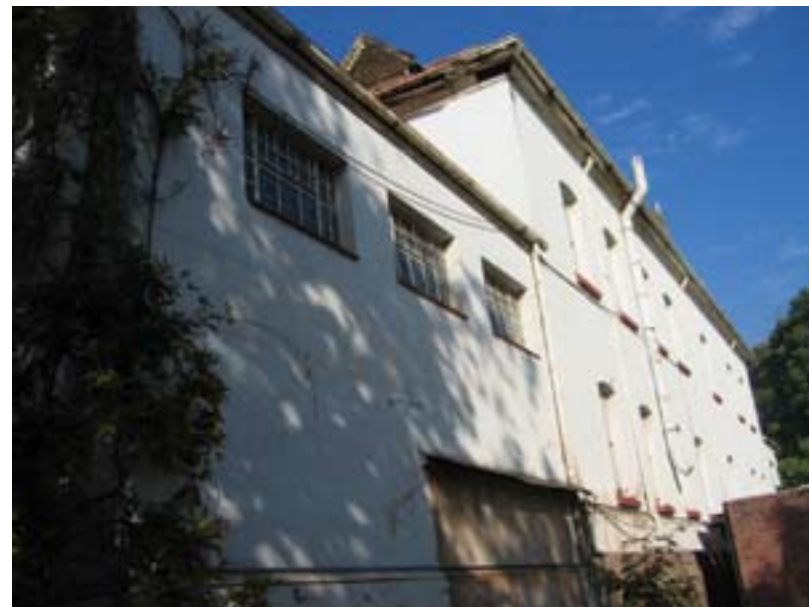
Image 29: Three later added steel windows can be found on either end of the northern wing

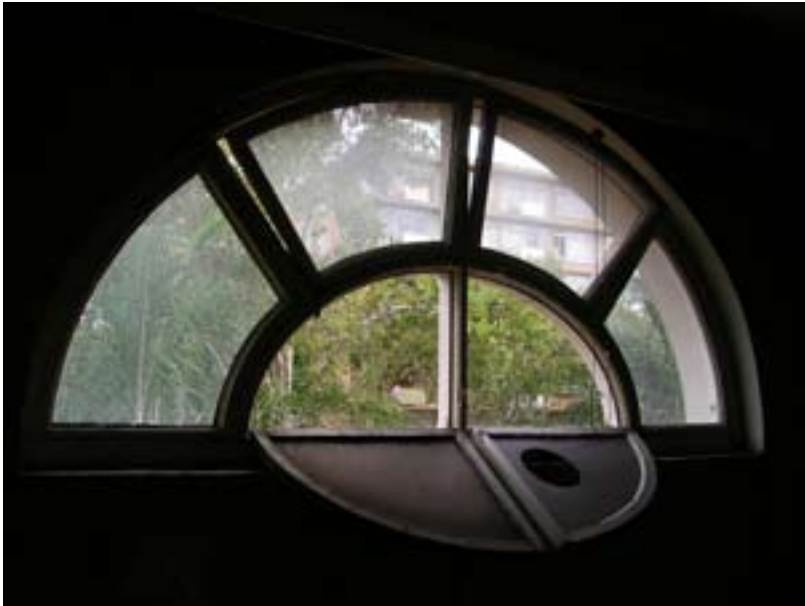
Image 30: A half round window is placed on every first floor of the front facade 'towers'

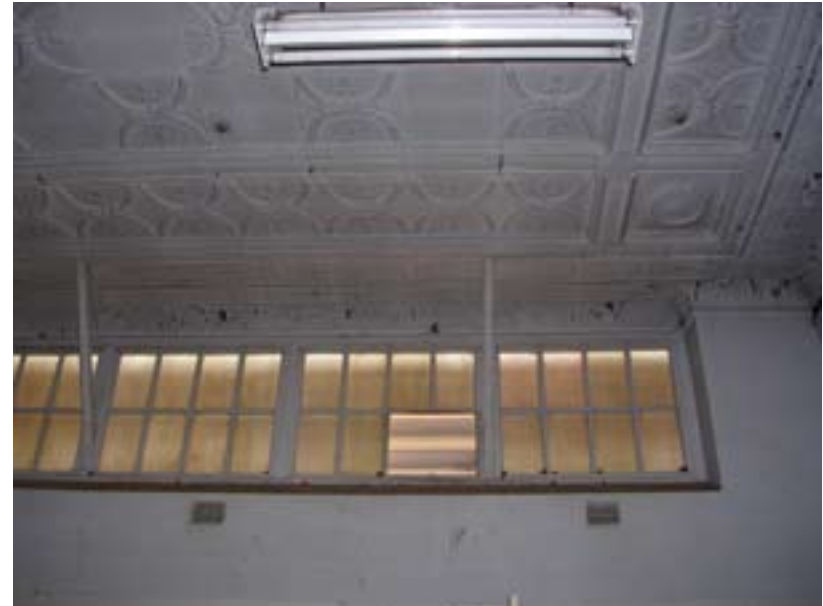
Image 31: Clerestory windows line many facades of the building

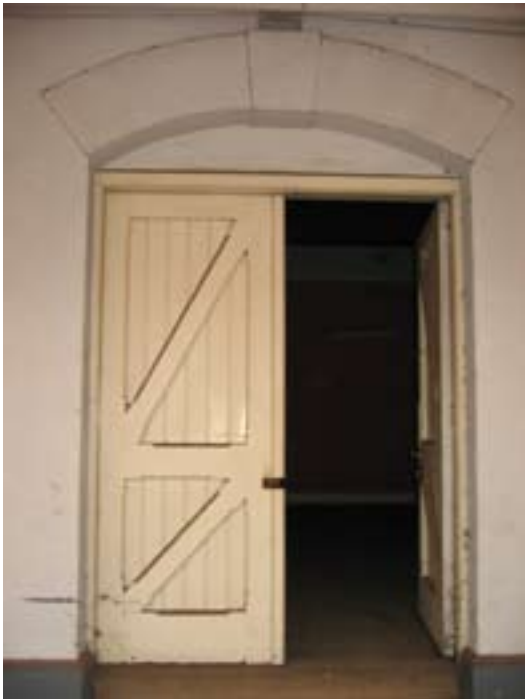
Image 32: These exterior double flb doors are found on the facades facing the courtyard

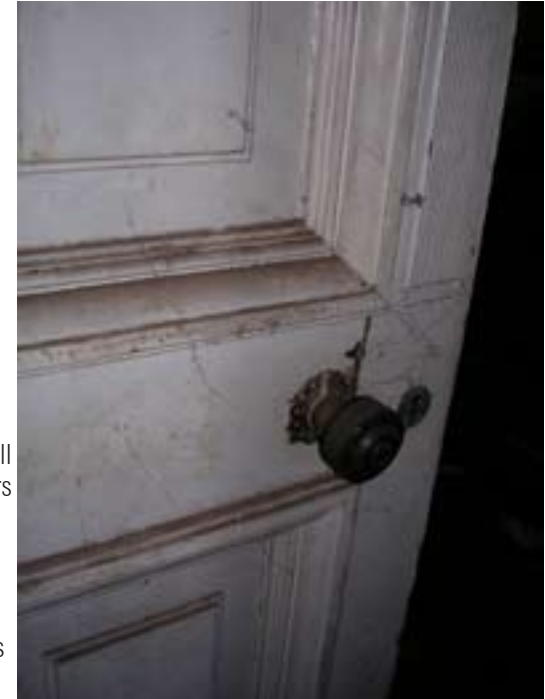
Image 33: Detailed door handles and finger plates are still found on most of the doors

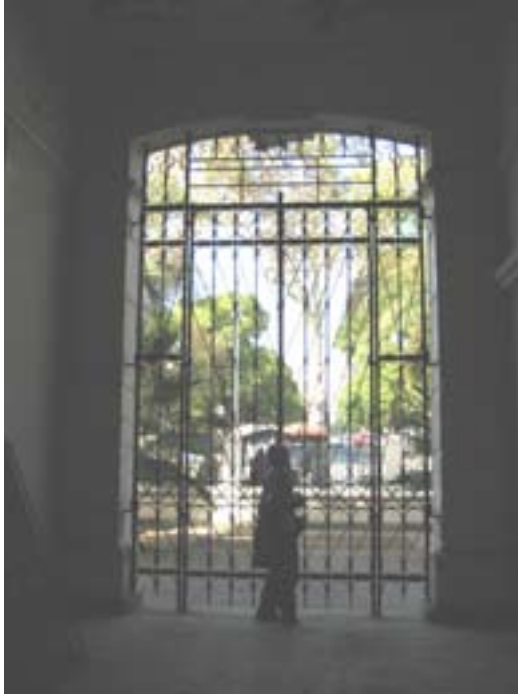
Image 34: The original wrought iron gate encloses the foyer

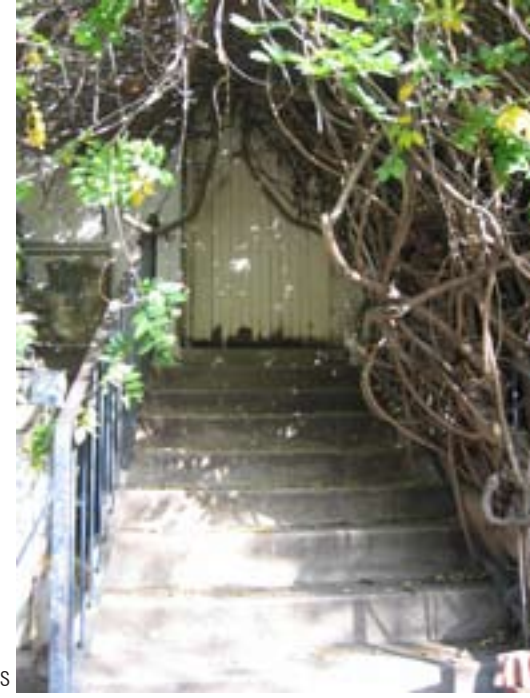
Image 35: The later added single door is overgrown by wild plants

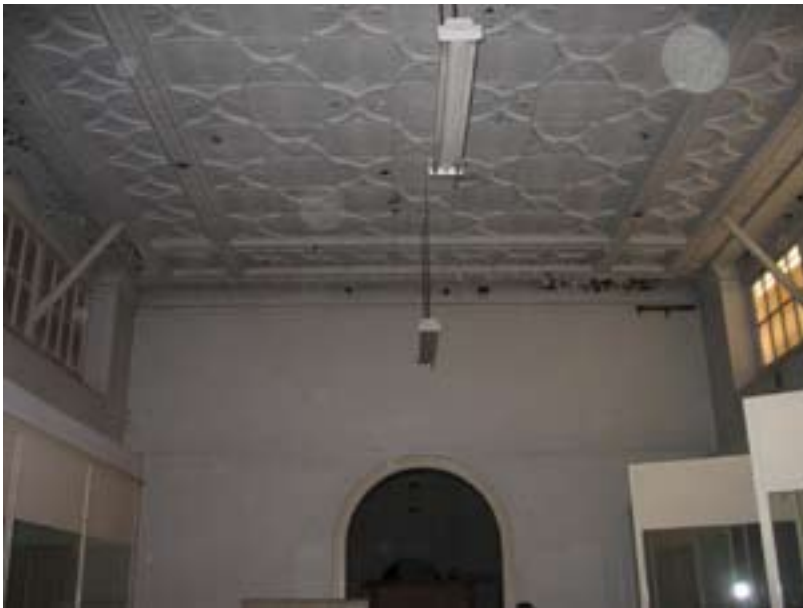
Image 36: The natural light quality in the eastern wing

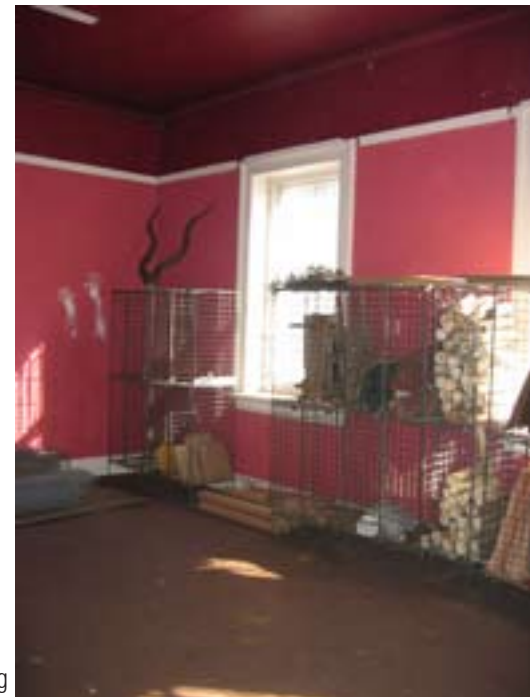
Image 37: Good natural lighting prevails the northern wing

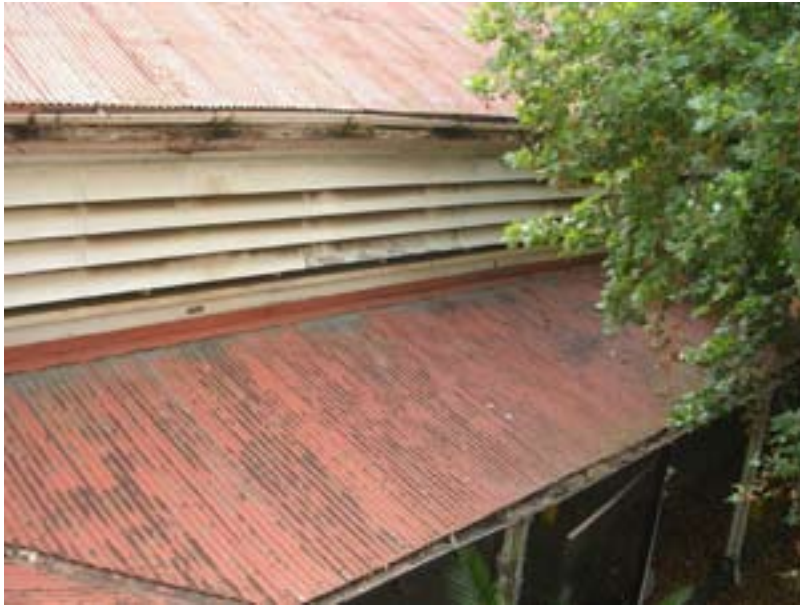
Image 38: Louvres were later added in front of all clerestory windows of the east and west wing

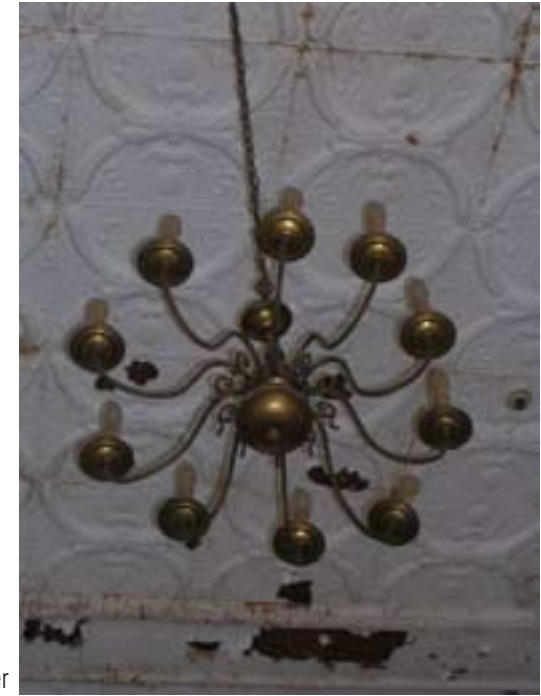
Image 39: The original chandelier is still hanging in the foyer

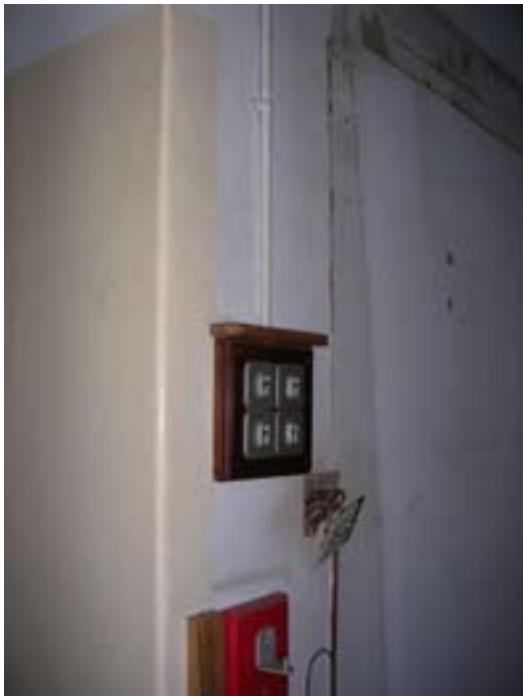
Image 40: Evidence of later added electricity is found throughout the building

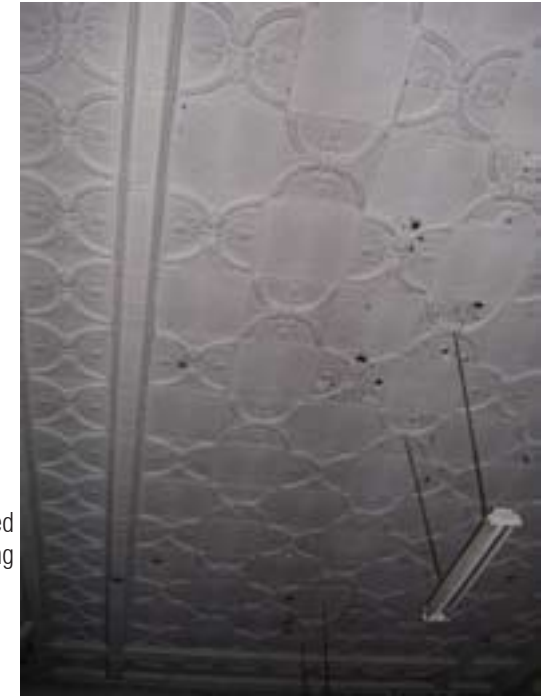
Image 41: Later added fluorescent light are suspended from the ceiling in the east wing

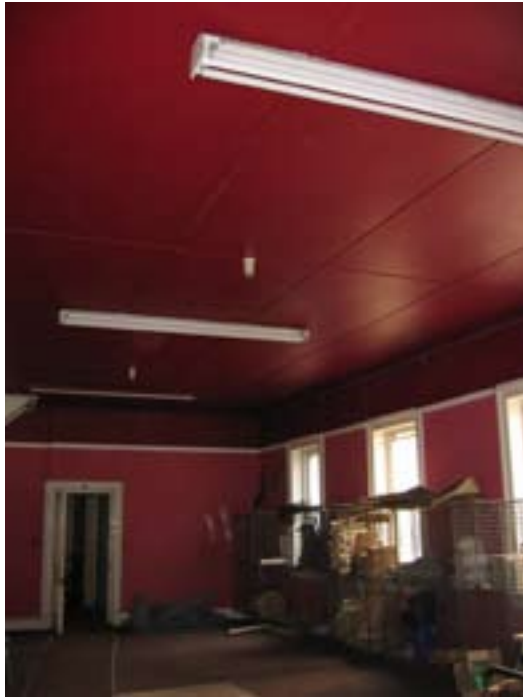
Image 42: Fluorescent light are placed along the northern wing

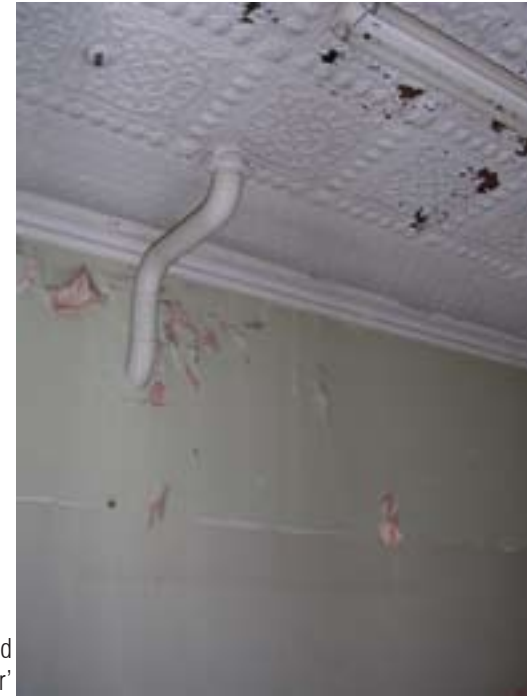
Image 43: A vent pipe pierces through the pressed steel ceiling in the eastern 'tower'

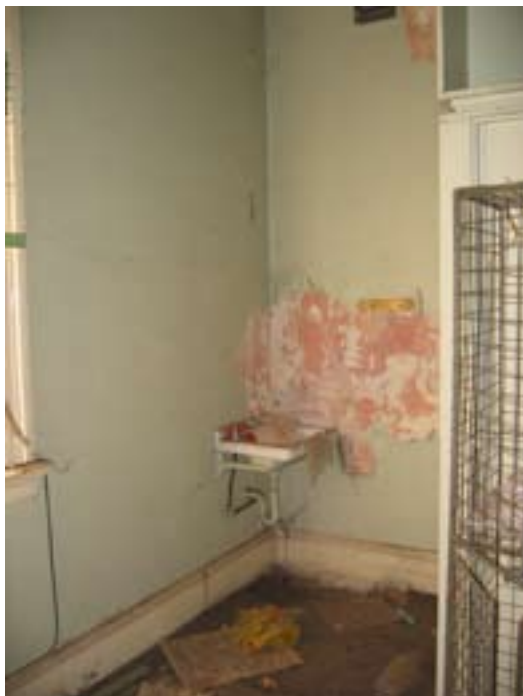
Image 44: A hand basin is found in the eastern 'tower'

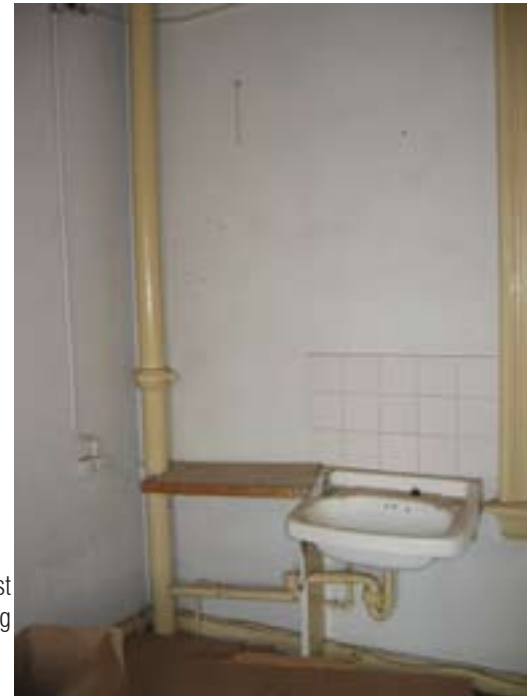
Image 45: The other hand basin found on the first floor of the northern wing

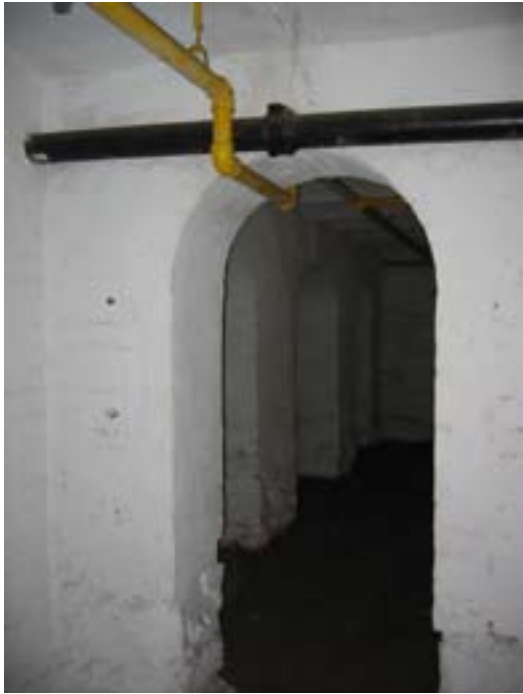
Image 46: Sewage and other pipes run through the basement

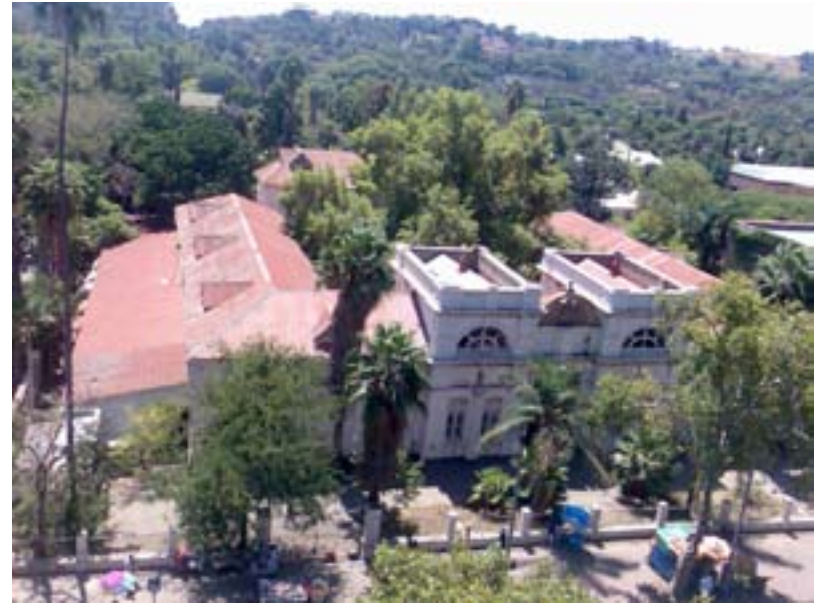
Image 47: A chimney can be seen on either 'tower' roof

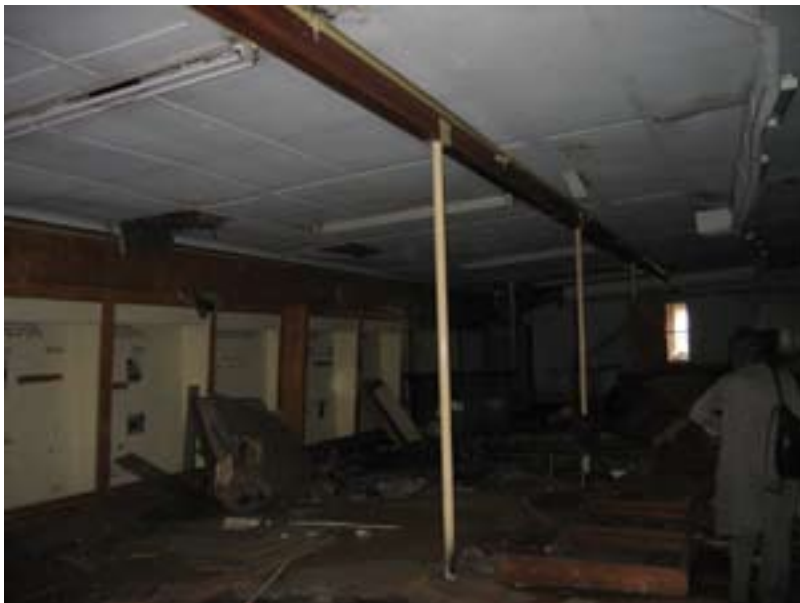
Image 48: The interior courtyard addition is left damaged by water and lack of maintenance
