CHAPTER 2

OVERVIEW OF THE SOIL DEGRADATION SITUATION IN THE EASTERN CAPE

2.3 DEGREE AND EXTENT OF SOIL EROSION IN THE EASTERN CAPE

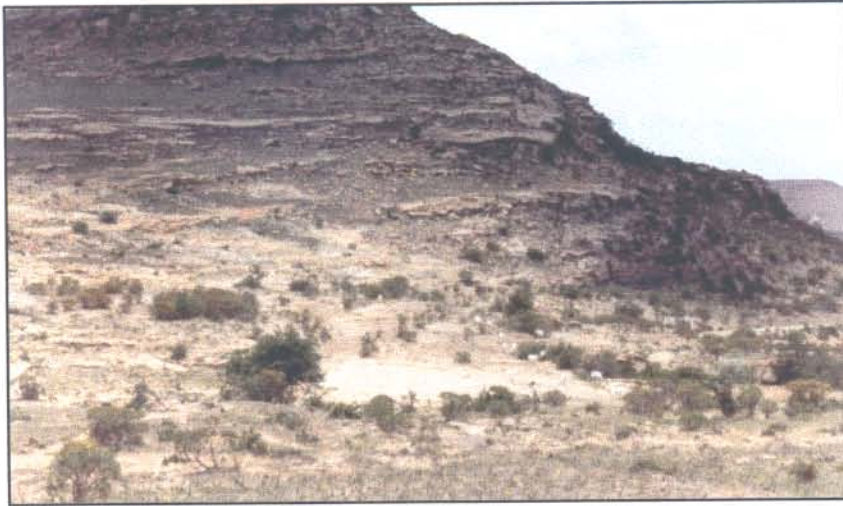
Plate 2.3 – Bare patches with severe surface sealing due to overgrazing in former Transkei (Photograph: Tracor, 1984)

Overgrazing is the main problem causing soil erosion in most parts of the Eastern Cape province. Veld fires are the norm in all parts of the province, especially in winter. Both overgrazing and uncontrolled veld fires result in the removal of vegetation, which in turn results in rainwater running off instead of seeping into the ground. Indiscriminate bush-clearing by burning strips the land bare and leaves it highly susceptible to both water and wind erosion. Brush fires have been identified as the main cause of ground cover annihilation (Ouattara, Robinson, Morna, Ajayi, Anza, and Wainaina, 1993). Judicious burning is essential to maintain many types of veld in good condition. However, injudicious burning for the wrong reason is harmful. Ouattara *et al* (1993) stress that the elimination of vegetation and litter has a catastrophic effect on protection of soil against erosive rainfall and prevents the build up of protective organic matter. Undue trampling by livestock in overstocked areas results in bare areas and footpaths from which soil erosion starts. (Plate 2.2, foreground). The situation is aggravated where surface sealing of the bare patches occurs (Plate 2.3).

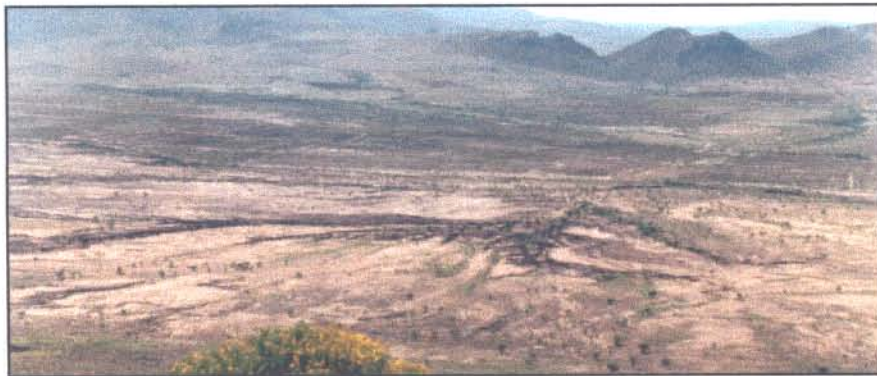
Plate 2.6 – Abandoned severely eroded cultivated field demarcated for cultivation by planners in the former Transkei. (Photograph: Tracor, 1984)

Those areas are heavily eroded and many have been abandoned. One of such areas is the Lubisi Dam catchment area, where the planners recommended cultivation and production of sorghum on Sterkspruit soils as indicated by Tracor (1984). See Plates 2.5, 2.6 and 2.7.

The Lubisi Dam catchment area, where Plates 2.5, 2.6 and 2.7 were taken was ironically called a "rehabilitated" area. Instead of recovering, its condition deteriorated drastically because of the inappropriate rehabilitation measures and the Lubisi dam is silting up (Tracor, 1984).
