**COMMUNITY BASED SOIL CONSERVATION AS BASIS FOR  
LAND RECLAMATION IN THE EASTERN CAPE** ..... 5

**Submitted in partial fulfillment of the  
requirements for the degree** ..... 14

**M. Inst. Agrar** ..... 14

**UNIVERSITY OF PRETORIA** ..... 14

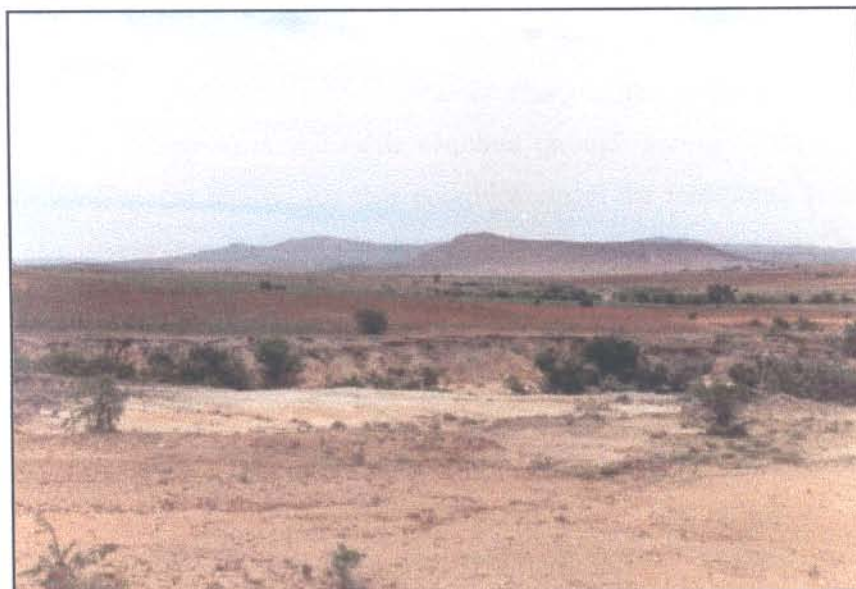
Plate 2.2 – Sheet and gully erosion in overgrazed area (foreground) in former Transkei. (Photograph: Tracor, 1984)

Overgrazing is the main problem causing soil erosion in most parts of the Eastern Cape province. Veld fires are the norm in all parts of the province, especially in winter. Both overgrazing and uncontrolled veld fires result in the removal of vegetation, which in turn results in rainwater running off instead of seeping into the ground. Indiscriminate bush-clearing by burning strips the land bare and leaves it highly susceptible to both water and wind erosion. Brush fires have been identified as the main cause of ground cover annihilation (Ouattara, Robinson, Morna, Ajayi, Anza, and Wainaina, 1993). Judicious burning is essential to maintain many types of veld in good condition. However, injudicious burning for the wrong reason is harmful. Ouattara *et al* (1993) stress that the elimination of vegetation and litter has a catastrophic effect on protection of soil against erosive rainfall and prevents the build up of protective organic matter. Undue trampling by livestock in overstocked areas results in bare areas and footpaths from which soil erosion starts. (Plate 2.2, foreground). The situation is aggravated where surface sealing of the bare patches occurs (Plate 2.3).

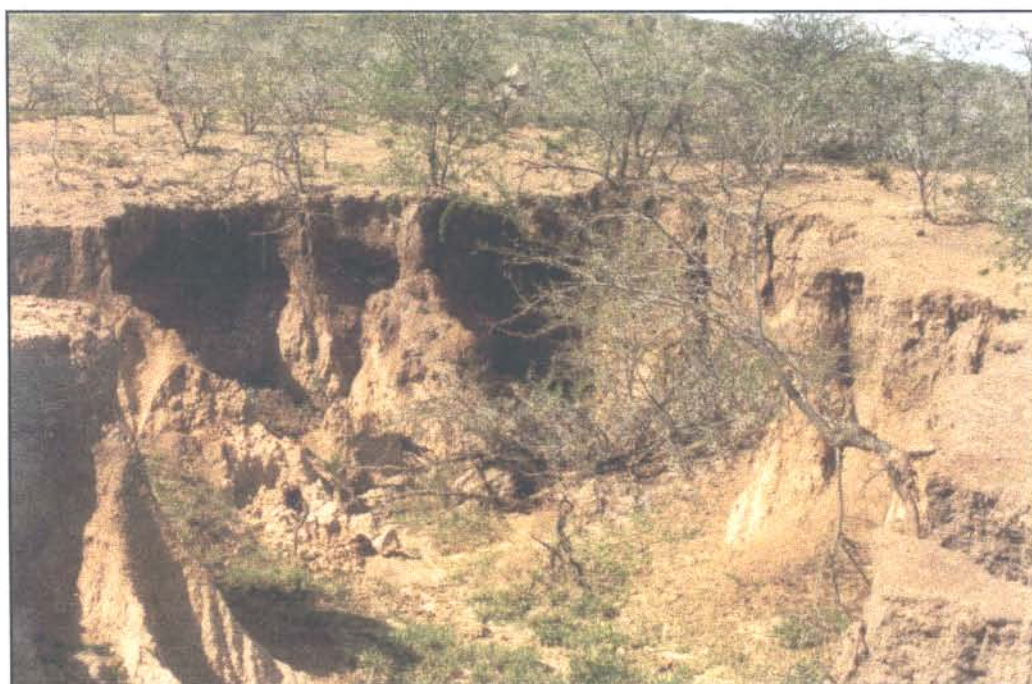
**Plate 2.4 – Sheet and gully erosion due to overgrazing of sweetveld grassland and bush encroachment caused by injudicious elimination of goats and burning in former Ciskei. (Photograph: J.L.H. Williams)**

Bush encroachment into grassland areas is a major problem in the province (Trollope and Coetzee, 1978). It is a problem in areas where incorrect stock ratios exist, i.e. where the ratio of goats to cattle is too low. Injudicious elimination of burning may also result in bush encroachment (Trollope and Coetzee, 1978). Bush encroachment limits the carrying capacity of veld. Replacement of a dense grass sward by trees aggravates soil erosion, because the full ground cover and dense root system of grass protects and stabilizes the soil against erosion (Plate 2.4).

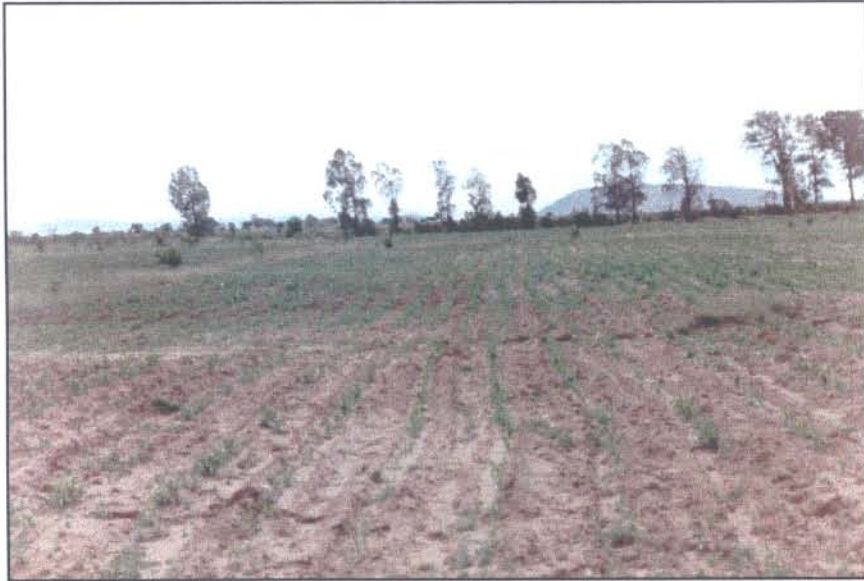
Plate 2.5-First signs of rill and gully erosion in an area incorrectly demarcated for cultivation by planners in the former Transkei (Photograph: Tracor, 1984)

Those areas are heavily eroded and many have been abandoned. One of such areas is the Lubisi Dam catchment area, where the planners recommended cultivation and production of sorghum on Sterkspruit soils as indicated by Tracor (1984). See Plates 2.5, 2.6 and 2.7.

The Lubisi Dam catchment area, where Plates 2.5, 2.6 and 2.7 were taken was ironically called a "rehabilitated" area. Instead of recovering, its condition deteriorated drastically because of the inappropriate rehabilitation measures and the Lubisi dam is silting up (Tracor, 1984).

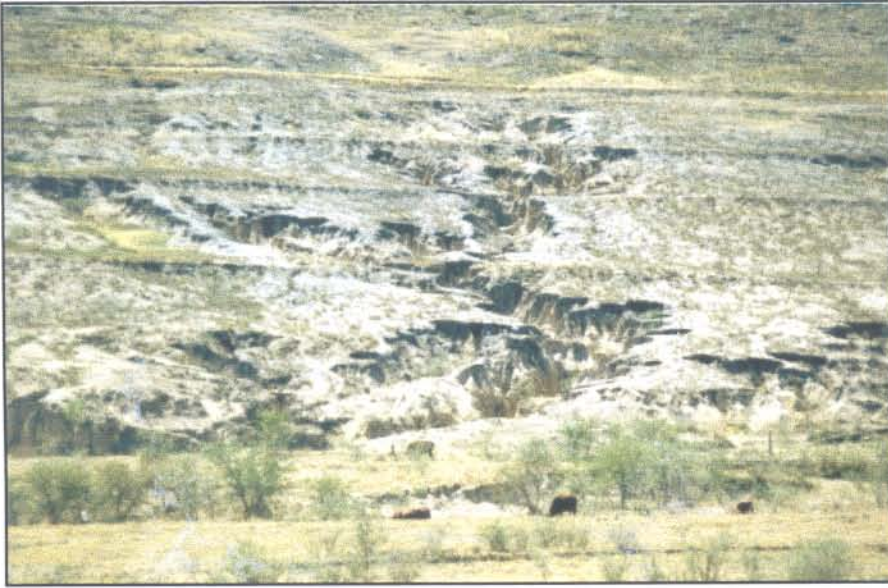
Plate 2.8 – Lack of recovery of abandoned planned cultivated area in Ciskei 10years after being abandoned. (Photograph: J.L.H. Williams)

A major problem is the low resilience (recovery potential) of the degraded cultivated areas. Laker (2000) gives an example of a degraded, abandoned cultivated area in the former Ciskei, which has not recovered more than 20 years after being abandoned (Plates 2.8 and 2.9). This is again an area that was demarcated for cultivation by planners during the 1960s. It was abandoned during the 1970s. Plate 2.8 was photographed in 1987 and Plate 2.9 in 1997. In both plates the contours are still visible. The important aspect is to look at the areas beside the gully. It is mainly bare patches with some small shrubs. This area used to be covered with excellent dense,

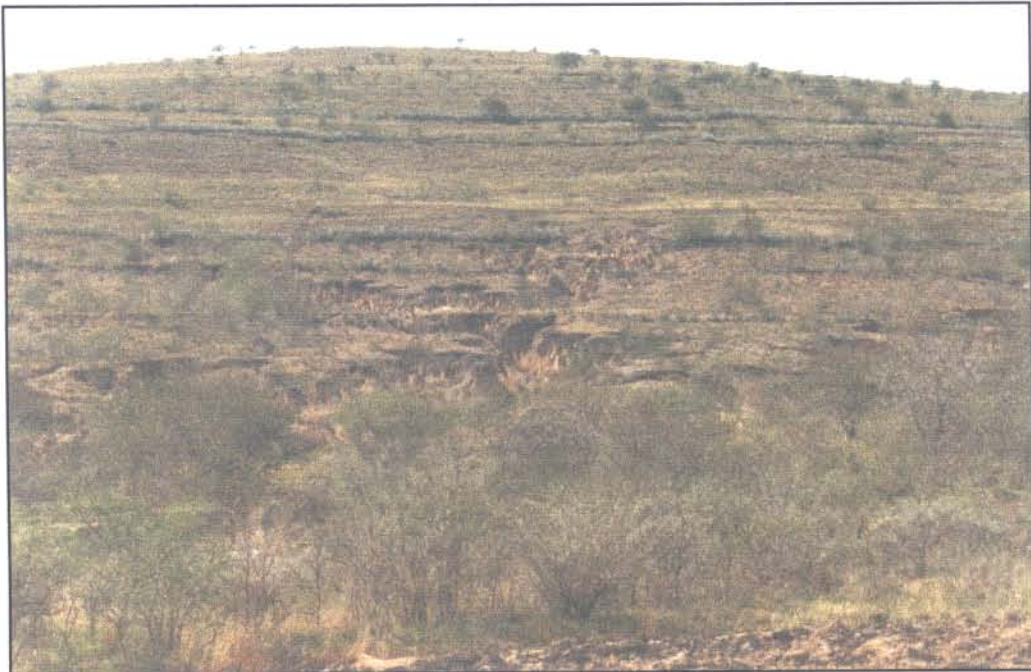
Plate 2.9 – Lack of recovery of the same area as in Plate 2.8, but now 20 years after being abandoned. *Agave americana* hedges planted in an attempt to arrest further degradation (Photograph: J.L.H. Williams)

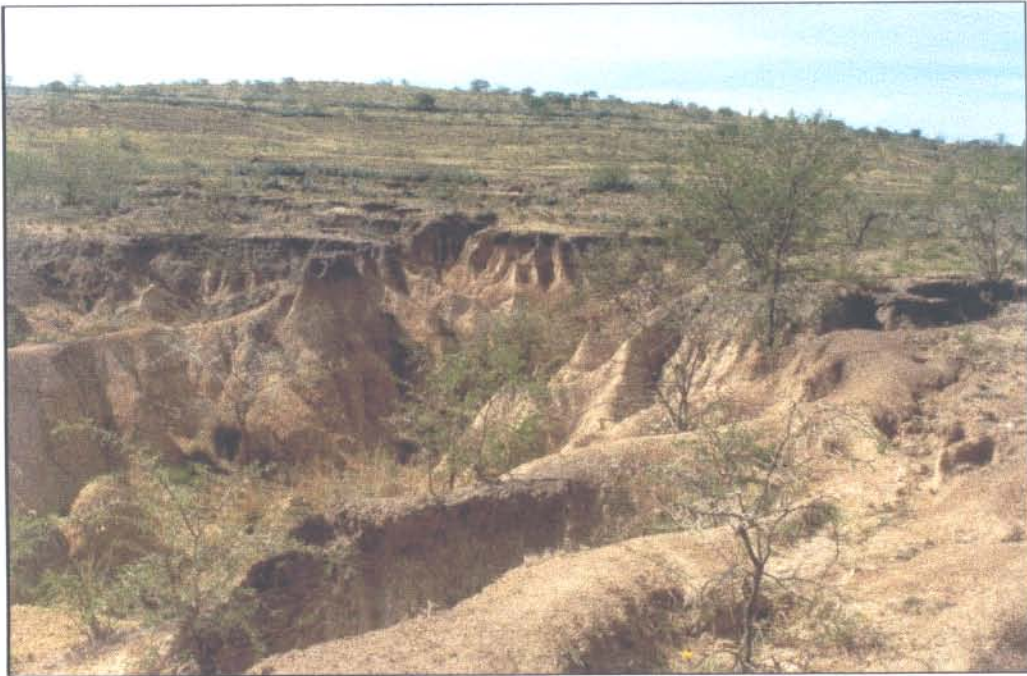
**Plate 2.10 – Size of the gully in the lowest lying part of the area depicted in Plate 2.9  
(Photograph: J.L.H. Williams)**

high quality grassland, which is simply not able to return. Plate 2.10 gives an idea of the enormous size of the gully, which developed in the lowest part of this area.

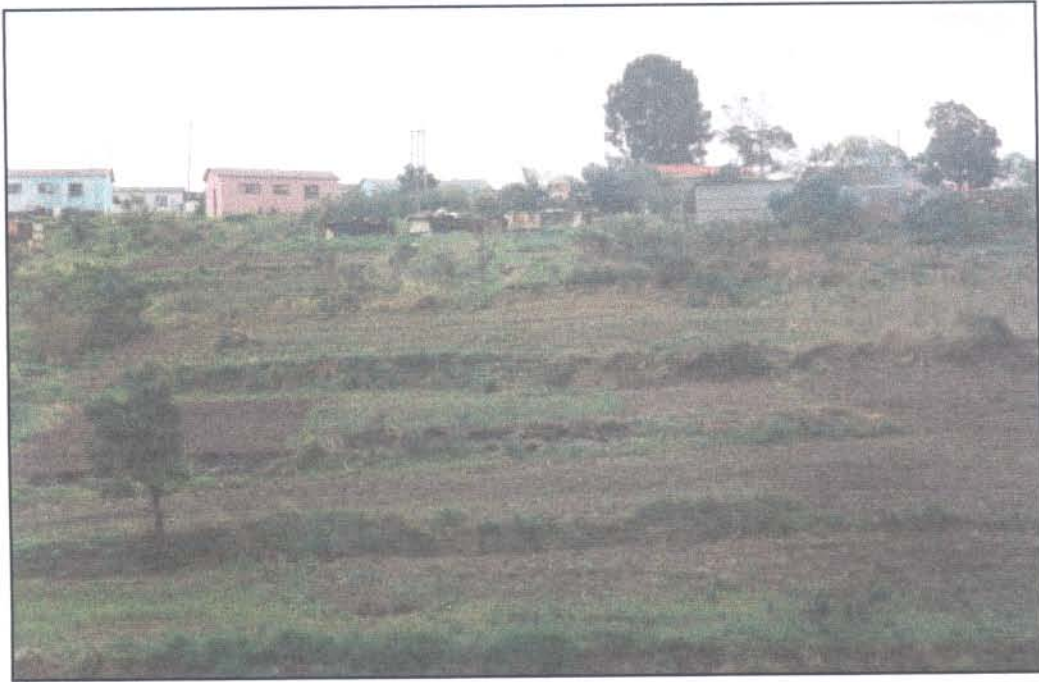
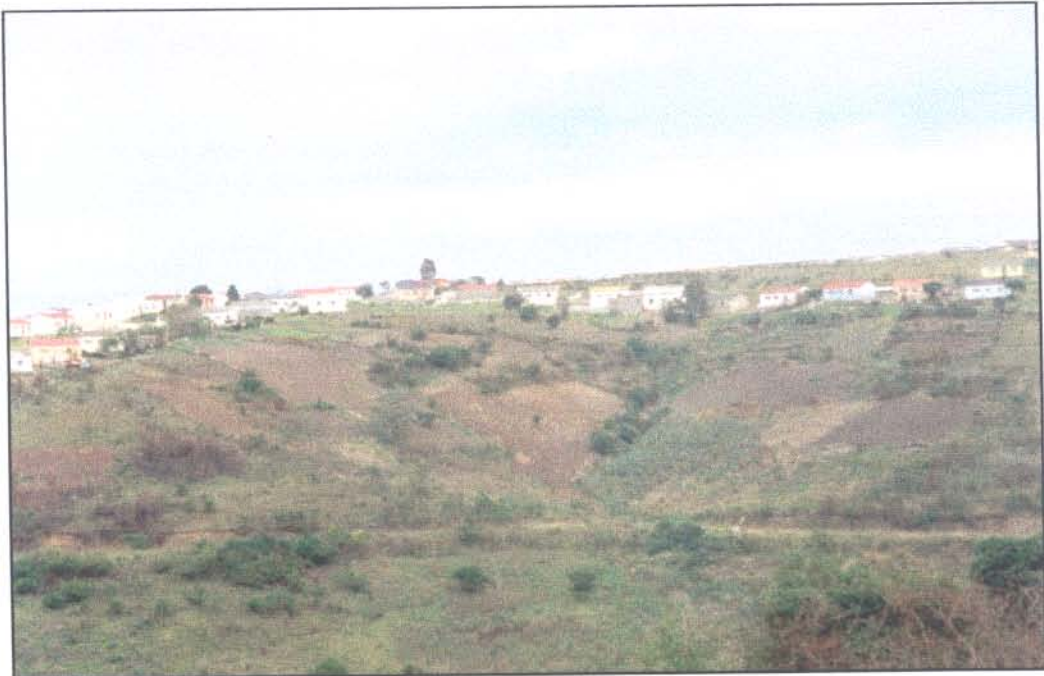
**Plate 3.1 – General layout of Mdantsane on hilltops (Photograph: N.N. Maswana)**

Mdantsane is the second largest township in South Africa and is situated about 15 km southwest from the city centre of East London. Mdantsane is situated in a steeply undulating area with hills with broad crests and deep, narrow gorges with very steeply sloping sides. The township has developed on the crests, with no residential development in the gorges, including their sides. This township is overpopulated and has got a very high rate of unemployment, hence people have resorted to intensive crop production in the open areas throughout the township, including the sides of the gorges where the terrain is very steep (Plate 3.1).

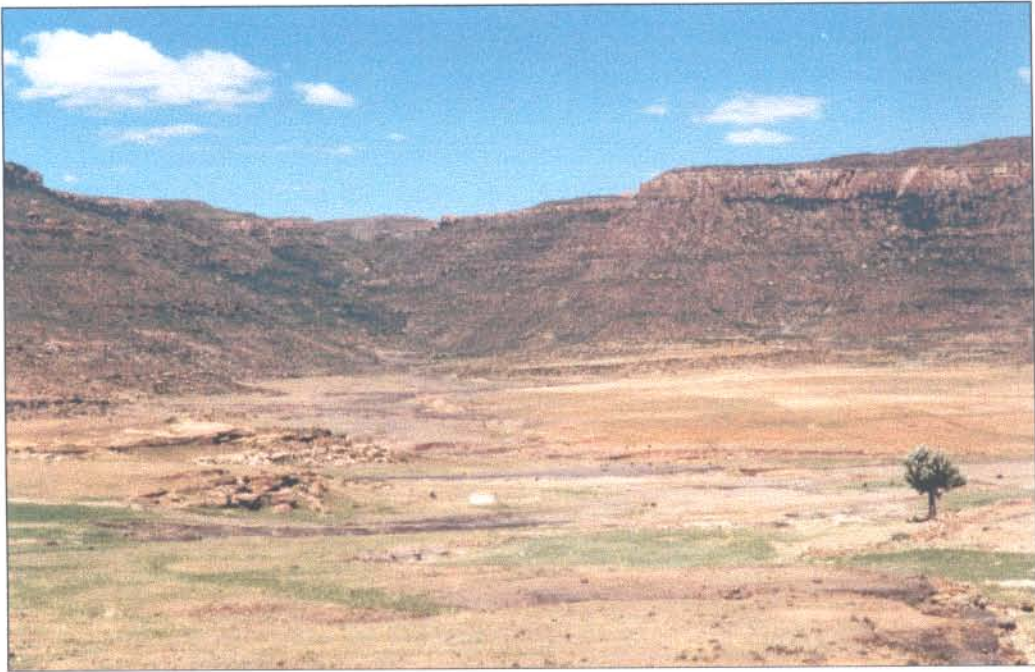
**Plate 3.2 – A typical Sterkspruit/Herschel scene with rocky mountains and severely overgrazed and eroded lowlands (Photograph: N.N. Maswana)**

More than 70% of the area consists of rock outcrops and very shallow soils (Hensley and Laker, 1975). The area is overgrazed and that has resulted in the exposure of the fragile soils to the rainstorms that are often encountered in summer (Plate 3.2).

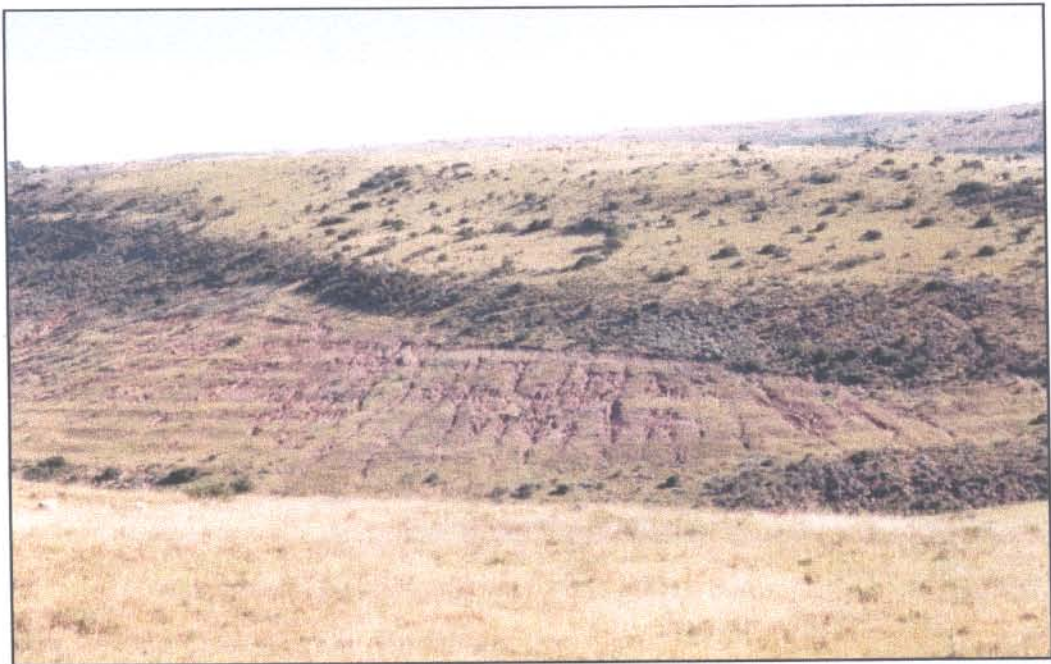
**Plate 4.1 – Abandoned cultivated area, demarcated by planners for cultivation, at Madliki. Note contouring still visible (Photograph: N.N. Maswana)**

Agricultural production is through dryland cropping. Poor yields are a norm due to poor resources (see Section 4.3) and bad farming practices. The croplands are typical of the drier areas of the Eastern Cape, i.e. severely eroded (with dense networks of big gullies), despite the fact that "betterment planning" determined their locality and contouring was done. As outlined earlier, this is due to the fact that the planners had inadequate knowledge of soils and did not adapt land suitability evaluation to the specific qualities of the different soils. Most people stopped ploughing and abandoned their arable lands due to soil erosion (Plate 4.1)

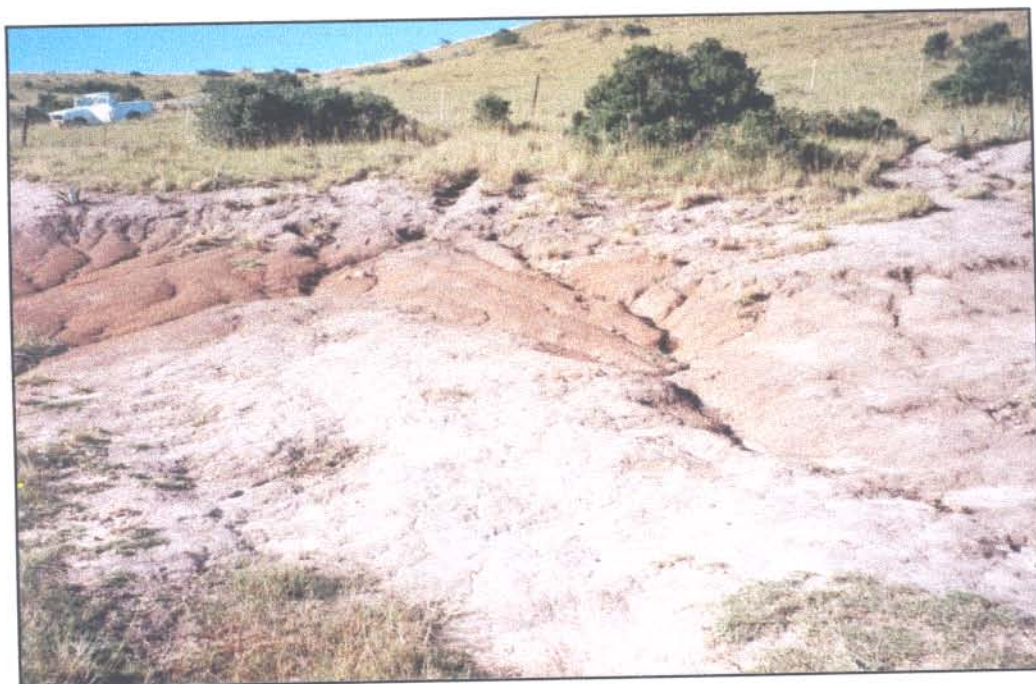
Plate 4.2 – Area with total topsoil loss through sheet erosion at Madliki. Rills and gullies starting to develop. (Photograph: N.N. Maswana)

Shallow soils are highly erodable, because they are easily saturated with water during a rainstorm, after which runoff starts (D'Huyvetter and Laker, 1985). These poorly structured soils are also very prone to crusting (surface sealing), thus having low water infiltration, excessive runoff and erosion. This is aggravated by the very low

organic matter contents of the soils. In most areas the topsoil has been totally washed away (Plate 4.2).

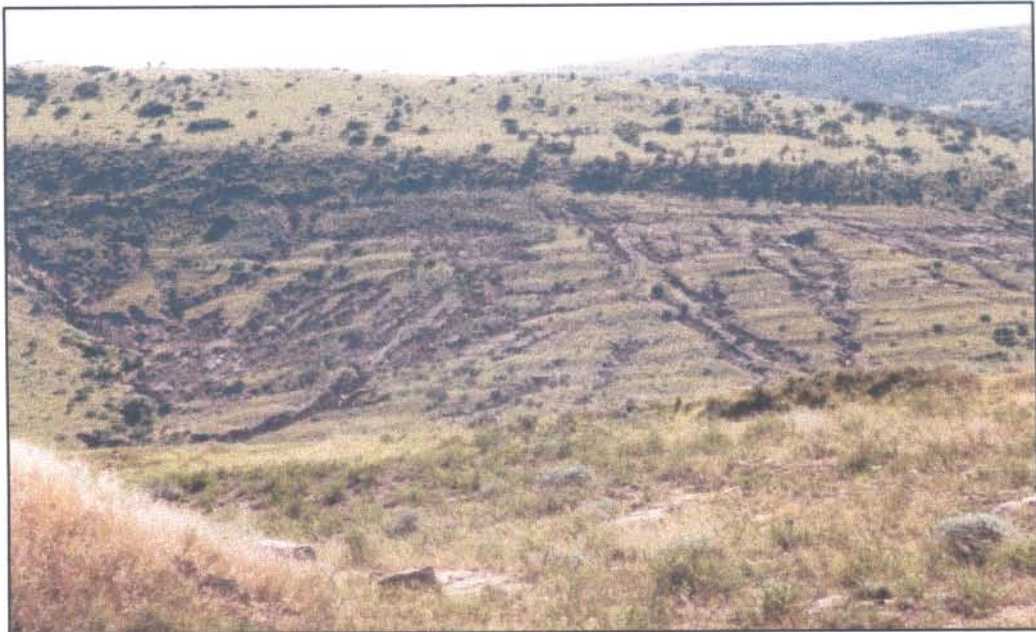
Plate 4.3 – Gully erosion in rangeland (left) and cultivated area (right) at Madliki. Note virtual total destruction of the area on the left. (Photograph: N.N. Maswana)

In addition huge dongas (gullies) have developed throughout the area (Plates 4.3 and 4.4).

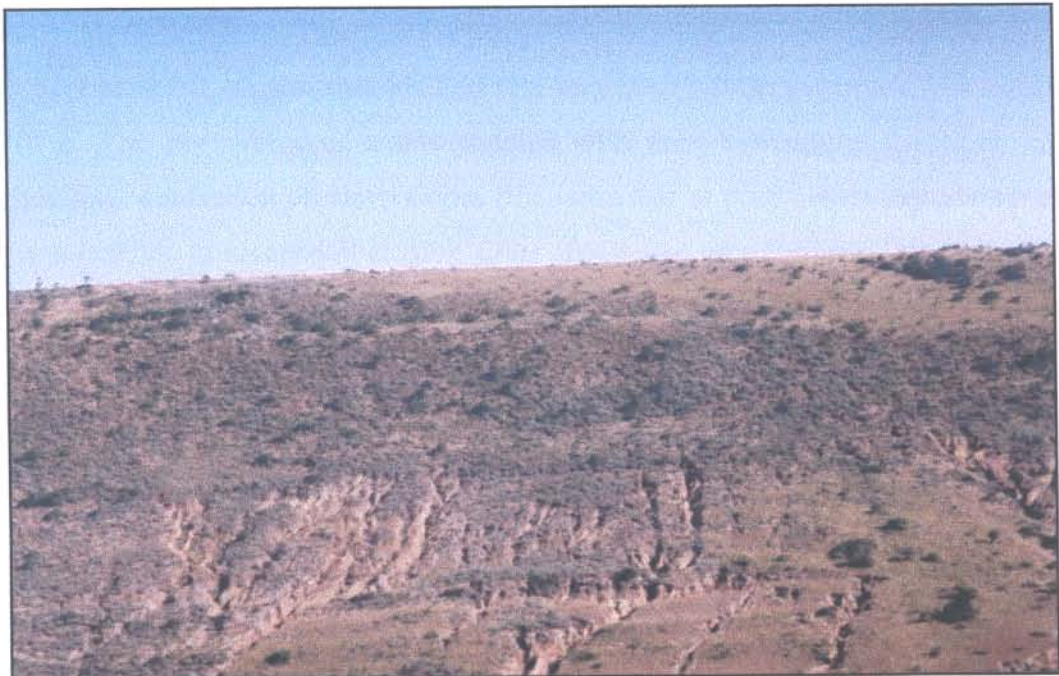
Plate 4.4 – Very dense network of gully erosion at Madliki. (Photograph: NN Maswana)

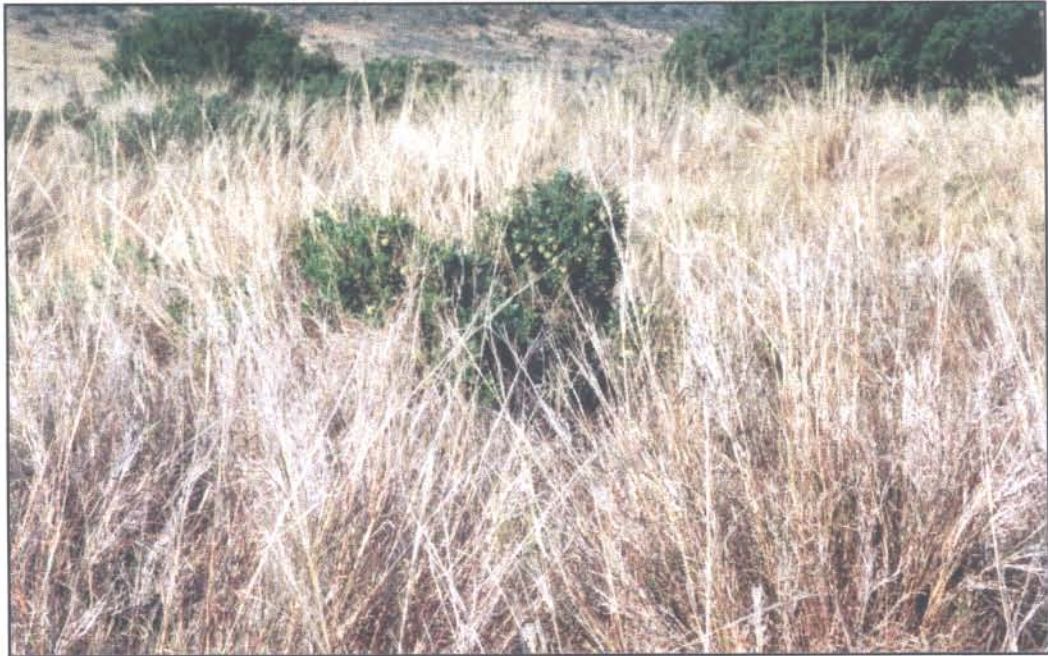
Plate 4.5 – Dense growth of grass and shrubs due to exclusion of livestock from the graveyard No 2 area at Madliki. (Photograph: N.N. Maswana)

Elimination of grazing due to exclusion of livestock encouraged natural growth of shrubs and grasses, i.e. it increased the amount of livestock fodder produced in the area, resulting in a tangible benefit to the community from excluding livestock from the area, apart from the erosion control of the sensitive graveyard area (Plate 4.5).

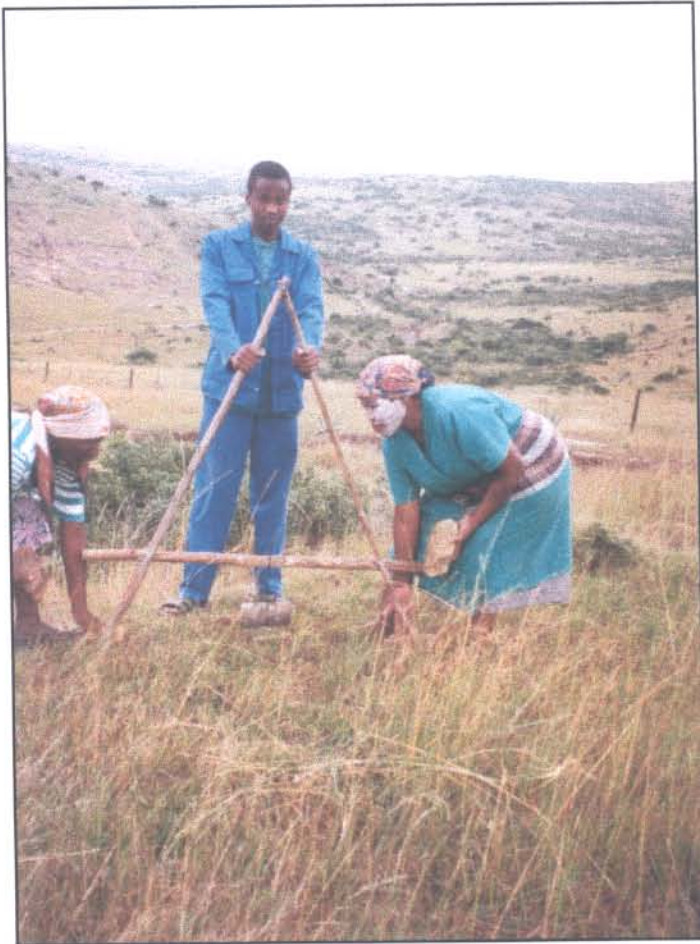
Plate 4.6 –The community in action, measuring out contours. (Photograph: N.N. Maswana)

Contouring was seen as one of the effective ways of reducing runoff, whilst enhancing absorption of water. An ‘A’ frame, with a plumb line attached to its

horizontal bar and a stone as plumb bob was used to mark level contour lines (Plate 4.6).

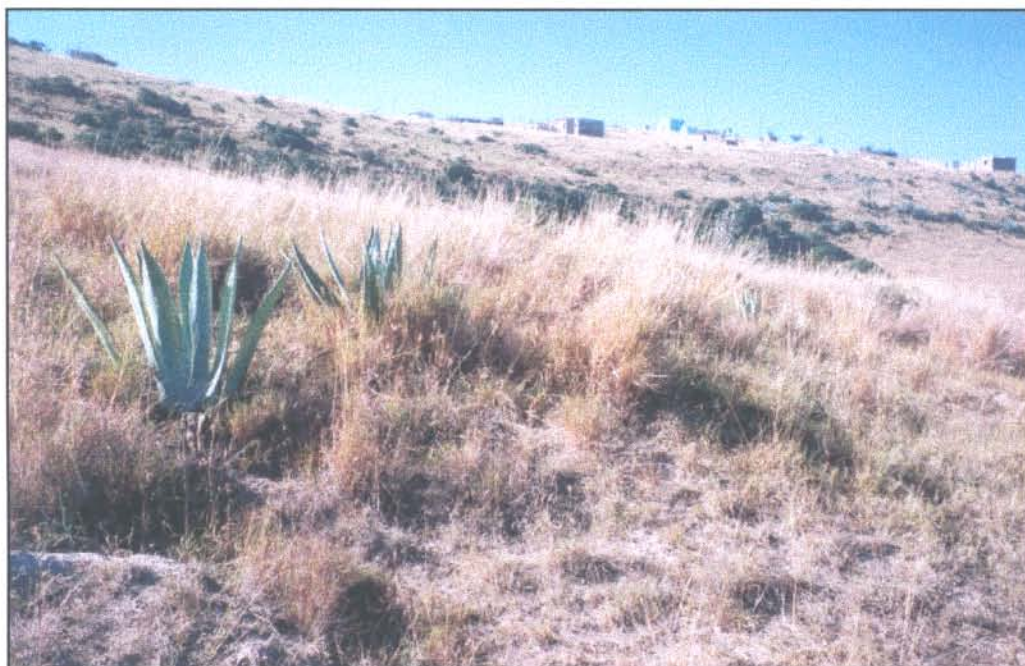
Plate 4.7 – Establishing of *Agave americana* seedlings to stabilize vulnerable areas  
(Photo: NN Maswana)

It was discovered that the dongas were being extended by erosion as the soil was collapsing from their sides and they were also eating upslope. Then it was decided to plant *Agave americana* seedlings in such vulnerable areas to stabilize the dongas. This was very successful in stabilizing the soil (Plate 4.7).

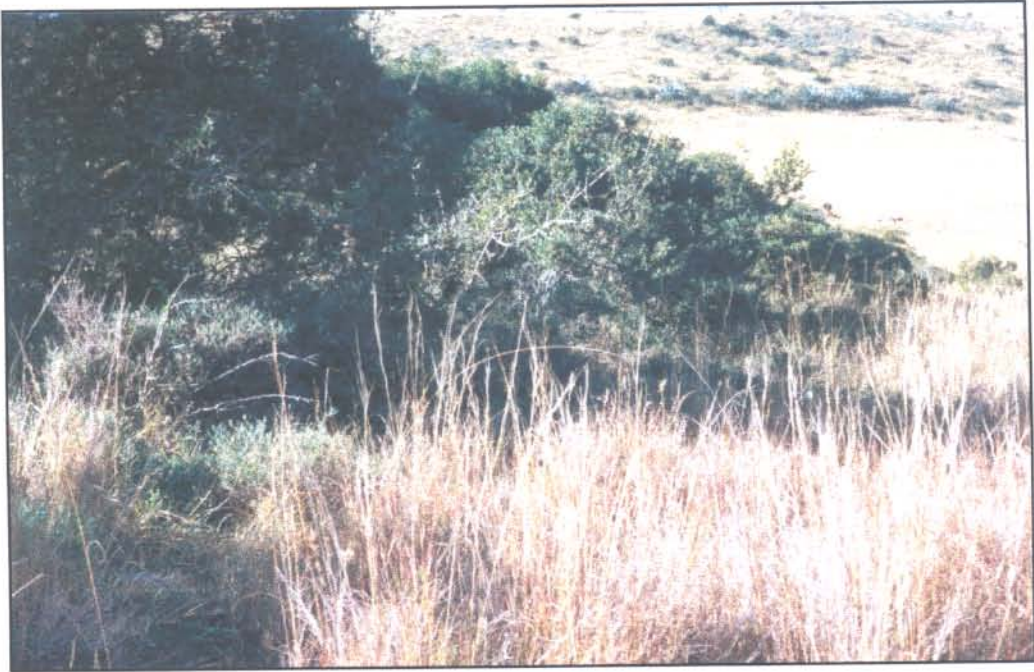
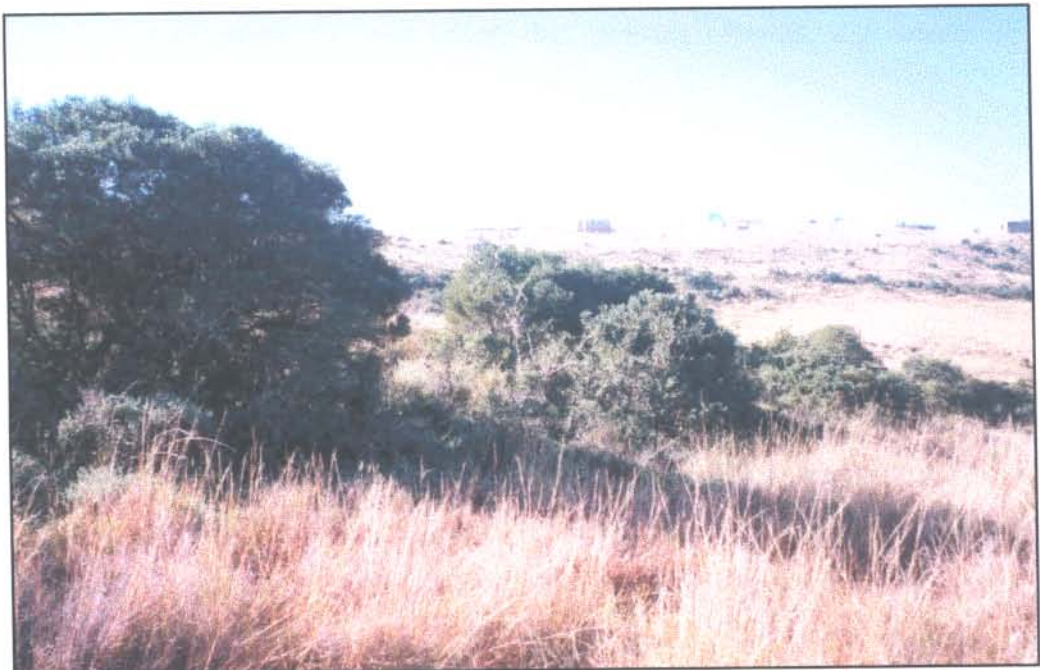
Plate 5.1 *Diosporos dichophilla* well established along the contours
