2.1 INTRODUCTION

The remainder of the chapter intends to clarify an understanding of the chosen site. The site is defined in focus on a number of scales. Since the 1909 CEO / 2011 POPUP building finds context in a number of scales, it is these contexts which will be explored and analysed. The study will consider both, the entire POPUP site, and the 1909 CEO / 2011 POPUP building.

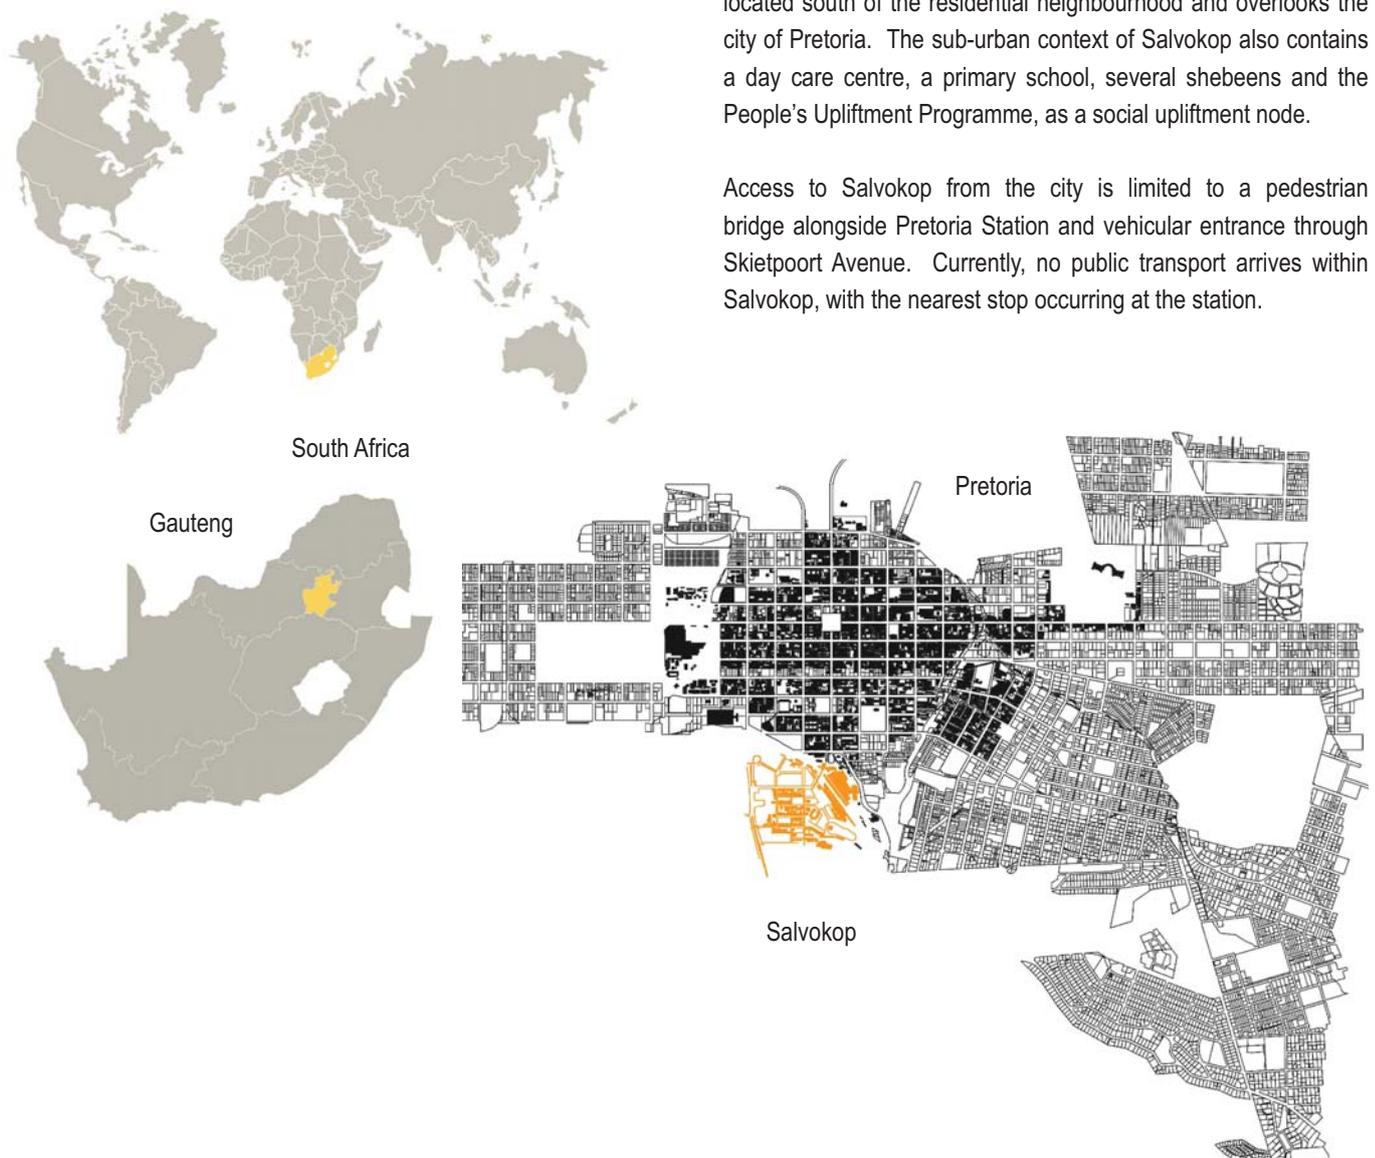
Illus 2.1 Locality Maps (Author, 2011)

The region of Salvokop is located south of Pretoria's central business district (Illus 2.1). Its current programme predominantly consists of low density housing in historical railway houses as well as informal structures. Freedom Park, a world heritage site, is located south of the residential neighbourhood and overlooks the city of Pretoria. The sub-urban context of Salvokop also contains a day care centre, a primary school, several shebeens and the People's Upliftment Programme, as a social upliftment node.

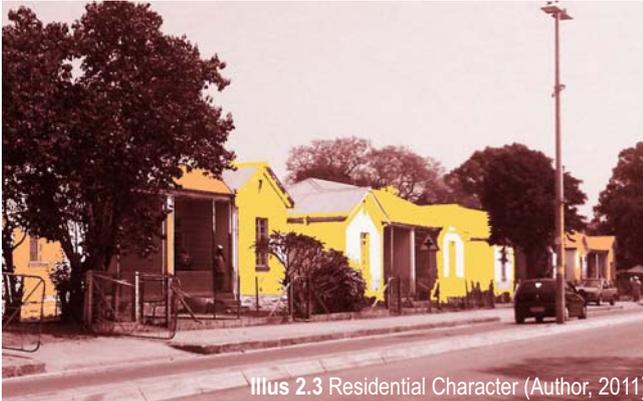
Illus 2.3 Residential Character (Author, 2011)

1. Residential (Illus 2.3): The historical railway houses of Salvokop provide a distinct character to the neighbourhood. Their scale, relationship with the street edge and interior to exterior transition (stoep) all form positive urban characteristics in this neighbourhood, creating a pleasant pedestrian environment.

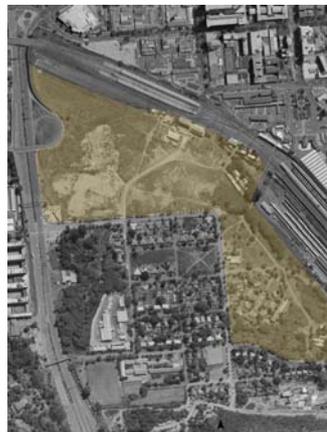
Illus 2.4 Breathing Space
(Google Earth, 2011) edited by
(Author, 2011)

2. Breathing Space (Illus 2.4): The neighbourhood of Salvokop can be strongly characterised by the substantial landscape buffer between the city and Salvokop, along the edge of the railway line. This green space isolates Salvokop and protects it from the noise, pollution and traffic of the city.

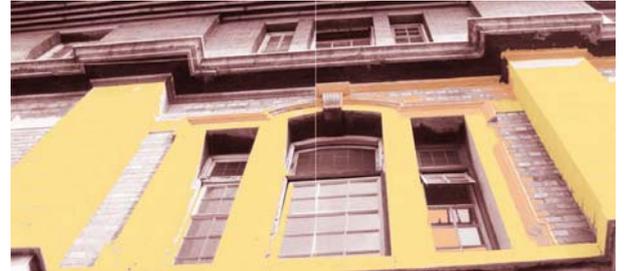
Illus 2.5 Historical Character (Author, 2011)

3. Historical (Illus 2.5): The neighbourhood of Salvokop was developed to service the railway line from the 1880's. The settlement's legacy of historical architecture and infrastructure remnants has partially survived. Currently, while many historical buildings still exist, their presence is threatened by the development of the new Gautrain station along the railway line, access routes to Freedom Park and lack of maintenance. These historical structures include two typologies of railway housing, the 1909 Chief Engineer's Office (now occupied by POPUP), an abandoned shed along and several obsolete railway lines.

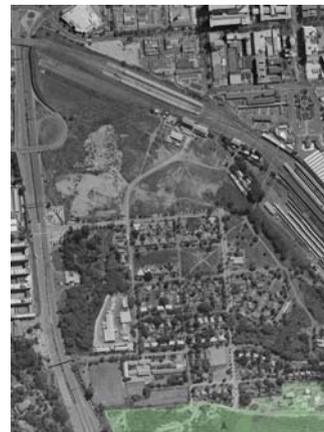
Illus 2.6 Ecological Systems
(Google Earth, 2011) edited by
(Author, 2011)

4. Ecological Systems (Illus 2.6): The ecologically diverse landscape systems in this region have been predominantly destroyed due to lack of maintenance. The restoration of these historical landscapes has been partially addressed in Freedom Park (Freedom Park, s.a.). This provides opportunity for precedent in landscape rehabilitation and the creation of green urban spaces.

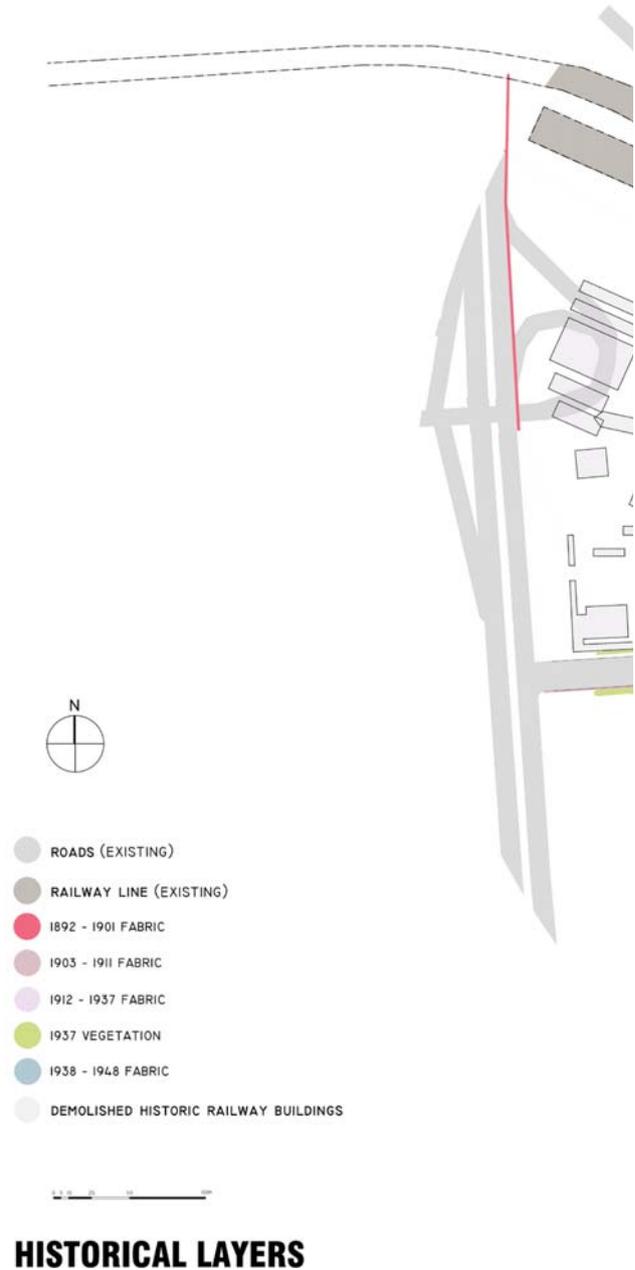
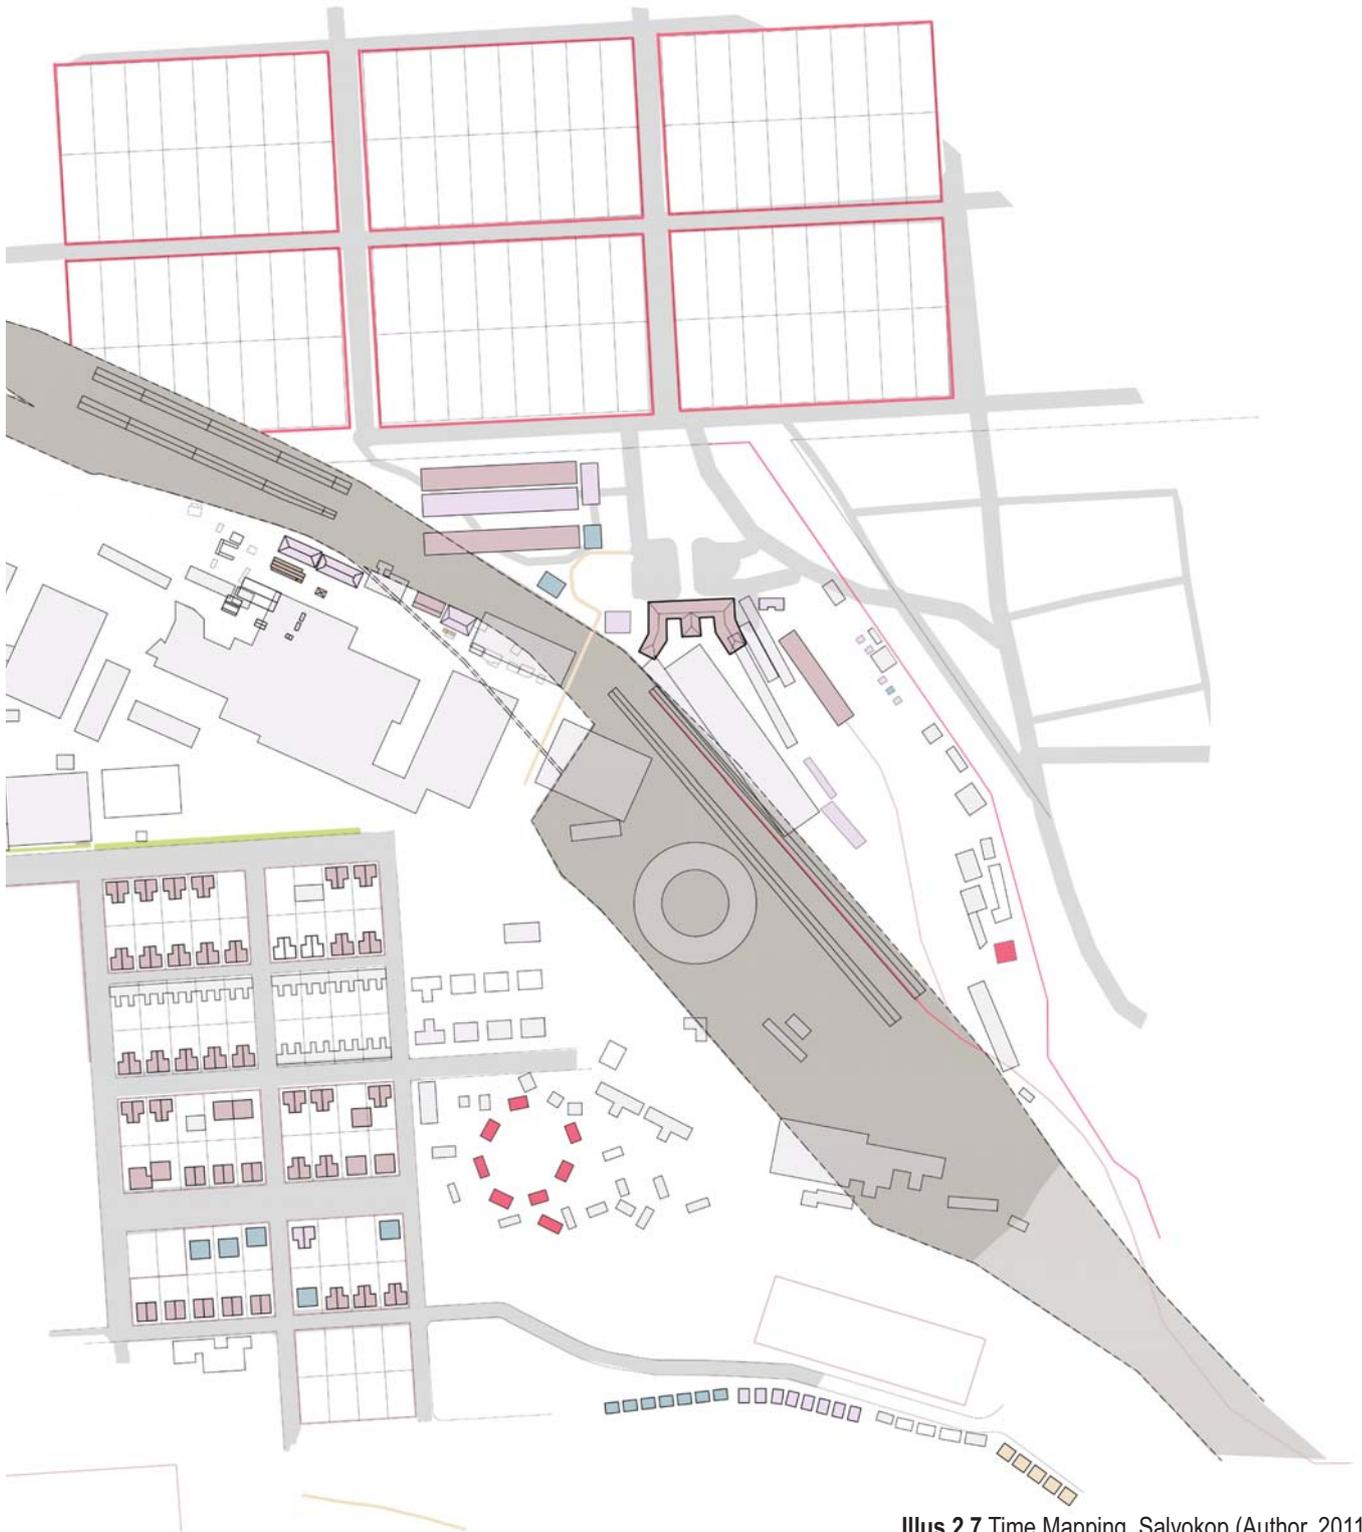
Illus 2.7 Time Mapping, Salvokop (Author, 2011)

A record of building development through time has been mapped as demonstrated alongside in Illus 2.7.

The mass demolition of fabric in the maintenance yard is of note and could provide design direction, especially with regards to expressing memory.

This map contextualises the relationship between the 1909 Chief Engineer’s Office and other built fabric in Salvokop over time.

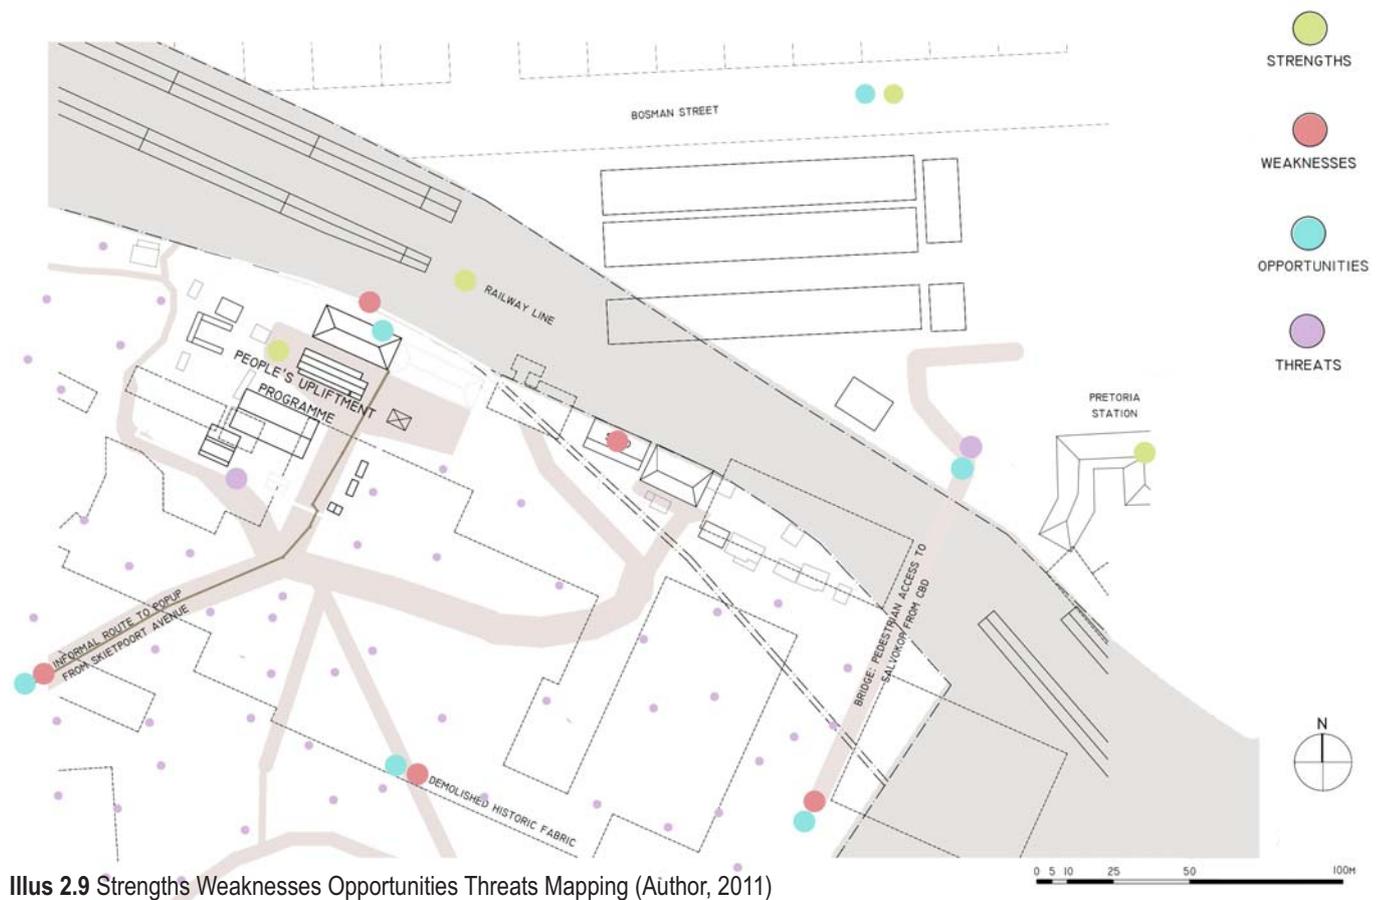
Illus 2.9 Strengths Weaknesses Opportunities Threats Mapping (Author, 2011)

The following site analysis (Illus 2.9, Illus 2.12) is limited to the boundaries of POPUP's site. The analysis identifies the existing allocation of programme on POPUP's site and analyses the site through the following categories: Urban to Interior (Illus 2.10), Sense of Place (Illus 2.11), Internal Spatial Quality (Illus 2.13), Space and Use (Illus 2.14), and Alterations and Additions (Illus 2.15). The analysis is represented through identification of strengths, weaknesses opportunities and threats and extends itself to the interior of the 1909 CEO / 2011 POPUP building.

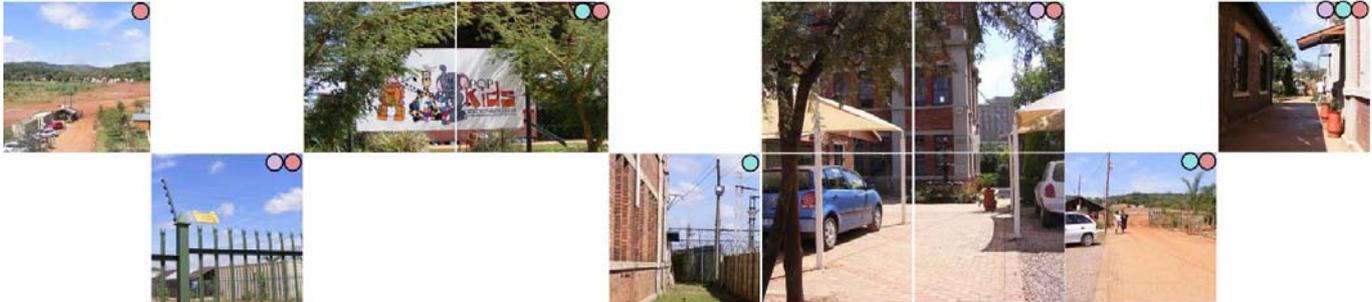
Illus 2.10 Urban to Interior (Author, 2011)

POPUP's site is accessed from the South through an informal dirt road. Its site is located along the railway edge and is isolated from the nearest street (Skietpoort Ave) by the unprogrammed landscape described as the "breathing space" in chapter 2. Its accessibility is visually and physically poor. POPUP's site is completely fenced, further removing it from its context.

POPUP's site is disconnected and buildings are scattered and isolated. Structures range from permanent and load bearing (brick and concrete) to lightweight and temporary (portal frames and prefabricated classrooms). The railway environment is not acknowledged.

The 1909 CEO / 2011 POPUP building is crowded by carport structures, the brick medical clinic and the brick services and soup kitchen buildings alongside.

There is a poor sense of entrance to any of the buildings since they exhibit poor relationships to each other. The entrance to the 1909 CEO / 2011 POPUP building is overcrowded by the services and soup kitchen building, a wasted opportunity given the hierarchal elements celebrating the entrance, symmetry and axis.

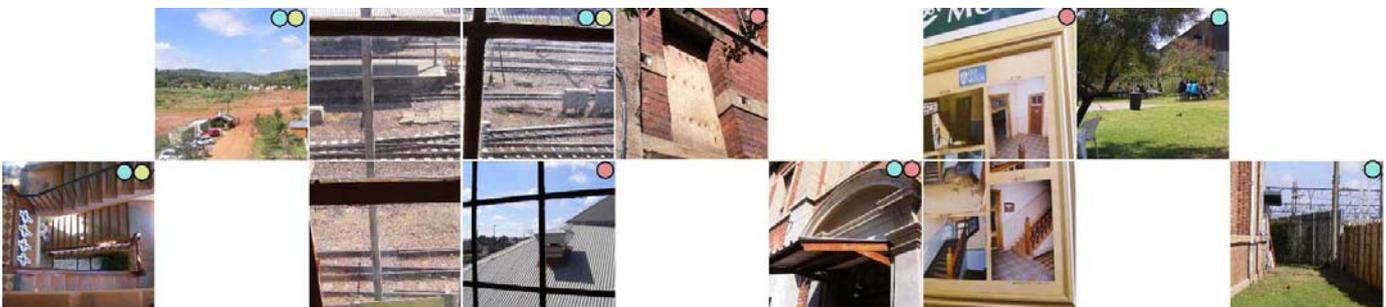
Illus 2.11 Sense of Place (Author, 2011)

POPUP's site displays potential for the incorporation of views and vistas. From the 1909 CEO / 2011 POPUP building, immediate views to the railway line, as well as distant views to Salvokop's neighbourhood are available but under utilised. Interior vistas include the staircase, which is open and visible from the lobby of each level in the building. The staircase is a beautiful building element with arts and crafts influence.

The building, although having been restored partially in 2002 (Bakker, 2002) is still incomplete in a sense. The historical bridge leading from the building across the railway line had been removed. Its void has been uneventfully enclosed by a sheet of shutter board, posing aesthetic and safety threat to the building.

POPUP's site does not address the railway edge. It is removed from its context and chooses to fence itself in as opposed to integrating with its historical connection to the railway line. The Gautrain Station development on the opposite side of the railway line provides the opportunity to revive this connection and interest to the building and POPUP's site. Although the site is located along the railway edge, frequency of trains through the day are minimal and the noise from these momentary, providing little disturbance.

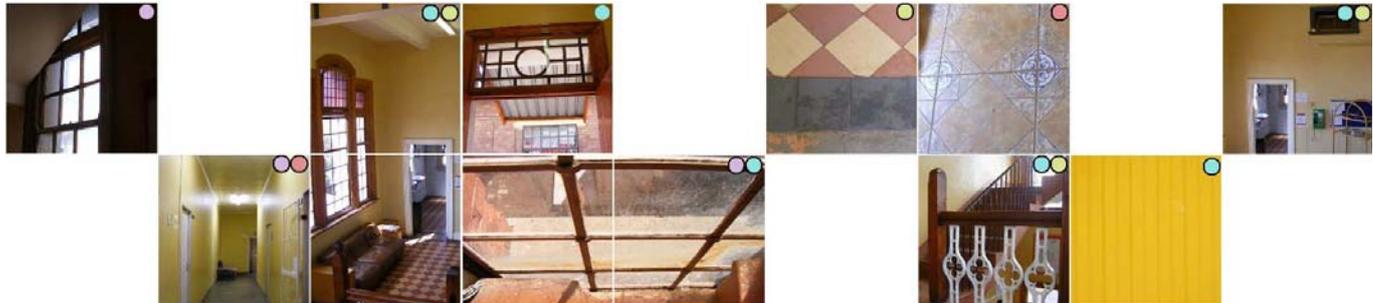
Illus 2.13 Internal Spatial Quality (Author, 2011)

The 1909 CEO / 2011 POPUP building exhibits excellent consideration for natural light and volume. Its high and frequent windows allow the passage of natural light into the building. The ground and first floors are double volume, creating a sense of public hierarchy. The open staircase, emphasises the building volume and is surrounded by windows and well illuminated. The 2nd floor, an addition to the building in the 1950's represents a weakness in this regard. It is single volume, enclosed, depends on artificial light during the day and has no visual connection to the exterior, making it a threatening environment.

The historic materiality of the building has been partially preserved, restored (windows and frames) and replaced (floor tiles). The original floor finish of terracotta tiles still cover most of the floors. Other floor areas have been finished with vinyl, screed and ceramic tiles. Walls are brick and mortar finished with plaster and paint. The third floor also contains wood panel partitioning. The staircase balustrades consist of carved varnish posts and cast iron filling.

The building is naturally ventilated through windows. Passages pose a potential problem in ventilation, being far from windows and could require assisted ventilation. The building is thermally comfortable.

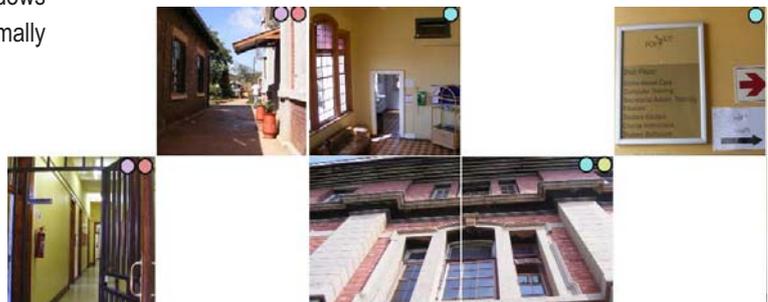
Illus 2.14 Space and Use (Author, 2011)

The rectangular floor plan of the building implies versatility since it is not prescribed or particular. The double volume creates opportunity for the development of new mezzanine spaces. The symmetrical structure and frame and infill system can allow ease of removal of fabric and expansion.

The building facade displays strong hierarchal sense of entrance and arrival through ornamented openings. Once inside the building, however, an idea of public to private spaces is only understood through signage and is otherwise implied by seating furniture in the lobby of each floor.

Signage style varies from temporary to permanent and does not have a sense of continuity in the building. Its locality is inconsistent on each floor. Signage on the third floor, brushed aluminium wall mounted rectangular signage, is more permanent, informative and tactile.

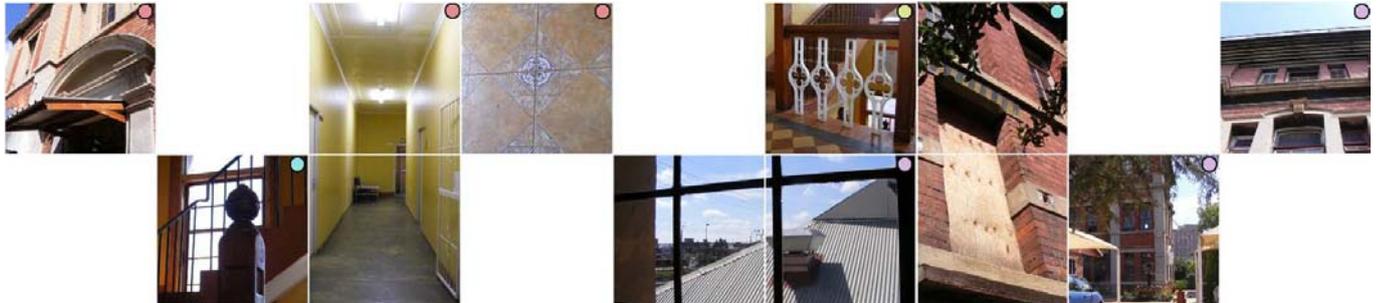
Illus 2.15 Alterations and Additions (Author, 2011)

The building has been restored in several areas. Extensive restoration of timber door and window frames have occurred. Some doors have also been restored. Several portions of the concrete door and window ornament have been restored.

The building has been preserved in several aspects: the terracotta tiles, the staircase and its cast iron fill have been preserved.

A bridge from the building across the railway line to Scheiding Street had been removed. The void has been covered with a shutter board sheet.

The addition of a second floor occurred in the 1950's. The parapet gables were used as a means to inform the continuity of the facade. A gabled roof on timber trusses now caps the building. The enclosure of the portico on the west of the building occurred concurrently.

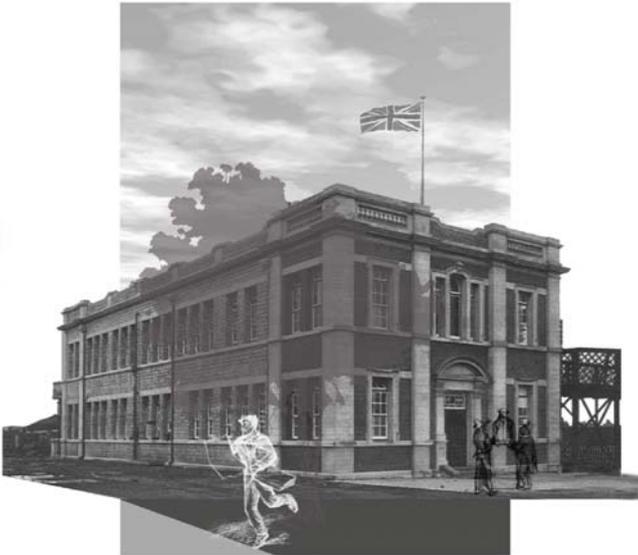
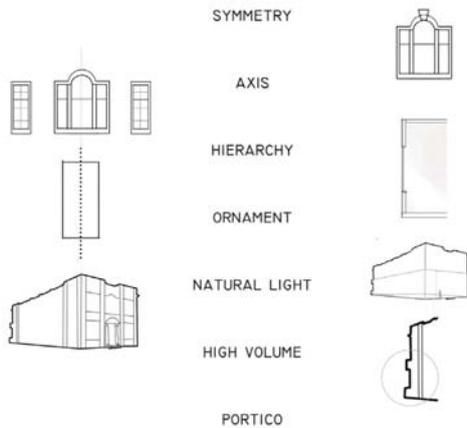
Illus 2.16 Establishing Ideal (Author, 2011)

The stripping back method, as outlined by Fred Scott (2008: 108) has been considered as the design method for treating the altered building. The process of stripping back involves three stages, the first of which is “establishing the ideal” (Scott, 2008: 108). The ideal is defined as the building’s utopian form, its original vision. To determine the “historical ideal” of the 1909 CEO / 2011 POPUP building, an analysis of the building’s early image has given rise to the recognition of its major design elements. The figure alongside (Illus 2.16) illustrates these principles in diagrams. The historical character pertaining to these principles are predominantly evident on the building facade.

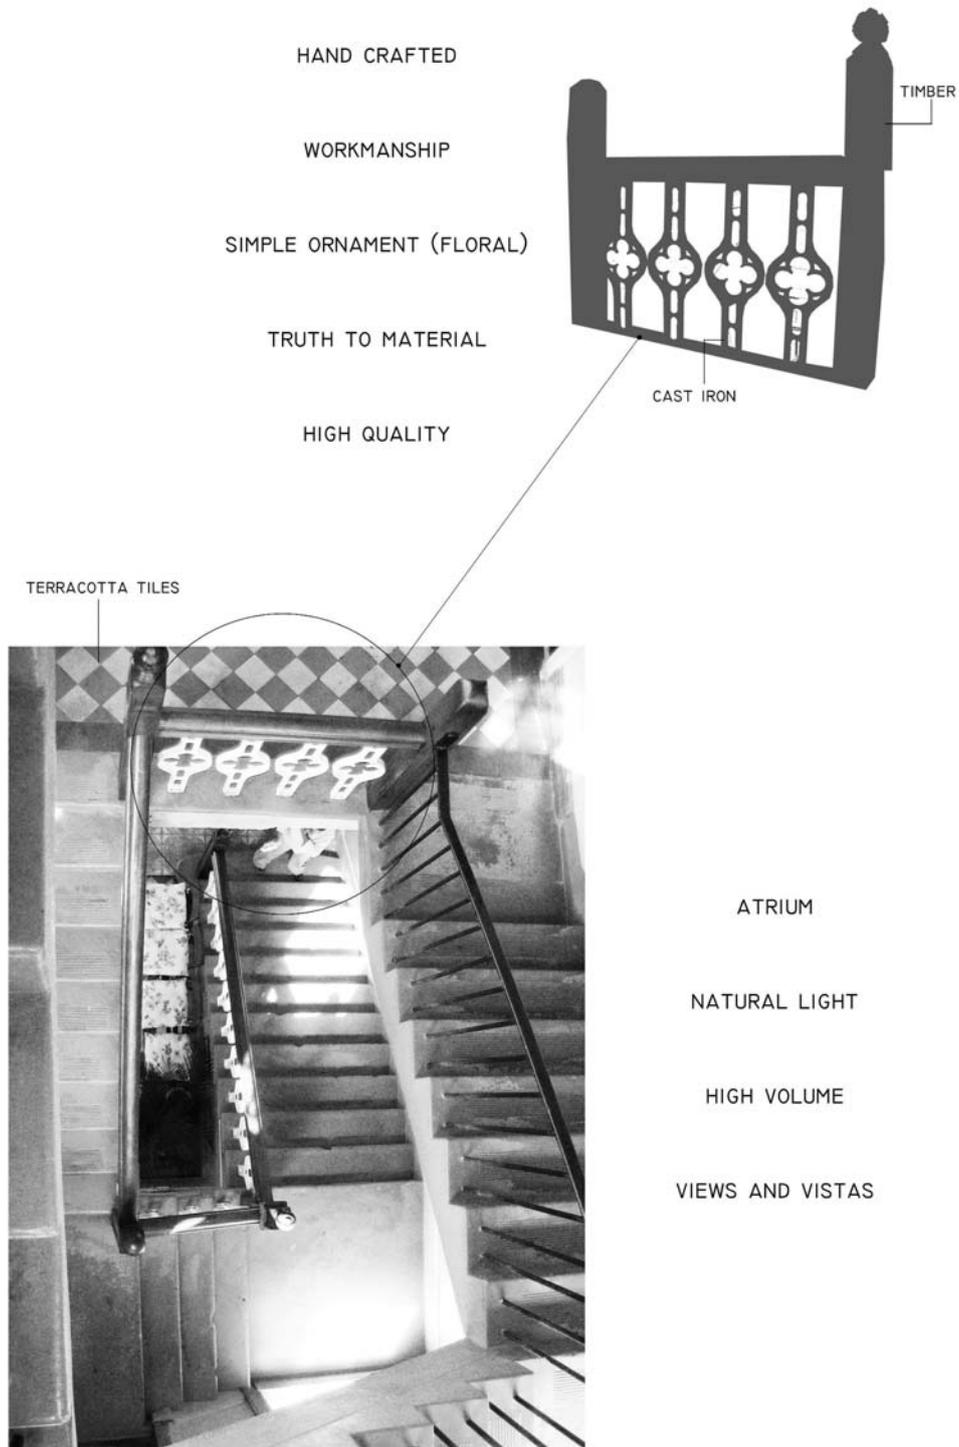
Illus 2.17 Establishing Ideal (Author, 2011)

Also illustrated is the building’s internal staircase (Illus 2.17), identified as an “ideal” element as a result of its distinctive character and balustrades of arts and crafts style. The application of terracotta tile finish on the staircase and first floor are notable.
