Appendix A

Hove's Drift

University of Pretoria etd - Butcher, A (2003)

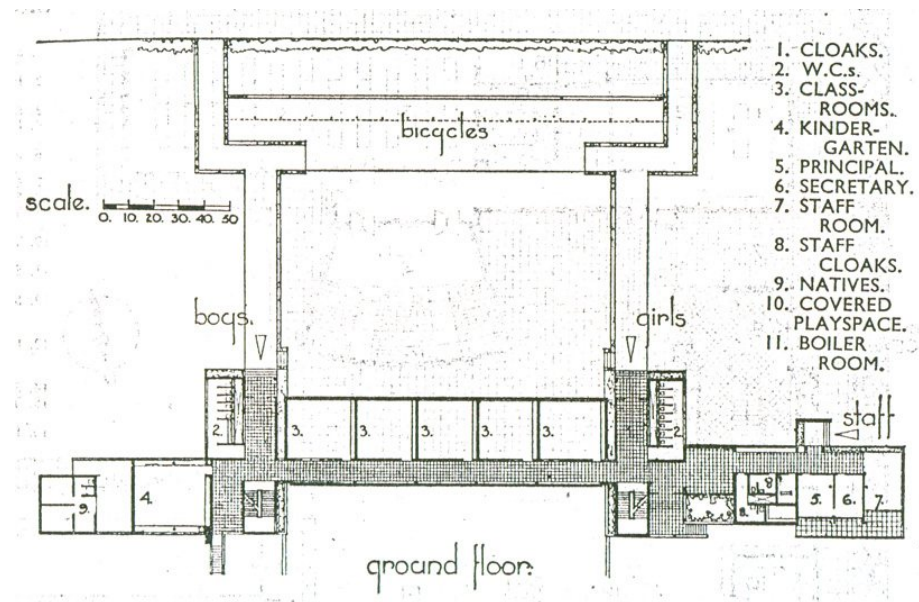
A.01 Ground Floor plan of the original building (Richards, 1944, pg 113)

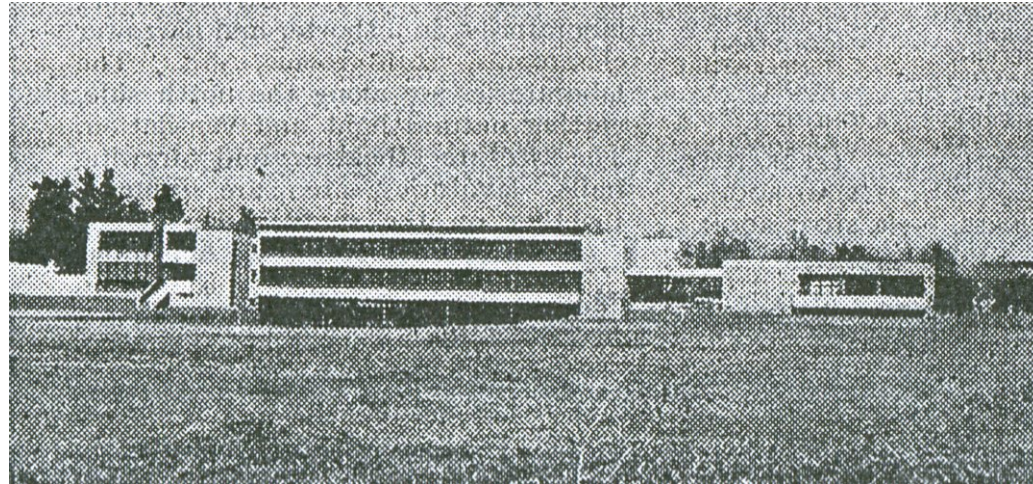
A.02 North elevation of the original building (Richards, 1944, pg 113)

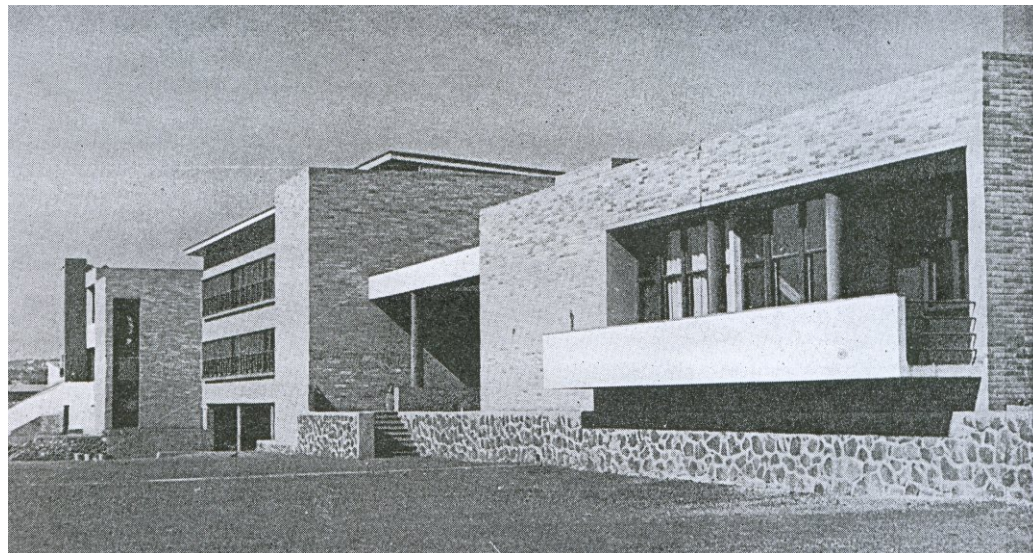
A.03 North west elevation of the original building (Richards, 1944, pg 113)

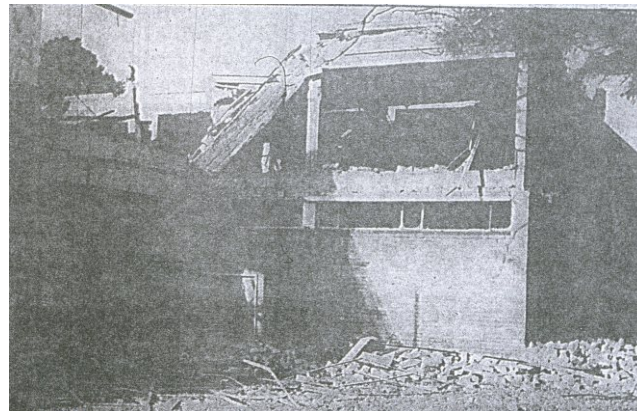
A.04 Damage to the main school building from the first bomb (Wolhuter, 1991, pg1)

'scorched earth' policy and became quite apparent when on 15 July 1991 at 1:50am, a bomb exploded from inside a first floor classroom of the main school building partially destroying it. Blame was placed on the Boere-Vryheidsbeweging although they denied having anything to do with the bombing (Dunn, 1991, pg1).

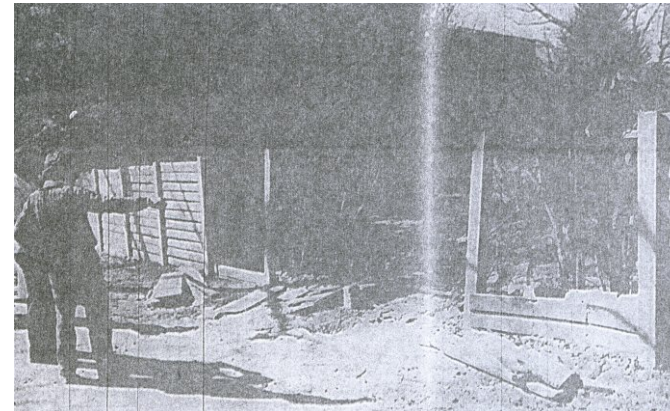
A.05 Damage from the second bomb along Du-Toit street (Pitso, 1991, pg1)

One week later on 22 July 1991 at 1:24am a second bomb exploded on the campus, this time on the boundary of Dr Savage Street leaving a 5m hole in the concrete perimeter wall. The leader of the Orde-Boervolk, although denying involvement, stated that all 'white' schools standing empty

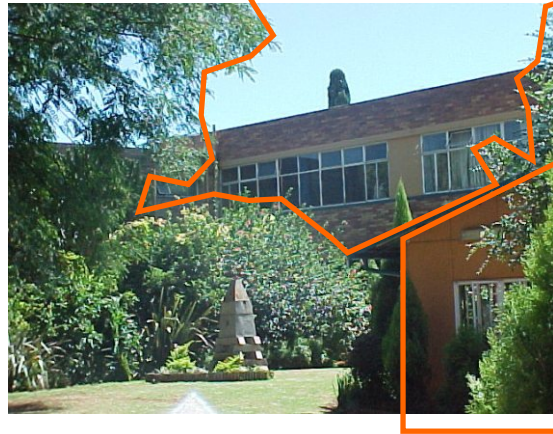
A.06 South elevation of the original building from the entrance to the campus. To a certain extent, the landscaping celebrates the building by framing it, however overgrowth should not hide the building any further. The small prefabricated security hut has no architectural merit and does not respect the *place* behind (Burra, 1998, chapt3.1).

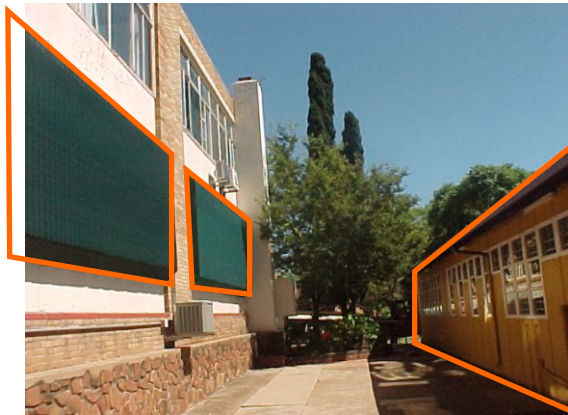
A.07 North elevation. When change is being considered, a range of options should be explored to seek the option which minimises the reduction of cultural significance (Burra, 1998, chapt15.1). Sun shading was obviously a necessity, however the materials used (shade netting) are very inappropriate and reduce the merit of the building. Fortunately their nature makes them very temporary.

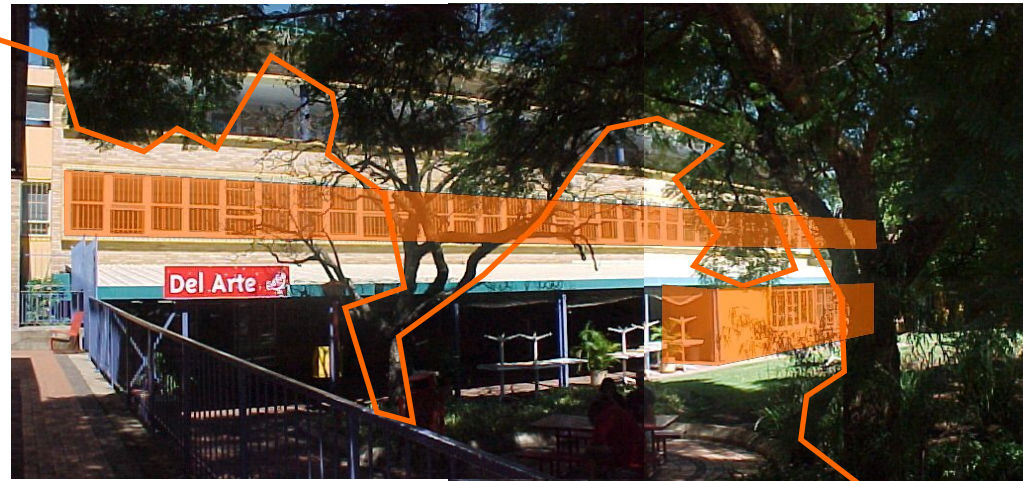
A.08 North elevation, showing classrooms and cafeteria. Permanent fixtures that change the character of the building are the strip windows on the ground floor and the cafeteria additions. These should have been designed in such a manner that they stood apart from the building, thus becoming easily identifiable (Burra, 1998, chapt15.1).

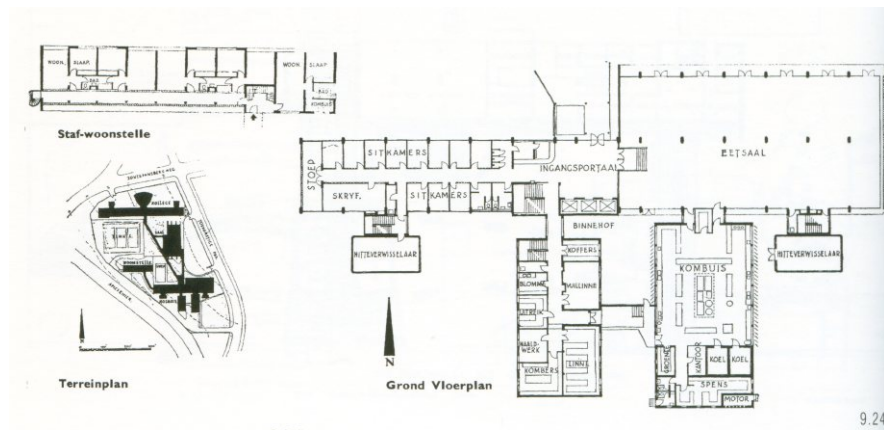
B.01 Site plan and ground floor plan of staff facilities (Gerneke, 1998, pg228)

The site plan (Fig.2.56) indicates the original design intended for paths leading to social and recreational spaces along

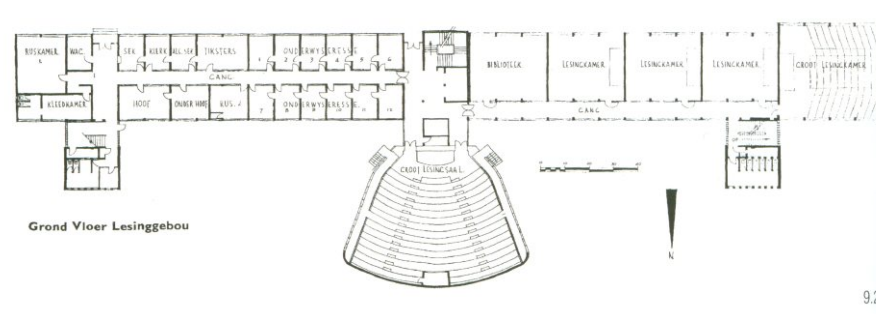
B.03 Lecture hall ground floor plan (Gerneke, 1998, pg228)
