5

Site Analysis

5.1 Context

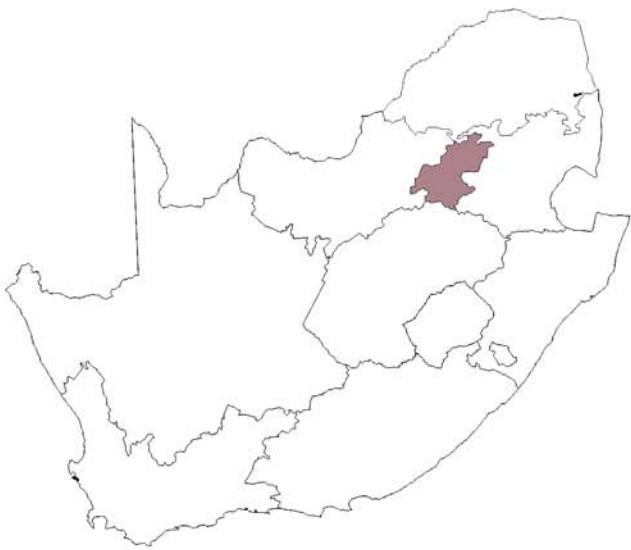
Illus. 5.2: Location of Gauteng in South Africa. Not to scale (manipulated by Author, May 2011)

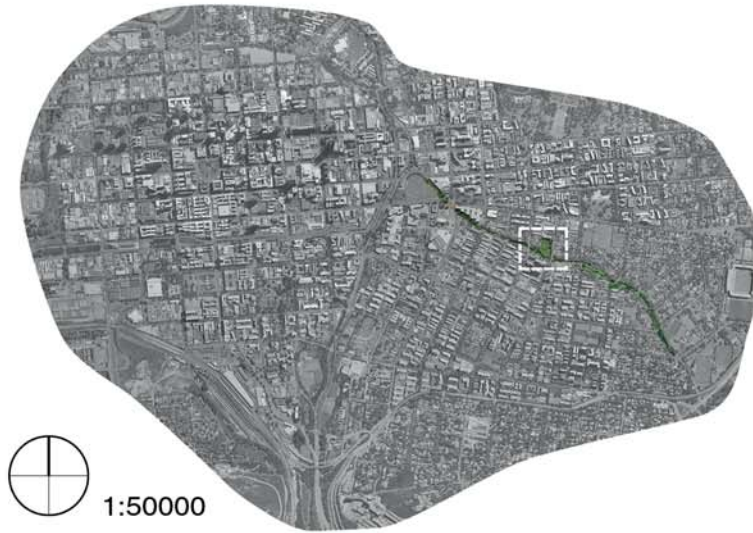
Illus. 5.5: Aerial photo showing the site within greater Pretoria. Note how the streets run perpendicular to the Walker Spruit, based on the layout of irrigation furrows. (manipulated by Author, May 2011)

Sunnyside as a suburb was incorporated into Pretoria in 1890. Some old houses still exist to the eastern side, while large five- to seven-storey housing blocks dominate the western and southern part of the suburb. The direction of irrigation furrows influenced the layout of the area (note how the streets run perpendicular to the Walker Spruit on Illus. 5.5.) (South Africa, Map of Pretoria and suburbs, [s.a.]).

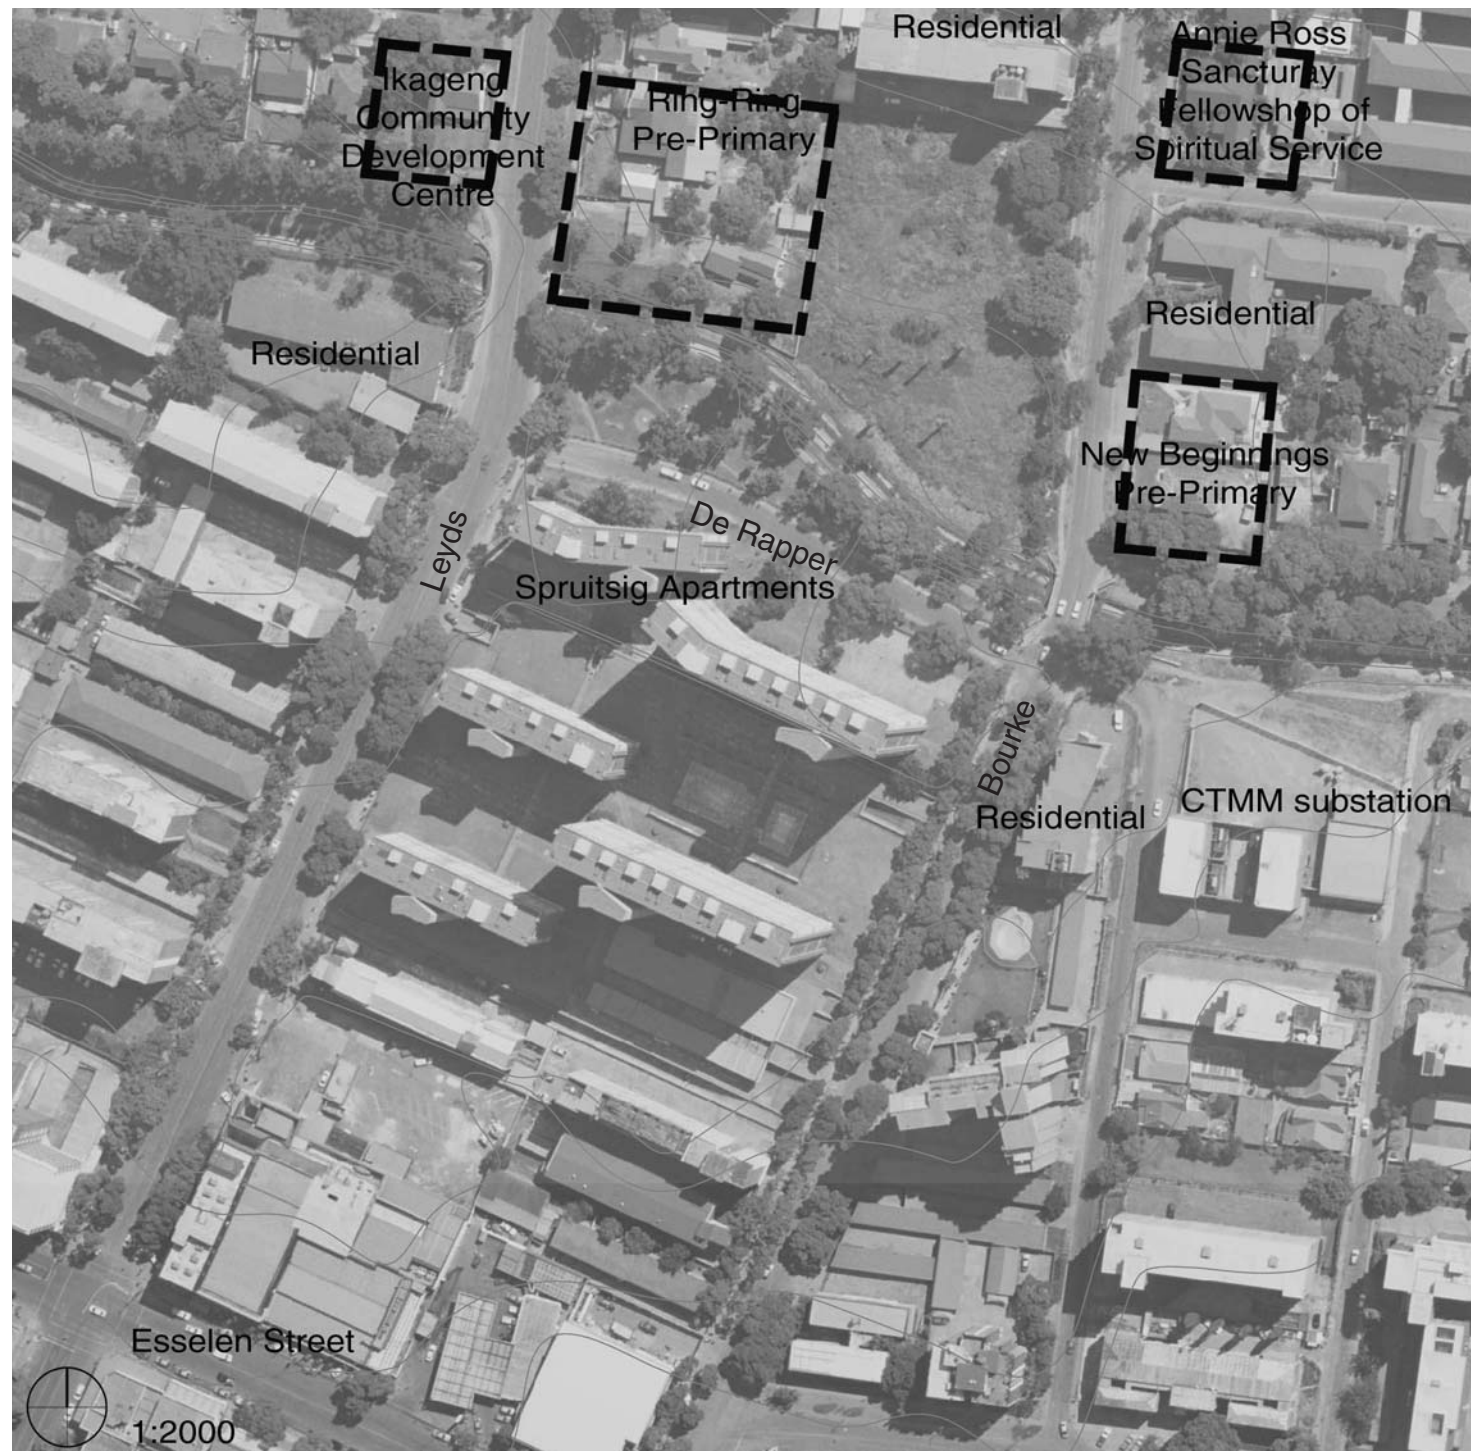
As indicated on Illus. 5.6, the site is bordered to the South by Spruitsig Park, which consists of five apartment blocks with a total of 531 flats. De Rapper Street, a quiet one-way, separates the site from the

apartment blocks. To the north another housing block of six storeys overlook the site. On the east side, a crèche, a housing block and a church face the site. The Ring-Ting Pre-Primary school is on the west side of the site. The site is one block north of Esselen street, the economic vein of Sunnyside.

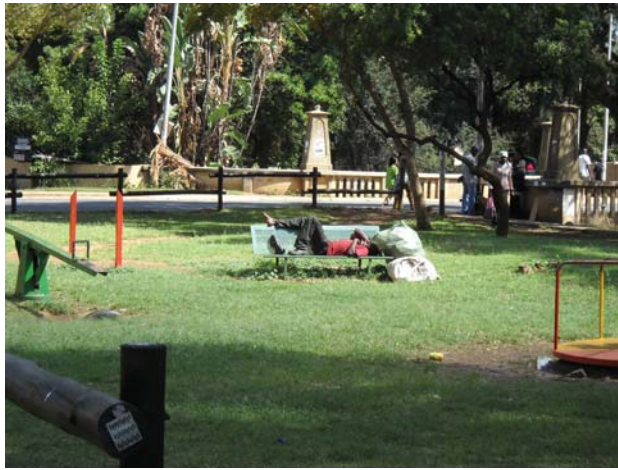
Illus. 5.7: Homeless people appropriating park furniture. (Author, April 2011)

There is constant pedestrian traffic along Leyds, Bourke and de Rapper streets. On the north-eastern corner of the site about seven homeless individuals live permanently. They wash themselves and their laundry in the Walkerspruit, drying their laundry along the banks. During the day, they use the existing street furniture to sleep on (Illus. 5.7).

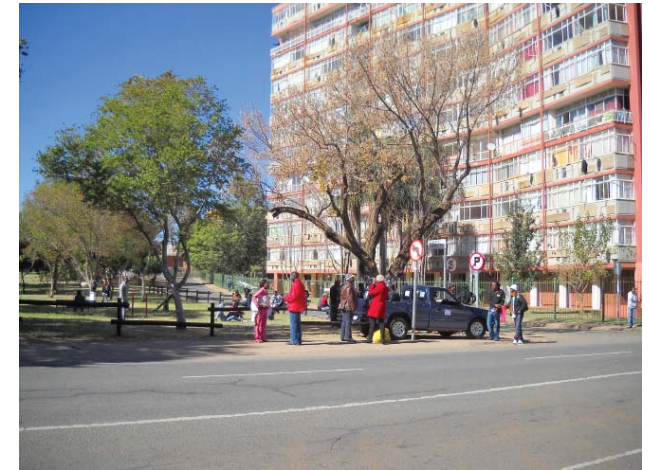
Illus. 5.9: Informal gathering space on the corner of Leyds and De Rapper Streets. (Author, July 2011)

Some children use the existing play equipment, and a few lunch goers were observed. At the western-most edge of the site, a natural gathering space has formed (Illus. 5.9). A tree in the space is used to pin up advertisements.

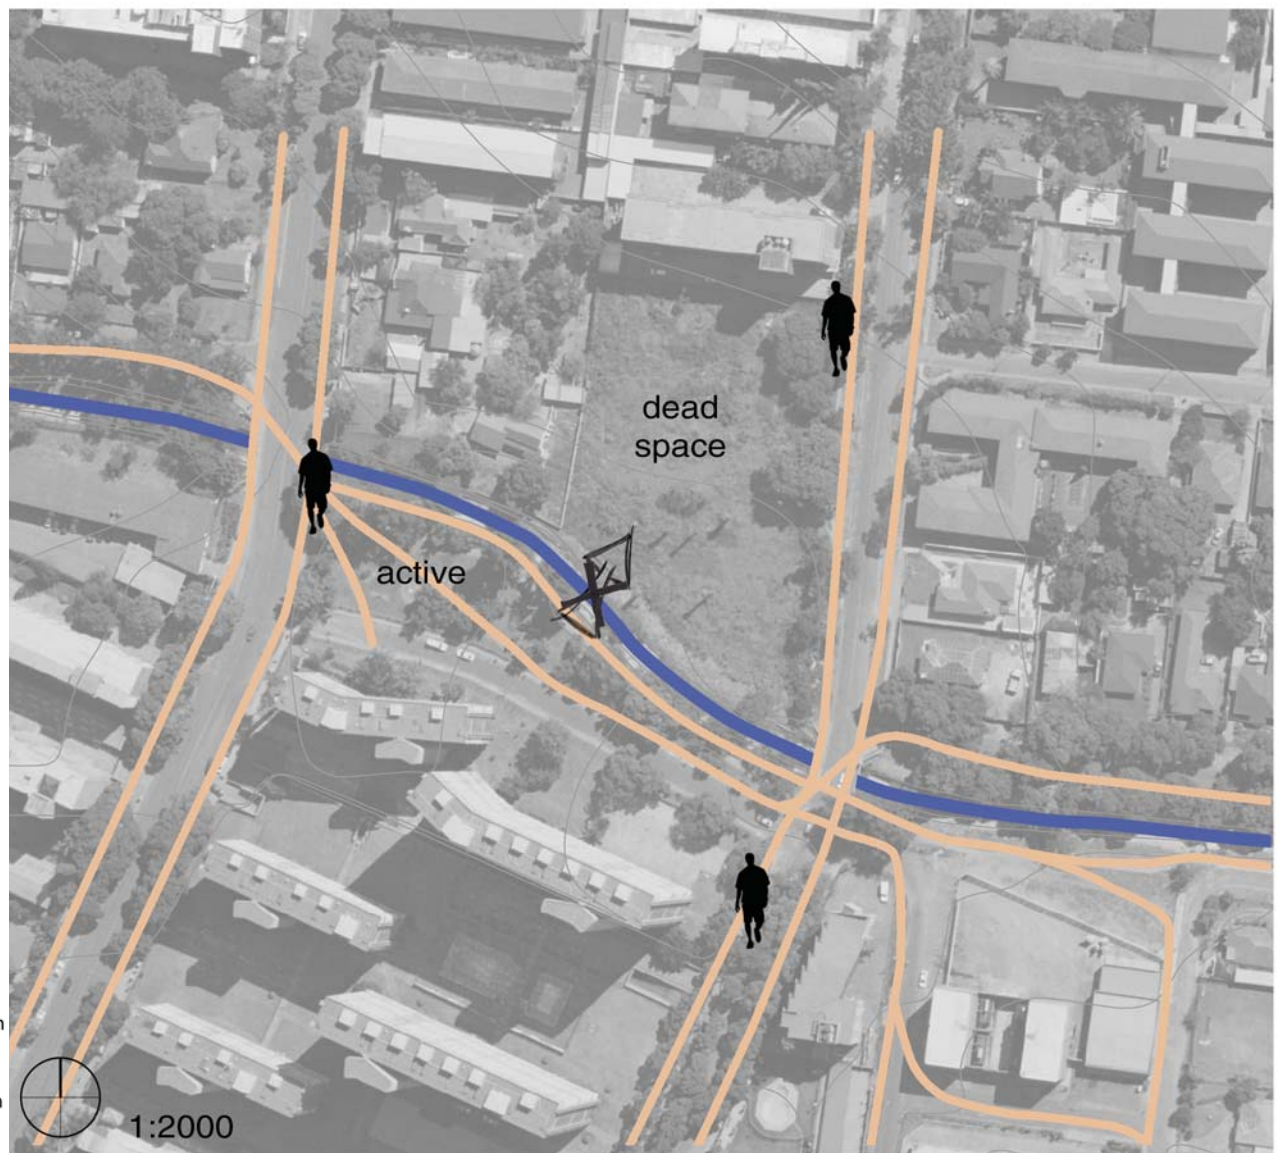
Illus. 5.10: Movement and access on site (Author, April 2011)

The southern part of the site has the most activity, while only homeless people use the northern part of the site (the Spruit acts as a barrier and prevents people from taking the shortest route right across the site). A few street vendors sometimes trade at the positions shown on Illus. 5.10. They are however not permanently

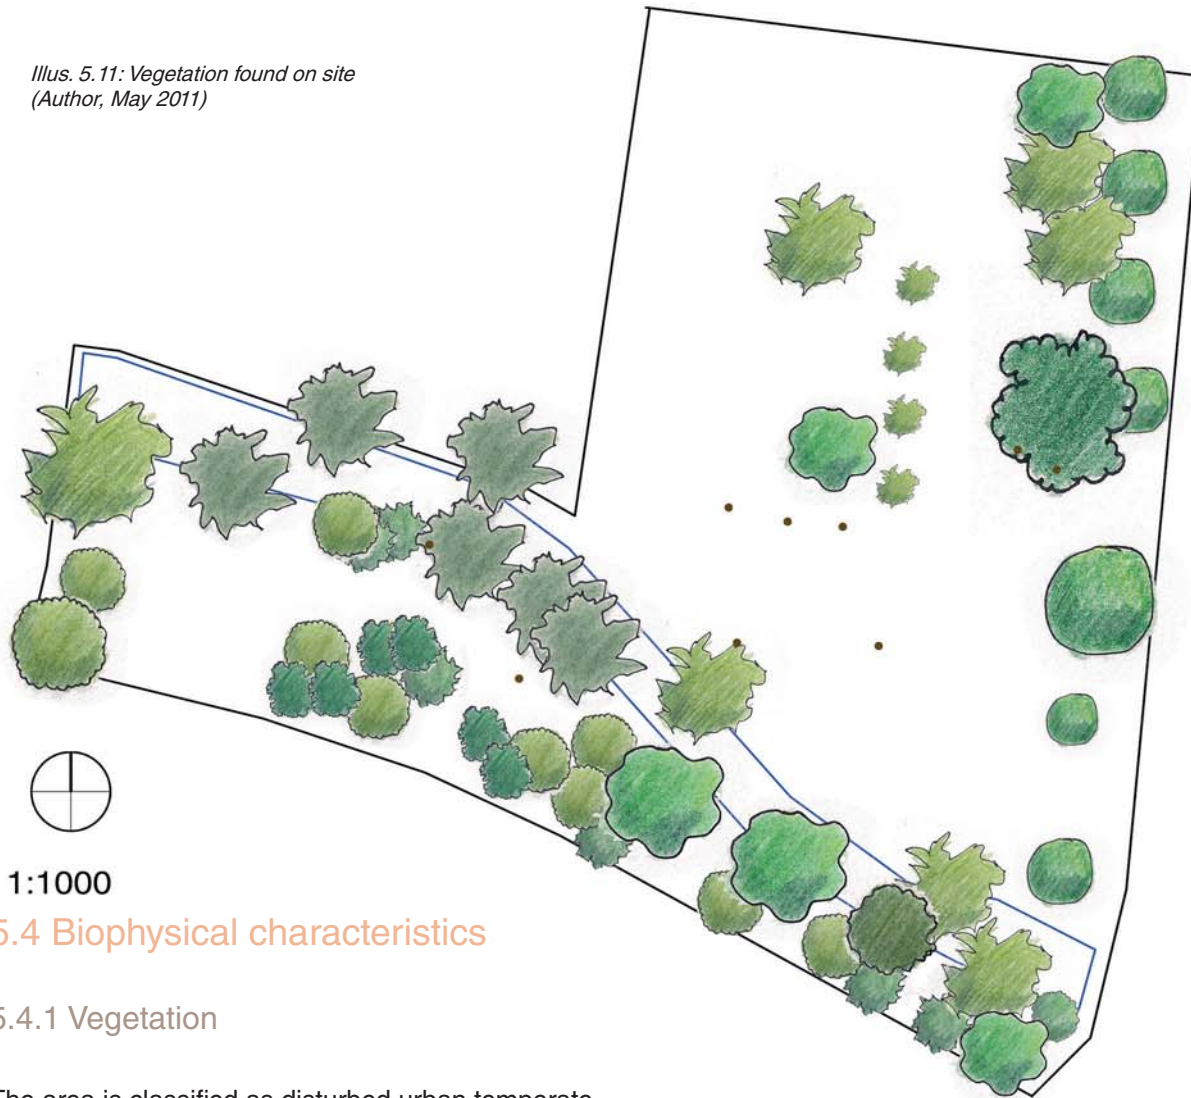
Illus. 5.11: Vegetation found on site
(Author, May 2011)

The site has several alien plants: *Tipuana tipu*, *Jacaranda mimosifolia*, *Cestrum laevigatum* (Category 1), *Phytolacca dioica*, *Quercus robur* and *Pinus*

canariensis (see Illus. 5.11). According to the National Environmental Management Act (“NEMA”), Act 107 of 1998, Category 1 plants need to be removed and destroyed immediately. Category 2 plants do not need to be removed. However, a permit is needed to grow them, and then only for commercial industrial purposes. Category 3 plants also do not need to be removed, but no new plants may be propagated and reproduction of the plant must be controlled.

Besides the trees shown on Illus. 5.11 the surface of the site is covered with *Cynodon dactylon* and *Pennisetum clandestinum* (kikuyu, Category 1) lawn, with some low-growing weeds. There are several dead trunks of *Phoenix canariensis* palms. They were planted in the 1920's at the same time as the palms planted along University Road, but have all been killed by a virus between 2005 and 2011.

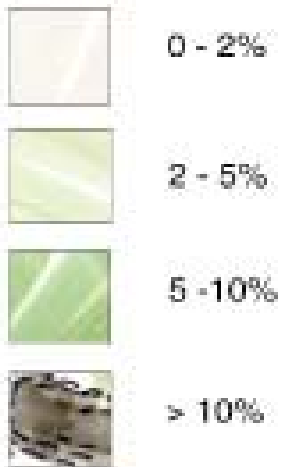
Illus. 5.12: Slope analysis (Author, June 2011)

5.4.4 Topography: The site has a gentle slope towards the southwest (Illus. 5.12). The banks of the Walker Spruit channel are unnaturally steep and render the water inaccessible for humans.

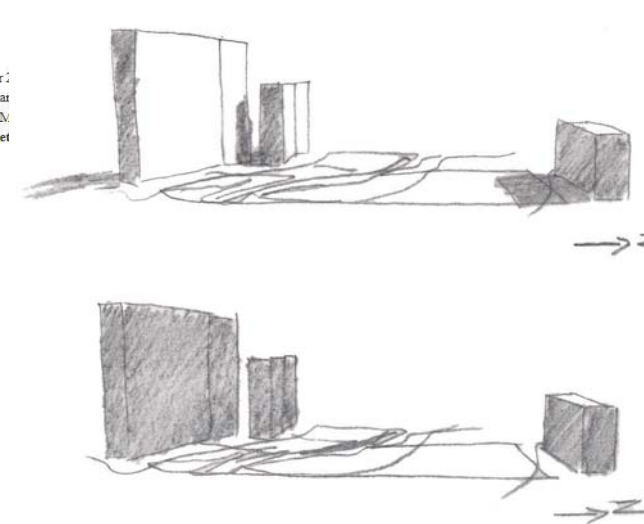
Illus 5.13: Above: Solar study at 12:00 on 21 June
Below: Solar study at 12:00 on 21 December
(Author, June 2011)

5.4.9 Sun angles: Illus 5.13 shows the implications of sun angles on the site. In winter the apartment block on the northern side casts a shadow onto the site which could create a cold spot. In the late afternoons in summer, a part of the site south of the Spruit receives shade from the Spruitsig apartments, which would be welcome relief from the summer's heat. Apart from this, the site is mostly exposed to the sun except for the shade cast by some existing trees.

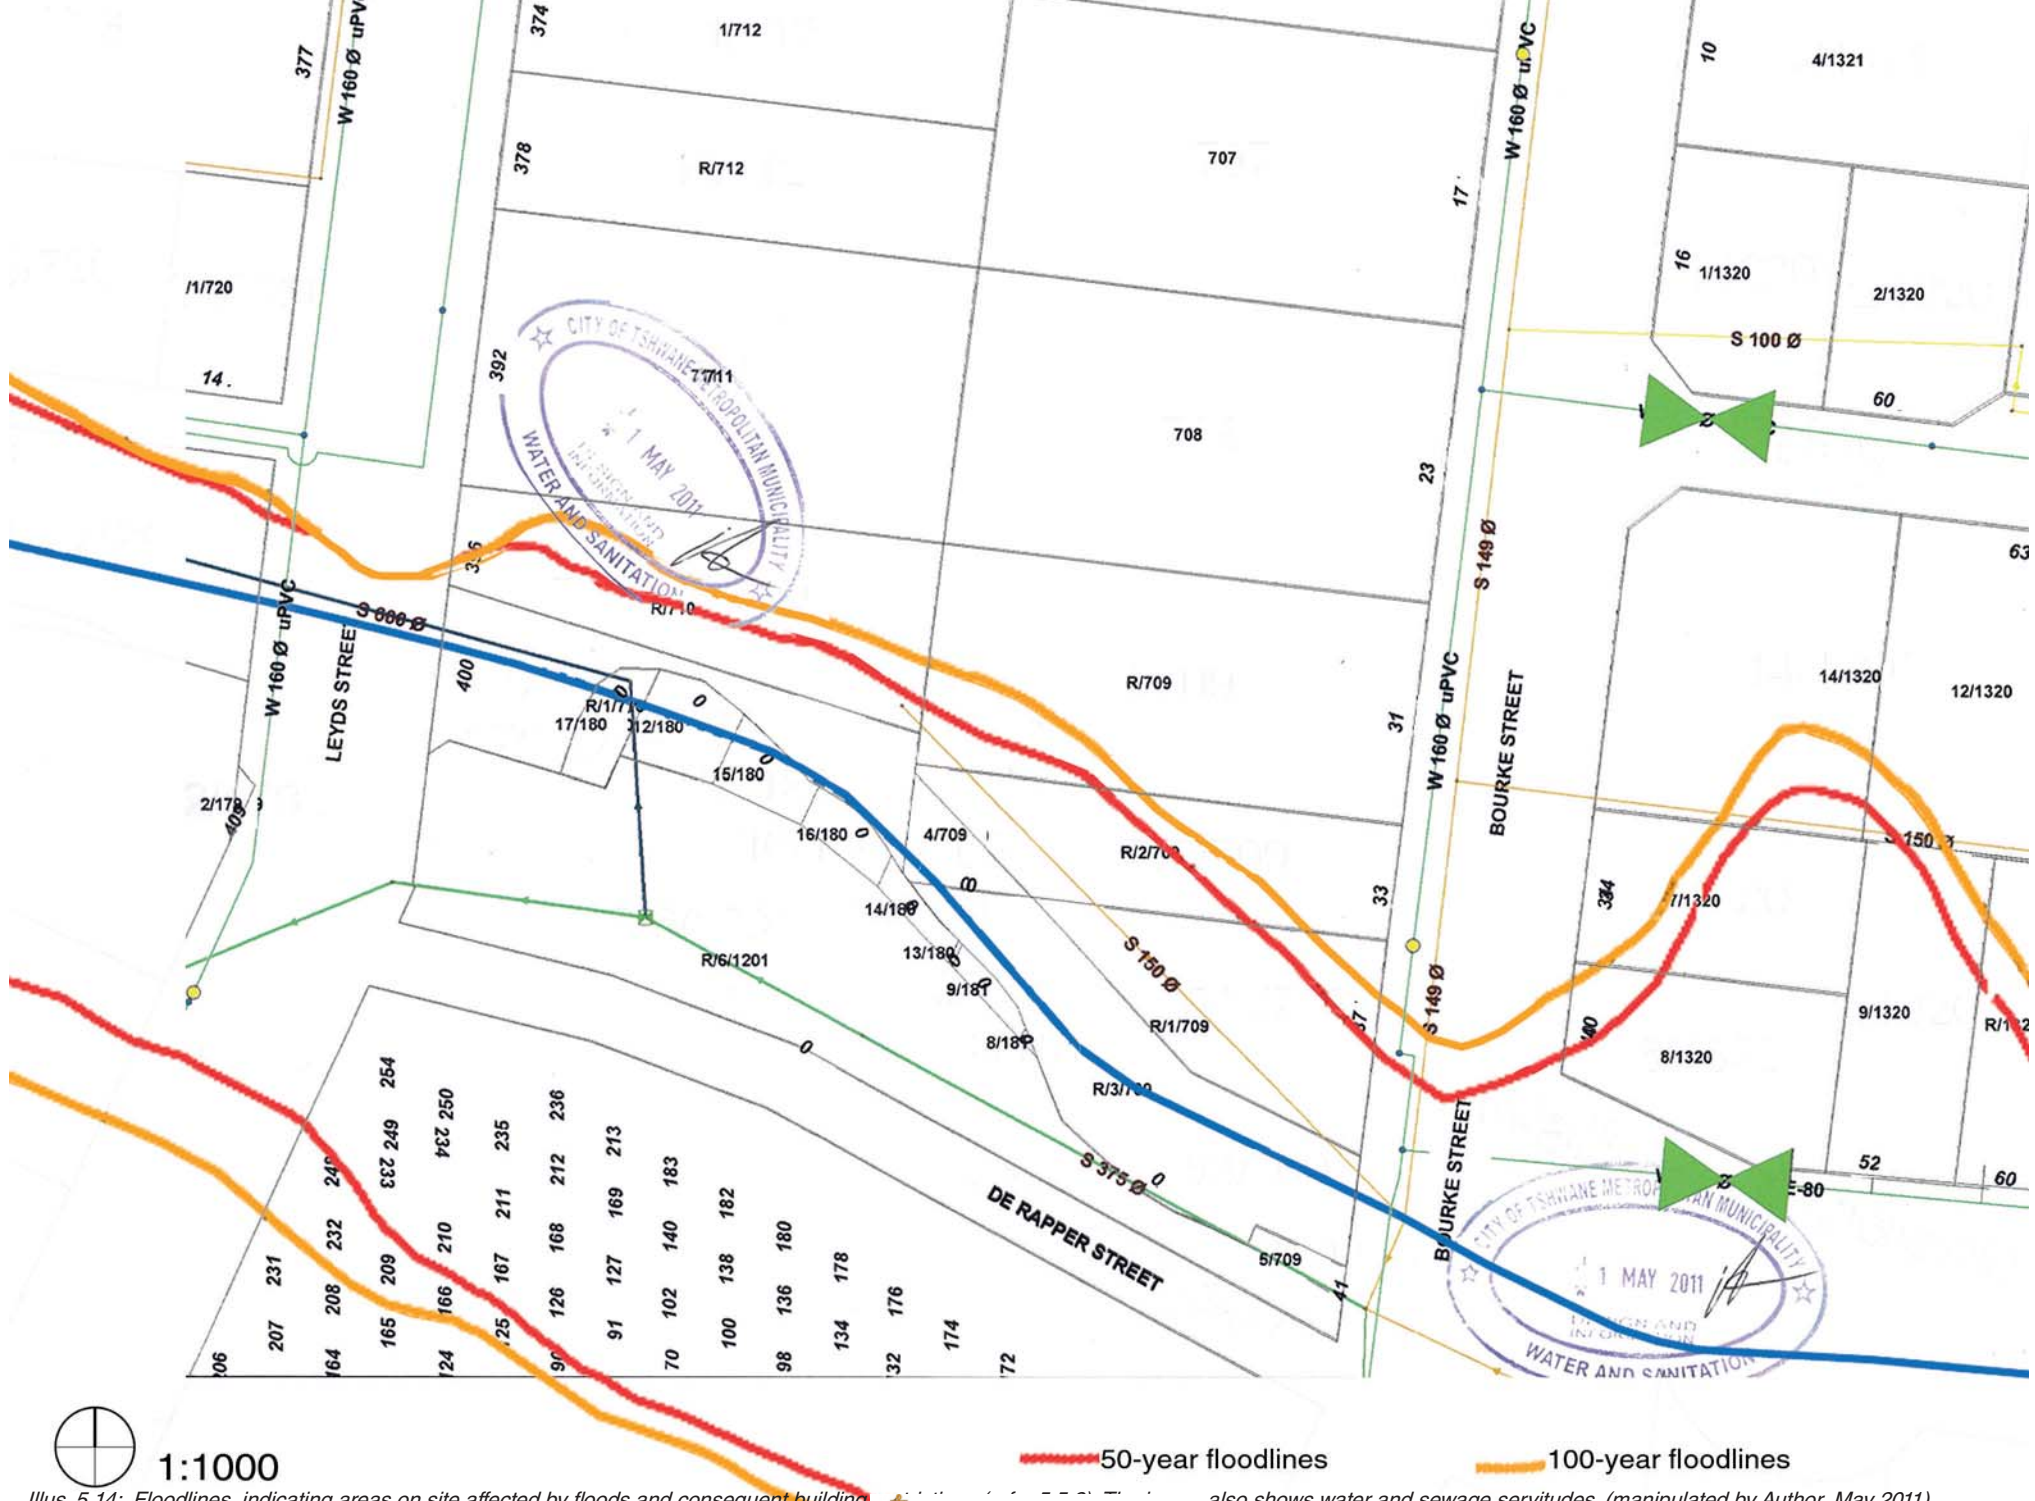
Illus. 5.14: Floodlines, indicating areas on site affected by floods and consequent building

5.5.2 Services: Illus. 5.14 shows floodlines, water and sewage servitudes on site. No structures which would alter the cross-sectional area of the flood are allowed within the 50-year floodline.

also shows water and sewage servitudes. (manipulated by Author, May 2011)

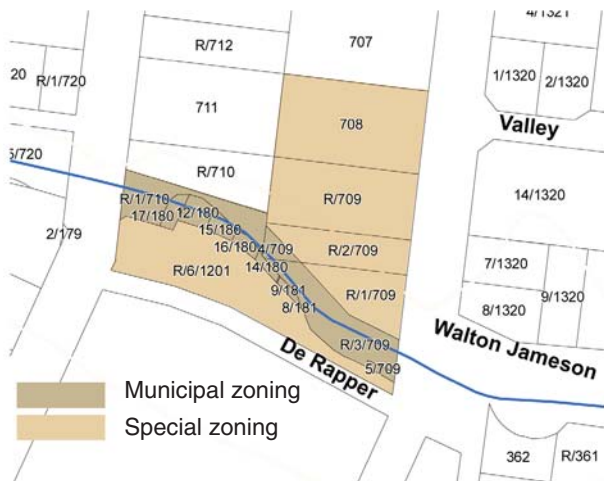
Illus. 5.15: Consolidation of erven. Not to scale (Author, May 2011)

5.5.3 Consolidation: For the design of the park, several erven currently belonging to the municipality will need to be consolidated (Illus. 5.15).

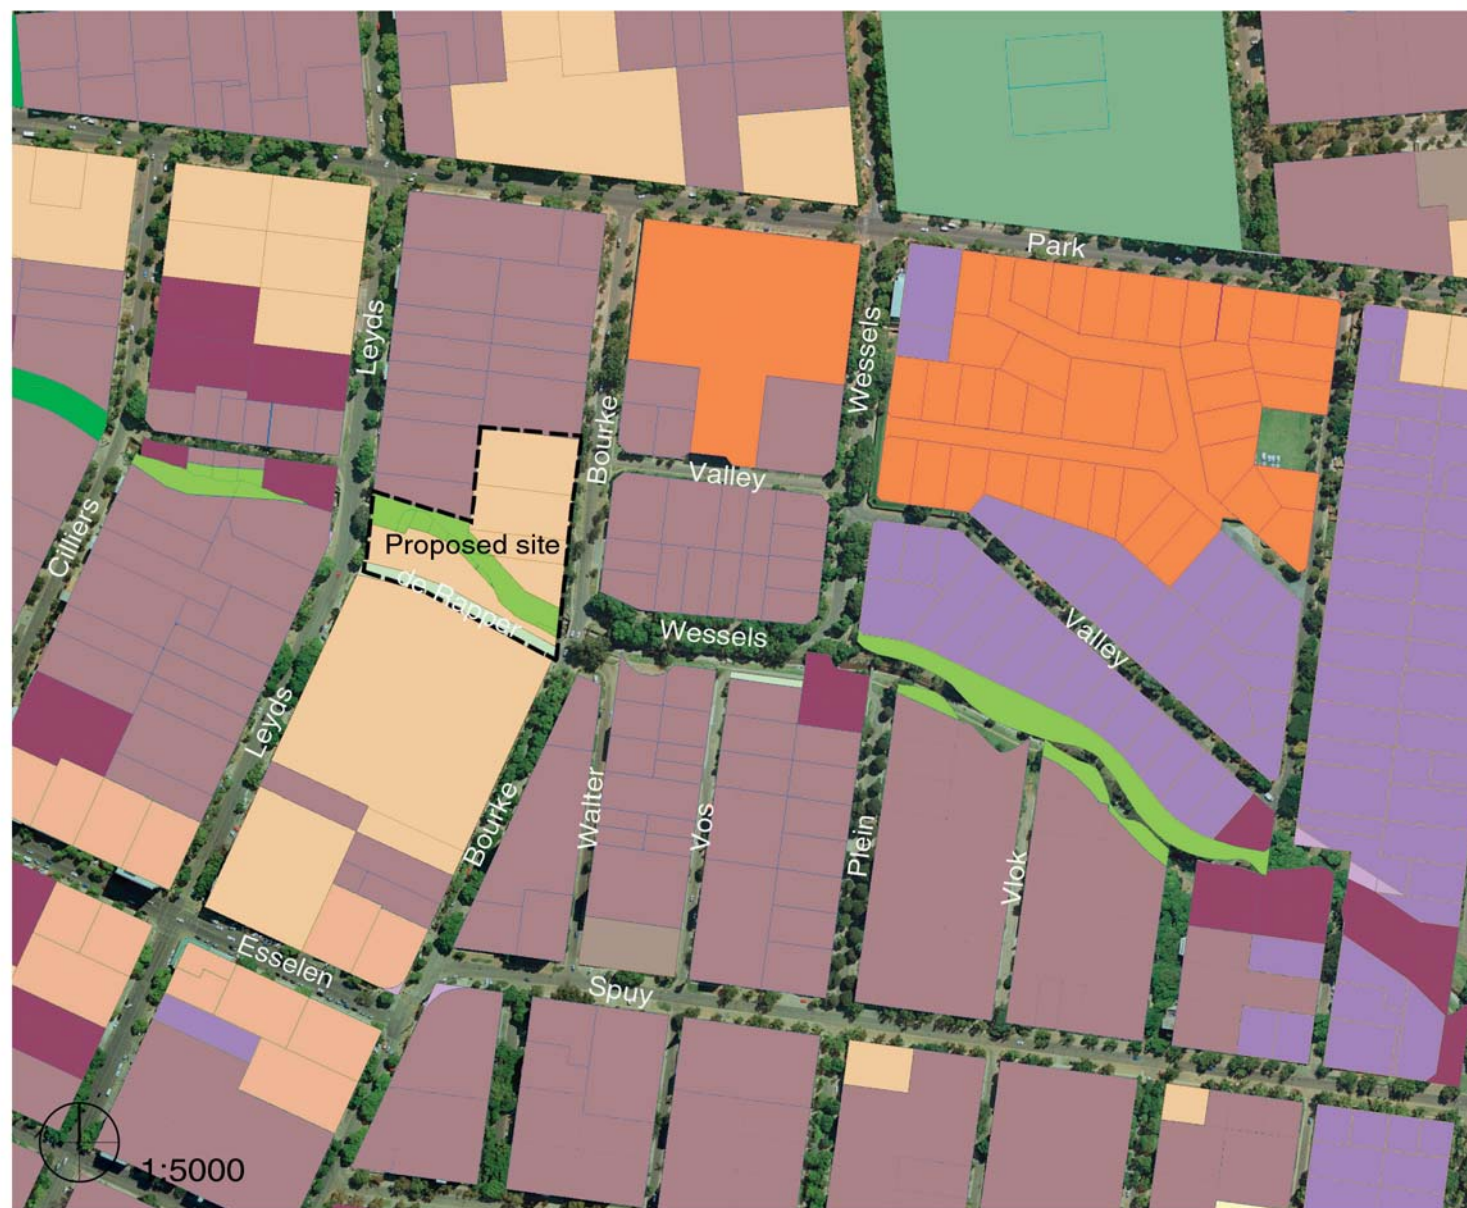
Illus. 5.16: Zoning (manipulated by Author, May 2011)

5.5.4 Zoning: The site is zoned as “special” and the erven containing the Spruit as “municipal”. The site does not need to be rezoned for the purposes of constructing a park.

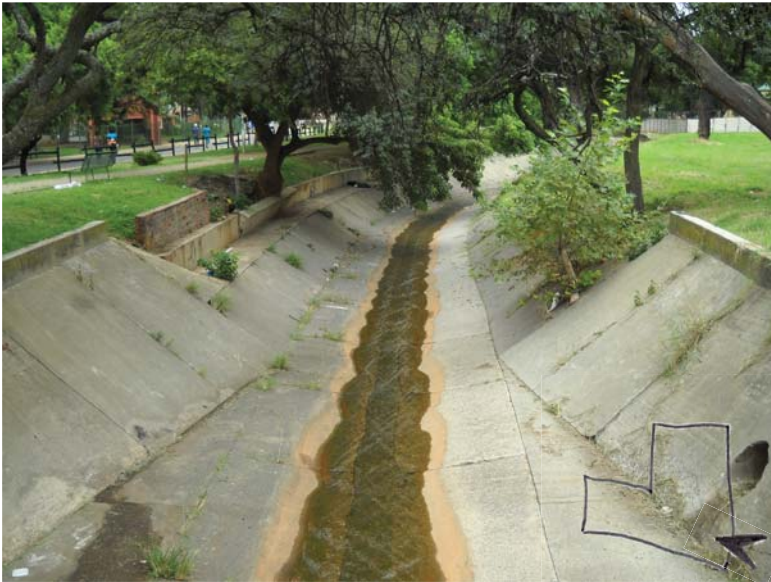
Illus. 5.17: The current concrete channel has a low base flow, but could become a safety hazard during rainstorms (refer to Illus. 5.15 for floodlines). It is not feasible to rehabilitate the channel due to space constraints, but there is an opportunity to clean the water and to beautify the channel. (Author, April 2011)

The Walkerspruit trail starts in the Brooklyn suburb and was intended to become a lovely walk in the city, especially for residents in Sunnyside and Arcadia. However, most buildings turn their back on the Spruit, which is not aesthetically pleasing due to it being channelised. The channel is lined with concrete (Illus. 5.17) and base flow in June were calculated at $0.26 \text{ m}^3/\text{s}$.

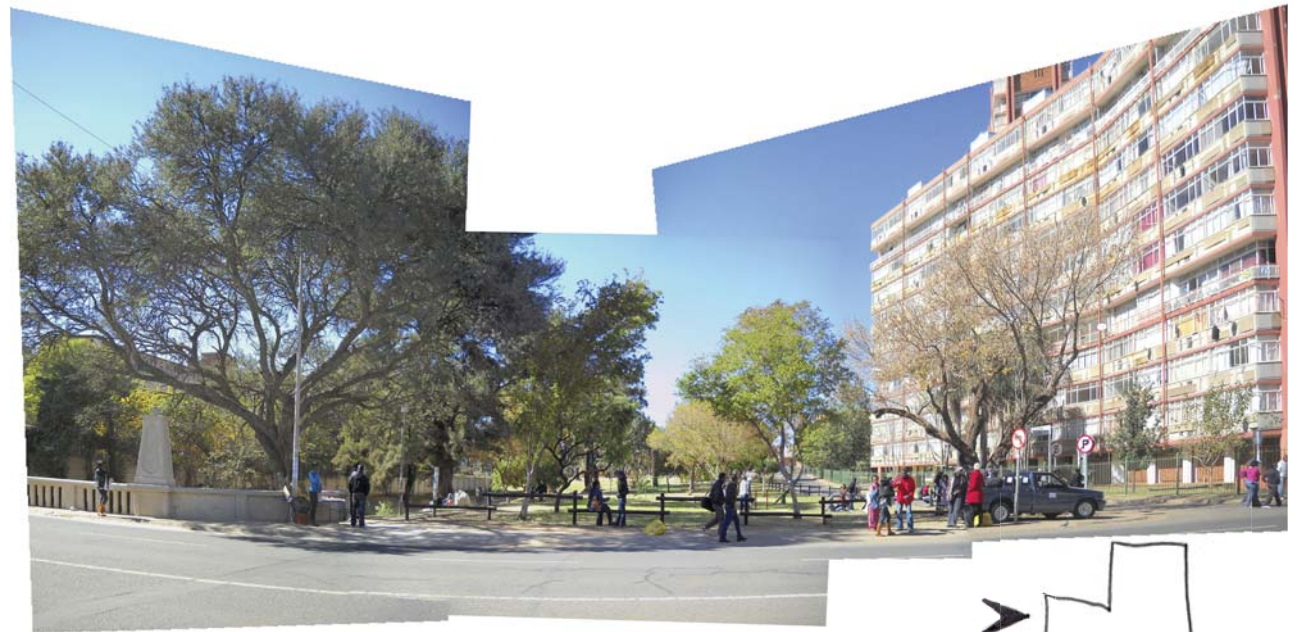
Illus. 5.18: View from west edge of site. Note the street vendor next to the bridge, the narrow sidewalk between the road and the street, as well as the waiting area that has formed on the south-western corner of the site. The tree behind the vehicle is used for advertising. (Author, June 2011)

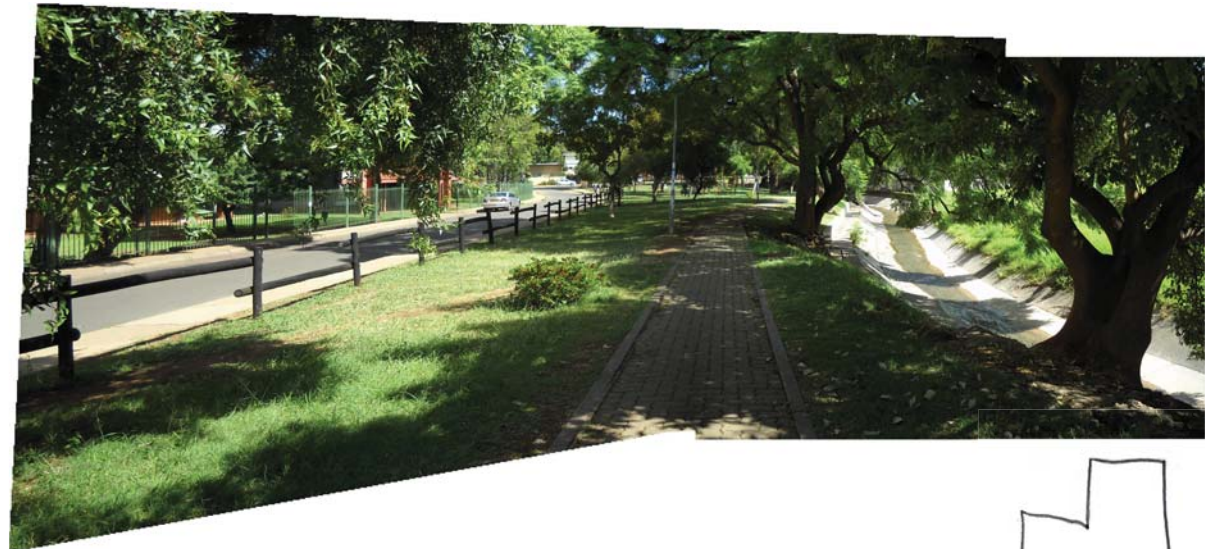
Illus. 5.19: The existing shade trees along the walkway will be kept. The site is very narrow on the south side of the Spruit. (Author, April 2011)

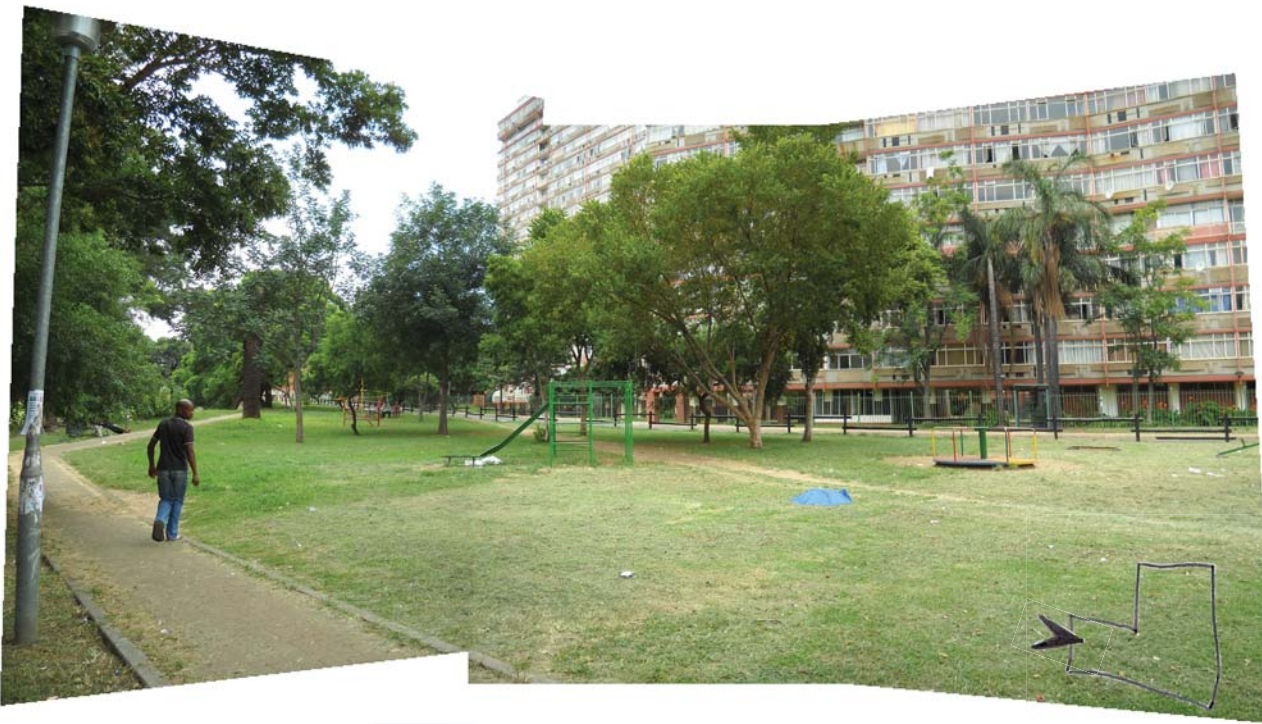
*Illus. 5.20: View of existing playground on site. Note the lack of shade, seating and enclosure. There are many *Combretum sp.*, *Sercea lancea* and *Ekebergia capensis* trees which provide shade on the southern part of the site. (Author, April 2011)*

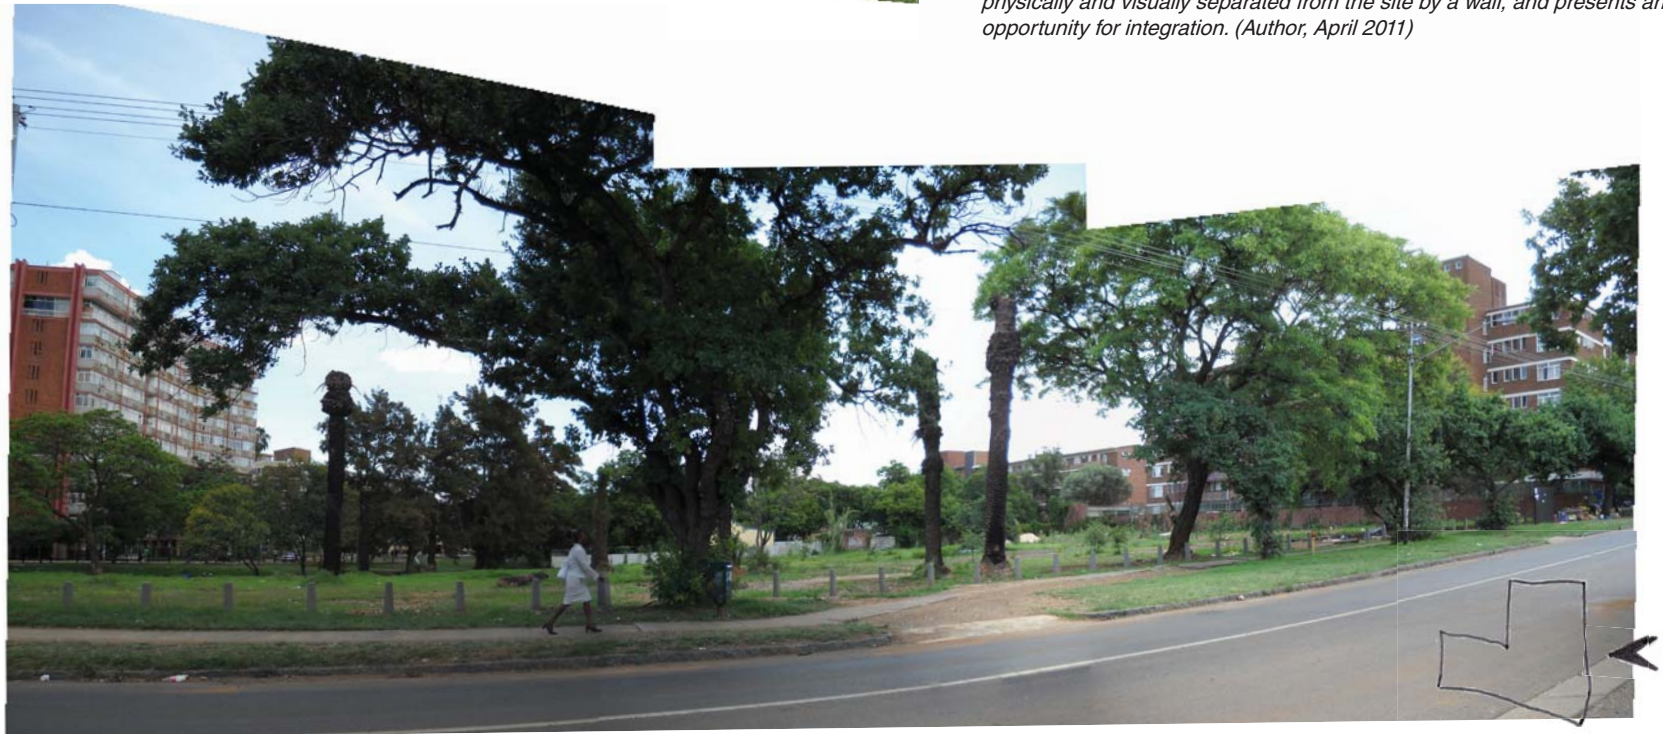
Illus. 5.21: View of site from the east. Note the gentle slope (2 to 5%), as well as some large trees along the edges of the site and the Spruit. The Ring-Ting Pre-primary school at the western edge of the site is currently physically and visually separated from the site by a wall, and presents an opportunity for integration. (Author, April 2011)

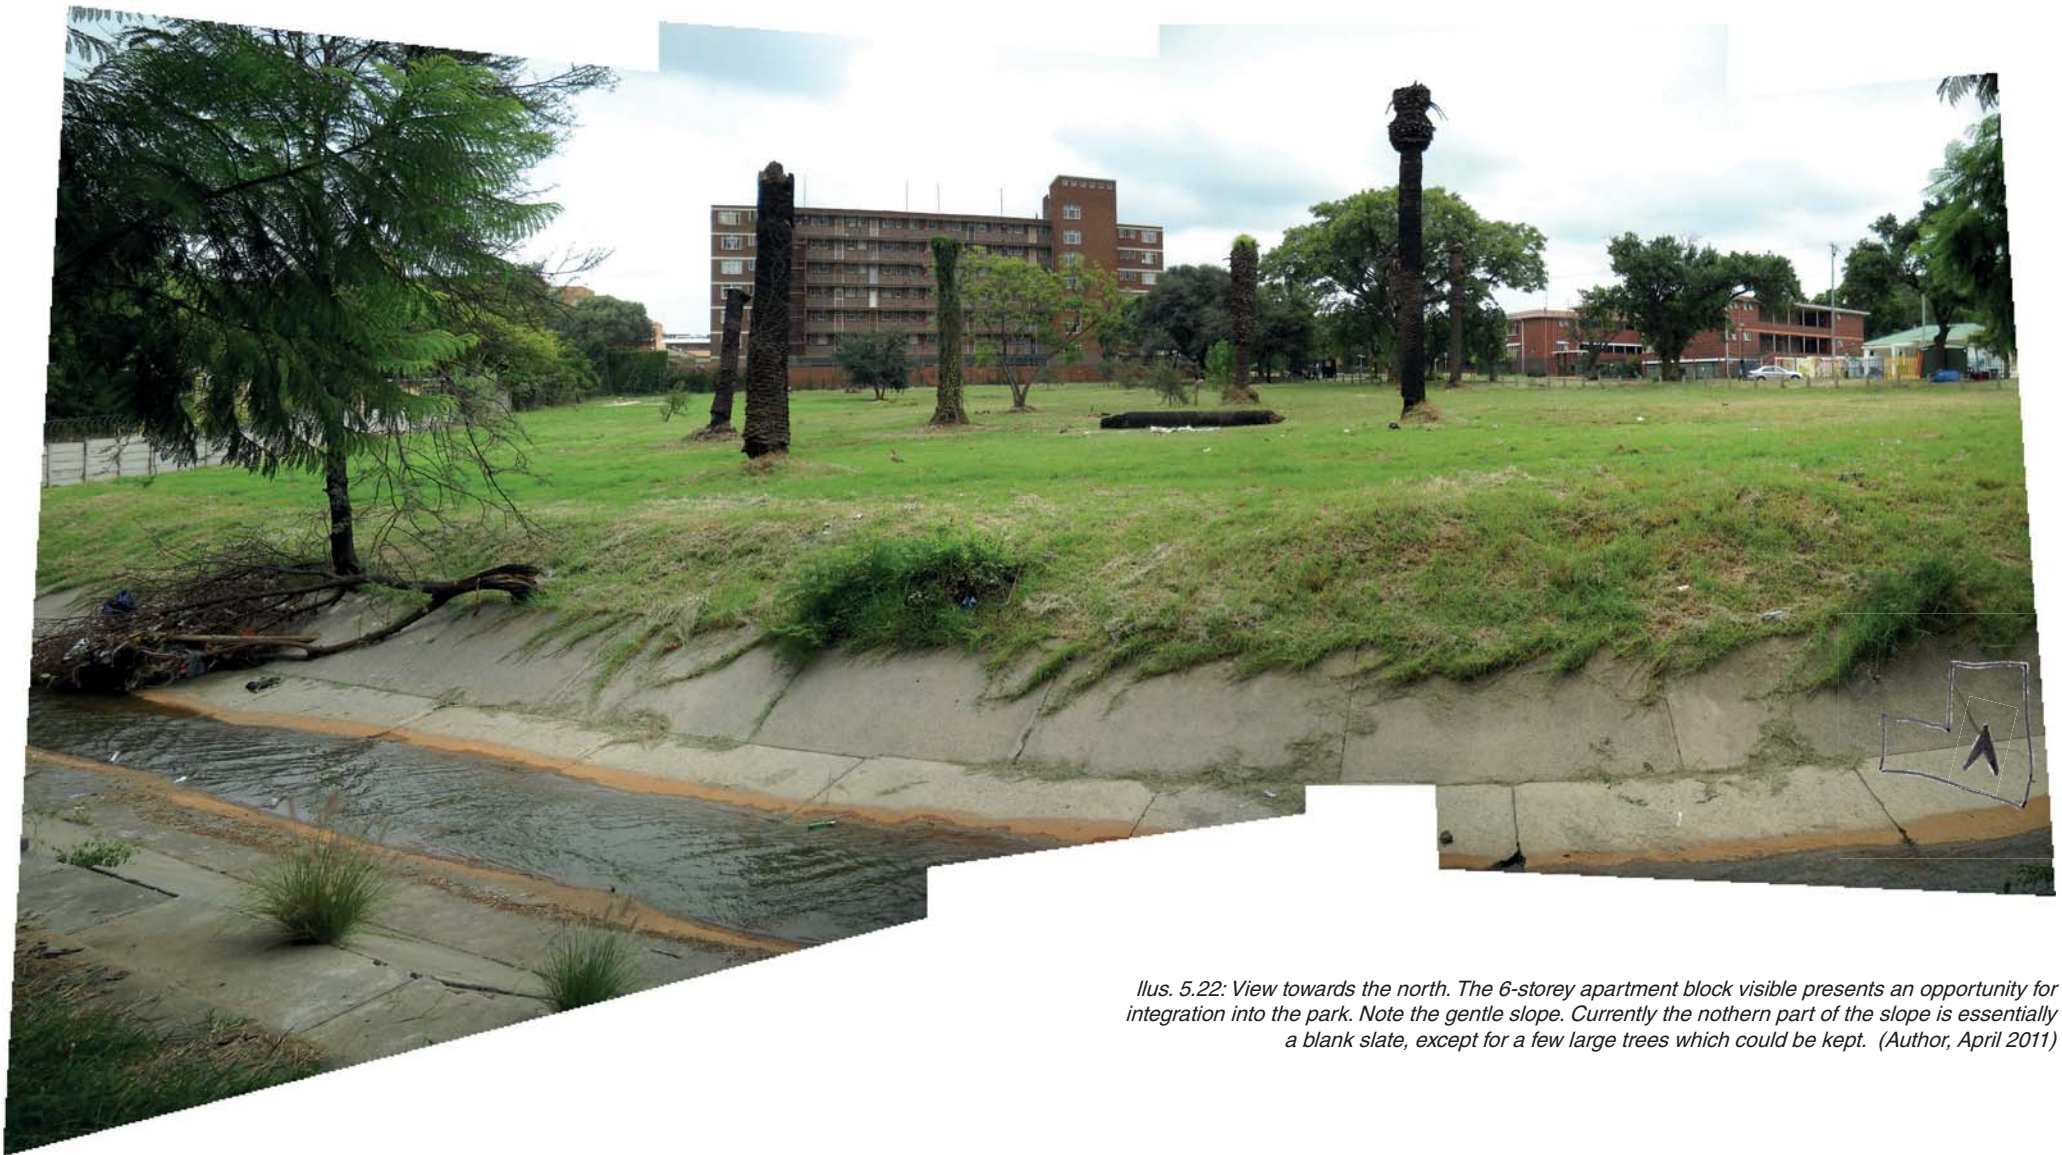
Illus. 5.22: View towards the north. The 6-storey apartment block visible presents an opportunity for integration into the park. Note the gentle slope. Currently the northern part of the slope is essentially a blank slate, except for a few large trees which could be kept. (Author, April 2011)
