05 | CONTEXT

5.1 CHAPTER OVERVIEW

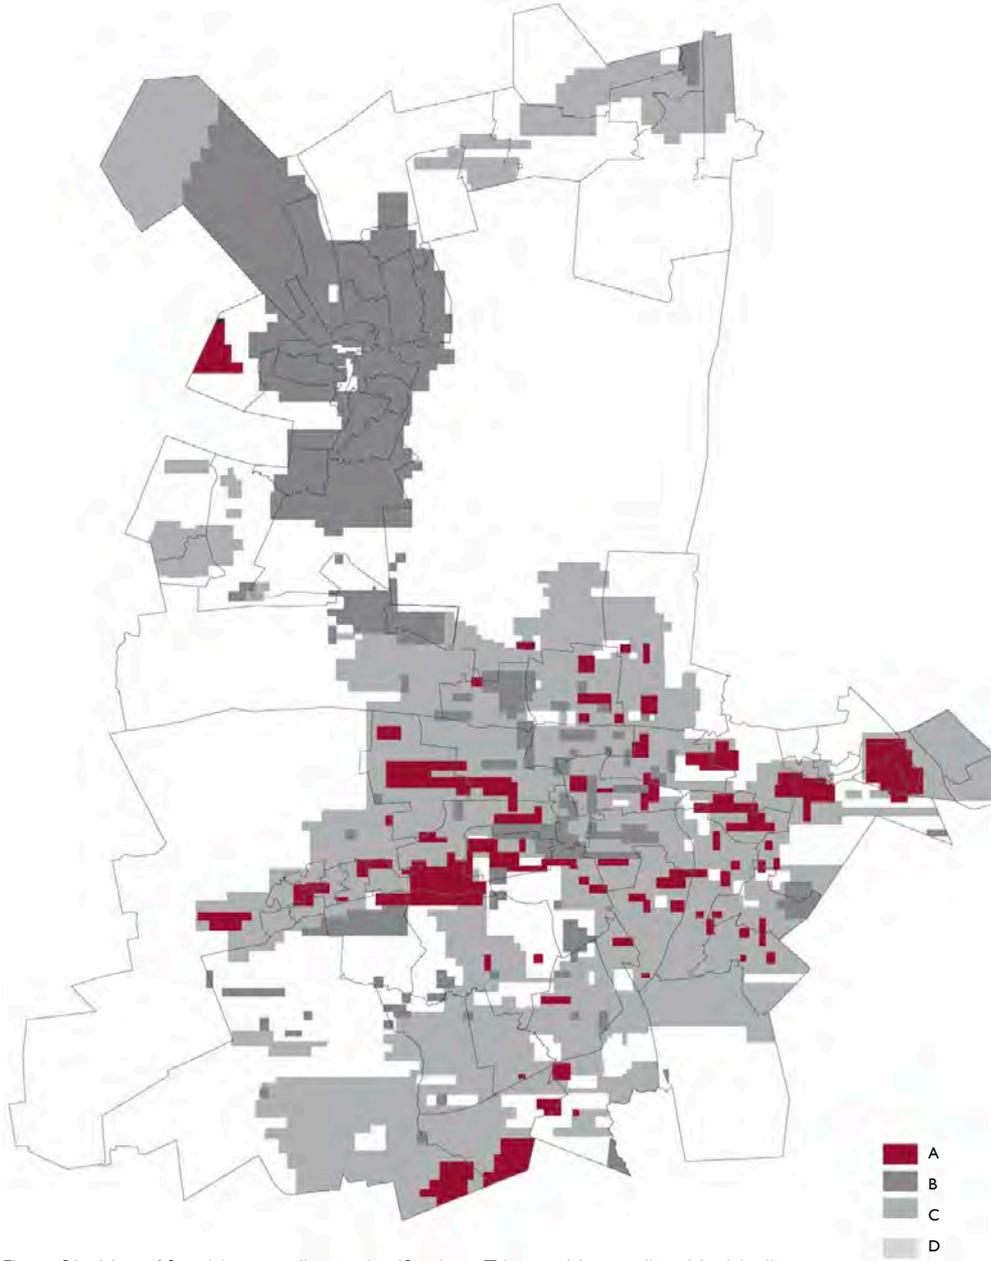
Figure 21 Map of fire risks according to classification • Tshwane Metropolitan Municipality (2006:113) [redrawn by author]

Cities are the crux of this hidden landscape and accidents are unfortunate part of everyday life. Figure 21 represents the Tshwane Emergency Call Register. It indicates that fires and floods are the most prevalent types of disasters in the Tshwane region and that prevention strategies have not succeeded.

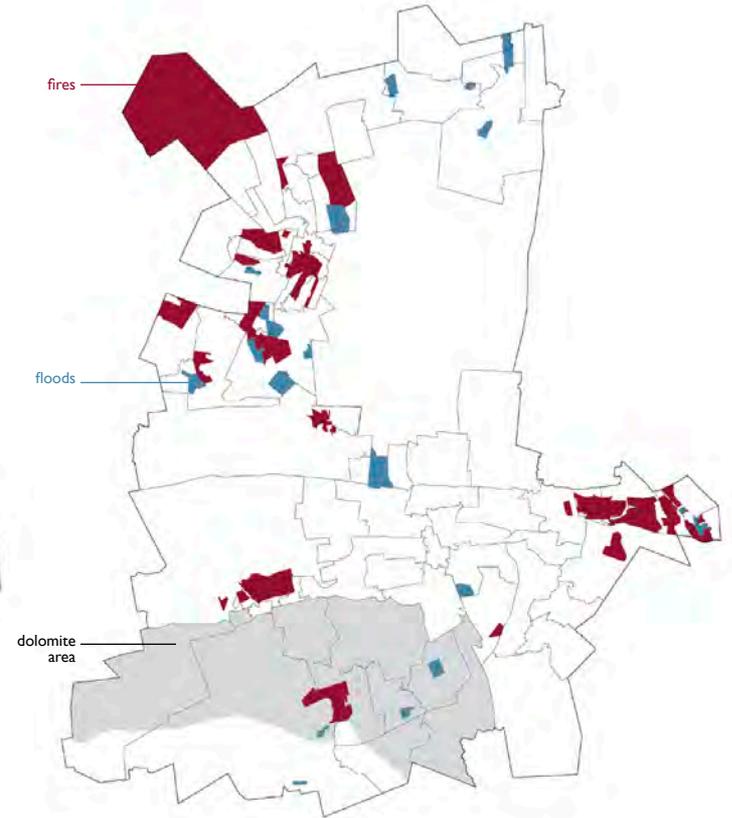
Figure 22 Map of Hazards in Tshwane for the year 2007/2008 • Department of Disaster management Services [compiled by author from various sources]

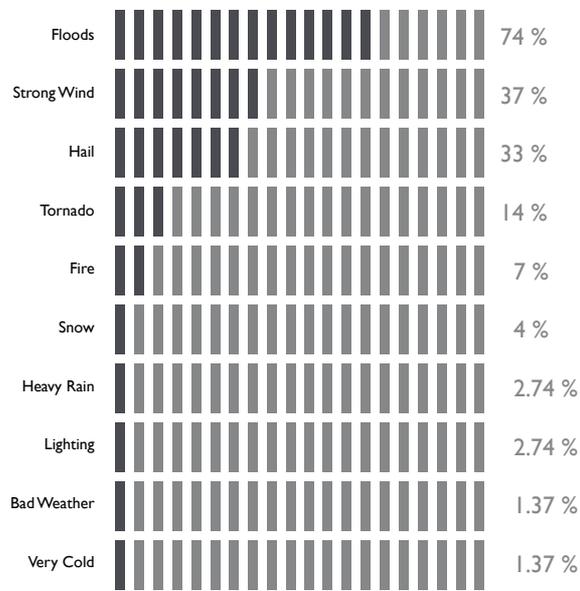
Figure 28 Likelihood that weather related events might occur at least once a year • Department of Disaster management (2008:5) [redrawn by author]

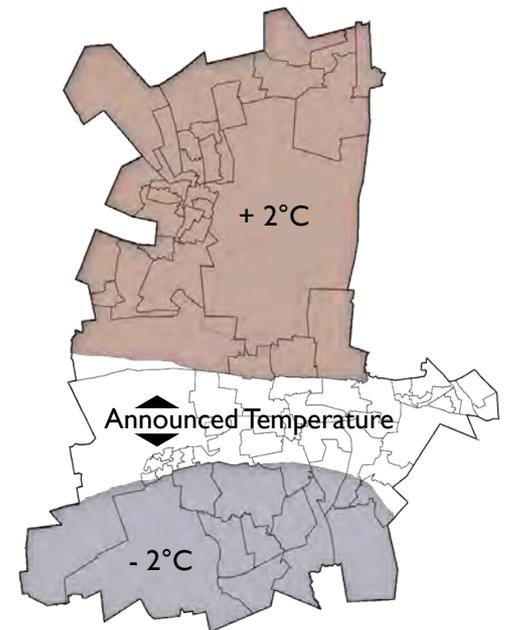
Figure 30 Climate differences in Tshwane • Tshwane Metropolitan Municipality (2004:10) [redrawn by author]

Tshwane has three distinctive temperature regions that vary within 2 degrees of the announced daily temperature.

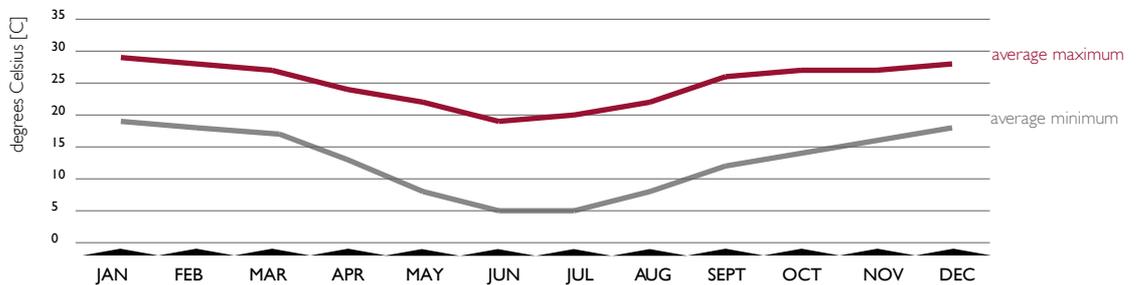
Figure 29 Average daily maximum and minimum temperatures • Tshwane Metropolitan Municipality (2004:9) [redrawn by author]

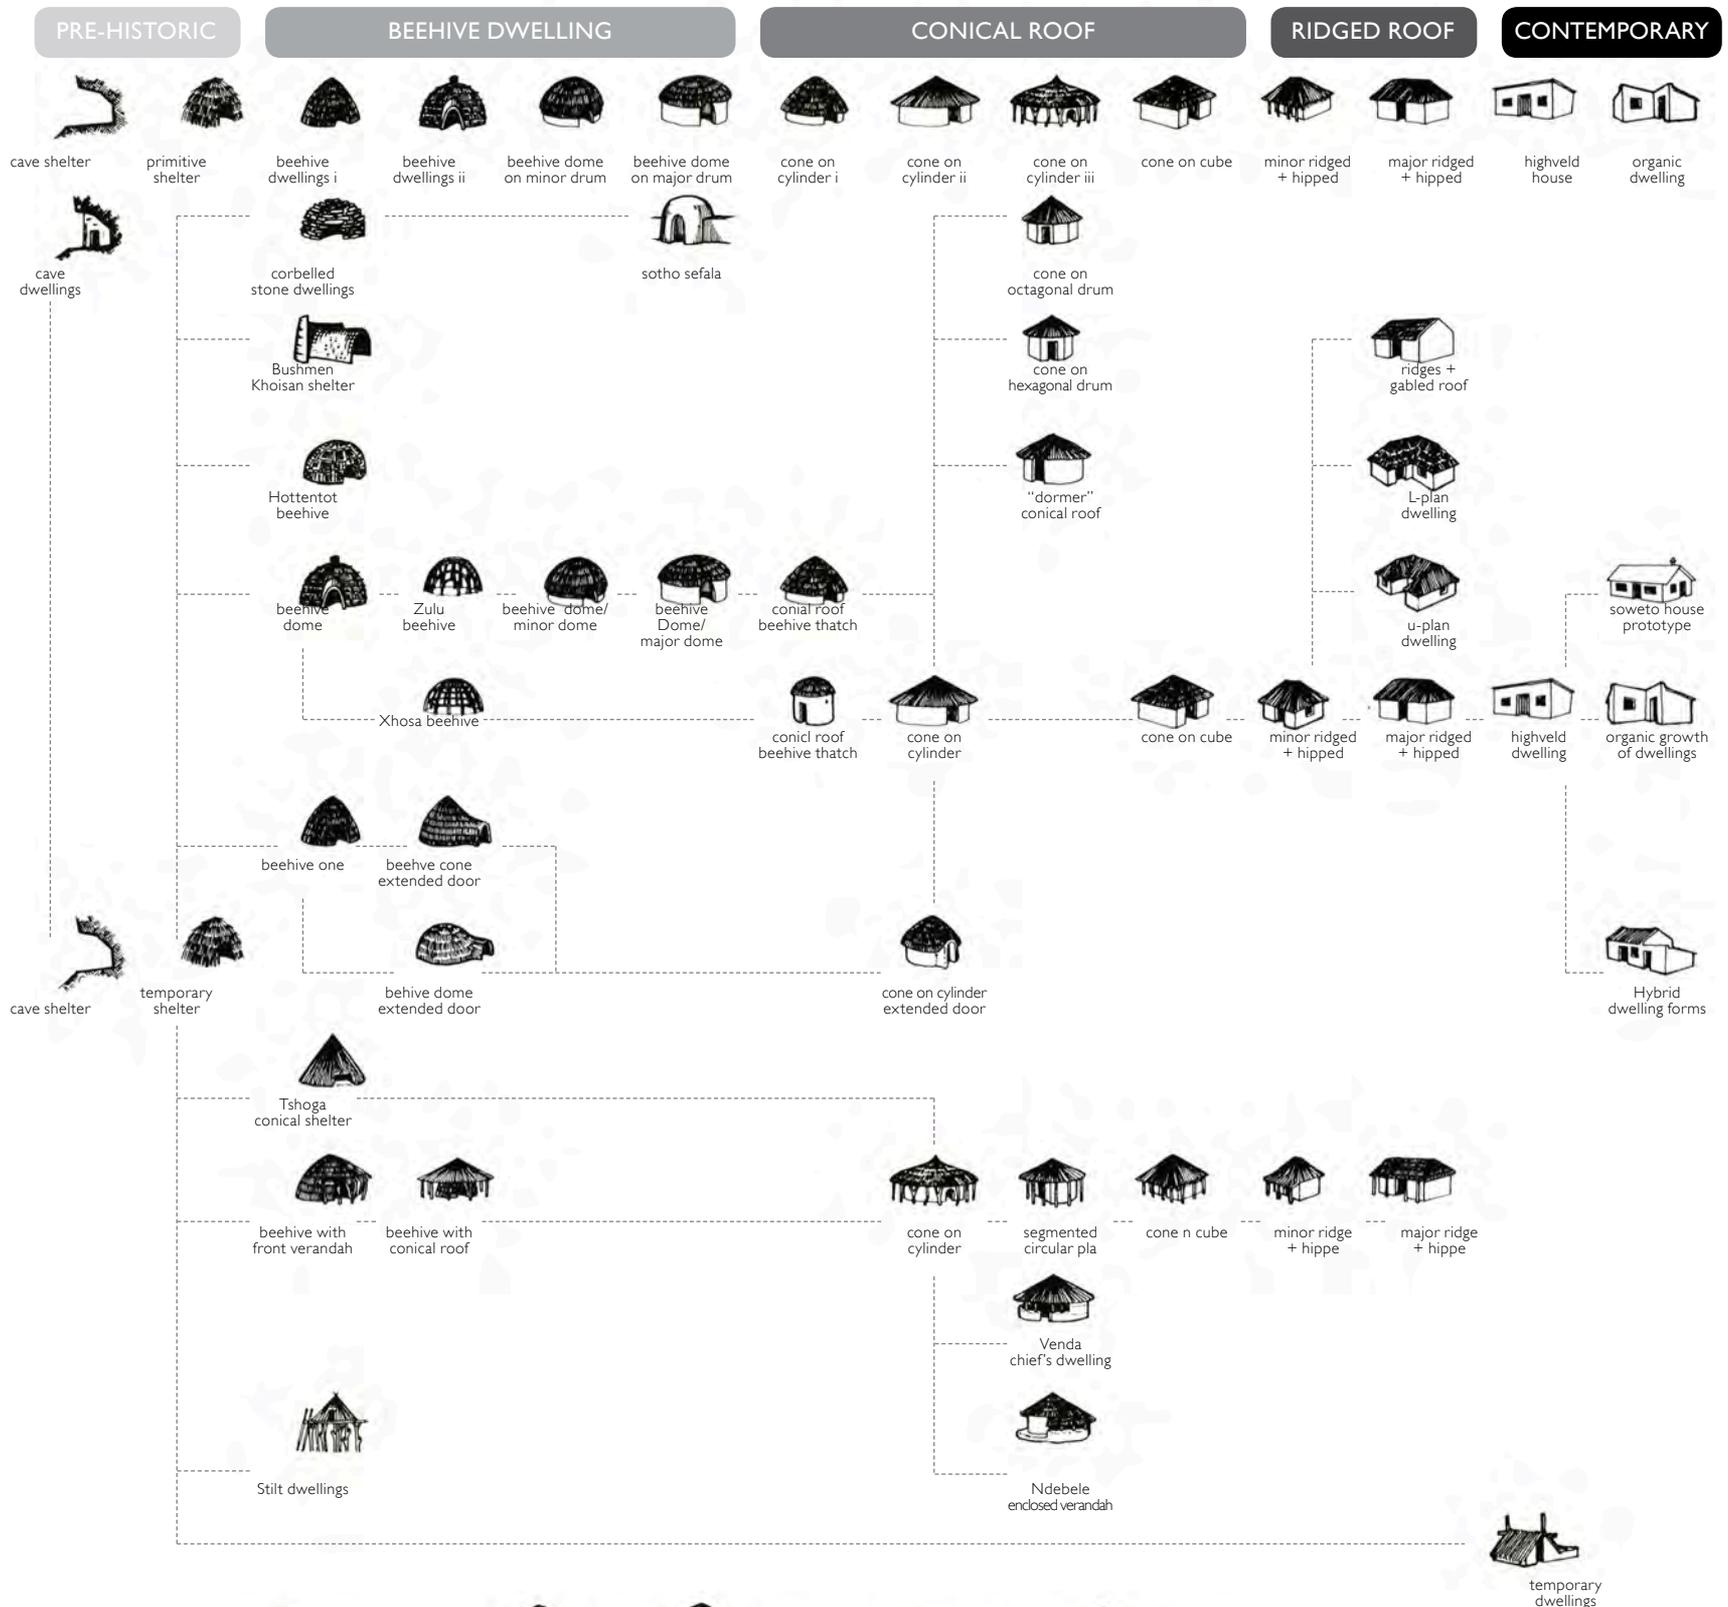
Figure 31 Development of two distinct technologies : Frescura (1981:12)

GRASS-ORIENTATED CONSTRUCTION seen in east Drakensberg regions where rain is prominent and many grass types are abundant

WATTLE AND DAUB CONSTRUCTION found in the drier highveld regions where rainfall is likely to erode exposed walling, and waterproofing technologies are in less demand.

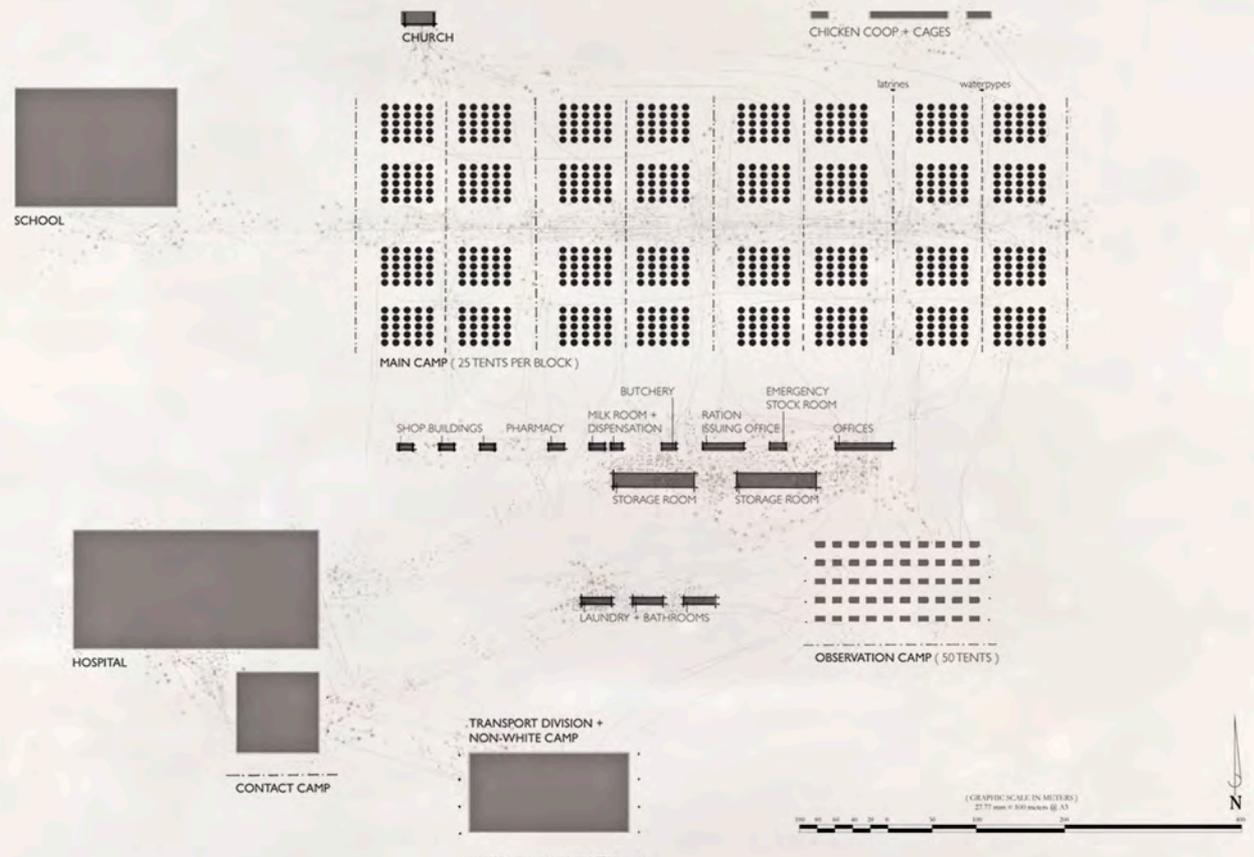
Figure 34 Typical concentration camp layout : Hattingh 1967:[n.p]) [redrawn by author]

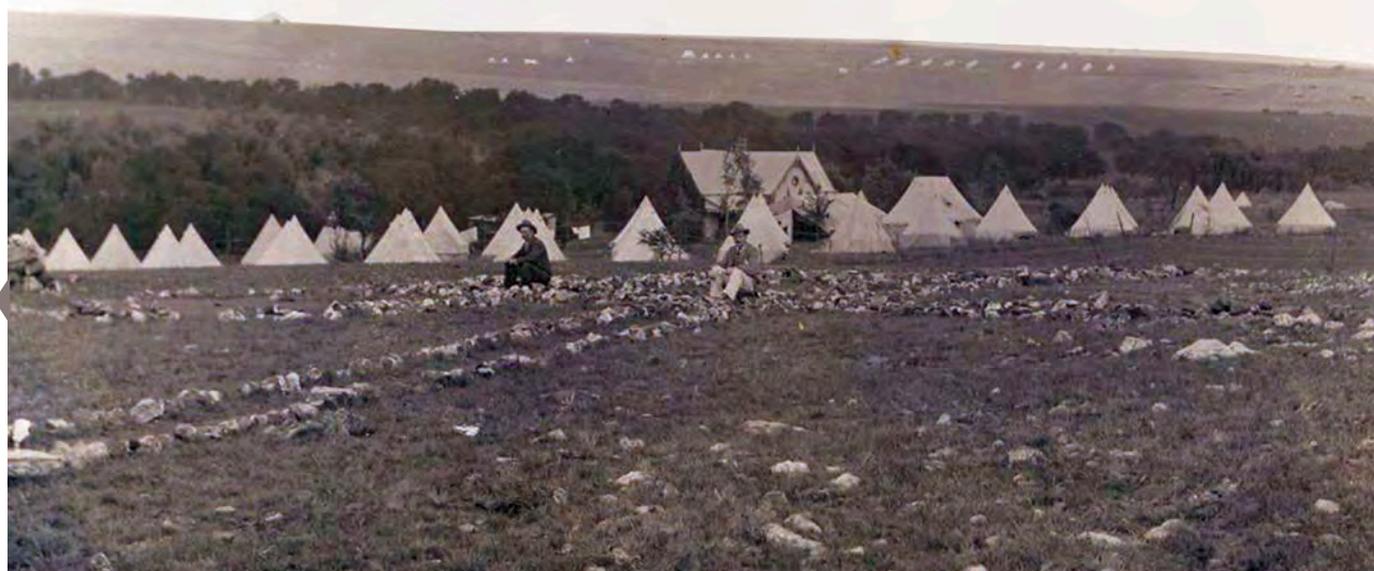
Figure 35 Irene Concentration camp (1902:[59of 171])

From this Fig. 35 shows how the camp layout was finally amended in an bid to prevent disease from spreading. Livestock and ablution facilities where kept separate from the main camp and an observation area was [influx management]

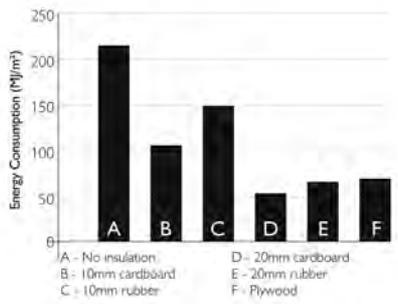
Table 10 Material cost and yearly savings for different cardboard insulation materials : Matthews et al (1995:430)

It was found that by adding 20mm of cardboard insulation the total energy consumption during the winter months would decrease by as much as 75% [Table 10].

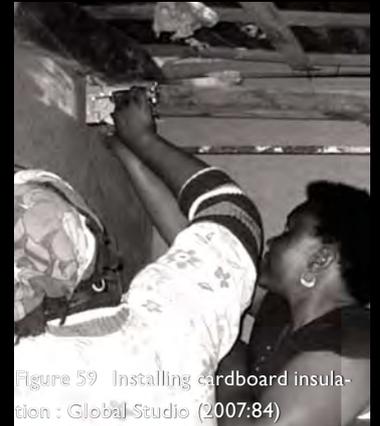
Figure 59 Installing cardboard insulation : Global Studio (2007:84)

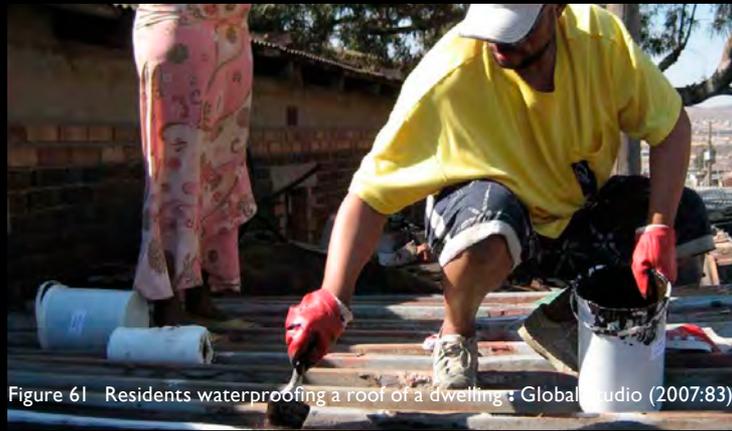
Figure 61 Residents waterproofing a roof of a dwelling : Global Studio (2007:83)

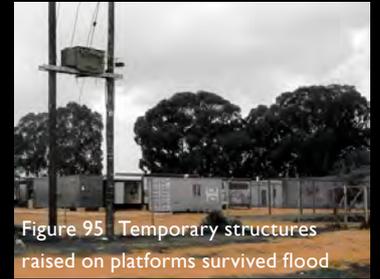
Figure 95 Temporary structures raised on platforms survived flood

Developments in high risk areas would benefit from raised platforms. Temporary container structures in the flood area survived with minimal damage because they are raised 400mm above ground level [figure 91].

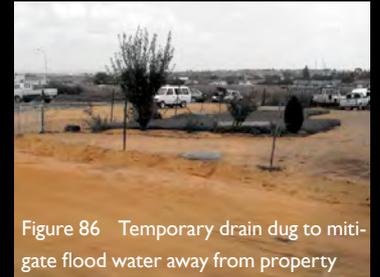
Figure 86 Temporary drain dug to mitigate flood water away from property

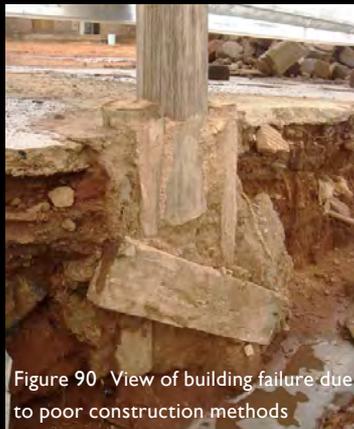
Figure 90 View of building failure due to poor construction methods

It was also noted that most of the building failures can be attributed to poor soil conditions and improper foundations [figure 84-86]. Again one sees that people construct their homes to meet their everyday needs and not for the event of a disaster.

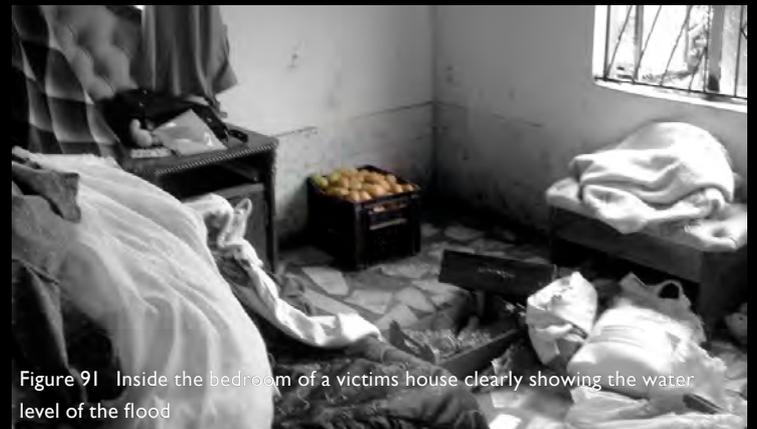
Figure 91 Inside the bedroom of a victims house clearly showing the water level of the flood
