# CONTEXT ANALYSIS

## 3.5. PHYSICAL SITE ANALYSIS

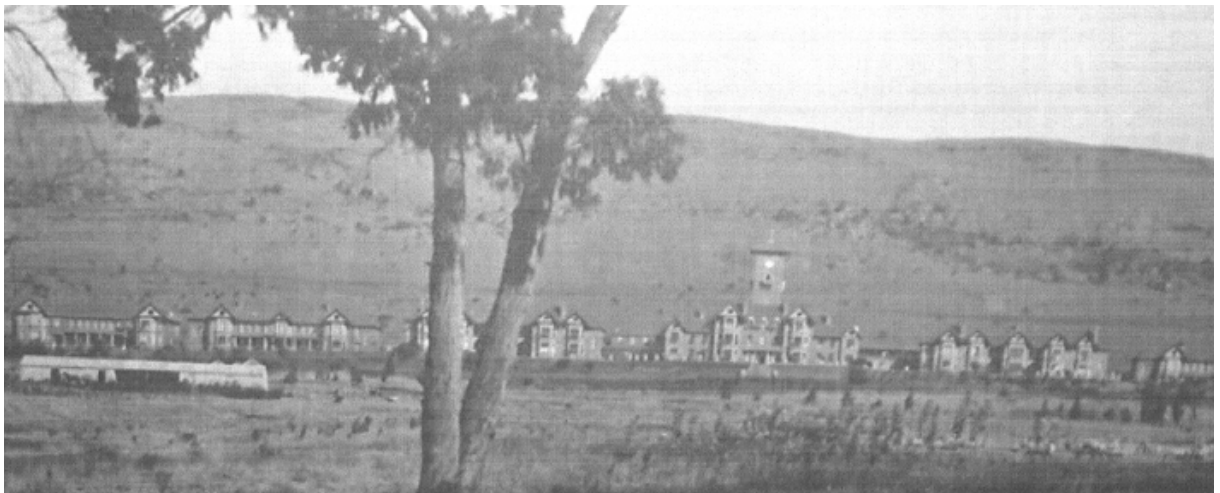
*Fig 3.7: The Hospital environment in 1892 (Breedt, 2009)*

The building was situated in the “Old Botanical Garden” and during the first year 500 trees were planted even though the water supply from a well in the grounds was limited. In 1893 the hospital was connected to the municipal water supply and a 2, 5 ha vegetable garden was laid out. At that stage the hospital was described as ‘a beautiful building very healthily situated, with large gardens and cultivated fields’ (Plug & Roos, 1992:219).

### 3.3.1. THE HOSPITAL ENVIRONMENT (Fig. 3.7)

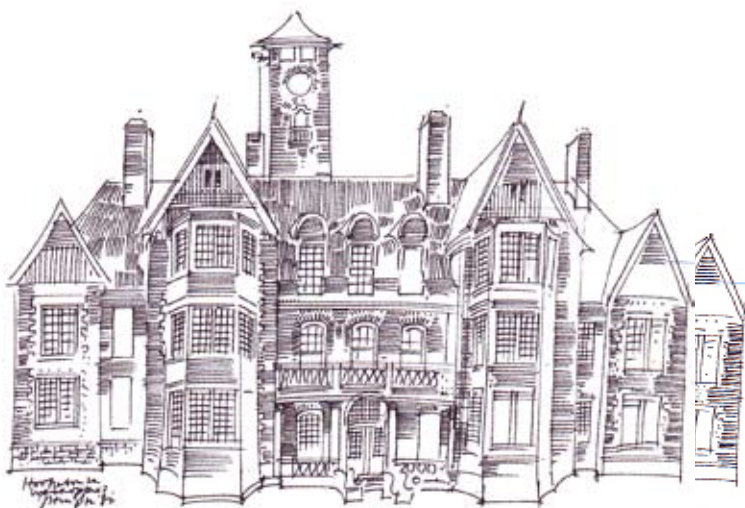
*Fig. 3.8 (below left): View from the north drawn by Hannes Meiring (Meiring1980:17)*

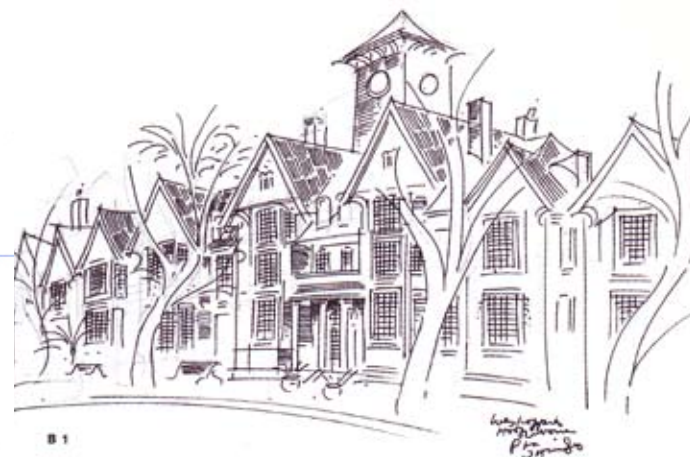
*Fig. 3.9 (below): Front view from the north west drawn by Hannes Meiring (Meiring1980:17)*

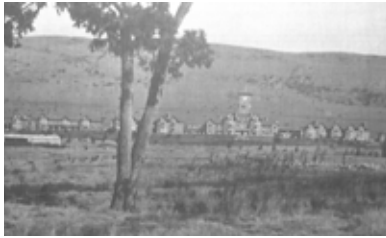
Fig 3.16 (right): Earlier years- an open view to the main building, very little trees in sight (Breedt 2009).

When the hospital was established in the vegetation type could be described as grass veld vegetation with very little to no trees (fig.1.16) . In the early years a lot of effort was put into creating a beautiful hospital environment and 1280 Trees were planted in 1918. On the northern side of the building complex Himalaya pine trees were planted (Lewende Monumente 1992: 11).

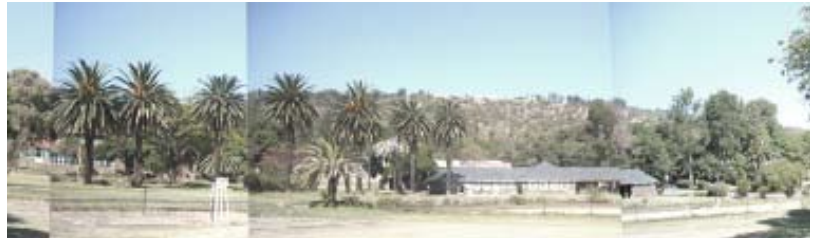
Fig 3.17 (far right): Today- trees block the views towards the building (Author 2009).

Today the site is characterized by lush indigenous and exotic trees on the lower slopes with typical Acacia caffra bushveld trees on the higher slopes (fig. 3.17). The FMU is in the process of removing a large number of exotic trees.

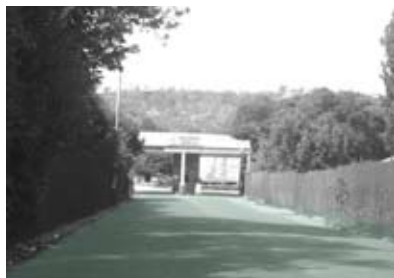
Fig. 3. 24. Weskoppies entrance, note the absence of a pedestrian path. Pedestrians have to make use of the vehicular route (Author 2009)

The site is accessed from a single access control point at the northern side of the site (fig. 2.24). Busses are accommodated with drop offs and pickups at bus stops on the site (fig. 2.25) and makes use of the prominent vehicular route (fig. 2.26) (Geel 2005:31) . However working patients and some staff members, that make use of other types of public transport outside Weskoppies have to walk from these transport nodes. To enter or exit the site, the pedestrian patients and staff have to make use of vehicular route that crosses the railway line with a bridge. This road is far too narrow for pedestrians and vehicles at the same time and becomes a safety hazard.

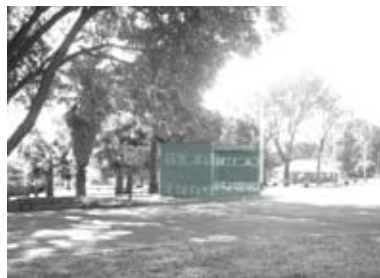
Fig. 3.25. Bus stops. Note the absence of a pedestrian movement system (Author 2009)

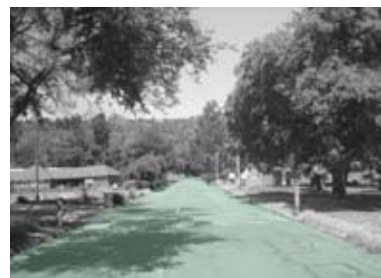
Fig. 3.26. Prominent vehicular route. Note the absence of a pedestrian walkway (Author 2009)

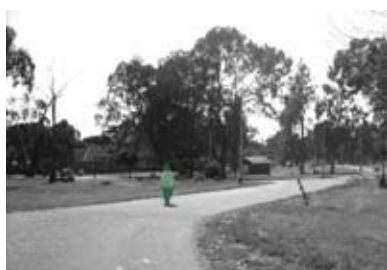
Fig. 3. 27. Pedestrians have to make use of the vehicular route due to the absence of a pedestrian movement system (Author 2009)

- Pedestrian movement and its links to public transport nodes need to be significantly improved in and around the campus (Fig. 3.27-29).
- For safety reasons vegetation and structures in the landscape should not obstruct views on the site.

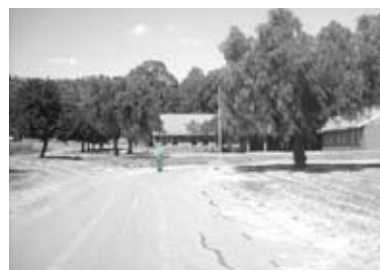
Fig. 3. 28. Pedestrians have to make use of the vehicular route (Author 2009).

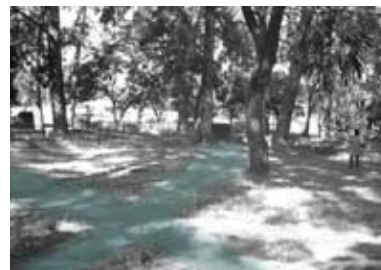
Fig. 3. 29. Informal pedestrian paths (Author 2009).

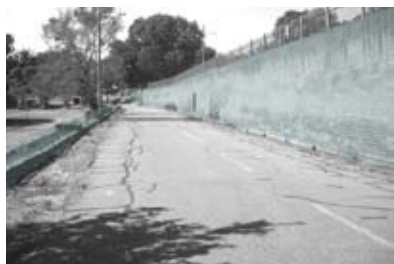
Buildings have very strict access control, especially closed wards and the maximum security unit. High retaining walls can be found at many areas on the site due to the steep slope, these become boundaries between different areas. There is a number of fenced off areas around buildings but also randomly around pieces of land.

Figure 3.30. (far left) retaining wall as a boundary (Author 2009)

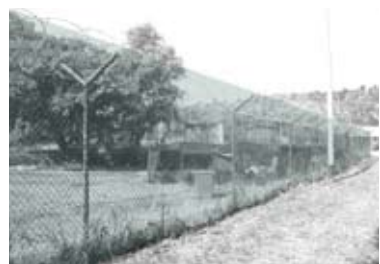
Figure 3.31. (middle) Fenced off areas without buildings (Author 2009)

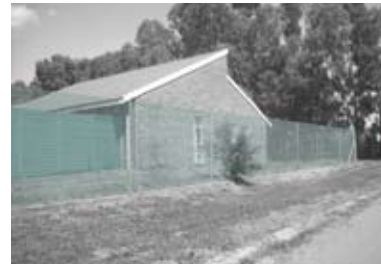
Figure 3.32. (left) Fenced off closed wards (Author 2009)
