1. Introduction _ 2. Global Context _ 3. Surrounding Urban Context _ 4. The Building _
5. The Building's Response to Climate _ 6. S.W.O.T. Analysis

4.1. Introduction

4.4. The Building

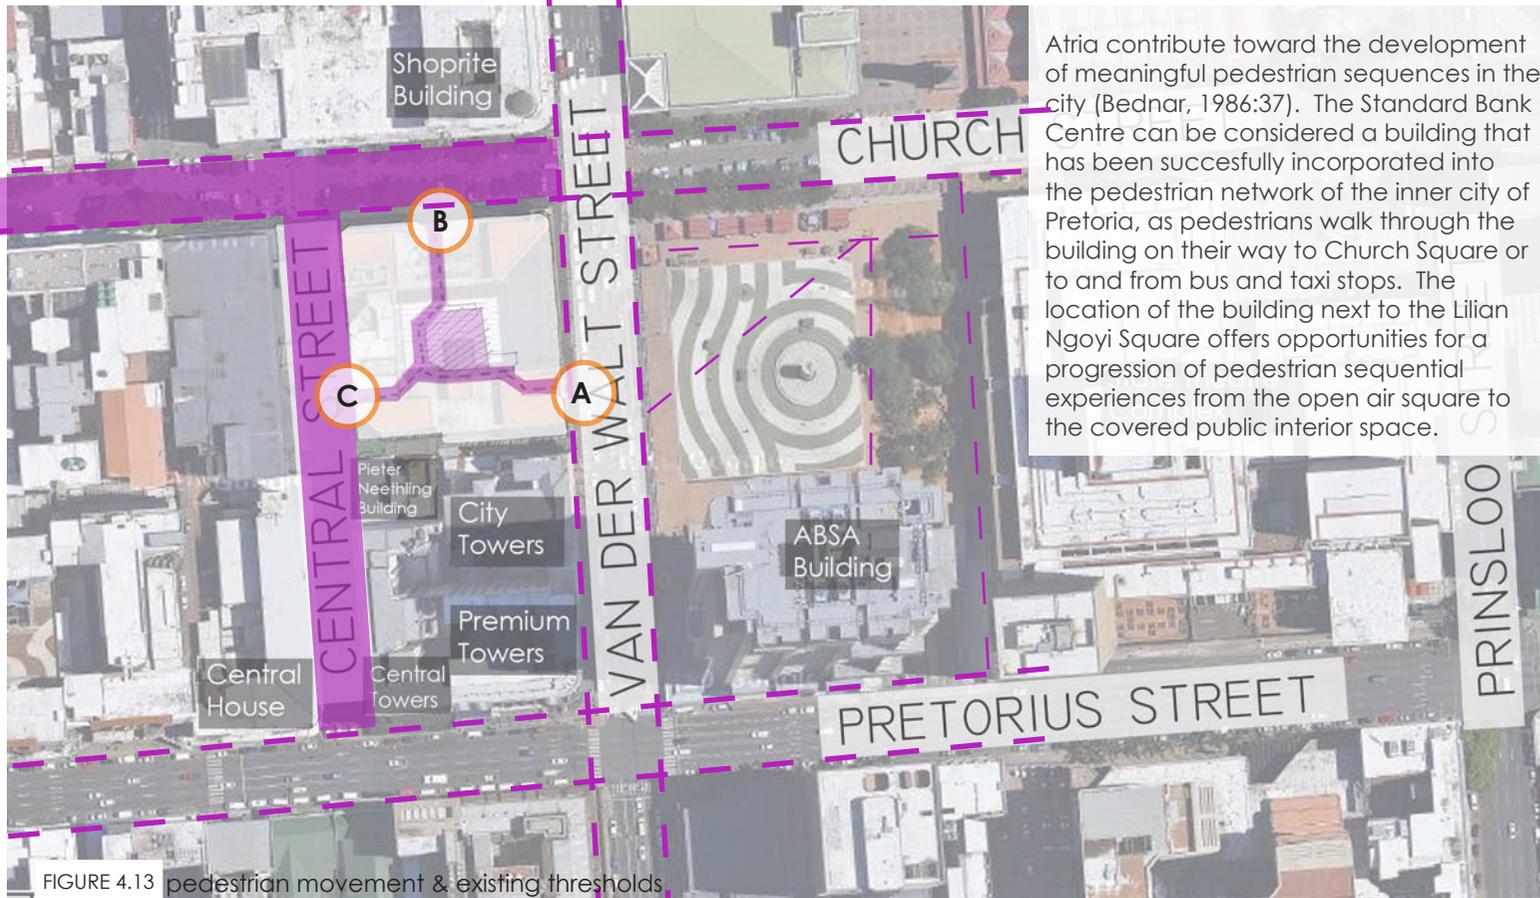
FIGURE 4.13 pedestrian movement & existing thresholds

Atria contribute toward the development of meaningful pedestrian sequences in the city (Bednar, 1986:37). The Standard Bank Centre can be considered a building that has been successfully incorporated into the pedestrian network of the inner city of Pretoria, as pedestrians walk through the building on their way to Church Square or to and from bus and taxi stops. The location of the building next to the Lilian Ngoyi Square offers opportunities for a progression of pedestrian sequential experiences from the open air square to the covered public interior space.

FIGURE 4.13 Aerial photograph and sketches indicating pedestrian movement and building entrances.
 FIGURE 4.14 Pedestrians walking in Church Street in front of the Standard Bank Centre.
 FIGURE 4.15 Pedestrians walking in Central Street.
 FIGURE 4.16 Eastern elevation of the Standard Bank Centre in context, not to scale.

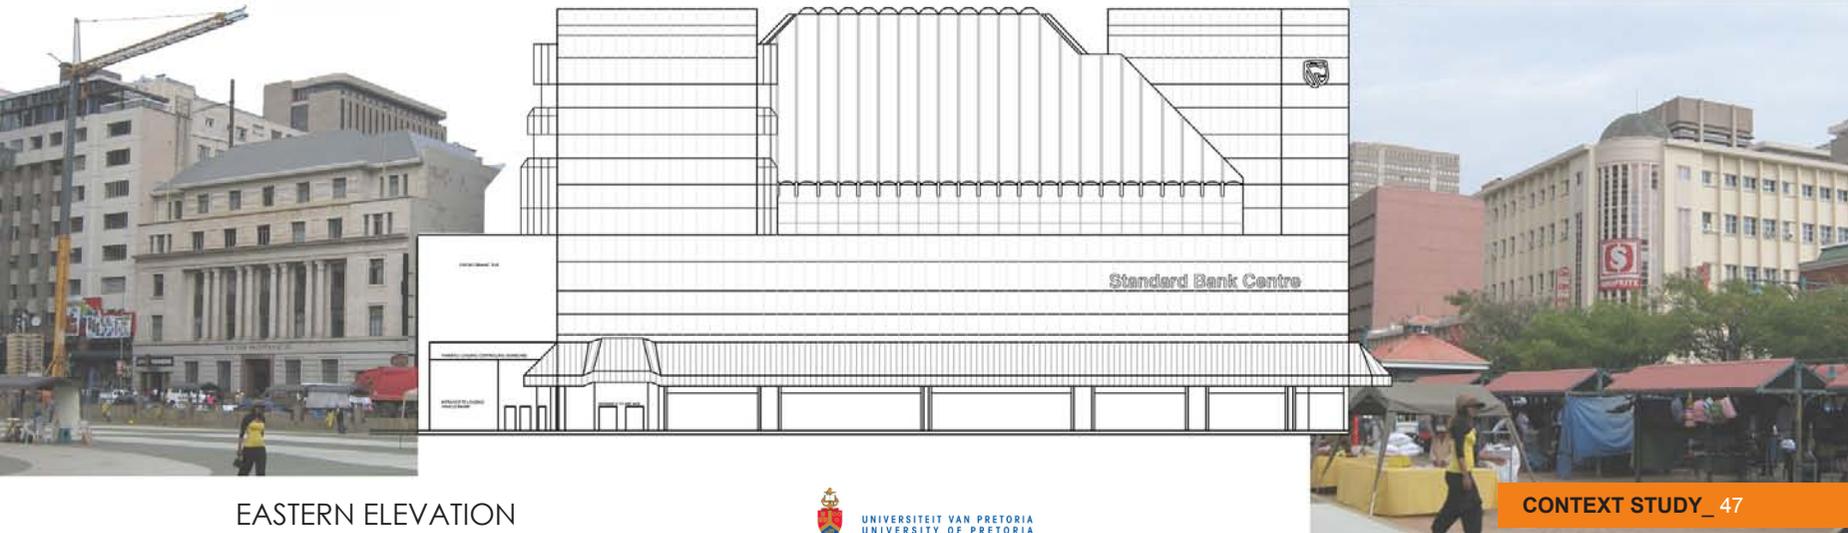
FIGURE 4.16

EASTERN ELEVATION

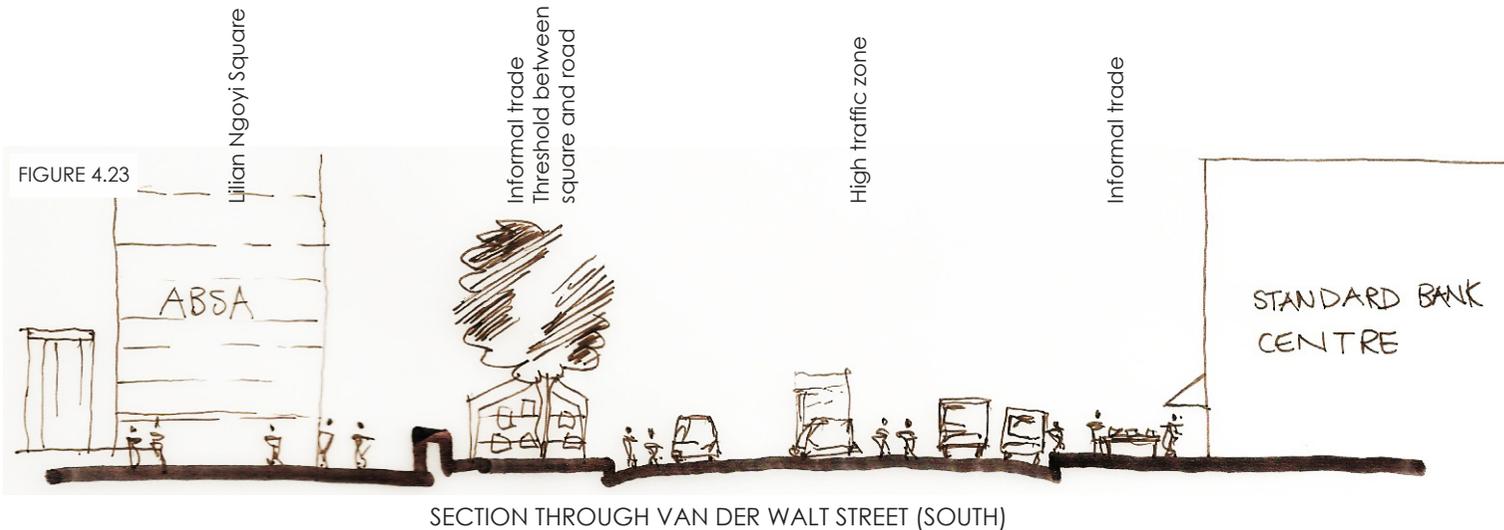
FIGURE 4.17, 4.18 Edge of building to Van der Walt Street. FIGURE 4.19 Edge of building to Church Street. FIGURE 4.20 Corner edge Van der Walt Street and Central Street. FIGURE 4.21, 4.22 Building edge to Central Street. FIGURE 4.23 Section through Van der Walt Street (not to scale). FIGURE 4.24 Section through Church Street (not to scale). FIGURE 4.25 Section through Central Street (not to scale).

5.3.5 Street Sections

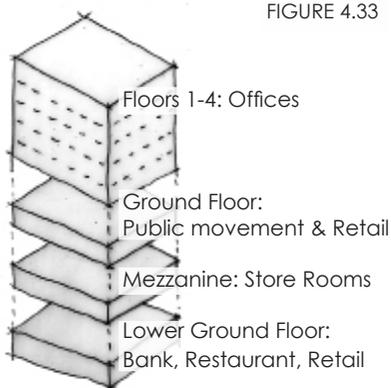
FIGURE 4.33 Diagram indicating current use of the building. FIGURE 4.34 View of the Standard Bank Centre from the Lilian Ngoyi public square.

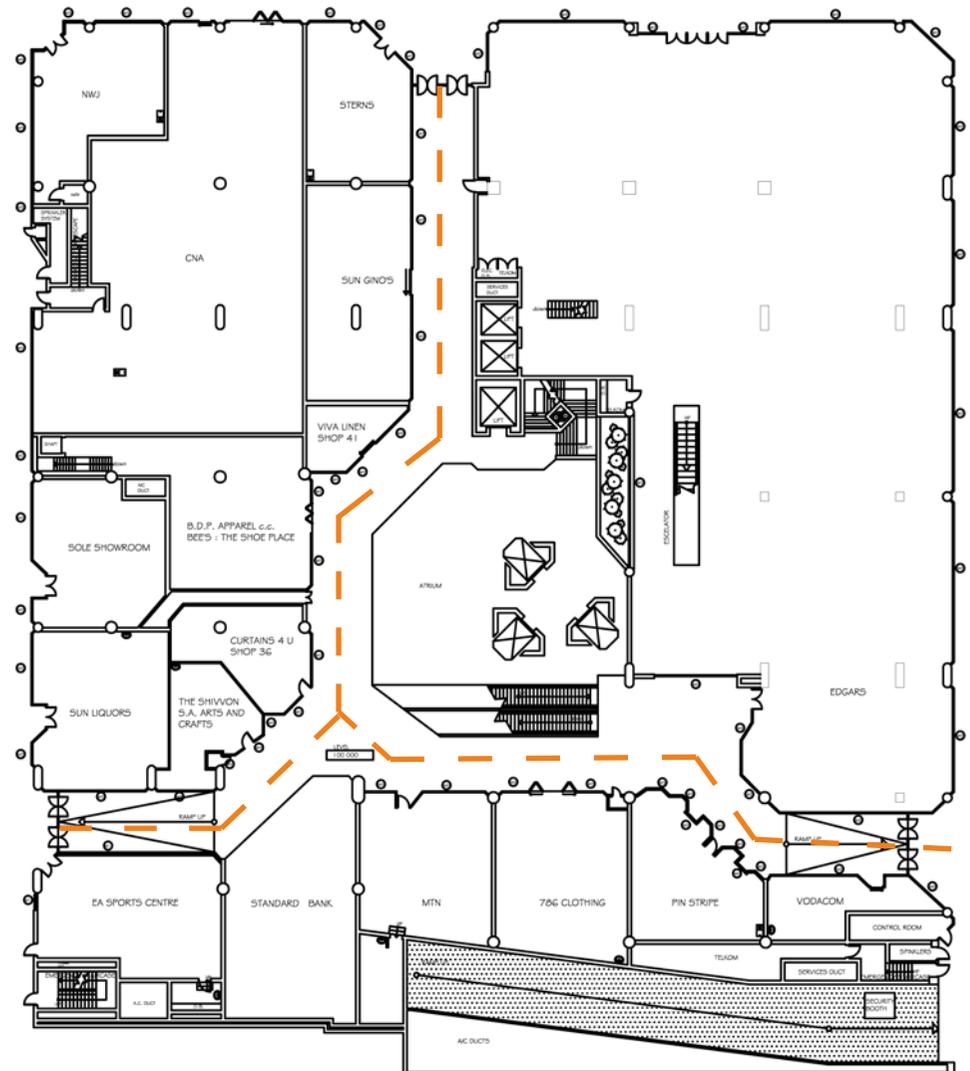
Access and circulation determines the success of the atrium space (Bednar, 1986:34). The Standard Bank Centre has three entrances on the ground floor level, each exiting on a different street, allowing access to the building from different directions. From the three entrances, passages lead to the atrium space in the centre of the building. The layout of the building and the width of the hallways encourage circulation to and through the atrium space, giving it value as a public space.

FIGURE 4.35 Existing Ground floor plan of the Standard Bank Centre.

Ground Floor
STANDARD BANK CENTRE

The floor is comprised of retail spaces that border the four meter wide passages. Pedestrians use passages through the building in a similar way that arcades are used; as a shortcut to get from one street to another or for a quick stroll past window displays on the way to a destination. An anchor shop is the large clothing outlet Edgars that takes up retail and storeroom space on four levels of the building. The Edgars store occupies most of the Eastern facade on the ground floor level, but does not make use of the window display opportunities as the windows are covered with roller doors.

The main entrance to the building is the entrance located on Van der Walt Street that people use in order to avoid traffic and informal traders when they are in a hurry. People enter the building on the ground floor to take the escalator down to the lower ground floor where the Standard Bank is situated.

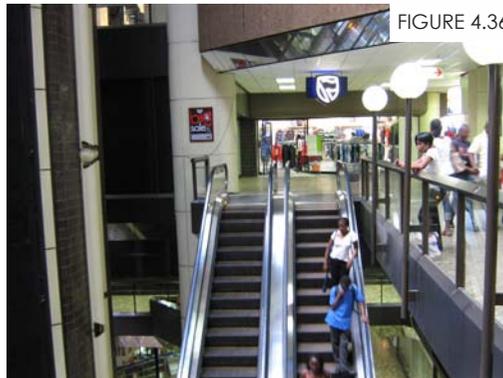
FIGURE 4.36 Escalator between ground floor and lower ground floor.

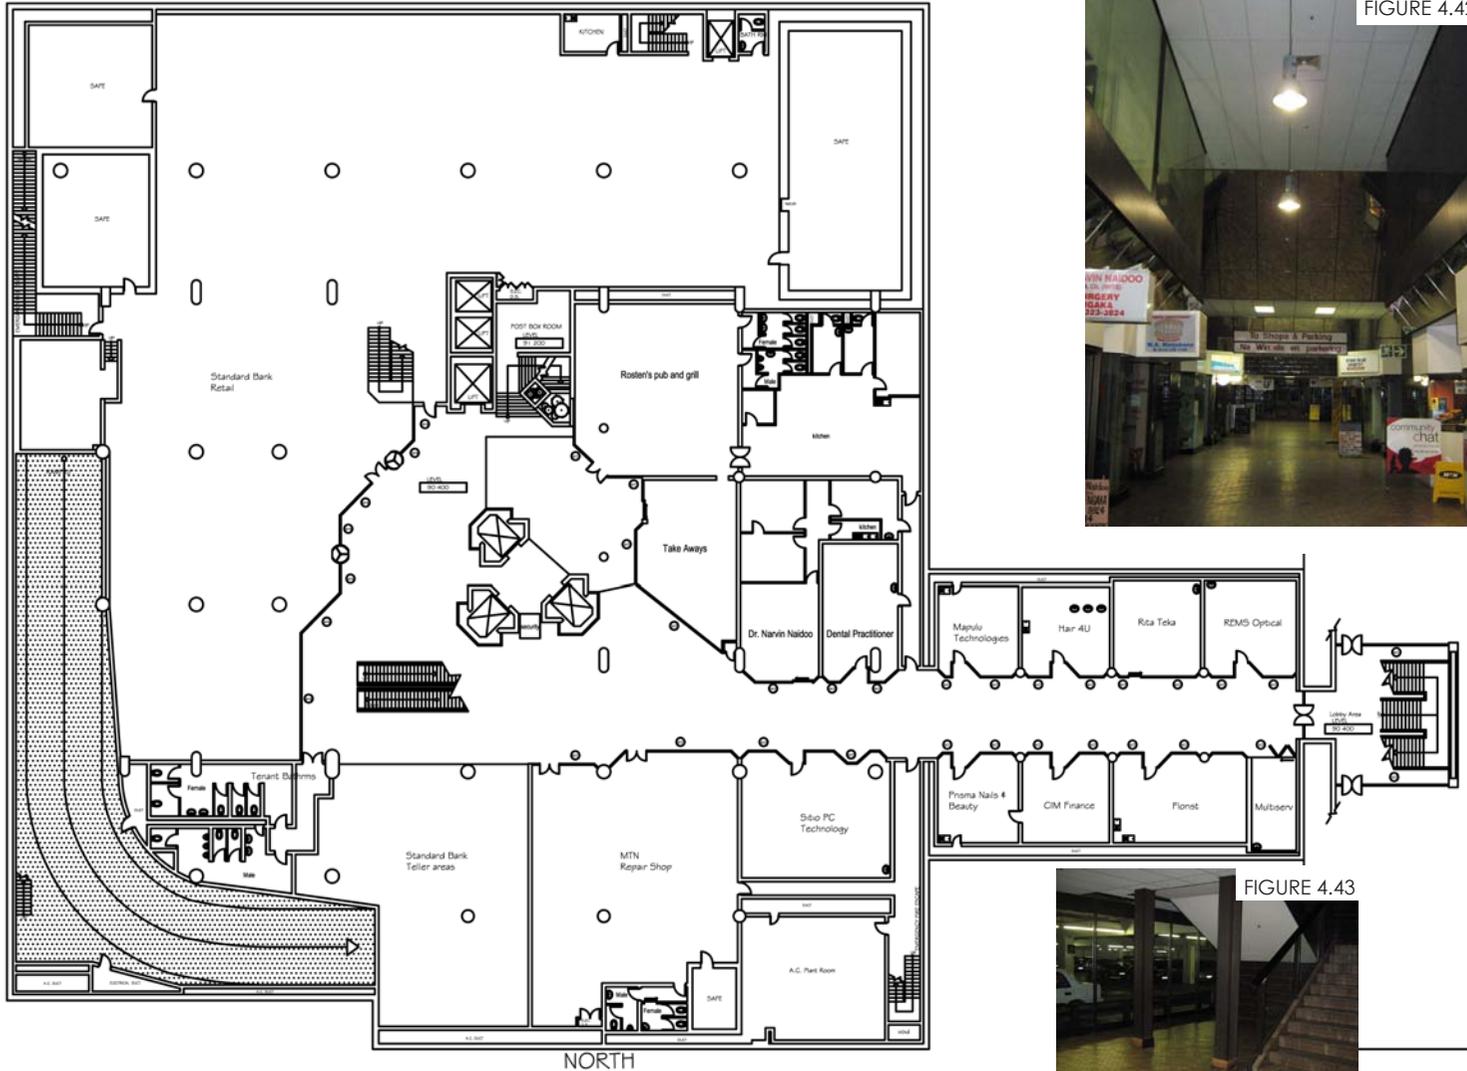
The Lower ground floor of the building contains the Standard Bank entrance, a major attraction for users of the building. To the Eastern side, an arcade leads to an underground parking lot that the Standard Bank Centre shares with the State Theatre.

FIGURE 4.40 People waiting for the bank to open. FIGURE 4.41 Existing Lower Ground floor plan of the Standard Bank Centre. FIGURE 4.42 The arcade leading to the underground parking lot. FIGURE 4.43 The staircase leading to the underground parking lot.

Lower Ground Floor Level
STANDARD BANK CENTRE

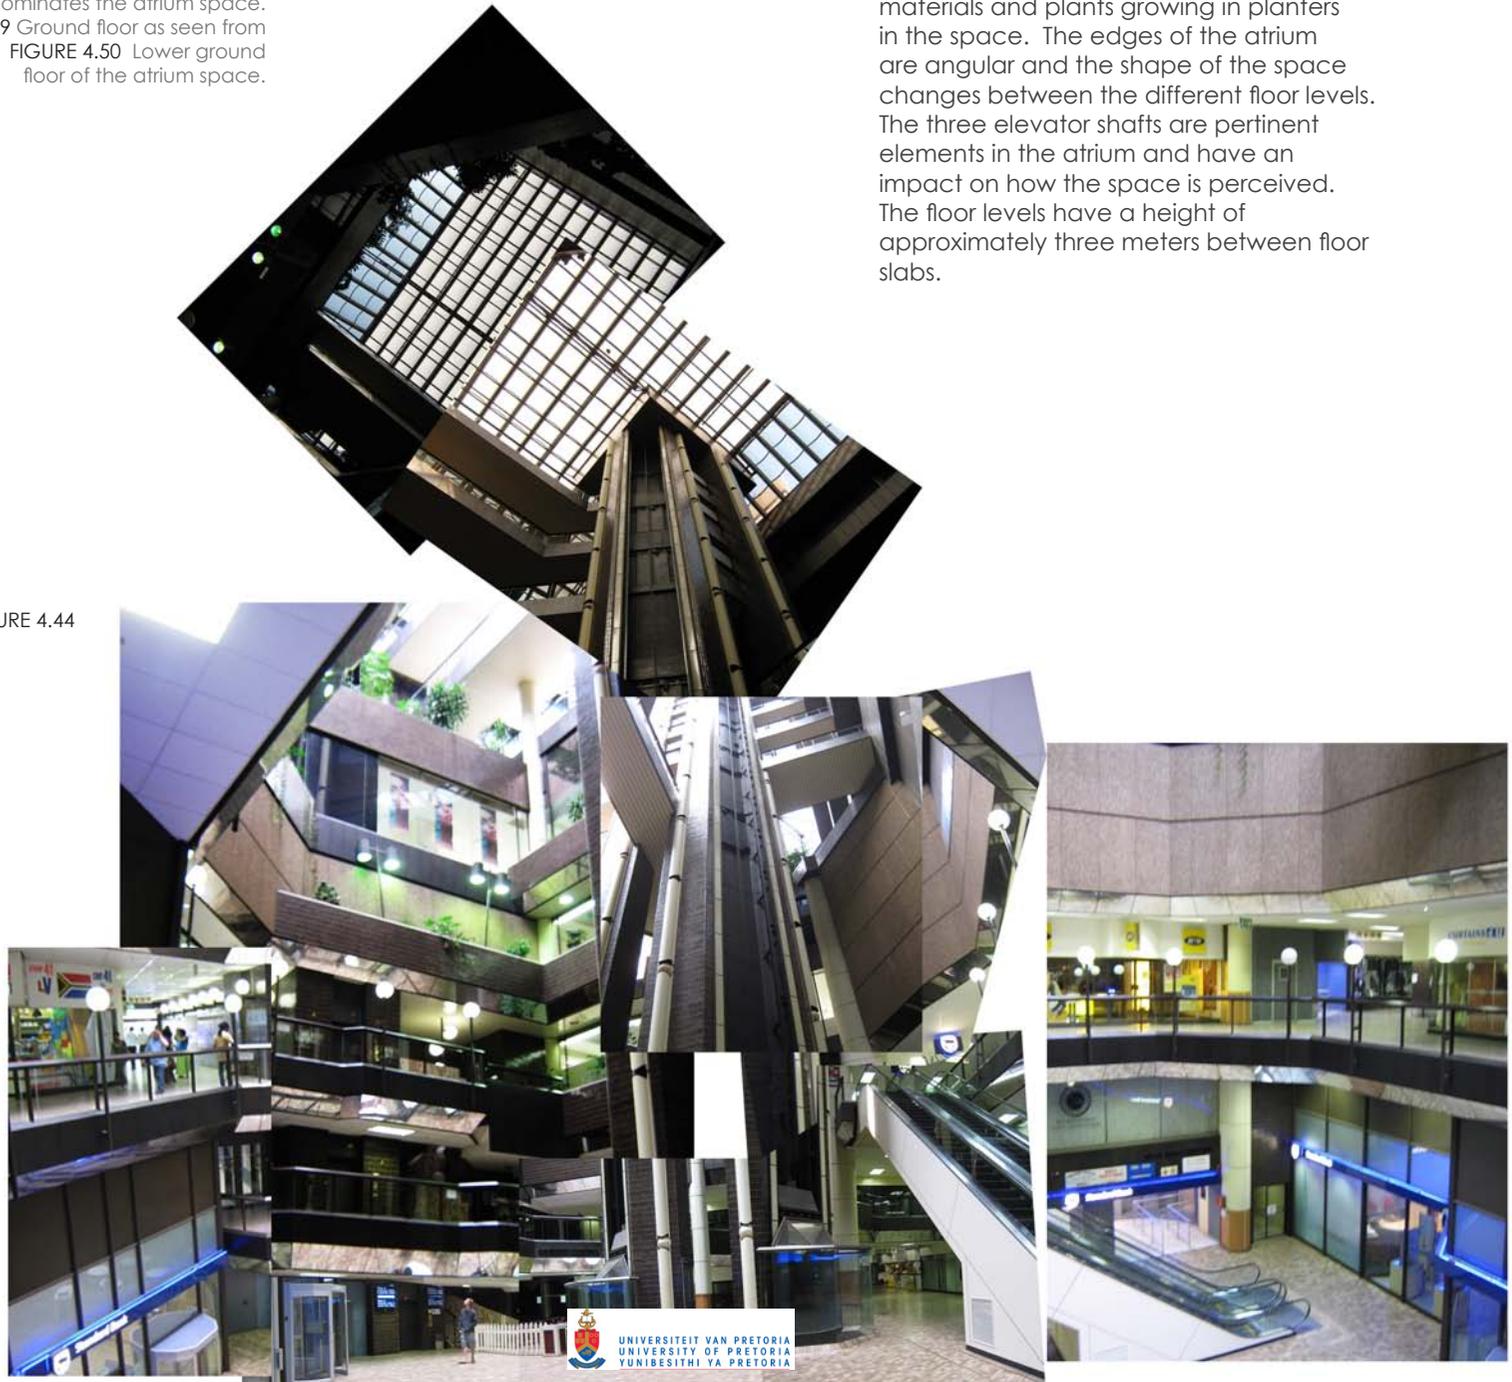
FIGURE 4.44 Digital collage of interior atrium space. FIGURE 4.45 Interior view of the skylight. FIGURE 4.46, 4.47 View of the atrium as seen from the third floor. FIGURE 4.48 Elevator shaft that dominates the atrium space. FIGURE 4.49 Ground floor as seen from the atrium. FIGURE 4.50 Lower ground floor of the atrium space.

The atrium space appears visually cluttered because of the change in materials and plants growing in planters in the space. The edges of the atrium are angular and the shape of the space changes between the different floor levels. The three elevator shafts are pertinent elements in the atrium and have an impact on how the space is perceived. The floor levels have a height of approximately three meters between floor slabs.

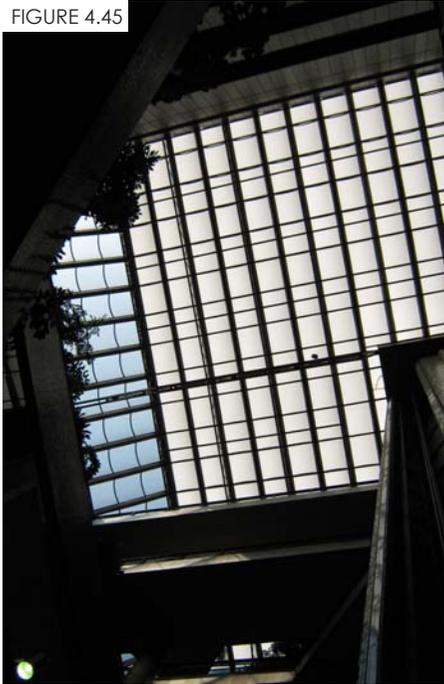
FIGURE 4.45

The skylight provides an effective transmission of daylight that replicates outdoor lighting levels. It also ensures balanced light distribution. Daylighting in atrium buildings is simpler than in other building types and heat loss and gain is reduced (Saxon, 1983:6). The sloping panels of the skylight drain the inevitable condensation that takes place. According to Richard Saxon (1983:20), the transmission loss through glass is minimized by angling the glass panes towards the late morning and early afternoon sun, thus receiving a continuous, strong solar flow for three hours around mid-day. The glass panes of the Standard Bank Centre faces East, meaning the morning sun flows into the building.

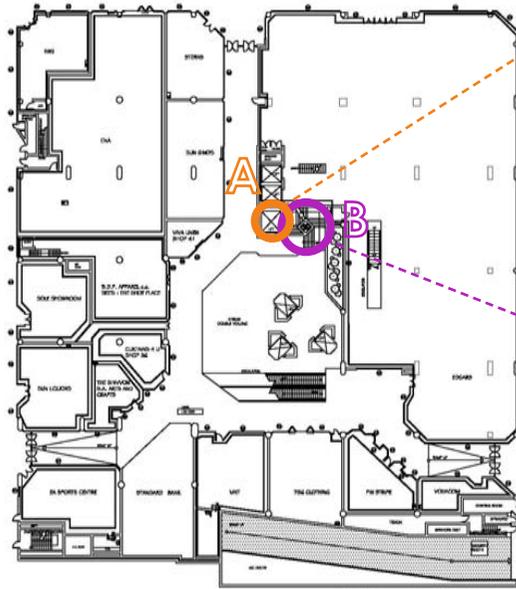
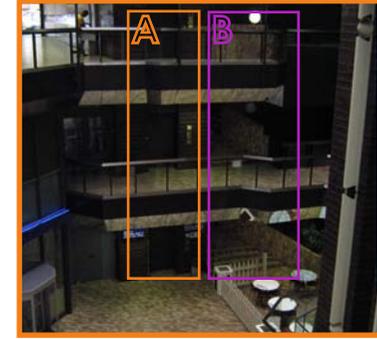
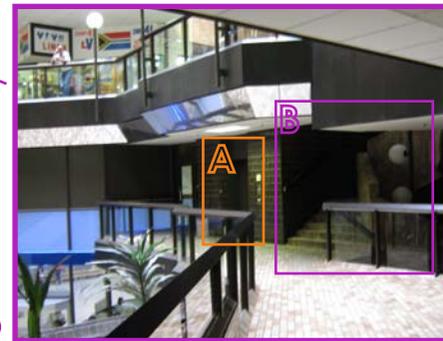
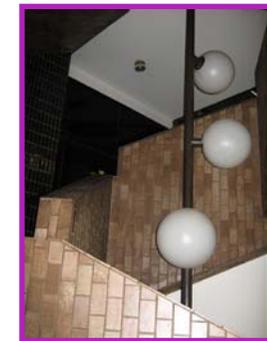
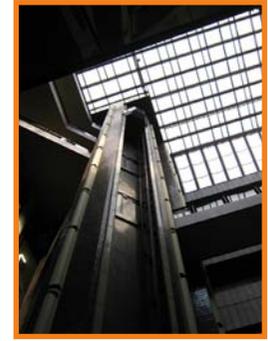
FIGURE 4.51

FIGURE 4.51, 4.52 Diagrams of plans and photographs explaining the circulation through the building.

Type	Elevator
Location	Next to the atrium space and staircase B.
Provides circulation	between Lower Ground floor and Ground floor.
Users	Mainly cleaning staff with cleaning equipment.
Usage	Minimal
Visibility of movement	The elevator movement is not visible and does not impact the atrium space.

Type	Staircase
Location	Next to the atrium space and elevator A.
Provides circulation	between Lower Ground floor and Ground floor.
Users	Security staff and other people who work inside the building.
Usage	Minimal; on the Lower Ground floor the restaurant imposes on the movement.
Visibility of movement	Movement is visible but because of minimal use it is not significant.

Type	Observation Elevator
Location	In atrium space.
Provides circulation	between Basement and Fifth floor, excluding the Ground floor and Mezzanine level.
Users	People working in offices on floors 1 to 4.
Usage	Minimal; not all the offices are occupied.
Visibility of movement	The elevator movement is visible and purveys a dynamic quality to the atrium space. A person in the elevator has a dramatic view of the atrium from above.

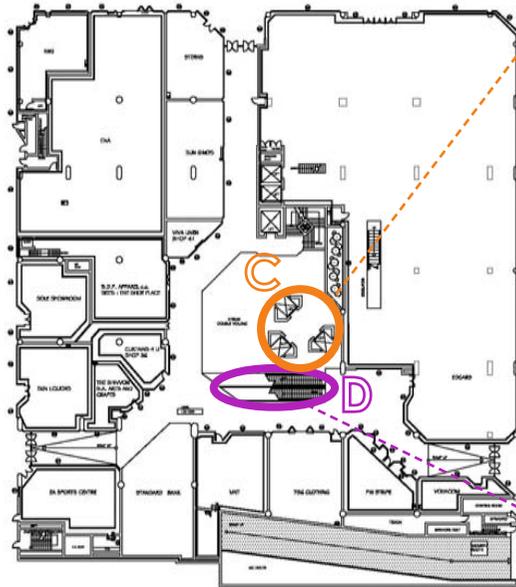
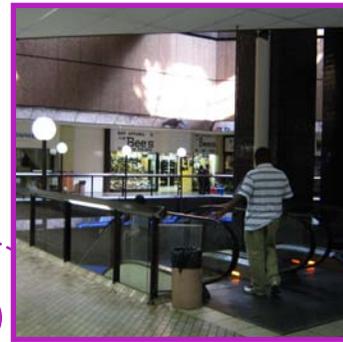
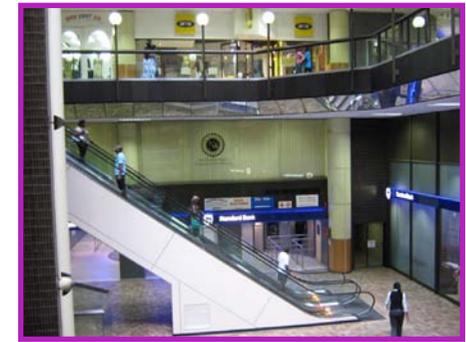
FIGURE 4.52

Type	Escalator
Location	In atrium space.
Provides circulation	between Lower Ground floor and Ground floor, excluding Mezzanine level.
Users	Customers of Standard Bank, entering the building on Ground floor.
Usage	Maximum usage; the escalator is the main circulation method between the Lower Ground floor and Ground floor.
Visibility of movement	Movement is visible but because of minimal use it is not significant.

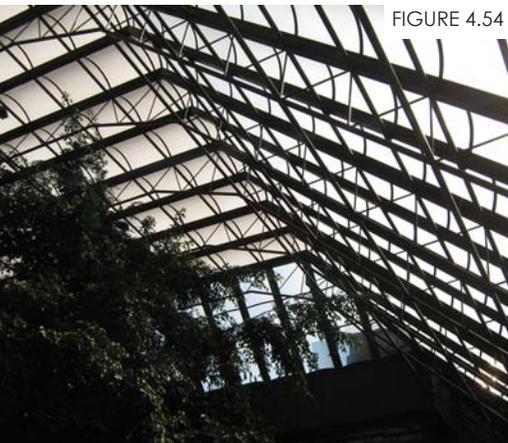
FIGURE 4.53 View of office floor levels from atrium space. FIGURE 4.54 View of skylight.
