CHAPTER 1

INTRODUCTION

1.1 Development history of total hip replacement

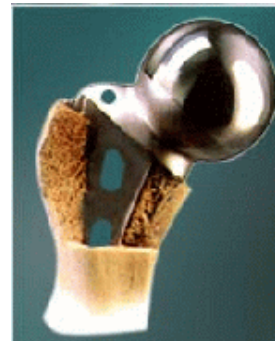
Figure 1.1: Austin-Moore prosthesis

In the 1950s Thompson and Moore (<http://www.utahhipandknee.com/history.htm>) separately developed replacements for the entire ball of the hip. These could be used to treat hip fractures and also certain arthritic cases. This type of hip replacement, called hemi-arthroplasty, only solved the problem of the arthritic femoral head (ball). The diseased acetabulum (hip socket) was not replaced. The prosthesis consisted of a metal stem which was placed into the marrow cavity of the femur, fitted with a metal ball (one-piece construction) which fitted into the hip socket (see Figure 1.1).

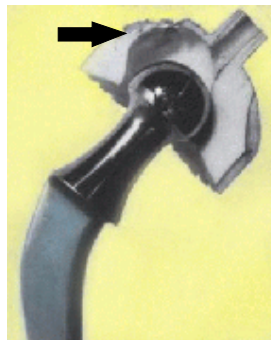
Figure 1.2: The early prosthesis as designed by Sir John Charnley. Note the migration of the femoral head into the Teflon.

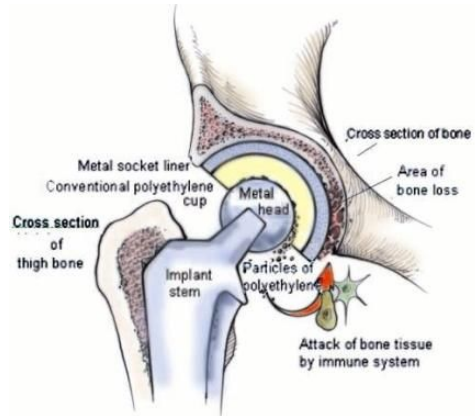
Figure 1.4: Schematic presentation of mechanism resulting in osteolysis (http://www.geocities.com/hip_replacements/history)

The clinical presentation of aseptic loosening can be explained as an attack on the bone tissue by the immune system as a result of the polyethylene wear debris present in the area. The schematic presentation of the mechanism is presented in Figure 1.4 with a clinical case shown on X-ray in Figure 1.5. The osteolastic bone resorption is shown in Figure 1.6.

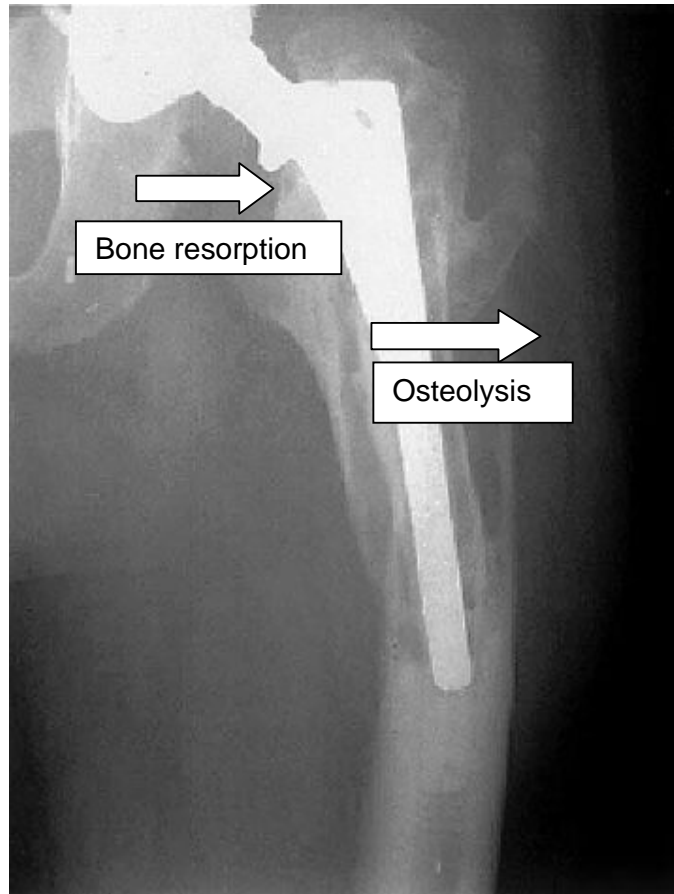
Figure 2.2: Femoral osteolysis with signs of bone resorption below collar (Dumbleton et al., 2002)

The use of a collar determines the design of the collar. The principal reason for the use of the collar is to transmit the load via the smaller trochanter area into the cortical bone of the femur. These designs tend to cause bone resorption (degeneration of the bone in the area under compression) just below the collar in the cortical bone. (See illustration of bone resorption below collar in Figure 2.2.)

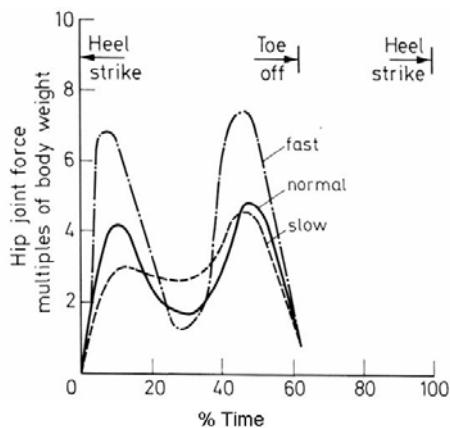
Figure 2.10: Variation with time of hip joint forces for slow, normal and fast walking (Paul, 1976). The scale of the x axis is percentage time

An exact analysis of the resultant load, acting on the hip joint, is difficult since the precise load in the relevant muscles has not yet been determined nor can the force transmitted by the ligaments at any instant be inferred from external measurements. By making reasonable assumptions for the position of the resultant force transmitted by certain groups of muscles, Paul (1976) was able to establish a basic loading pattern for the hip joint. The graphical presentation of these forces can be seen in Figure 2.10 and a summary of the results obtained in Table 2.1.

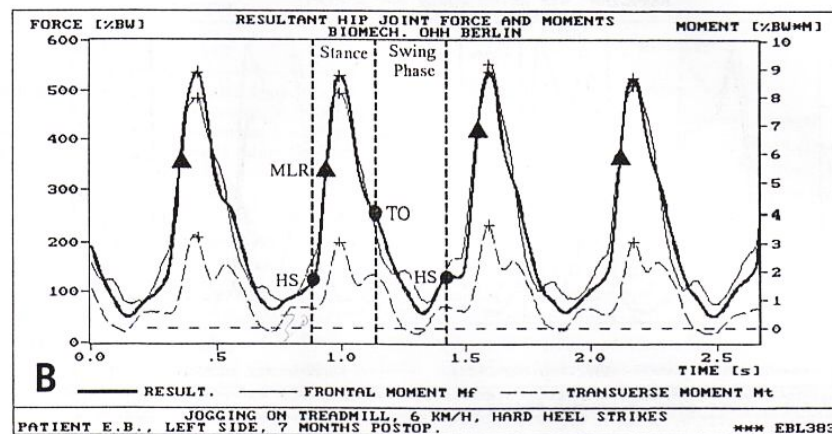
Figure 2.11: Resultant force on hip joint for patient jogging on treadmill at 6 km/h (Bergmann et al., 1993, Bergmann et al., 1995). HS: heel strike, TO: toe off; MLR: measured load profile

The work done by Paul was verified by Bergmann (1985; 1993). Two femoral components were instrumented with strain gauges and transmitters. The two prostheses were then implanted into two patients. After the recovery period, strain measurements were taken while the patients were walking at different speeds on a treadmill. The data were analysed and plotted as a resultant force acting on the hip joint during the walking cycle. The plotted data can be seen in Figure 2.11.

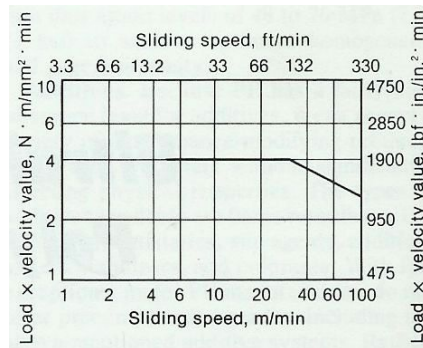
Figure 2.12: PV values for UHMWPE at 20°C (Engineering Materials Handbook, 1987)

A frequently used guide to the capacity of marginally lubricated or dry bearings (Hutchings, 1992) is the value of the product PV, where P is the mean bearing pressure in MPa (load divided by projected bearing area) and V is the sliding velocity in ms⁻¹. A typical dry PV value for this material is 4 N/mm².m/s, as shown in Figure 2.12, with a maximum compression strength of 10 MPa determined at room temperature.

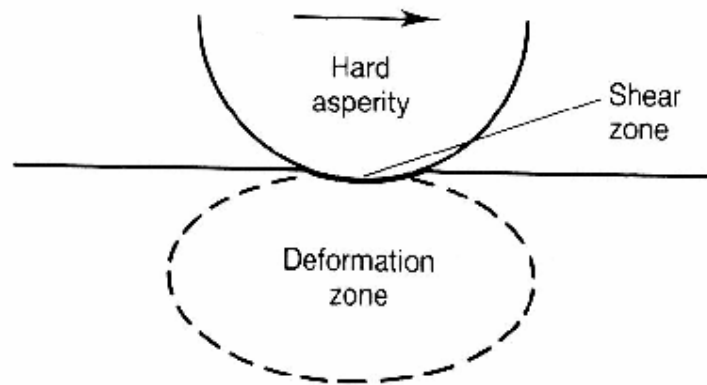
Figure 2.15: The origins of the friction associated with the sliding of a hard, smooth surface over a polymer surface (Hutchings, 1992)

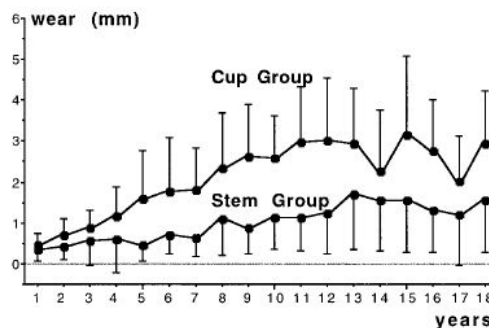
Figure 2.19: Linear wear in the cup replacement and stem replacement group (Kesteris et al., 2003)

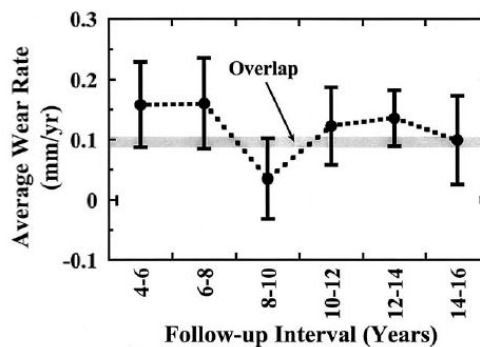
Figure 2.28: Average wear rate for acetabular components sterilised with gamma radiation (Orishimo et al., 2003)

In a study done by Orishimo et al. (2003), the long-term in-vivo wear performance of two groups of well-functioning cementless acetabular cups sterilised by two different methods, namely gamma irradiation and ethylene-oxide were compared. The first group consisted of 31 acetabular cups sterilised by means of gamma irradiation while the second group consisted of 28 acetabular cups sterilised with ethylene oxide. The linear wear rate follow-up data for the gamma-sterilised acetabular cups can be seen in Figure 2.28 while the follow-up data for the ethylene oxide acetabular cups can be seen in Figure 2.29. On average, it can be seen that the linear wear rate in mm/year for the gamma-sterilised cups is slightly better than for the ethylene oxide cups.

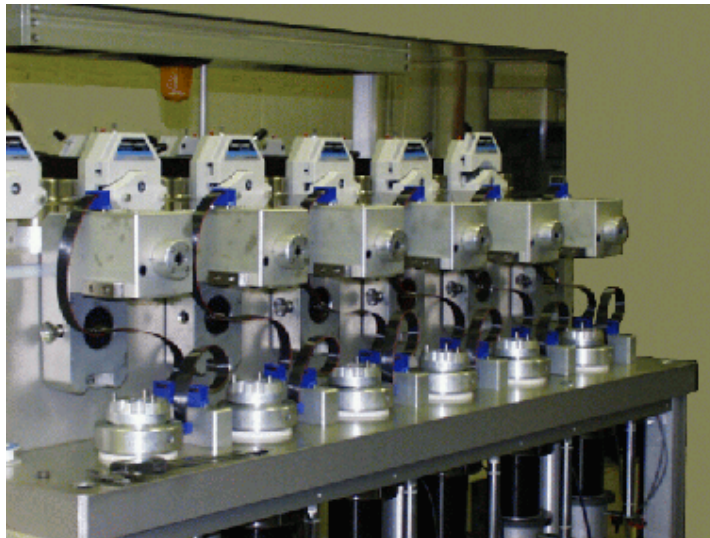
Figure 2.35: Boston hip simulator
