REGENERATING BEREA PARK

[Design in pursuit of rekindling appropriation]

Submitted in partial fulfilment of the requirements for the degree of
Masters of Architecture, MProf(Arch),
Department of Architecture
Faculty of Engineering, Built Environment and Information Technology
University of Pretoria, South Africa

Programme:	Sport and recreational centre
Site description:	Berea Park Clubhouses, Berea Park neighbourhood, Tshwane
Site location:	Erf R/2375
Address:	600 Lillian Ngoyi Street
GPS Coordinates:	25° 75' 80.49" S , 28° 19' 39.31" E
Research field:	Heritage
Clients:	Department of Sport and Recreation South Africa Tertiary institution (Unisa or University of Pretoria) Individuals from the Berea Park neighbourhood
Keywords:	regeneration, belonging, heritage, adaptive reuse, sport, recreation
Premise:	Design in pursuit of rekindling appropriation

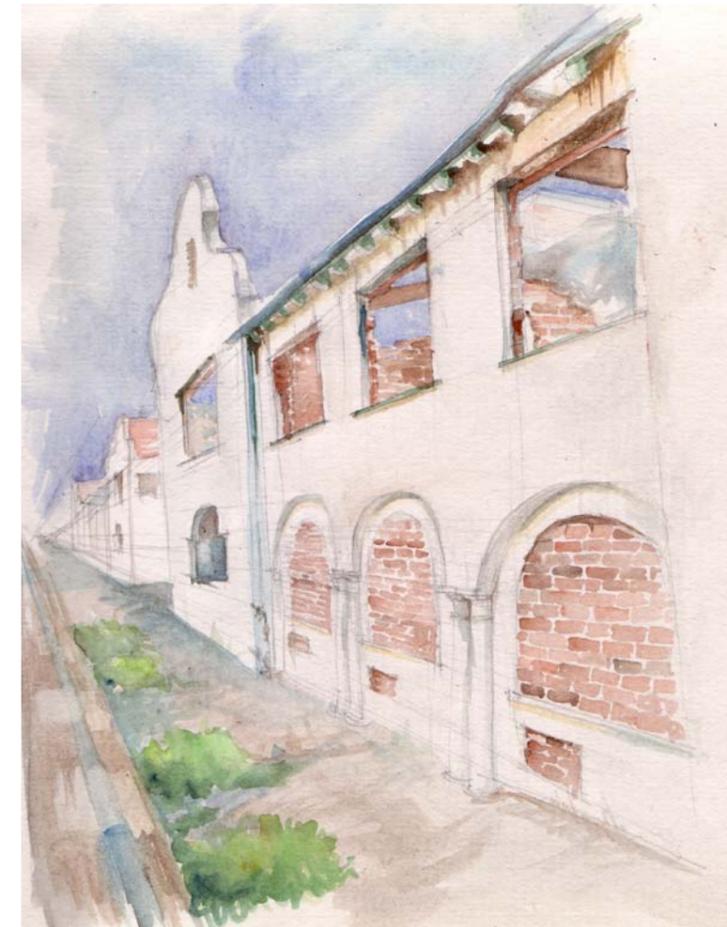
Figure 45: Fire damaged southern clubhouse (Author 2013)

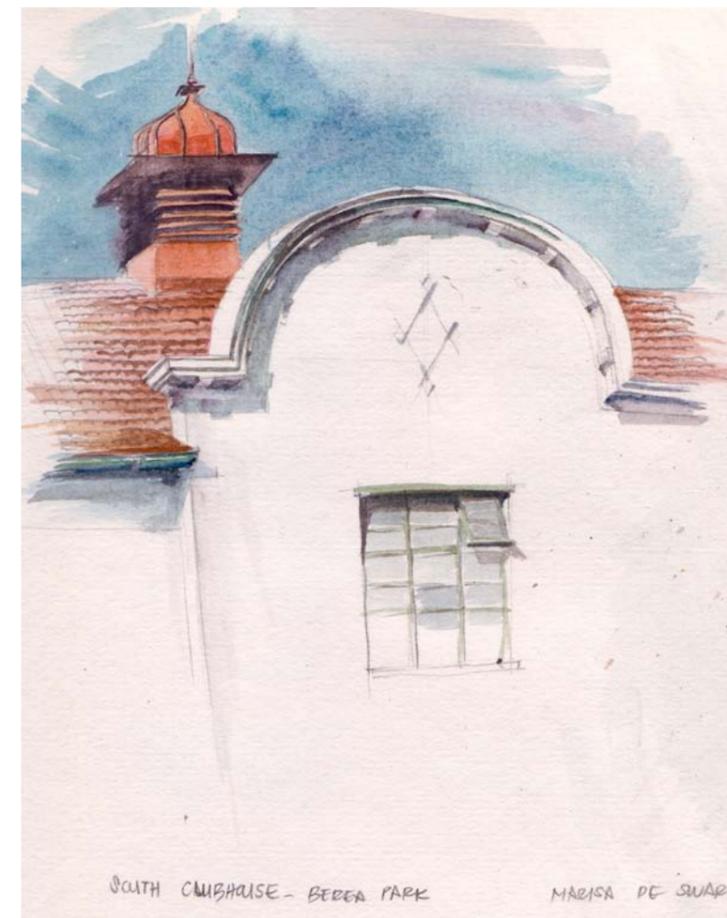
Figure 46: Central gable of southern clubhouse (Author 2013)

verandas run along the eastern facade of the building, creating pavilion spaces. Profiled timber supports, that were later replaced with steel ones, support the profile steel roof over the veranda spaces. Other notable elements in the building include the stone plinth on the eastern facade as well as the use of two-coloured roof tiles.

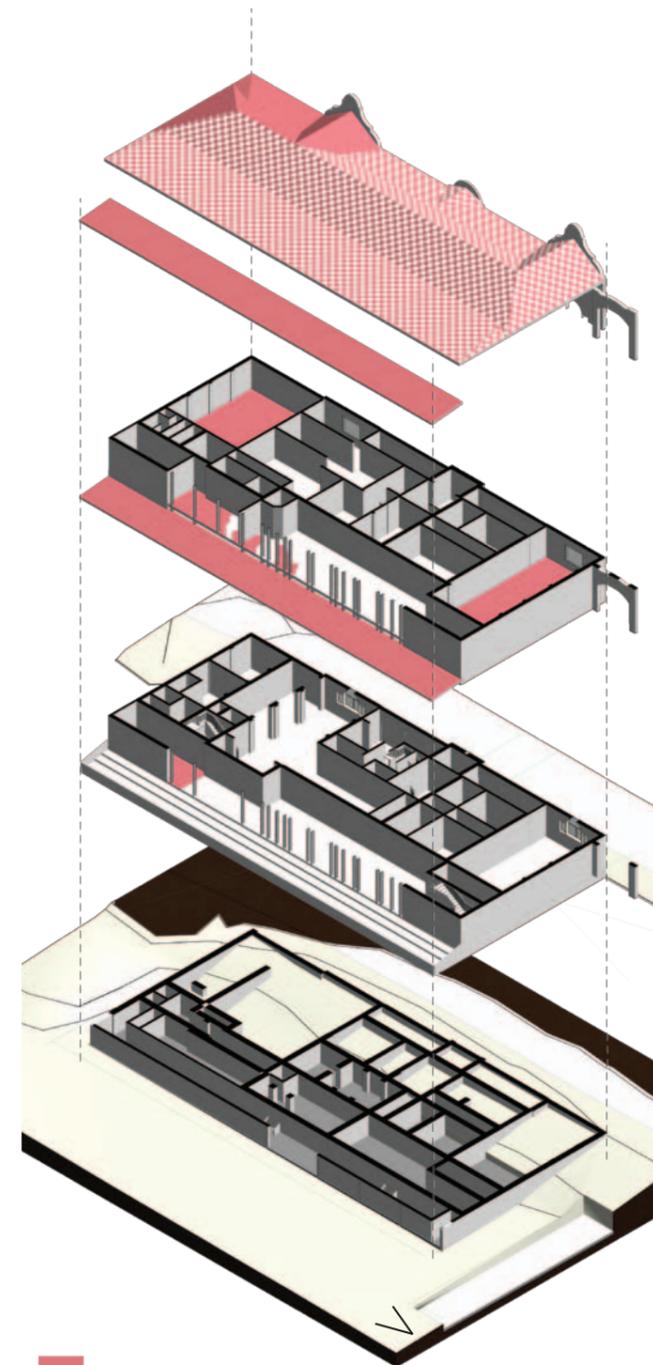
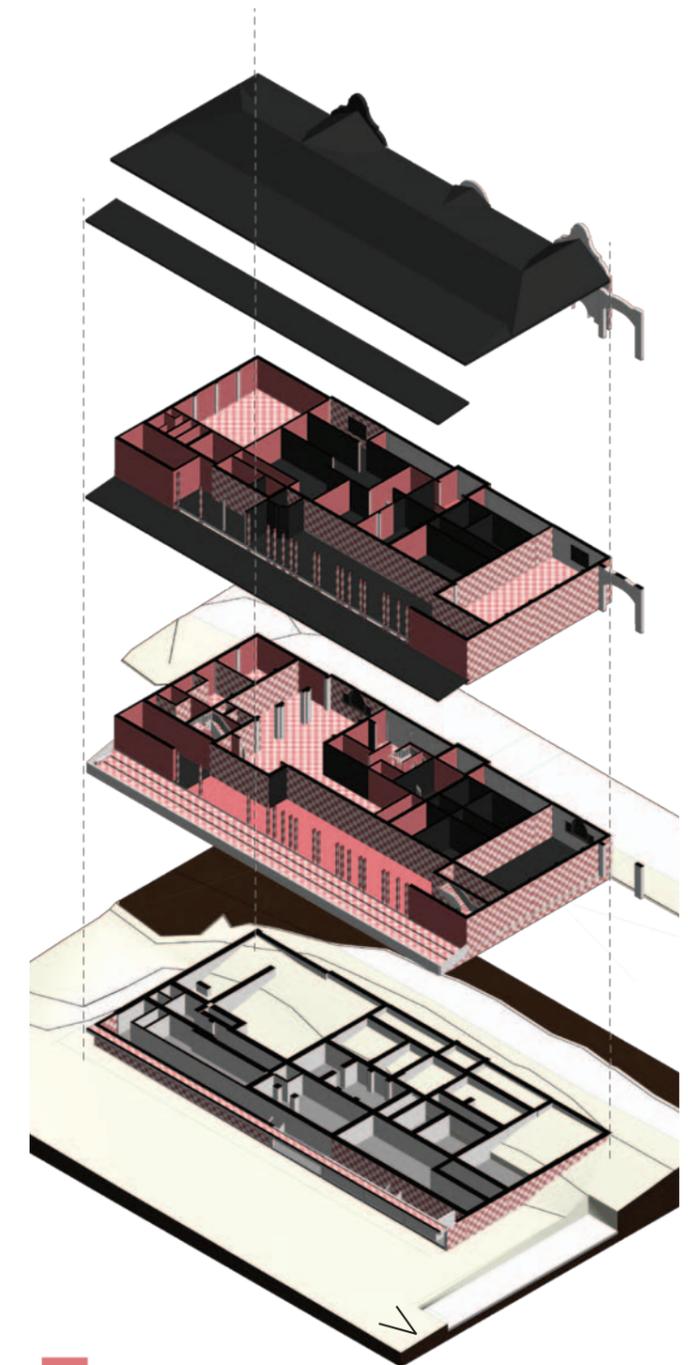
- SEVERELY DAMAGED
- NEEDS ATTENTION

- SEVERELY DAMAGED
- NEEDS ATTENTION
- DAMAGED BEYOND REPAIR (GONE)

Figure 47: Graphic representation of heritage importance, and lost or damaged elements of the southern clubhouse (Author 2013)

Physical model mapping damaged and removed elements (Figure 62, Figure 63, Figure 64) based on HIA done by Bruwer and Paine and structural analysis by engineer Carl von Geysso, as well as visual analysis done by author. (Figure 47, Figure 55)

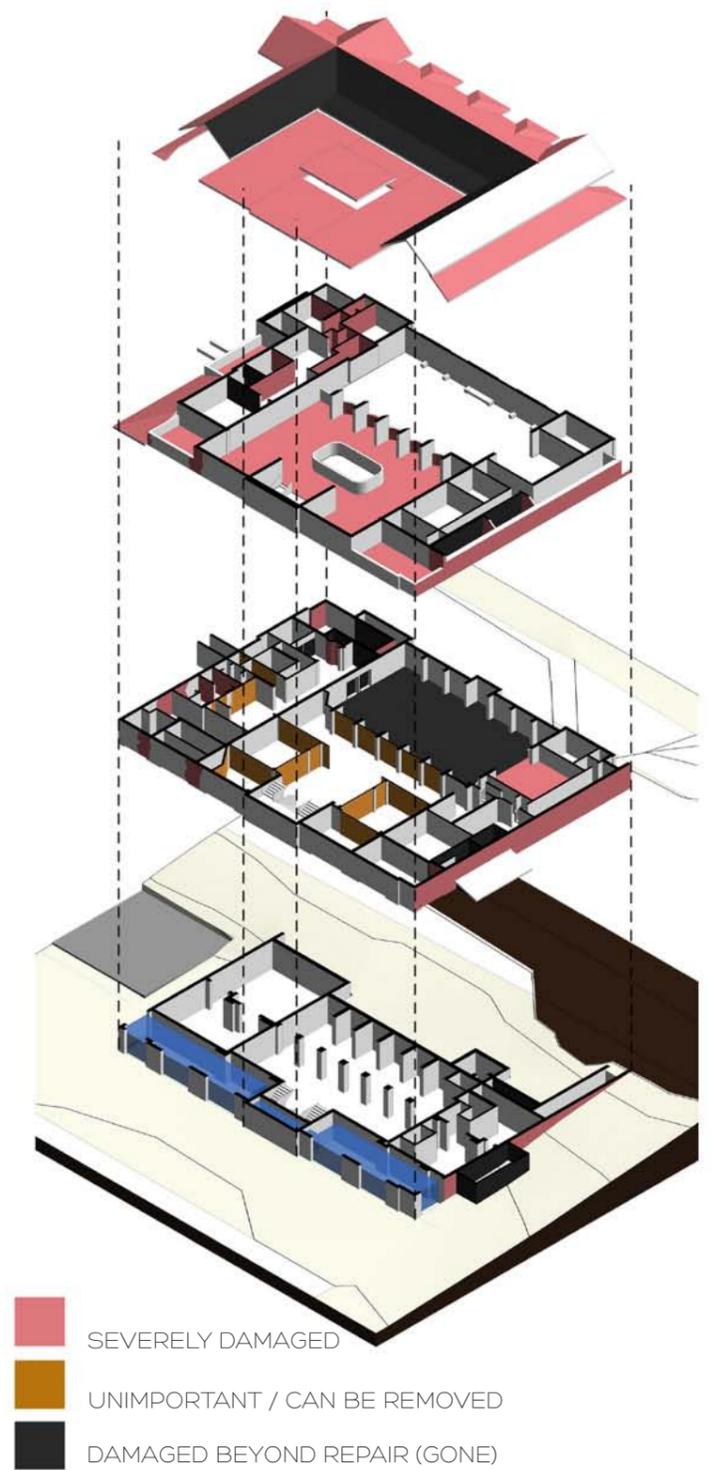
Figure 55: Graphic representation of heritage importance and lost or damaged elements of the northern clubhouse (Author 2013)

The Cape Dutch gables as well as the proportioning of the doors and windows form an intricate part of the design. Some of the later additions were done insensitively, and does therefore not contribute to the heritage and cultural significance of the building. These elements could be removed or sacrificed to enhance the integrity of the building. The later additions include: the northern mono-pitch addition, partitioning and false ceilings, in most cases these elements have suffered extensive damage. (Figure 55)

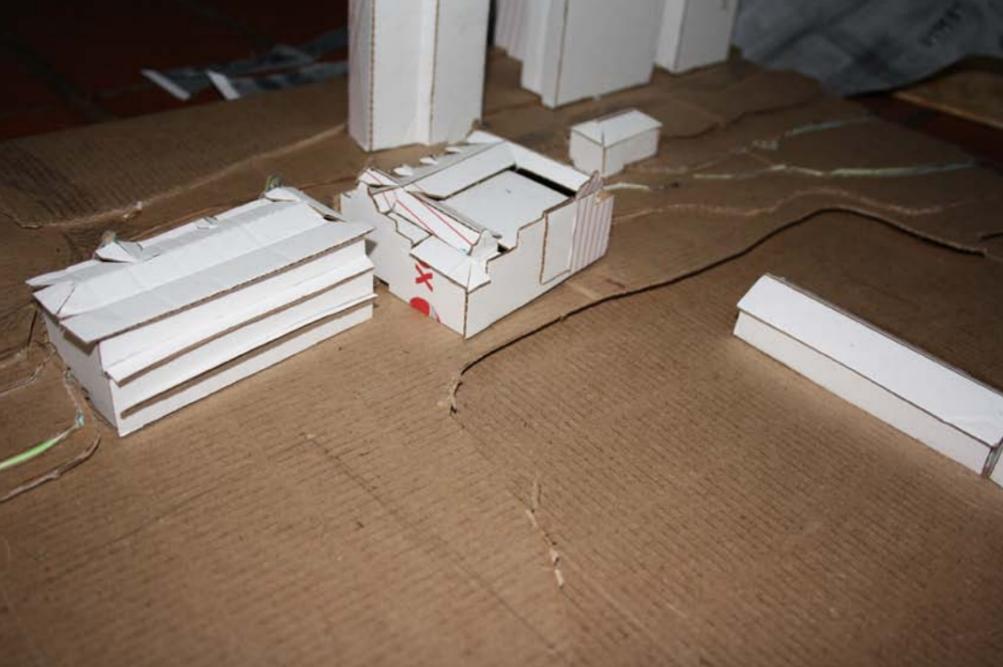
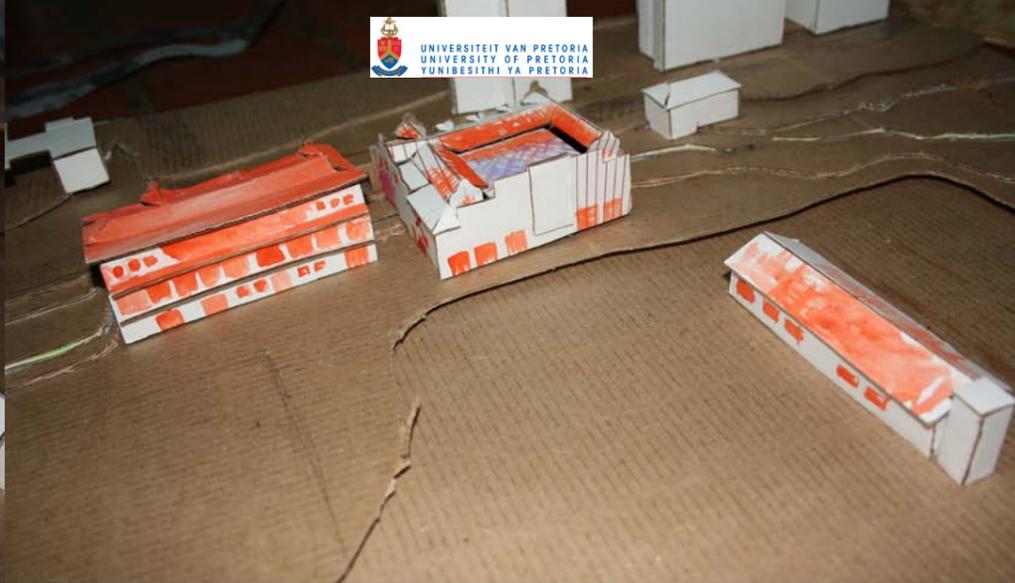
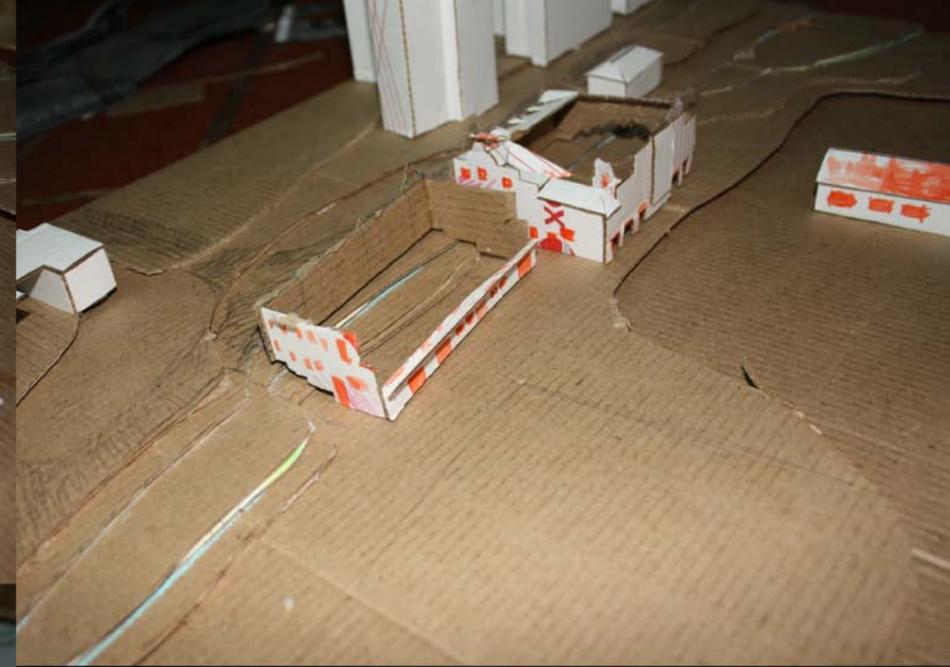
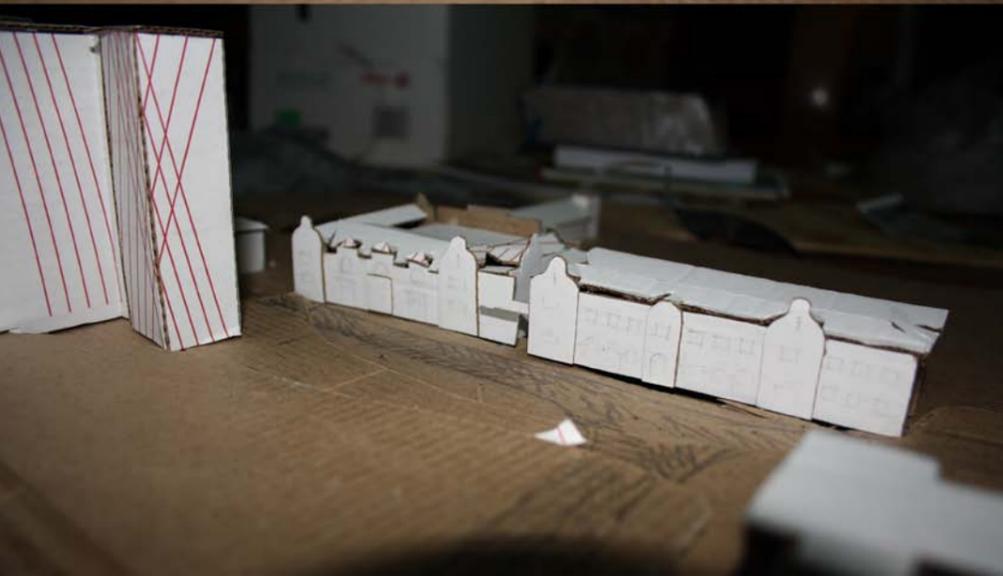
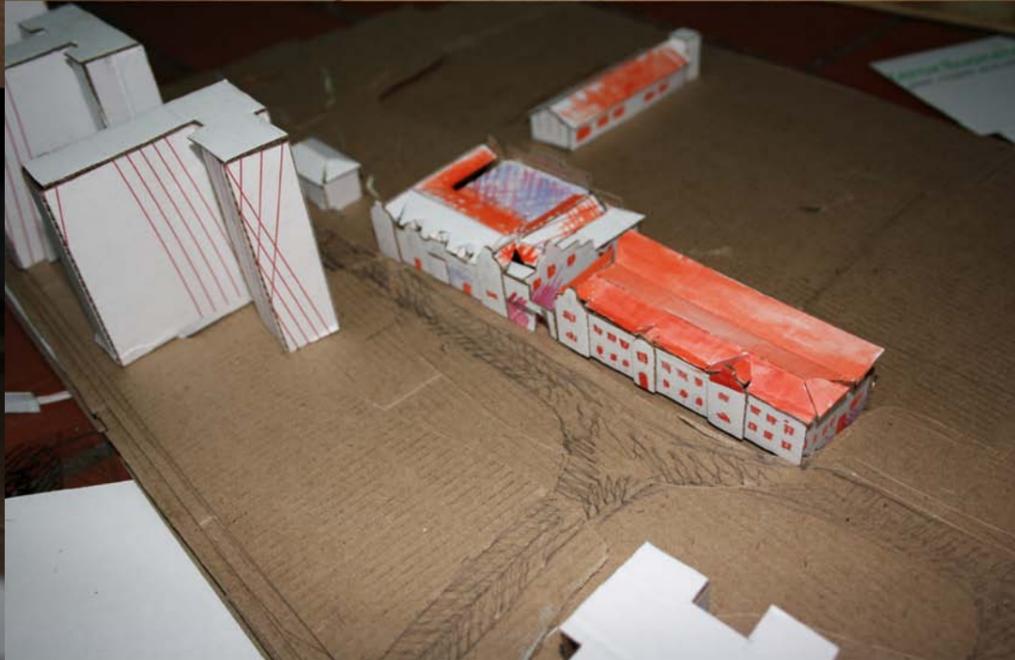
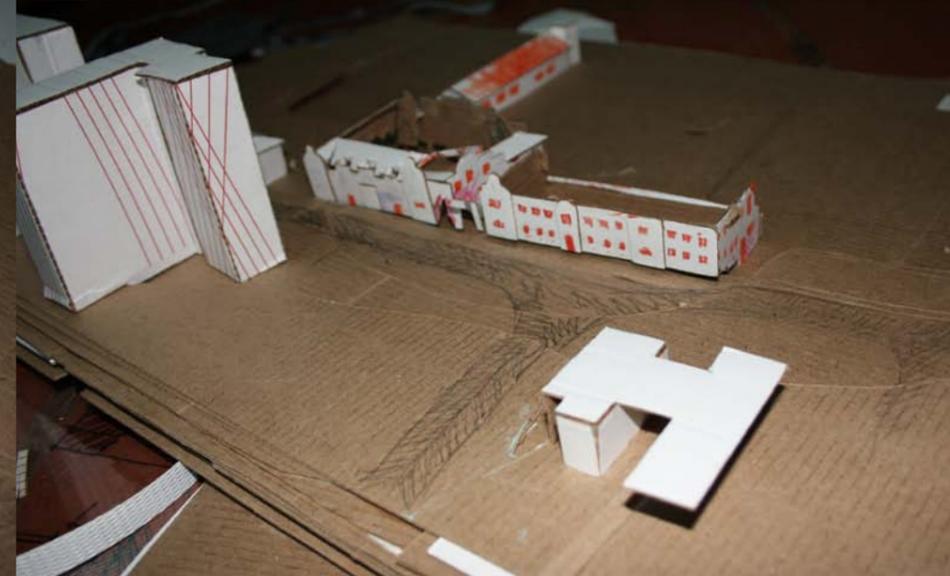
Figure 62: Model of Berea Park buildings (Author 2013)

Figure 63: Model of Berea Park buildings with mapping of damaged/lost elements (Author 2013)

Figure 64: Model of Berea Park buildings with damaged and lost elements removed (Author 2013)

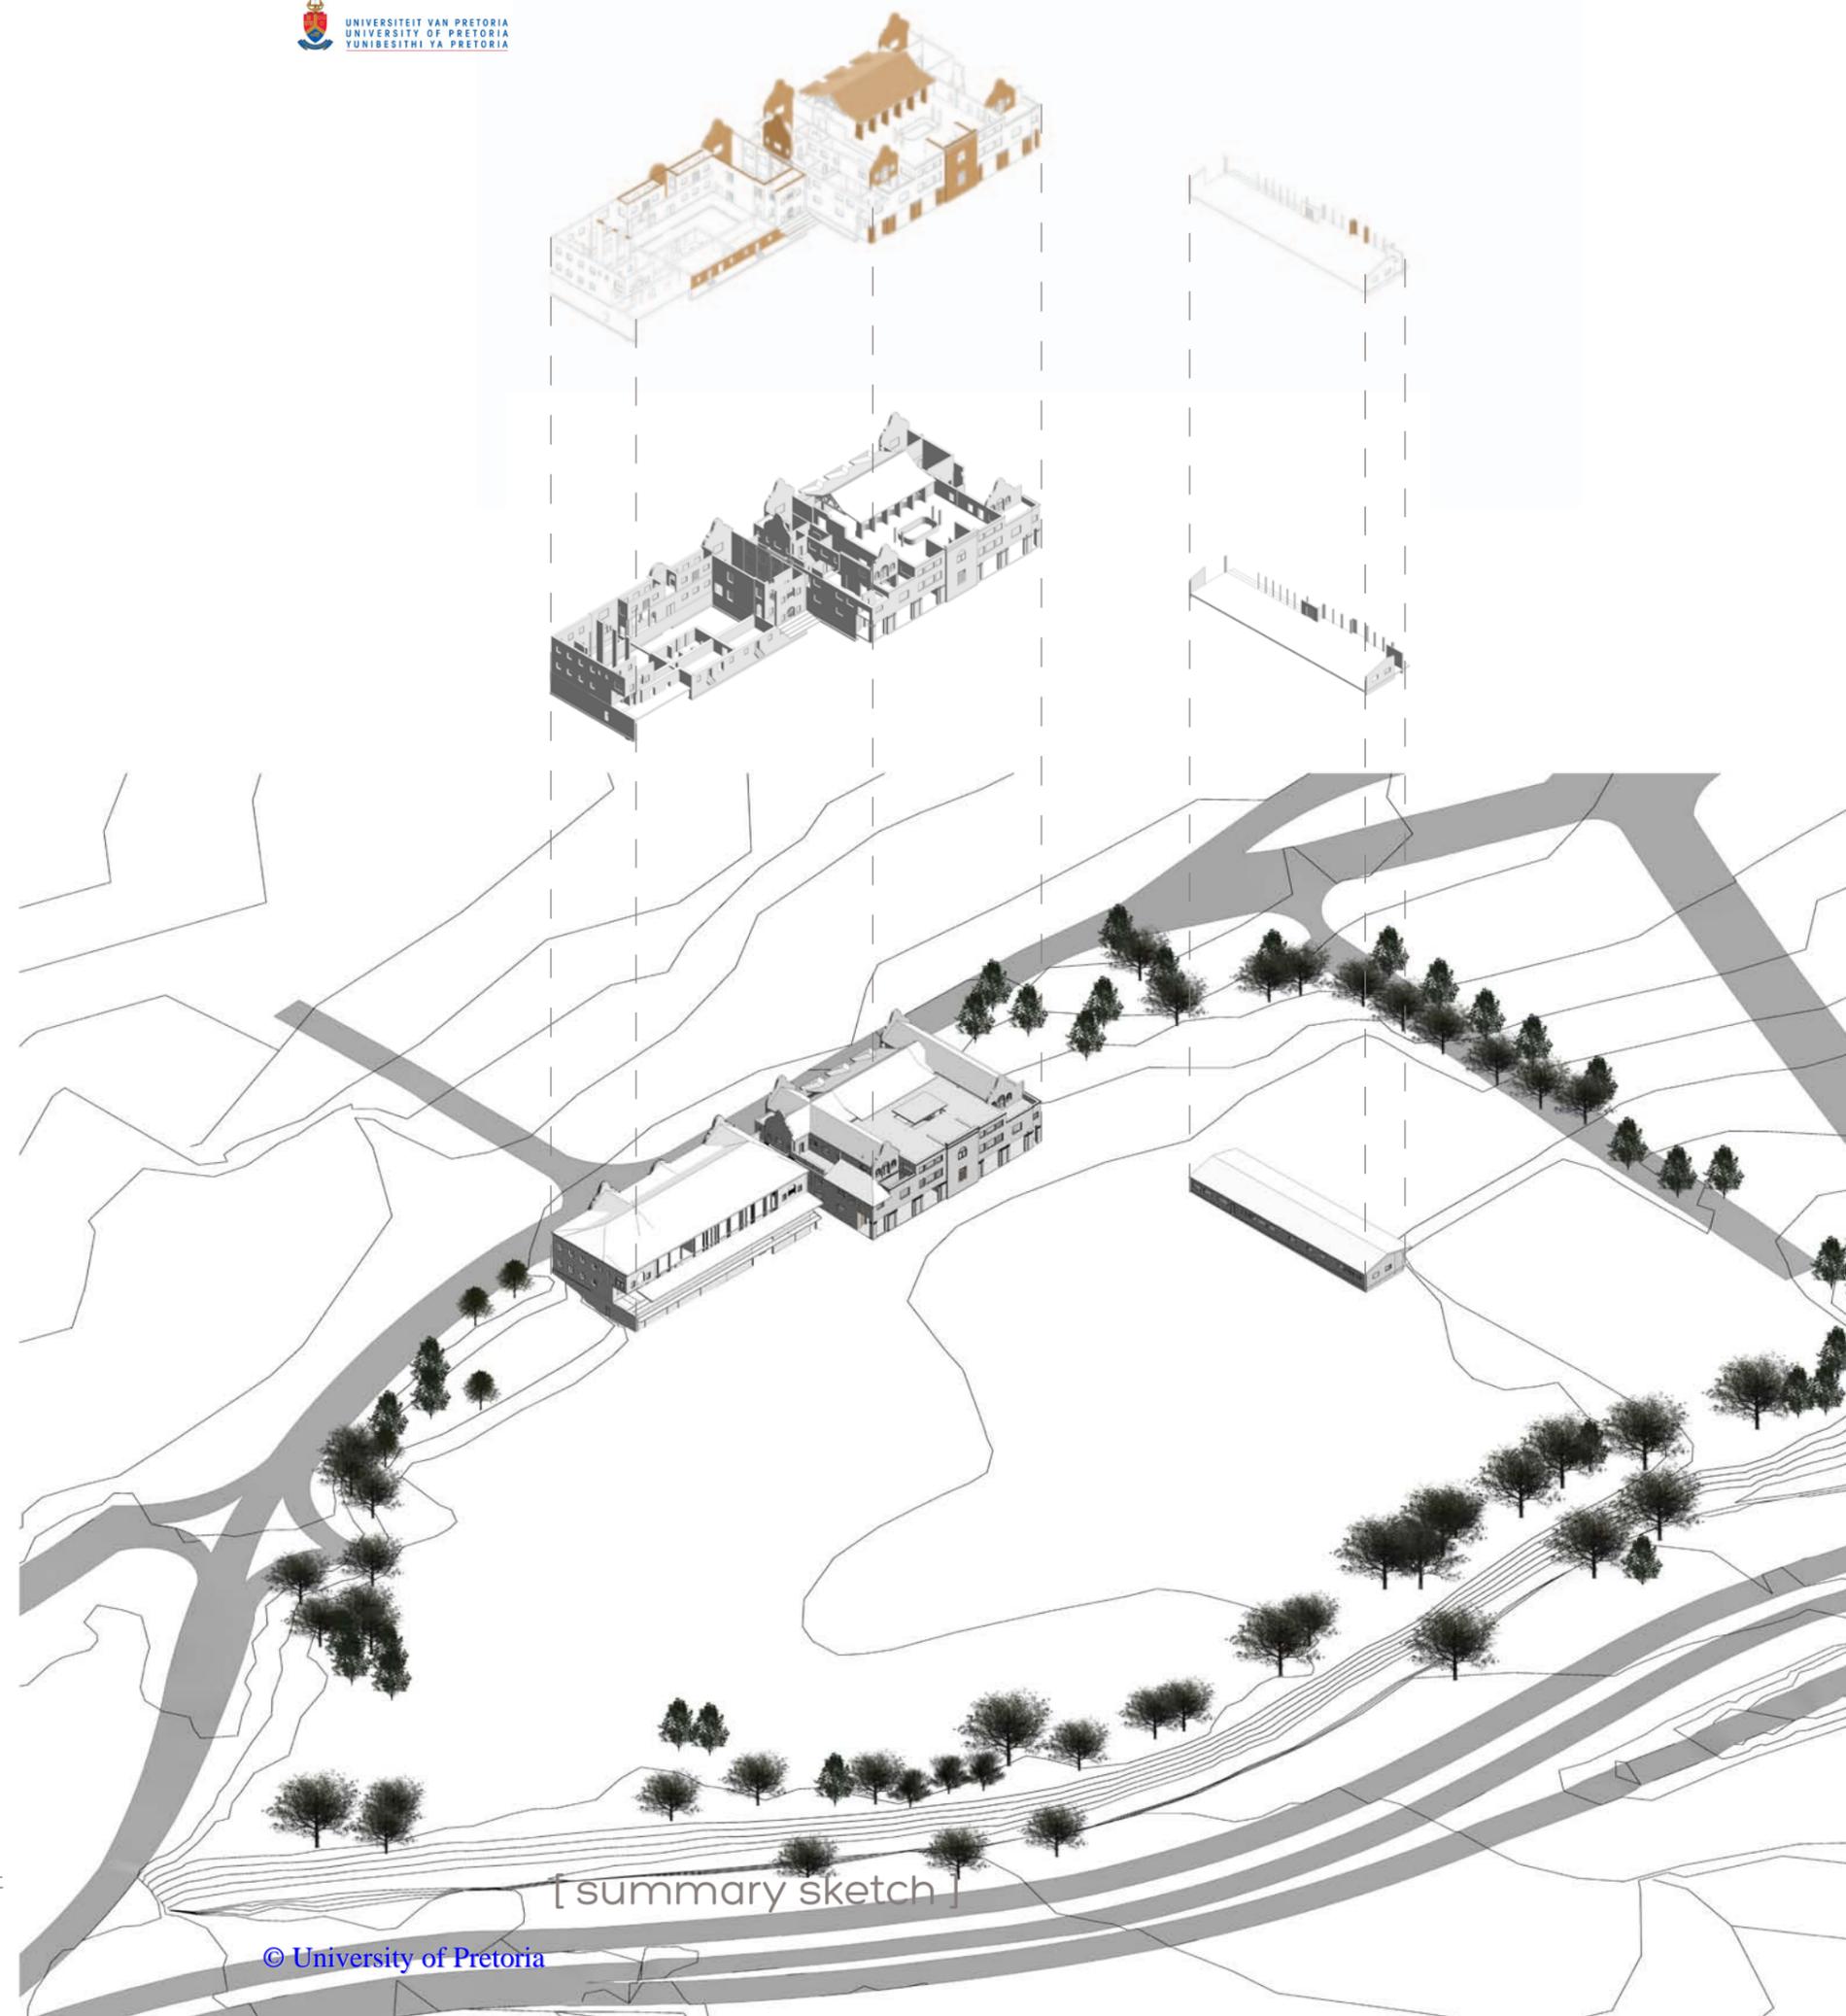
Figure 65: Old structures: state before extensive damage, cleaned up structure, important elements (Author 2013)

It is clear from the data collected in this chapter that the history of Berea Park renders it an important heritage building. (Figure 65) Berea Park is relevant in both the context of Pretoria and the sport development of South Africa. It is also clear that the site has suffered extensive damage due to neglect and misuse. A suitable heritage approach to deal with the removal of damaged or lost elements will have to be decided upon (Figure 64), as well as an approach to restoring the remaining fabric. It is also important to acknowledge the past programmes and events associated with Berea Park when formulating future interventions and programmes.

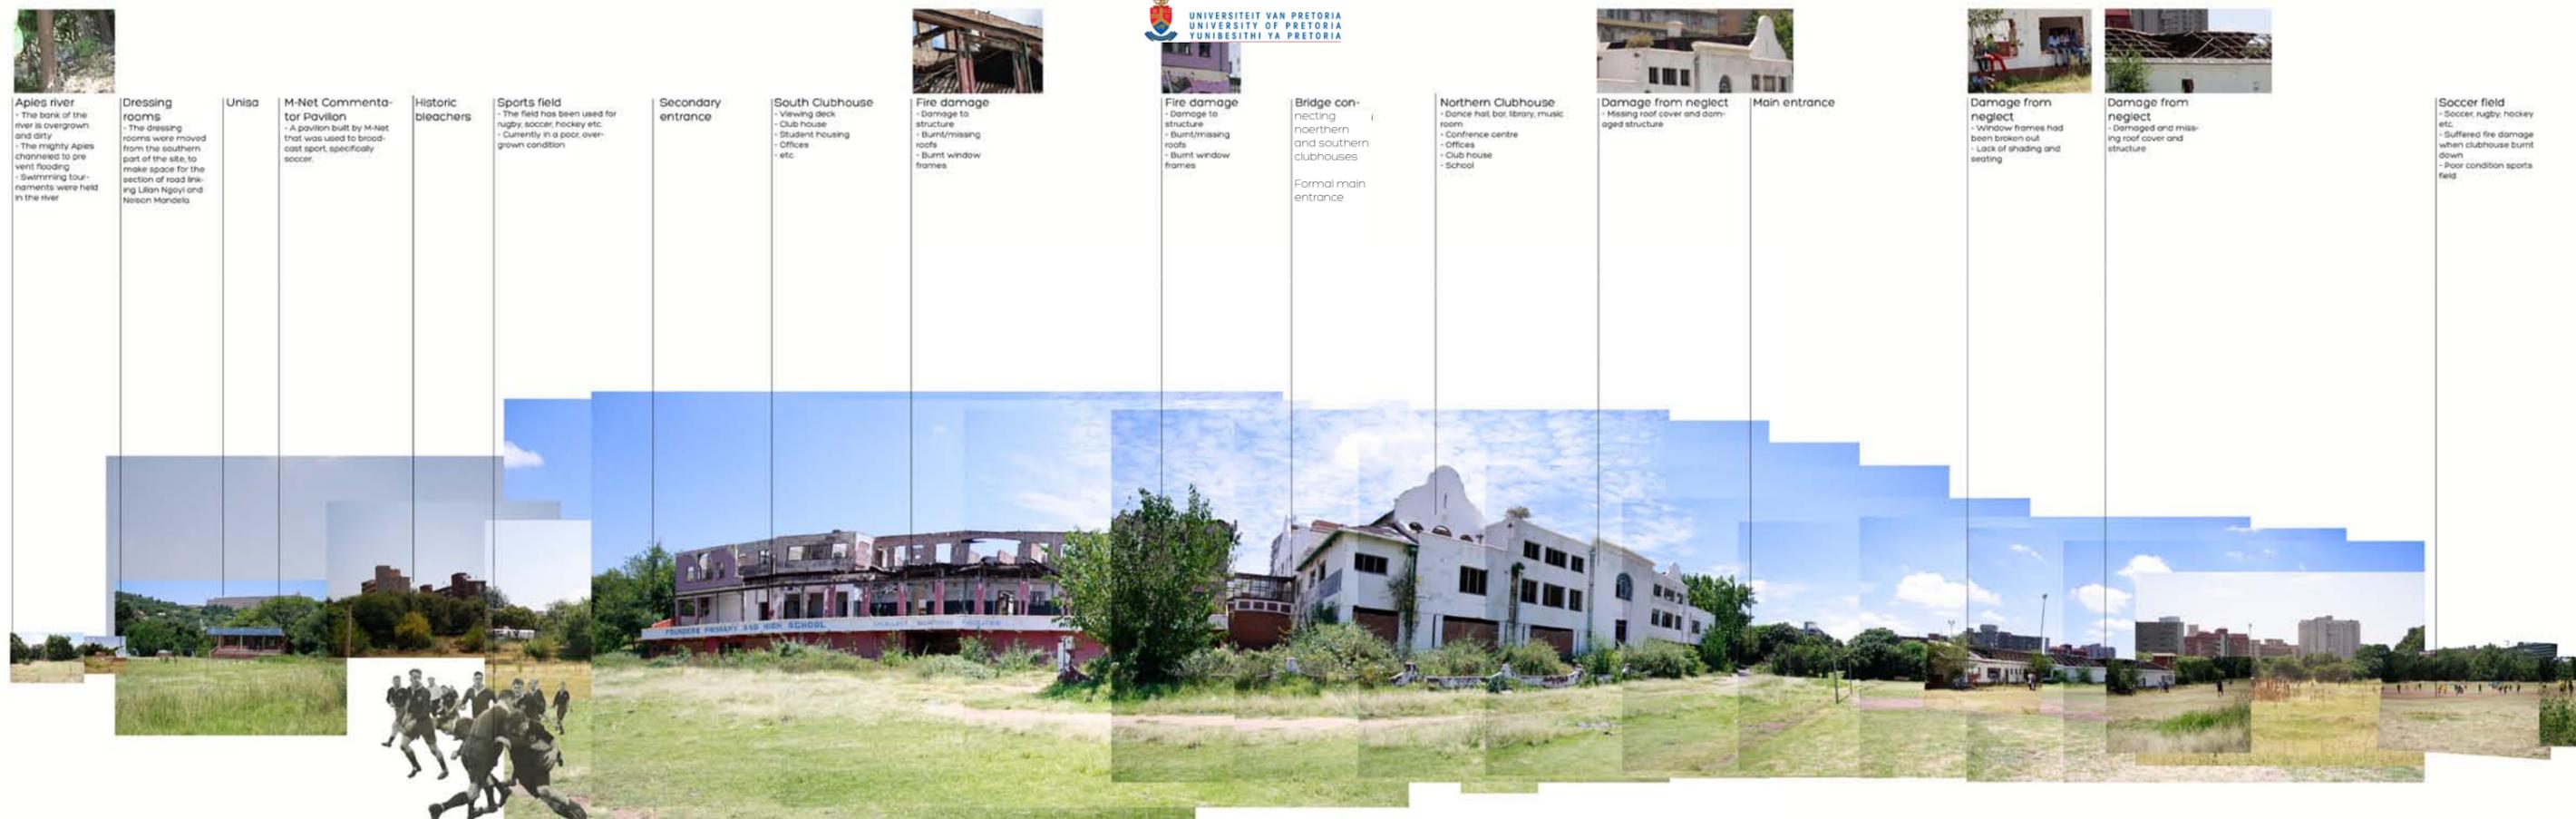
Figure 88: Current condition panoramic view of Berea Park structures and sports fields (Author 2013)

Sports field
- The field has been used for rugby, soccer, hockey etc.
- Currently in a poor overgrown condition

Fire damage
- Damage to structure
- Burnt/missing roofs
- Burnt window frames

Damage from neglect
- Missing roof cover and damaged structure

Damage from neglect
- Window frames had been broken out
- Lack of shading and seating

Damage from neglect
- Damaged and missing roof cover and structure

Soccer field
- Soccer, rugby, hockey etc.
- Suffered fire damage when clubhouse burnt down
- Poor condition sports field

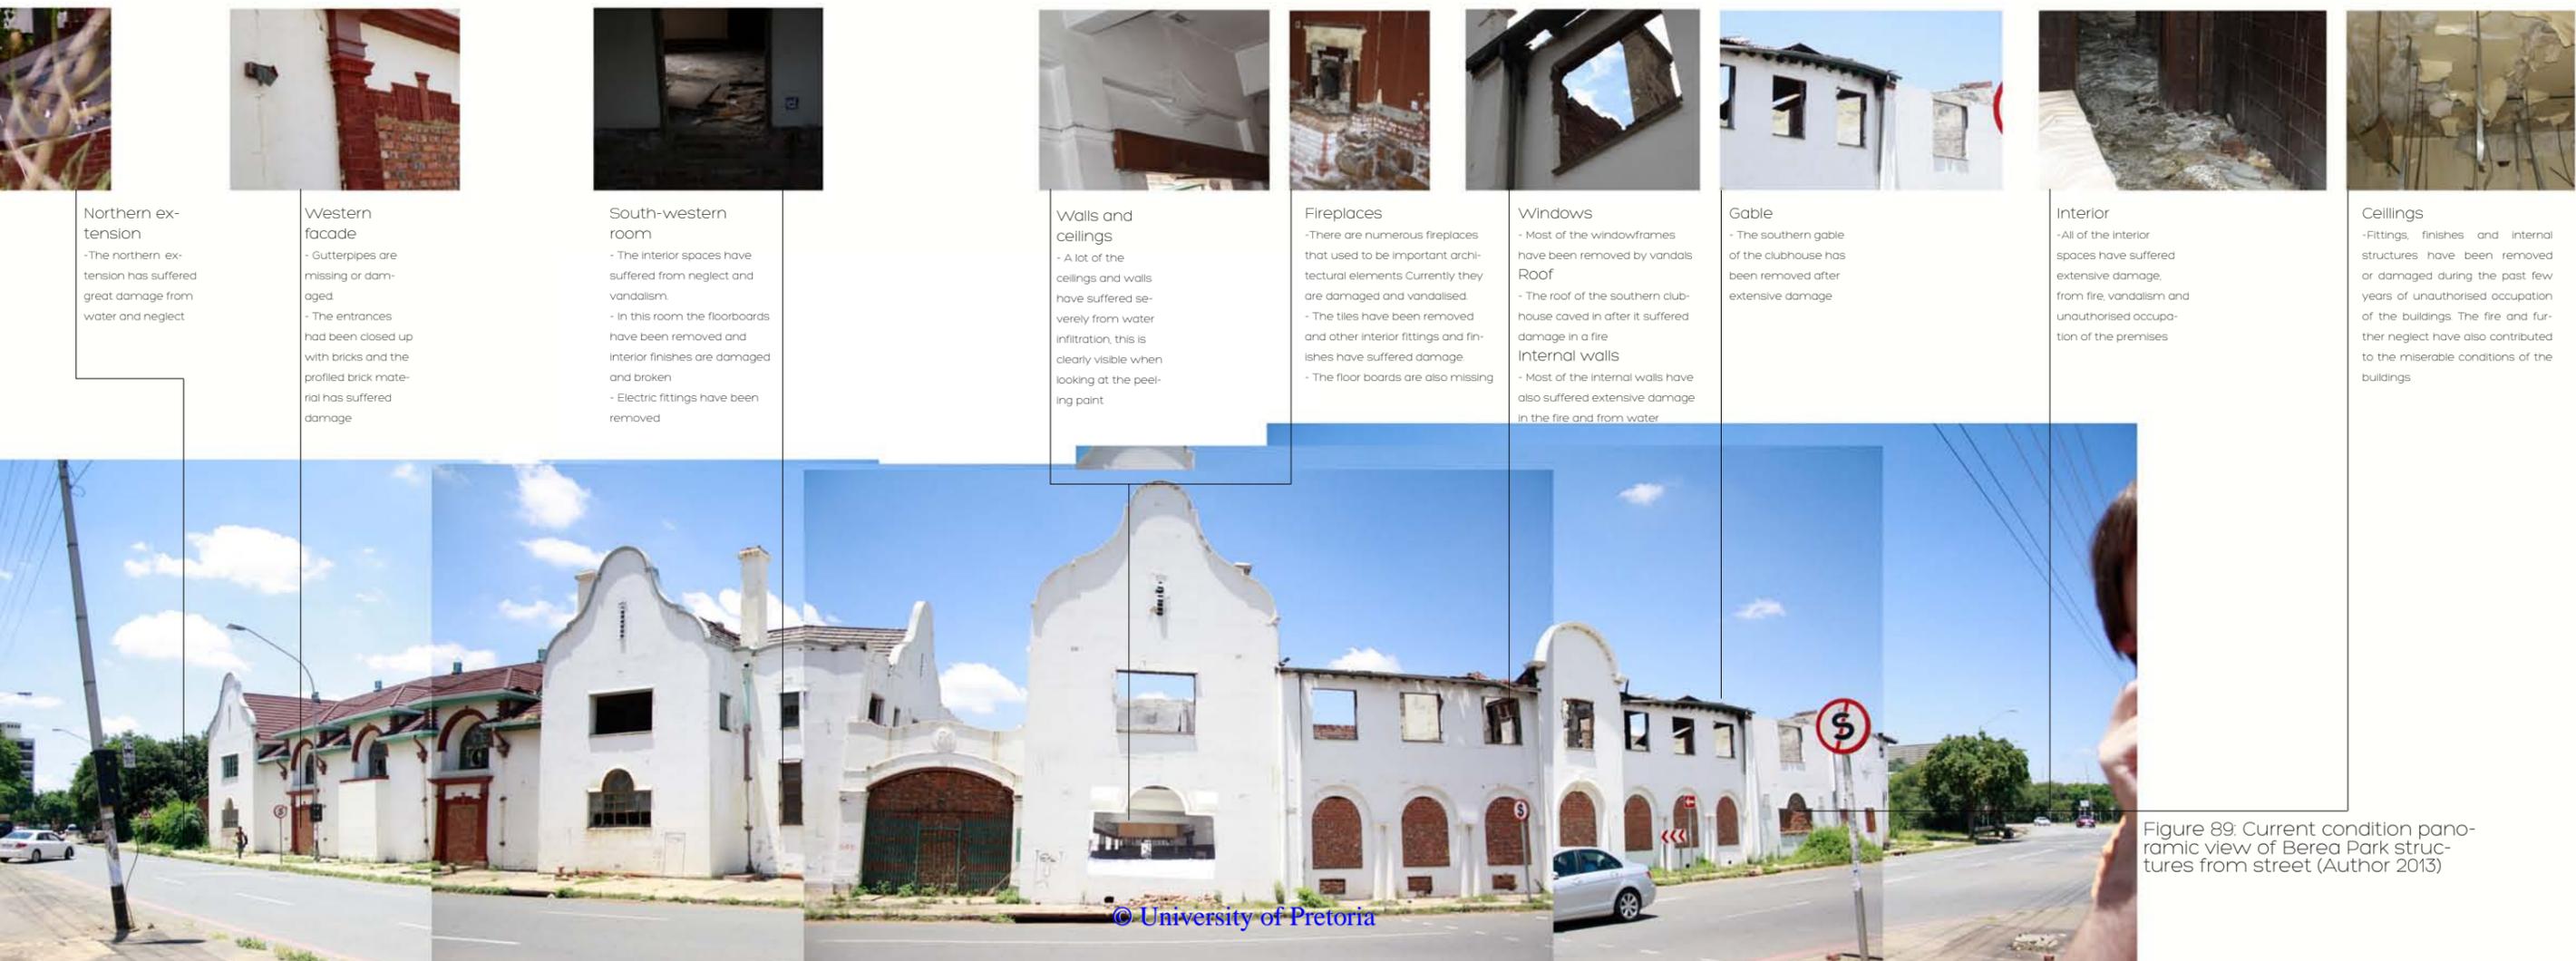
Northern extension
- The northern extension has suffered great damage from water and neglect

Western facade
- Gutters are missing or damaged
- The entrances had been closed up with bricks and the profiled brick material has suffered damage

Walls and ceilings
- A lot of the ceilings and walls have suffered severely from water infiltration, this is clearly visible when looking at the peeling paint

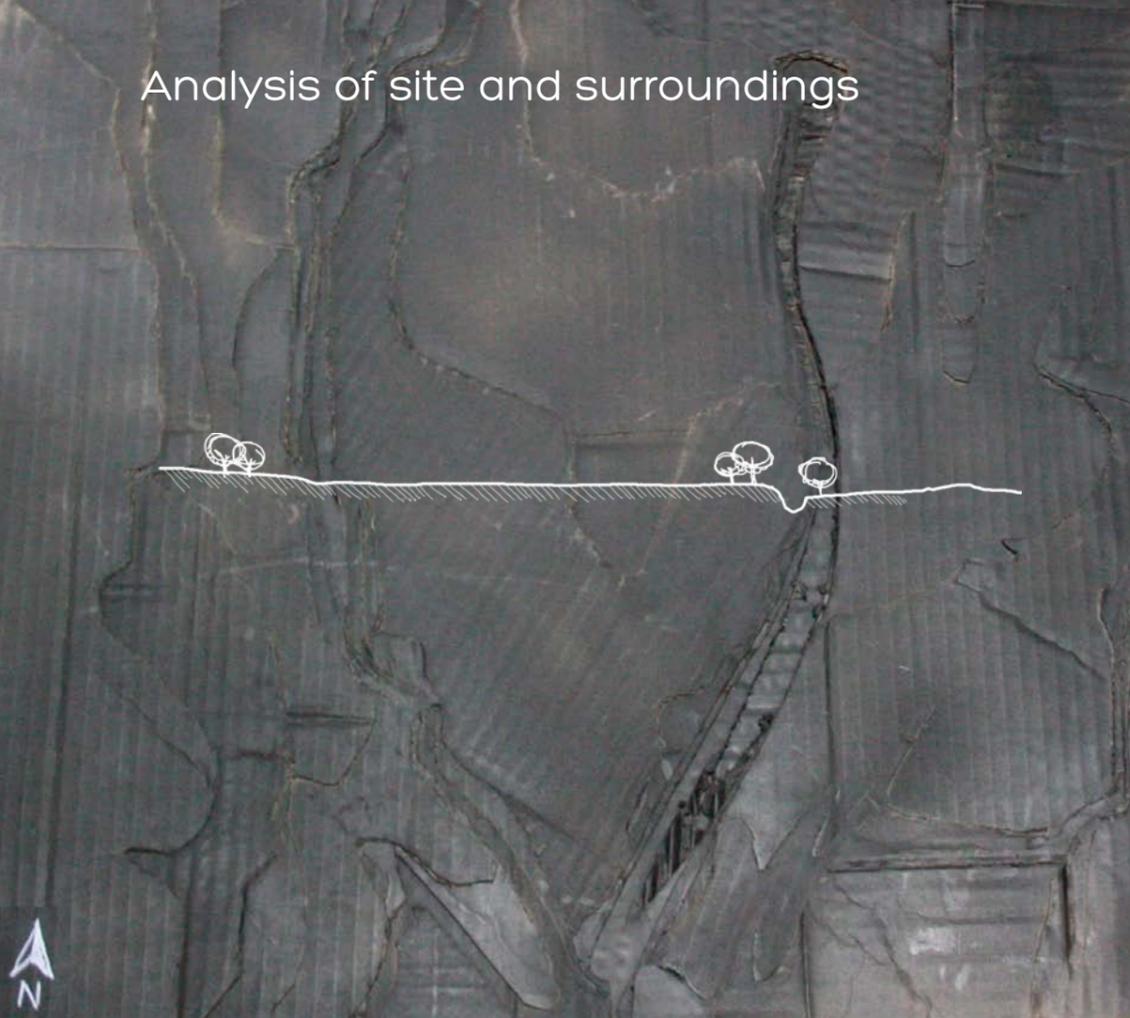
Figure 90: Model of site contours (Author 2013)

Berea Park is located in a natural basin, with the Apies River running along its eastern perimeter. A steep slope forms the western boundary, while the central area of the site is relatively flat. (Figure 90)

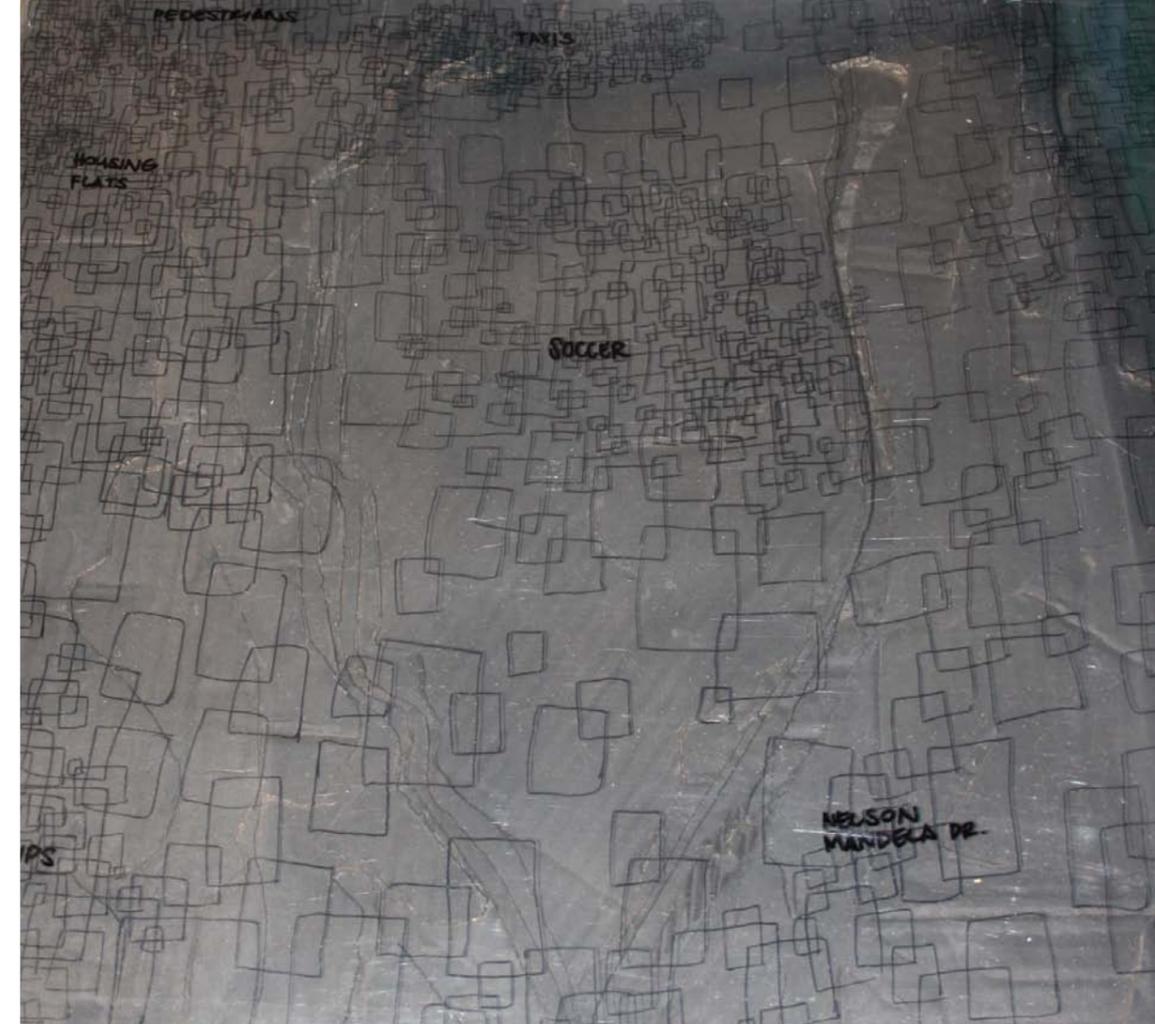
Figure 91: Model of site contours, buildings and roads (Author 2013)

Berea Park is located in the Berea Park neighbourhood, with high rise residential areas along the north-west and north. There are also some of the smaller residential units left along the northern edge. (Figure 91)

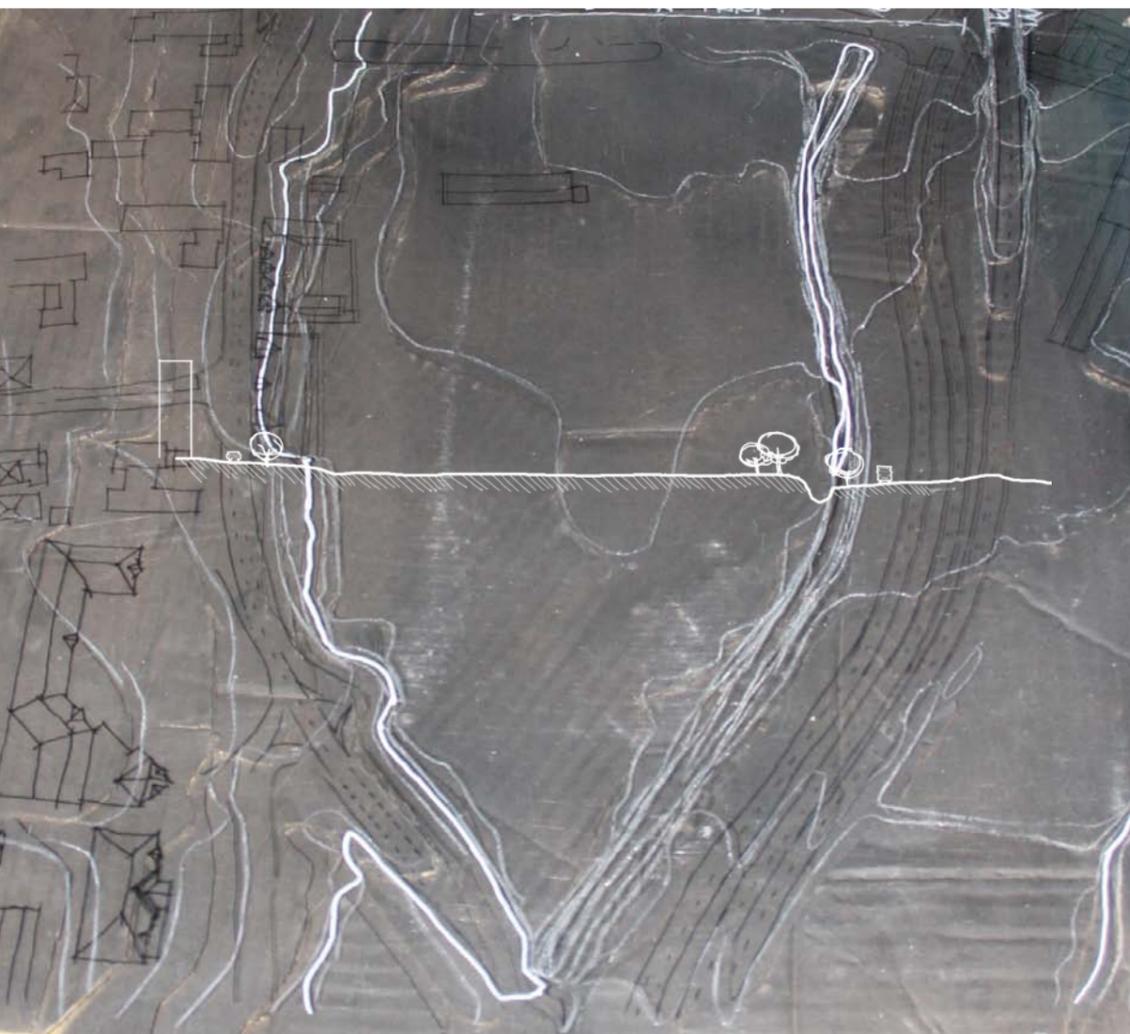
Figure 92: Energy map of site (Author 2013)

Energy is mapped according to activity levels and frequency. The current energy on and around Berea Park was mapped. There is energy focused near the soccer field where matches are still frequently played. Most of the other energy is located on the major vehicle routes, especially Nelson Mandela Drive. The rest of the energy comes mostly from the north or north-west, from central Pretoria. (Figure 92)

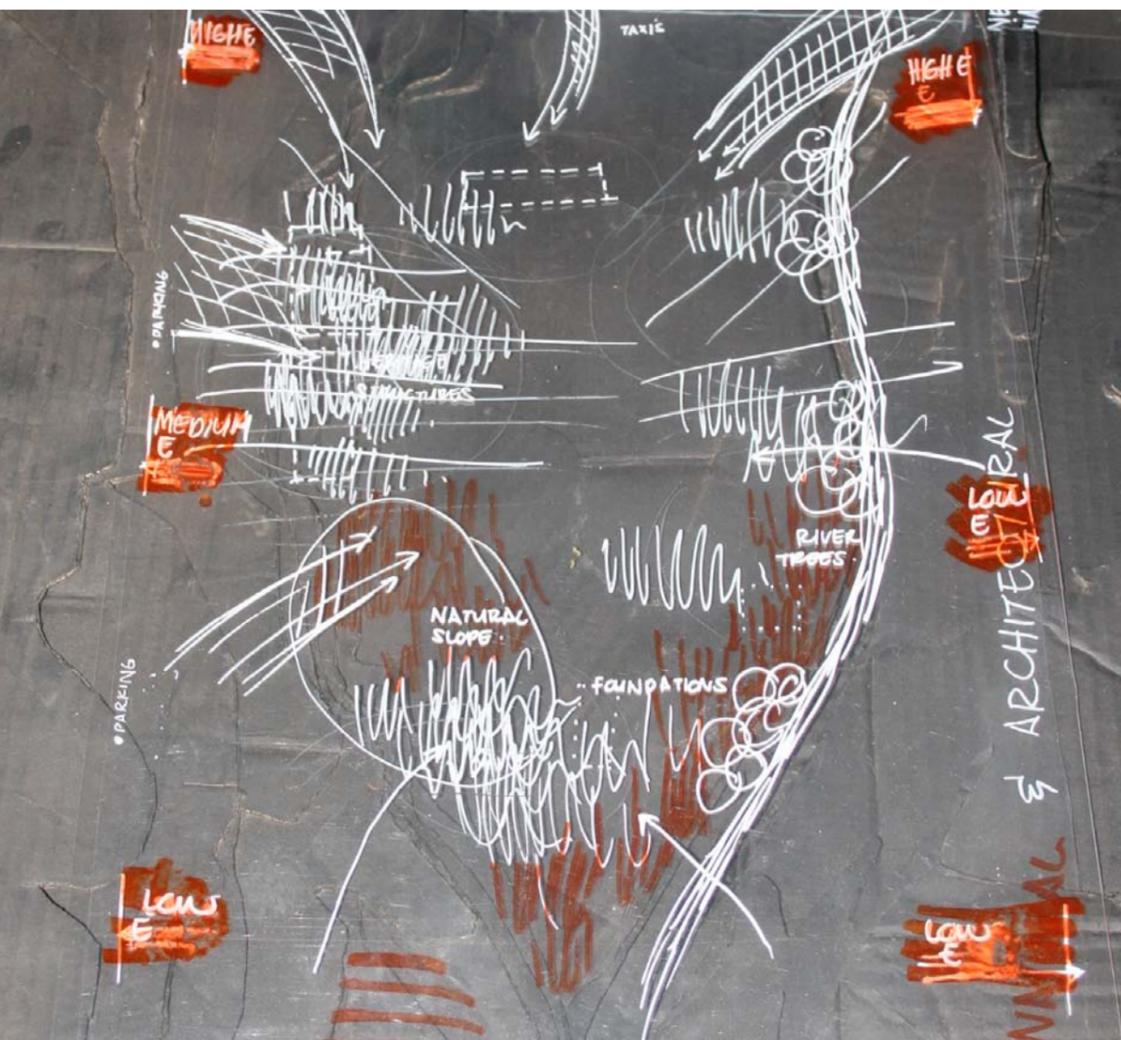
Figure 96: Mapping of historic locations of sporting and recreational activities on Berea Park (Author 2013)

Past programmes associated with Berea Park are depicted in iconographies. The placement of these graphical representations, roughly indicate the location of these programmes. (Figure 96)
