REGENERATING BEREA PARK

[Design in pursuit of rekindling appropriation]

Submitted in partial fulfilment of the requirements for the degree of
Masters of Architecture, MProf(Arch),
Department of Architecture
Faculty of Engineering, Built Environment and Information Technology
University of Pretoria, South Africa

Programme:	Sport and recreational centre
Site description:	Berea Park Clubhouses, Berea Park neighbourhood, Tshwane
Site location:	Erf R/2375
Address:	600 Lillian Ngoyi Street
GPS Coordinates:	25° 75' 80.49" S , 28° 19' 39.31" E
Research field:	Heritage
Clients:	Department of Sport and Recreation South Africa Tertiary institution (Unisa or University of Pretoria) Individuals from the Berea Park neighbourhood
Keywords:	regeneration, belonging, heritage, adaptive reuse, sport, recreation
Premise:	Design in pursuit of rekindling appropriation

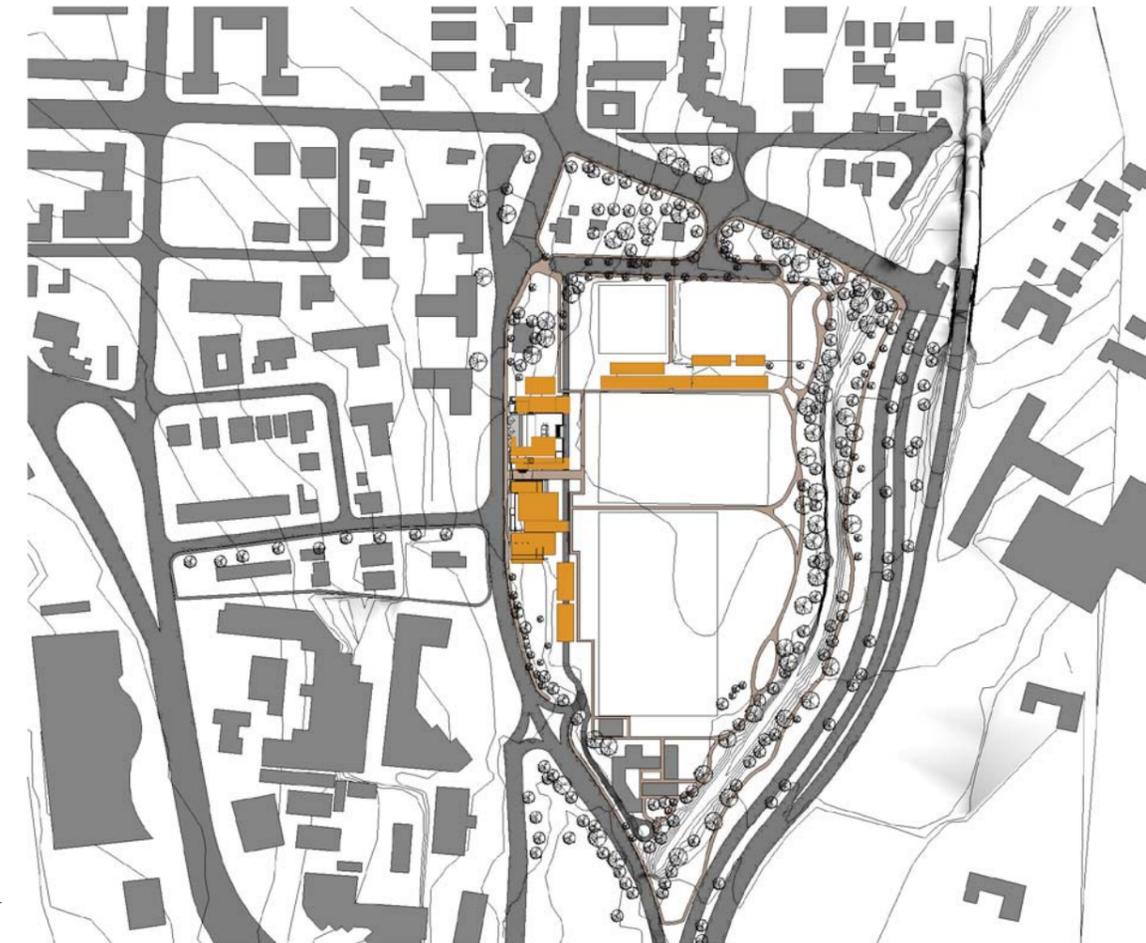
Figure 102: Proposed sport structures (Author 2013)

Proposed location of sport facilities
Sports facilities are proposed in areas where there are already existing architectural interventions. These areas spread along the western edge of the site (incorporating the northern and the southern clubhouses) and east-west across the site between the bowling and soccer fields (including the bowling clubhouse). (Figure 102)

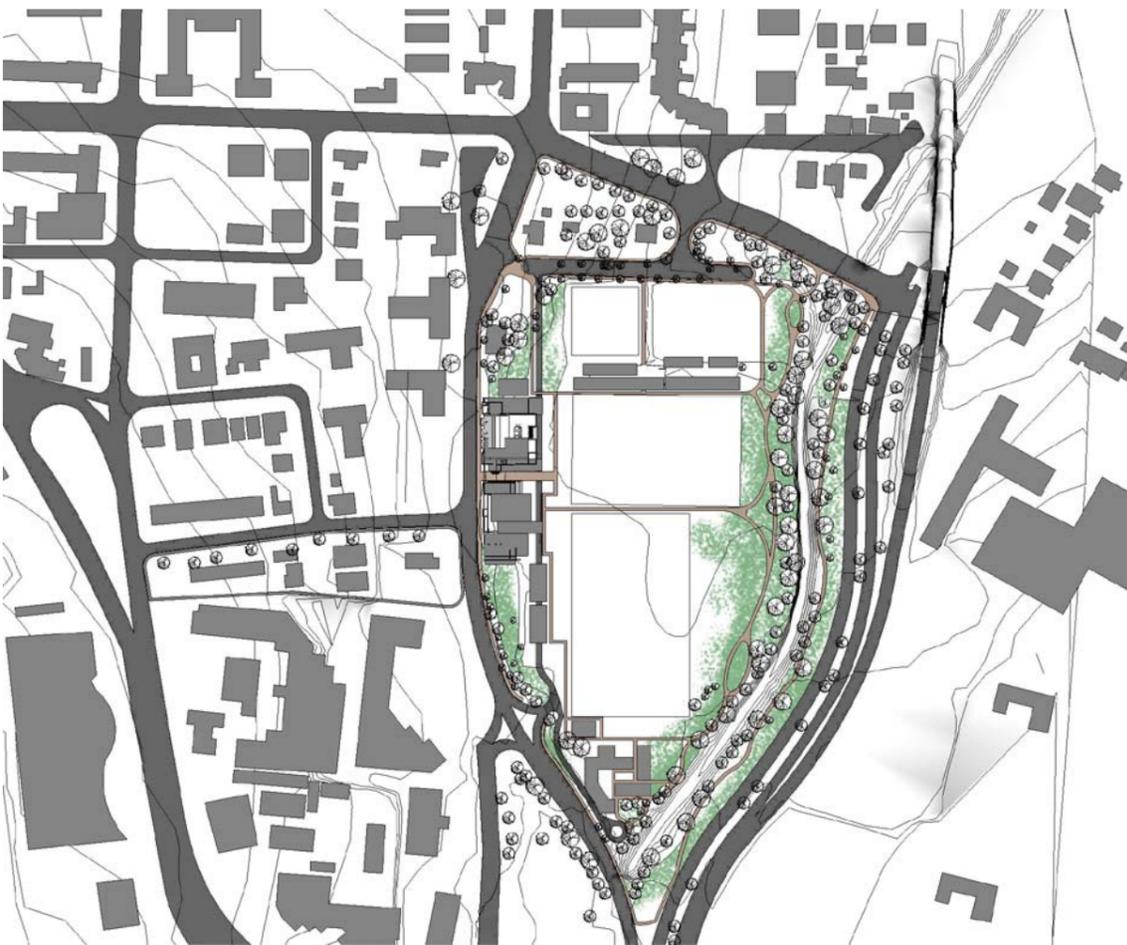
Figure 101: Proposed landscaping areas (Author 2013)

Green space layout: landscaping
Designed and natural landscape areas are proposed along the Apies River and the western edge of the site. These areas will form part of the recreational spaces of Berea Park. As part of the designed landscape area, outdoor gym areas and jungle gyms are proposed as part of the Apies River boardwalk. (Figure 101, Figure 109)

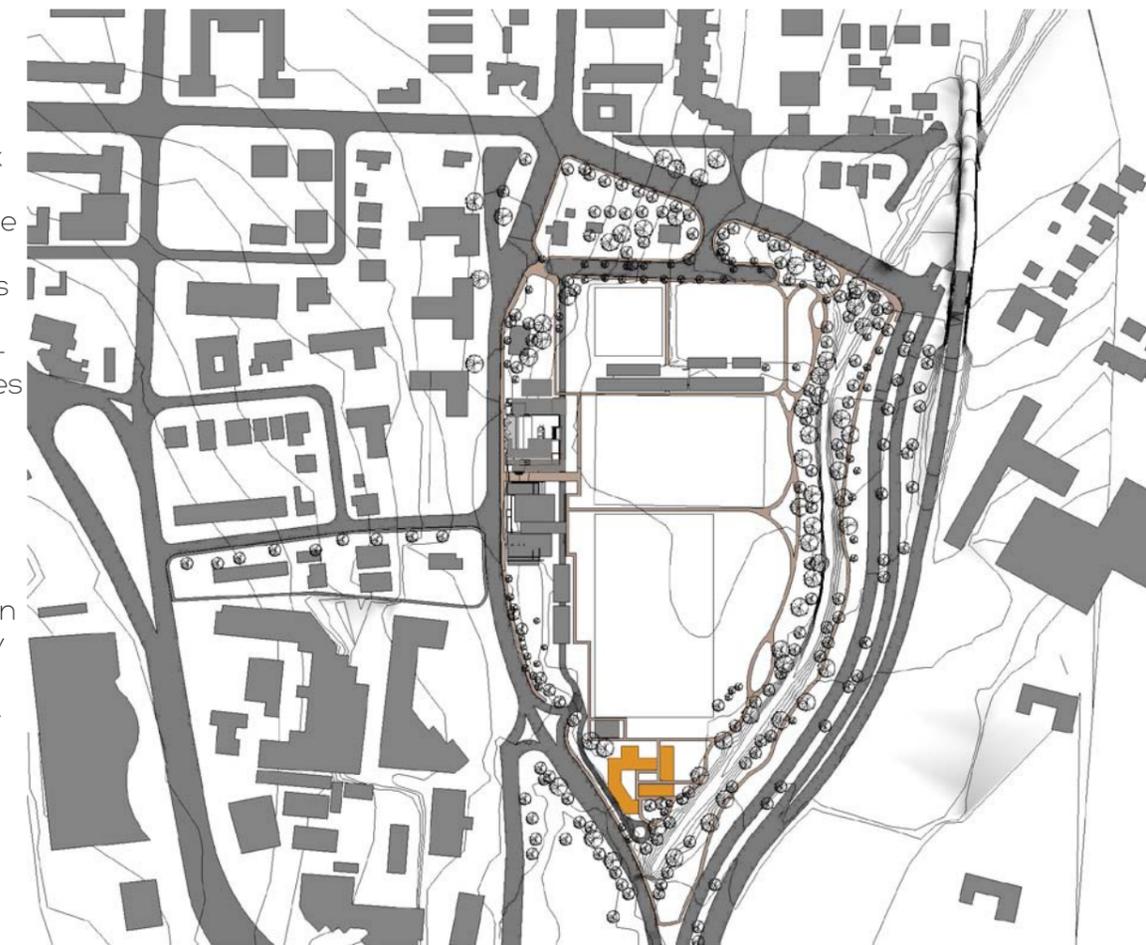
Figure 103: Proposed housing structures (Author 2013)

Proposed location of housing units
Future development of Berea Park include building housing units on the southern corner of the site. These units will serve to house sponsored developing athletes, coaches and caretakers of Berea Park. Ideally students studying sports management and psychology courses at the University, housed in these units, actively participate in the sport development. (Figure 103, Figure 108)

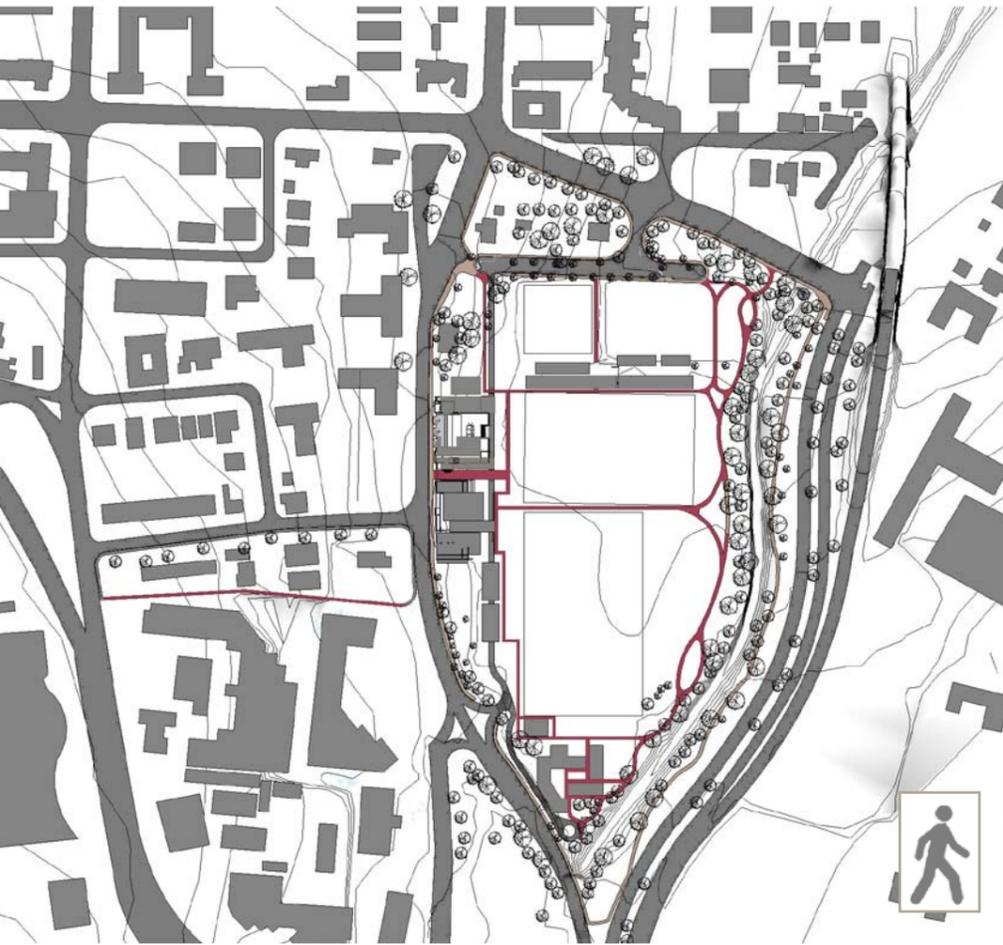
Figure 104: Proposed informal green spaces: new walkways (Author 2013)

New walkways
Walkways serve to link the structures and entrances with the proposed structures. The walkway that interacts with the clubhouses run at street level, linking with the main entrances located between the clubhouses and those at the north-western corner of the site. Organic walkways meander along the eastern edge of the site, interacting with both the designed and natural landscaping elements. Development of the servitude that runs through the Fountains Motown retail centre is proposed to serve as a linking walkway between the site and the Gautrain station. (Figure 104, Figure 109)

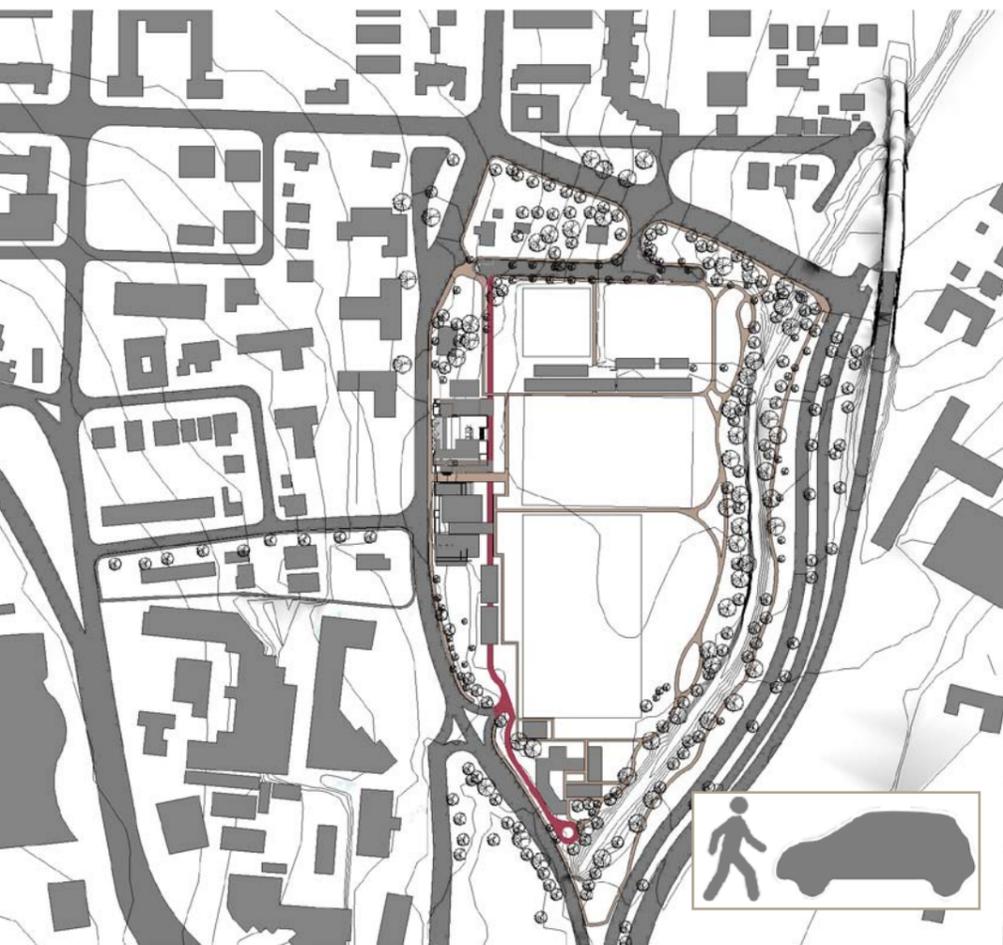
Figure 105: Proposed new vehicle access (Author 2013)

New walkways that can accommodate vehicles
Wider walkways are introduced at field level. These walkways are able to accommodate vehicles. Ambulances can move through the site to treat injured athletes. The north-south route also allow easy access for delivery and service vehicles, while the route along the south-western edge, allows access to the housing units. Access to these routes are gained through existing vehicle gates. (Figure 105, Figure 108)

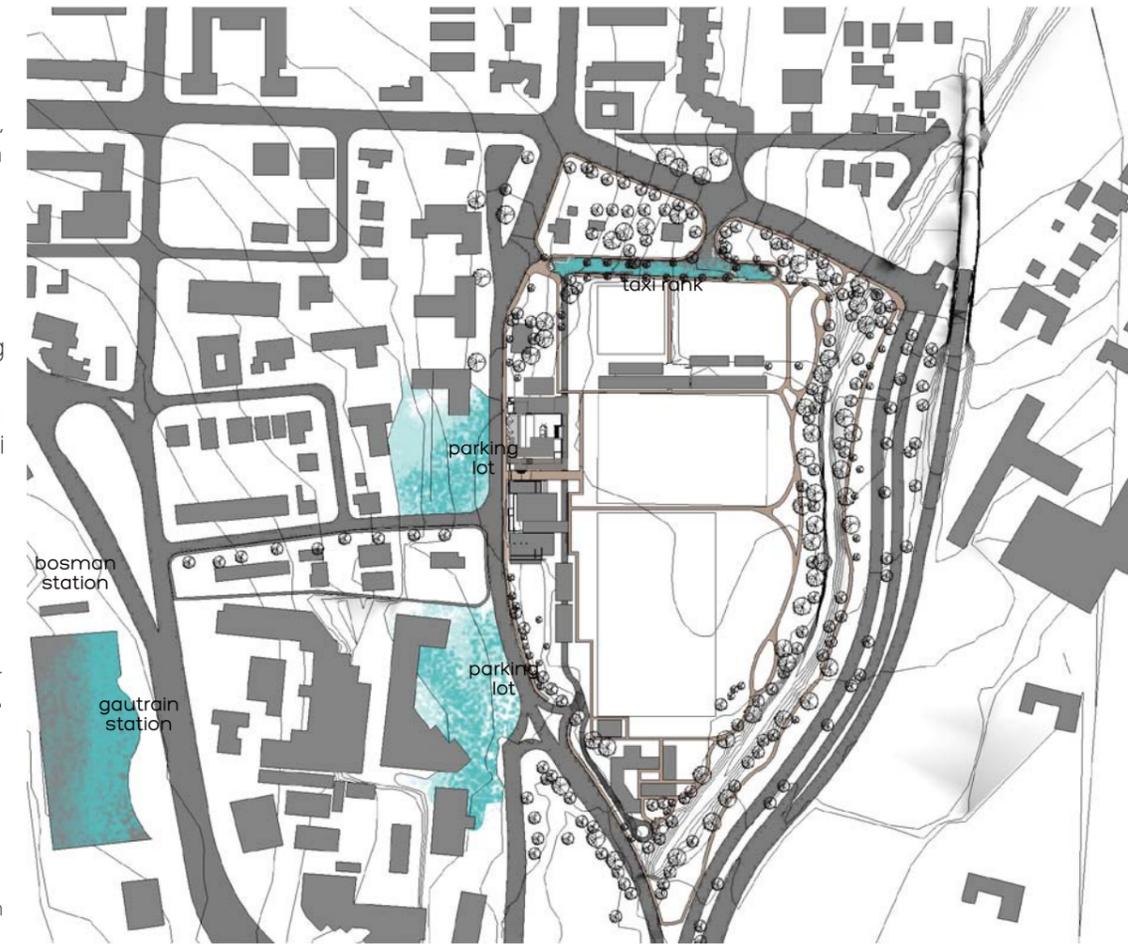
Figure 106: Proposed off site access areas: taxi rank, parking and Gautrain/Bosman station (Author 2013)

Off site access
Accessing the site is made possible by the existing taxi rank, parking lots, Gautrain and Bosman stations. The northern parking lot is mainly being used for driving lessons, while the southern parking lot stands almost completely deserted during the day. A taxi rank is proposed in Bosman Street, that currently serves as a taxi stop during the day. The site is ideally located for access from the stations located a mere block away. (Figure 106)

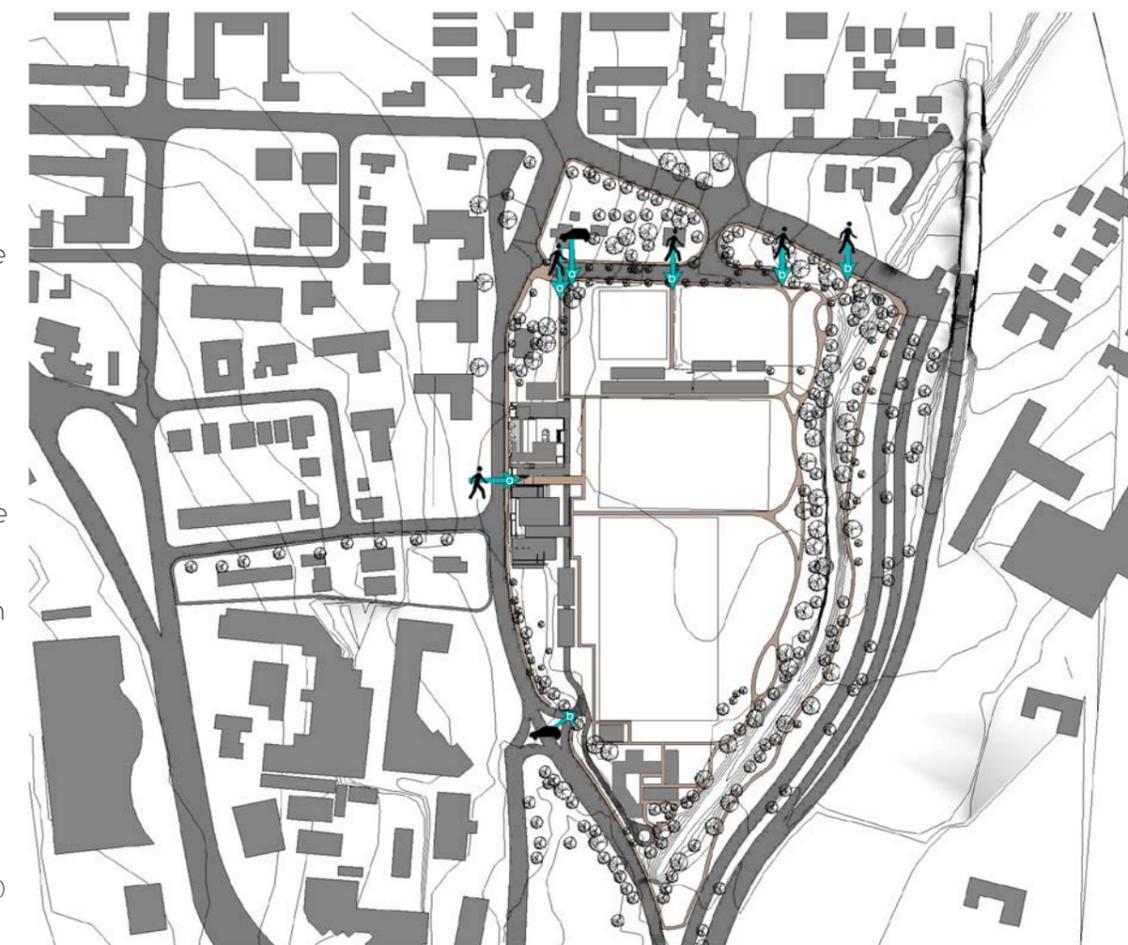
Figure 107: Proposed access to site: pedestrian and vehicle (Author 2013)

Access to site
Access to the site, for both vehicles and pedestrians is proposed. The entrances marked "a" serve as the main entrances. The entrances marked "b" will serve as the secondary entrances, that can be closed when controlled access to the site is required. For security reasons, the possibility will exist to close off any of the entrances when needed.

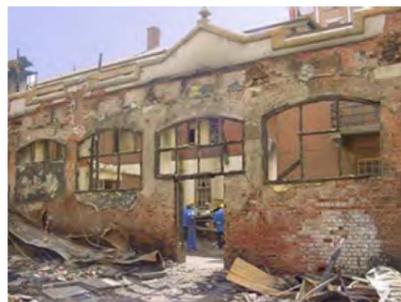
Figure 118: Damage caused by fire (Unknown)

Over the years the building has sadly suffered from numerous damaging incidents. In 1968 a gas cylinder exploded within the building and in 2002 ten homeless people lost their lives when the Drill Hall partially burnt down. (Figure 116, Figure 117, Figure 118)

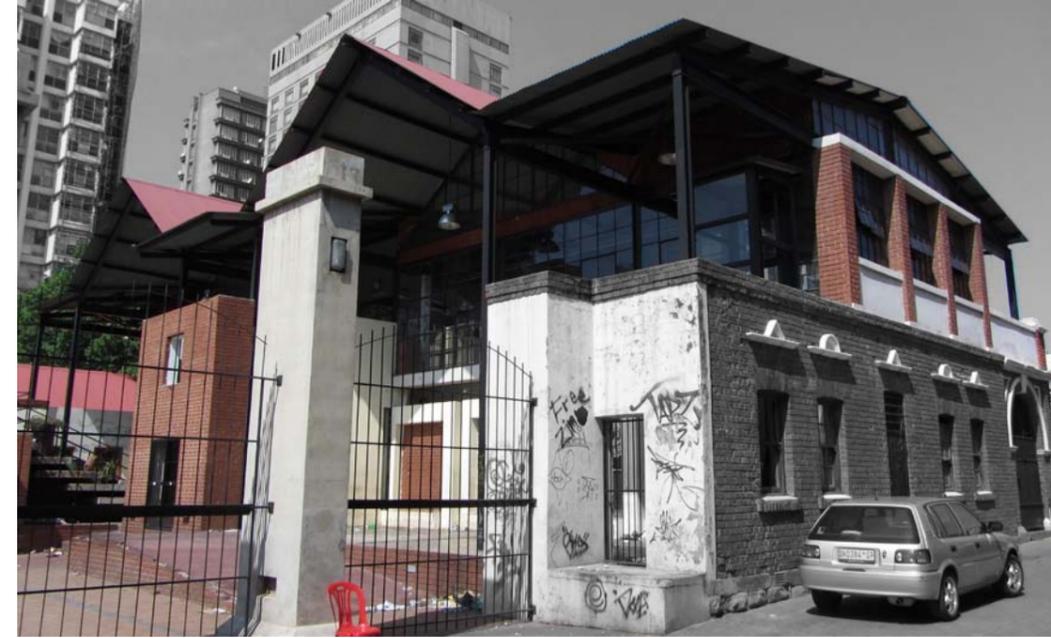
Figure 121: Eastern facade looking towards inside courtyard. (Wilkinson 2012)

The structure now leads to public square where the columns were placed along the footprint of the demolished building. (Figure 121)

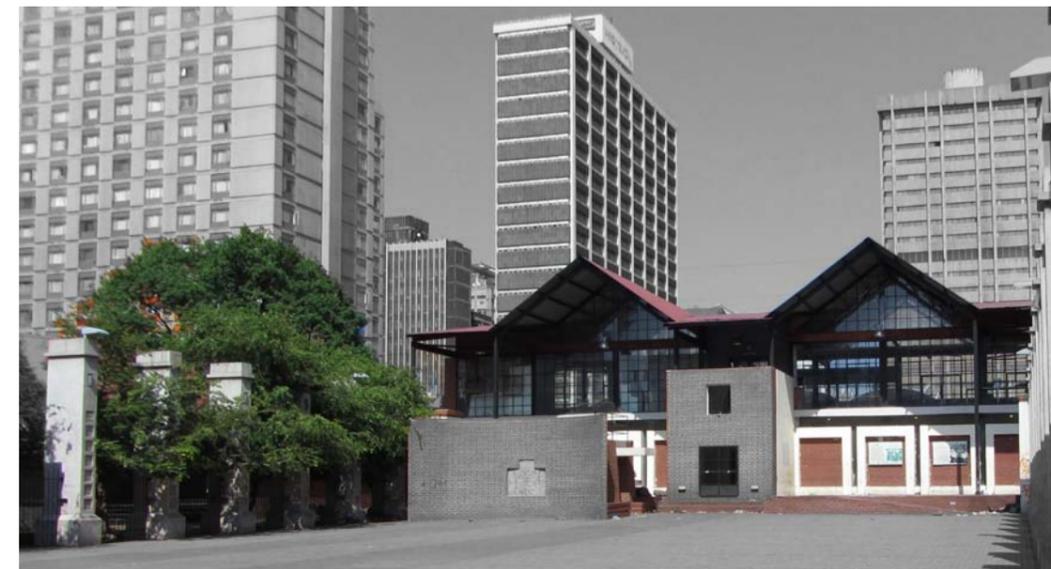
Figure 120: Vacant interior (Wilkinson 2012)

H Extensions to the existing structure were done in steel and glazing to allow for optimal light and to ensure that the new structure acted as a standalone structure that could aid in supporting the damaged remains of the existing building. (Figure 119, Figure 120) (Wilkinson 2012)

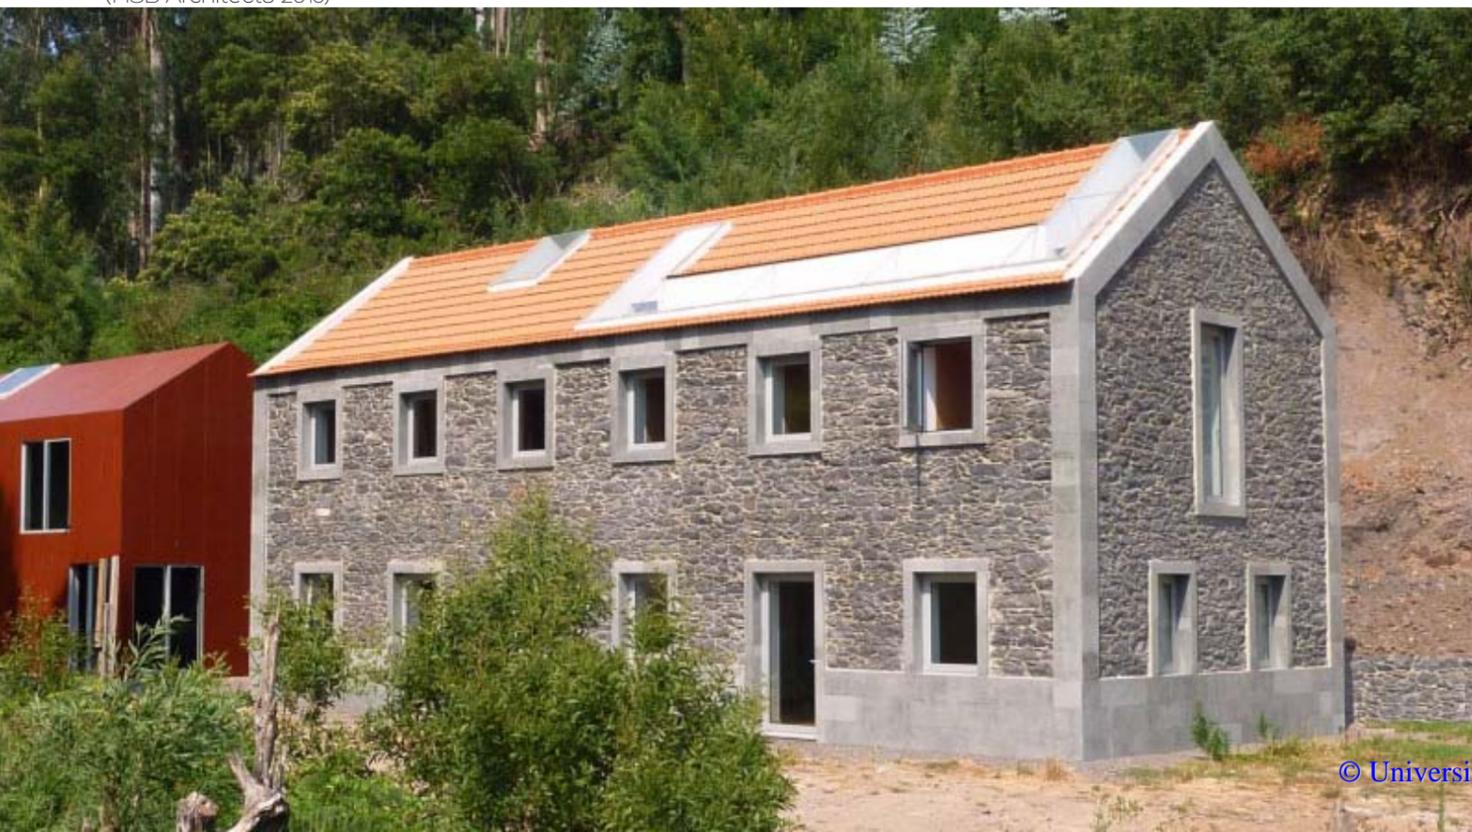
Figure 122: Exterior facade (MSB Architects 2010)

B The old butter factory looks like the surrounding single family houses. (Figure 122) The architects tried to preserve the visual association with the surrounding houses, by preserving the characteristic image of the neighbourhood with minimal, simply constructed houses.

R In the case of the next door building, the old bakery was beyond rehabilitation, and was therefore replaced by a completely new structure. (Figure 122)

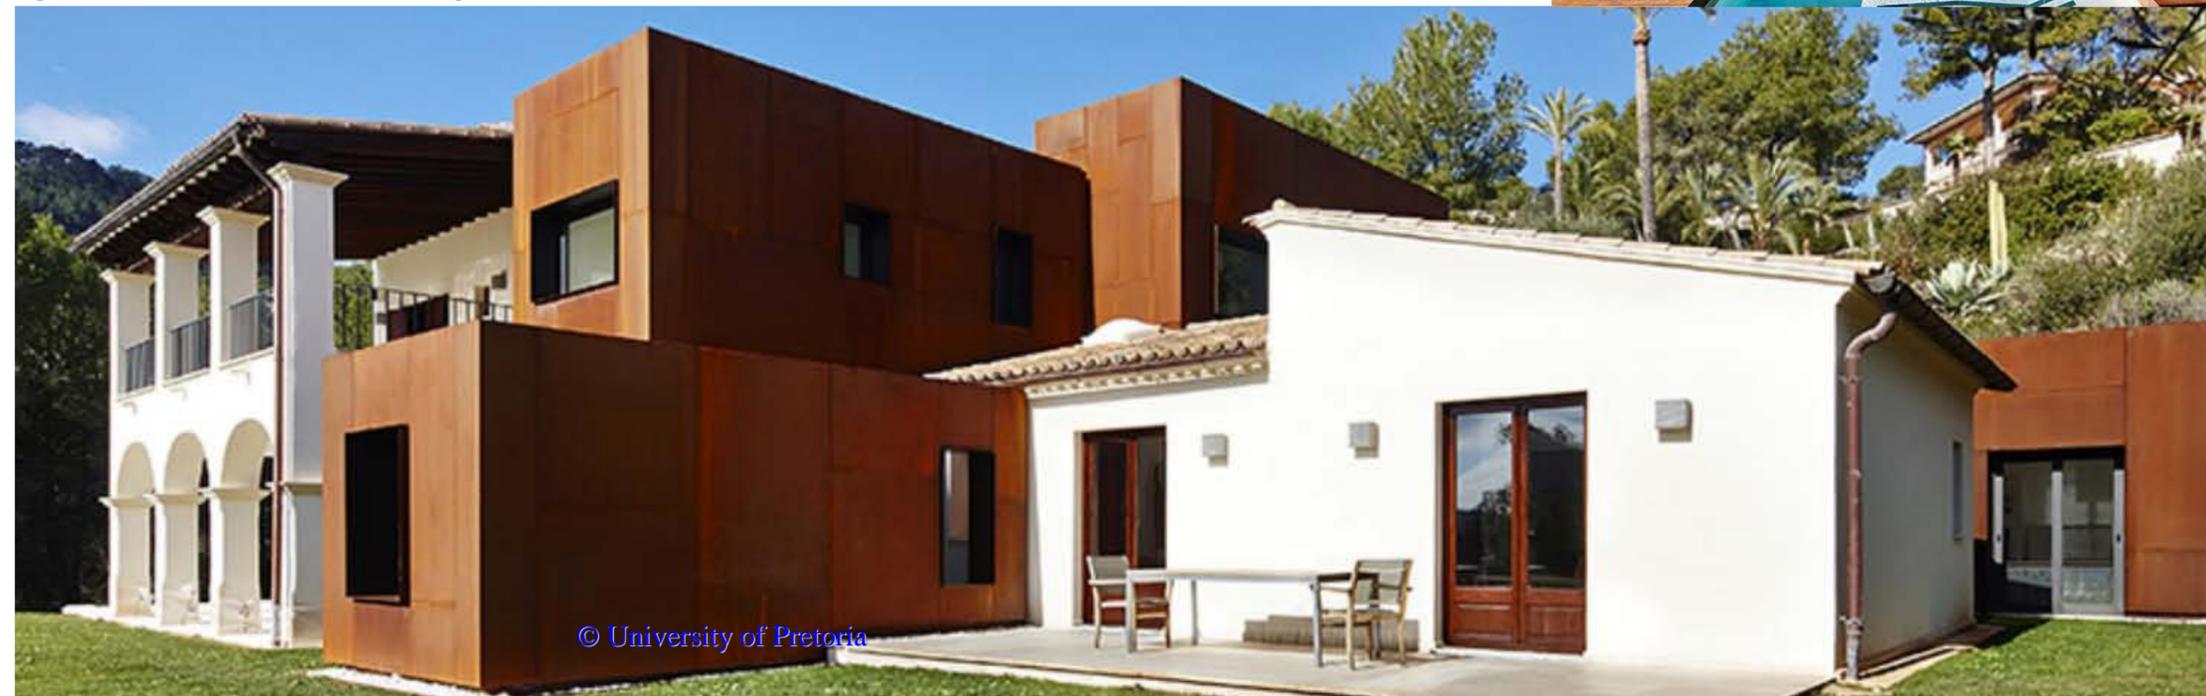
Figure 131: Extended: series of contrasting Corten steel boxes (José Hevia 2013)

H The existing building with white painted walls, timber carpentry and Arab tile roofs was kept unchanged. (Figure 131) (Dezeen 2013)

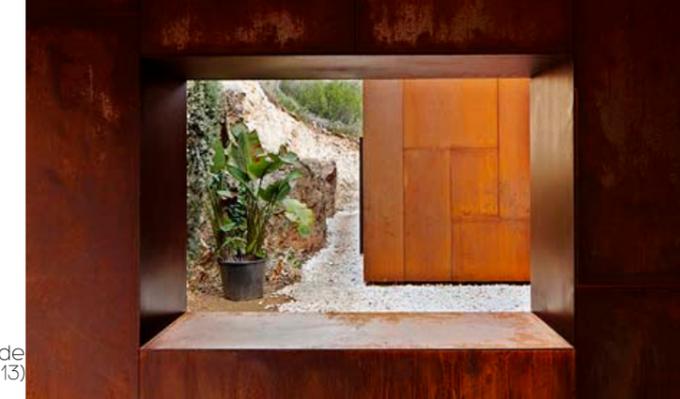
Figure 132: Framing outside view (Hevia 2013)

The new boxes, made from corten steel, slots into gaps created by the existing structure, or latches onto the exterior walls. The new boxes "surround and embrace" (Archdaily 2013) the old structure and frames new spaces surrounding the building. (Figure 132)

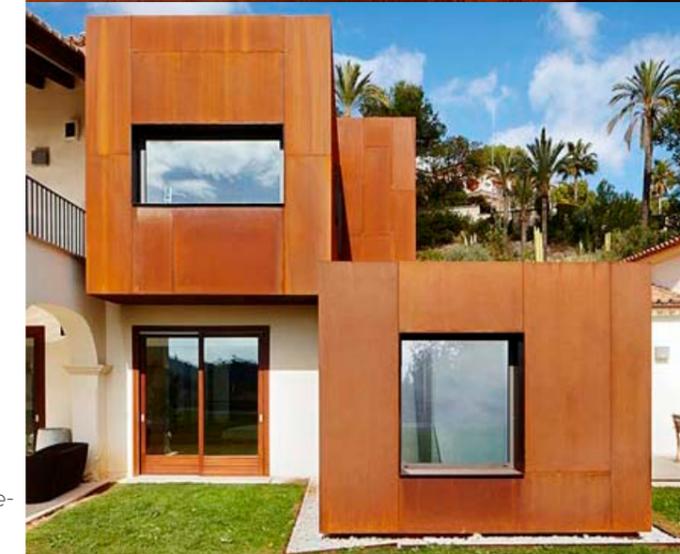
Figure 133: Boxed Corten extensions (Hevia 2013)

The heritage approach that was taken was to create a clear contrast between the old and the new, (Figure 126, Figure 127) extreme contrast is achieved by inserting numerous new volumes. This was executed in a contemporary aesthetic to maximize the contrast. (Figure 133) The style, material usage and colours of the old and new buildings are just some of the contrasting elements.

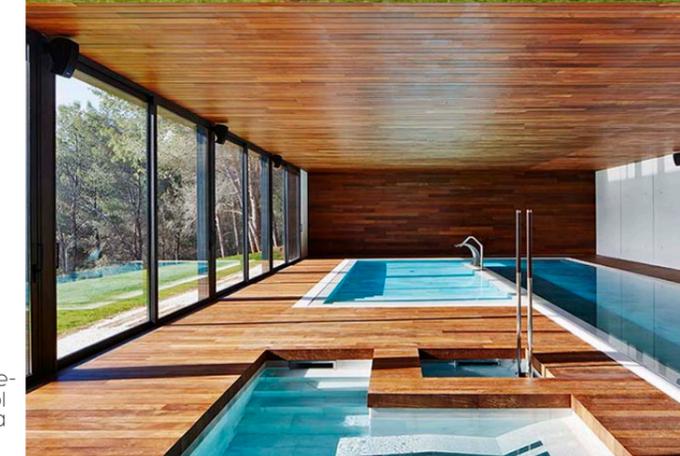
Figure 134: Interior space: pool and spa (Hevia 2013)

B The larger new spaces, including the swimming pool area, utilise natural day lighting by orientating the spaces so that they face south. (Figure 134)

R Spaces are specifically designed according to the needs of the client. Internal spaces are designed to ensure a cosy and comfortable, well lit environment for the users. The subterranean rooms are clad in wood for a warm finish to these cold concrete spaces. (Figure 134)

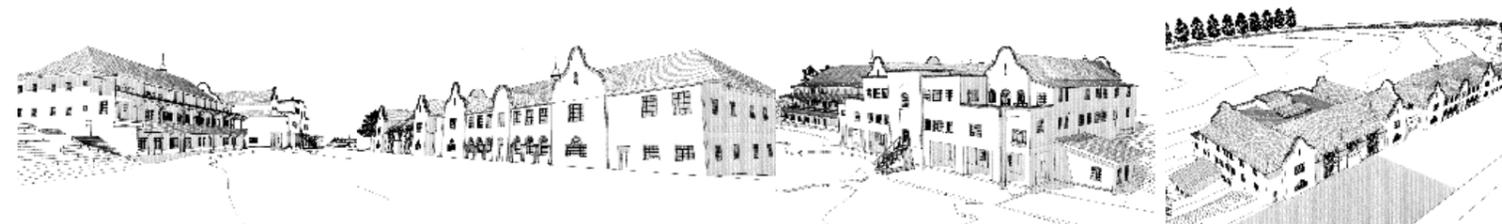
Figure 141: Berea Park complex re-use (Henry Paine + Partners 2010)

The heritage proposal was set forward by Henry Paine and Partners. (Figure 141) This proposal entails restoring as much as possible of the old fabric of the building, while removing some of the internal walls to enable re-use of the structure. (Paine + Partners 2010) This proposal is no longer viable, since the structures have suffered extensive damage, since the report was originally drafted in 2009.

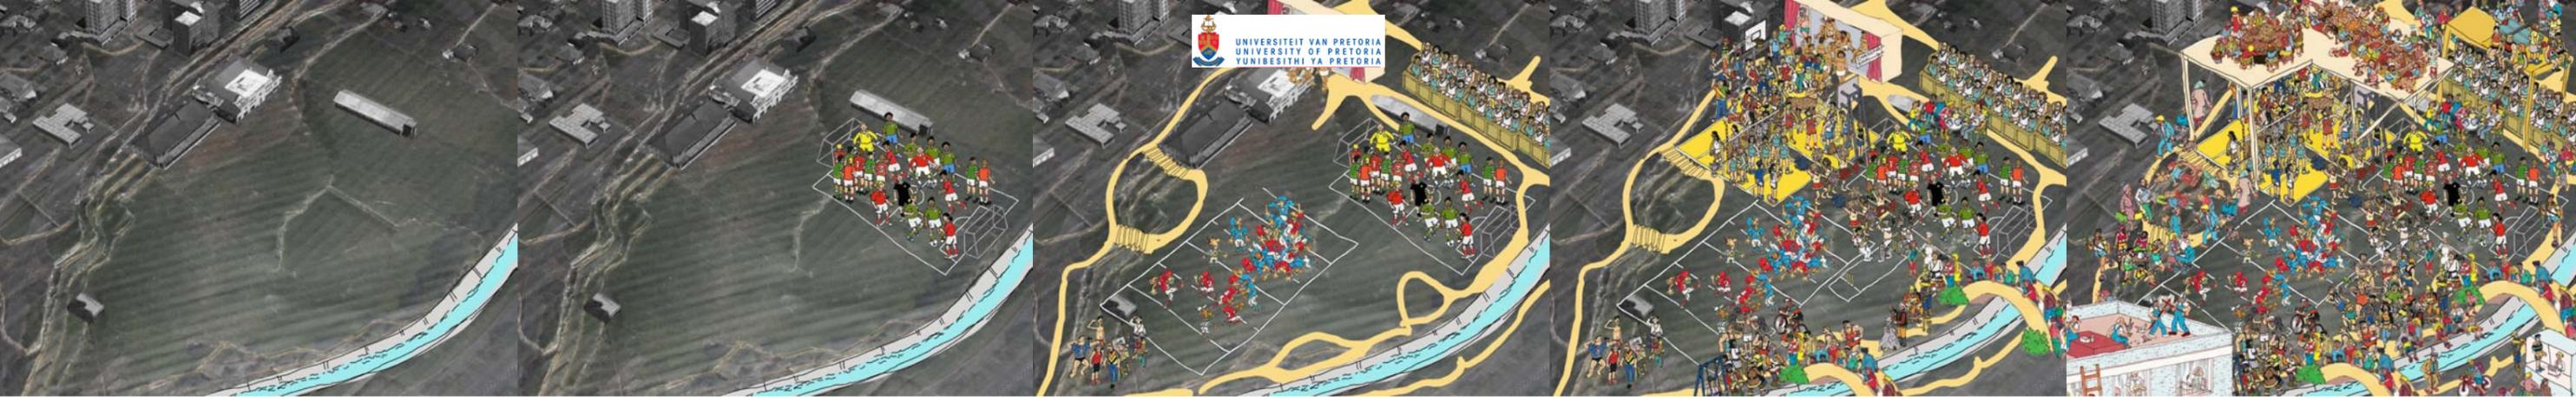
Figure 151: Concept development phase 1: activity informing architecture (Author April 2013)

The concept entails using the existing activities at Berea Park. A hypothetical example would be the soccer being played at Berea Park that act as an informant. This activity in turn leads to certain needs and architectural interventions arising, for example shaded spectator seating and dressing rooms. Once these amenities have been put in place, they create the opportunity for other activities, for example a rugby field, to be implemented, and so forth. (Figure 151)

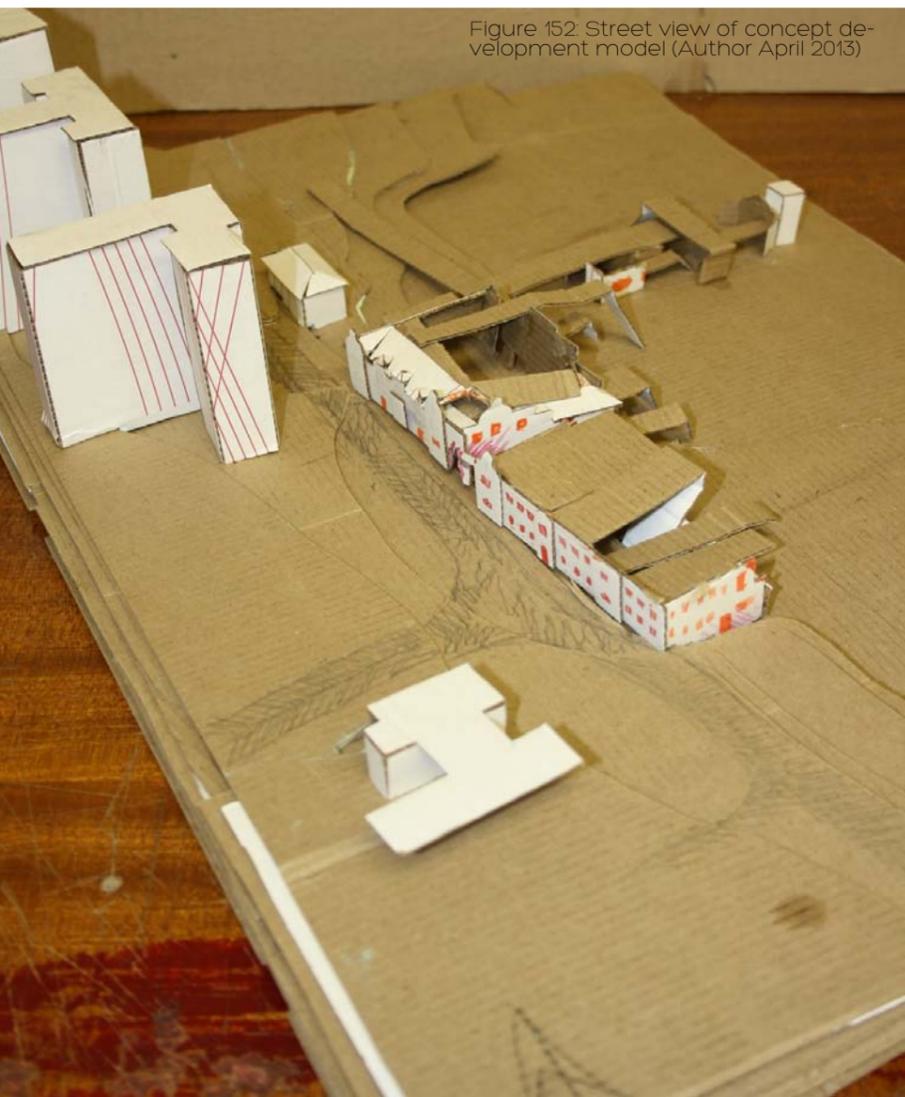
Figure 152: Street view of concept development model (Author April 2013)

This phase is based on linking the site to its surroundings. Routes link access points onto the site and into buildings. Strips of activity are inserted into the existing fabric of the structure. Some of these strips are tugged into the existing structure, while others protrude over the remnants of the existing buildings. (Figure 152, Figure 153)

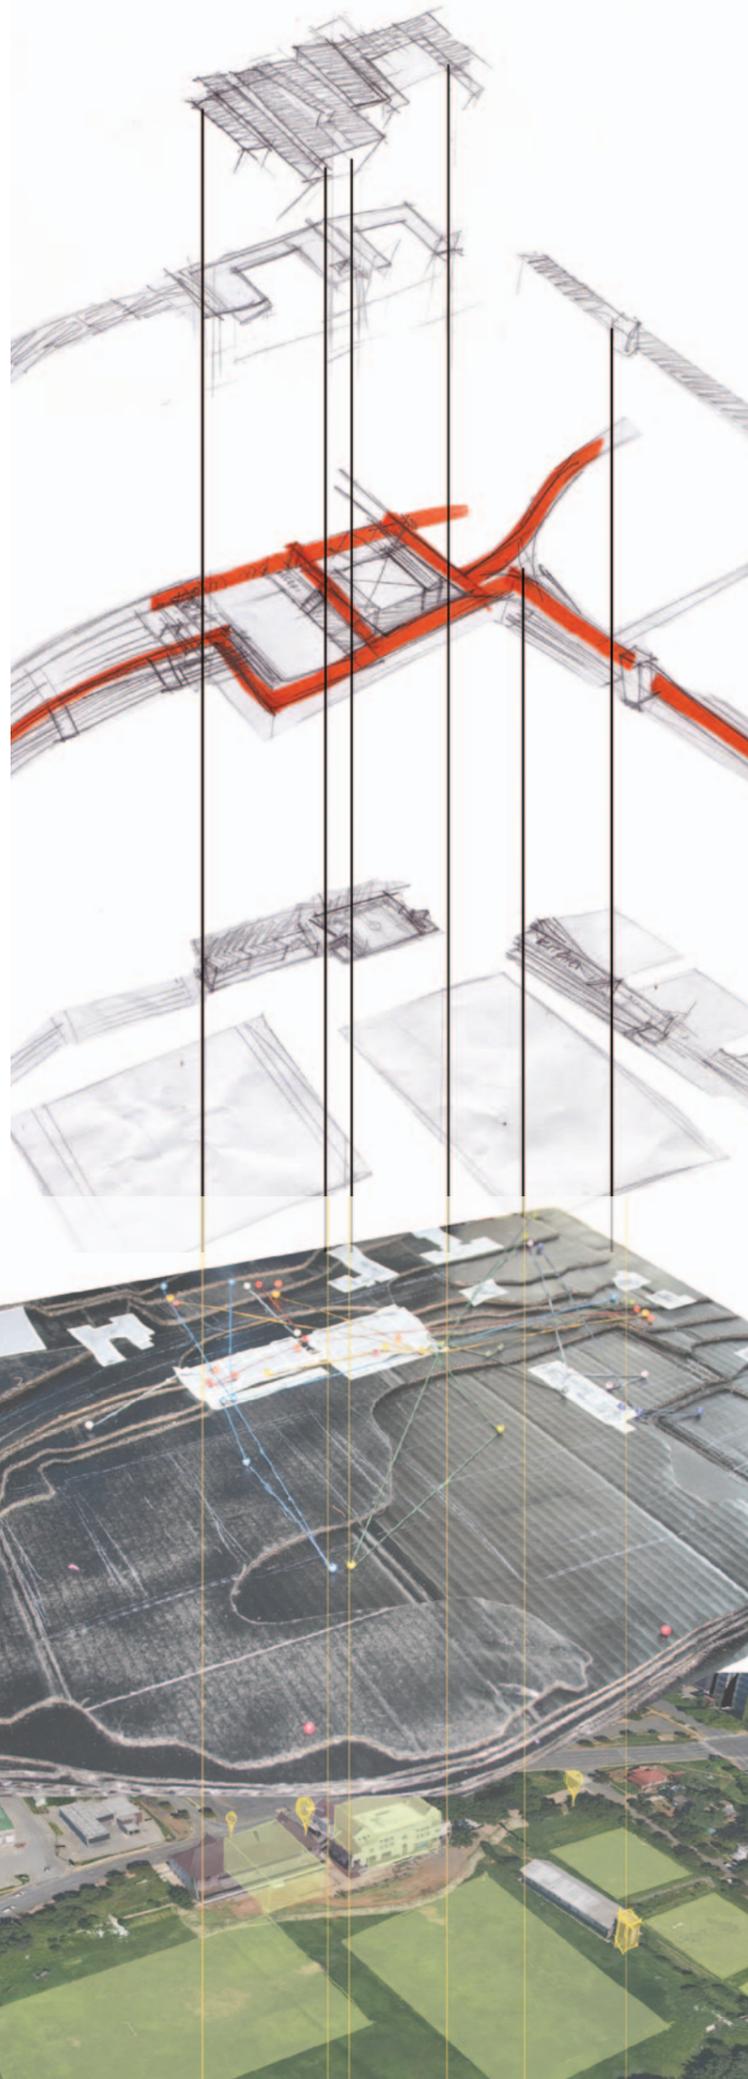
Figure 154: Concept development phase 3: activity informing architecture, route as binding element (Author May 2013)

The routes start at the main entrance points. The field level mainly houses facilities for athletes. The routes run around the main activity areas, before continuing upon its original course. The strips of roof cover defines the various spaces located within the buildings. (Figure 154)

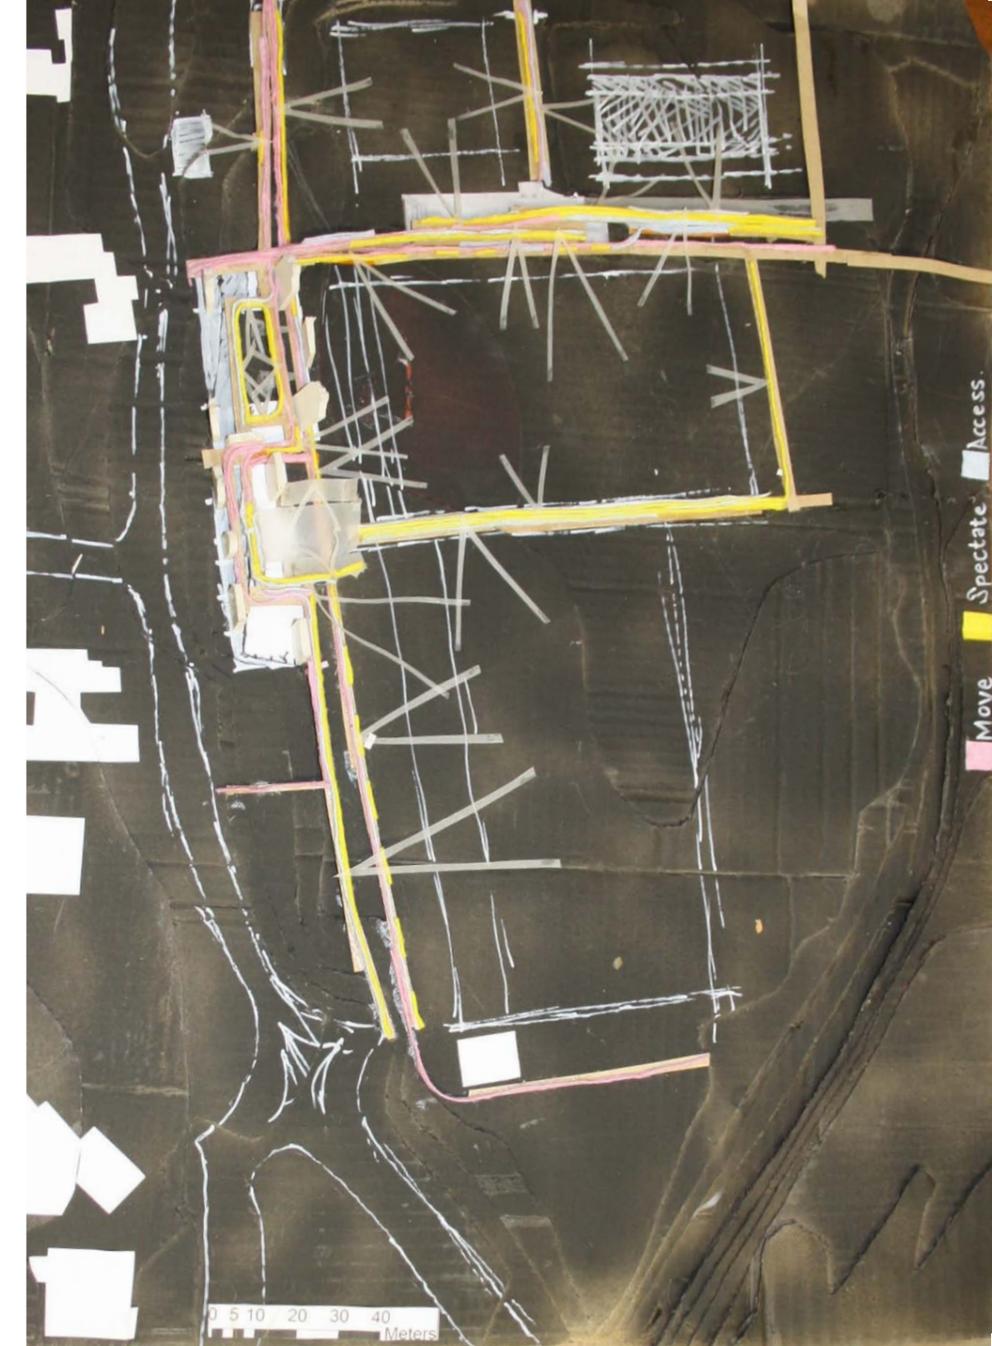
Figure 164: Aerial view of route model: types of routes and important views from them (Author April 2013)

Taking into account the importance of the routes (see chapter 9: concept phases 2 and 3), route 'zones' and viewing points were mapped. (Figure 164) Three types of route zones were identified, namely: zones focused on circulation (movement), zones dedicated to access, for example stairs and ramps (access), and zones that serve as vantage points (spectator). The route interacts with the existing fabric (Figure 165) as well as with the surrounding sports fields and facilities. The routes step between field and street level. The routes focus in areas around existing fabric, providing access to the existing built up zones.

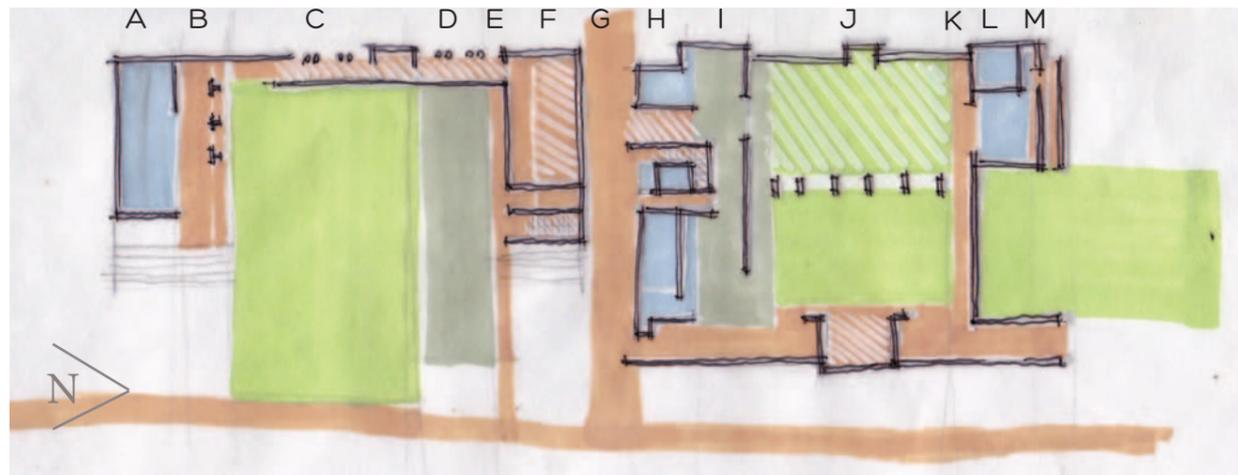
Figure 180: Diagram of zones in plan (Author July 2013)

grammed zones would dictate the layout and programming of the new interventions. (Figure 180) These zones run east-west, contrasting the north-south orientation of the existing structures. These zones were inserted into the existing structures, they either fit inside the building's shell or protrude from it. (Figure 180) These zones dictate the programme layout. (Figure 181) The zones' edges are stepped, both on plan and in section according to each zone's spatial and programmatic requirements. (Figure 180, Figure 183)

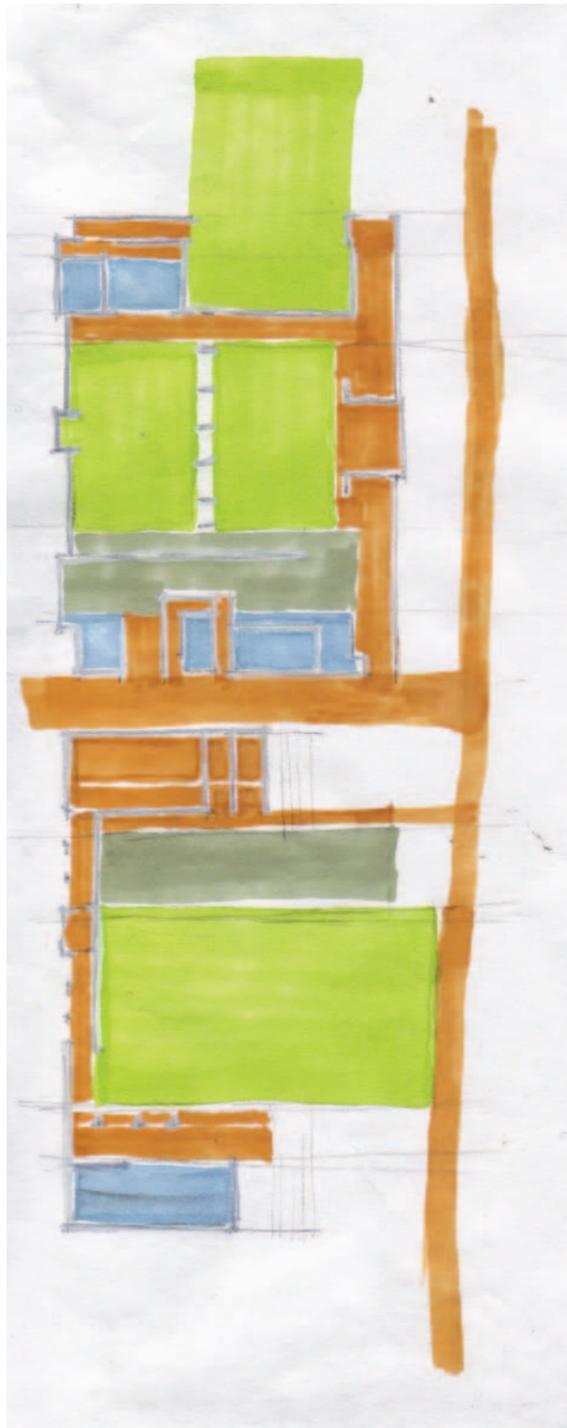
Figure 184: Diagram of zones (Author August 2013)

In dealing with the heritage, the aim was to retain the essence of some of the spaces. These include the hall located in the northern clubhouse, the main staircase on the eastern edge of the northern clubhouse and the passage along the western edge of the southern clubhouse. (Figure 184)

essence of the typical Cape Dutch original u-shaped plan of the two clubhouses. Each wing of the plan ends with gables. (Figure 184)
