REGENERATING BEREA PARK

[Design in pursuit of rekindling appropriation]

Submitted in partial fulfilment of the requirements for the degree of
Masters of Architecture, MProf(Arch),
Department of Architecture
Faculty of Engineering, Built Environment and Information Technology
University of Pretoria, South Africa

Programme:	Sport and recreational centre
Site description:	Berea Park Clubhouses, Berea Park neighbourhood, Tshwane
Site location:	Erf R/2375
Address:	600 Lillian Ngoyi Street
GPS Coordinates:	25° 75' 80.49" S , 28° 19' 39.31" E
Research field:	Heritage
Clients:	Department of Sport and Recreation South Africa Tertiary institution (Unisa or University of Pretoria) Individuals from the Berea Park neighbourhood
Keywords:	regeneration, belonging, heritage, adaptive reuse, sport, recreation
Premise:	Design in pursuit of rekindling appropriation

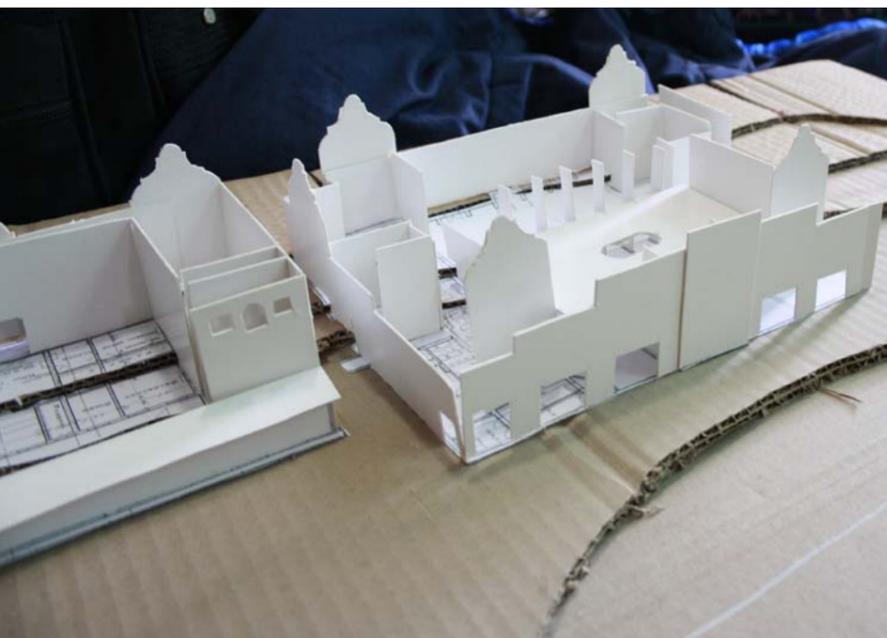
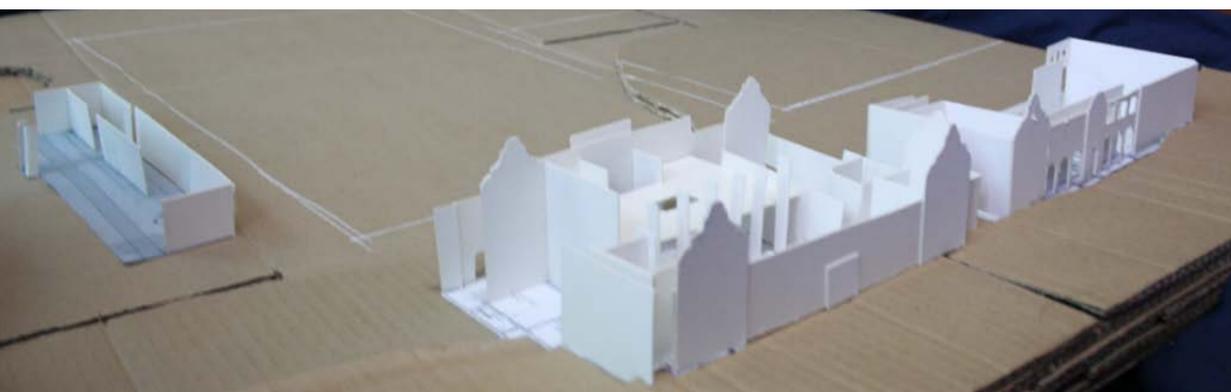
The existing structure is cleaned up, retaining as much as possible of the identified important heritage spaces as discussed in phase 5. Damaged elements, including walls and roofs are removed, as well as unnecessary interior walls and fabric. (Figure 194, Figure 195, Figure 196) The new zones are then inserted into the existing structure, acting as supports for the remaining existing fabric. (Figure 199, Figure 198, Figure 197) The new interventions house the new programmes, while plugging into existing building elements, such as the hall space, staircases, etc.

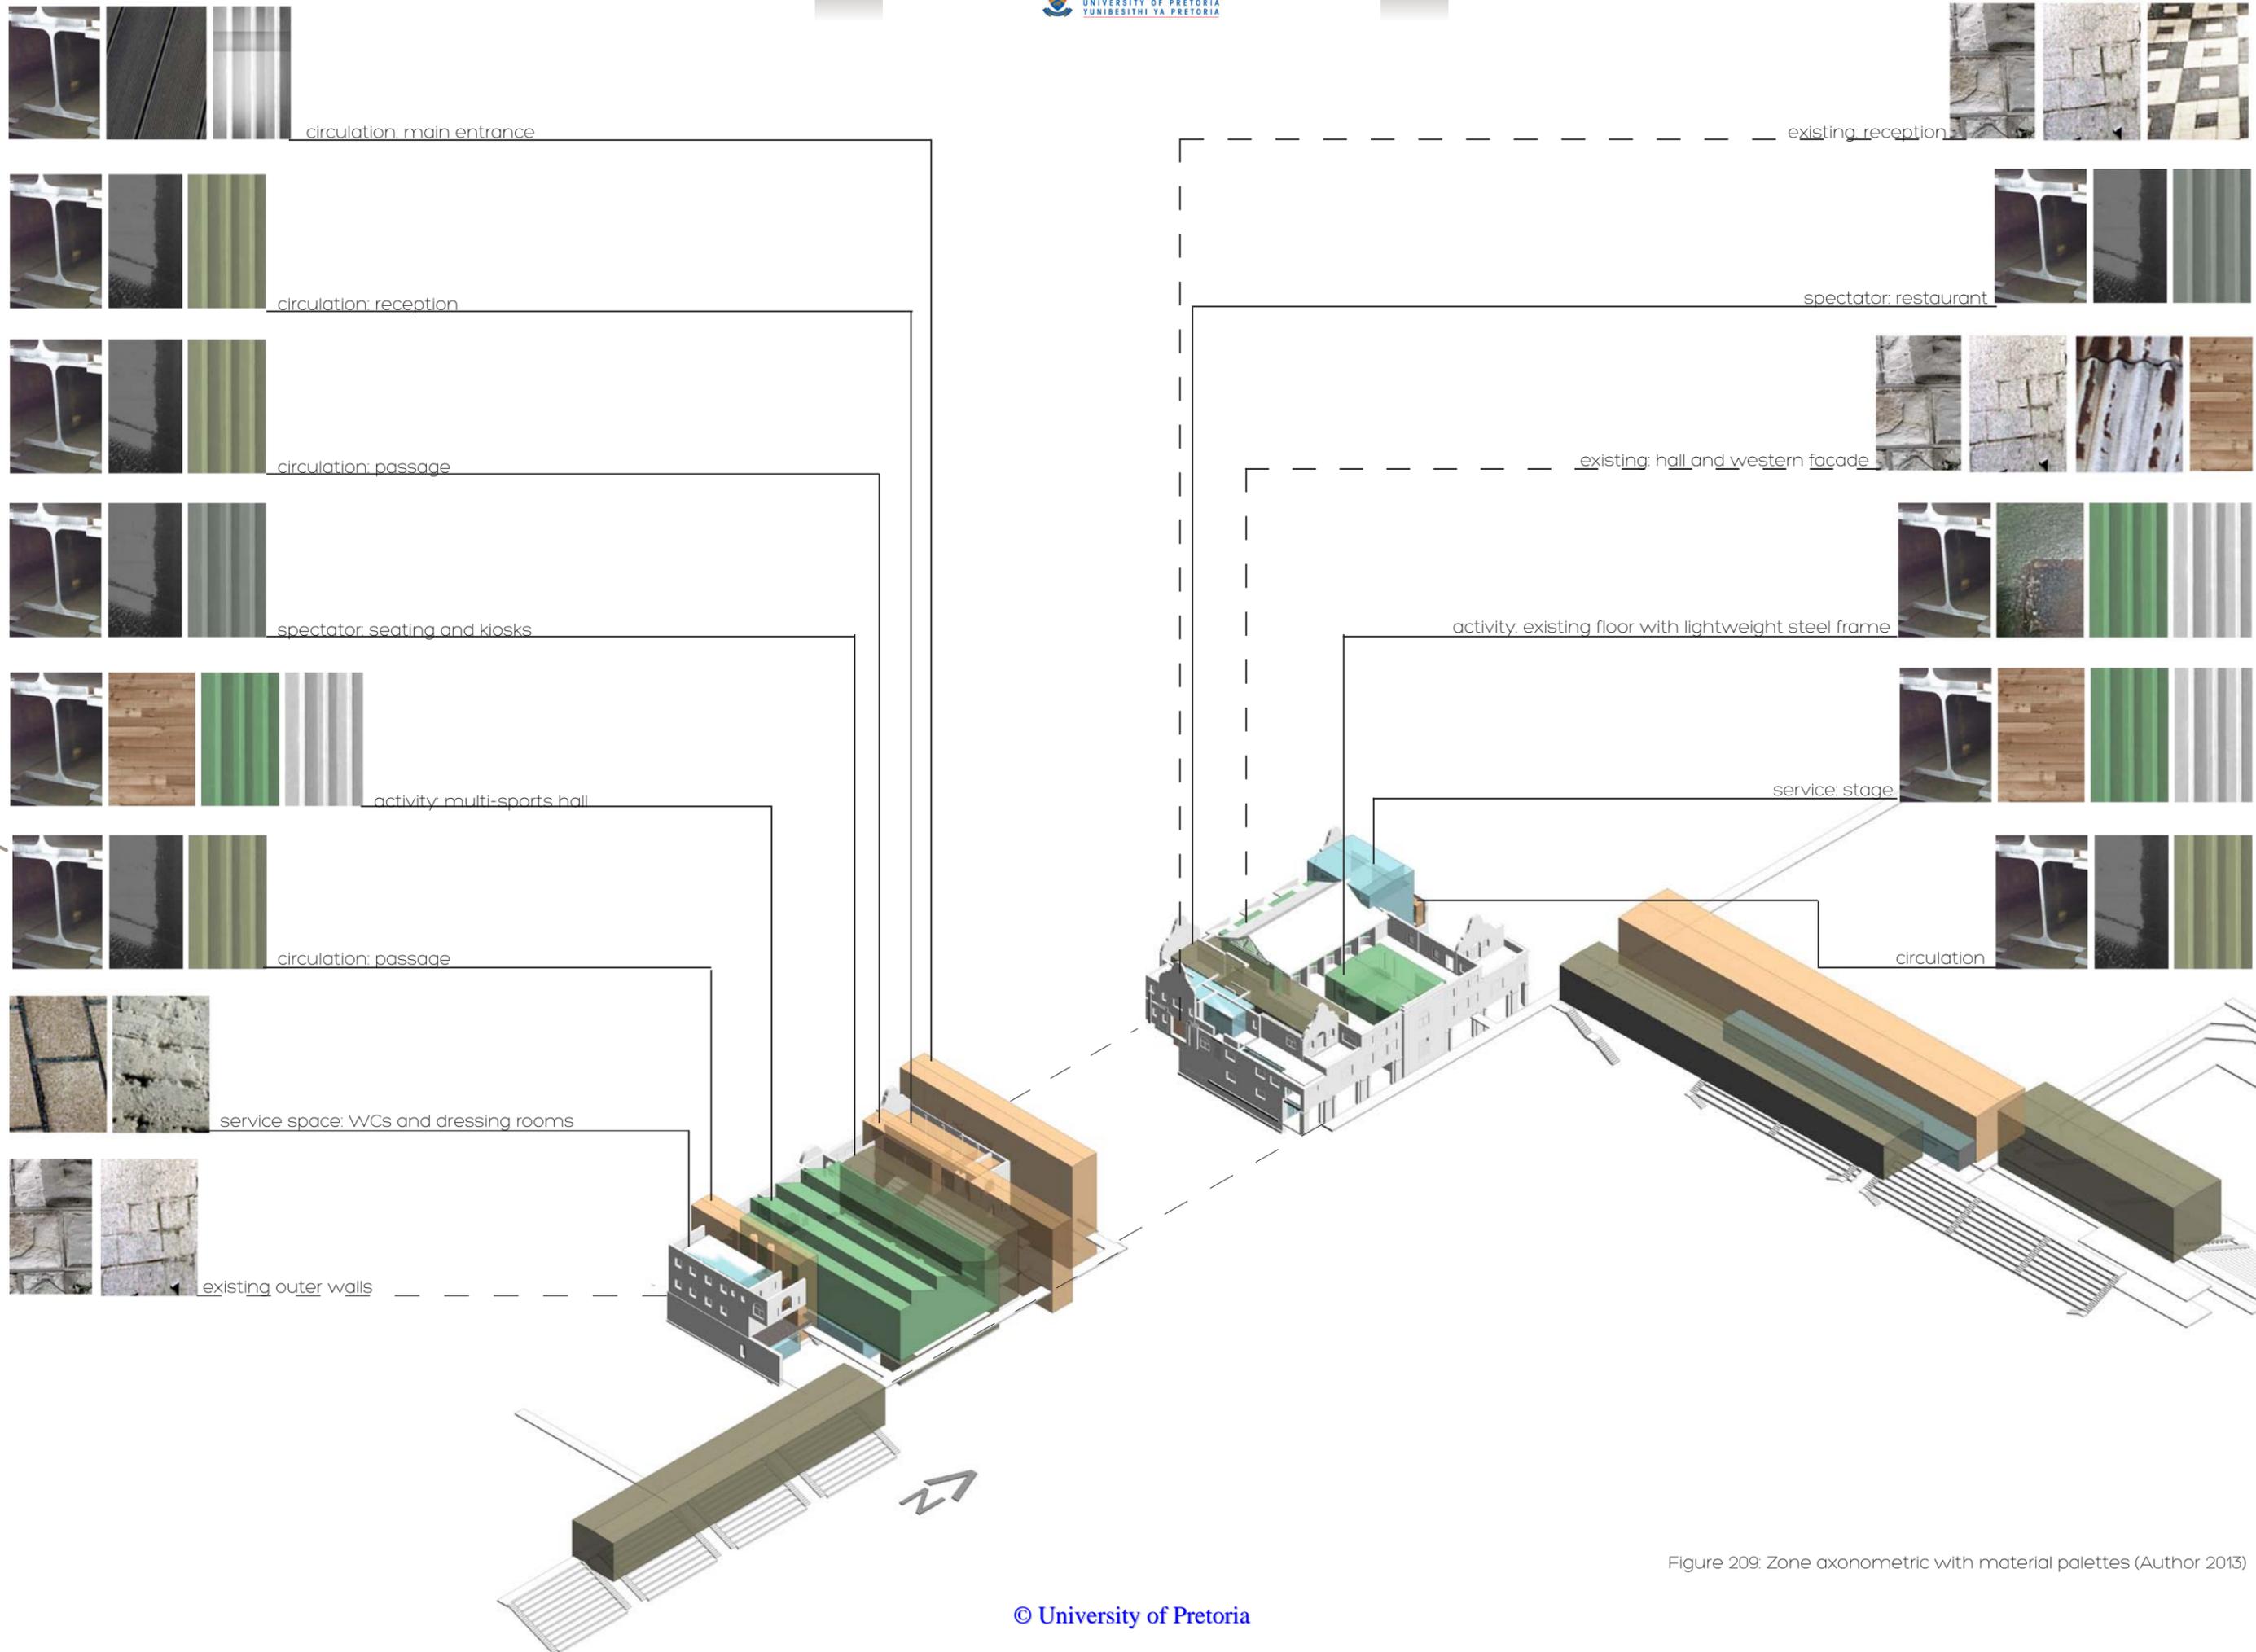
Figure 209: Zone axonometric with material palettes (Author 2013)

The existing aesthetic of Berea Park embodies a strong reference to Cape Dutch revival. Cape Dutch is known for its stereotomic thick masonry wall and heavy stone plinths. (Figure 203: existing fabric) The walls and plinths by and large constitute the residual elements at Berea Park. To contrast this, light weight, tectonic steel boxes will be inserted into the heritage fabric. (Figure 203: Primary structural support, skins, Figure 209)

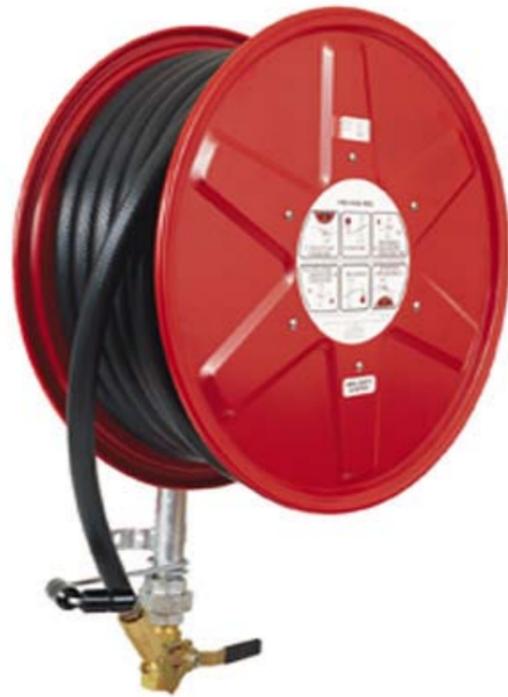
Figure 210: Fire hose reel (Trisafe solutions 2013)

The building has more than two storeys, and should therefore be equipped with hose reels. (Figure 210) A hose reel is required on every storey, for every 500m² of floor. These fire hydrants must comply with SABS 1128.

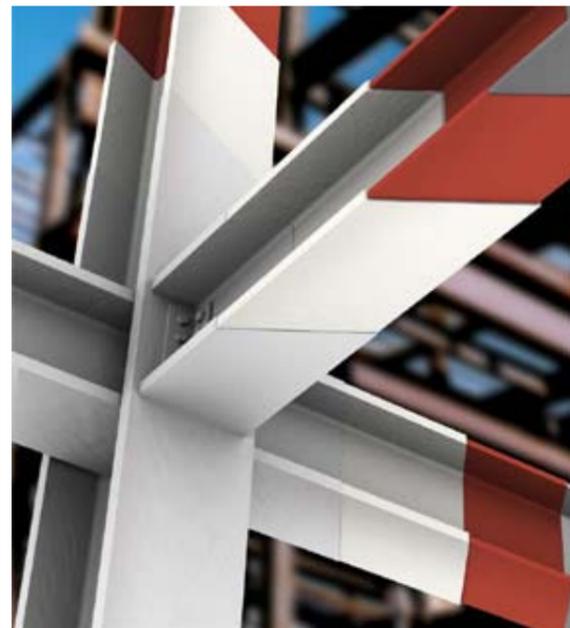
Figure 211: Intumescent paint system (Tadbir Banda Aryan 2012)

The steel structures will be treated with intumescent paint for fire protection. (Figure 211, Figure 212) Either zinc phosphate paint that complies with SABS 1319, or red lead paint that complies with SABS 312 will be used to treat the steel elements that form part of the new interventions. For fire protection, the steel has to be primed with two layers of either red lead paint or zinc phosphate paint, before a layer of alkyd based paint can be applied to the steel as finish. (SANS 10400-T 2011)

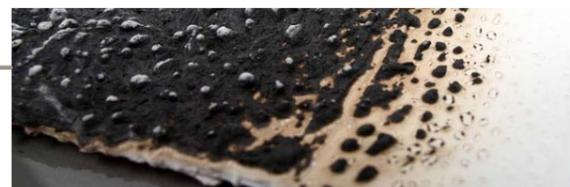
Figure 212: Burnt intumescent paint (Starkem 2011)

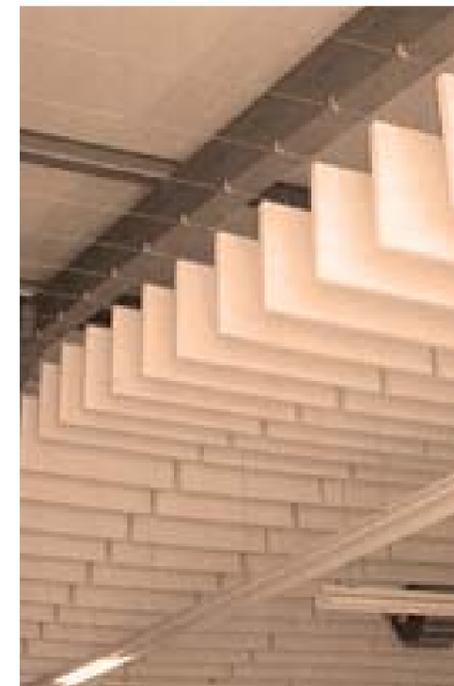
Figure 216: Installation of acoustic baffles (Acoustical world 2009)

The ceiling baffles are installed by hanging them from ceiling cables that span between the roof trusses. (Figure 216) (Acoustical world 2009)

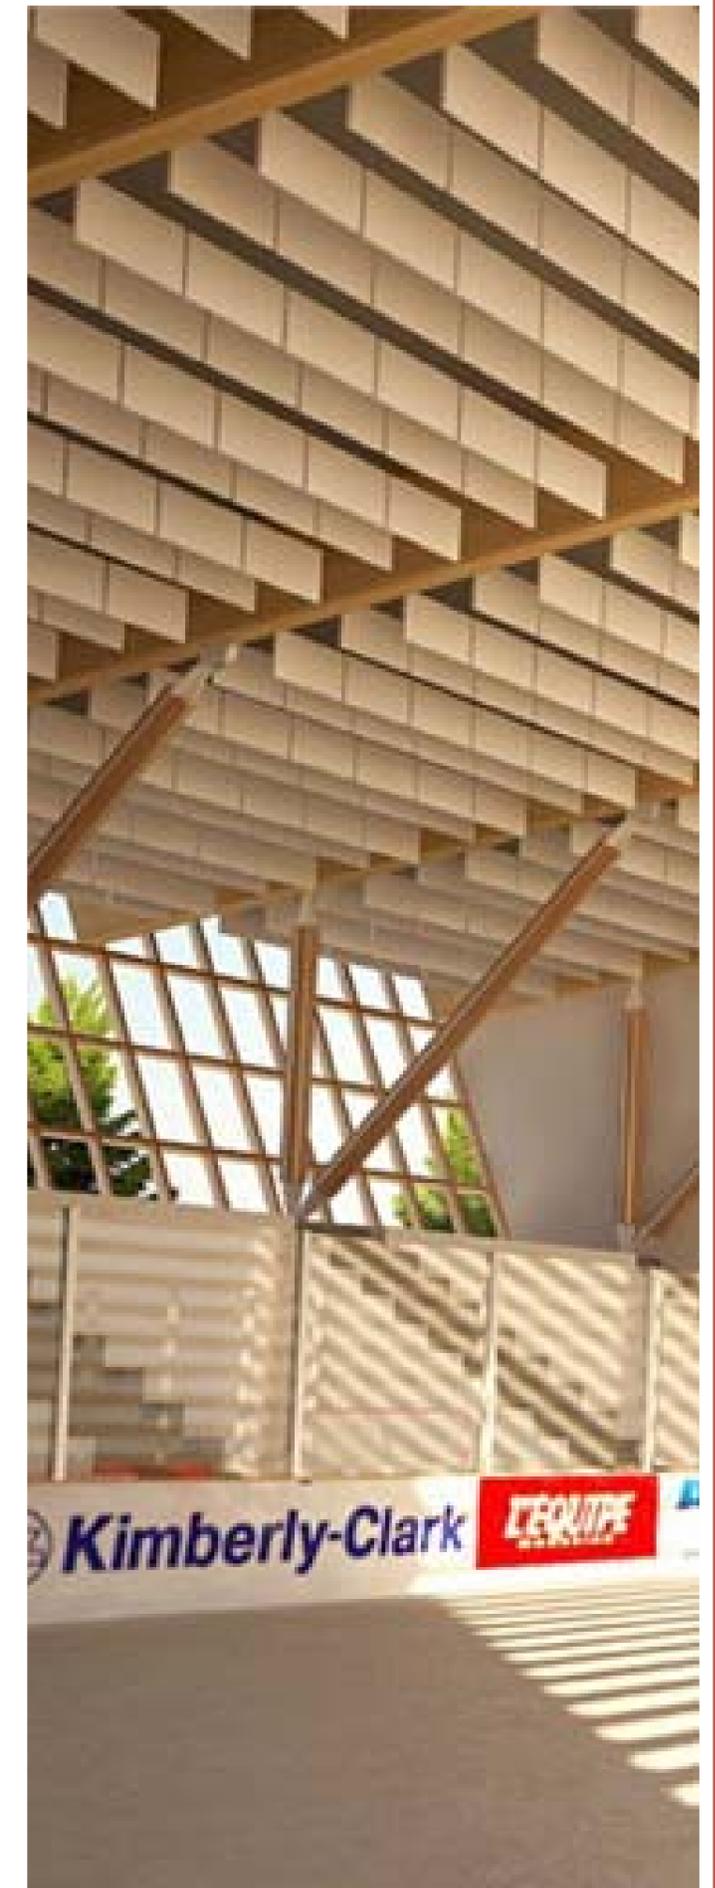
Figure 215: Acoustic baffles (Rockfon 2012)

The baffles have a sound absorbing glass fibre core and fabric finish. The proposal is to install baffles with a white finish to enhance its light reflective ability. (Figure 215)

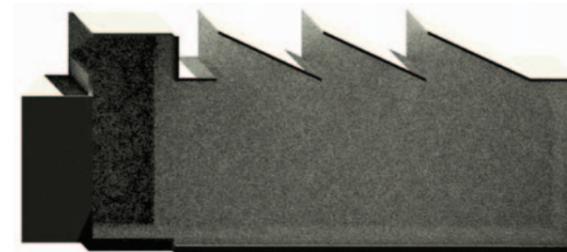
Figure 222: Roof profile B: Spring (Author 2013)

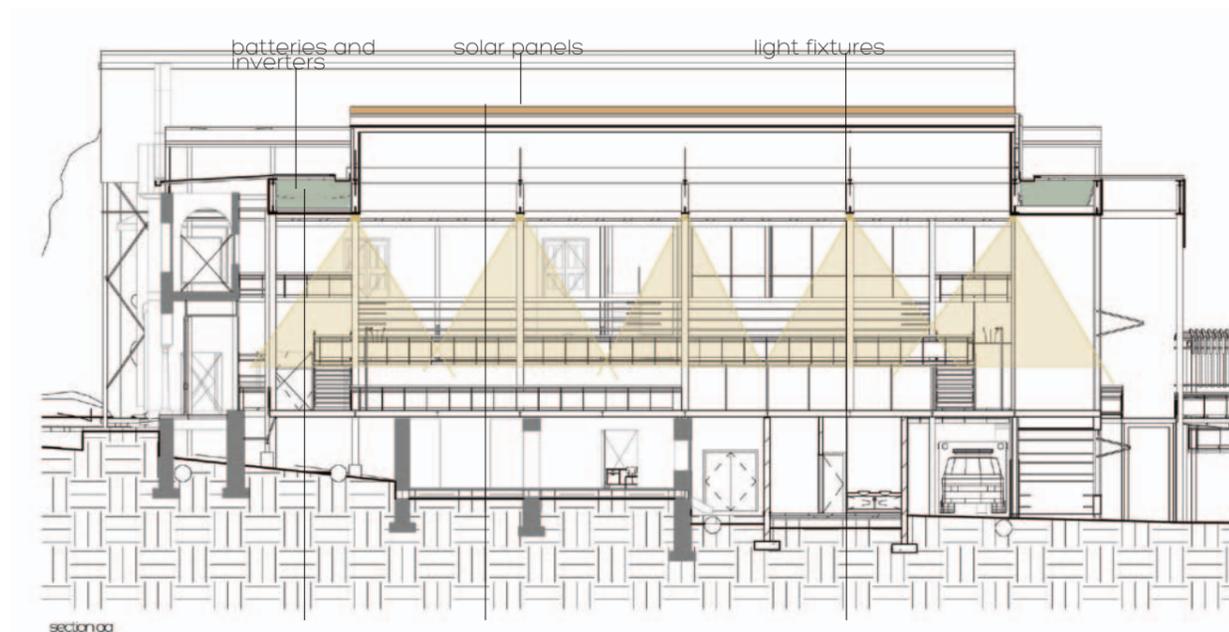
Figure 234: Solar panels, batteries and inverters (Author 2013)

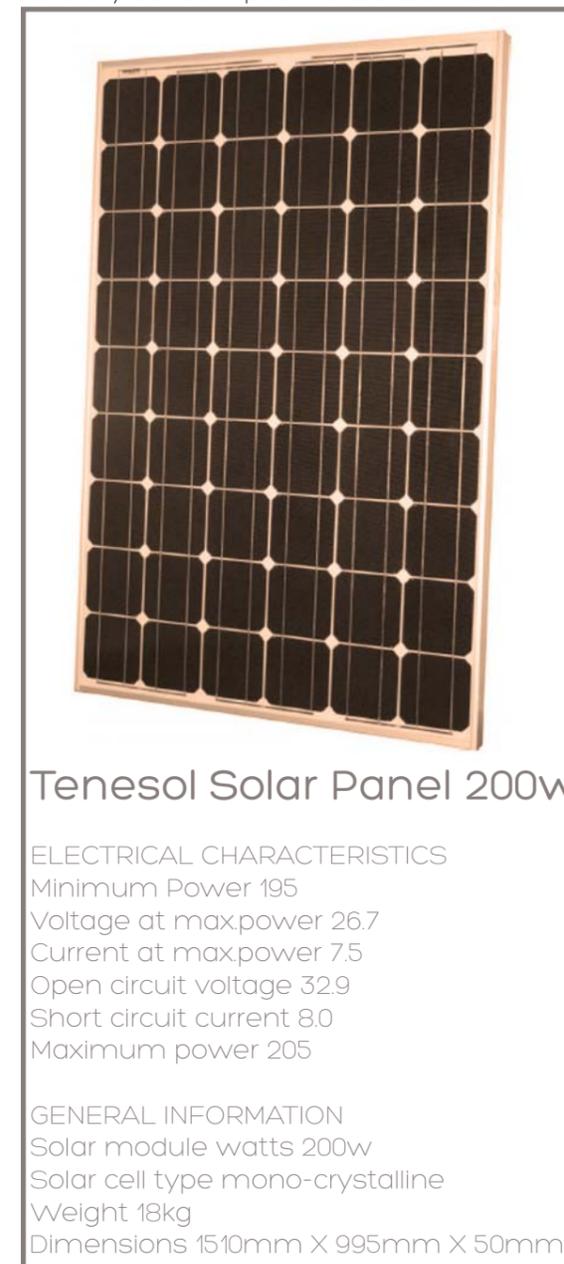
Tensol Solar Panel 200w

Solar panels will be installed on the saw-tooth roof. (Figure 232, Figure 234) The roof has an ideal roof profile, with an angle of 25° from the horizon, facing north. (Figure 232) These are ideal average conditions for solar panels in South Africa. Battery packs, inverters etc. are located in the ceiling bulkheads along the eastern and western edges of the multi-sports hall. (Figure 234) Exterior lighting will be done by flood lights with incorporated solar panels and battery packs, designed by Philips. (Figure 233) These flood lights are already being widely implemented at rural sports fields in the Cape region. (Alfreds 2013)

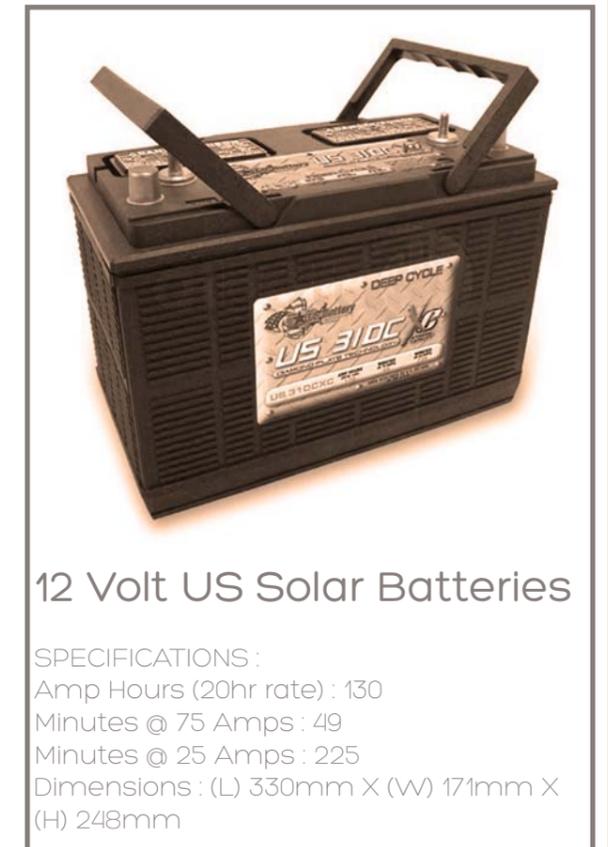
12 Volt US Solar Batteries

Figure 236: Battery (Tensol 2012)

Hundred and sixteen 105A batteries are required. (Figure 234, Figure 236)

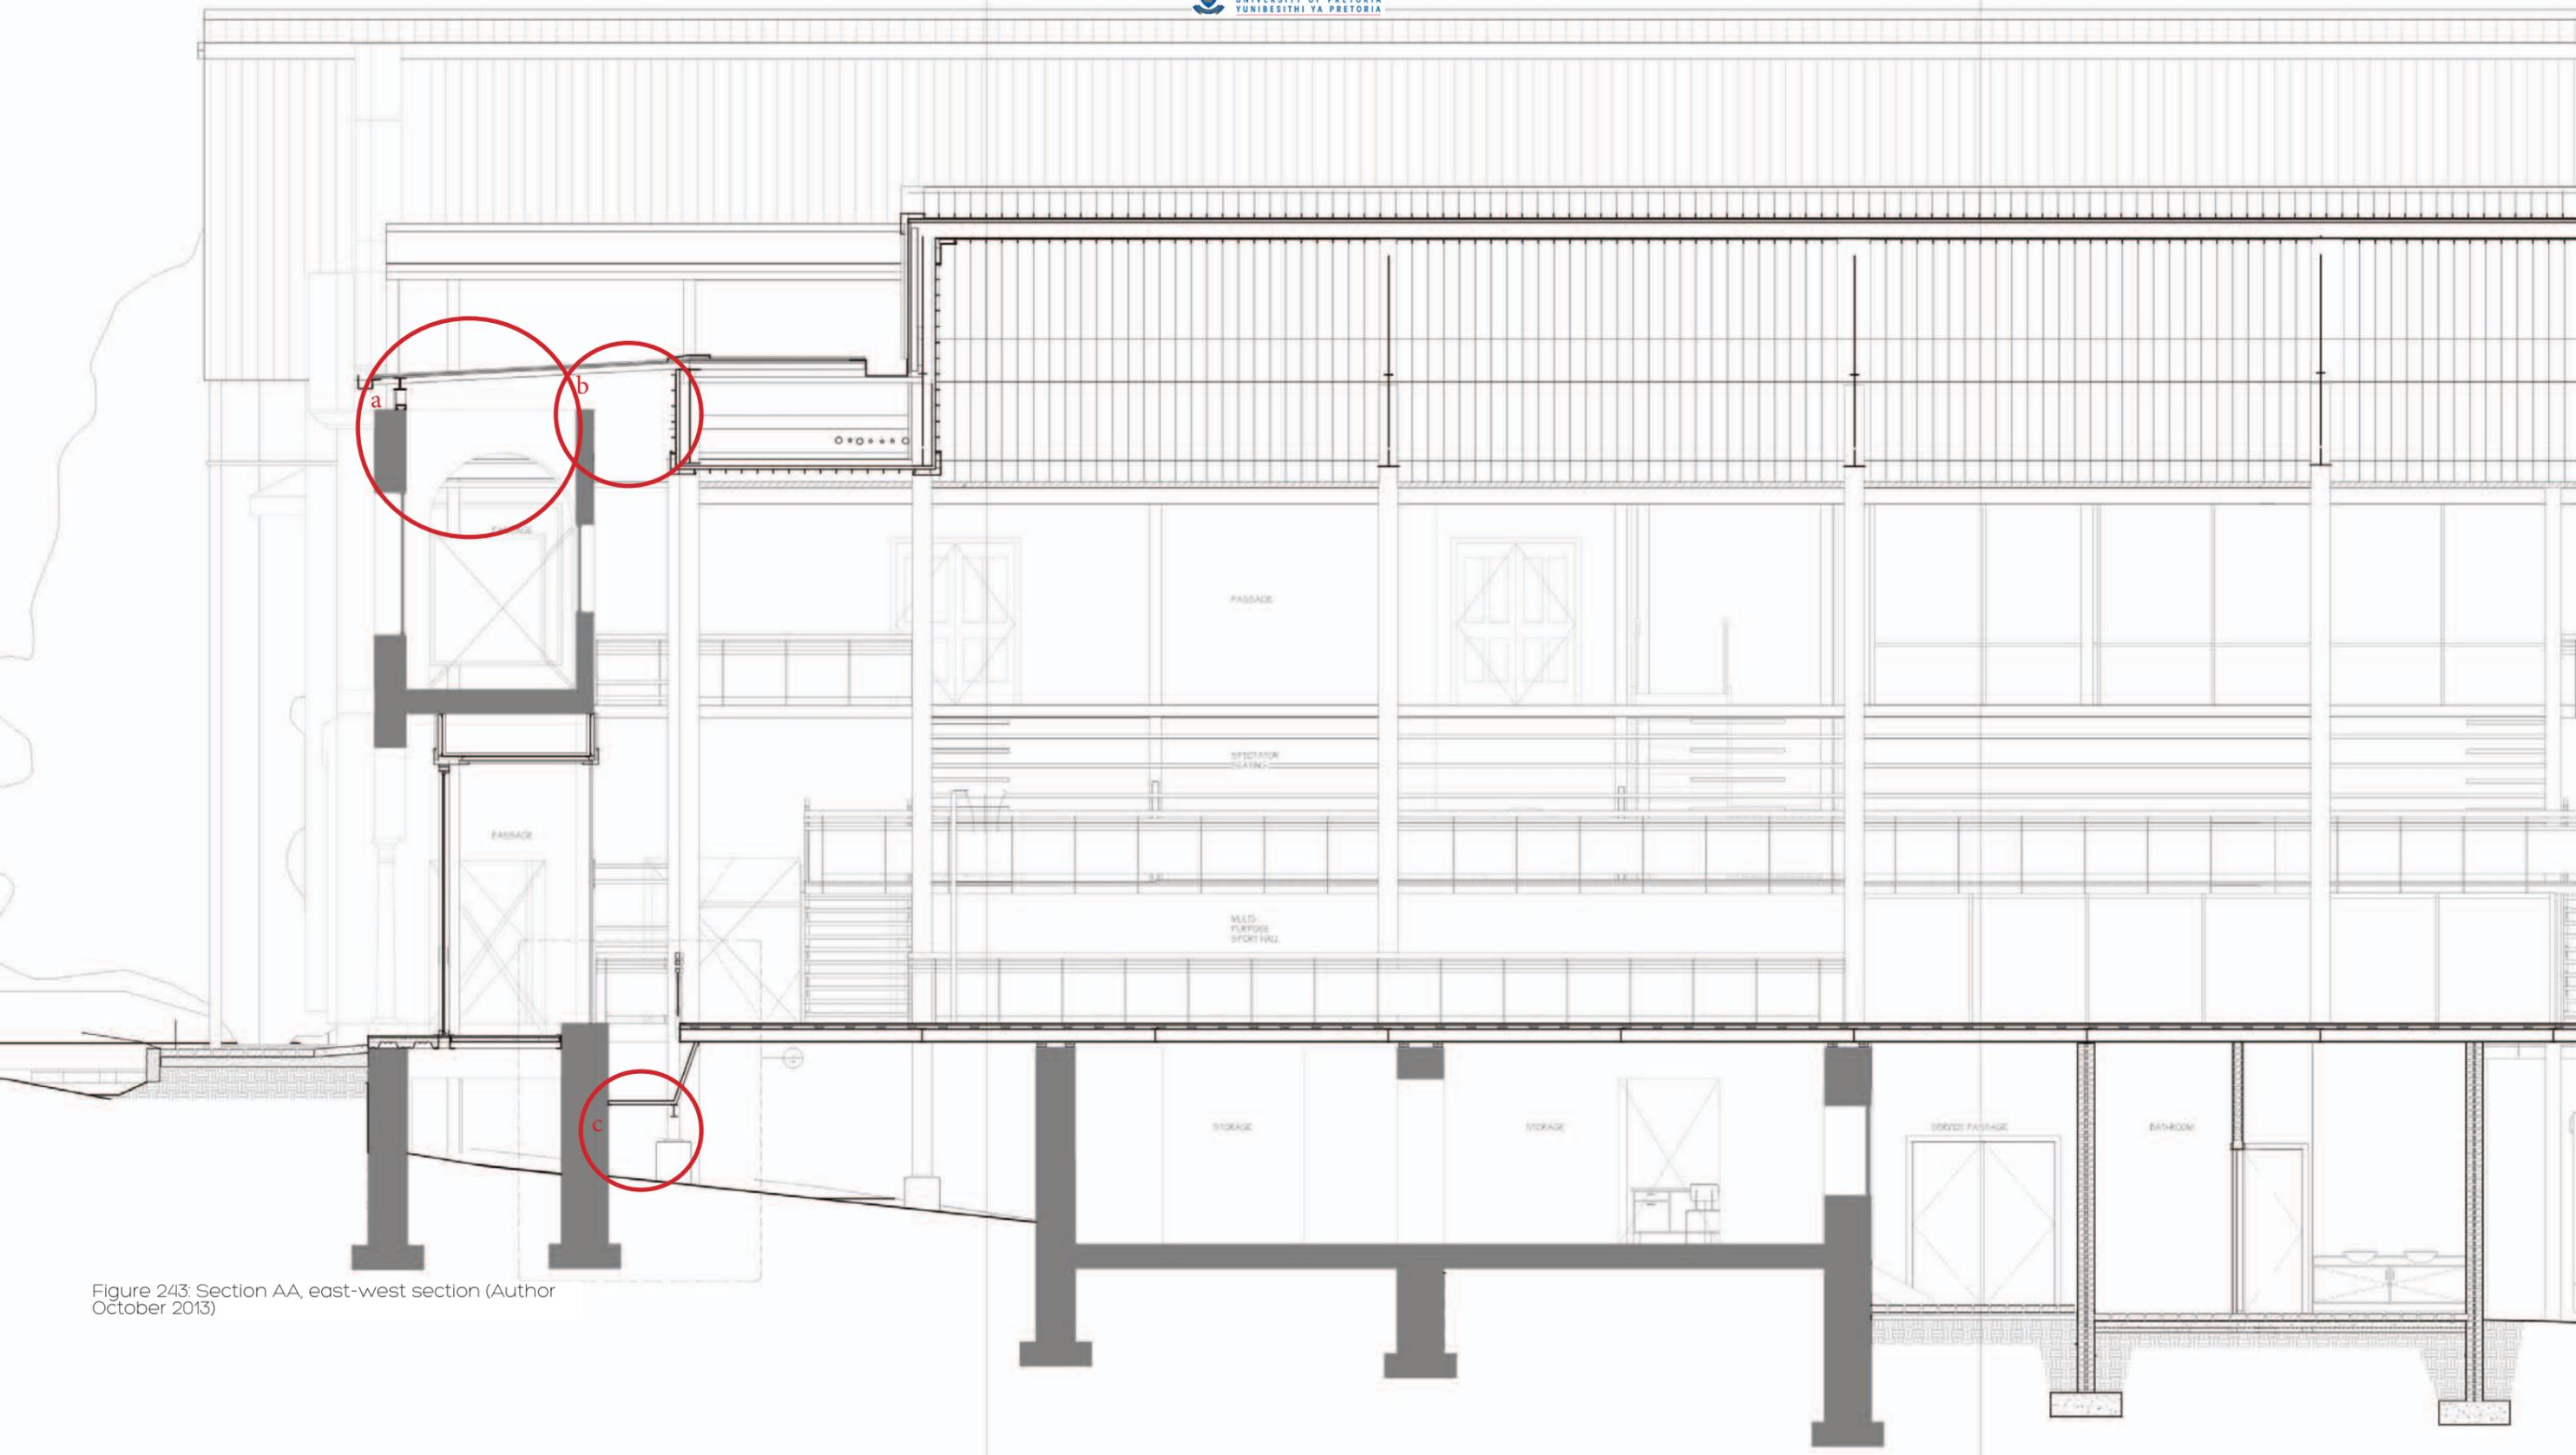
Figure 243: Section AA, east-west section (Author October 2013)

Exploration and development of details were done through rough Revit sketches. (Figure 239 - Figure 242)

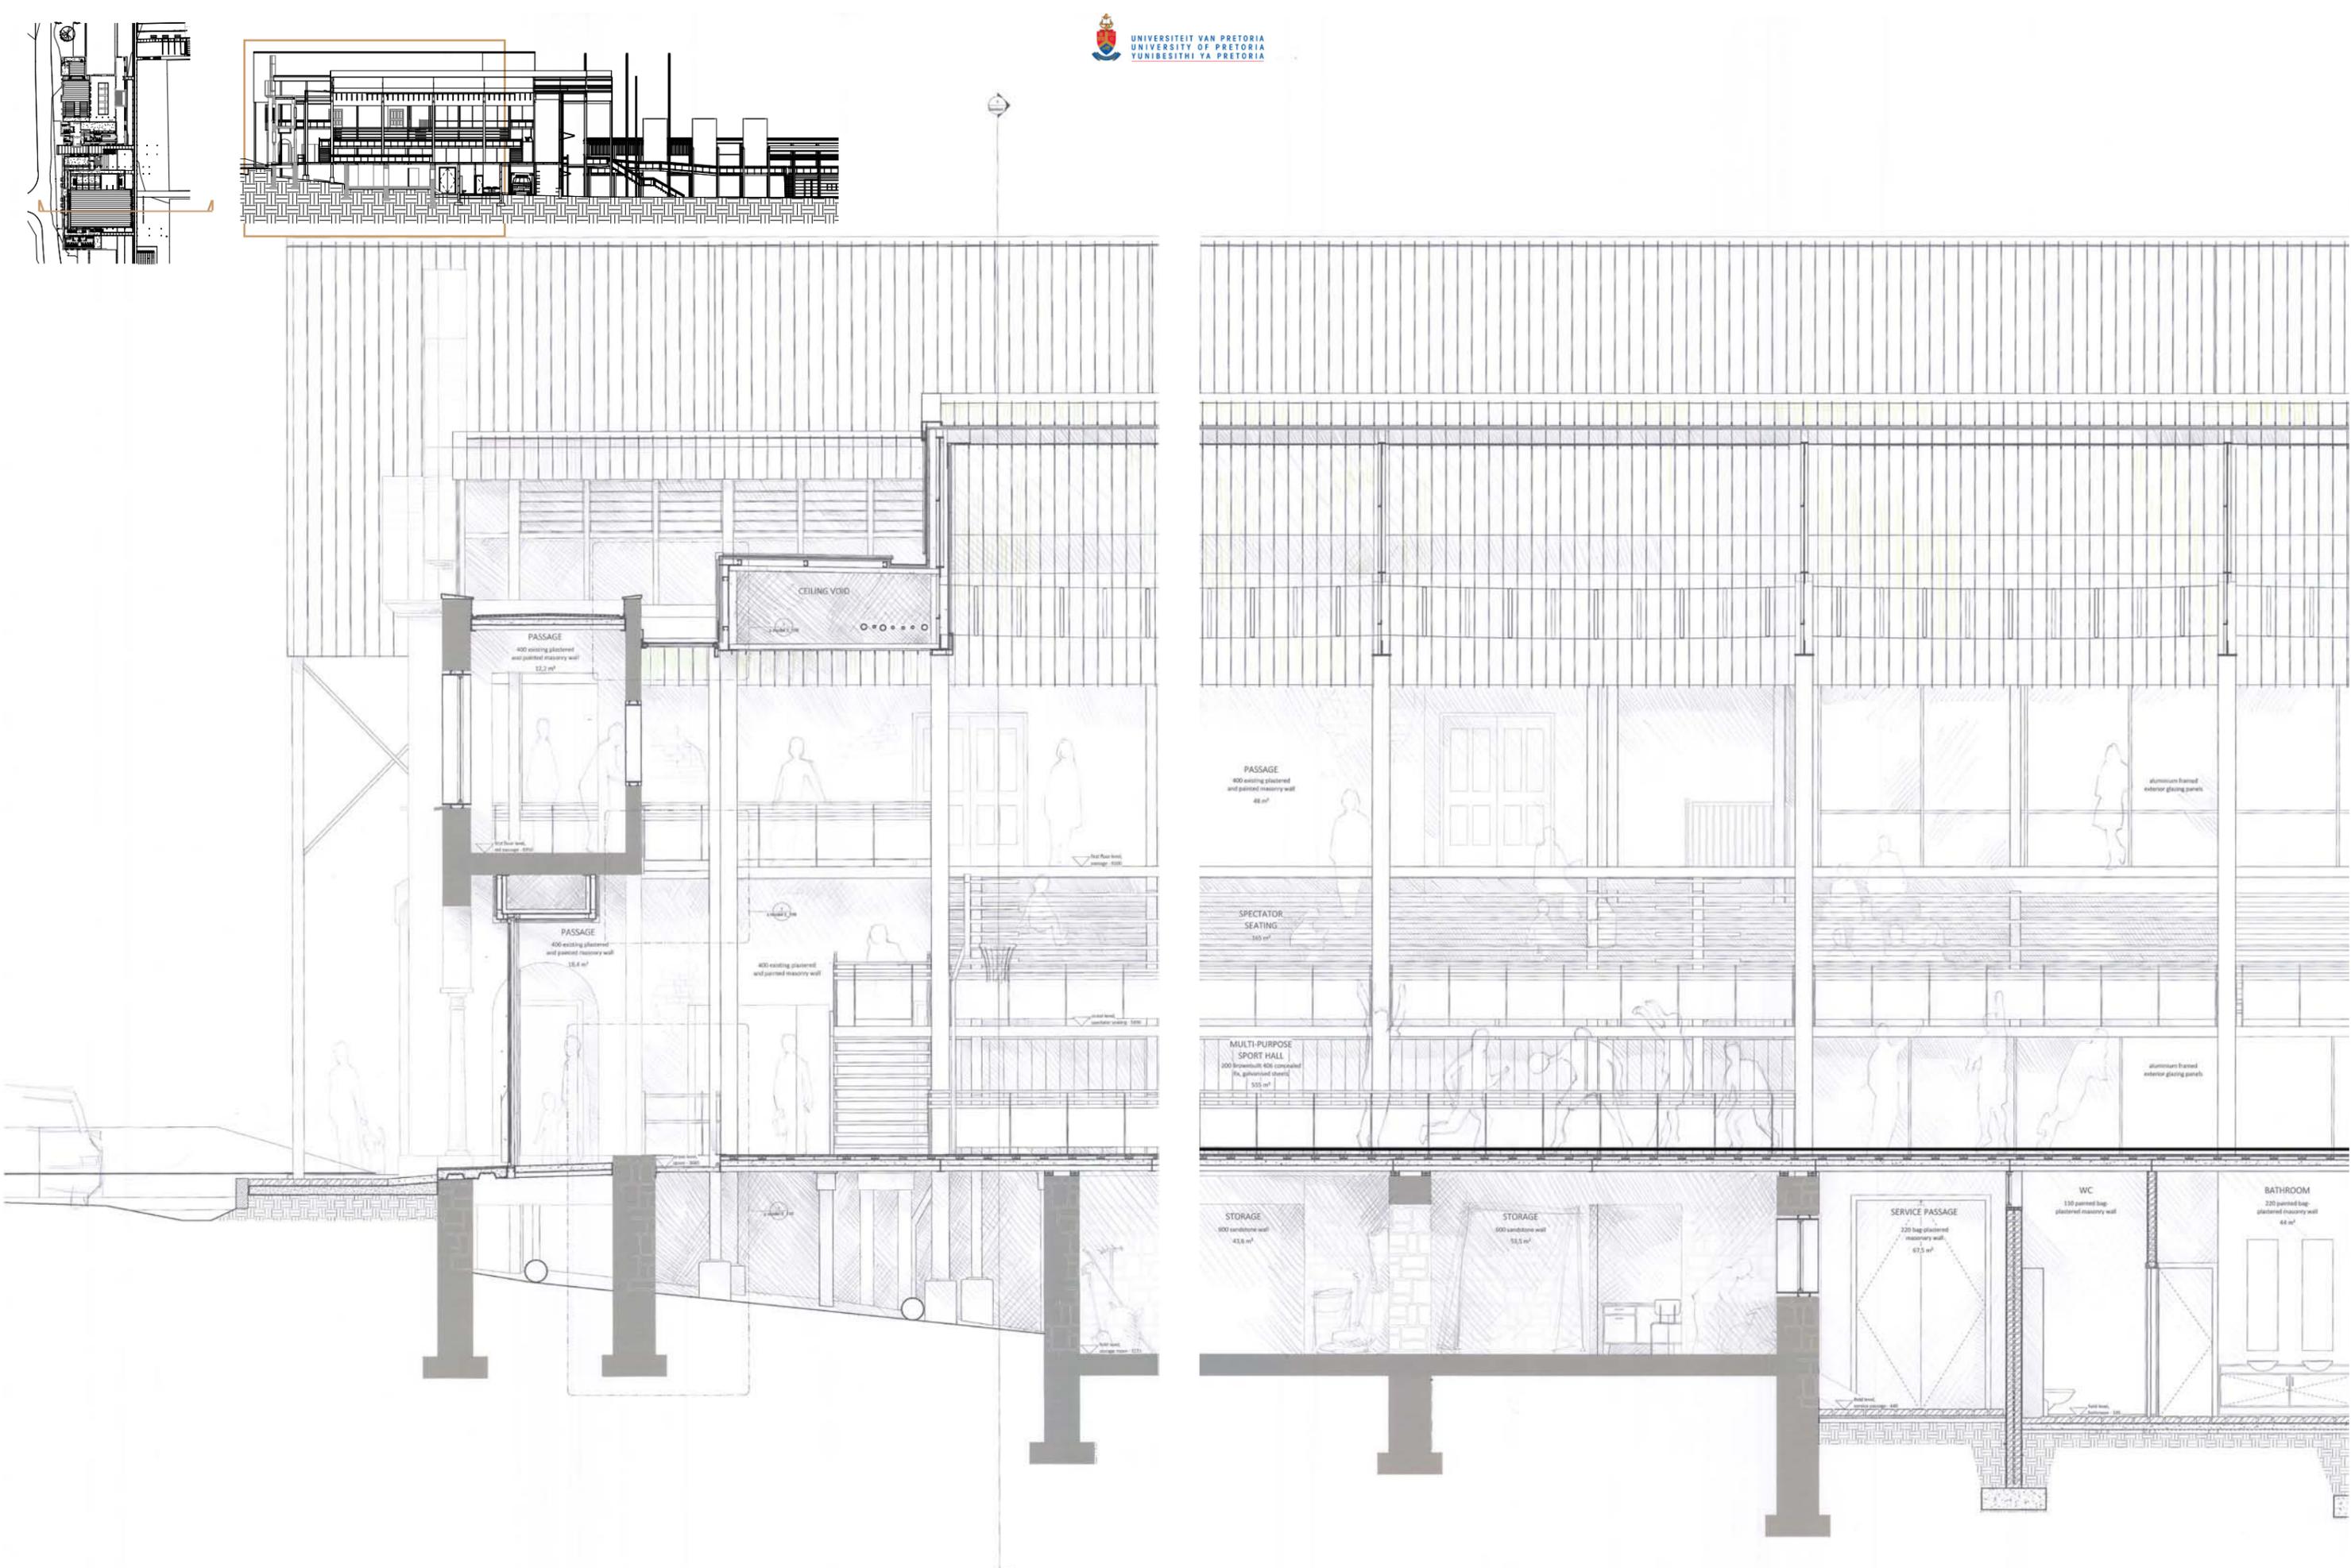
SECTION A : EAST-WEST SECTION THROUGH SPORT HALL | SCALE 1:20

Figure 275: Presentation page 25: Section AA - east-west section through multi-sport hall (Author November 2013)

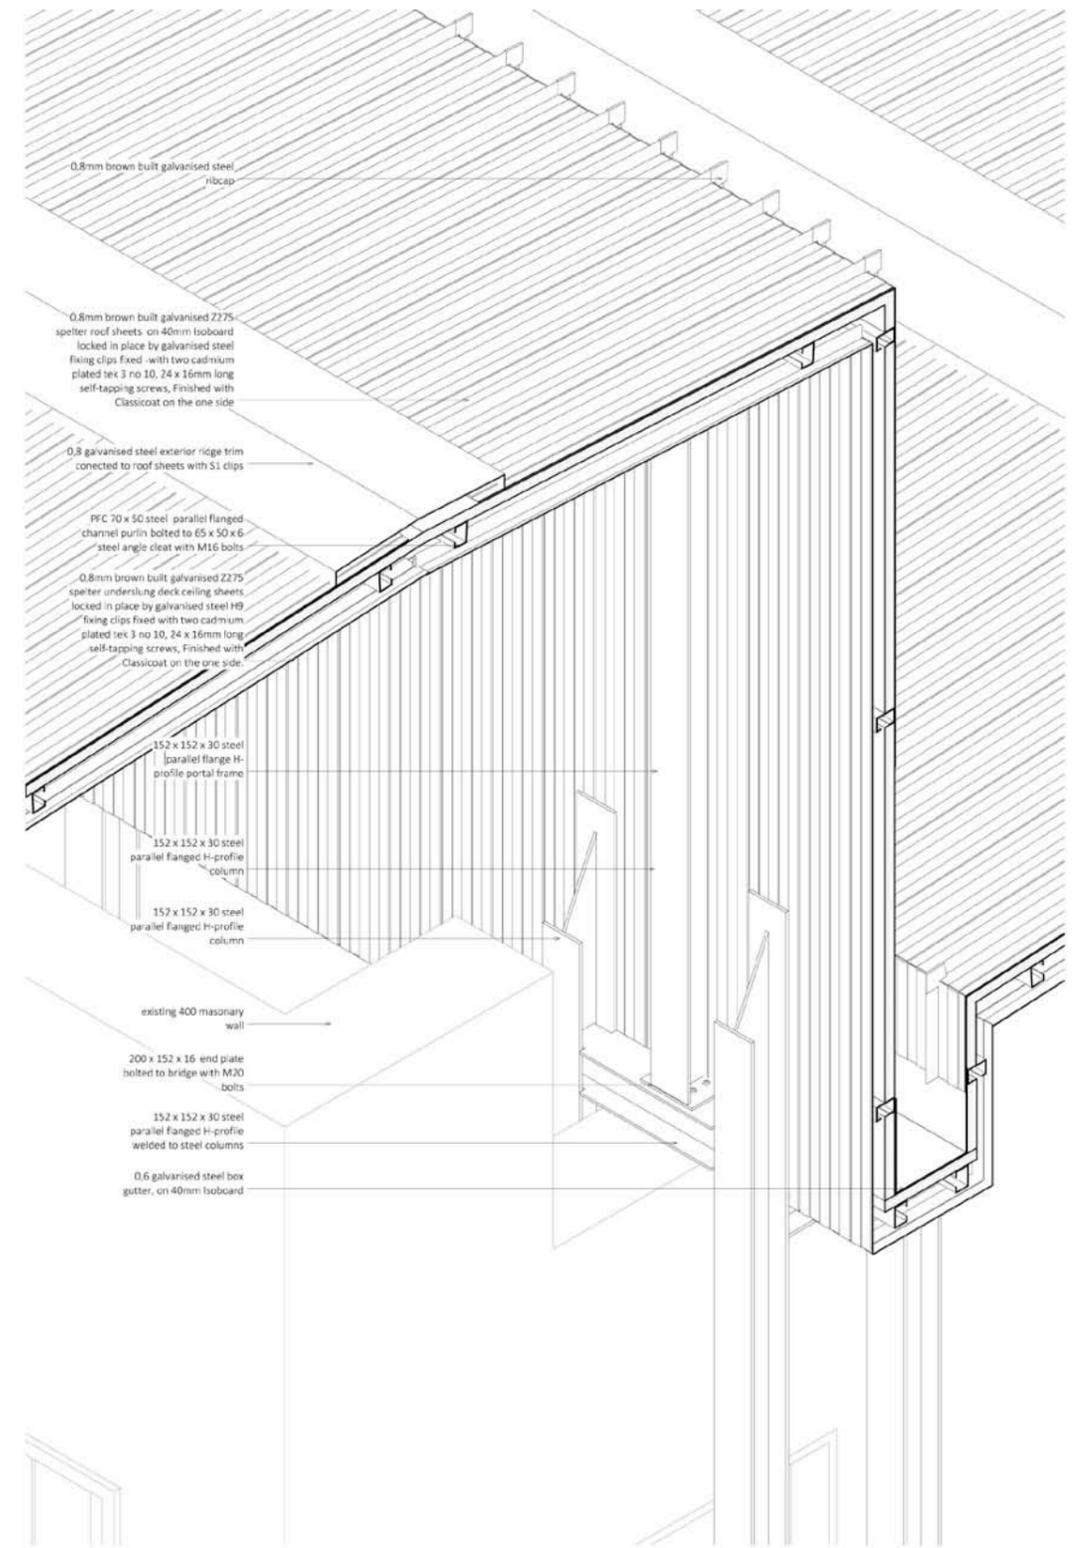
Figure 284: Presentation page 30: detail 2: roof- and skylight detail (Author November 2013)

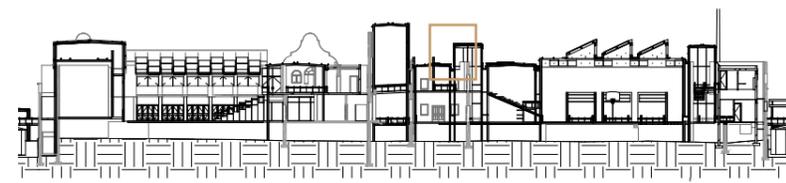
Figure 285: Presentation page 32: detail 2: stepped portal frame (Author November 2013)

The portal frame is stepped where the structural grid intersects. The portal frame is stepped to avoid undue damage to the existing structure. These steps from also serve as support for the existing walls. Historic fabric should be prioritised and retained where possible. This will where one kept as they are as far as possible, especially in the cases where there is limited direct contact between water and the old structure. In other cases, where it is deemed necessary to separate, the plaster will be removed and replaced. Where it is deemed necessary to replace mortar joints, special care should be taken to ensure that the clay bricks are not damaged.

A more subtle resolution of the stepped portal frame was required (l). (see Figure 285) While some attention had to be paid to the gutter (m), purlin and girt detail (k) as discussed in "October: detail 2" on page 197.

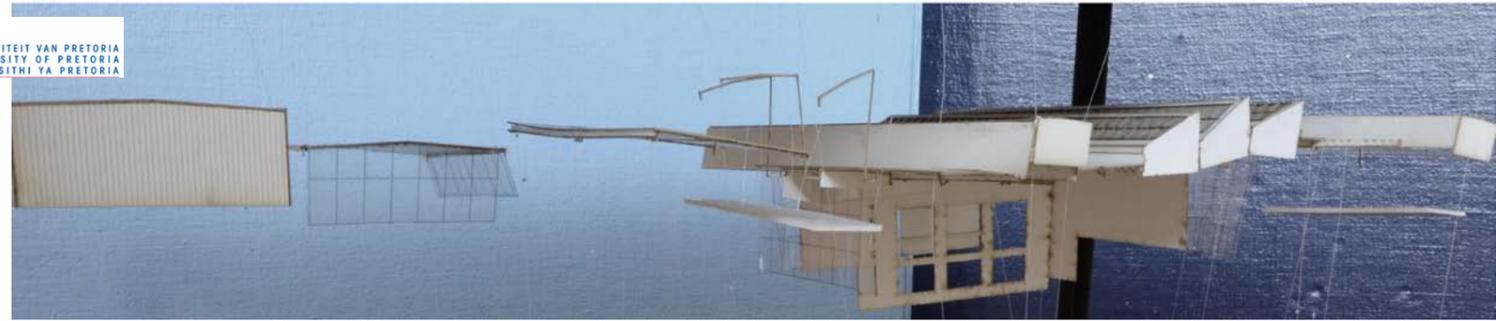
Figure 288: Model 1: suspended and exploded model - western elevation - new skins (Author November 2013)

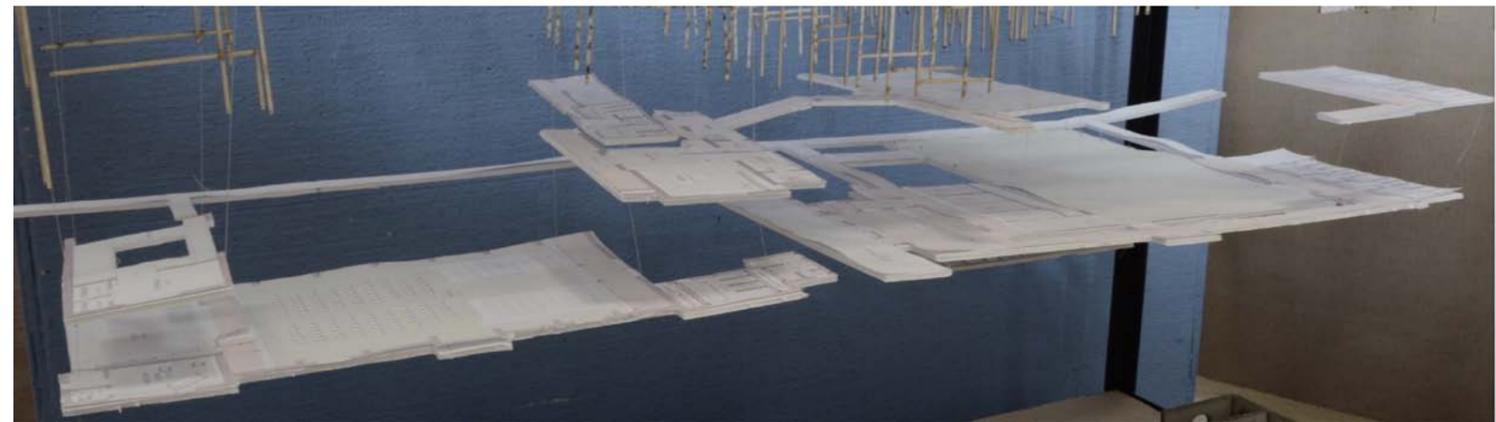
Figure 290: Model 1: suspended and exploded model - western elevation - new floors (Author November 2013)

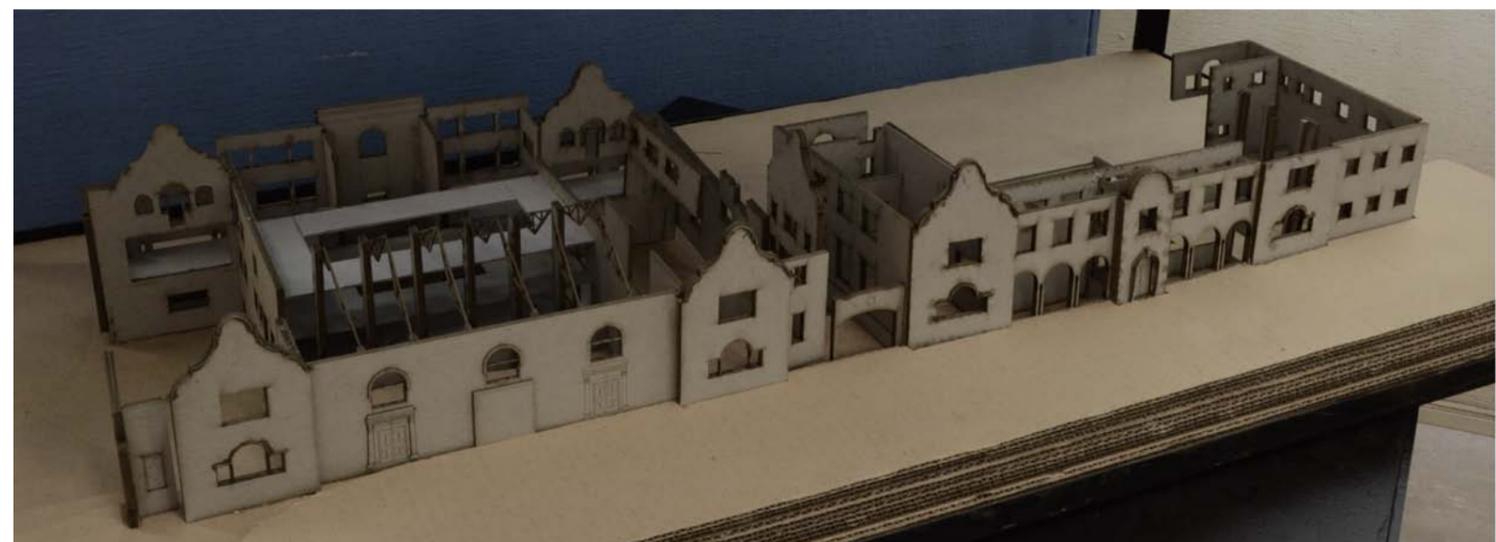
Figure 291: Model 1: suspended and exploded model - western elevation - existing structure (Author November 2013)
