REGENERATING BEREA PARK

[Design in pursuit of rekindling appropriation]

Submitted in partial fulfilment of the requirements for the degree of
Masters of Architecture, MProf(Arch),
Department of Architecture
Faculty of Engineering, Built Environment and Information Technology
University of Pretoria, South Africa

Programme:	Sport and recreational centre
Site description:	Berea Park Clubhouses, Berea Park neighbourhood, Tshwane
Site location:	Erf R/2375
Address:	600 Lillian Ngoyi Street
GPS Coordinates:	25° 75' 80.49" S , 28° 19' 39.31" E
Research field:	Heritage
Clients:	Department of Sport and Recreation South Africa Tertiary institution (Unisa or University of Pretoria) Individuals from the Berea Park neighbourhood
Keywords:	regeneration, belonging, heritage, adaptive reuse, sport, recreation
Premise:	Design in pursuit of rekindling appropriation

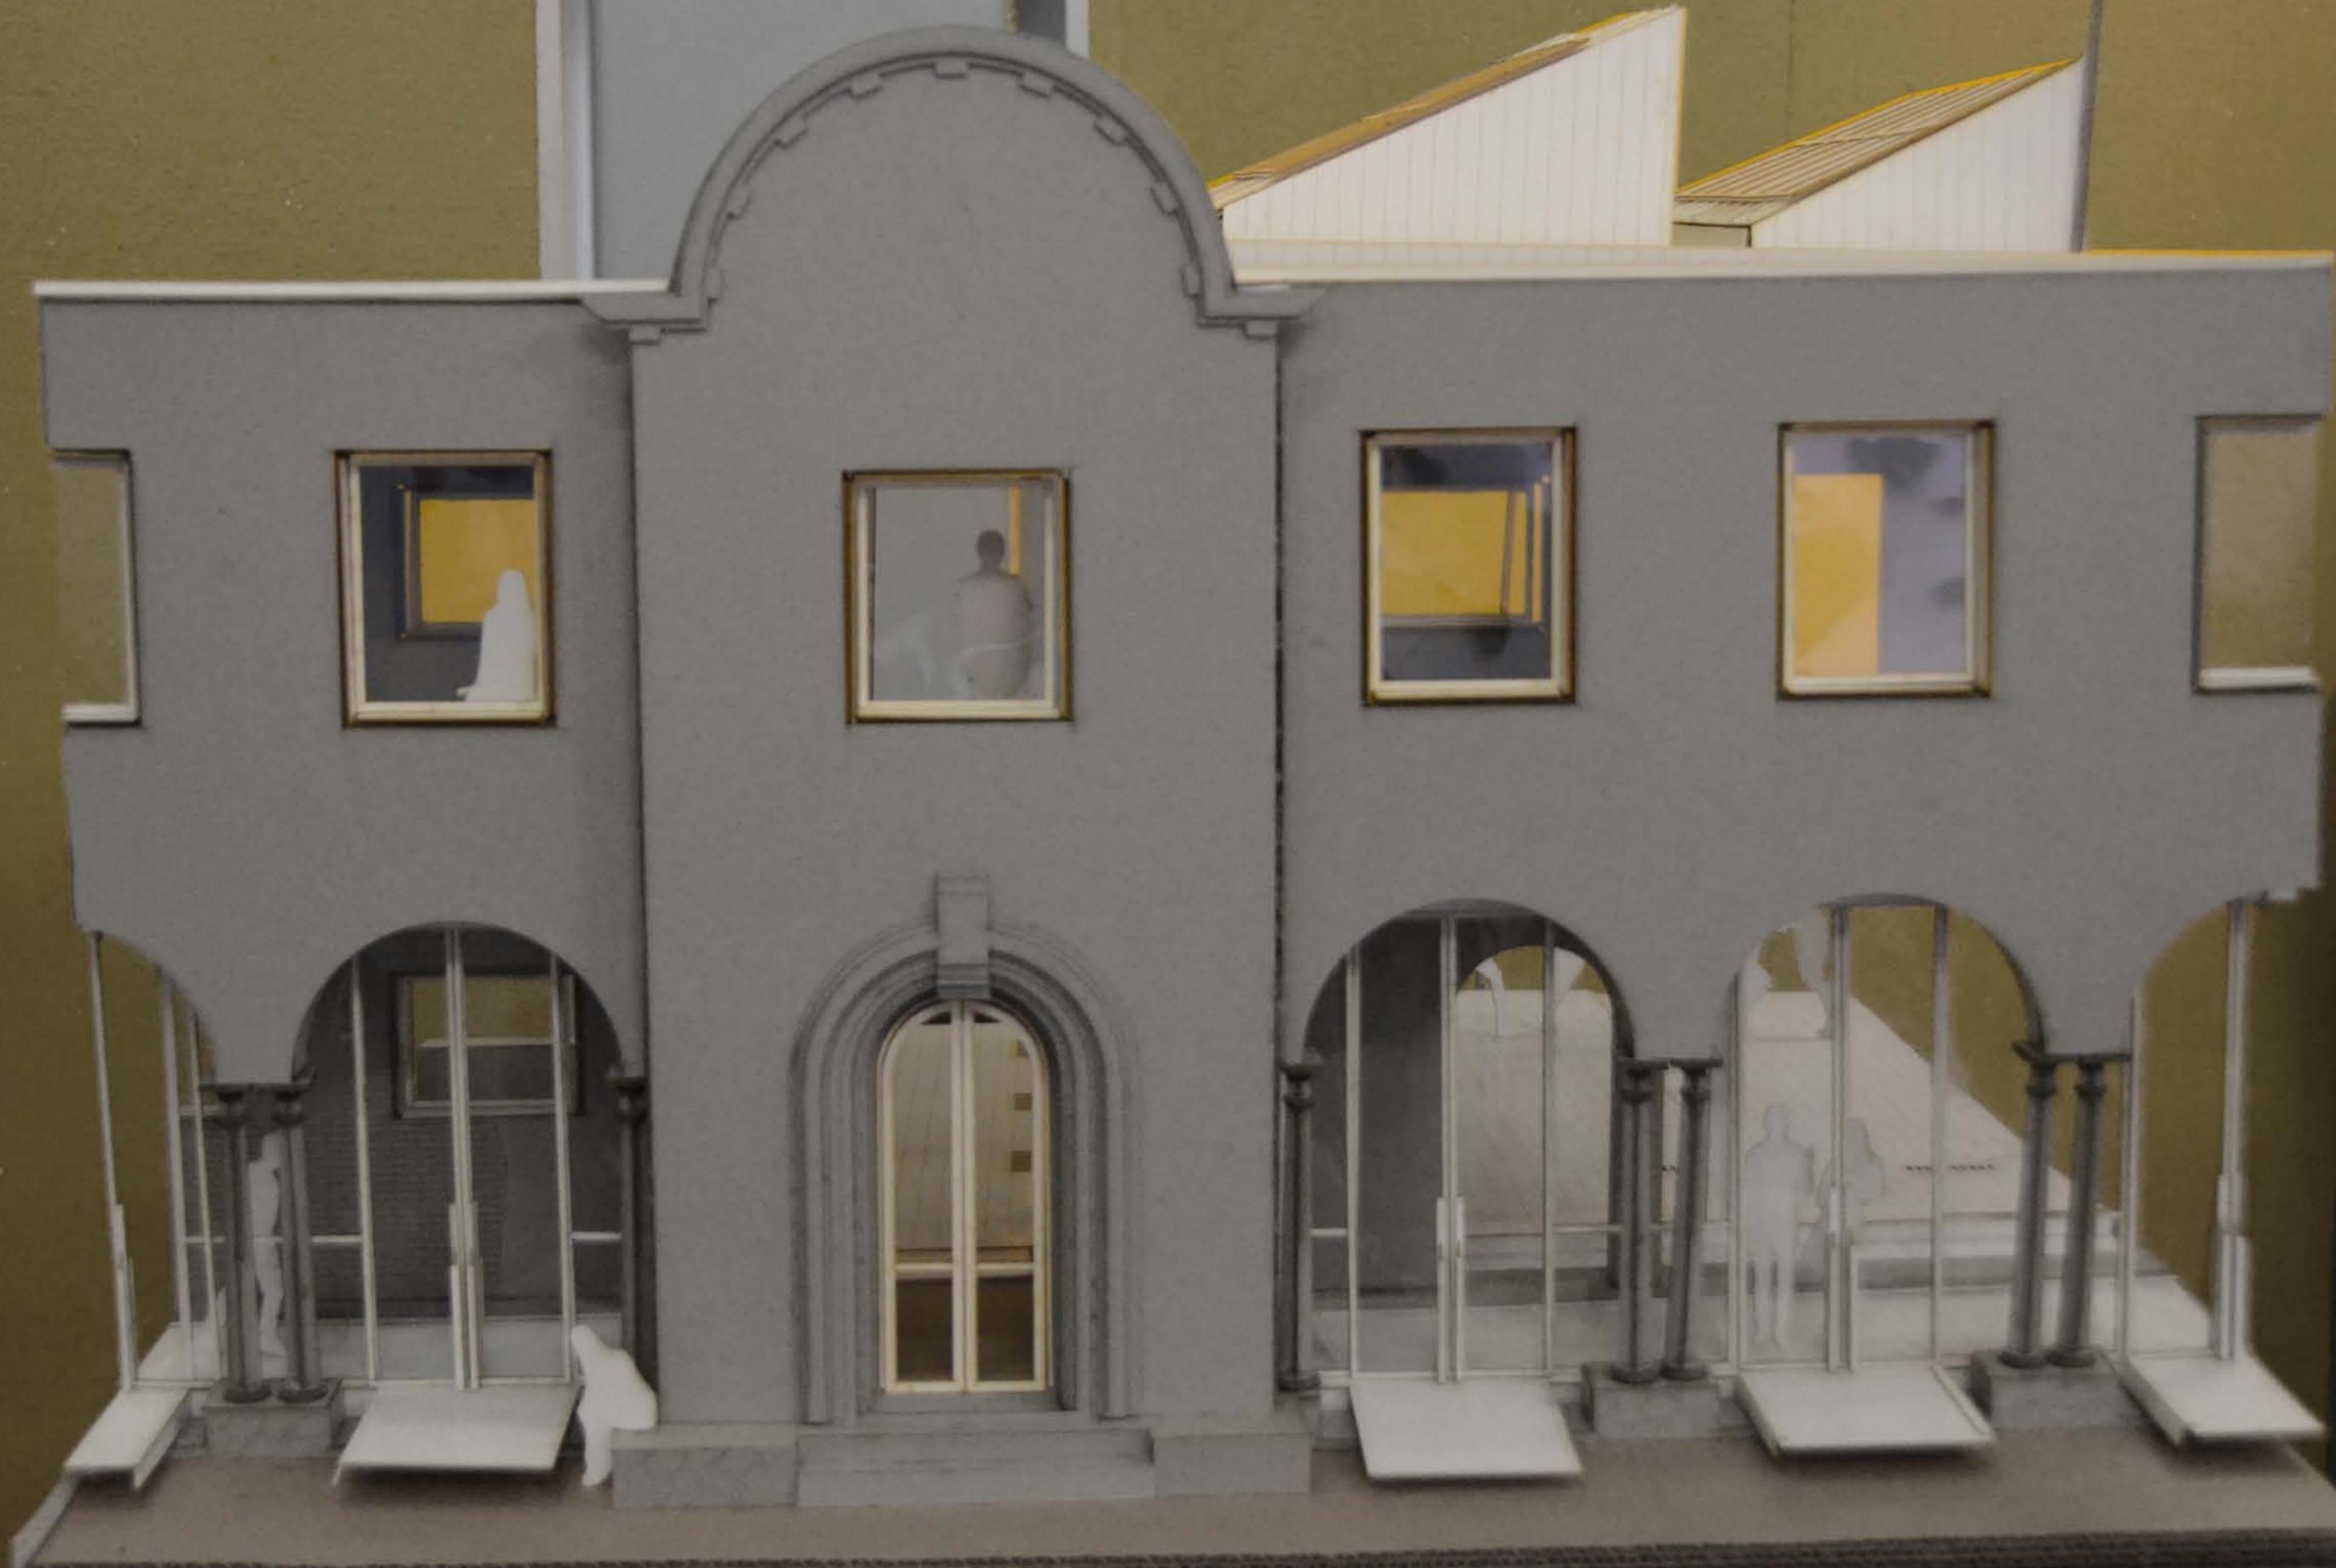
Figure 293: Model 2: detail model: central bay of western facade (Author November 2013)
