ELECTRON MICROSCOPIC OBSERVATIONS ON THE LUMINAL SURFACE OF TEAT CUP LINERS OF MILKING MACHINES USED UNDER SOUTH AFRICAN CONDITIONS

W. H. GIESECKE*, A. M. SPICKETT*, ANETTE M. DURAND*, J. J. VAN STADEN* and J. A. ERASMUS†

GIESECKE, W. H., SPICKETT, A. M., DURAND, ANETTE, M., VAN STADEN, J. J. & ERASMUS, J. A., 1984. Electron microscopic observations on the luminal surface of teat cup liners of milking machines used under South African conditions. *Onderstepoort Journal of Veterinary Research*, 51, 47-70 (1984).

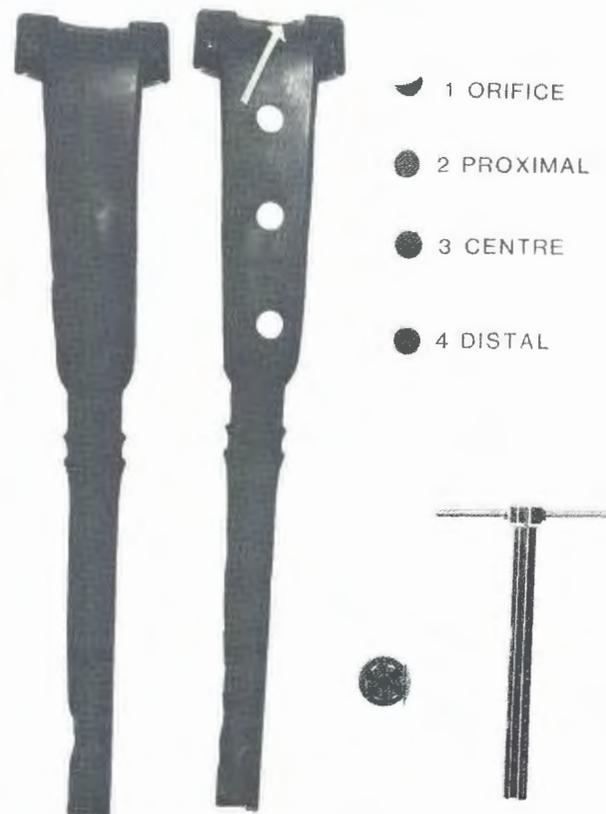
FIG. 1 Halves of teat cup liner (left not sampled; right sampled); sample No. 1 and 2-4 excised from orifice and respectively proximal, central and distal third of liner wall; cork borer; small sample bottle viewed through its bottom towards star-shaped portion of stopper

One half section of each liner was placed luminal surface up on a wooden board and sampled by means of a sharp cork-borer with a diameter of 13 mm. The excision was always performed from luminal towards peripheral surface. Four samples were excised from each of the halves, 1 each from the edge of the orifice, the proximal, central and distal third of the liner wall (Fig. 1).

Differences between liners were always evaluated from micrographs of the central portion (Fig. 1) of the liner wall.

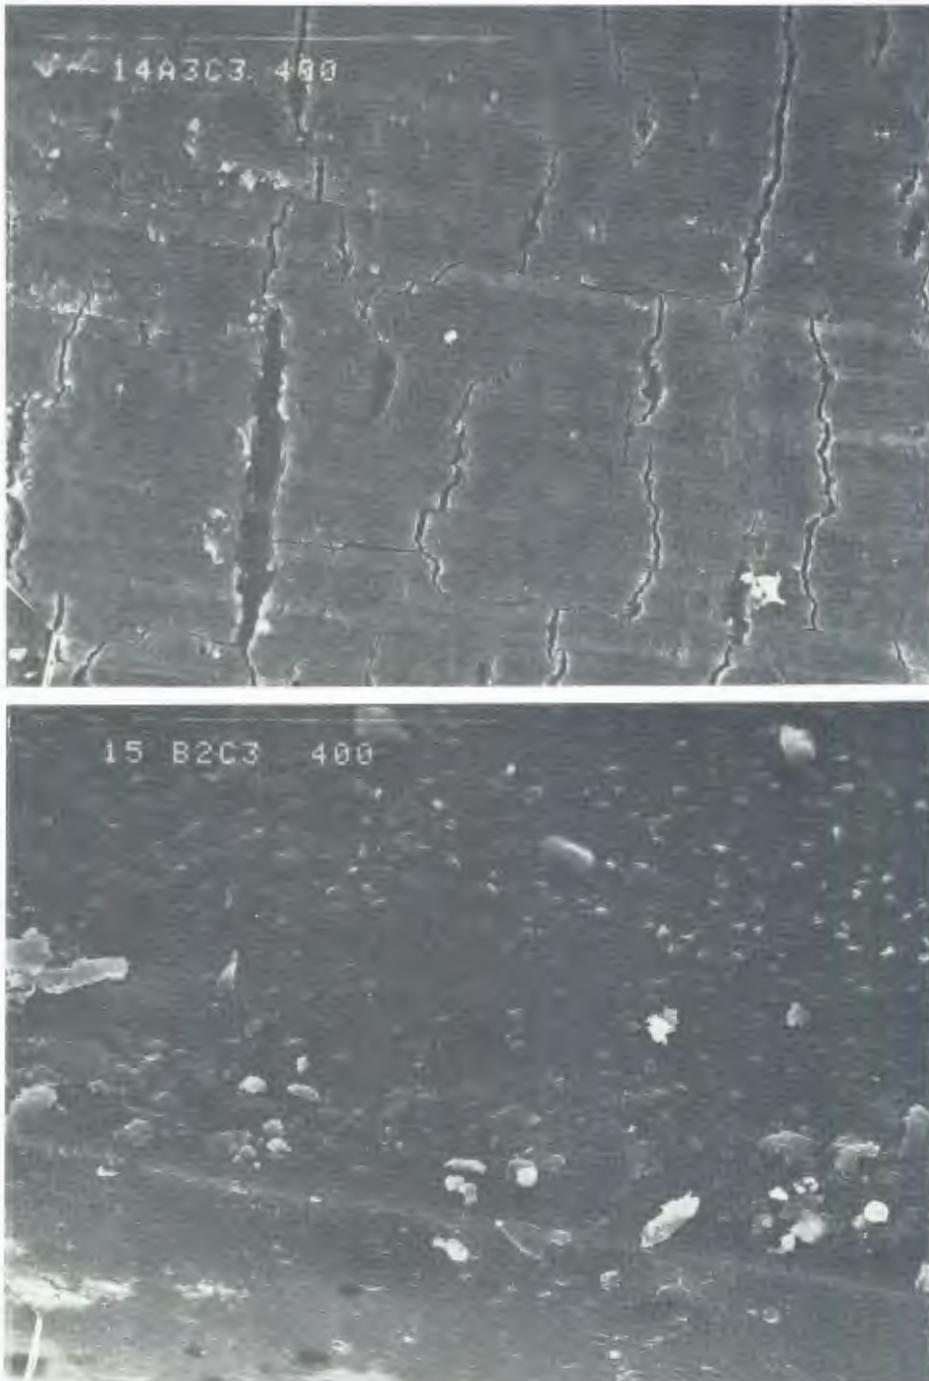
FIG. 4 Distributor controls 14A (top) and 15B (bottom) with 14A surface generally cracked, pitted and creviced, and 15B surface solid, though rather uneven, as examples of the condition of brand-new liners further investigated as farmer controls and used liners

The luminal surfaces of teat cup liners from different manufacturers sold during 1982 as brand-new show marked qualitative differences (Fig. 3 & 4).

It should be noted that liners 4A and 4B (Fig. 5), though apparently identical in make and model with those of liners 14A and 15B (Fig. 4), differed markedly from their respective distributor control.

The pitted, grooved and cracked surface of distributor control 14A already has been described (Fig. 4). Though the condition of its surface differed considerably at the orifice (Fig. 8, top) and the proximal (Fig. 8, bottom), central (Fig. 9, top) and distal third (Fig. 9, bottom) of its wall, all the parts showed distinct cracking and various other changes.

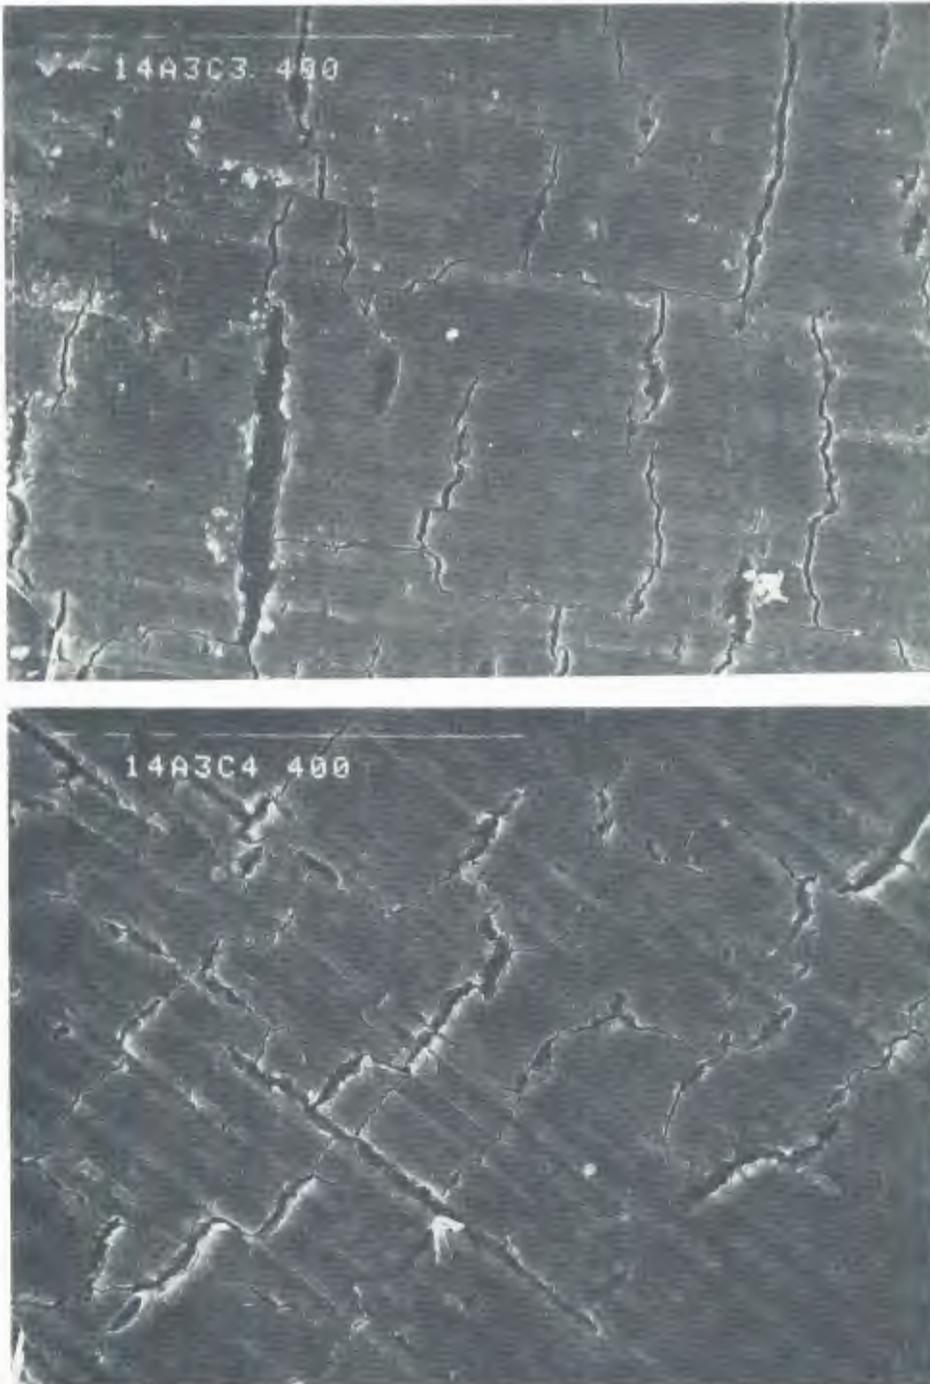
FIG. 9 The surface of the same liner (i.e. distributor control 14A; Fig. 10) investigated at central and distal third of liner wall
