# THE SIGNIFICANCE OF NON-MOTORISED TRANSPORT INTERVENTIONS: A CASE STUDY OF GREATER SEKHUKHUNE, LIMPOPO PROVINCE, SOUTH AFRICA

# **M MOKITIMI\*** and M VANDERSCHUREN\*\*

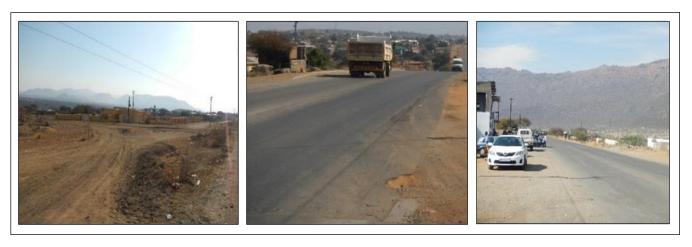
Fig. 3. Existing Road infrastructure and challenges along Link A1 and R555

Transport infrastructure is crucial to the development of any nation (DBSA: 2006). Sustaining an effective accessible road network in rural areas, like the study area, is a challenge (Greater Sekhukhune District Muncipality 2010). The study area is mainly characterised by gravel road, which showed to be rarely maintained through municipal programs. Fig 4 illustrates an example of the road conditions in the studies area which are in bad condition, filled with potholes and faded barrier lines

drop off user's at all demarcated origins and destinations stops. Public transport facilities are important not only to encourage the use of services, but also to stop problems related to spontaneous parking on the side of road. Existing road and pavement conditions on the two study routes are in a bad condition, with potholes and drainage issues due to poor design and maintenance.

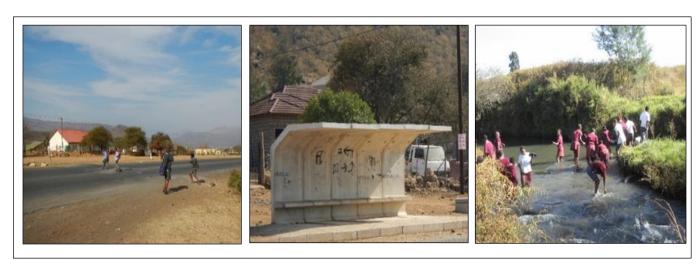
Fig. 4 Existing NMT infrastructure and challenges along Link A1 and R555

Pedestrian sidewalks that are supposed to serve the large amount of commuters travelling by foot are non-existent. The only provisions made are pedestrian crossings which need to be repainted and a few bus shelters constructed on the new link just off the A1. Another challenge for pedestrians in the area, predominantly school kids, is the lack of crossing bridges over the distributaries running through the community from the Steelpoort River, see Fig. 4.

The study found exiting pedestrian raised speed humps and zebra crossings. However all the crossings had faint road markings and with the majority not done according to the standard specifications. Poorly maintained roads constrain mobility, significantly increase accident rates, and aggravate isolation, poor health, poverty, and illiteracy in rural communities (Burningham and Stankevich 2005).
