# THE MODERN ROUNDABOUT – TRANSITION FROM RURAL TO URBAN ENVIRONMENT?

## ABSTRACT

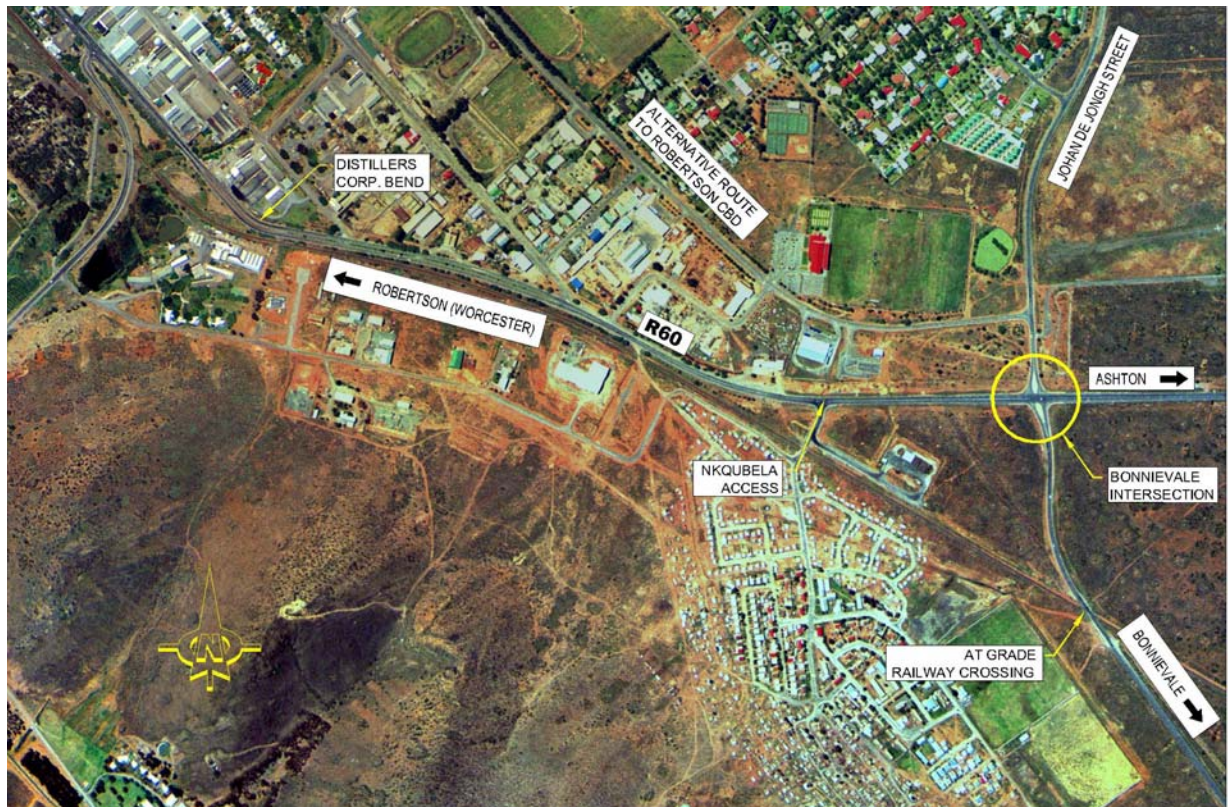
**FIGURE 1: General layout of study area**

together with the loading/off-loading of taxis are experienced on the R60. The second factor is the sharp bend outside Distillers Corporation, approximately 1 450 metres to the west of the Bonnievale intersection (see Figure 1).

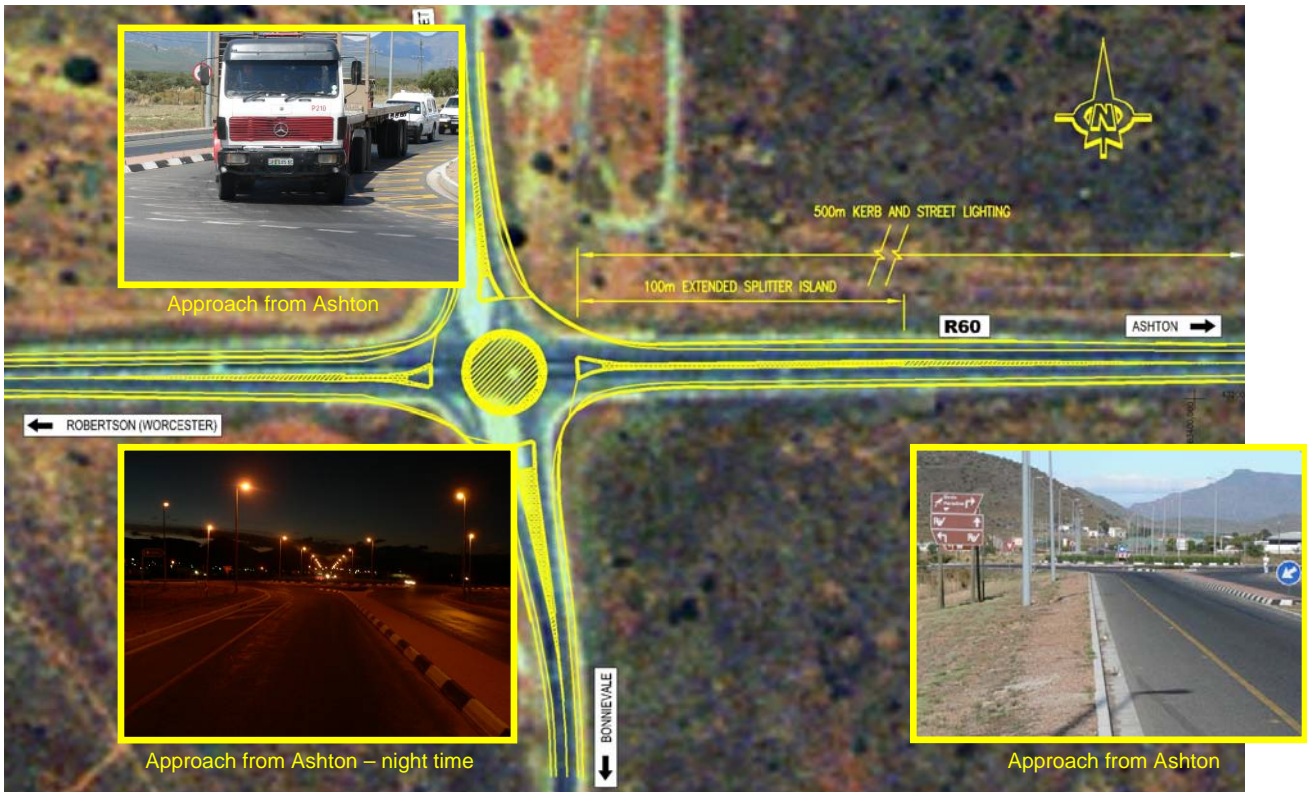
The Bonnievale intersection is the first intersection within the Robertson municipal boundary, which prior to the construction of the roundabout was a priority controlled intersection with priority given to traffic on the R60. Figure 2 shows the layout of the roundabout.

**FIGURE 2: Roundabout at Bonnievale intersection**

On the approach from Ashton, the path of vehicles entering the roundabout did not follow the yellow edge line provided for guidance. Vehicles were cutting across the yellow line (visible on the top photo insert on Figure 2). The survey revealed that the yellow line has not been painted according to the design. The design yellow line would have been in the correct position for the observed vehicle travel path. It must be noted that the normal design standard of the kerb defining the inside line of the entry into the roundabout was deviated from in order to cater for the shoulder on the approach.
