HEAVY VEHICLE SIMULATOR (HVS) EVALUATION OF LOAD TRANSFER EFFICIENCY AND CONTINUOUSLY REINFORCED CONCRETE INLAYS ON THE N3 NEAR PIETERMARITZBURG

The paper addresses two different HVS studies conducted on concrete: (1) load transfer through aggregate interlock and the use of dowels, and (2) the evaluation of the performance of an in-service continuously reinforced concrete inlay on National Route 3 near Pietermaritzburg.

For the second HVS study, the residual life of an existing CRCP inlay was determined. The asphalt on the slow lane on a steep uphill section of the National Route 3 near Pietermaritzburg was milled and replaced with a 180mm of CRCP inlay in 1998. The inlay design was based on an anticipated 6 million equivalent 80 kN axles over five years, and it was envisaged that a concrete overlay would subsequently be placed over the full width of the road at the end of this period. However, at the end of six years, only approximately

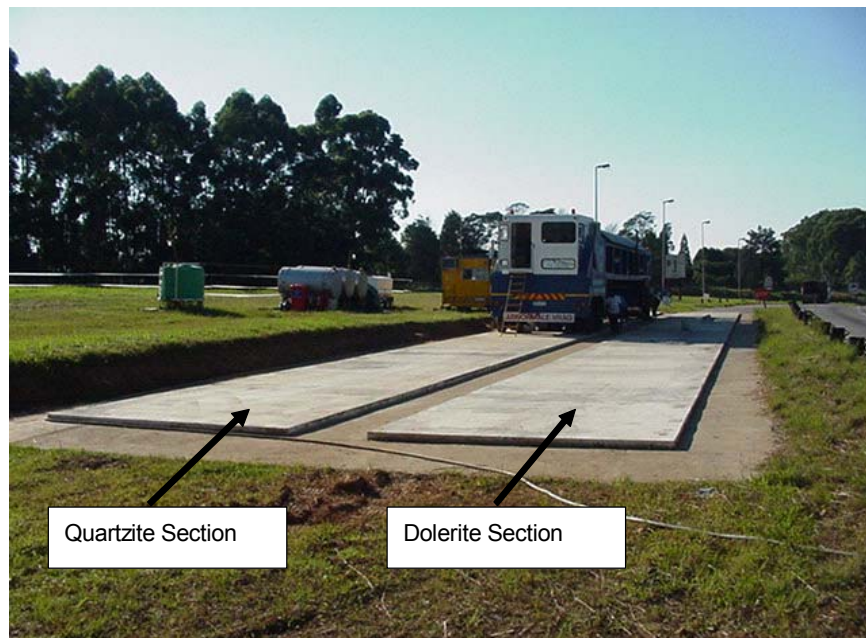
The scope of the accelerated pavement-testing programme was limited to the investigation of doweled and plain jointed 3.5m x 4.0m x 150mm thick slabs with both 19mm dolerite and quartzite stone. In order to evaluate the relative contribution of these variables to joint behaviour and thus to performance of the pavements, the test sections were constructed on top of three 150mm layers of natural gravel with in situ CBR of 15 (Brink 2004). The test site is shown in Figure 1.

Figure 1. General view of the test site.

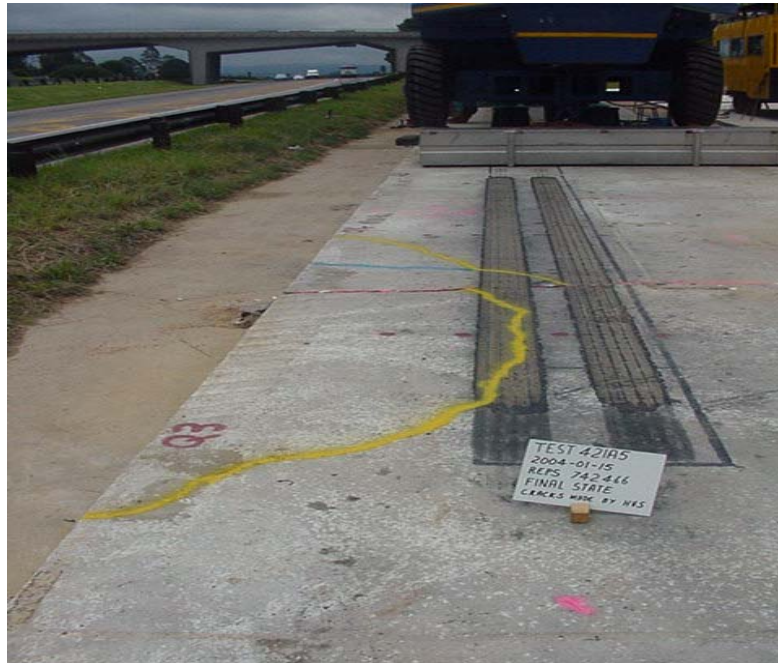
Figure 2 shows the typical crack pattern that had developed by the end of the HVS test. The transverse joint is indicated in a reddish colour while the cracks that developed later are indicated in yellow and blue, the blue being a crack that developed at the very beginning of the testing. The crack pattern indicates a bigger void under the leave slab than under the approach slab. This void was as a result of pumping (as shown in Figure 3), where pumped material is more prominent at the side of the leave slab.

Figure 2. Crack pattern at the end of the test on the undowelled dolerite section.

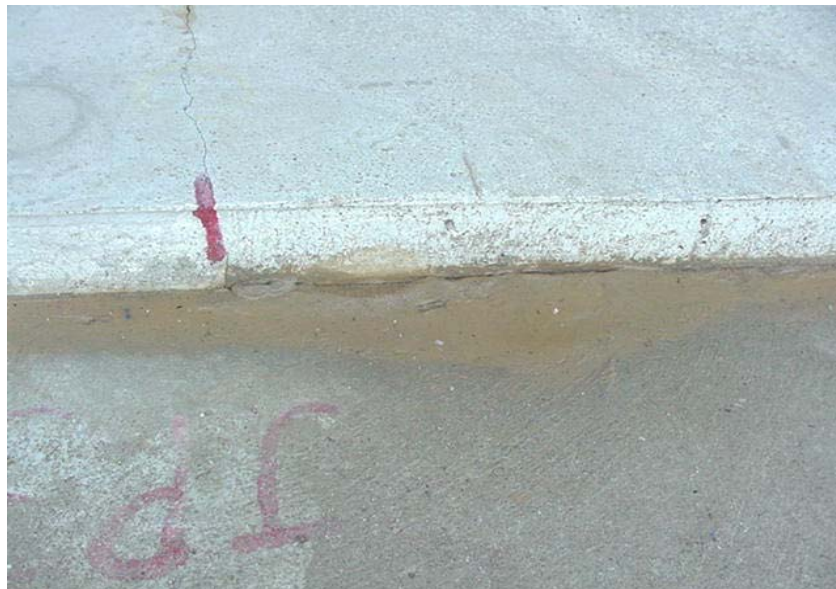
Figure 3. Pumping from under the leave slab, the right hand side of the crack.

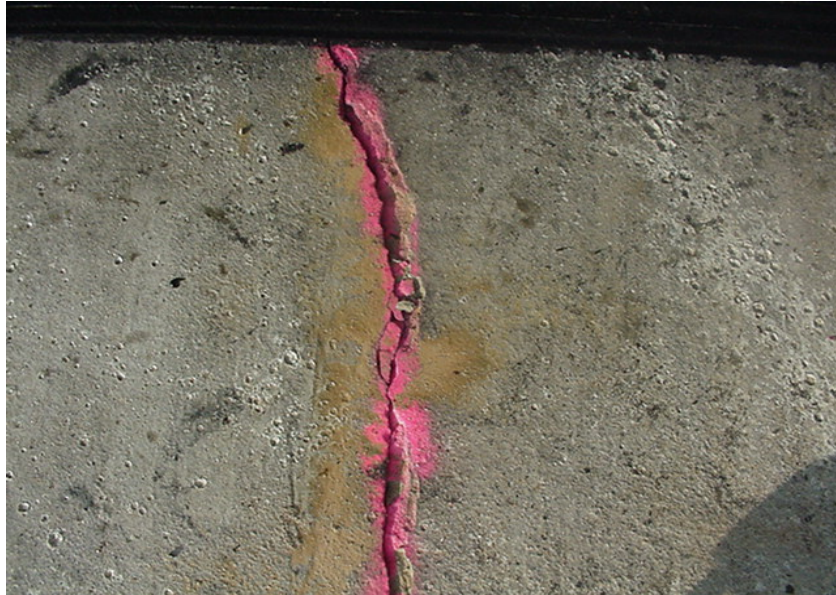
Figure 4. Spalling of a crack as a result of relative vertical movement and pumping.

As a result of the void and thus larger relative vertical movements at the joint and the cracks, spalling as shown in Figure 4 occurred. For greater detail on the sequence of distress at each test, reference is made to the first-level-analysis report (Brink and du Plessis, 2004).

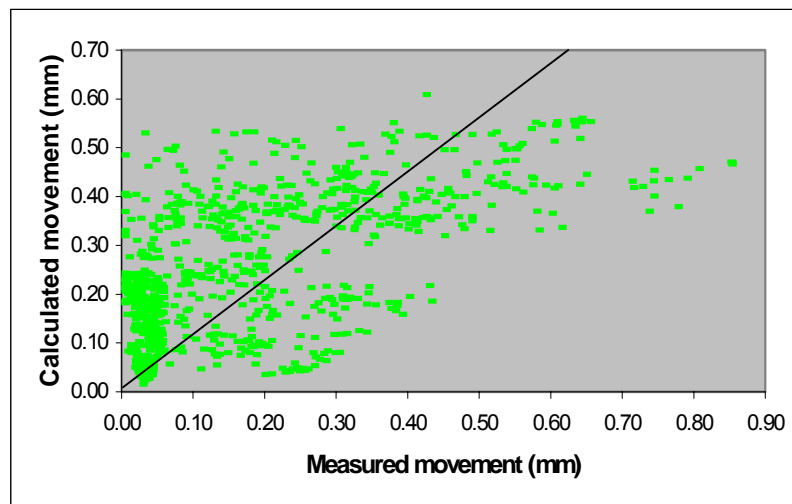
The calculated crack widths do not render the same reliable relative vertical movement at the crack under HVS loading (equation 11) as do the measured crack widths (equation 10). Note that the slab thickness, the humidity and the rainfall were not significant (did not contribute to an improved R^2) or the coefficients did not make engineering sense. Accepting that equation 10 depicts the best relationship between relative vertical movement and crack width, a plot of the measured relative vertical movement versus the predicted values can be compiled and is shown in Figure 6 below.

Figure 6. Calculated versus Measured Relative Vertical Movements under 40 kN HVS loading.

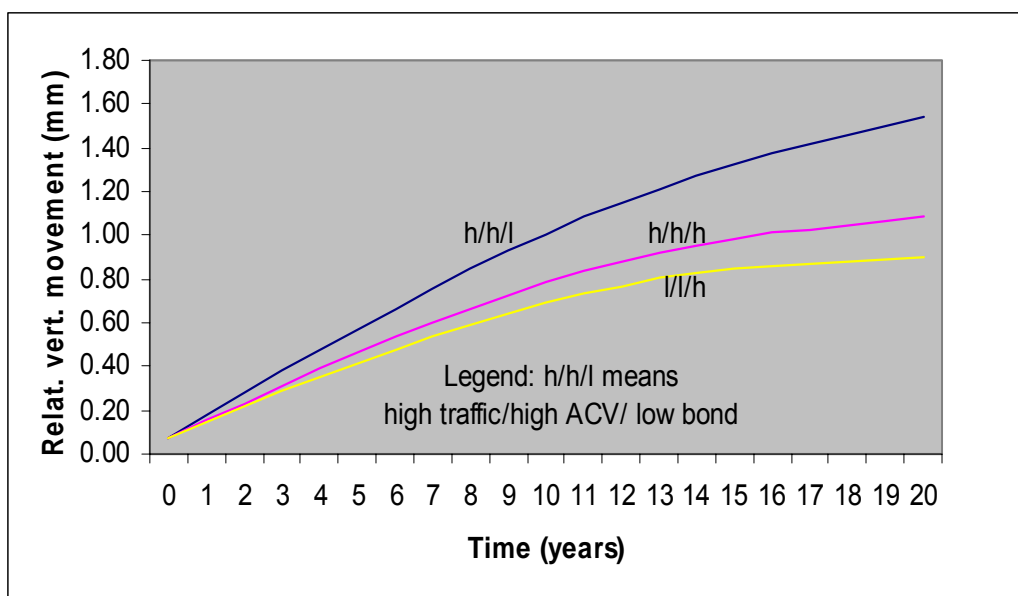
Equation 12 was used to calculate relative vertical movement at a joint as a function of time, taking into account traffic loading, the ACV of the stone and the bond between the subbase and the slab. The three cases that were considered and which are shown in Figure 9, are the following:

1. a traffic load of 20 million E80's using a stone with an ACV of 25 and with very little bond between subbase and slab;
2. a traffic load of 20 million E80's using a stone with an ACV of 25 and with high bond between subbase and slab.
3. a traffic load of 5 million E80's using a stone with an ACV of 15 and with very little bond between subbase and slab,

Figure 9. Calculated relative vertical movement as a function of time, traffic loading, ACV of the aggregate and bond between subbase and slab in a dry, hot climate.

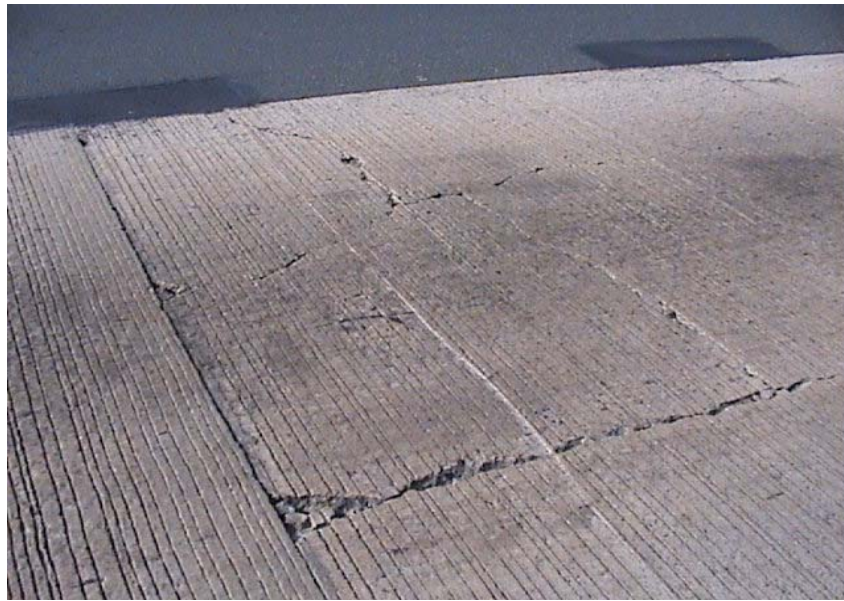
to the development of punch-outs as typically experienced on the CRC inlay. Figure 11 shows the most likely location where a punch-out is to be expected, namely at a construction joint where closely spaced and erratic cracking occurs at a permeable edge joint between the concrete inlay and the adjoining flexible pavement. The cracks are normally associated with relatively poor concrete, possibly caused by segregation, excessive fines, excessive water in the concrete or adverse environmental conditions during construction. As soon as the cracks start showing spalling, relative vertical movements occur under a wheel load moving across the cracks, initiating a loss of load transfer and a loose block develops as shown in Figure 12. This is defined as a punch-out since the block will become loose and create a safety hazard. Figure 13 shows the development of a longitudinal crack down the middle of the travelling lane as a result of a combination of a loss in slab support at the edge of the pavement and wheel loading close to the edge of the inlay.

Figure 11. A cluster of cracks at a transverse construction joint and an open edge joint.

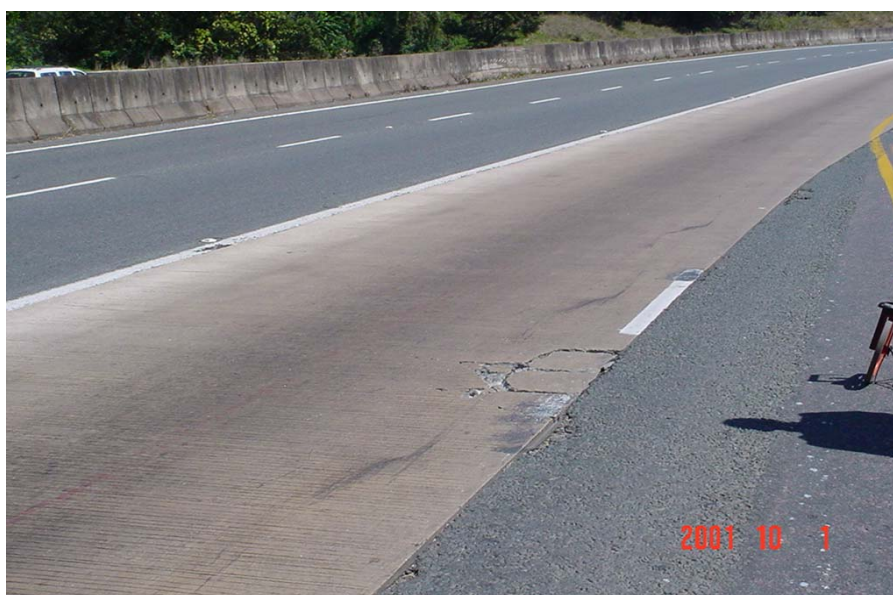
The CRC inlay was designed to carry 6 million equivalent 80kN (E80) axle loads and several punch-outs had occurred after approximately 7 million E80 axle loads. Figures 11 to 13 illustrate the type of distress encountered on the pavement which was found to lead

Figure 12. A cluster of cracks, an open edge joint and edge loading lead to a punch-out.

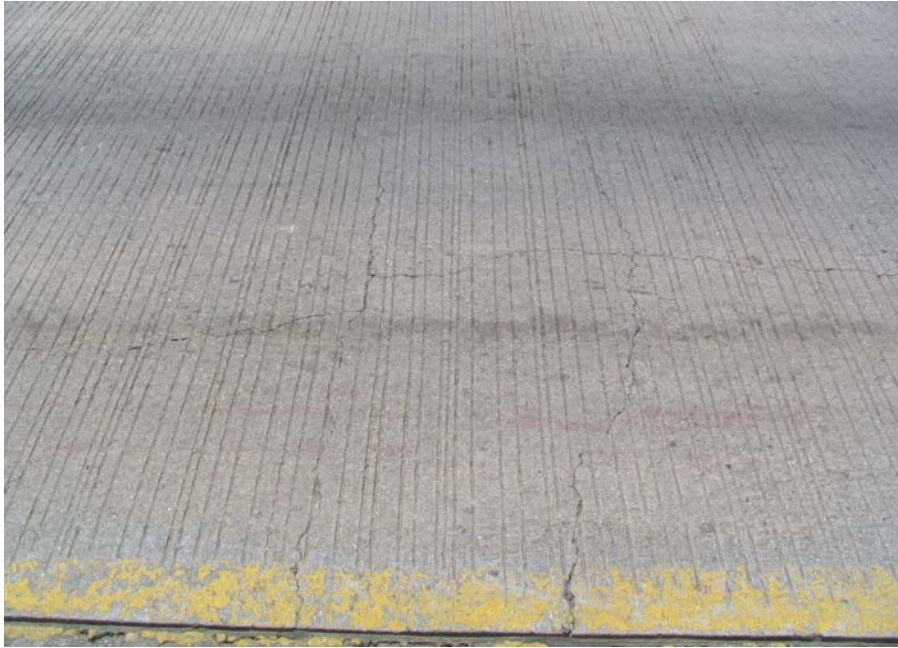
Figure 13. Longitudinal cracks at clustered transverse cracks can lead to punch-outs.

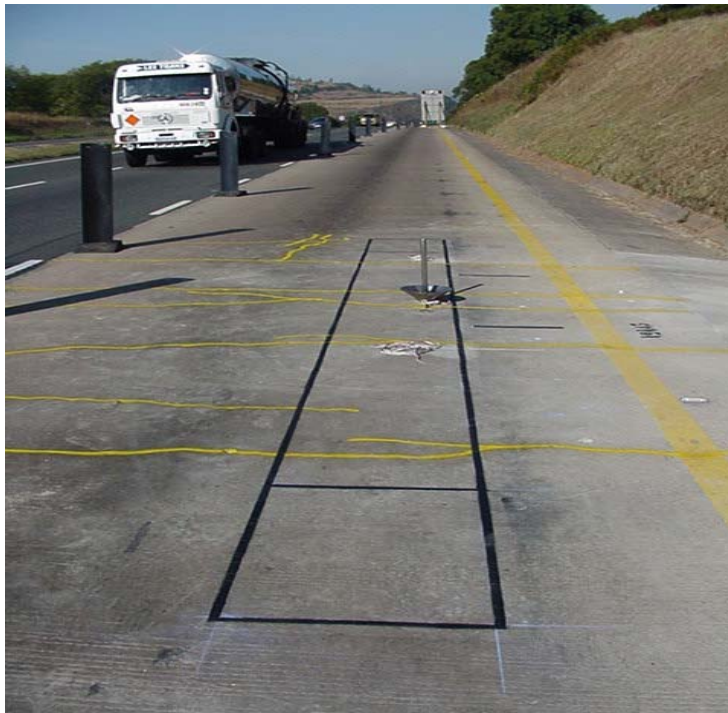
In order to obtain an indication of remaining life, a section was selected for testing with the HVS in a location where the existing crack pattern suggested the potential of a punch-out developing. As shown in Figure 14, cracks occur in a cluster with some secondary cracking already occurring – suggesting the possibility of imminent failure.

Figure 14. Test site for HVS testing.

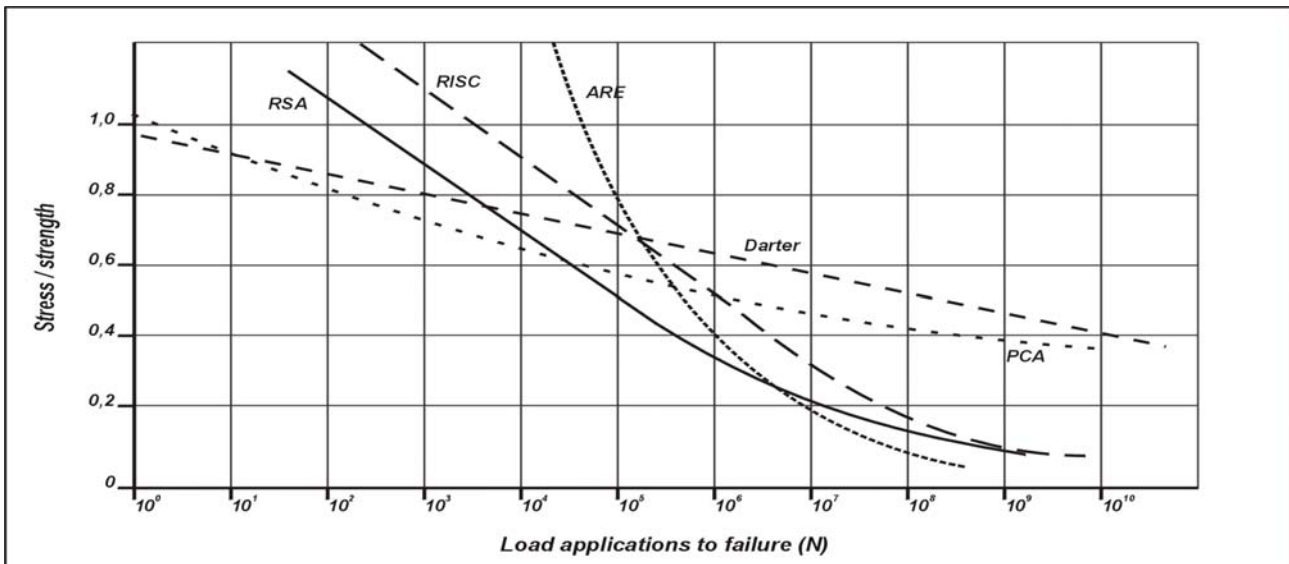
Both the RISC (Hilsdorf and Kesler 1966) and ARE (Treybig et al. 1977) curves are based on AASHTO data, the first assuming a terminal serviceability index of 2.0 and the second (ARE) a terminal serviceability of 2.5. Referring to *a* and *b* in equation 1 above, the value of *b* for the RISC data is 4.3 and that for ARE 3.2. The value for *b* of the RSA curve also is 4.3, but the difference between the RSA and RISC curves is the value of *a*. Darter (1977) carried out laboratory beam fatigue tests to produce the curve in Figure 15 which is similar to the findings of other laboratory studies. The performance curve used by PCA (Portland Cement Association 1984) is also illustrated in this figure and is used, in similar format, for design procedures in Australia and Canada.

Figure 15. Load applications to failure as a function of the maximum stress in the pavement and the bending strength of the concrete.

The curves defined as RISC and ARE in Figure 15 were all developed from field data as opposed to the Darter curve which was based on laboratory studies. Initially the program cncRisk (Strauss et al. 2001) was based on the RSA curve, but with data subsequently obtained from concrete pavements presently under traffic in South Africa, a value for b closer to 4.5 was found. This implies a curve with a slope slightly flatter than the RSA curve indicated above and closer to the PCA curve which has a b value of 15.

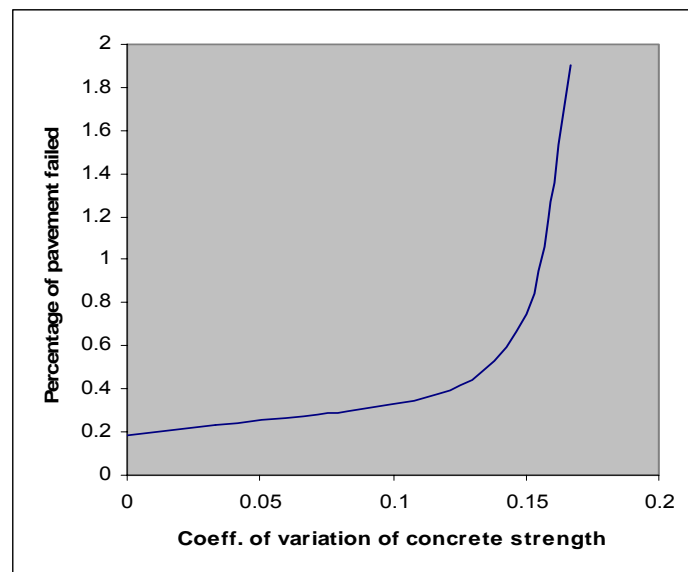
The effect of variable concrete strength on the development of punch-outs can be illustrated by a plot, shown in Figure 16, of variation in concrete strength versus percentage of inlay failed after 7 million equivalent load applications. The mechanistically-based design program cncPave, which uses variation in input parameters to predict the area failed through Monte-Carlo simulations, (Strauss et al. 2001 and 2004) was used to develop the curve. The area failed was calculated assuming an absolute maximum value for concrete strength likely to be attained in the field and the coefficient of variation for concrete strength was allowed to increase from 0 to a value of 0.17. Figure 16 clearly illustrates the importance of uniform concrete in the construction of inlays. It is also clear that a coefficient of variance in concrete strength above 0.15 implies a high risk of punch-outs occurring.

Figure 16. The effect of a variation in concrete strength on the development of punch-outs.
