# TOWARDS A BETTER UNDERSTANDING OF MODERN ROUNDABOUTS

A recent survey of 37 roundabouts in the Western Cape has confirmed that there is a lack of application of design standards and an inconsistent approach to the design of roundabouts. This inconsistency applies to both single- and multi-lane roundabouts in urban and rural areas.

The purpose of this paper is twofold: to highlight what are some of the elements of the roundabouts that could be contributing to the perception relating to safety and to increase the designer's awareness of the interacting nature of the different design elements. These elements will be compared to design guidelines developed in several countries including Australia, Germany, United Kingdom and United States of America.

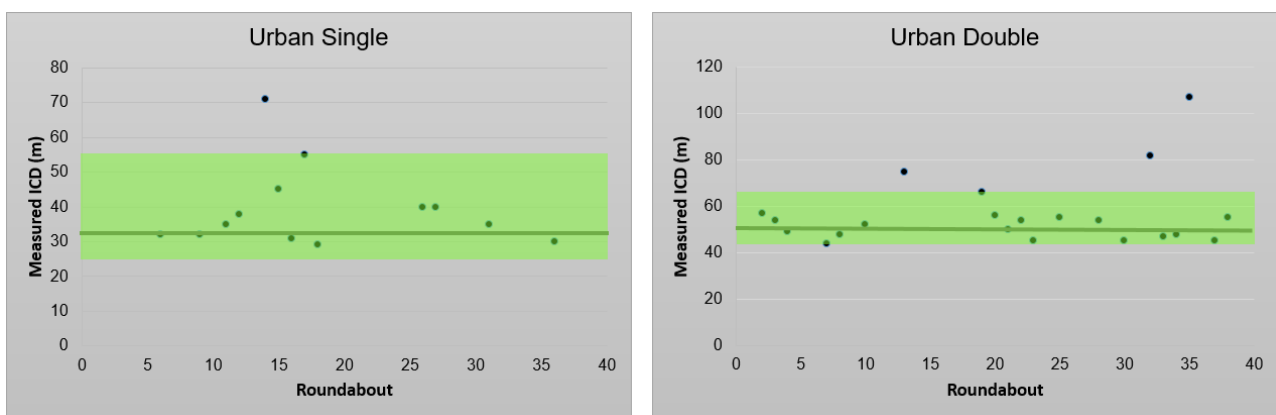
Figure 1: Inscribed Circle Diameter (ICD)

### a. Inscribed Circle Diameter (ICD) (Figure 1)

A minimum and maximum ICD for single and double lane roundabouts were identified from international literature and are shown as a green band. The data collected indicates that most of the ICDs fall within this range. The roundabouts where the ICD is larger than the maximum, were constructed before the advent of the modern roundabout. International guidelines suggest that the ideal size is on the lower end of the range, reflected by the green line.

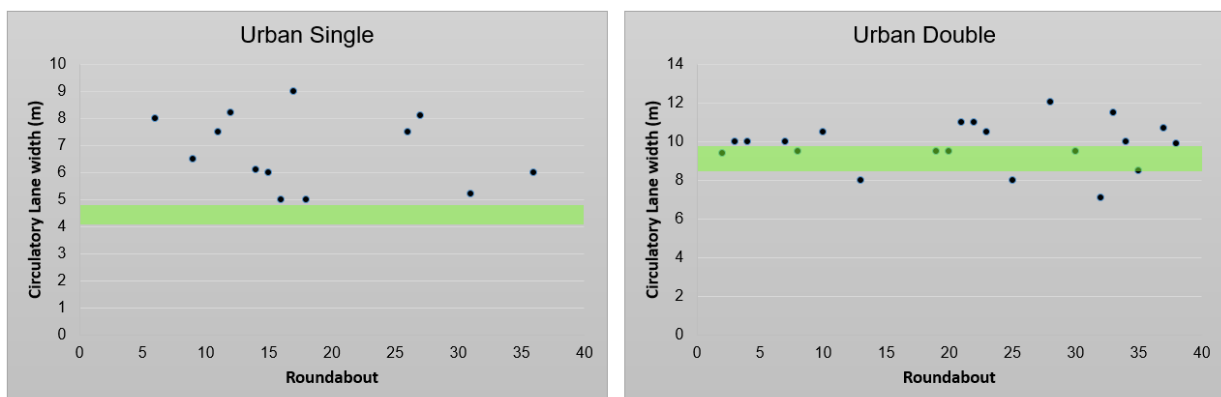
Figure 2: Circulatory lane widths

### b. Circulatory roadway width (Figure 2)

The range of the values that were measured varies significantly. For single lane roundabouts, the observed widths are mostly wider than the internationally recommended width (green band). For double lane roundabouts, there is a similar trend although there is less variation in the width and generally there is a smaller deviation from the international norm. It is important to note that the circulatory lane widths exclude the truck apron width, where such an apron has been provided.

It is clear that, at most of the roundabouts assessed, the sizing of the circulatory lane is problematic.

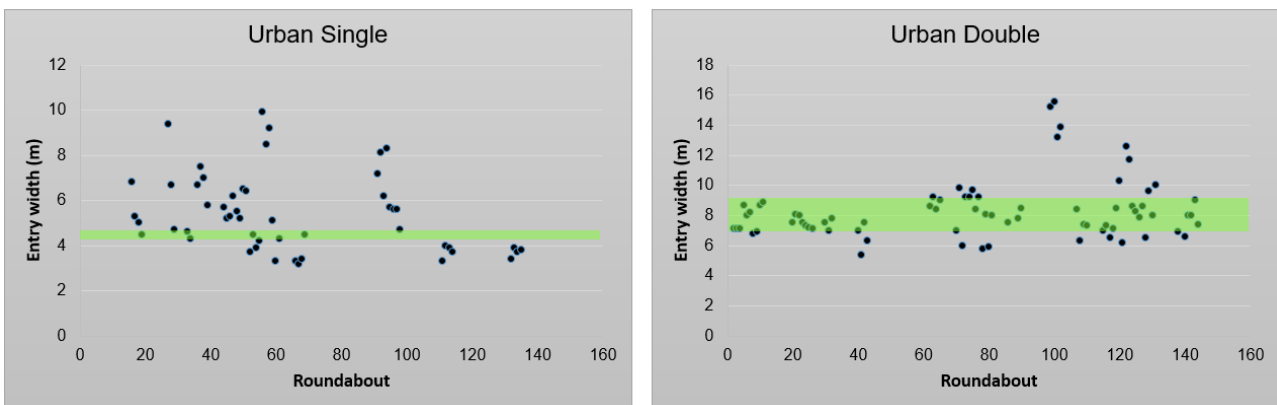
**Figure 3: Entry width**

**c. Entry lane width (Figure 3)**

The range of values that were measured, varies significantly. The widths are much wider than the international best practice. This contributes to faster speeds through the roundabouts. The acceptable range according to international guidelines are indicated within the green bands.

It is notable that many of the measured entry widths at single lane roundabouts are too wide. There is also evident at the double lane roundabouts, but not to the same extent.

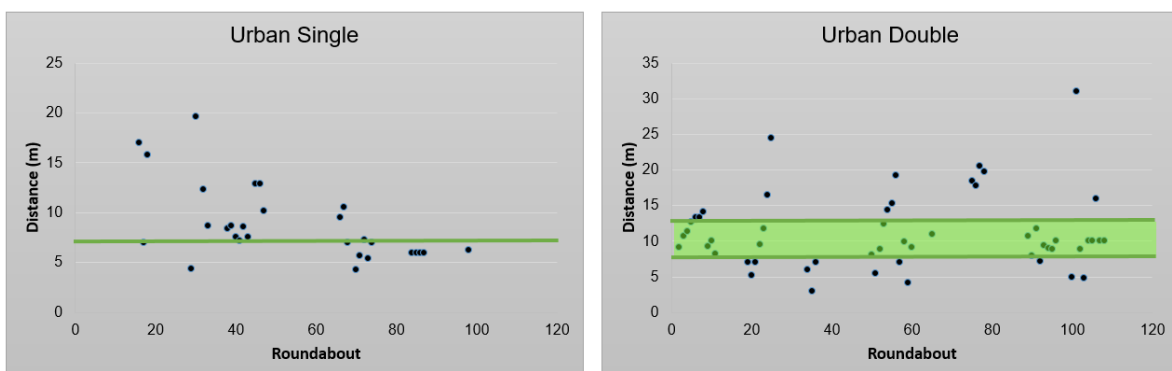
**Figure 4: Pedestrian crossing set back from yield line**

**d. Pedestrian crossing position before yield line (Figure 4)**

This is a critical element in terms of the safety of pedestrians. The correct placing of the pedestrian crossing will also encourage pedestrians to use the pedestrian crossing rather than to cross at other uncontrolled locations (including through the central island).

International guidelines indicate that a pedestrian crossing should be between one and two car lengths behind the yield line, as shown by the green band. There is no consistency in the placing of the pedestrian crossings and many of the crossings are placed too far away.

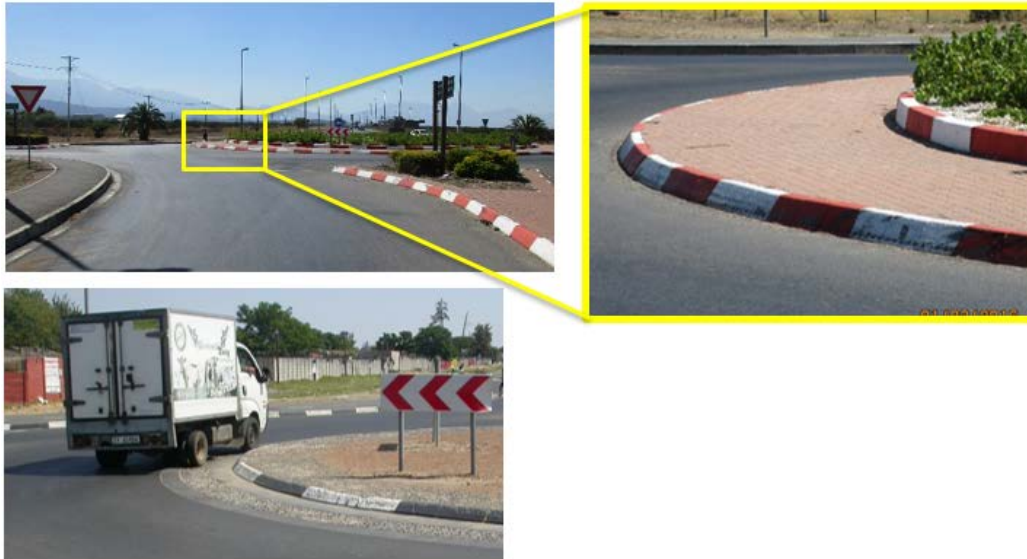
**Figure 5: Truck apron not serving the purpose of design**

The widths measured vary greatly. At the roundabouts where there are no truck aprons, the circulatory lanes are wide enough to accommodate larger vehicles. These roundabouts tend to have higher than acceptable theoretical fastest path speeds and under low volumes could experience too high speeds. The latest international guidelines suggest that the minimum width for a truck apron should be 2 m. Many of the truck aprons observed were not functional for the purpose they are designed for. Below are a few illustrations of inappropriate design and reasonable designs of truck aprons.

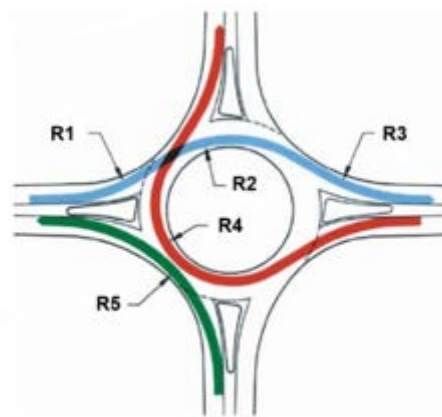
**Figure 8: Fastest Path**

The *theoretical fastest path* is the smoothest, flattest path possible for a single vehicle to travel through the roundabout, in the absence of other traffic and ignoring all lane markings in the roundabout.

For this paper, only the fastest path for through movements are reported. The speed is based on the radii at R1 (entry), R2 (Mid-point) and R3 (exit).

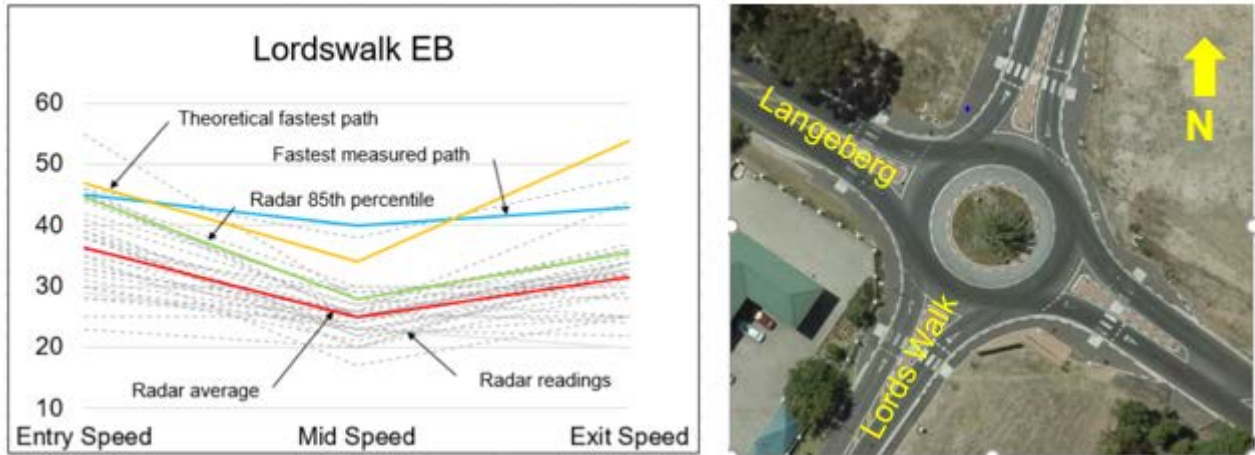
**Figure 9: Langeberg/Lords Walk Roundabout**

- i. This roundabout is considered one of the better constructed roundabouts with the theoretical fastest path achieving a design speed of 30 km/h.
- ii. The fastest measured path through the roundabout is also located within the limits of the recommended design speed.
- iii. The results of the speed gun measurements show that most drivers operate at or below the theoretical speed.

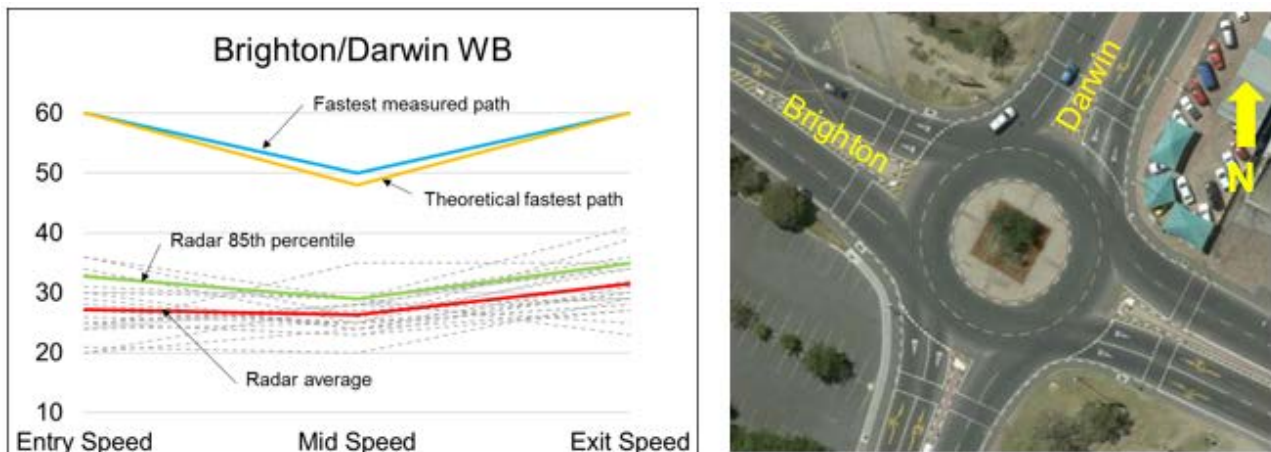
**Figure 10: Brighton/Darwin Roundabout**

- i. The speeds that could be achieved based on the theoretical fastest path show that at this roundabout the upper limit of the recommended design speed (40 km/h) for a double lane roundabout is exceeded and this is confirmed by the actual measured speeds. It is interesting to note how close the actual measured speeds are to the theoretical fastest path speeds.

- ii. The results of the radar gun speed measurements show that during daytime the typical speeds are well below (50%) the theoretical and measured fastest path. This is surprising however, it can mostly be explained by the high traffic volumes. It was difficult to identify any vehicle whose travel speed through the roundabout was not influenced (by varying degrees) by other traffic.

- iii. There is minimal deflection on the approaches at the entry into the roundabout, and without traffic and ignoring lane discipline, one can drive through the roundabout without significant deviation.

- iv. Although possible to drive through the roundabout at high speeds this is generally not the case. During the daytime drivers tend to use the roundabout safely. Even at night time when the average readings are between 5 to 10 km/h higher, the maximum measured speeds were still significantly lower than the theoretical speeds.

- v. During the day, the measured speeds at the entry and exit points, which coincides reasonably well with the position of the pedestrian crossings, are acceptable for the promotion of safe pedestrian movement.

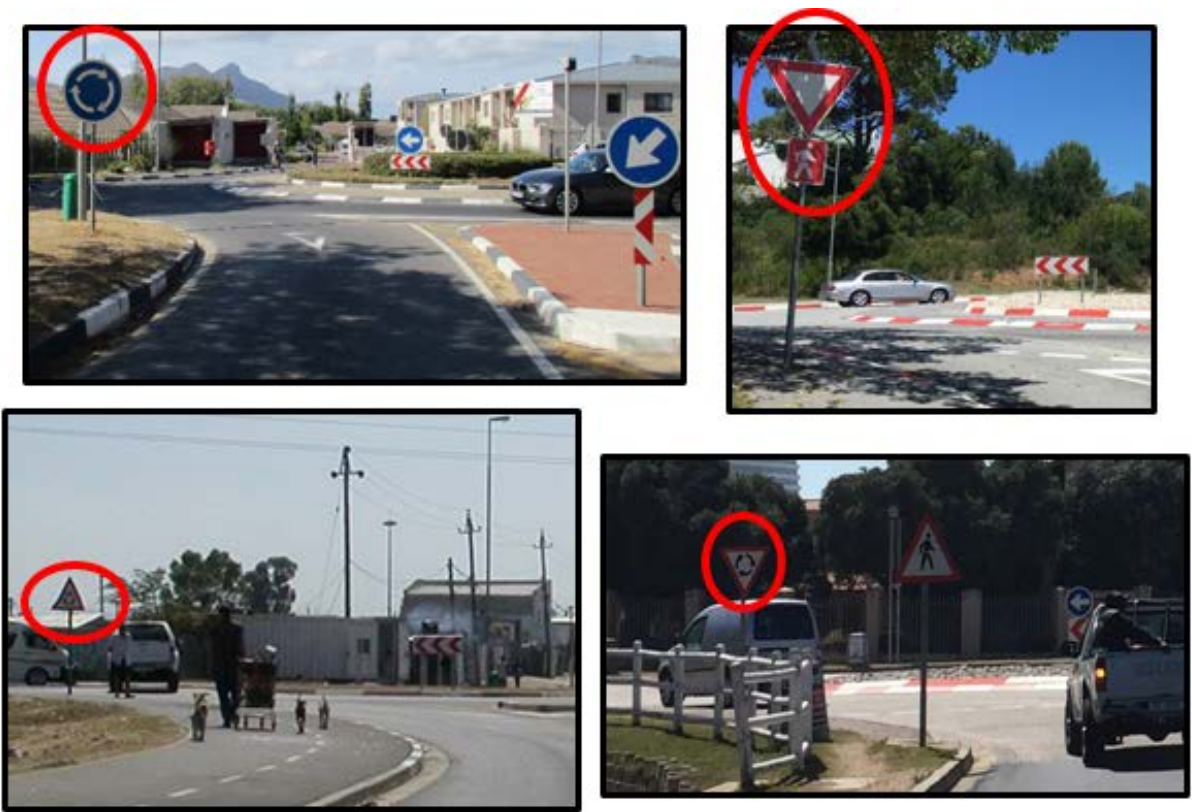
**Figure 12: Difference in signage used at the yield line of roundabouts**

The variation in the use of road signs and marking reflects either the lack of knowledge, or the lack of attention to detail or the lack of clear guidance (within the SADC-RTSM) for the implementation of road signs and road markings. A few examples of the variation are provided below:

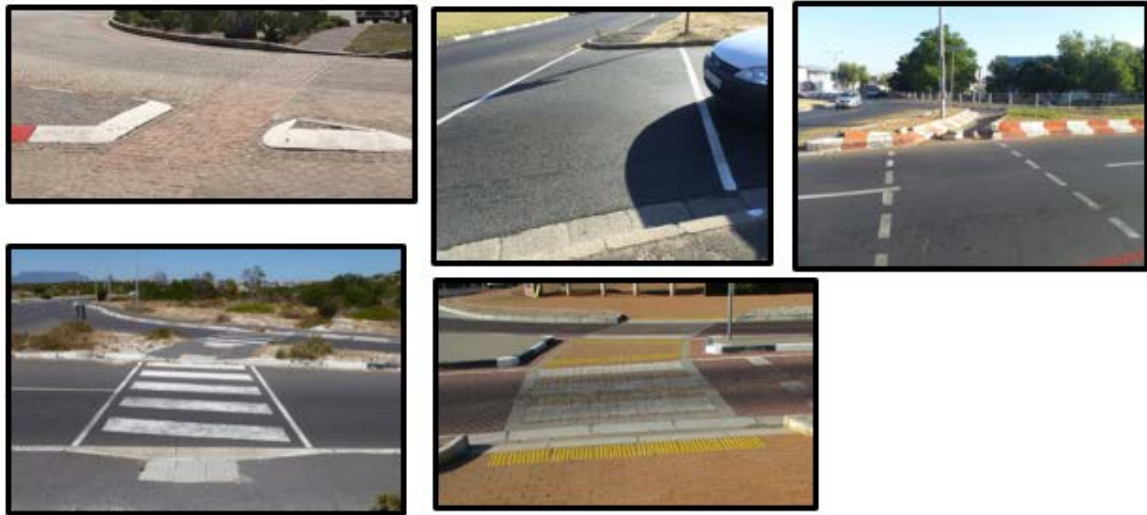
**Figure 13: Difference in road markings at pedestrian crossings**

Similarly, road markings are not well maintained, and the variation of road markings is considerable. A few photos illustrating the variation at pedestrian crossings are included below:
