Pipeline leak detection using in-situ soil temperature and  
strain measurements

A dissertation submitted in partial fulfilment of the requirements for the degree of

MASTER OF ENGINEERING (WATER RESOURCES ENGINEERING)

University of Pretoria

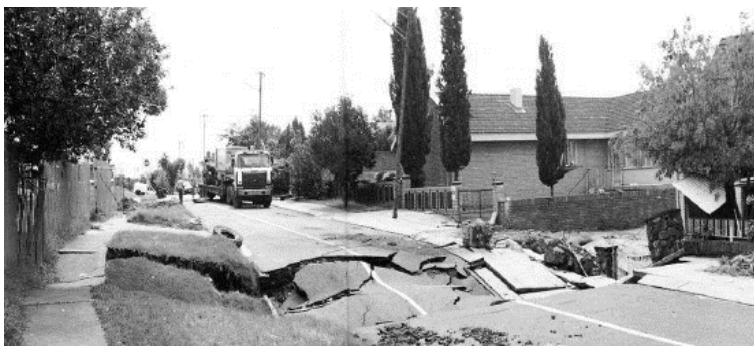
Figure 2-6: Damage to houses in Pretoria due to a sinkhole (Oosthuizen and Richardson, 2011)

In addition to a loss of potable water and the associated expense, distribution pipeline leaks in dolomitic areas can cause catastrophic surface failures known as sinkholes (see Figure 2-5 for details), which can also be formed naturally due to surface water ingress. Weathering of dolomitic rock occurs when rain water absorbs carbon dioxide, forming a weak carbonic acid. The slightly acidic groundwater enters tension fractures, faults and joints within dolomitic rock formations, which causes leaching of carbonate known as a dissolution process. The weathered dolomitic rock is usually overlain by much younger rock and soil cover which is highly variable, but typically less than 10 meters thick. These mechanisms cause the soil cover to erode or slump, losing support and exposing a cavity which leads to the formation of a hole as shown in Figure 2-6 and Figure 2-7. The process of dolomitic dissolution is slow and takes place over geological time (Oosthuizen and Richardson, 2011).

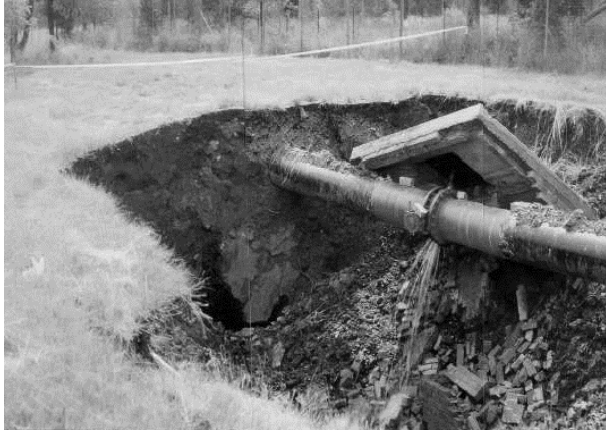
Figure 2-7: Leaking water pipe caused a sinkhole to form Pretoria (Oosthuizen and Richardson, 2011)

Being able to detect small settlements around a service pipe caused by subsurface failure can indicate a leaking service pipe and possibly lead to saving lives and limiting excessive damage to infrastructure caused by sinkholes.

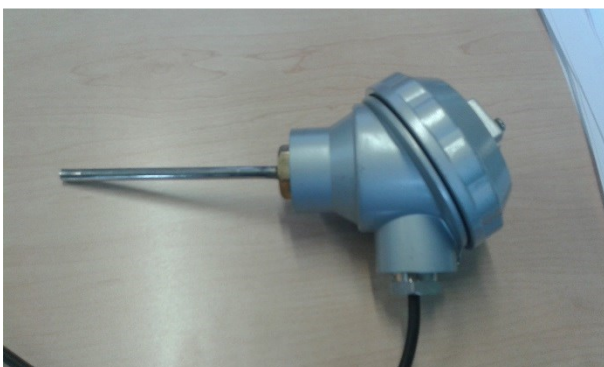
Figure 3-5: RTD 4 - 20 mA corresponding to >0 – 100 °C output

The specific RTD used for the experiment is shown in Figure 3-5, a current output of 4mA – 20mA corresponds to a temperature of 0°C – 100°C. See Figure 3-6 for the installed RTD in the valve chamber. A data logger was used to capture the temperature data every hour.

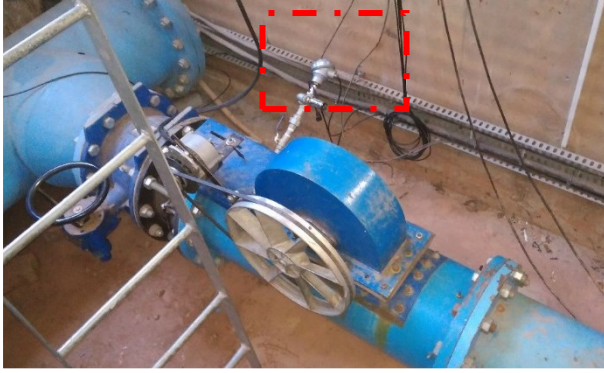
Figure 3-6: RTD installed at Pierre van Ryneveld reservoir

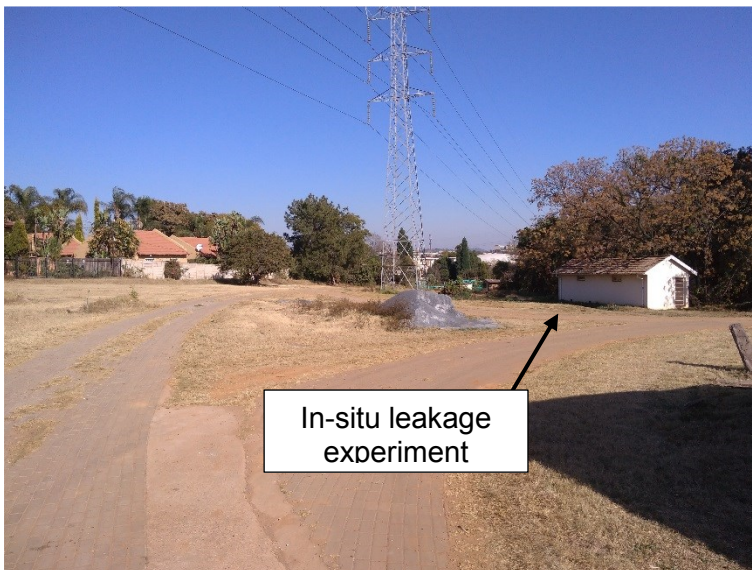
Figure 3-10: View of the location of pipe leakage experiment

A short pipeline section installed on the University of Pretoria's experimental farm is illustrated in Figure 3-9 (see Figure 3-10 for locality). It was instrumented with an array of FBGS and conventional thermistors. This was done to verify whether the proposed leakage detection system would be able to detect leakage from a pipeline in the field. This was necessary because the ambient temperature changes occurring in the field are different from those in the laboratory and it is necessary to observe whether temperature changes from leakage can be distinguished from the ambient. Furthermore, the effect of soil wetting in the pipe trench on the support condition around the pipe had to be investigated.

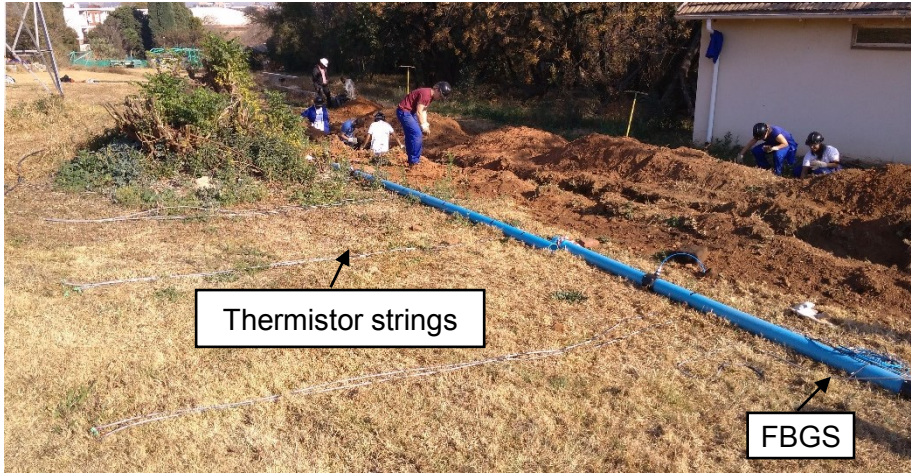
Figure 3-13: Sensor layout and levelling bottom of trench

Following trenching, the sensors were laid out according to their planned installation location to the side of the trench. The base of the trench was levelled with reference to the undisturbed ground and the design invert depth of 800mm. A slope of 1:0.026 was created to aid the drainage process in the flow direction from the upstream municipal connection to the downstream drainage tanks used to hold the water circulated through the system. The slope amounts to a level drop of 400mm over the 15m long trench (see Figure 3-13).

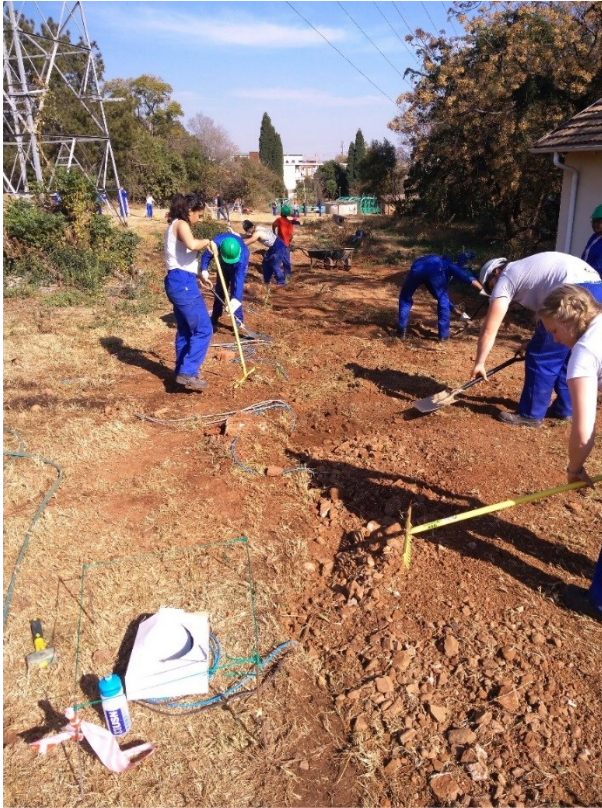
Figure 3-18: Finishing off installation

The field installation was completed by ensuring that the trench is sufficiently compacted throughout and that there are no sharp edges or potential for erosion gullies on the surface that can form in close proximity to the trench during rain storms (see Figure 3-18). Care was taken to ensure that the pipe ends were sufficiently compacted, acting as thrust blocks. Arrangements were made so that the internal pipe pressure could be limited during testing at the upstream valve to prevent unnecessary and unintended leaks forming at connections,

joints and couplings. A downstream valve was provided that could be used to relieve the internal pipe pressure if necessary.

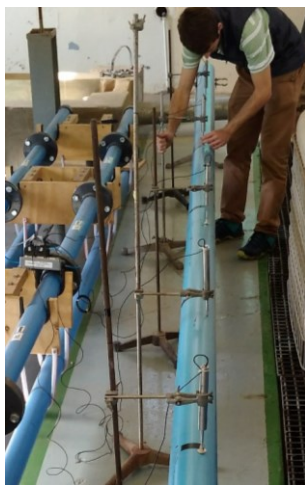
Figure B-2: LVDT setup along pipe

The results indicate that adding one or two collar does not have a significant effect on its stiffness or resistance to bending compared to a pipe with no collars. The pipe collars in the graphs are indicated by a red vertical line the Figure B-3 indicating no collars, Figure B-4 indicating one collar and Figure B-5 indicating two collars.
