CHAPTER

02

context + site analysis

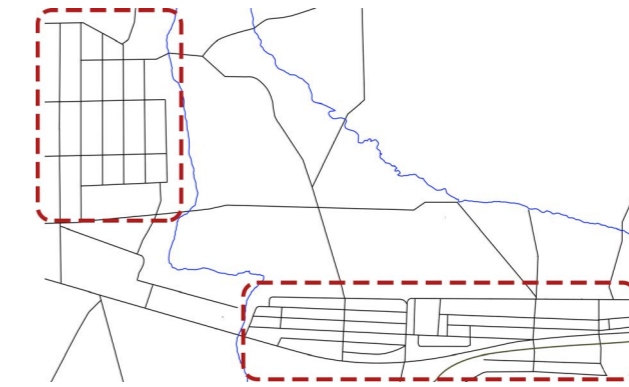
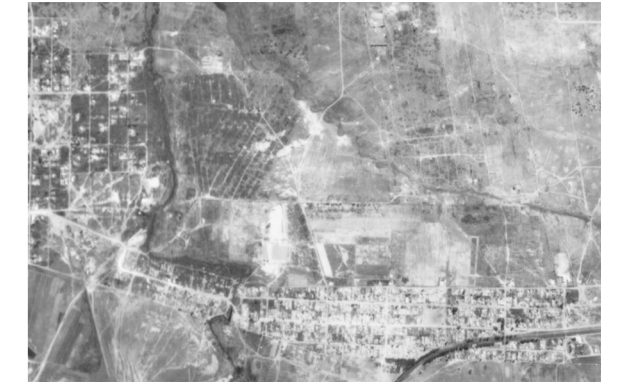
Fig. 2.8 + 2.9 Site in 1958 (National Geo-Spatial Information Database, 2018; Author, 2018)

- The first residential area of Eersterust, visible south of future Era brick factory site.
- The suburb of Jan Niemand Park, visible to the west.

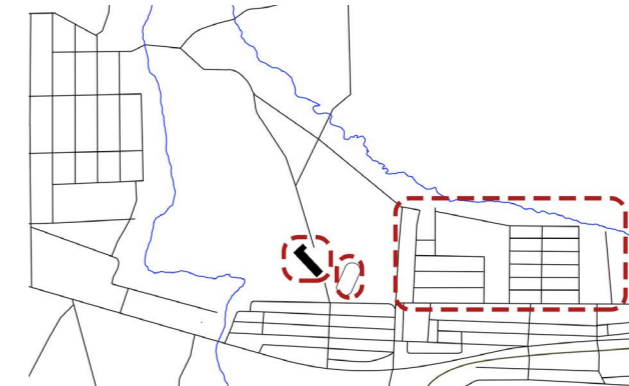
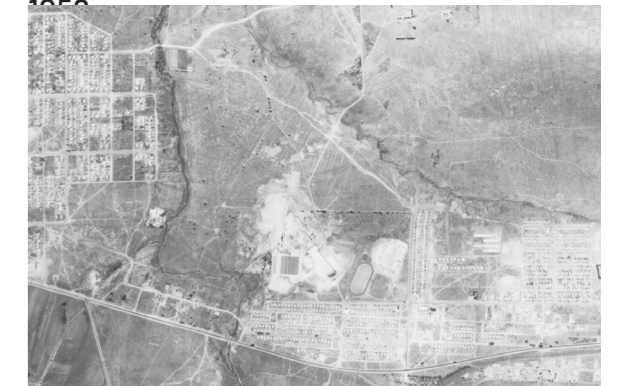
Fig. 2.10 + 2.11 Site in 1968 (National Geo-Spatial Information Database, 2018; Author, 2018)

- First Era-Brick Building is visible.
- Soccer field visible east of Era-Brick factory site.
- Expansion of Eersterust to the east.

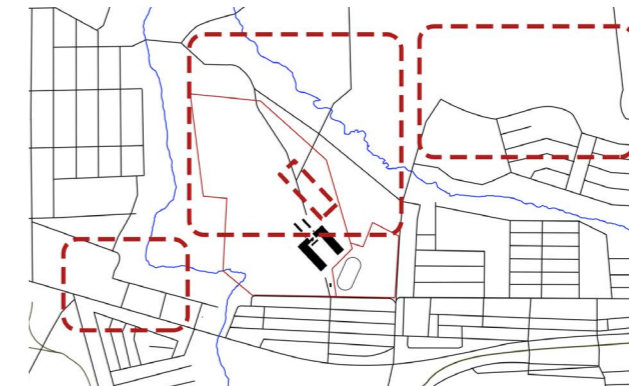
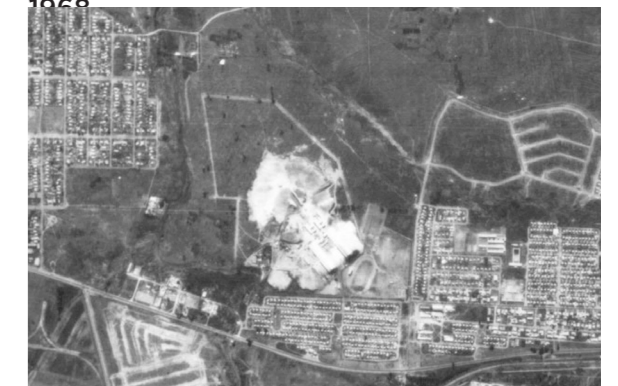
Fig. 2.12 + 2.13 Site in 1976 (National Geo-Spatial Information Database, 2018; Author, 2018)

- Expansion of Era-brick site, additional buildings and demarcated site visible.
- Soccer field east of Era-brick site boundaries visible.
- Expansion of Eersterust to the north.
- Industrial area to the south-west is visible.
- Decommission of oldest oven.

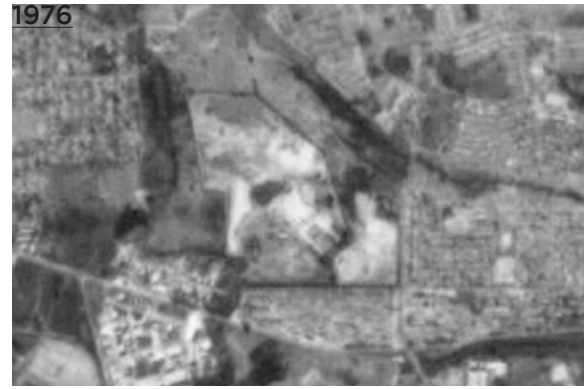
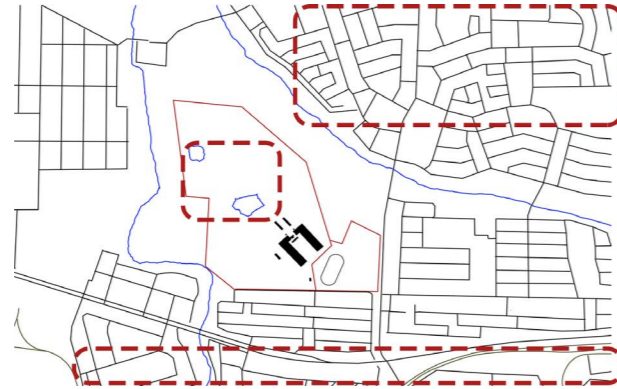
Fig. 2.14; 2.15 Site in 1984
(National Geo-Spatial Information Database, 2018 + Author, 2018)

- Further expansion of Eersterust to the north.
- Water is visible on site, because of quarry.
- Industrial sites expand to the south.

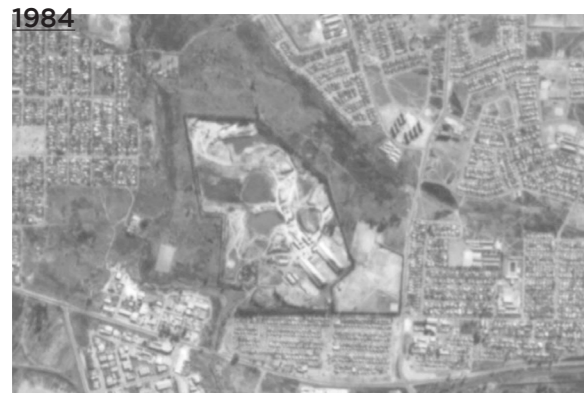
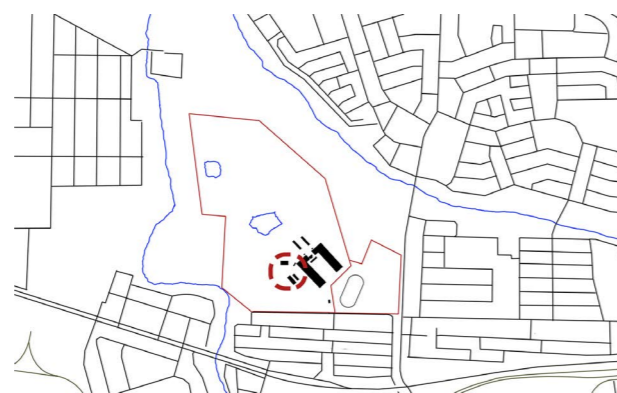
Fig. 2.16; 2.17 Site in 1991
(National Geo-Spatial Information Database, 2018 + Author, 2018)

- Auxiliary buildings added to site.

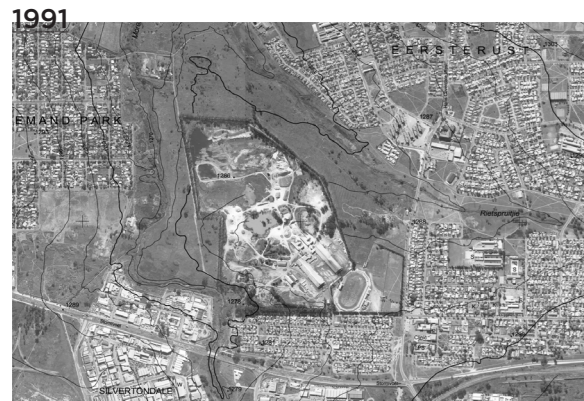
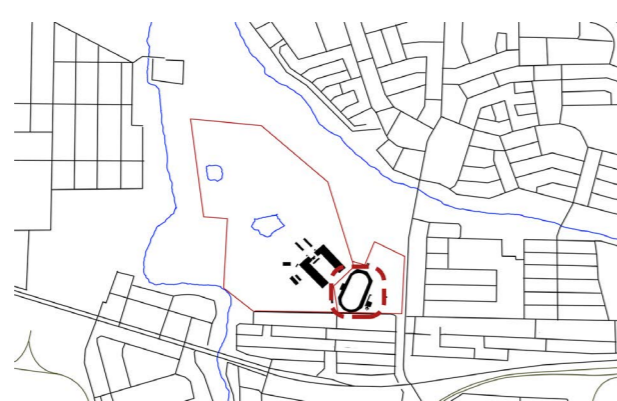
Fig. 2.18; 2.19 Site in 2001
(National Geo-Spatial Information Database, 2018 + Author, 2018)

- Major upgrades to soccer stadium and surrounding site.

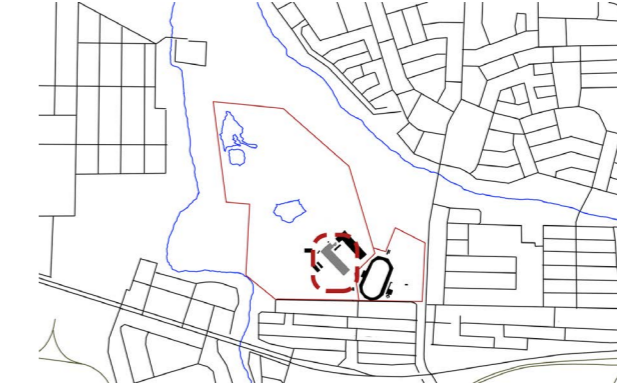
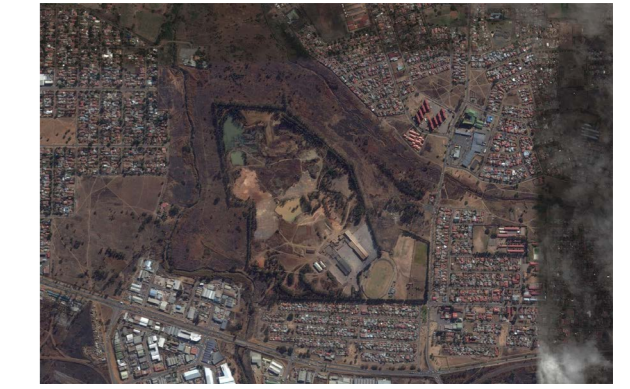
Fig. 2.20; 2.21 Site in 2014
(National Geo-Spatial Information Database, 2018 + Author, 2018)

- Demolition of oldest brick oven.

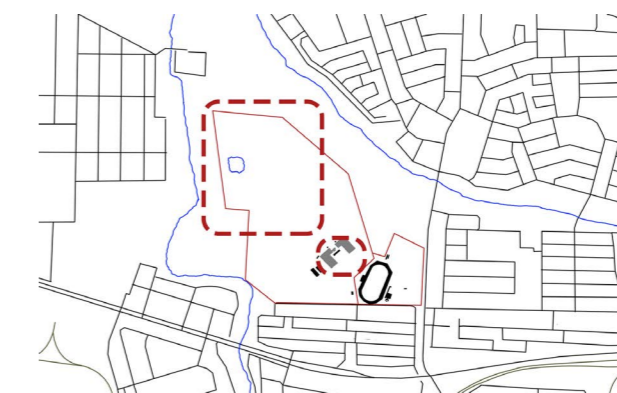
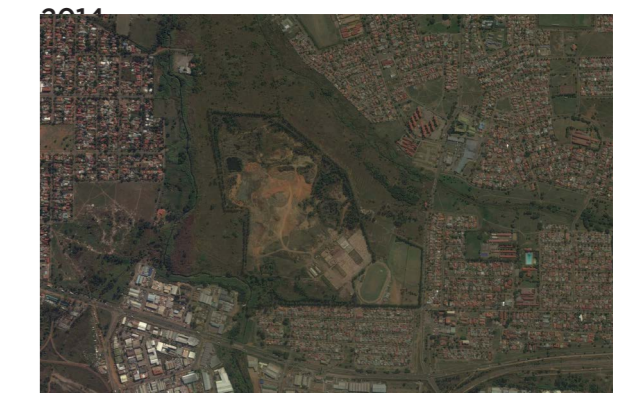
Fig. 2.22; 2.23 Site in 2015
(National Geo-Spatial Information Database, 2018 + Author, 2018)

- Entire brick factory now decommissioned, various buildings now demolished.
- New owners of the site using it as a dumping ground, most of the ponds on site have been filled up with imported soil and building rubble.

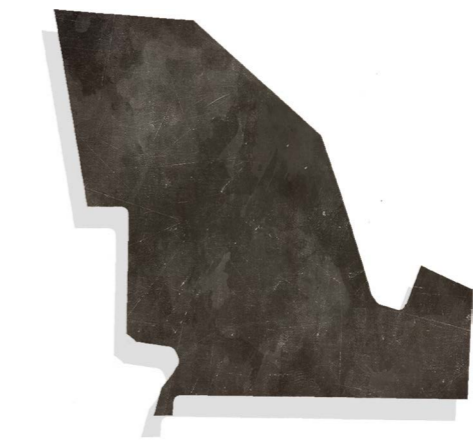
Fig 2.35 Original Condition of site - Natural (Author, 2018)

The diagrams to the right depict the various states the site has been in, from a totally natural state before the factory or quarry existed (Fig. 2.35), to a disturbed "nature" when production was at its peak. (Fig. 2.36)

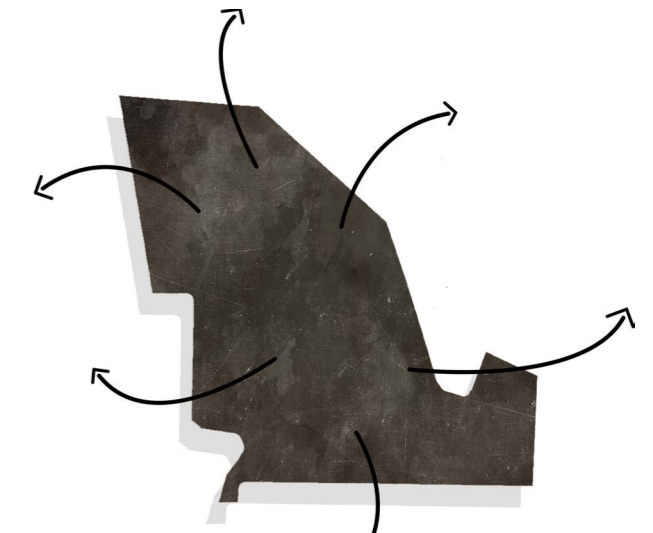
Fig 2.36 Quarry & Factory Condition - Extraction (Author, 2018)

As seen in Fig. 2.36, at this stage, the clay resources were extracted from the site, processed, baked and sold as bricks; natural resources were used to produce the bricks.

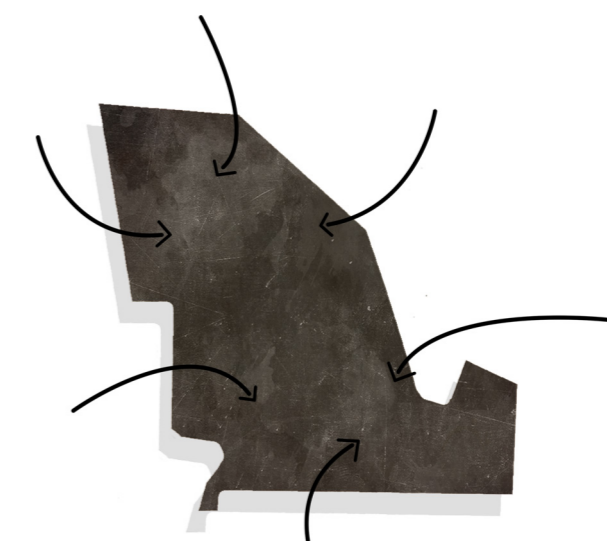
Fig 2.37 Current Condition of site - Insertion (Author, 2018)

Figure 2.37 represents the current condition of the site, where soil extracted from sites in and around Pretoria is transported and deposited on site, by the current owners, Labucon. On site, there are visible deposits of building rubble. Although the intention was to rehabilitate the site after the closure of the quarry (see section 02.3), it seems that this intention has fallen by the wayside in recent times.

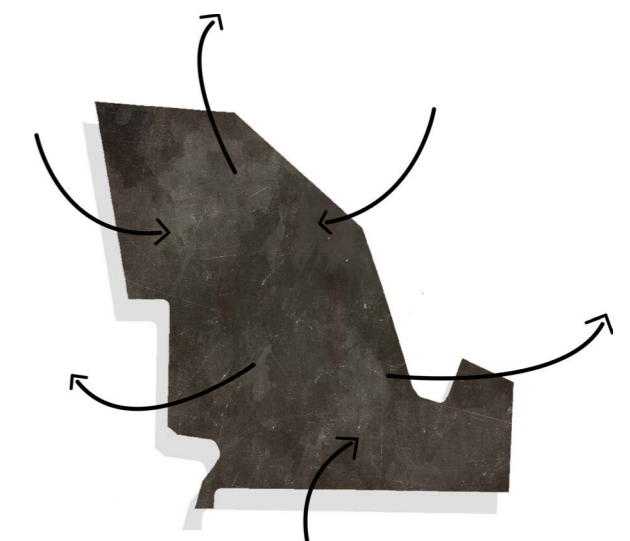
Fig 2.38 Desired Condition - Equilibrium (Author, 2018)

This dissertation argues that the desired condition would rather be to have a state of equilibrium, where resources are extracted and brought back on equal terms as in Figure 2.38.

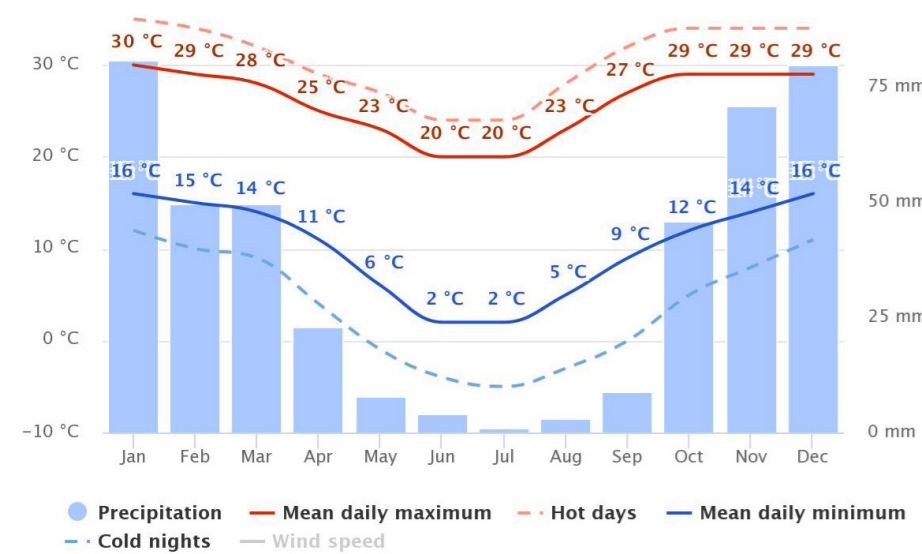
Fig 2.40 Average temperatures & precipitation of Pretoria (Meteoblue, 2018).

Pretoria falls in a summer rainfall zone, with rain reaching its peak from November to January, during the winter months there is little to no precipitation. (Figure 2.39-2.40) The city has an average of 8.8 daily sunshine hours, with winter days being predominantly sunny (Meteoblue, 2018) & (Avg Sunshine Hours, 2018).

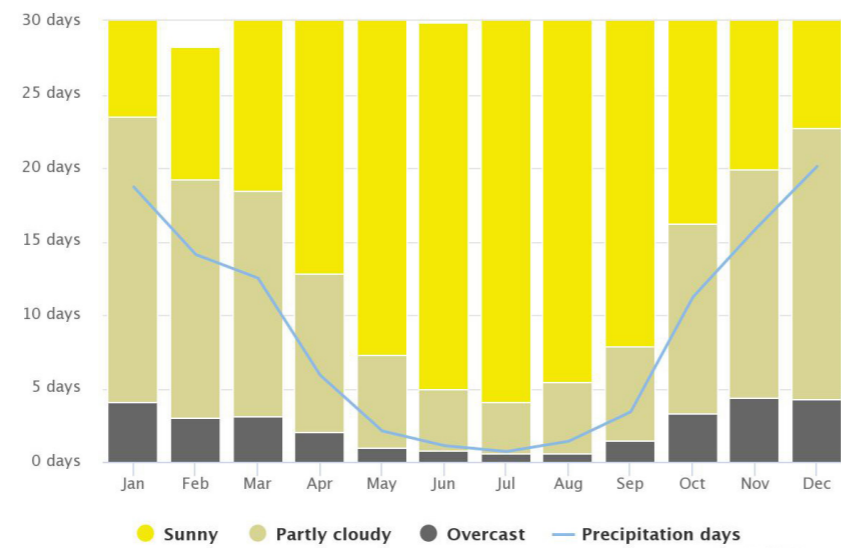
Fig 2.41 Average daily sunshine hours of Pretoria (Meteoblue, 2018).

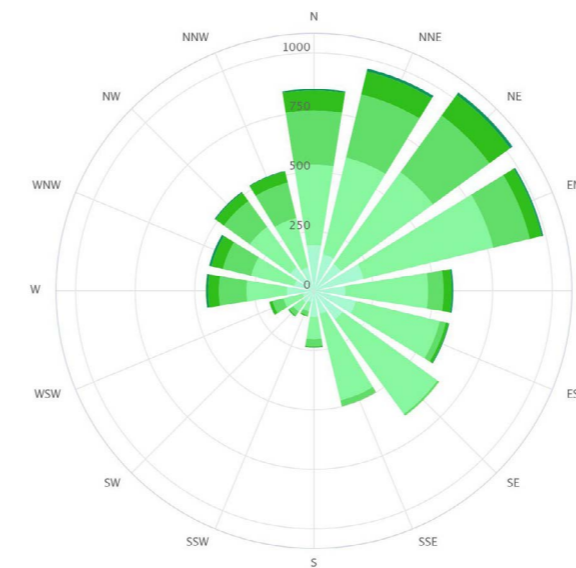
Fig 2.42 Wind rose diagram of Pretoria (Meteoblue, 2018).

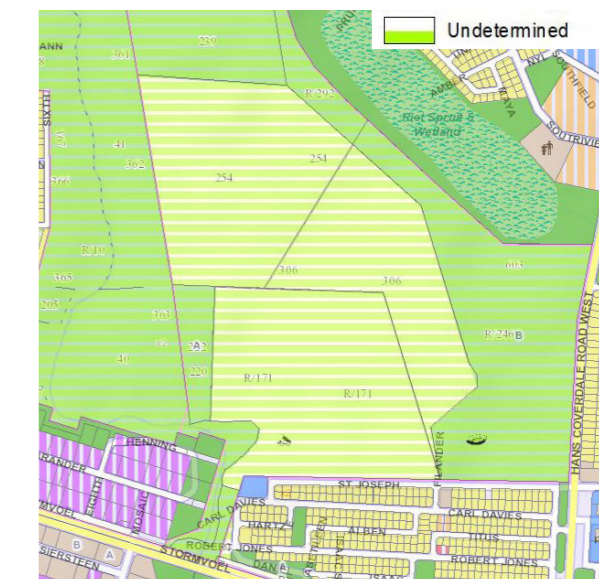
Fig 2.43 Zoning of Eersterust (Tshwane GIS, 2018).

According to current zoning the site is zoned as undetermined, most likely because the previously industrial site has been unused since the end 2013. The Tshwane Regional Spatial Development Framework (RSDF) indicated that the site has to be zoned at a suburban density (see Figures 2.43 and 2.44). This makes sense for a prospective housing development as is currently at a proposal stage. (Tshwane GIS, 2018).

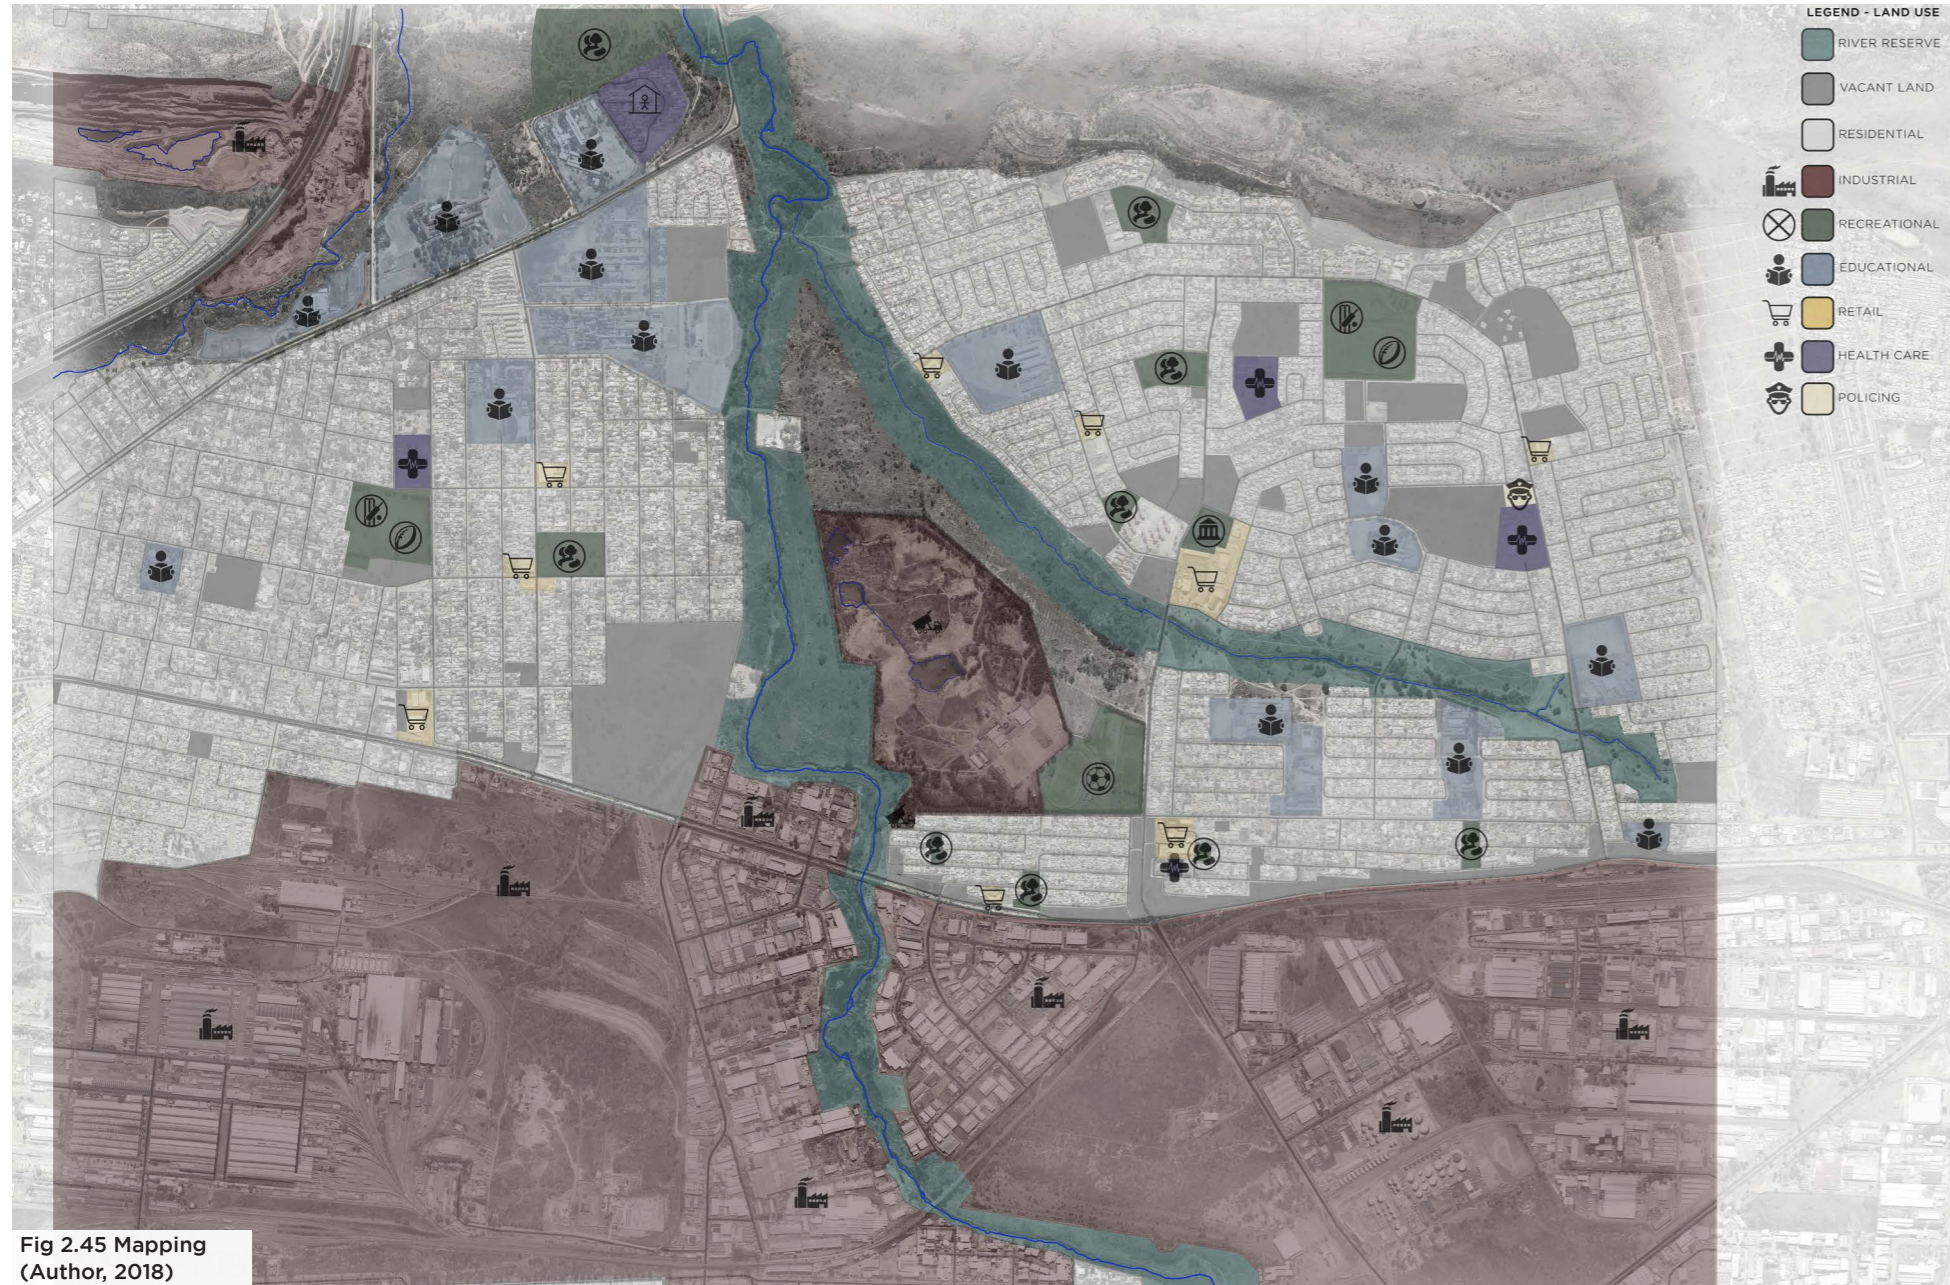
Fig 2.45 Mapping (Author, 2018)

While mapping the area, it became clear that there are many schools surrounding the site (marked in light blue in Figure 2.45). The pupils attending school in Jan Niemand park are often from Eersterust, as better school facilities are available in this area.

The vacant land available for further development and densification is marked in dark grey (Fig. 2.31). Eersterust is only 12km away from the Pretoria CBD, making it much better for settlement than the informal settlements forming further to the east, in places like Mamelodi.

Because Eersterust is so close to the large industrial area to the south, (marked in red) economic opportunities are available to residents, without the need to commute long distances to work - as opposed to those travelling from the further eastern settlements.

As illustrated in the diagram to the left, the flood plains and reserved land beside the rivers form quite a barrier between the two settlements. At the same time the rivers offer a connection between the settlements where the areas can be cleaned up and linked.

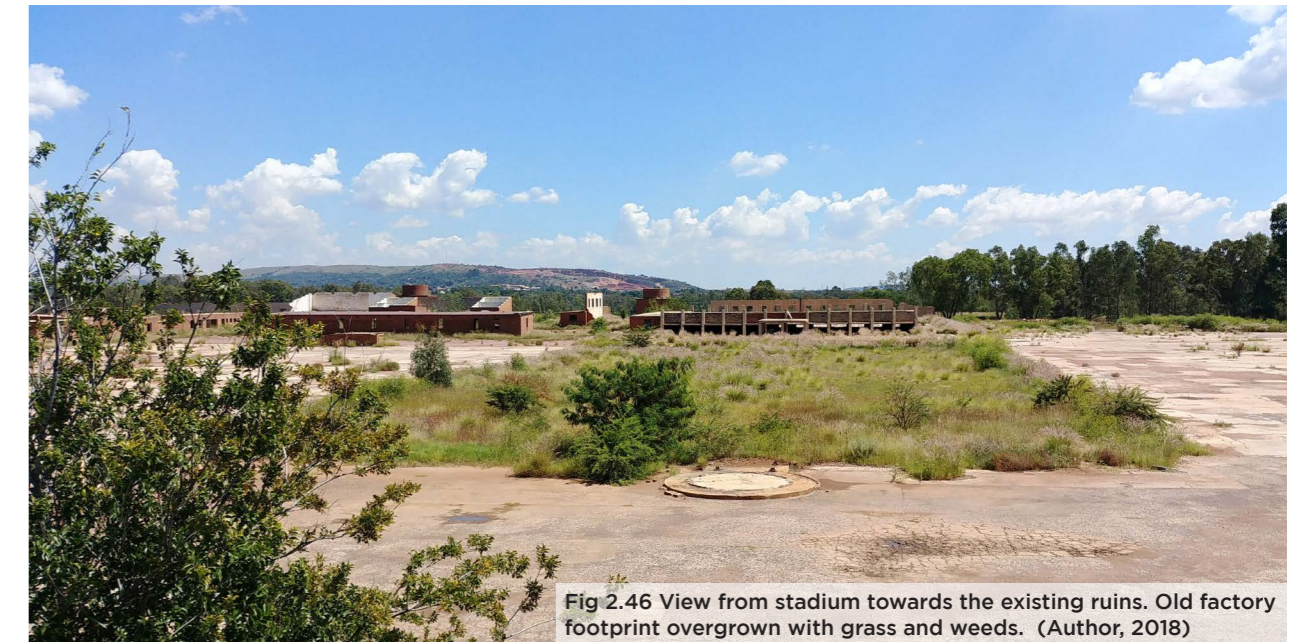
Fig 2.46 View from stadium towards the existing ruins. Old factory footprint overgrown with grass and weeds. (Author, 2018)
