Clinical evaluation of the loop-design fibre-reinforced composite and the band-and-loop space maintainers.

SADJ August 2018, Vol 73 no 7 p436 - p441

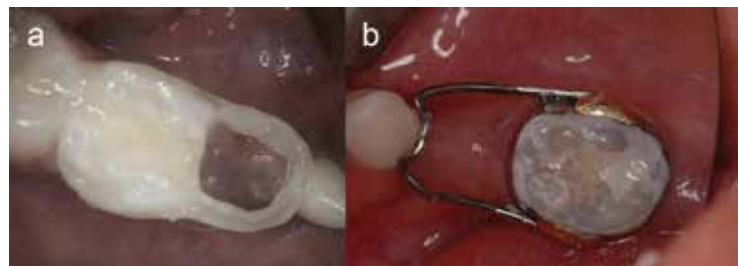
Figure 1: Examples of (a) a FRCSM; (b) a BLSM immediately after placement.

The glass fibre was then moistened with unfilled adhesive resin⁹ (Adper Scotchbond 1XT adhesive, 3M ESPE, St Paul, USA), using a bond applicator brush and the entire loop was cured for 40 sec. Flowable composite (3M ESPE) was applied to cover the whole loop and light-cured for 40 sec. An ELITEDENT® Q-4 LED curing light was used, and the curing tip was kept within one mm of the material to ensure a complete cure. The curing light was regularly tested with a Bluephase® meter to ensure a consistent output of 1000–1100 mW/cm². The FRCSMs were finished and polished using a yellow striped, flame-shaped diamond finishing bur (Dentsply Sirona, Switzerland; ISO 806 314 249 504 012) and the Enhance polishing system (Dentsply Sirona, Milford, USA) (Figure 1a).

The BLSMs were placed according to the standard clinical procedure. An orthodontic band was fitted around the anchor tooth and an impression was taken with the band in place. The band was then transferred to the impression and secured before the impression was sent to the laboratory for pouring of the model and manufacturing of the space maintainer. The BLSMs were cemented with glass ionomer cement (GIC) (Fuji ORTHO, GC America, Illinois, America) according to the manufacturer's instructions (Figure 1b).

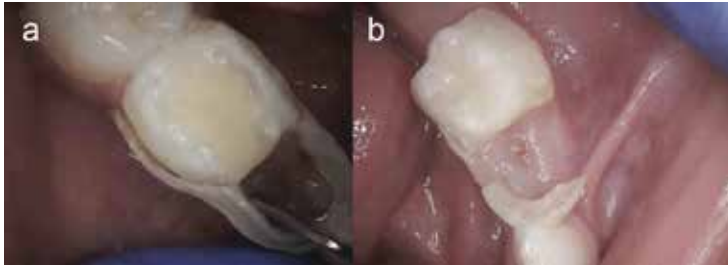
Figure 2: Examples of (a) bond failure on the functional cusp side (the visible metal instrument is being used to demonstrate the loose fibre bundle); (b) fibre fracture on the functional cusp side.

Breakdown of the enamel-composite interface (Figure 2a) accounted for 40% of the FRCSM device failures. This finding is consistent with those of previous studies,^{1,4,10} and is attributed to a relatively weak bond between composites and the aprismatic enamel of deciduous teeth.^{1,10,12,15} Kirzioglu and Ertürk⁴ reported failure rates of 32%, within just one month when fibres had been placed without rubber dam protection and emphasized the importance of moisture control during placement to ensure good bond strength.

Interestingly, both FRCSM devices that fractured in this study retained contact with their non-abutment teeth (Figure 2b). Thus, although the devices were reported as failures according to the failure criteria, clinically they still fulfilled their space-maintaining purpose. The unlikely success of these two “broken” fibres could indicate the possibility of placing half a loop, bonded to the non-functional side of the abutment tooth, as the loop seems to fracture on the functional cusp side. Indeed, Kirzioğlu and Ertürk⁴ have previously suggested using a single fibre bonded to the non-functional side of both teeth. Whilst it might prove challenging to place half a loop without bonding it to the anterior tooth, this approach could be investigated further.

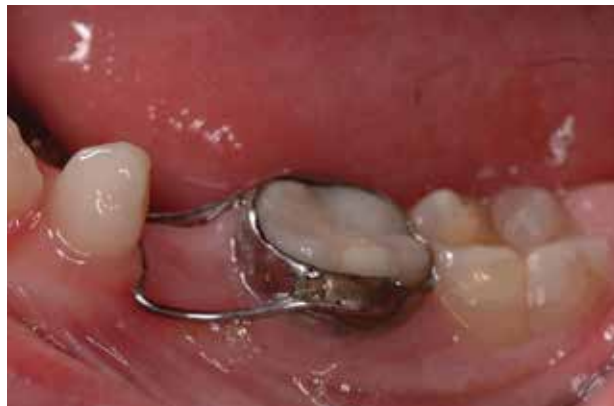
Figure 3: BLSM with bent wire impinging on soft tissue with signs of inflammation.

The main reason for failure (80%) in this study was bending of the loop to impinge on soft tissue as illustrated in Figure 3. Distortion of the loop has been reported in two previous studies as a failure in, respectively, 3.3%¹⁰ and 9%⁷ of cases. Intermittent functional loading on the space maintainer causes high compressive stresses on the tooth supporting the cantilever extension.¹⁹ Losing contact with the non-attached abutment tooth has been suggested as the major factor leading to bending of a loop with subsequent submerging of the wire beneath the gingiva.^{18,20} Previous BLSM studies did not limit placement to deciduous molars and included those placed on permanent teeth. Therefore the loop extended further, giving the cantilever wire a larger contact surface in comparison with the situation in this study, where all the wires extended to a deciduous canine with a smaller contact area. The absence of a rest could have contributed to the instability of the loop.

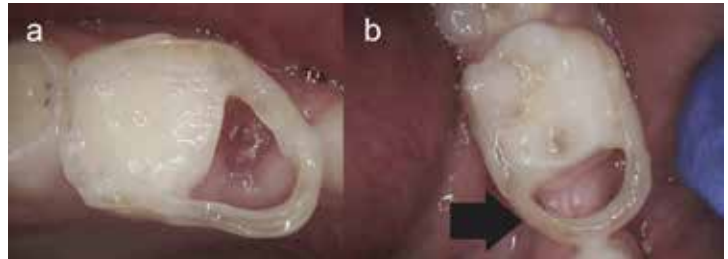
Figure 5: (a) Skew orientation of a fibre loop during placement; (b) chipping of composite from the fibre frame

Placement of FRCSMs proved to be technique sensitive. Manipulation of the fibres to form a uniform loop was a challenge. As a result, not all fibres had a perfect loop shape (as illustrated in Figure 5a). However, this did not prove to affect the FRCSM failure rate in this small sample, as even the non-uniform fibre loop was intact after six months.

During the study, it became evident that the composite covering the fibre would chip off over time (Figure 5b). Although this was not reported as an FRCSM failure in this study, it has previously been reported as a type of device failure.¹ Chipping of the composite could influence plaque retention, patient comfort, device strength, and device longevity. Repairs can of course be effected chairside with flowable composite.

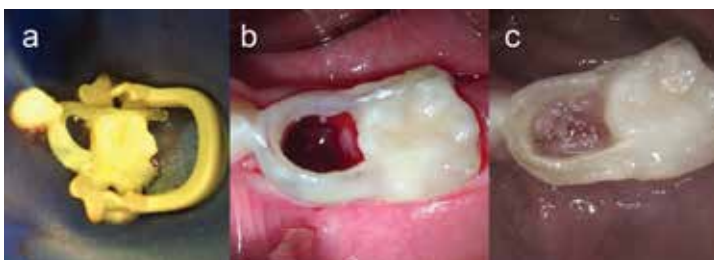
Figure 4: (a) Placement in theatre, rubber dam applied directly after an extraction; (b) Placement in theatre, directly after an extraction; (c) one week follow-up.

convenient to place FRCSMs in theatre directly after an extraction. Bleeding was controlled and the rubber dam was positioned, enabling the FRCSM to be placed immediately. Follow-up visits indicated normal healing of the extraction socket. (See Figure 4.)
