Particle image velocimetry for strain measurement on a railway line

BACKGROUND

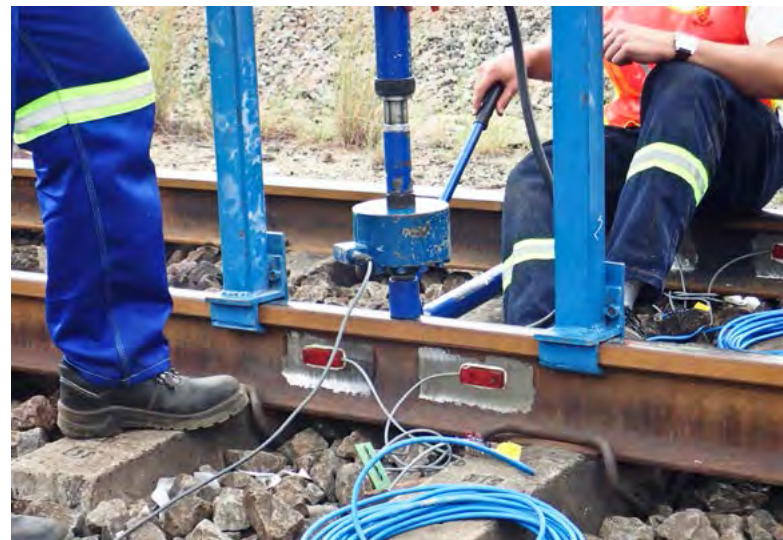
Figure 1 Typical strain gauge setup for wheel load measurement with a calibration frame positioned between two sleepers

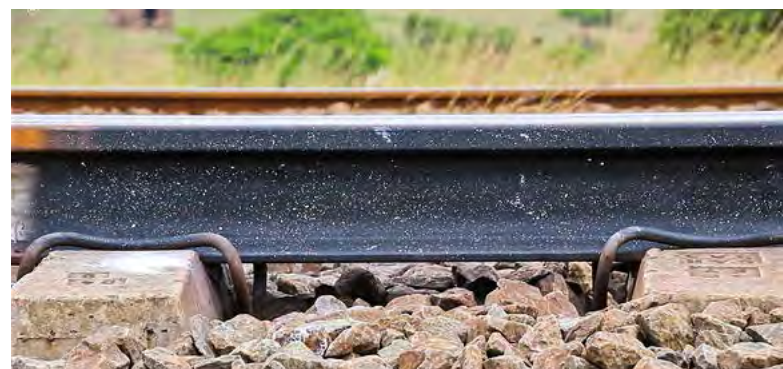
Figure 2 Typical field setup using PIV where the rail is painted with black paint first and then with a random spray of white speckles

In this study, particle image velocimetry (PIV) testing was done on a rail under different dynamic load frequencies in a laboratory to investigate the use of PIV to perform the same function as strain gauges to measure wheel load. A typical field setup using PIV would entail the painting of the rail, firstly with black paint and then with a random spray of white speckles, as shown in Figure 2. This is done to enable the software to trace particle movements with digital algorithms.

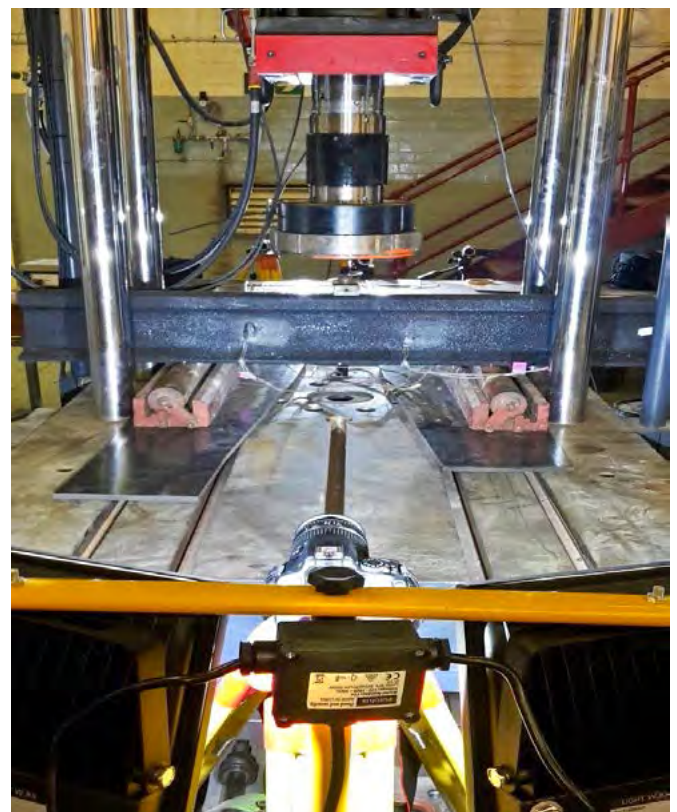
Figure 4 LED lights were set up behind the camera to improve the image quality of the rail surface

The experiment was conducted on a section of UIC-60 rail using an MTS dynamic actuator to simulate a train's load and movement, with supports similar to those of a conventional railway track. Strain gauges in a full-bridge configuration (see Figure 3) and PIV measuring equipment were used to measure rail deformation and strain. A DSLR camera was set up on a tripod to reduce movement. LED lights were set up behind the camera to improve the image quality of the rail surface (see Figure 4).

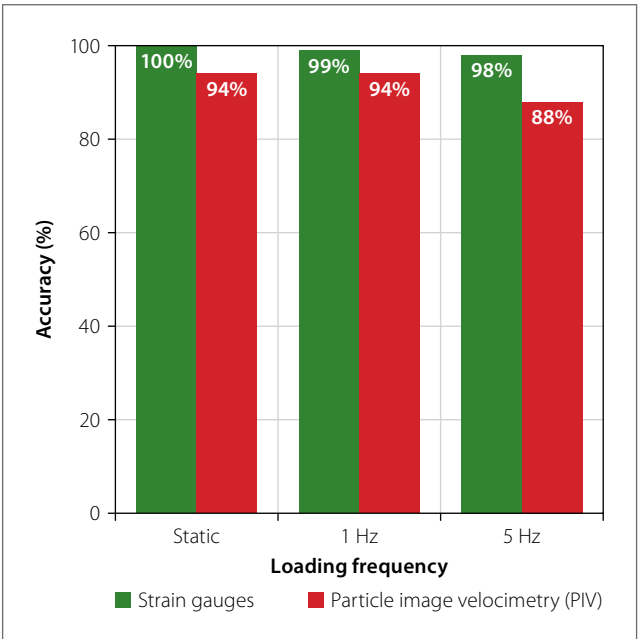
Figure 5 Results of both the strain gauge and PIV measurements at 1 Hz and 5 Hz

Strain gauge measurements at a load application of 1 Hz showed a small variation from static measurements. A 99% accuracy was calculated for strain gauge measurements, while the accuracy of PIV measurements at the same frequency resulted in a slightly lower accuracy of 94%. Figure 5 shows that, by increasing the frequency to

5 Hz, both the strain gauges and PIV measurements deviated further from the calibrated strain. Strain gauge measurements were 98% accurate, while PIV measurements were 88% accurate.

Strain measurements from both techniques were compared under different loading conditions. As the frequency increased, both the accuracy of the strain gauges and the PIV measurements reduced. Figure 5 shows the accuracy of both the strain gauge and PIV measurements at 1 Hz and 5 Hz.
