THE INFLUENCE OF THE GAP ON PLATFORM TRAIN INTERFACE OCCURRENCES

**A dissertation submitted in partial fulfilment of the requirements for the degree of
MASTER OF ENGINEERING (TRANSPORTATION ENGINEERING)**

Dissertation Summary

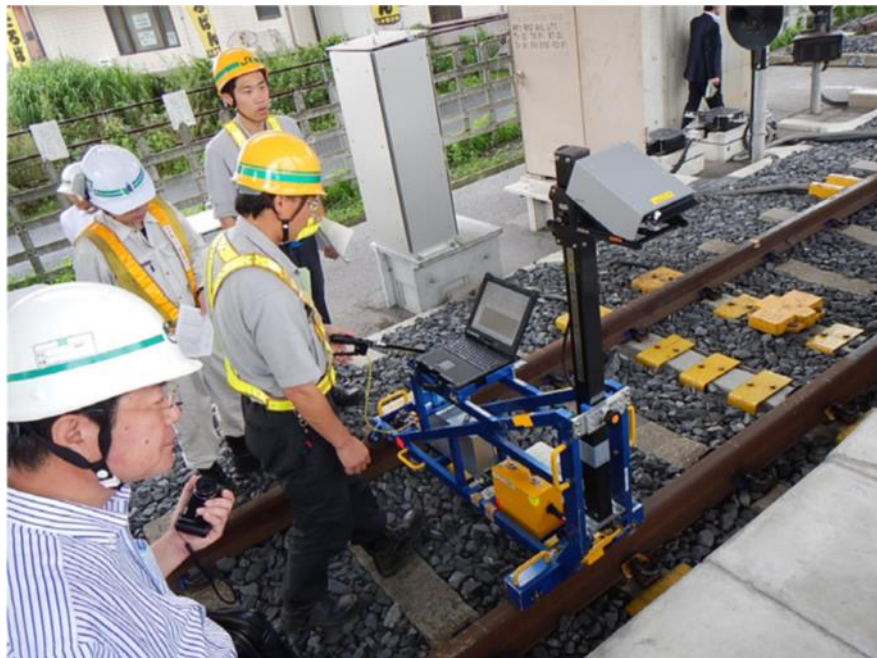
In Japan, the gap clearance is measured manually on the track using a system composed of a 2D range scanner, a “note-type computer”, an odometer, a battery, and a hand cart (Shimizu, 2016). Figure 2-1 illustrates this technology

Figure 2-1: The current measurement system used in Japanese train stations (Shimizu, 2016)

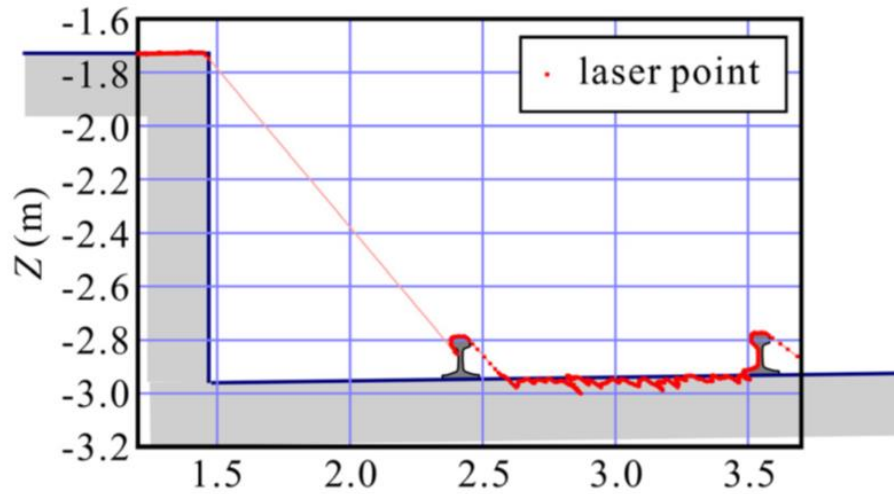
Figure 2-4: Example of readings obtained from the proposed method (Shimizu, 2016)

Based on the results presented in Figures 2-4 and 2-5, the proposed method was considered feasible and perceived to have the potential of extensive application in track condition measurement in train stations. However, implementation of the method would involve a significant financial cost in the purchase of the laser scanner (FARO Focus3D X 330) used in the study. For this reason, it was concluded that the method was not cost effective for this research.

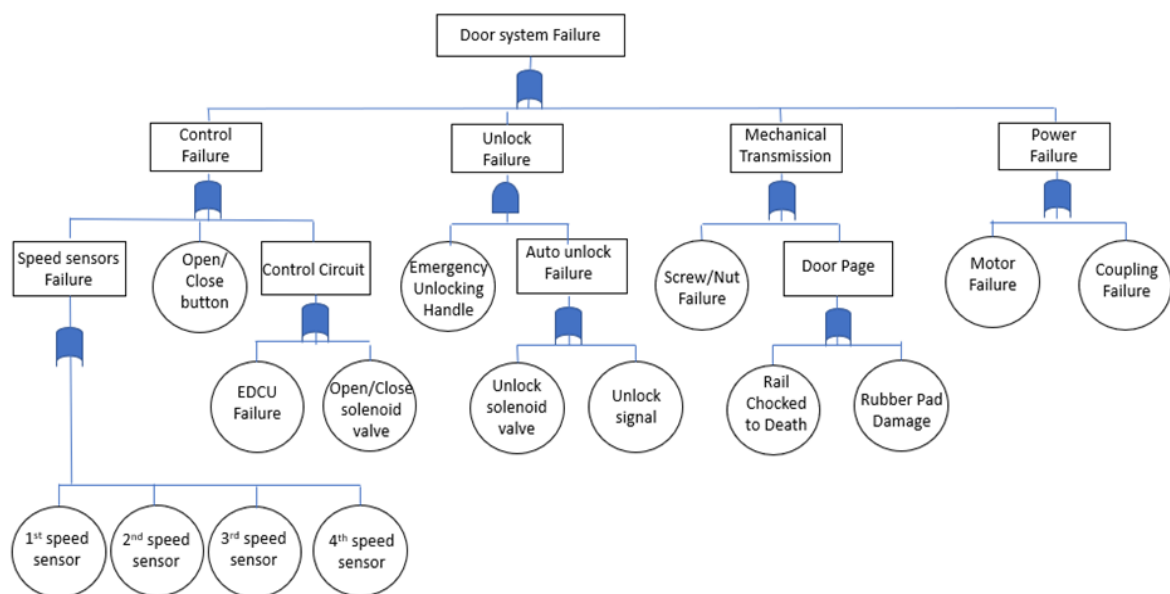
Figure 2-6: Fault tree of a metro vehicle door system adapted from Liming et al. (2010)

Research conducted by Liming, Jianwei, Guoqiang and Limin (2010) depicts this method of systems using a Monte-Carlo simulation based on fault tree analysis to analyse the reliability of a door system of metro vehicles in an urban railway system. The fault tree analysis depicted the different door components as a system of elements influencing each other (Figure 2-6). Considering a similar approach, the application of a Monte-Carlo simulation to determine the likelihood of a PTI occurrence and the effects thereof would provide a means of quantifying the effects (or cost) of an incident to either the rail service provider or the victim of the occurrence and the rail service users.

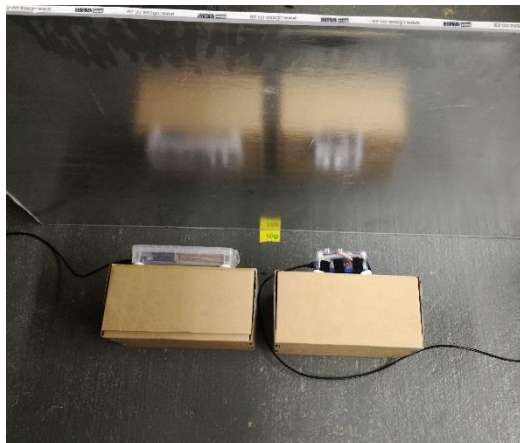
Figure 3-6: Silver reflective surface

The first calibration test involved carrying out measurements against a black (non-reflective surface) and silver (reflective) surface to determine the effect of the surface's reflectance on the sensors' performance. The measurements were carried out at distances ranging from 100 mm to 500 mm at 100 mm intervals. The experimental setup is presented in Figure 3-6 and 3.7.

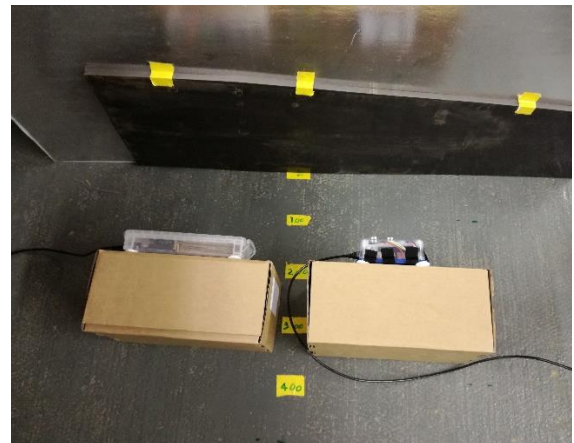
Figure 3-7: Black non-reflective surface

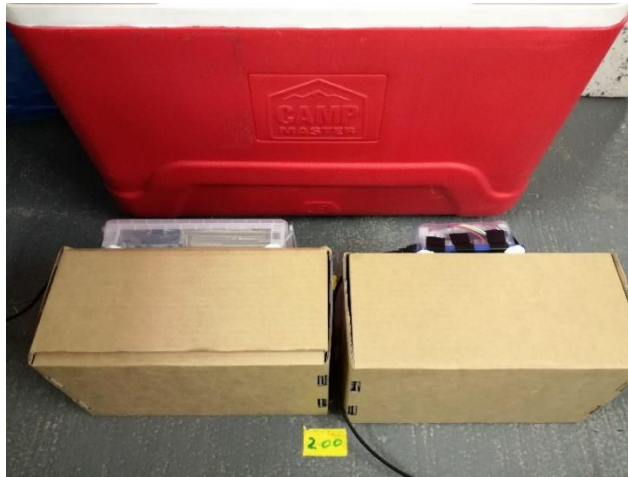
Figure 3-10: Experimental setup of an irregularly shaped surface

The second calibration test involved carrying out measurements against an irregular shaped target. The measurements were carried out at distances ranging from 100 mm to 500 mm at 100 mm intervals. This experiment was carried out to determine the performance of the sensors in the field in a scenario where the prototype was mounted onto the platform and reflection occurred on the surface of the train. The shape of the train exterior at the level the sensors would be mounted was irregular, thus necessitating the investigation of the effects of the target's shape on the accuracy of the readings. The experimental setup is presented in Figure 3-10. The results obtained from the experiment are presented in Figure 3-11.

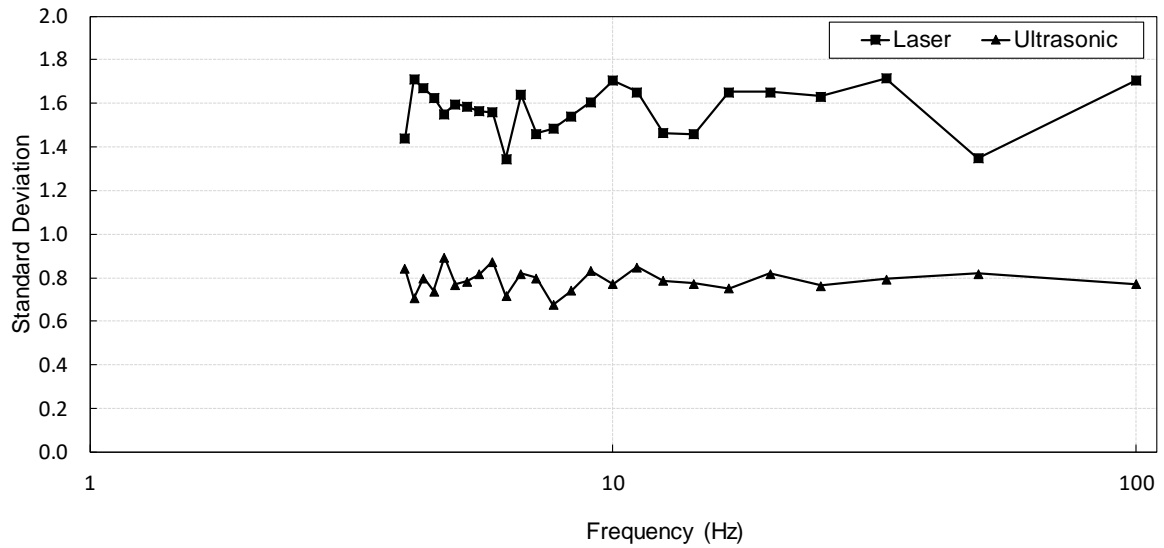
Figure 3-13: Standard deviation calculated from the ultrasonic and laser sensor readings against the corresponding measurement frequencies

The final phase of the calibration process was to determine the optimum measuring frequency. The aim of this phase was to determine the ideal frequency at which the sensors would perform as required. Performance was based on the accuracy of the readings (measured by the percentage error) as well as the stability of the readings (measured by the standard deviation). The approach taken was to measure a distance of 100 mm against a smooth cardboard surface at different frequencies ranging from 4 Hz to 100 Hz. Thereafter, the percentage error and the standard deviation were plotted against the frequency. The results are presented in Figure 3-12 and 3.13.

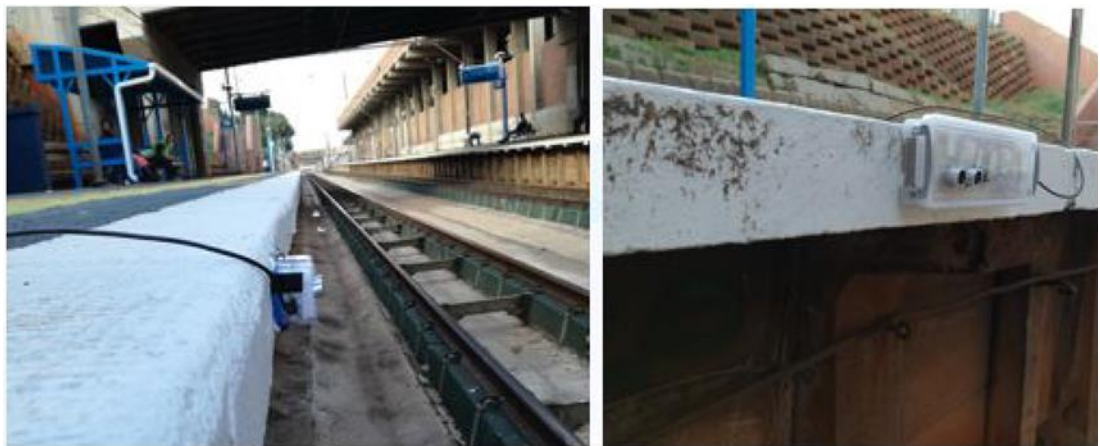
Figure 3-14: Prototypes mounted on the platform to measure the horizontal gap size between the train and the platform

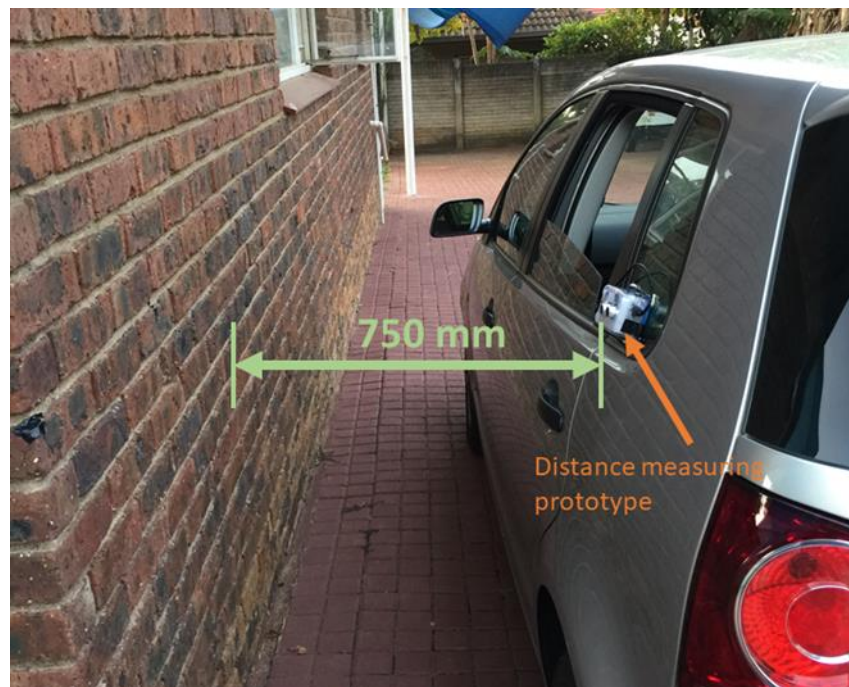
Figure 3-16: Experimental setup depicting measurements recorded at a distance of 750 mm

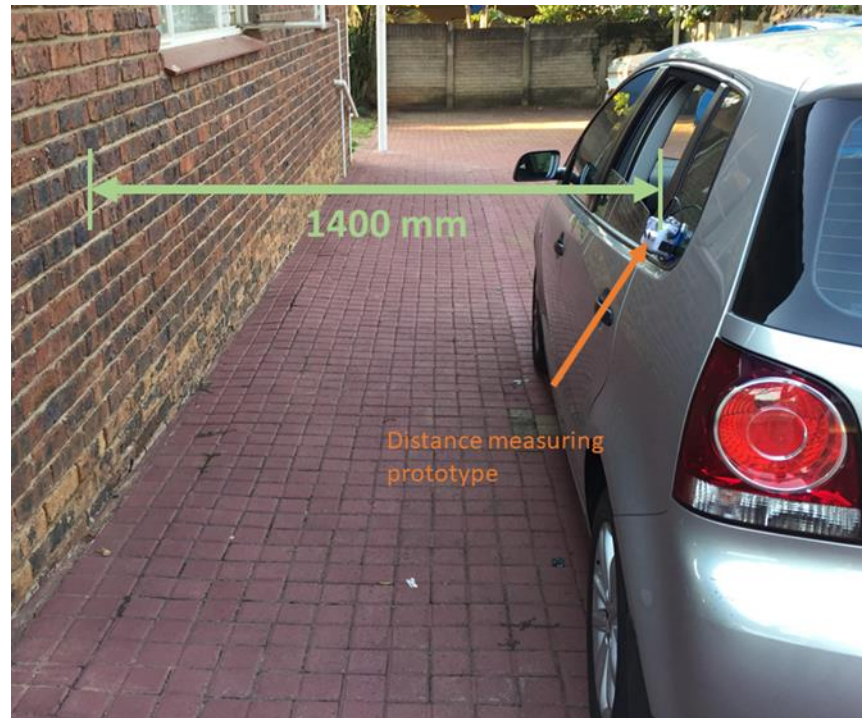
Figure 3-17: Experimental set-up depicting measurements recorded at a distance of 1400 mm

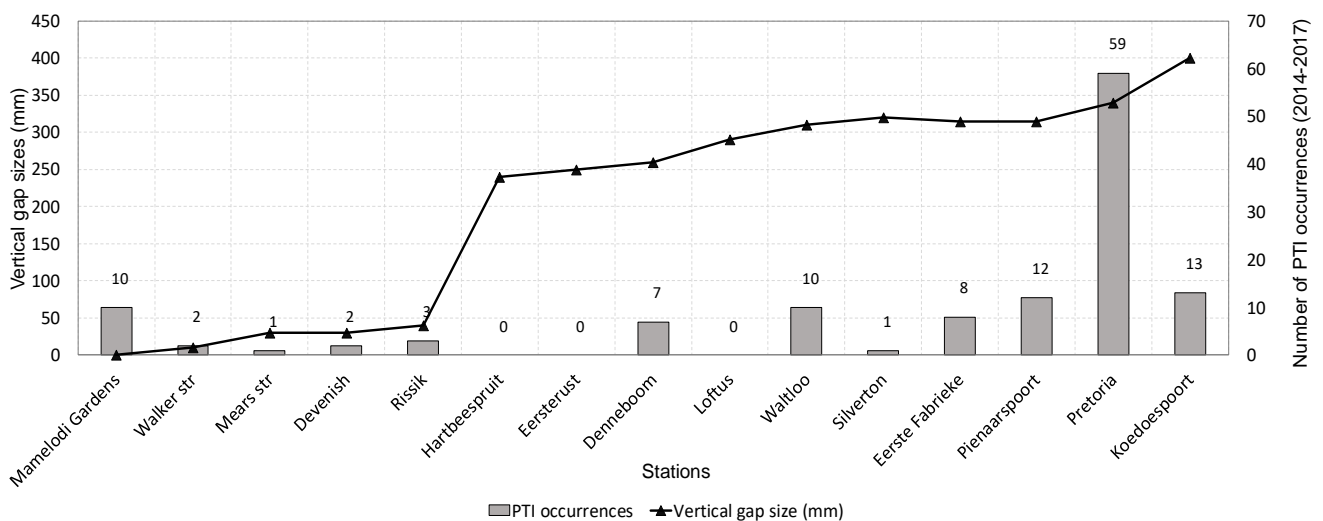
Figure 4-7: Vertical gap sizes measured at the different stations and the corresponding PTI occurrences recorded at each station (RSR, 2014-2017)

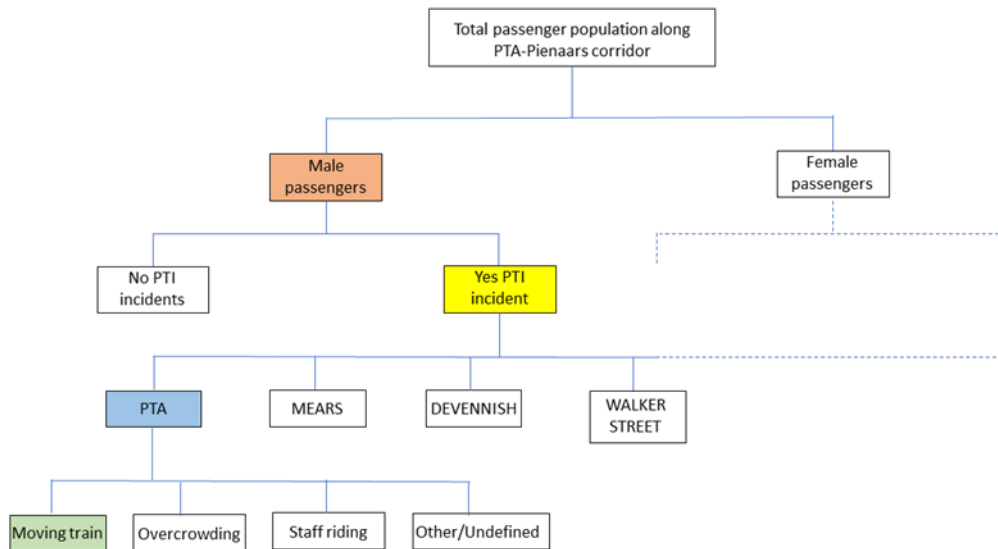
Figure 4-10: Partial schematic of the Fault tree approach

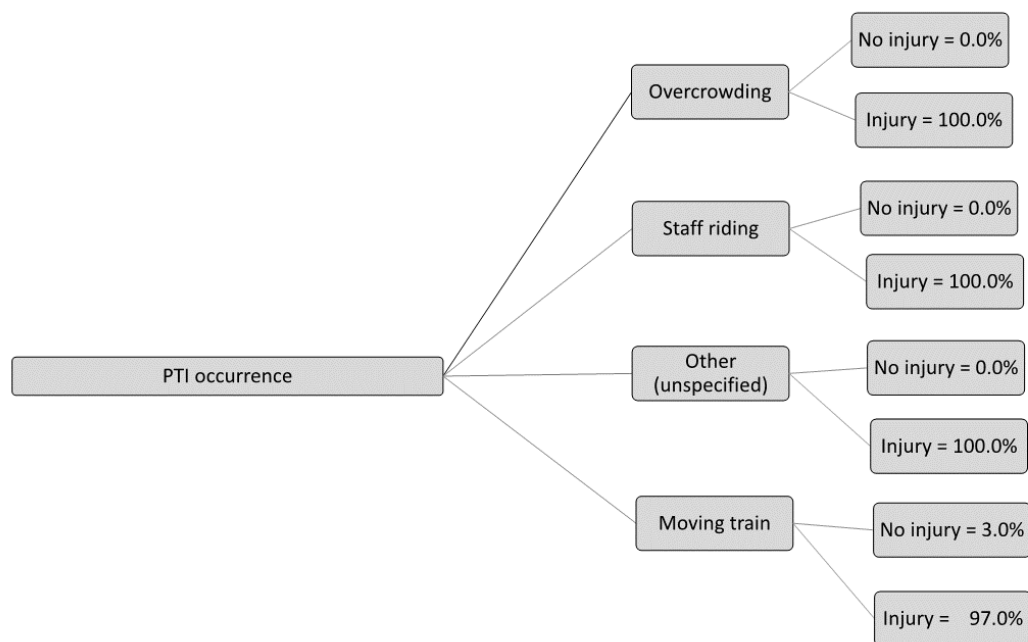
Figure 4-23: Fault tree representing the estimated probability of an injury caused by a PTI occurrence

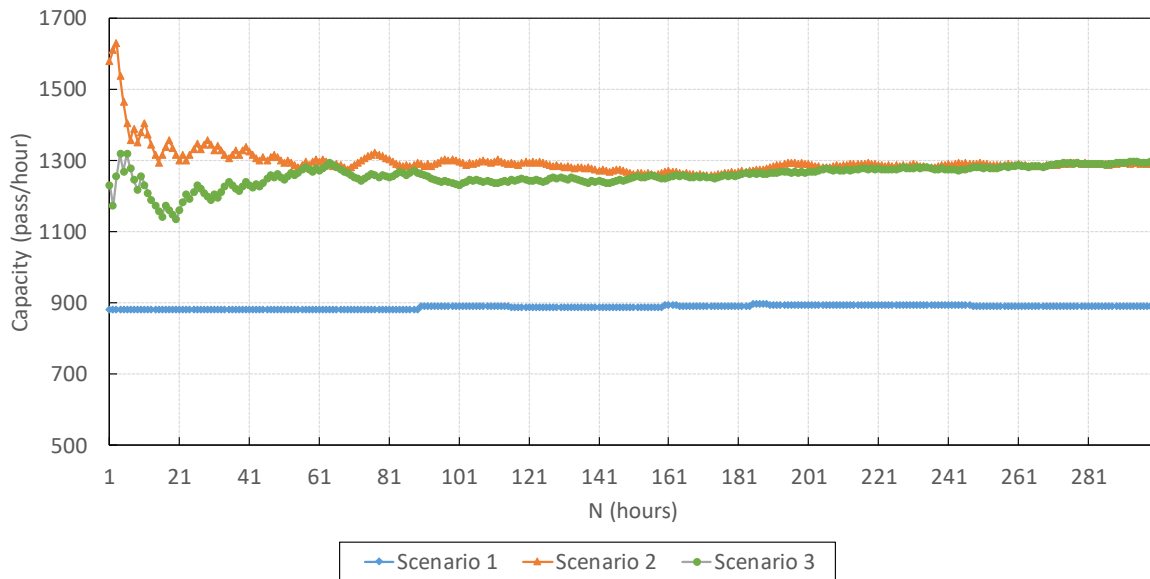
Figure 4-24: Train capacity in passengers per hour calculated for the different scenarios considered in the simulation
