SPEED MANAGEMENT IN TRANSITION ZONES BETWEEN HIGH-SPEED RURAL AND LOW-SPEED URBAN AREAS

M SCHRODER* and I BRITTEN**

Royal HaskoningDHV House, Tygerberg Park, 163 Uys Krige Drive, Platteklouf, 7500

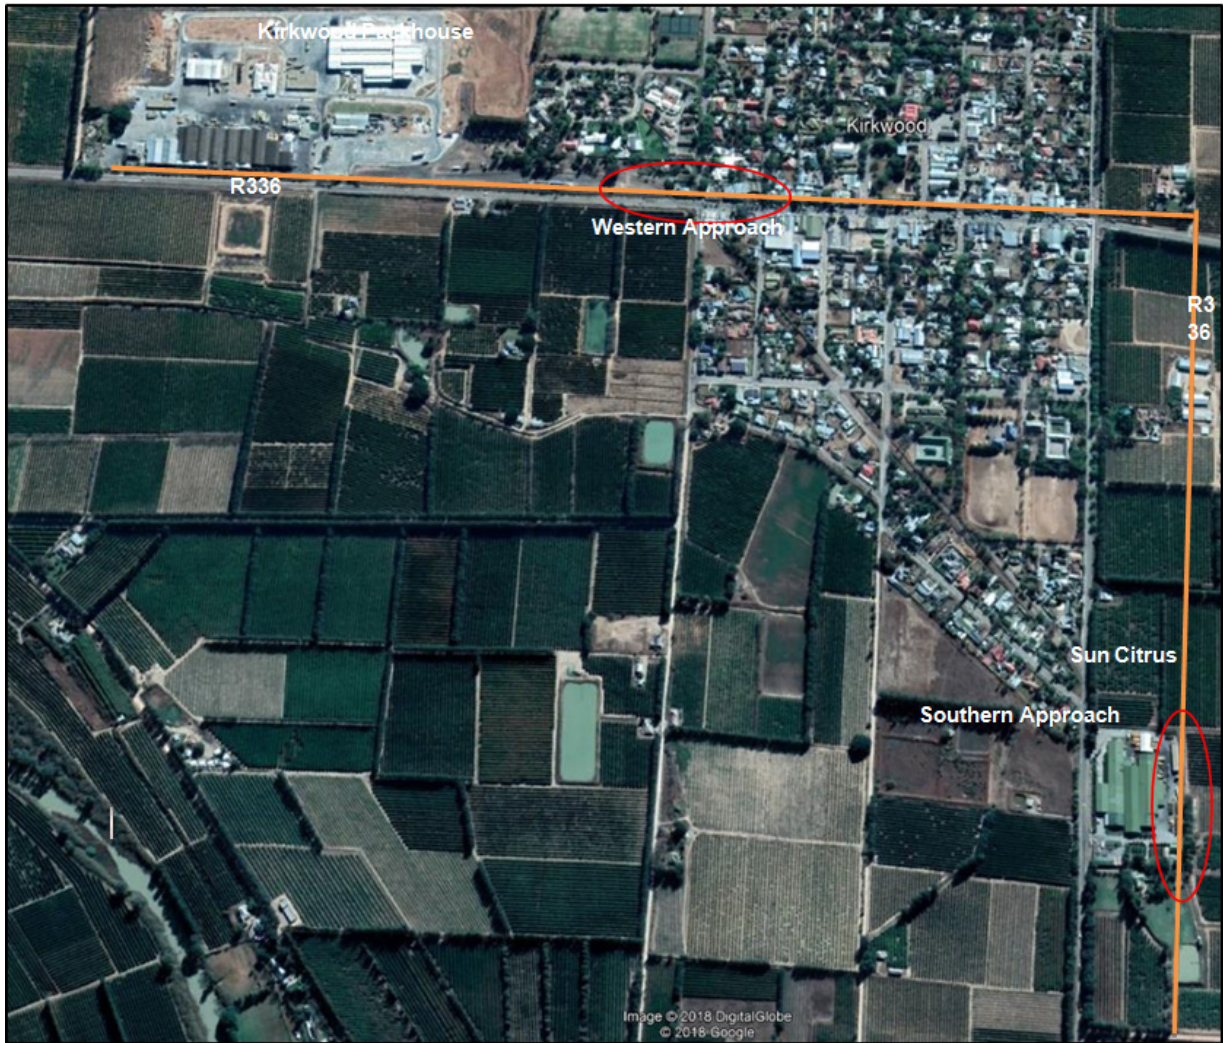
Figure 2: Kirkwood

Kirkwood, Figure 2, is the largest of the 3 urban areas. The town of Kirkwood is more established and has a more distinct urban edge. This distinct edge allows drivers approaching the town to identify when they are entering the town and inform them of the low-speed area.

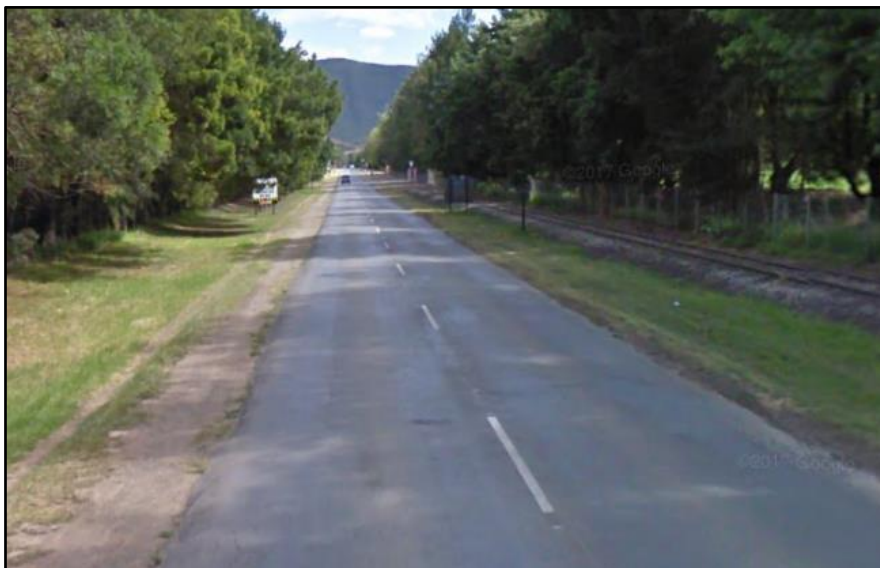
Photograph 1: Southern Approach to Kirkwood

The Western approach to Kirkwood was not assessed in detail as it was outside the extent of the case study. When entering Kirkwood from the South, as shown in Photograph 1, a natural transition zone with a distinct change is not as evident with the agricultural land running right up to the edge of the residential area. The adjacent residential area also has lower levels of activity compared to the central business district (CBD) which is situated more to the Western side of Kirkwood and this does not provide the drivers confirmation that they are entering an urban area. The 60 km/h sign is located 500 m before the urban edge on the Southern approach.

The wide road reserve including an open railway line hides the urban edge and does not provide for a natural transition zone. The section of road is straight with a flat grade. This situation leads to the encroachment of the high-speed area beyond the urban edge and before the motorist can reduce their speed they are within the residential area. There is a large access to Sun Citrus Packhouse at the urban edge with slow heavy vehicles turning in and out of the access. A severe accident was reported by the local residents in front of the Sun Citrus access. The accident involved a passenger vehicle colliding with a heavy vehicle turning at the access.

the case study at the access to Sun Citrus, at the Southern approach to Kirkwood. The following safety measures were implemented:

- The roundabout improved access to the road at this location and lowering the speed in this area.
- High visibility signage.
- COSBI lines.
- Raised speed bump blocks placed on the painted islands. Example illustrated in Photo 6.

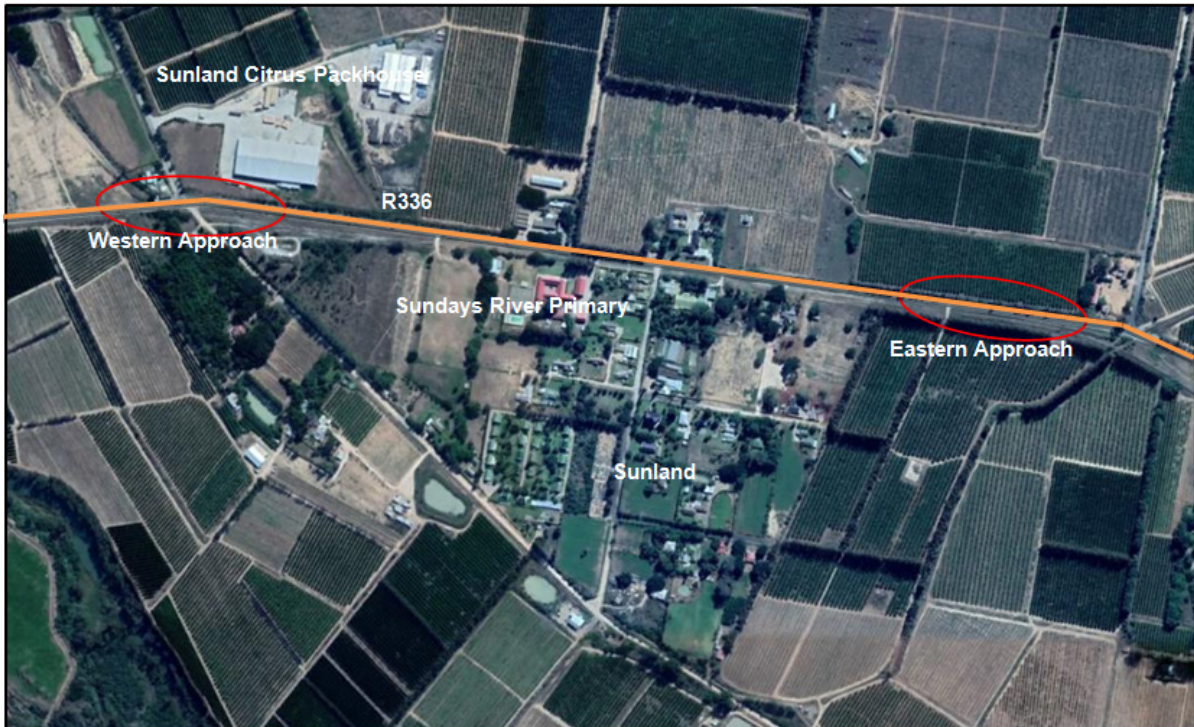
Figure 3: Sunland

The town of Sunland, shown in Figure 3, is located 7 km to the West of the R336/R335 intersection at Addo towards the end of the project. Sunland is situated on a 1 km stretch

of the R336 with a Packhouse, school and residential houses in the town, of which the school and the small residential area lie adjacent to the R336. This is the smallest of the 3 towns in the area and the low density and poor definition of the urban area and edges makes it difficult to distinguish between the high-speed rural area and low-speed urban area.

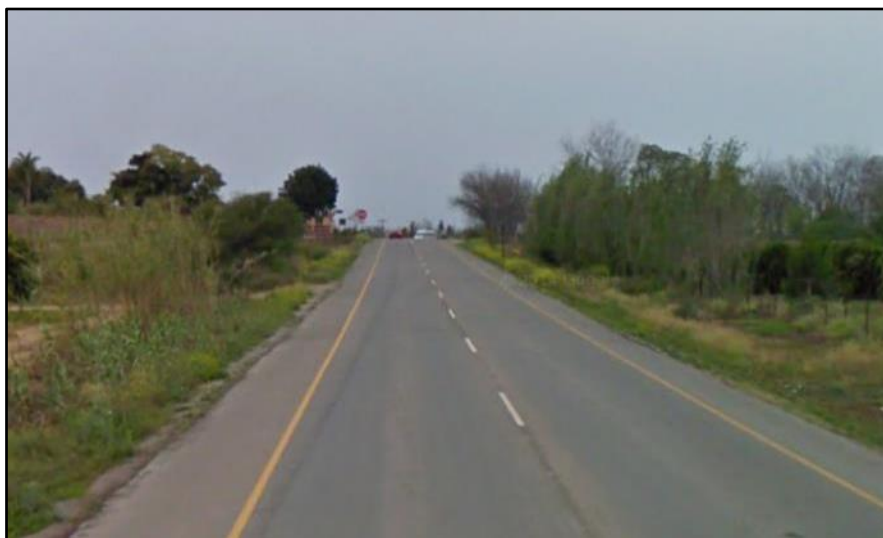
Photograph 2: Western Approach to Sunland

Approaching Sunland from the West, Photograph 2, the road is straight with a vertical crest curve hiding the first intersection. There is very little distinction between the high-speed rural area and low-speed urban area. There is a railway level crossing just before the intersection approaching from the West. The 60 km/h sign is located 100 m before the urban edge on the Western approach.

The Western approach from Kirkwood to Sunland is a critical approach as the motorist has travelled on a high-speed rural area for over 20 km. An adjustment to the geometry was again proposed in the case study on this approach and the following safety measures were implemented:

- A roundabout.
- High visibility signage.
- COSBI lines.
- Raised speed bump blocks placed on the painted islands.

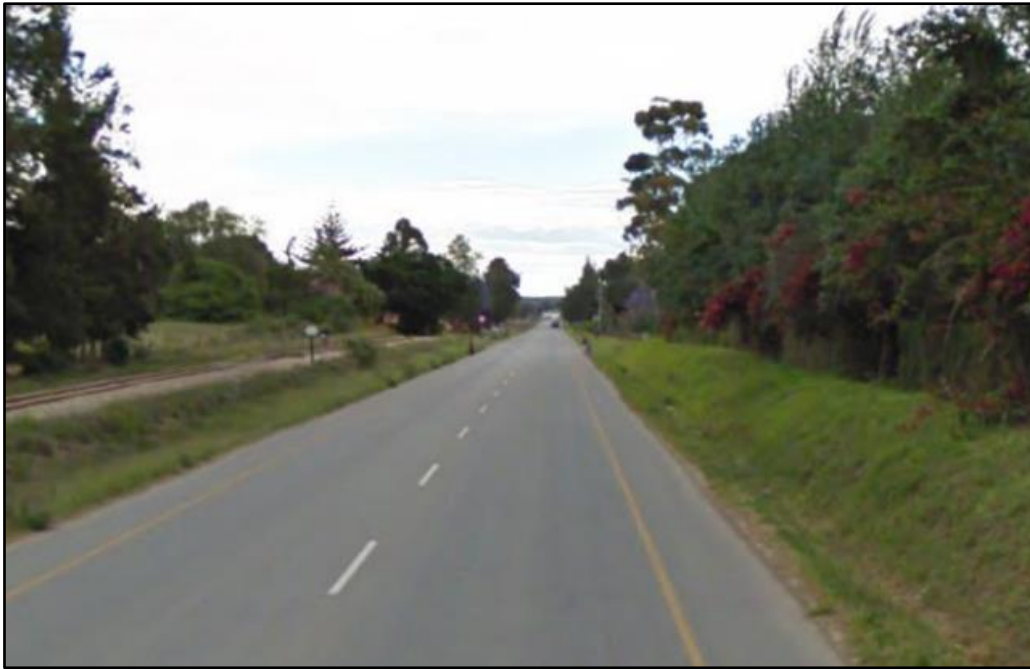
Photograph 3: Eastern Approach to Sunland

The Eastern approach to Sunland is straight and flat, as shown in Photograph 3. The natural vegetation, wide road reserve including an open railway line hides the urban edge and does not provide a natural transition zone. The short urban area frustrates motorists having to slow down for such a short section of road on their typical longer through journey. The 60 km/h sign is located 200 m before the urban edge on the Eastern approach.

The speeds on the Eastern approach to Sunland is more acceptable as there is only a distance of 3.5 km between Sunland and Hermitage. Only signage was proposed in the Eastern transition zone.

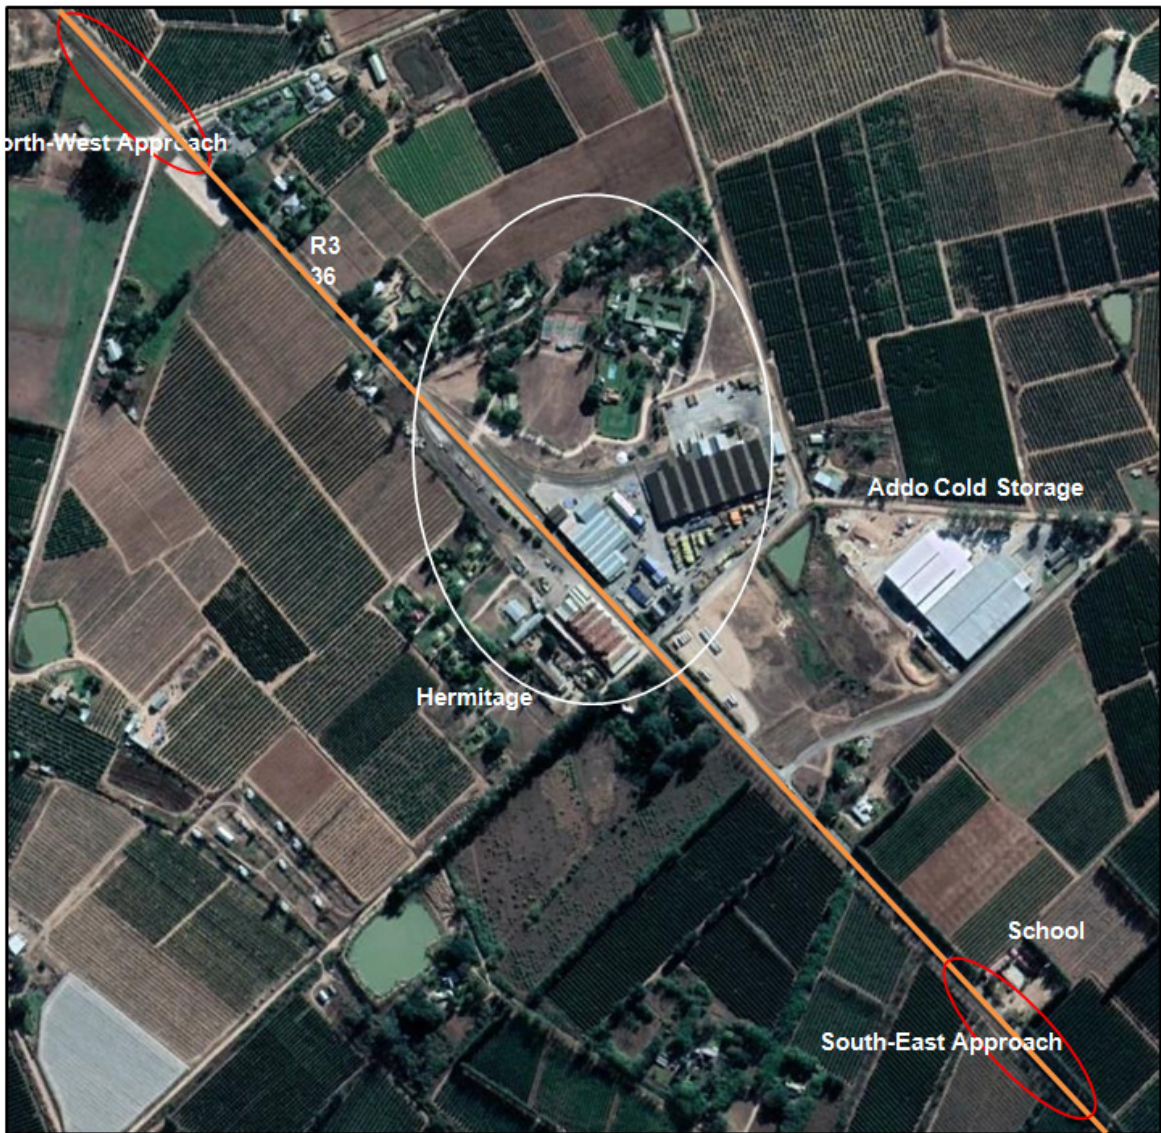
Figure 4: Hermitage

Hermitage is situated just before the end of the project, as shown in Figure 4, 1 km from the R336/R335 intersection at Addo. The town has a micro CBD area of 200 m situated in the middle of the town. Hermitage is slightly spread out over 700 m with isolated pockets of development along the R336. A large Packhouse, school and industrial activities are located in Hermitage.

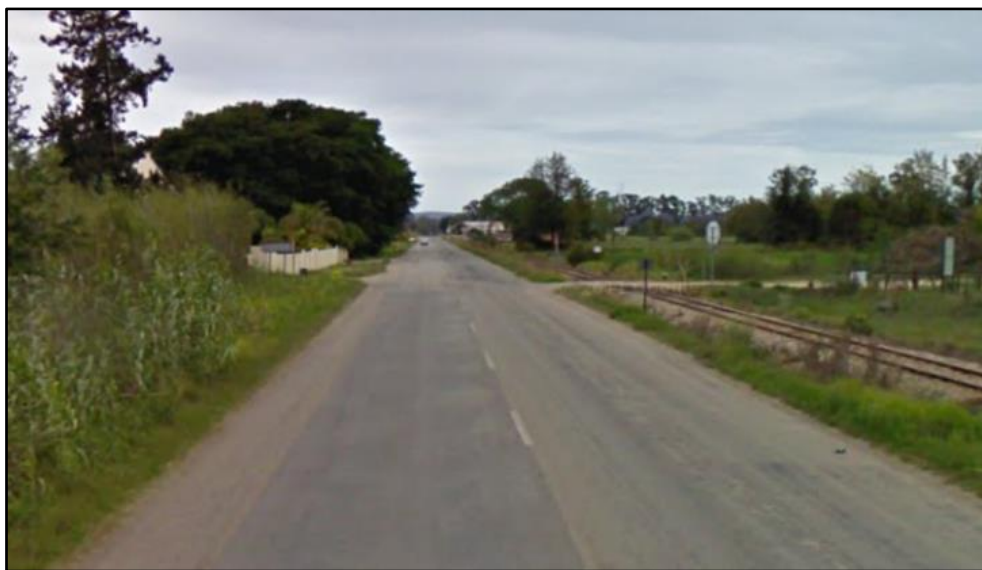
Photograph 4: North-Western Approach to Hermitage

When approaching Hermitage from the North-West the transition zone between the high-speed rural area and the low-speed urban area is slightly better than the South-East approach. It is still not good but the residential houses are visible as seen in Photograph 4. There is a short distance of 3.5 km between Sunland and Hermitage, therefore the transition zone on the Sunland side of Hermitage and the transition zone on the Hermitage side of Sunland is acceptable as drivers had already gone through a town. The distance between the two towns is such that driver have not become used to traveling at high-speed and may therefore more readily adapt to low-speed. The road is straight and flat leading into the town and there is a railway line inside the road reserve. The 60 km/h sign is located 100 m before the urban edge on the North-Western approach.

The North-West approach to Hermitage is similar to the Eastern approach to Sunland as the distance between the two towns is short. Only signs as safety measure in the transition zones were proposed.

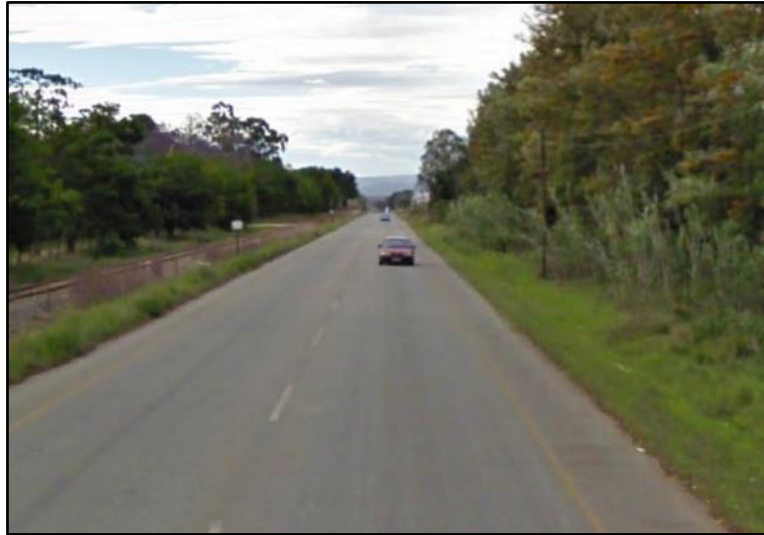
Photograph 5: South-Eastern Approach to Hermitage

The South-East approach to Hermitage seen in Photograph 5 is more deceptive than the North-West approach. It is at the end of the first straight, 1.5 km in length, after turning onto the R336 in Addo. The natural vegetation conceals the urban edge significantly in this zone. The road is straight and flat in this transition zone. A small school is hidden away in this section which creates a very dangerous situation with motorists travelling at high-speeds right past the school. The 60 km/h sign is located 100 m before the urban edge on the South-Eastern approach.

The South-East approach to Hermitage is at the start of the R336. The important to set the tone for the entire length of R336 was highlighted in the case study. It was therefore proposed in the case study to adjust the geometry by means of the following:

- A roundabout.
- High visibility signage.
- COSBI lines.
- Raised speed bump blocks placed on the painted islands.
