OLD CONCRETE MAKES WAY FOR NEW ASPHALT

AJ LAATZ¹, N COCKS² and N BURGER³

ABSTRACT

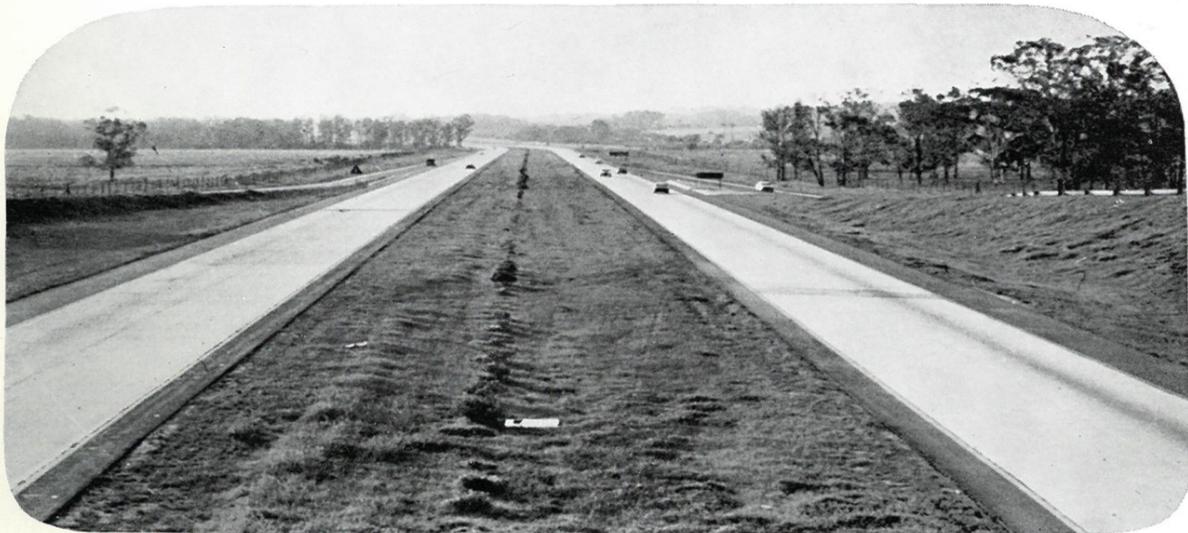
Figure 1: Old National Route 2 prior to 1974

The existing national route before the 1970's project was implemented was a two lane single carriageway road constructed from granular materials and sealed with a stone seal. The 1970's project upgraded this facility to a four lane dual carriageway. The interesting engineering challenge however was to construct the project using jointed concrete and utilising a slip-form paving train. A batching plant that could batch up to two thousand cubic metres of concrete per day was set up and concrete using the local hornfels stone was produced.

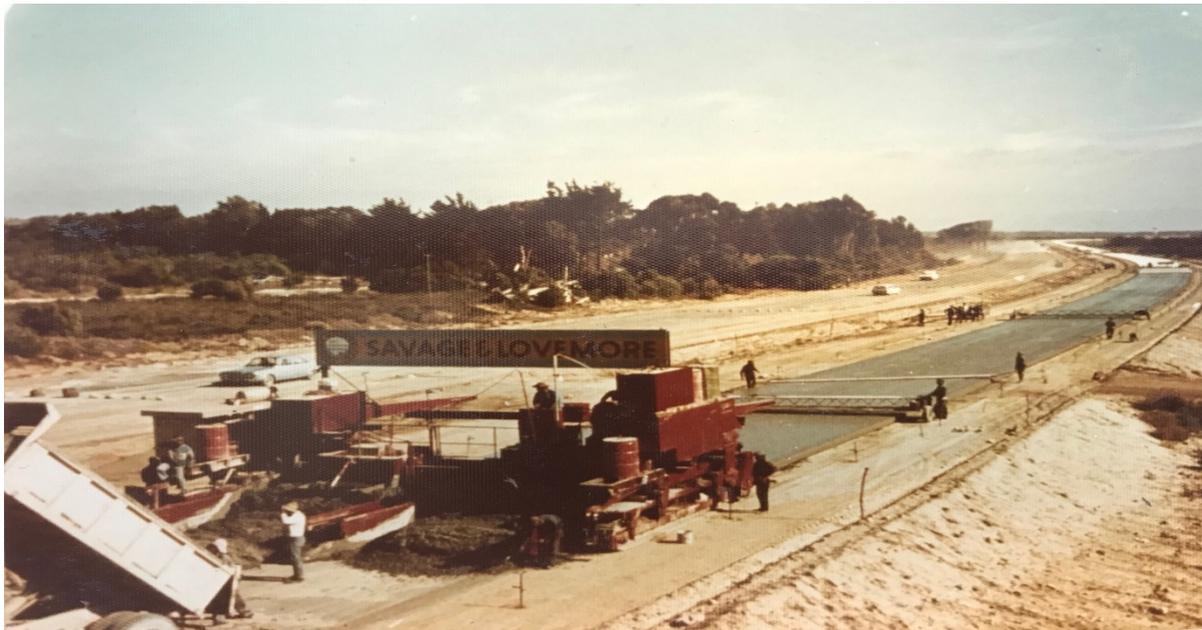
Figure 2: Concrete Construction Train

The paving train placed two full lanes around 8 metres in width in one operation, firstly placing a 100 mm layer of cement stabilised basecourse on top of a 75 mm layer of granular subbase and secondly placing a 200 mm layer of concrete. The concrete placement was combined with the insertion of polythene tape to separate the two concrete lanes with a centre longitudinal construction joint and used automatic tie-bar inserting techniques to place high tensile steel tie-bars down the split middle. At the end of each working day, steel dowels were placed for continuity to form keyed dowelled transverse construction joints. The surface of the concrete was textured using a hessian drag and sprayed with a curing compound. Transverse joints were cut to form weakened plane joints at approximately 4 metre intervals which resulted in the panel layout structure of the jointed concrete pavement.

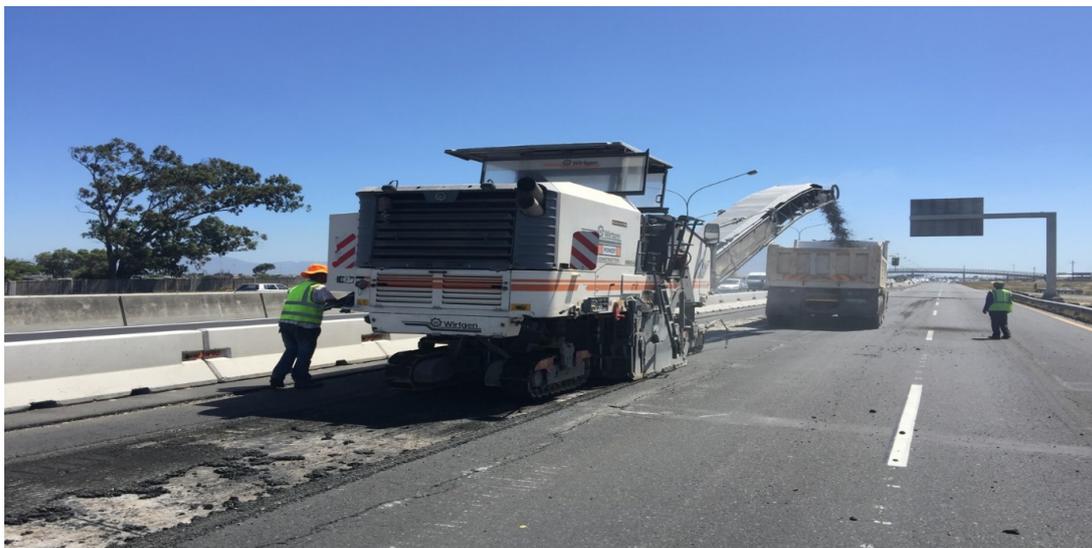
Figure 3: Reclaiming RAP

Within the 4.4 km of the existing road prism, 13 000 cubic metres of concrete material and 5 000 cubic metres of asphalt material (SAMI and asphalt overlay), was available to be recovered from the existing layer-works. This approximately 50mm layer of Reclaimed Asphalt Material (RAP) was all fully recovered for re-use in the new pavement layer-works.

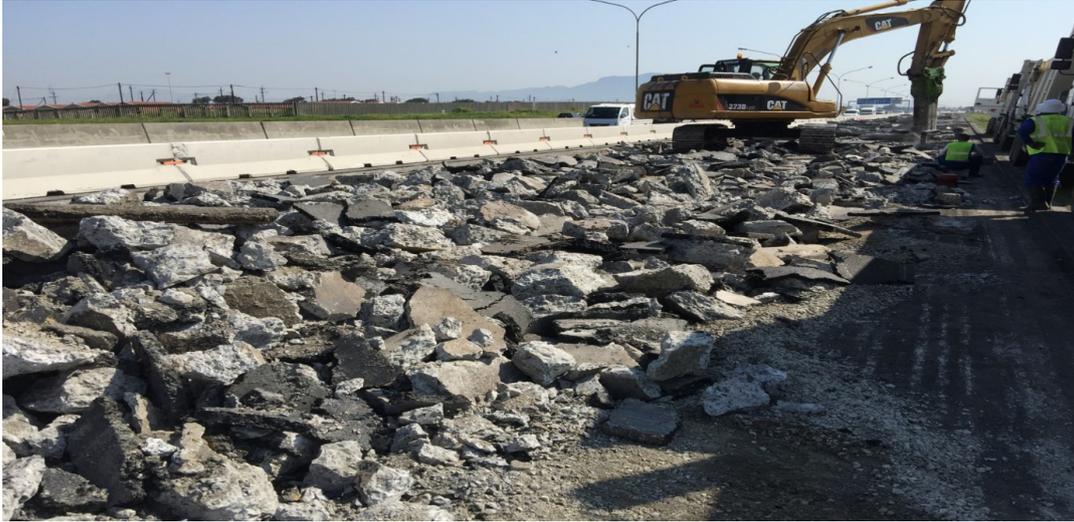
Figure 4: Breaking up Concrete

- Provision of a stockpile site and haul to and from the stockpile site to the work zones;
- Complete breakdown and crushing of recovered concrete and RAP to conform to minimum of COLTO G5 specifications;
- Allowance to add fines during the crushing process to ensure sufficient materials in the sand and dust grading regions.

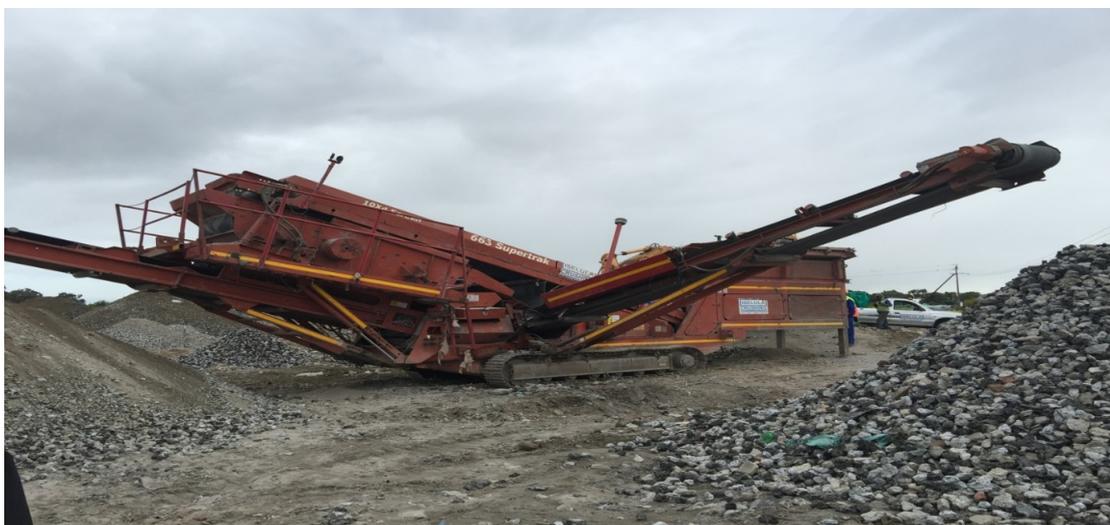
Figure 5: Crushing and Blending Concrete and RAP

The specifications required the concrete material to be broken down and crushed at a stockpiling site to comply with COLTO G5 material classification in terms of grading modulus. This requirement was to provide either COLTO G5 material that could be used for both upper selected pavement layers or for the aggregate for the COLTO C3 cement stabilised subbase layers. The specifications allowed the existing bituminous surfacing materials which were part of the reclaiming process to be included in the final material mix. The processing of the reclaimed material took place close to the site on private commercial property and did not trigger any environmental responses.

The RAP was blended with crushed concrete. No additional sand was necessary to be added to the blend. Approximately 500 tons of concrete and 200 tons of RAP was put through the two stage crusher and blended on a daily basis.

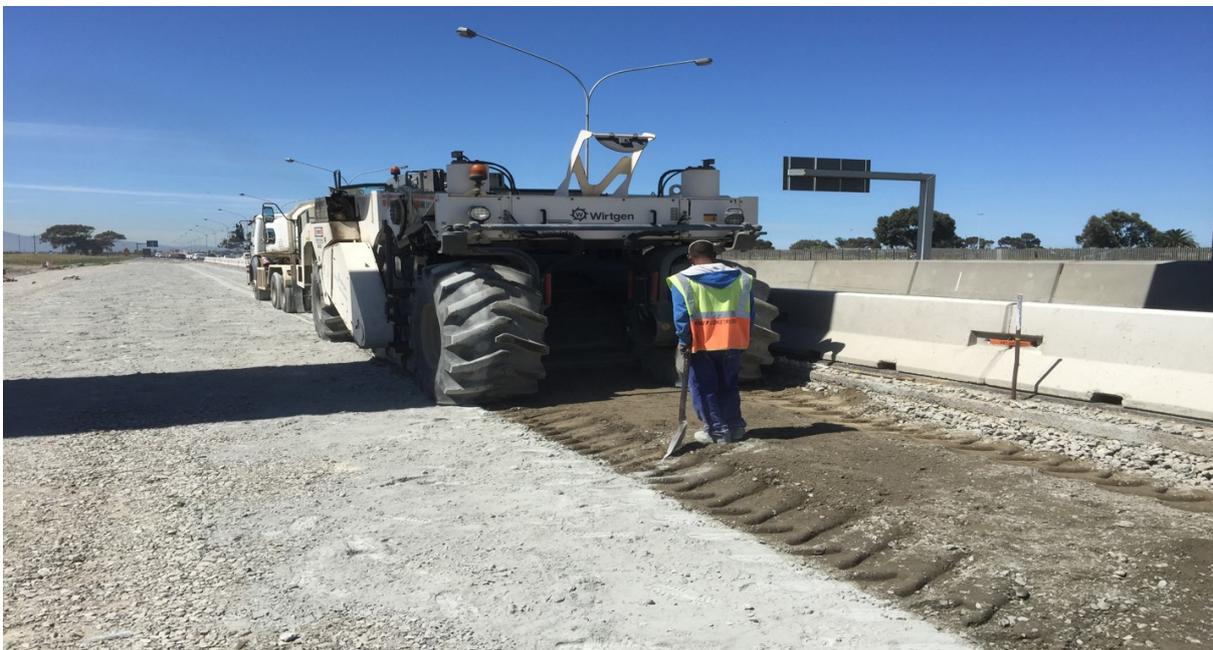
Figure 6: Stabilising Blended Material

The Blended concrete and RAP material was used for both un-stabilised selected layer-works complying with COLTO specifications, G6 and G5, as well as cement stabilised subbase complying with COLTO C3 standards. The grading modulus of the blended aggregate was around 2.6 on this project, achieved with two stage crushing. This fairly high grading modulus resulted in the material being more difficult to work with and test. The blended material exhibited no plasticity. Optimum moisture contents (OMC) were between 10 and 12 as expected in recovered material but adequate compaction was achieved at 50% to 60% OMC.

The blended material un-stabilised exhibited good CBRs as a result of the good grading and complied with COLTO G4 specifications. All testing on the project was in accordance with TMH1 (Technical Methods for Highways, Standard Methods of Testing Road Construction Materials, 1986). The blended material exhibited good and adequate UCS and ITS results. The blended material was easily combined with cement, processed as a stabilised subbase and compacted to 98% modified AASHTO density. UCS results always exceeded 1.5 MPa, meeting COLTO C3 specifications and often achieving over 3.0 MPa as well as uniformly recorded adequate ITS results around 200 kPa to 250 kPa.

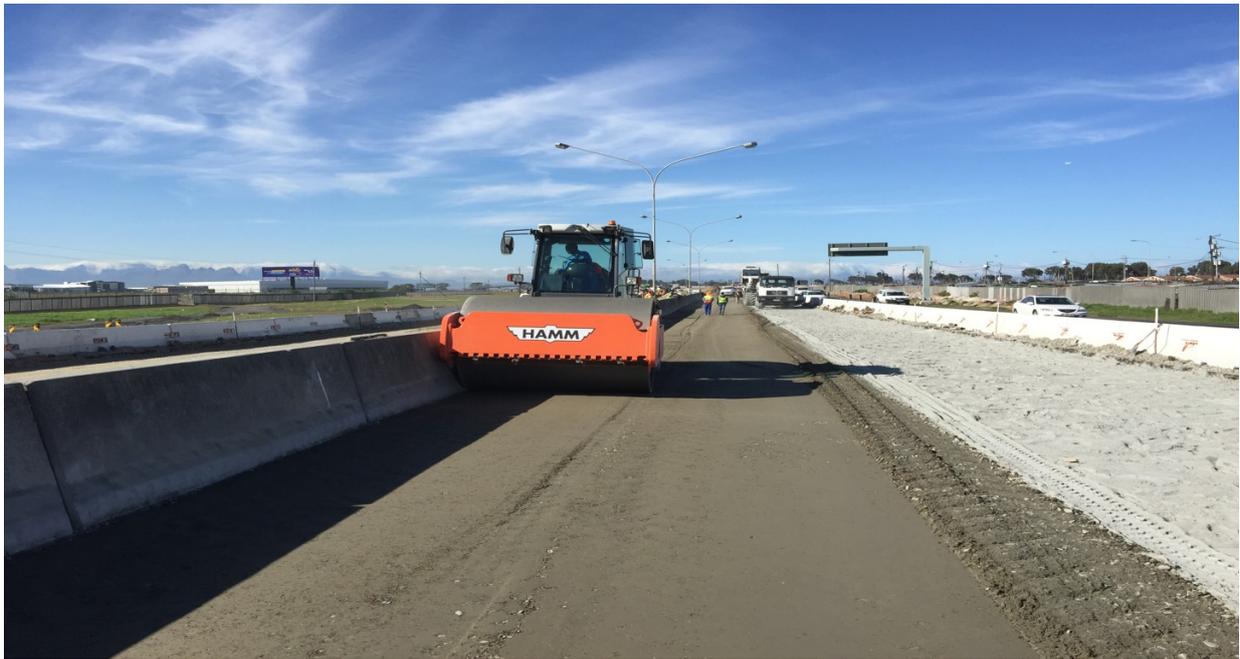
Figure 7: Final Processing of Blended Material

The asphalt pavement layers for the remaining cross section where the concrete was recovered were supported by a 250mm for the middle lane and 300mm for the slow lane cement stabilised recovered processed concrete material with around 10% of recovered asphalt material stabilised with 3% CEM II 32.5 cement. The stabilised subbase layers of this cross section were supported by 150mm of selected layer produced from un-stabilised recovered processed concrete material also with around 10% of recovered asphalt material.

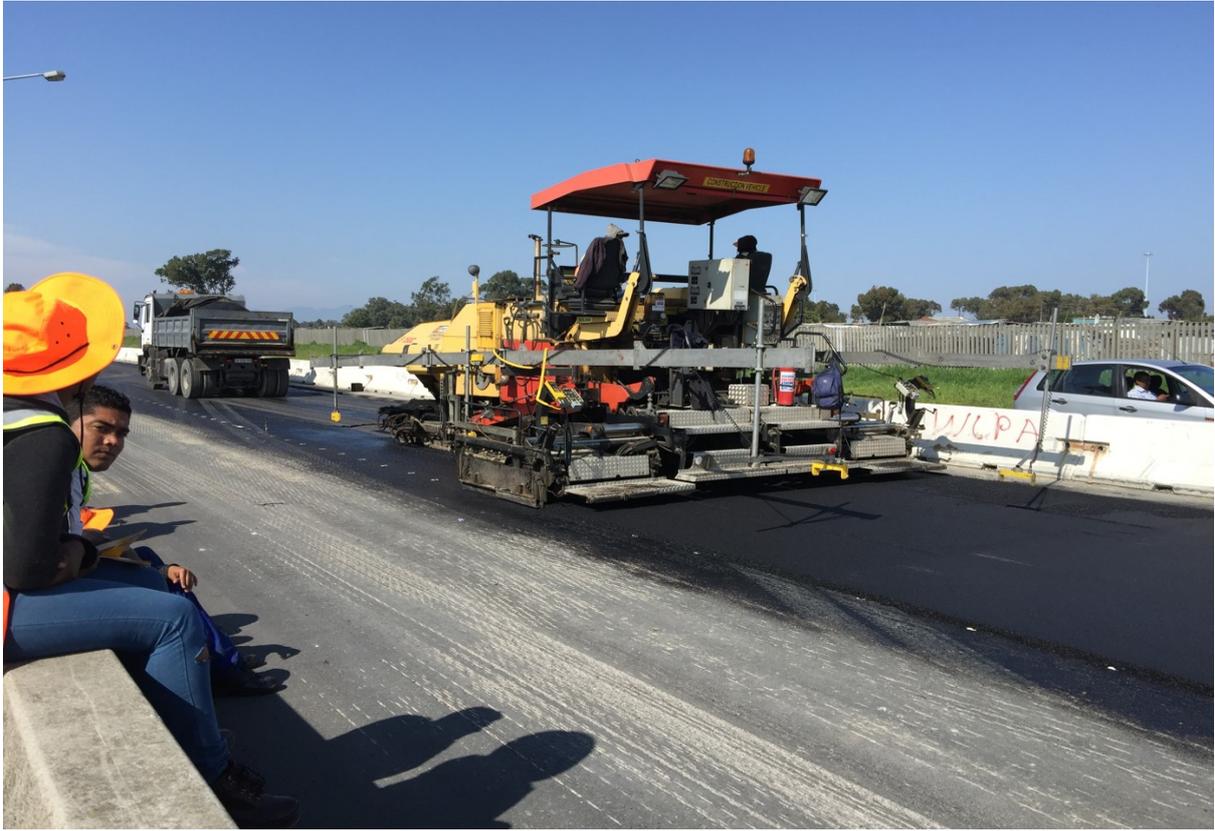
Figure 8: Placing Asphalt Base

The asphalt pavement layers consisted of, firstly a continuously graded base mix with 37,5mm maximum stone size with a polymer modified binder of TG1 A-P1 specification (Technical Guideline 1, 2015) at 4.1%, secondly a continuously graded surfacing mix with 13mm maximum stone size and a polymer modified binder of TG1 A-E2 specification at 5.3% and finally an ultra-thin friction course (UTFC) with 13mm maximum stone size with a polymer modified binder of TG1 A-E2 specification at 4.3%.

The larger stone continuously graded base mix with 37,5mm maximum stone size as used on this project is not often used anymore in the Cape due to differing preferences by the authorities. It has however been successfully used on many projects with negligible distress such as deformation and cracking on industrial and town roads for over 20 years. This material is also well placed to assist in the accommodation of traffic with changing

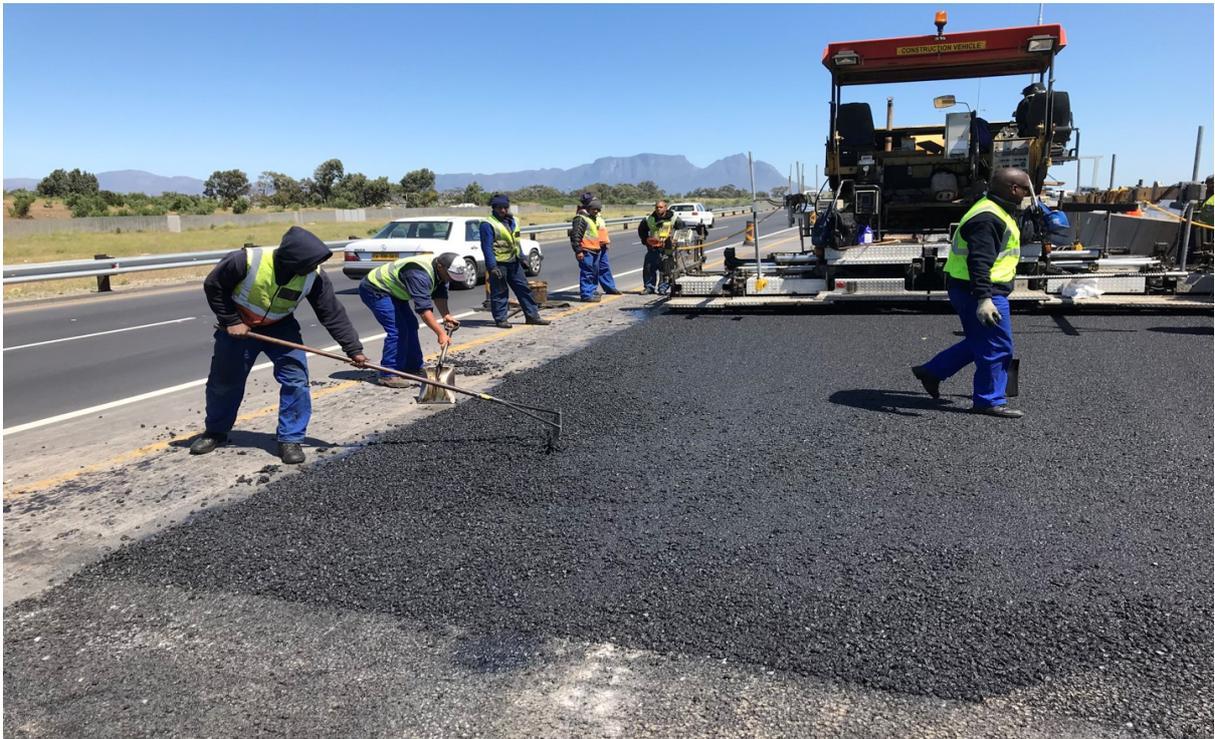
Figure 9: Placing Asphalt UTFC
