Errors in root canal preparation: a review of the literature and clinical case reports

SADJ June 2019, Vol. 74 No. 5 p246 - p254

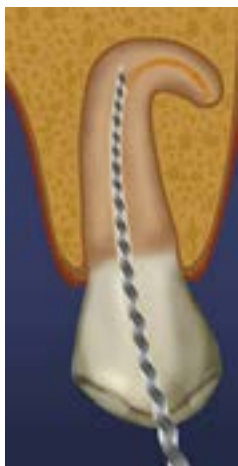
Figure 1. Schematic representation of a ledge formed within the original canal path as a result of skipping instrument sizes or erroneous working length estimation.

Typically, ledge formation occurs when stiff files with sharp inflexible cutting tips are used in a rotational motion in curved root canals. This common procedural error usually occurs on the outer side of the curvature when instruments are used aggressively, with exaggerated cutting during root canal instrumentation.⁶ Ledges are formed either within the original canal path or through creating a new false canal (Figure 1).

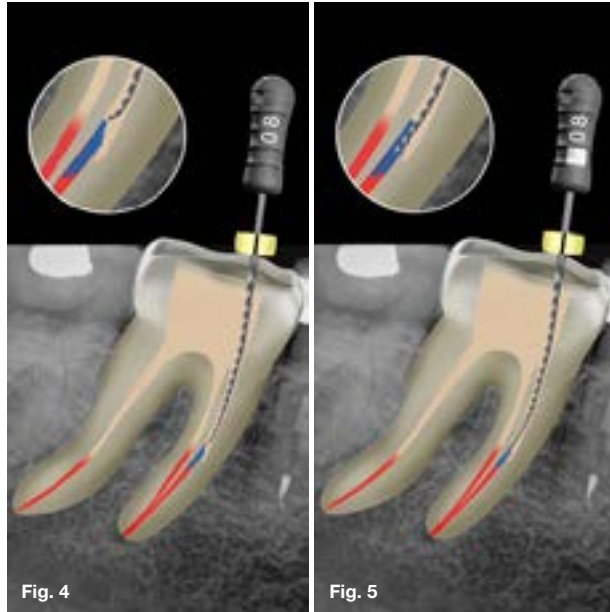
Figure 4. A size 08 C+-File (21 mm) with a distinct curve in the apical 2-3 mm of the file was selected in the attempt to bypass the ledge.

Figure 5. A size 08 C+- File was used in a slight rotation motion combined with a light “picking motion” to discover the original canal entrance.

Figure 6. Postoperative periapical radiograph immediately after obturation.

A size 08 C+-File, 21 mm long, with a distinct curve in the apical 2-3mm of the file was selected in the attempt to bypass the ledge. The directional marker on the rubber stop was positioned to indicate the direction of the curve placed on the tip of the file (Figure 4).

motion combined with a light “picking motion” was used to try to discover the original canal entrance. After several attempts, re-orientating the file in different positions, the pre-curved file tip advanced for about 0.5mm (Figure 5).

Figure 6 shows the final result after glide path preparation with a ProGlider (Dentsply Sirona), canal preparation with a Primary WaveOne Gold (Dentsply Sirona) instrument and canal obturation with gutta-percha and Pulp Canal Sealer (SybronEndo, Orange, California) using warm vertical condensation technique.

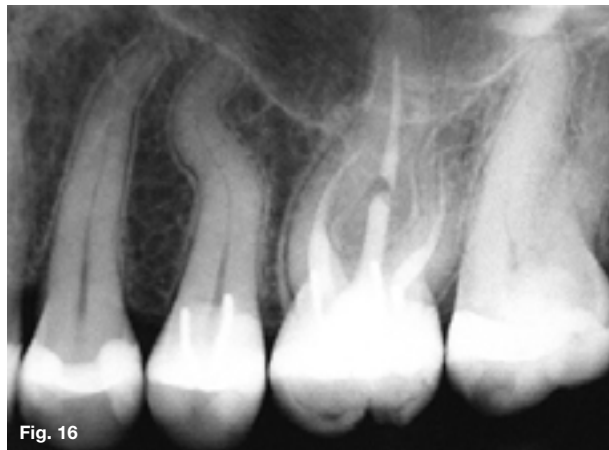
Figure 16. A preoperative peri-apical radiograph a maxillary left second premolar, restored with a large composite resin restoration and two retention pins. Note the “S” shaped or bayonet-shaped root canal configuration.

The patient, a 37 year old female presented with irreversible pulpitis on her maxillary left first second premolar. The tooth had been previously restored with a large composite resin restoration and two retention pins. A preoperative peri-apical radiograph (Figure 16) and a length determination radiograph (Figure 17) revealed and confirmed a challenging “S” shaped or bayonet-shaped root canal configuration.

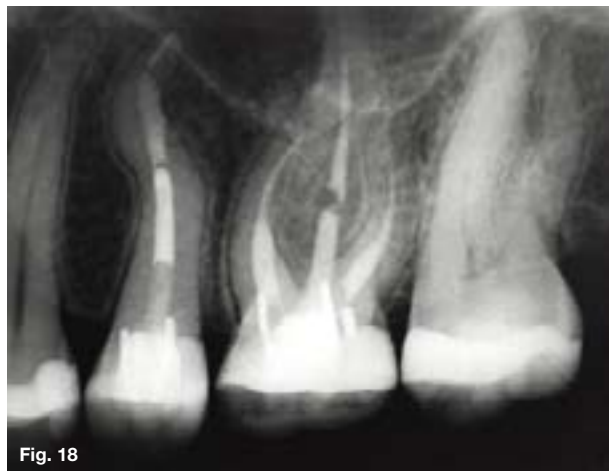
Figure 18. Rotary file fracture in the apical part of the root canal and a strip perforation at the point of maximum curvature on the distal aspect of the root that was repaired with ProRoot MTA (Dentsply Sirona) before conventional canal obturation, placement of a fibre post and composite to close the access cavity.

After canal irrigation, the perforation was repaired with ProRoot MTA (Dentsply Sirona) before conventional canal obturation (Figure 18).

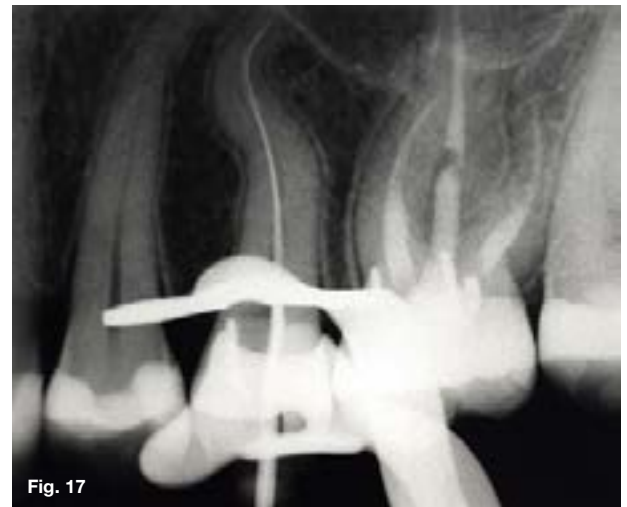
Figure 17. A peri-apical length determination radiograph confirmed the “S” shaped or bayonet-shaped root canal configuration.

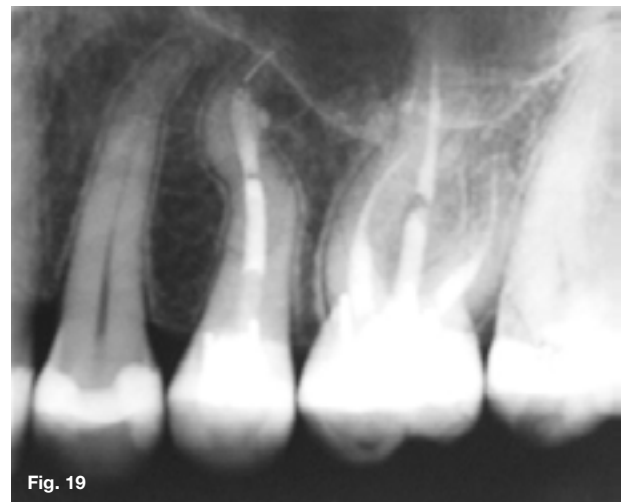
Figure 19. A four year follow up radiograph with some evidence of resorption of the extruded Proroot MTA material.

The access cavity was restored with composite resin and placement of a fibre post. Figure 19 shows a four-year follow up radiograph with some evidence of resorption of the extruded ProRoot MTA material.

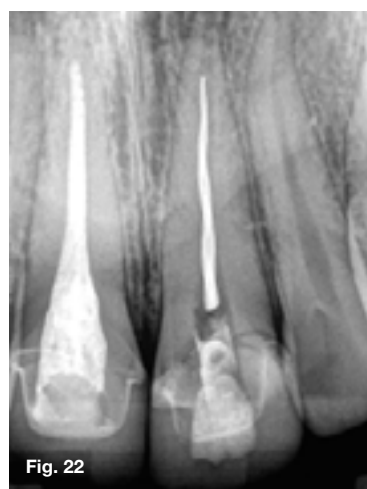
Figure 22. Peri-apical radiograph of a maxillary left upper central incisor with a fractured fragment (14 mm long).

The patient, a 21 year old male presented with a fractured rotary file in his maxillary left upper central incisor. The fragment (14 mm long) was located approximately 4 mm apically from the cemento-enamel junction at the coronal aspect extending apically to about 5 mm from the apical foramen (Figure 22). Under 15x microscope magnification, the fractured instrument was clearly visible in the canal (Figure 23).

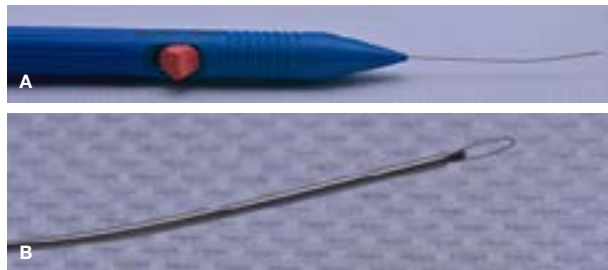
Figure 25. (A) The Yoshi Loop (Dental Cadre), a stainless steel micro-lasso that extends from the end of a stainless steel cannula attached to a handle with a retraction button for tightening the loop around a file segment; (B) Magnified view of the cannula and stainless steel micro-lasso.

the file and the canal wall in circular motion until it was noticed that the fractured file was loose in the canal. Considering the length of the fragment it was decided to attempt retrieval using the Yoshi Loop (Dental Cadre) (Figure 25a and 25b), a stainless steel micro-lasso that extends from the end of a stainless steel cannula attached to a handle with a retraction button for tightening the loop around the file segment.

Under magnification, the preformed loop was carefully placed around the exposed coronal aspect of the file. The loop was tightened around the fractured file by moving the retraction button on the loop system. The loop device was then used to slowly pull the loosened fragment from the root canal system (Figure 26). Figure 27 shows a magnified view of the retrieved instrument attached to the micro-lasso from the Yoshi Loop. Note that the tip of instrument is missing, indicating that the file tip must have been fractured in a previous clinical application prior to the case presented in this case report.

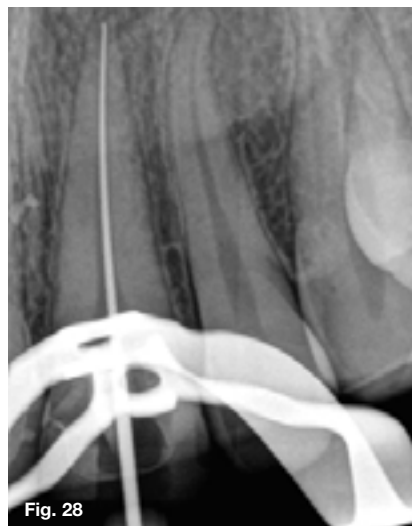
Fig. 28

Figure 28. Size 30 K-File fitted loose in the root canal up to working length as confirmed radiographically and with an electronic apex locator (ProPex Pixi, Dentsply, Sirona).

Having removed the fractured instrument, a size 30 K-File was fitted loose in the root canal up to working length as confirmed radiographically and with an electronic apex locator (ProPex, Dentsply, Sirona). According to the file selection criteria outlined by Van der Vyver et al. (2019)³⁸ for WaveOne Gold files, a size large WaveOne Gold File (45/05) was selected for canal preparation.

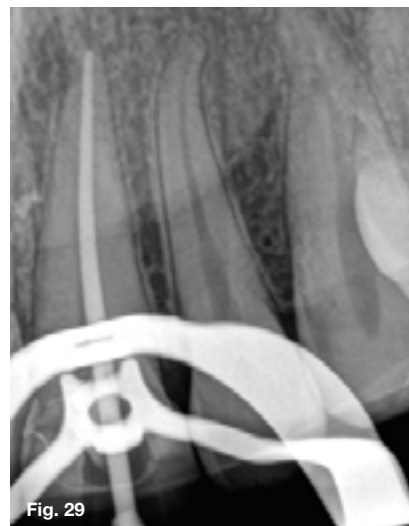
Fig. 29

Figure 29. Cone-fit peri-apical radiograph confirming the correct apical placement of the size Large WaveOne Gold Gutta Percha Point (Dentsply Sirona).

After canal preparation and irrigation with heated 3.5% sodium hypochlorite and 17% EDTA solutions, a size Large WaveOne Gold Gutta Percha Point (Dentsply Sirona) was fitted and the position verified radiographically.

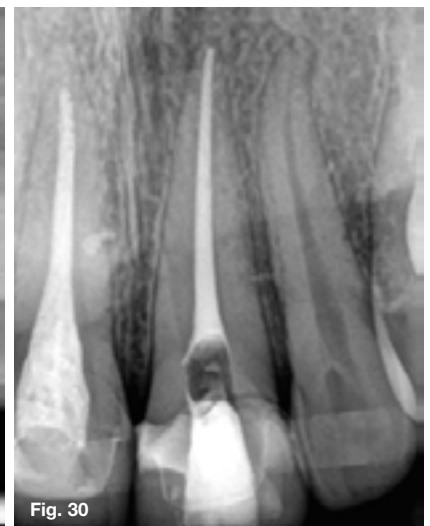
Fig. 30

Figure 30. Immediate post-operative result after canal obturation.

The canal was obturated with the selected gutta percha point and Pulp Canal Sealer (SybronEndo), using the continuous wave condensation technique with the Calamus Dual Obturation Unit (Dentsply Sirona).
