Investigation of damage detection methods for laminated composite materials using full field digital image correlation

By: Crown James Qambela

Master of Engineering

University of Pretoria

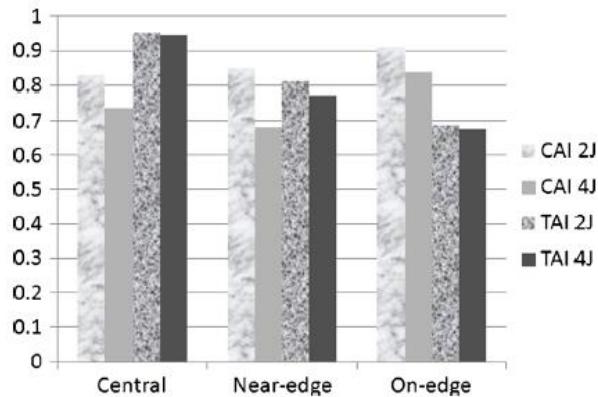
Figure 8: Effects of Impact energy in the CAI and TAI tests (Malhotra and Guild, 2014)

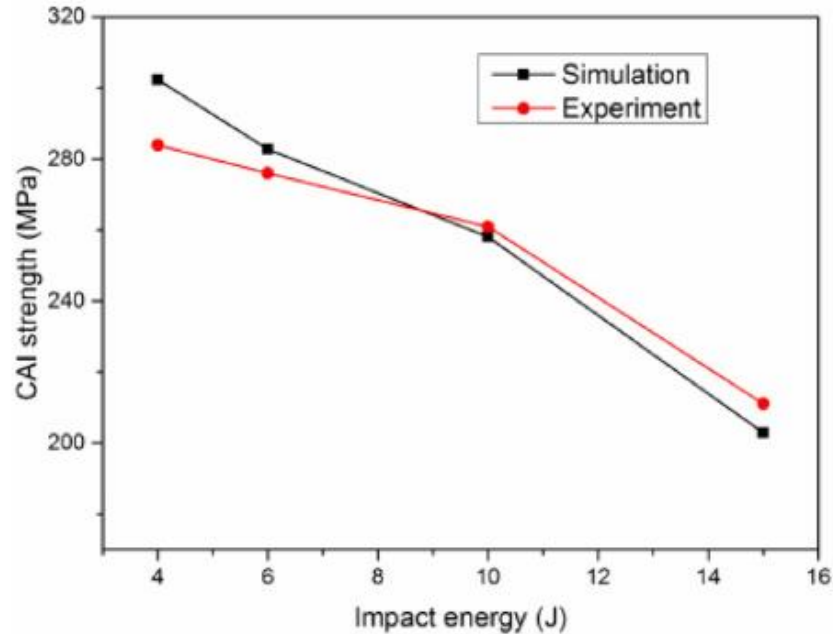
Figure 10: CAI strength results at various energies (Tuo et al., 2019)

Their compression after impact tests revealed that the compressive resistance of all the specimens decreased with increasing impact energy. This was due to the fiber damage incurred after high energy impact, a significant reduction in compression after impact strength was observed (Figure 10).

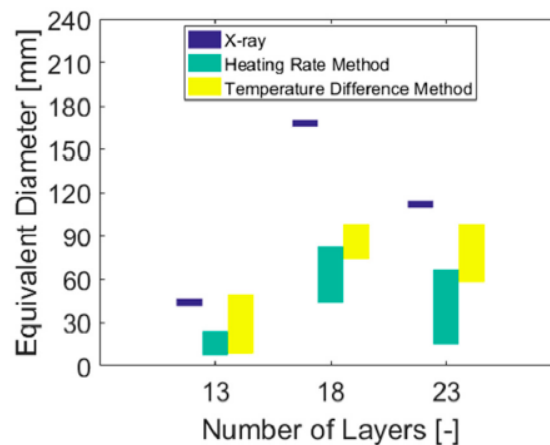
Figure 13: Comparison of the measurable values of equivalent damaged diameter for thermography and radiography (Manes et al., 2018)

Thermography is based on the fact that defects tend to change the thermal conductivity of materials. This method is especially useful for detecting damage in thin parts, because defects that lie deeper under the surface of the material tend to generate less detectable heat fluctuations than defects which lie closer to the surface of the part (Gholizadeh, 2016). Defects with a diameter smaller than their depth in the part cannot be detected using thermography. Flaws such as impact damage and delamination cause a change in the thermal radiation of the material (Meyendorf et al., 2013). (Manes et al., 2018) compared the effectiveness of radiography and thermography in detecting impact damage size in aramid/epoxy laminated composites with varying number of layers. Their results showed that thermographic techniques were able to detect smaller damage sizes caused by ballistic impact than x-ray radiography (Figure 13).

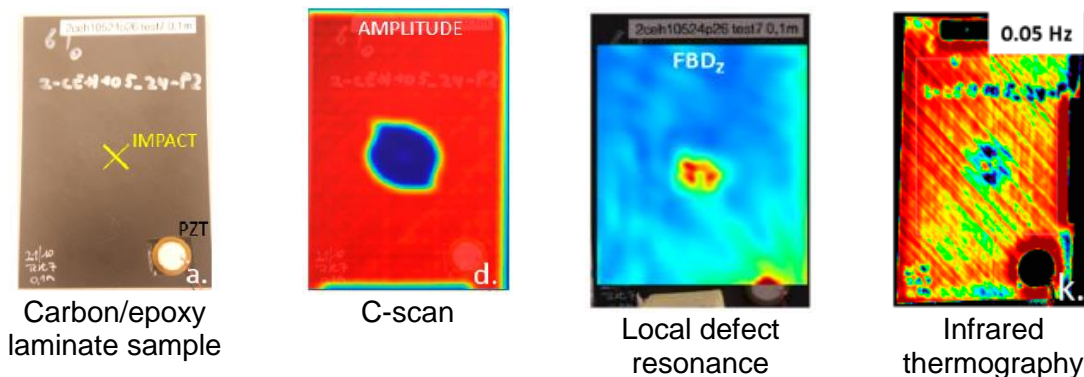
Figure 14: Barely visible impact damage images produced from ultrasonic C-scan, local defect resonance and infrared thermography (Kersemans et al., 2018)

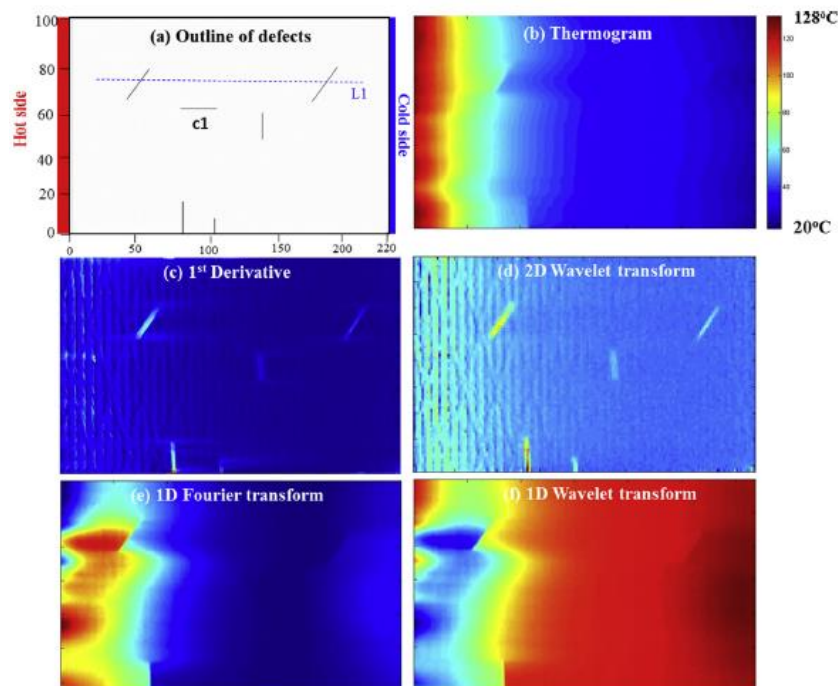
Figure 17: Sample with ply layup $(0^0)_2$: (a) location of known defects, (b) thermographic image after 20 seconds of excitation, (c) norm of the first derivative, (d) 2D wavelet transform, (e) 1D Fourier transform, (f) 1D wavelet transform (Chrysafi et al., 2017)

Some NDT techniques for Carbon Fiber Reinforced Plastics (CFRPs) are based on mathematical models for thermographic data processing from thermal excitation. (Chrysafi et al., 2017) made use of active infrared thermography and recorded the temperature of CFRP samples with delamination and cracks at known location. The thermograms of the laminates were processed in two ways: a) as two-dimensional images, b) as if each pixel was a one-dimensional signal over time. Their work demonstrated the accuracy of using the norm of the first spatial derivative as well as two dimensional wavelet transforms for crack detection. The delamination in the samples was more accurately detected by using one dimensional Fourier transforms and wavelets (Figure 17).

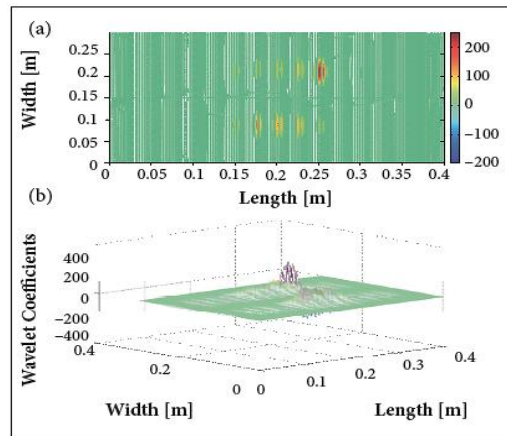
Figure 20: Wavelet coefficients of the discrete wavelet transform: (a) flat distribution along the flat surface, (b) spatial distribution for the plates' dynamic signal computations (Faria et al., 2017)

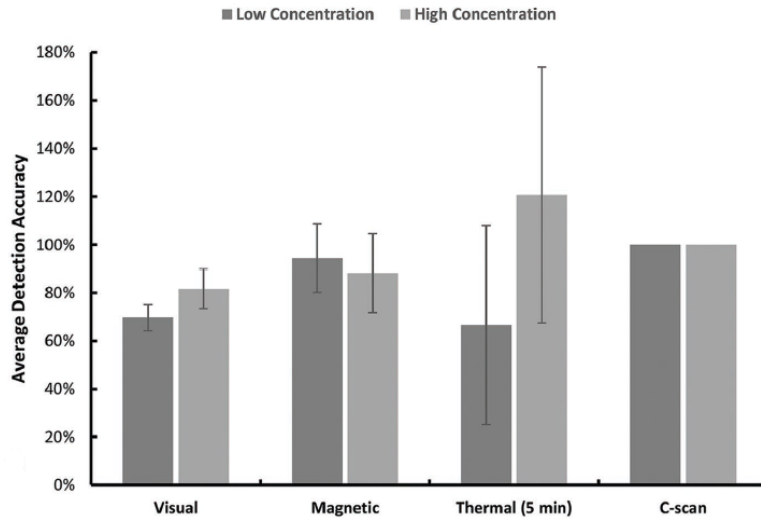
Figure 22: All methods accuracy compared to C-scan, error bars denote one standard deviation based on six models (Crall et al., 2019)

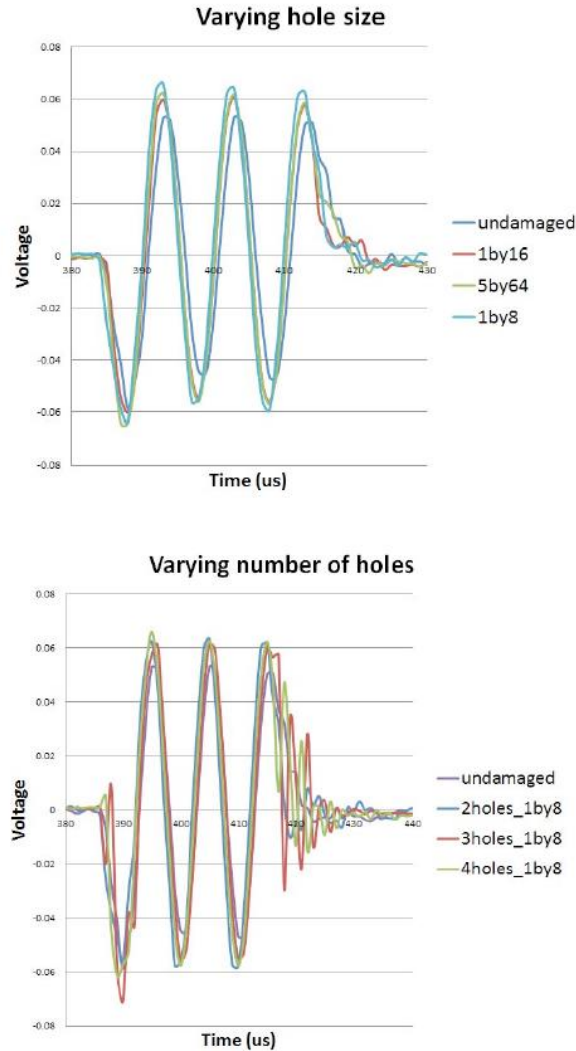
Figure 24: Response signal from varying hole size and number (Spiegel., 2014)

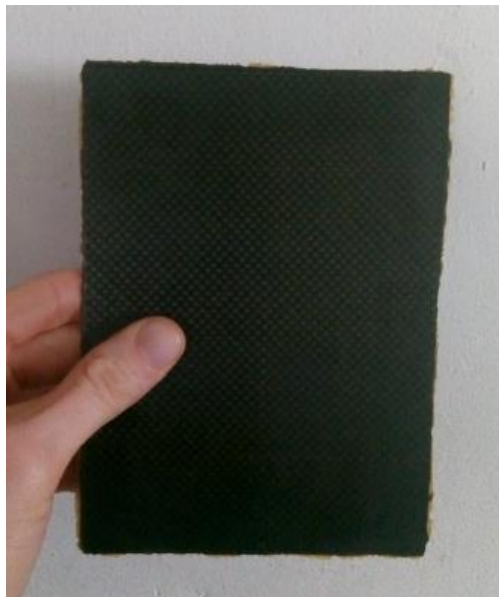
Figure 25: Woven carbon/epoxy laminated composite panel

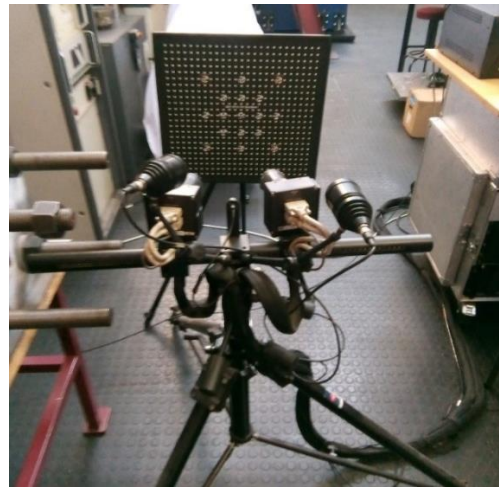
Figure 48: Calibration setup: (a) shows the calibration panel, (b) shows camera and calibration panel setup

(b) Calibration setup with calibration panel placed 480mm from GOM cameras

Figure 48 shows the camera setup for calibrating the GOM cameras. The cameras were mounted on a slider which is equipped with a laser to aid with centering of the cameras. Once the adjustments of the lenses and lights rendered images with sufficient contrast the cameras were calibrated using a calibration panel with two scale bars.

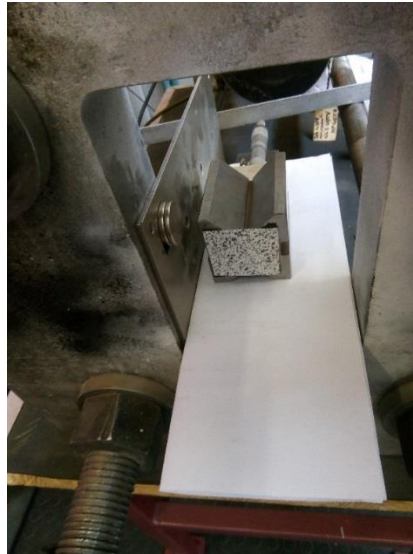
Figure 51: Experimental setup for rigid body motion tests

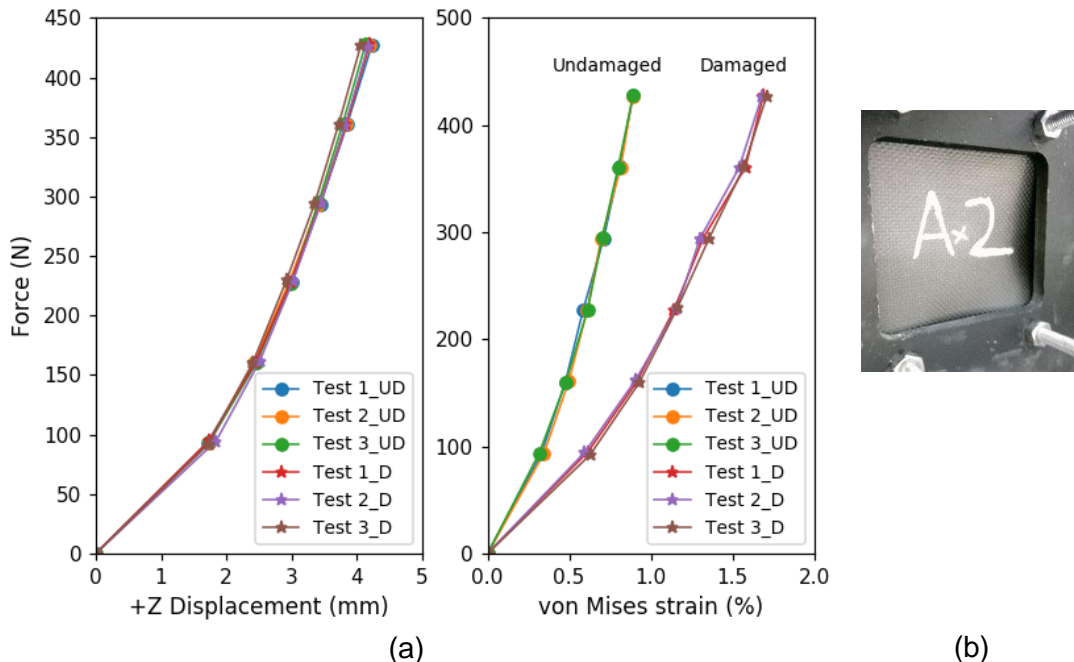
Figure 90: Full field DIC results of specimen A2 which was subjected to 9 J of impact energy: (a) shows the force vs out-of-plane displacement curves and force vs von Mises strain curves, where "UD" stands for undamaged and "D" stands for damaged, (b) shows specimen A2 directly after impact
