Investigating the use of polymer-modified cementitious thin spray-on liners as stope face support

M. du Plessis

D.F. Malan

Department of Mining Engineering, University of Pretoria, South Africa

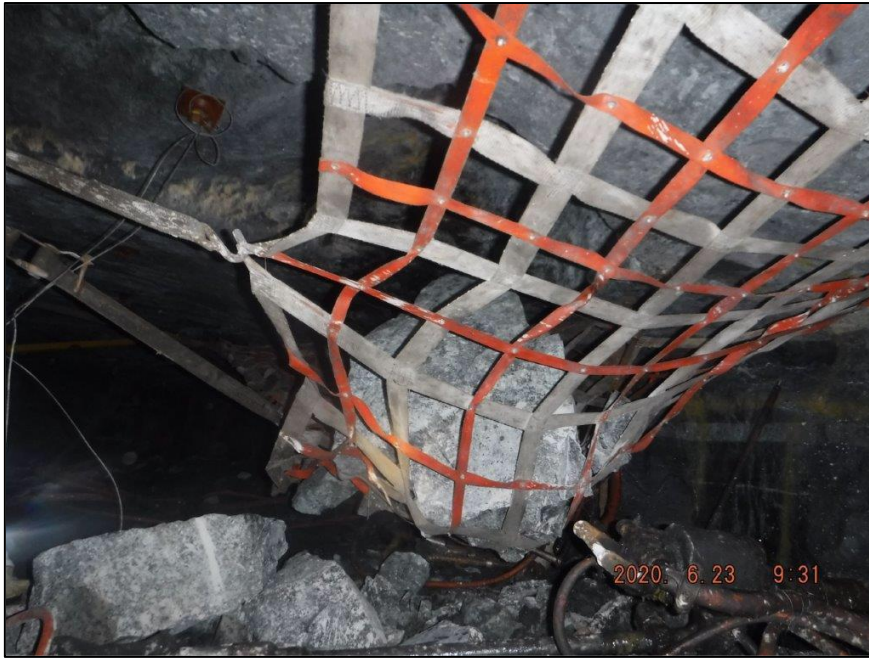
Fig. 1. A fall of ground arrested by a temporary net in the face area of a platinum mine.

cement blocks between support units, it will never be able to support the large fall of ground shown in Fig. 1. In contrast, Tannat¹¹ argued that the role of a liner is to assist the rock mass in supporting itself. If conditions allow the rock mass to unravel excessively, then the liners function should be to retain the loose rocks in place between rock bolts. The type of collapse shown in Fig. 1 is, however, a different failure mechanism consisting of a large single dislodged rock and it is not clear if a liner would be able to prevent this type of collapse. What was evident from the large scale tests conducted, once the cementitious TSL material experience tensile crack initiation and excessive deformation, failure is inevitable.

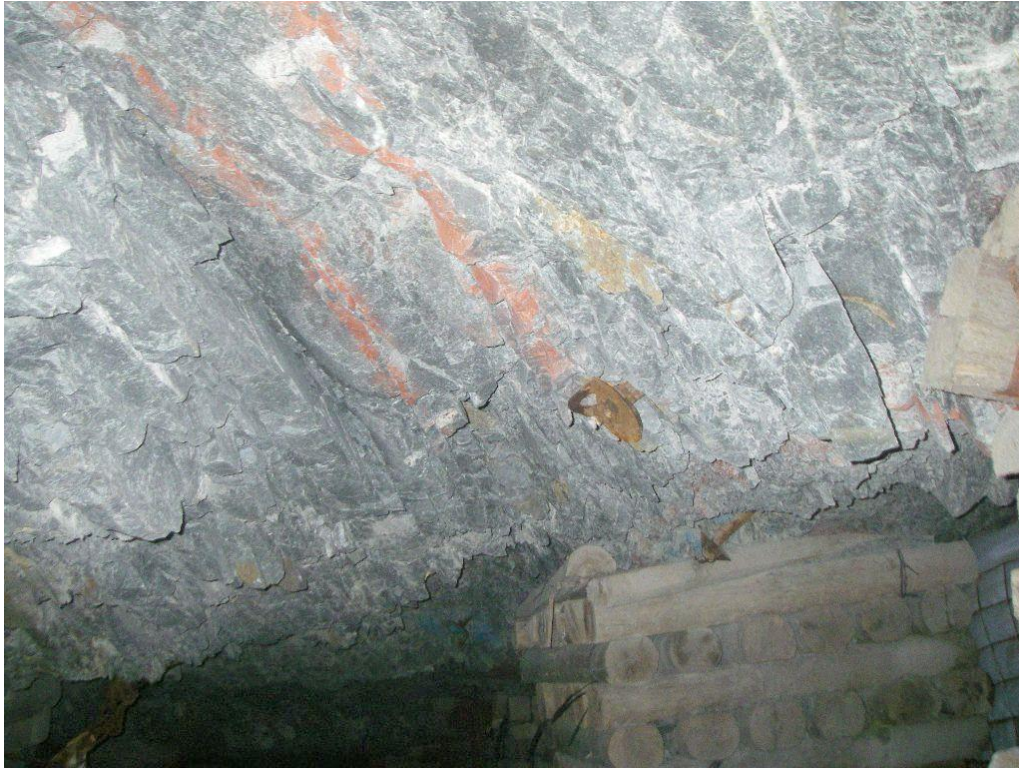
Fig. 3. Blocky hanging wall conditions in a deep gold mine.

Fig. 3. Blocky hanging wall conditions in a deep gold mine.

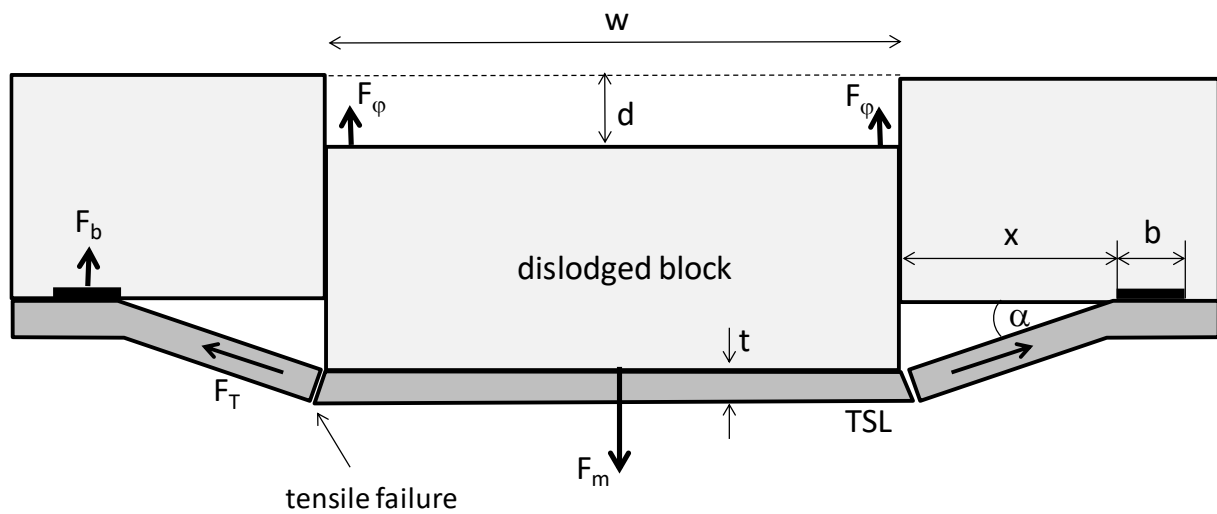
Fig. 6. A section through the block in Fig. 4 illustrating the failure mechanism caused by a loss of adhesive strength and eventual tensile failure of the TSL.

Failure at large deformations: For TSL failure at large deformations ($>> 1$ mm), adhesion loss typically occurs and this allows the TSL to stretch before failure. The failure mode is therefore adhesion loss followed by tensile rupture of the TSL. This will typically occur if the adhesive strength of the liner is less than the tensile strength. Note that not all types of TSL may experience this mechanism of failure as discussed below. The proposed mechanism of failure is shown in Fig. 6.

Considering the model in Fig. (6) and by inserting Eq. (5) and (11) in (15), at the point of tensile failure when $F_T = F_t$, the following relationship must hold:

It is problematic using these equations to calculate the height of rock, h , that can be supported. The debonded length x will depend on the weight of the loose block. Iterative techniques using Eq. (5), (15) and (16) needs to be used with different estimates of h to meet the condition in Eq. (17). Tannant also suggested the following relationship which should not be violated for the type liners that fails according to this mechanism (this can be derived from the diagram given in Fig. 6:

Fig. 6. A section through the block in Fig. 4 illustrating the failure mechanism caused by a loss of adhesive strength and eventual tensile failure of the TSL.

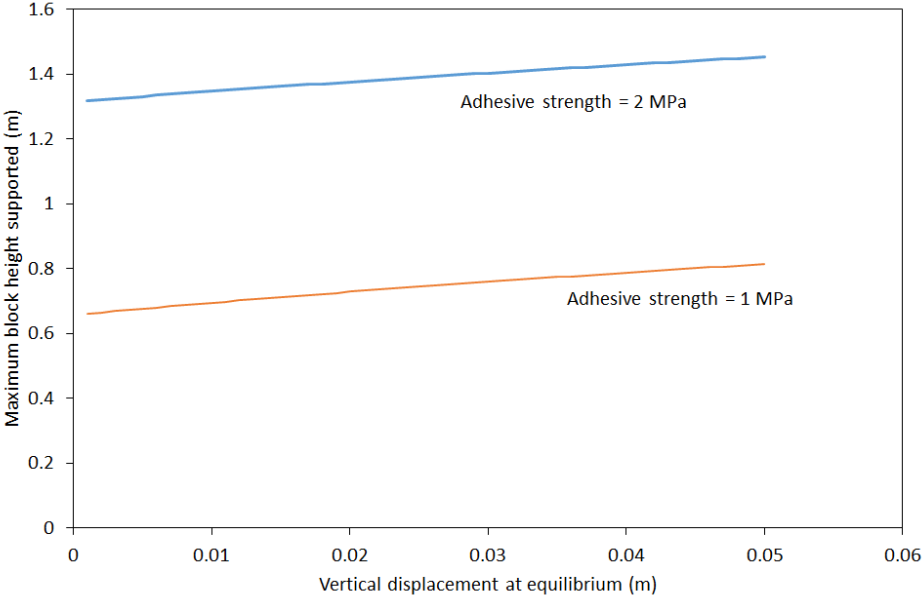
Fig. 7. Effect of adhesive strength on the height of block that can be supported.

The equations shown above were used together with the parameters in Table 1 to calculate the block height that can be supported at various values of displacement d . As iterative techniques need to be used, the “Goal Seek” function in Excel provided a simple solution, together with Eq. (5), (15) and (16), to modify the value of h to meet the condition in Eq. (17). Fig. 7 presents an example of the output generated following the methodology. Of importance

is that the results for this simple model indicate the sensitivity of the load-carrying capacity of the liner to its adhesive strength. This emphasises that care should be exercised when using an adhesive strength obtained from testing on a particular substrate as other rock types may result in different values and substantially smaller load carrying capacities. The influence of the rock type, environmental conditions and the liner thickness on adhesive strength were studied by Ozturk and Tannant^{26,27}. The importance of proper TSL and surface preparation and product application is vital to ensure improved bonding to the rock medium. It is not clear if this type of preparation will be possible in a production stope. Furthermore, the effect of bond width, b , is critical to estimate the performance of a TSL. When considering the results in Fig. 7, the estimated block height that can be supported will reduce further if the bond width is reduced to a smaller value, say 1 mm. This uncertainty regarding the performance and load carrying capability of a TSL makes it questionable if it can be safely used as a structural support element in mining stopes.

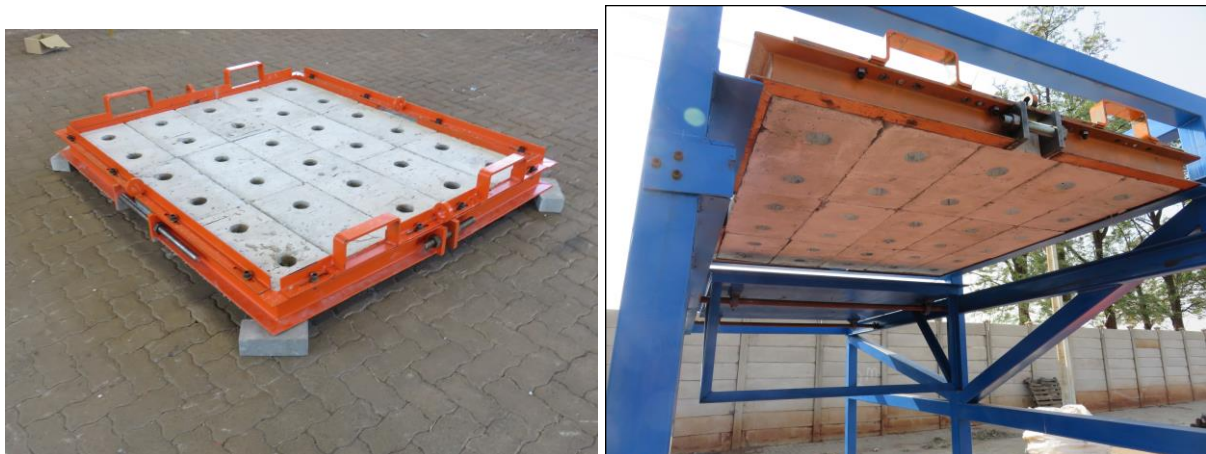
Fig. 8. Test rig to clamp a number of cement blocks before spraying it with a TSL.

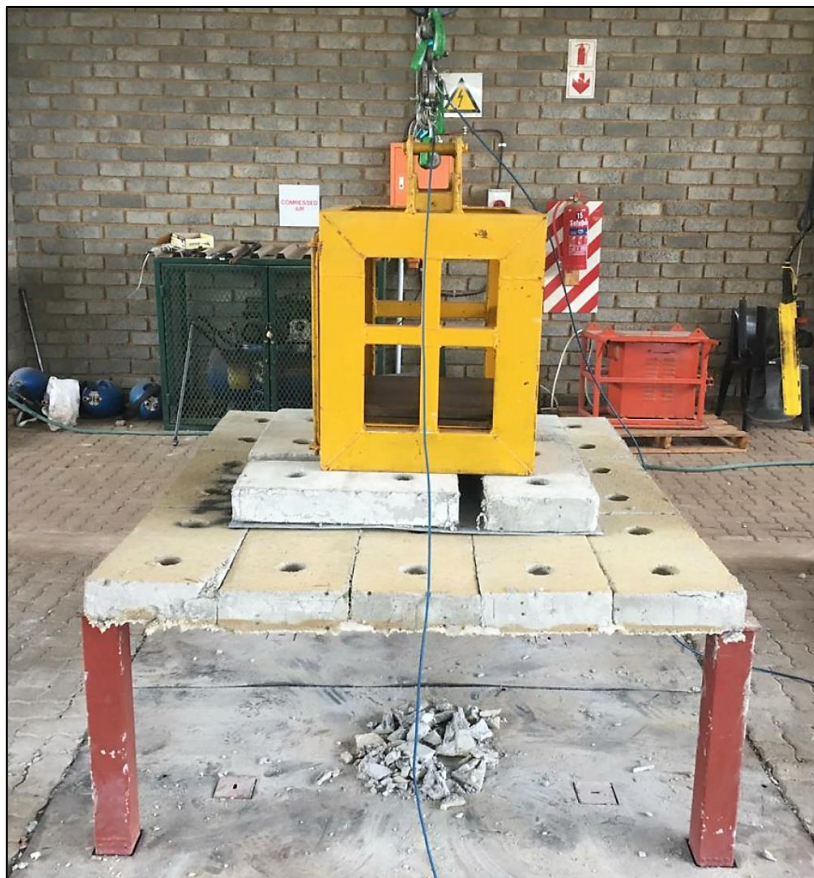
Fig. 10. Test configuration showing the sprayed cement blocks suspended on the rigid supports. A 1 m² area is being loaded in the middle of the blocks.

Regarding the loading of the panel, if the sprayed panel could support itself, the surface would be incrementally loaded on top of a 1 m² base plate in the centre of the assembly. A static load would be applied by carefully lowering the weight on the assembly of blocks. If the blocks did not fail, the applied mass would be increased and the loading repeated. Testing would be conducted until failure occurred. Fig. 10 illustrates the loading of the sprayed cement blocks.

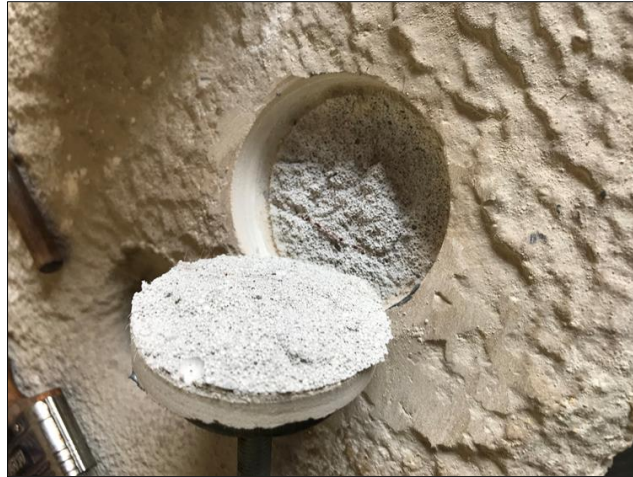
Fig. 12. Adhesion pull tests to determine the tensile adhesive strength for various curing intervals.

Fig. 12. Adhesion pull tests were conducted to estimate the tensile adhesive strength for various curing intervals. The photograph indicate tensile failure of the cement material below the TSL/surface interface.

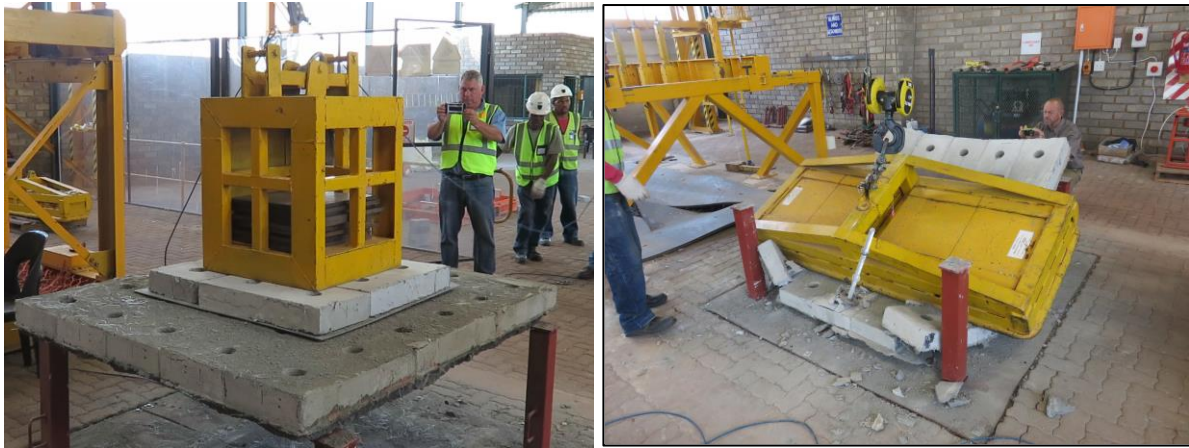
Fig. 13. Cement blocks, covered by 50 mm of shotcrete, was a) able to carry a load of 1100 kg after 24 hours of curing. B) The panel failed after it was loaded with a 2 000 kg mass.

As the large scale TSL tests indicated a small load carrying capacity, shotcrete tests were also conducted to serve as a verification of the test methodology. This indicated that a different type of sprayed liner can indeed provide a substantial load carrying capacity for this particular test methodology. Using the same method as described above, the cement blocks were sprayed with 25 mm and 50 mm thick, 40 MPa, accelerated oxi-fibre shotcrete. The tests were conducted after a 4 and 24 hour curing interval. Only the 24 hour cured 50 mm thick shotcrete assembly remained intact and could be tested. The assembly of blocks with this shotcrete succeeded in carrying a load of 1 100 kg. This is substantially more than the capability of the TSL product D. A 2 000 kg mass resulted in the failure of the assembly (Fig. 13). This was caused by the cement blocks breaking and not the because of failure of the shotcrete-cement block adhesion strength. This contradicts a popular belief in the South African mining industry that shotcrete does not bond well to rock or other substrates.

Fig. 13. Cement blocks, covered by 50 mm of shotcrete, was a) able to carry a load of 1100 kg after 24 hours of curing. B) The panel failed after it was loaded with a 2 000 kg mass.
