# **THE EFFECT OF GEOLOGICAL ALTERATIONS ON PILLAR STRENGTH**

M.Sc. Applied Science (Mining Engineering)

Department of Mining Engineering

21 March 2022

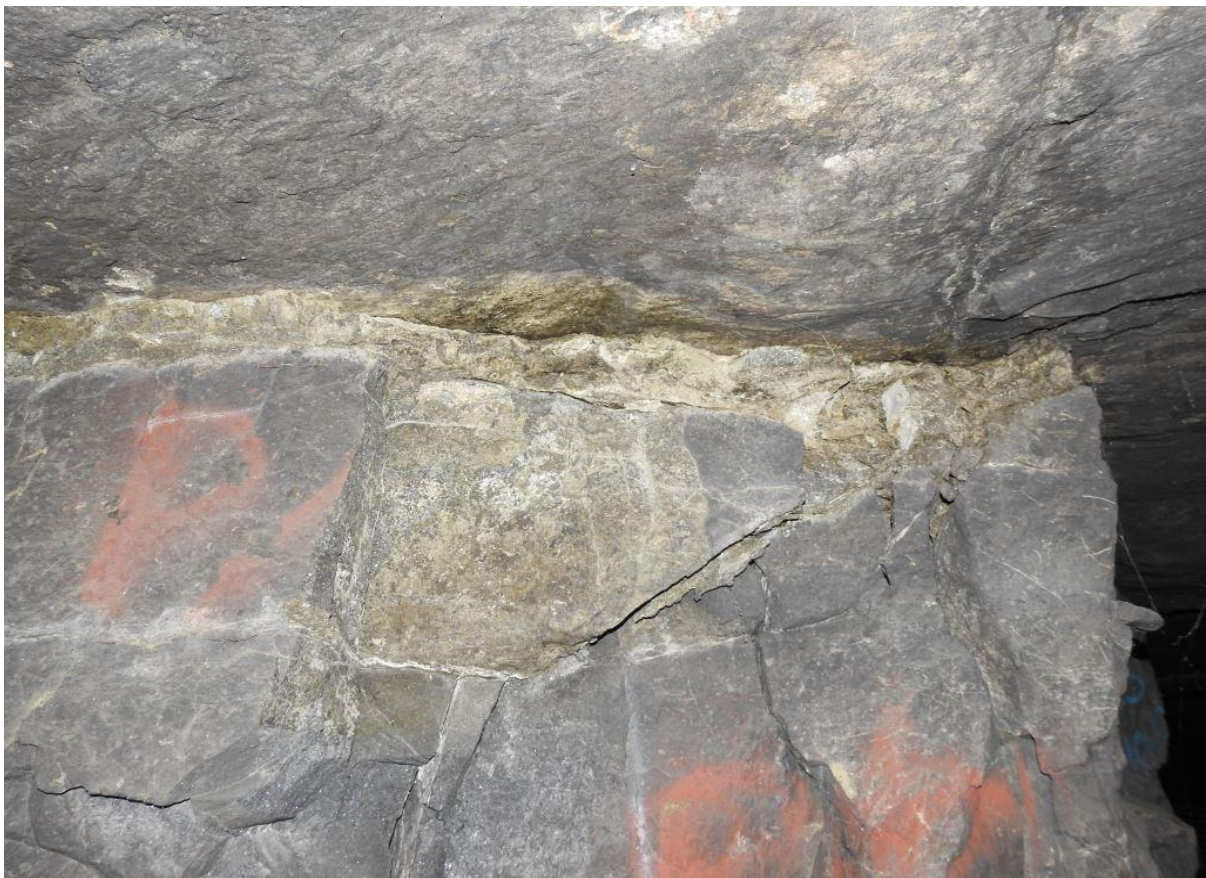
**Figure 1-1.** A weak alteration layer visible at the contact between the pillar and the hangingwall.

A study by Malan and Napier (2011) has shown that geological alterations may be present in the pillars in both the Western and Eastern Bushveld. These have a detrimental effect on pillar strength and on overall mine stability. Any weak layers in the pillars need to be carefully considered when mine designs are conducted. Figure 1-1 illustrates such a weak layer in a pillar and the resulting failure of a pillar with such a layer is shown in Figure 1-2.

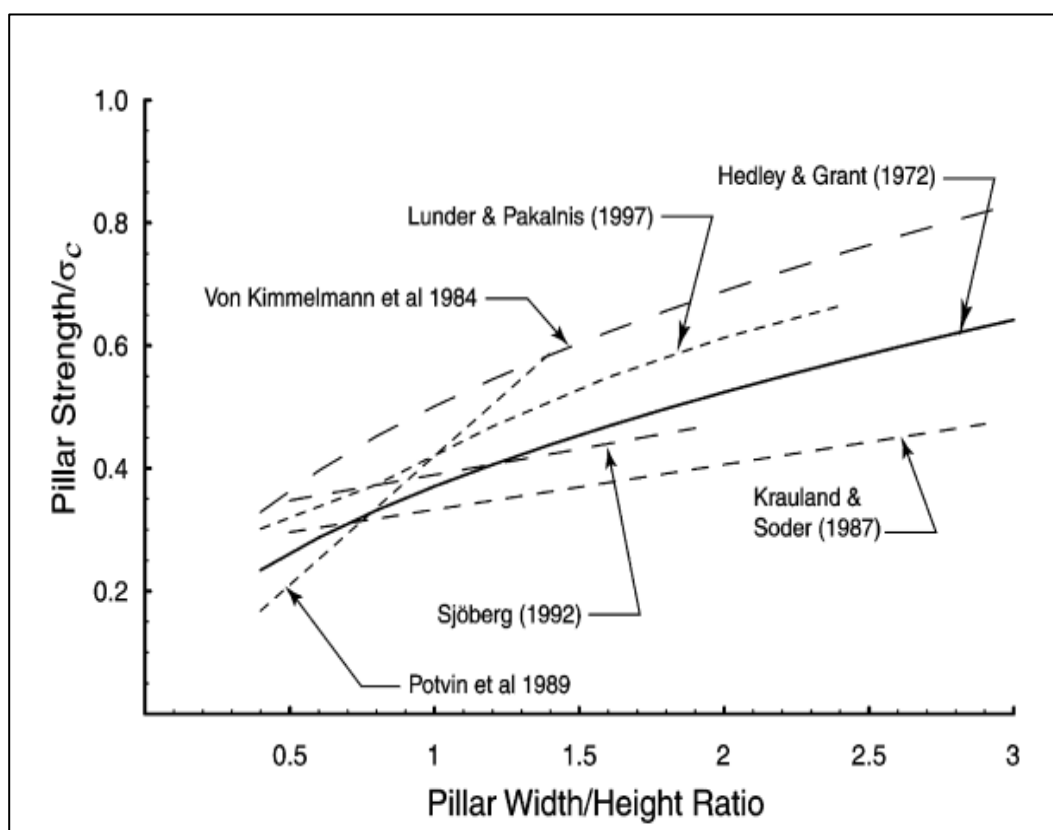
**Figure 2-4.** A comparison of the different empirical pillar strength formulas (after Martin and Maybee, 2000).

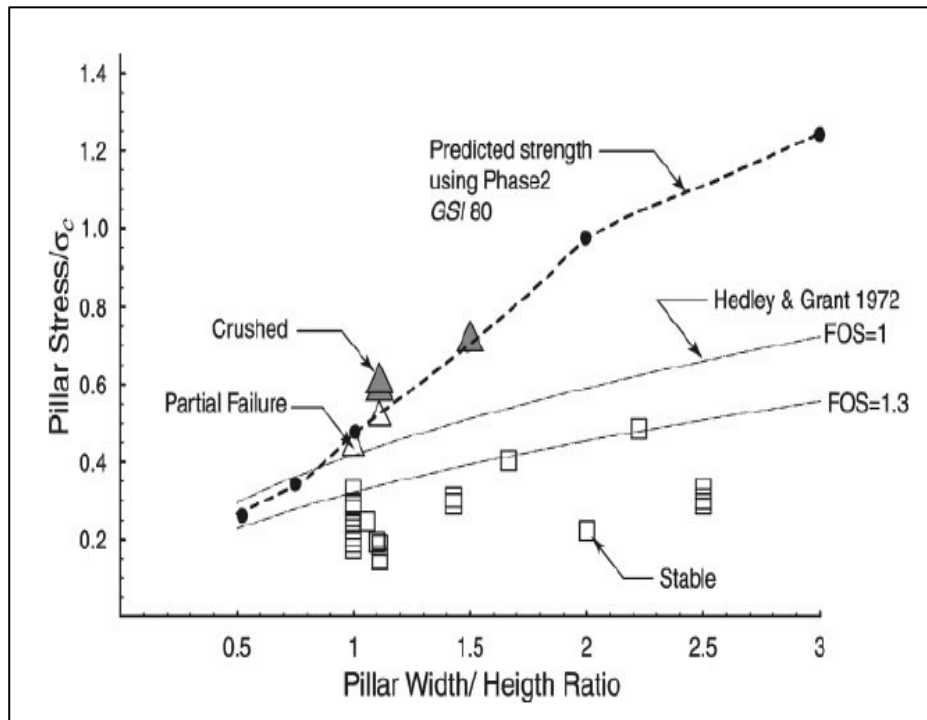
**Figure 2-5.** A comparison of the predicted rib pillar strength versus the observed rib pillar behaviour in the Elliot Lake uranium mines (Martin and Maybee, 2000).

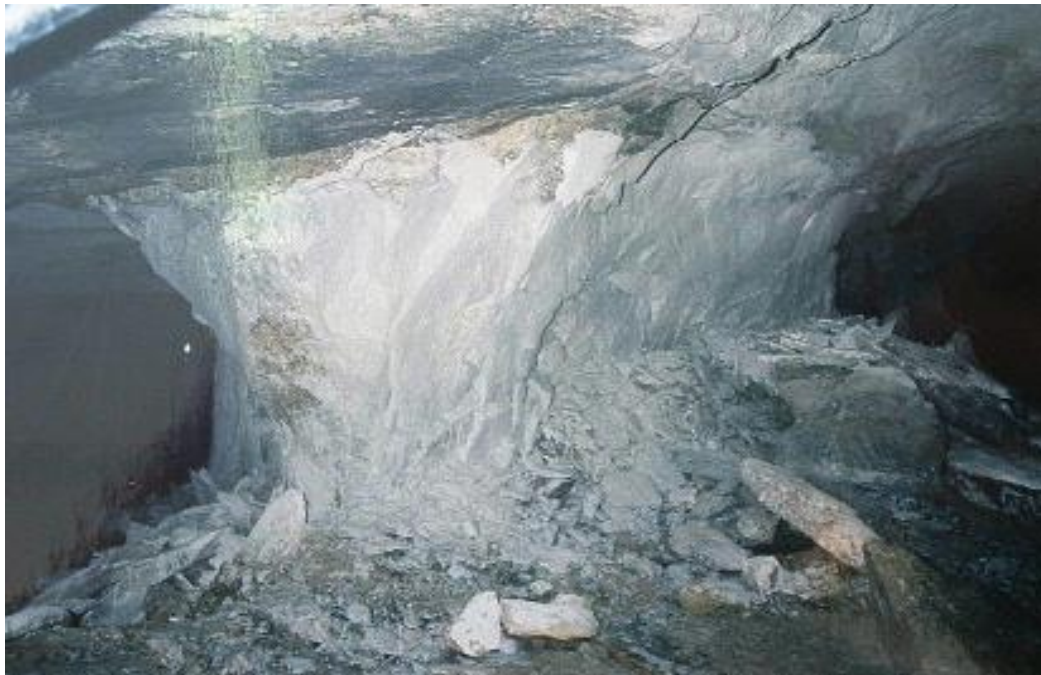
**Figure 2-11.** An example of pillar scaling in areas where there is a “frozen” interface between the pillar and the hangingwall. The typical “hour-glass” failure mode is evident (photograph courtesy F. Malan).

To illustrate the different modes of actual underground pillar failure, Figure 2-11 shows the typical failure observed for pillars with "frozen" (high friction angle) pillar and hangingwall contacts. Figure 2-12 shows the same mode of failure mode observed at Hossy Shaft where UG2 was mined. Hossy shaft is a shallow platinum mine on the western bushveld near Wonderkop Mine.

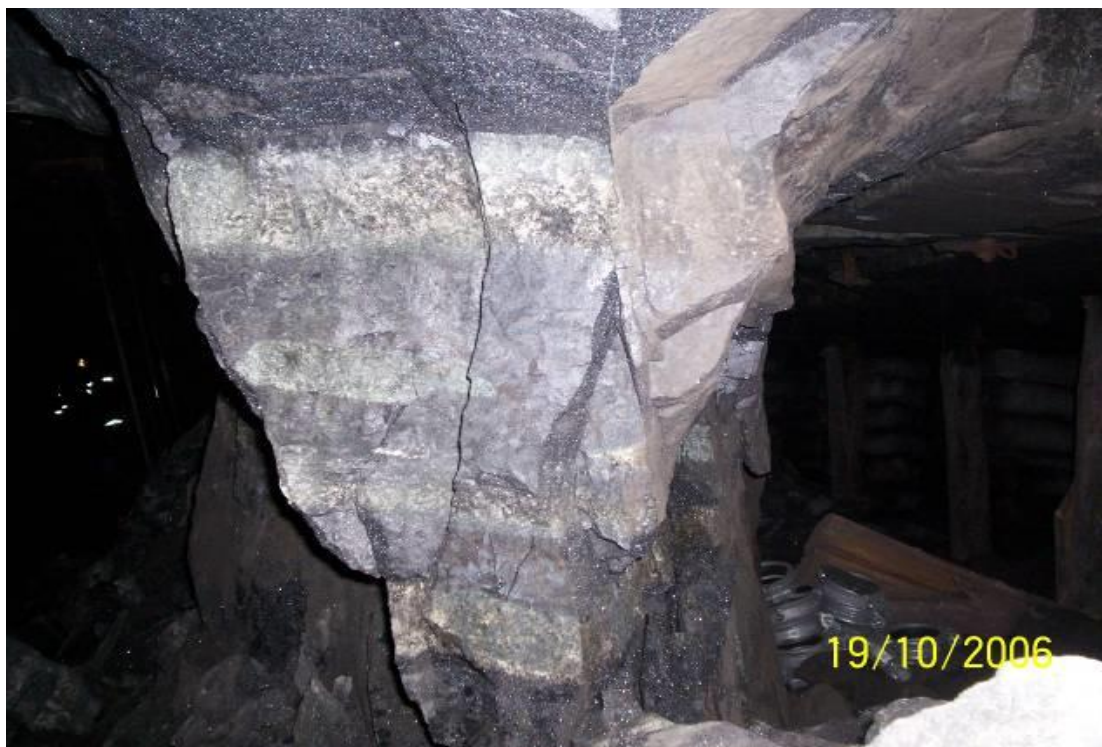
**Figure 2-12.** An examples of pillar scaling in areas where there is a “frozen” interface between the pillar and the hangingwall at Hossy shaft. Again, this results in the typical “hour-glass” failure mode (photograph courtesy F. Malan).

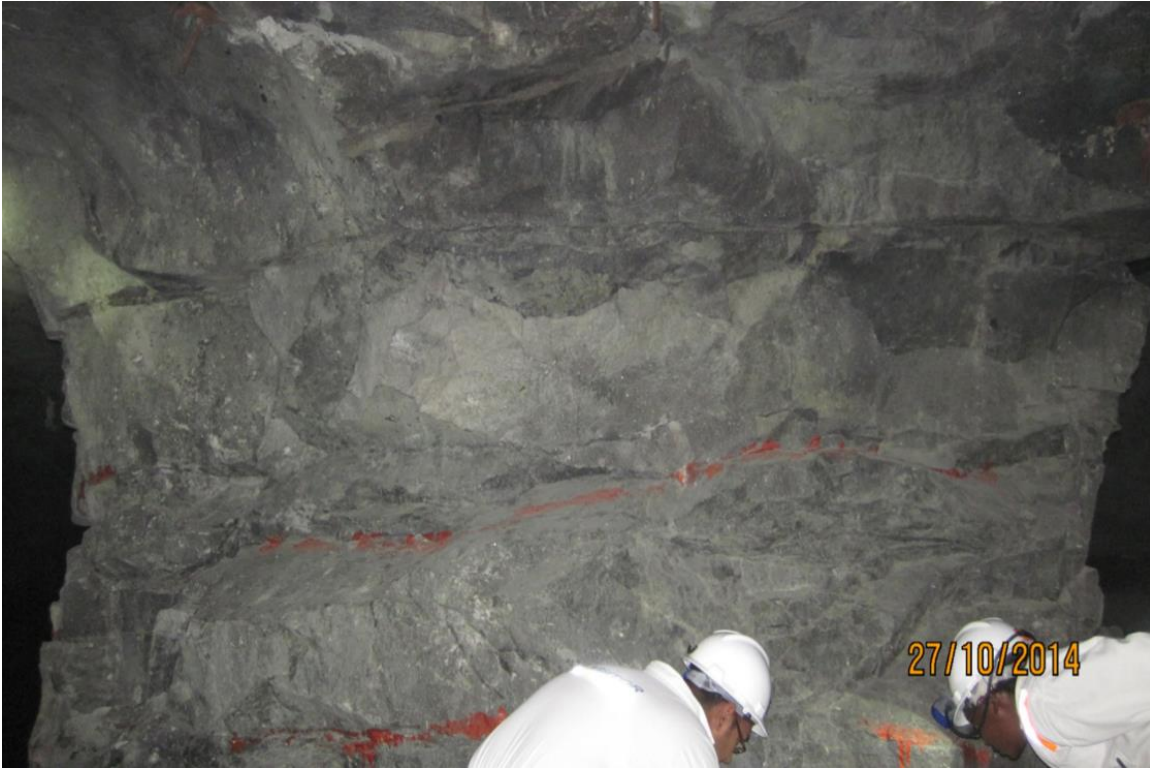
**Figure 3-6.** A pillar at Mine A showing the typical condition of the rock mass (courtesy N. Fernandes).

The observations below were made during the large-scale pillar failure that occurred in 2014 (see Figure 3-6 to Figure 3-13). Figure 3-6 to Figure 3-9 illustrate the underground observations of the geological alterations in the pillars. Figure 3-10 to Figure 3-13 illustrate the borehole cores, as well as the characteristics of the geological alteration.

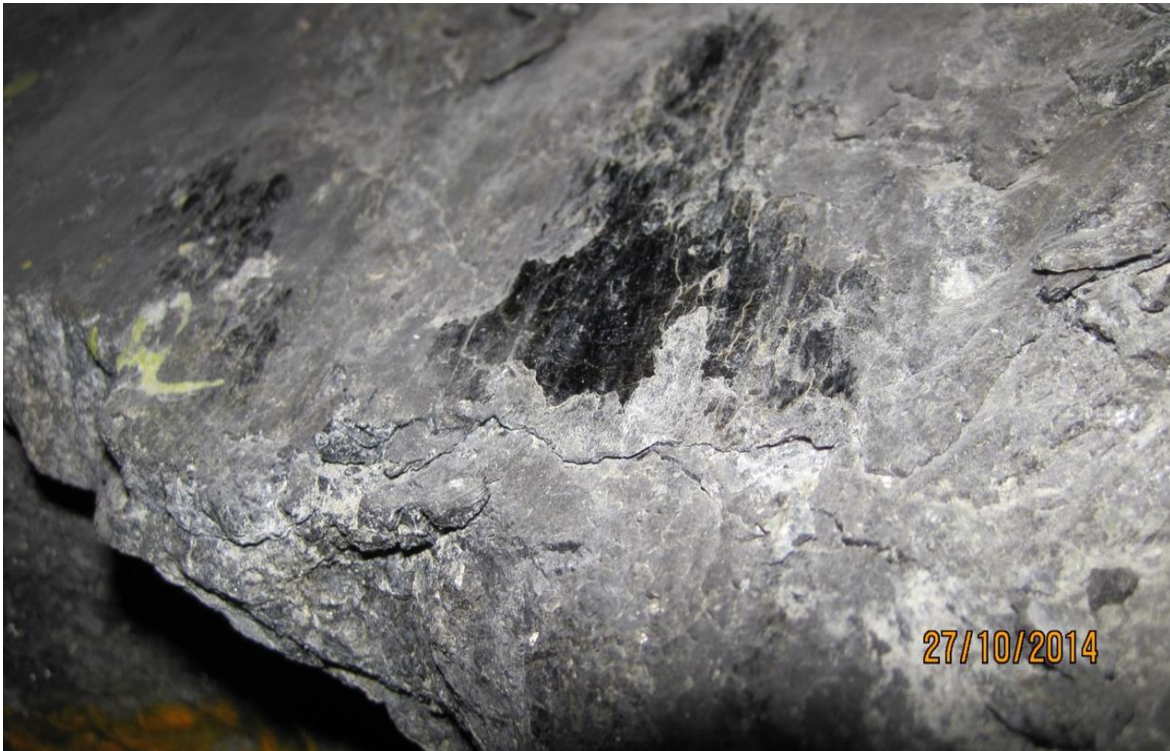
**Figure 3-7.** A close-up view of the alteration layer at Mine A illustrating the “slickenside” material (courtesy N. Fernandes).

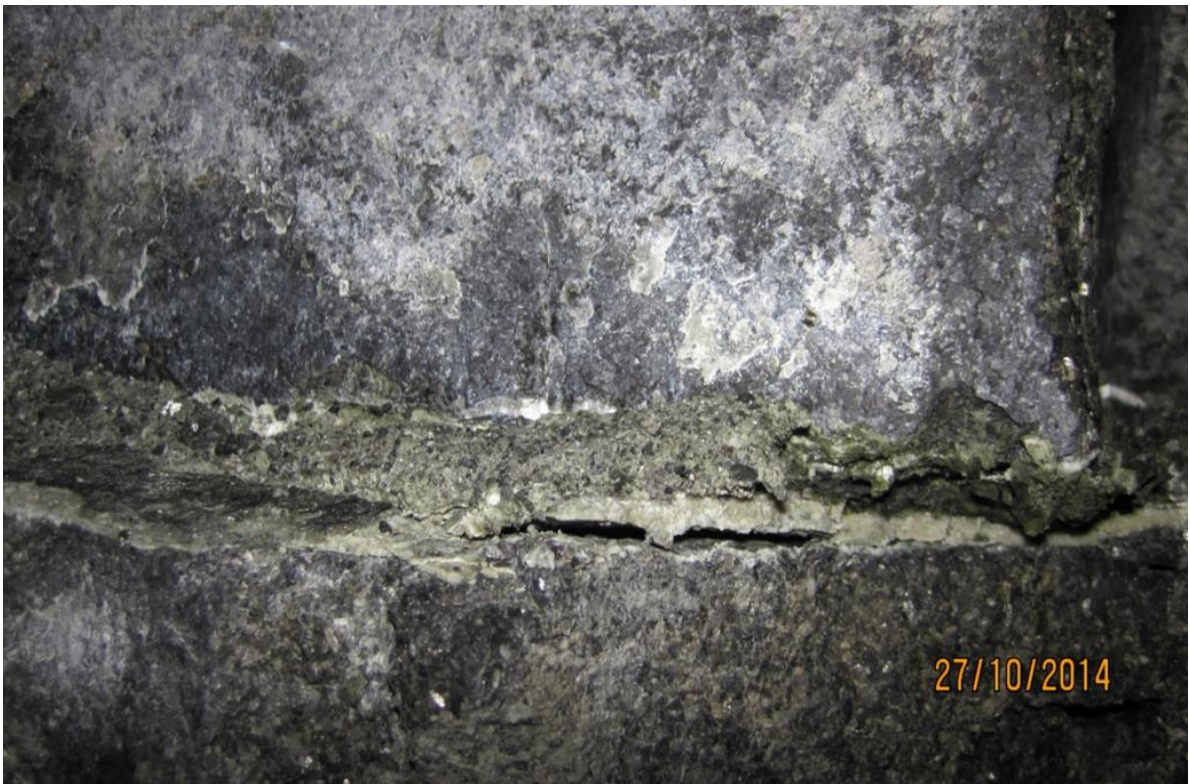
**Figure 3-9.** View of the alteration layer when weathered following exposure to moisture (courtesy N. Fernandes).

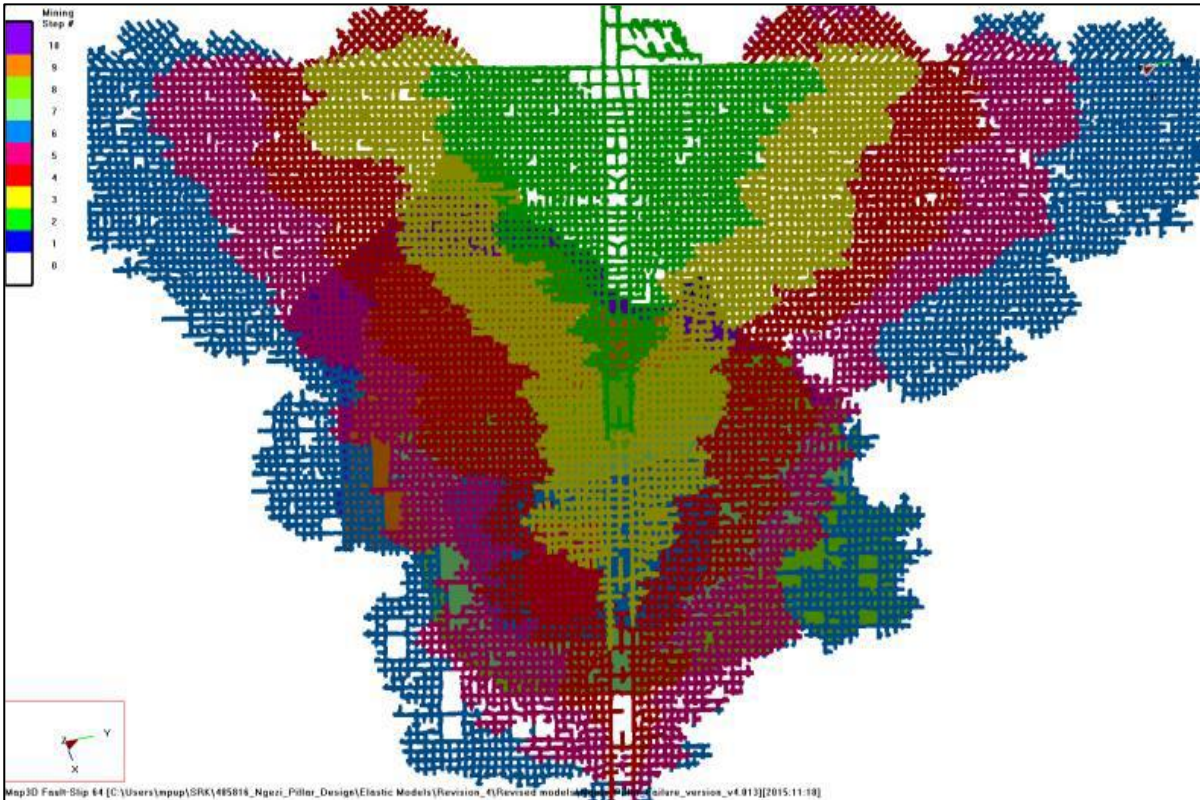
**Figure 3-20.** The area of pillar failure as recorded during May 2015 (courtesy N. Fernandes).

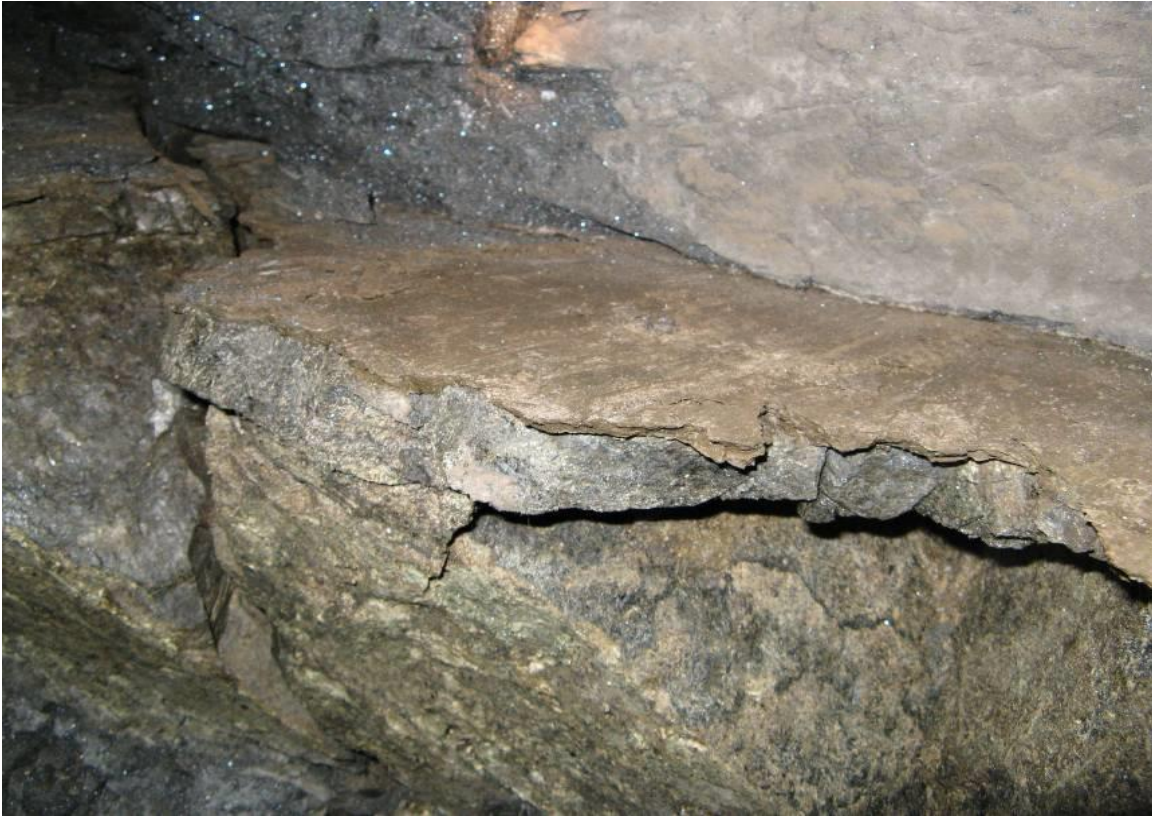
**Figure 3-24.** Presence of a weak alteration in the pillars at Wonderkop Mine. This photograph clearly illustrates the presence of the clay layer (Malan and Napier, 2011).

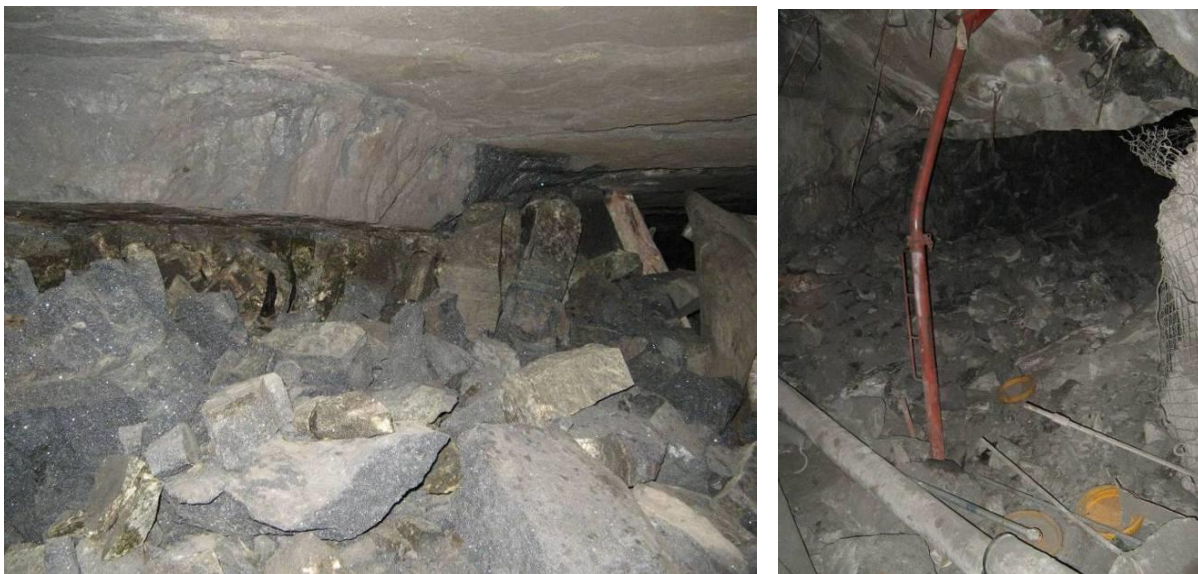
**Figure 3-27.** Mechanism of pillar failure at a mine adjacent to Wonderkop. For this pillar, a geological alteration was found between the upper LG6A chrome and the pyroxenite below it. This layer facilitates the fracturing of pyroxenite, causing it to scale out (left). The failures led to large amounts of convergence as can be seen in the photograph on the right (after Malan and Napier, 2011).

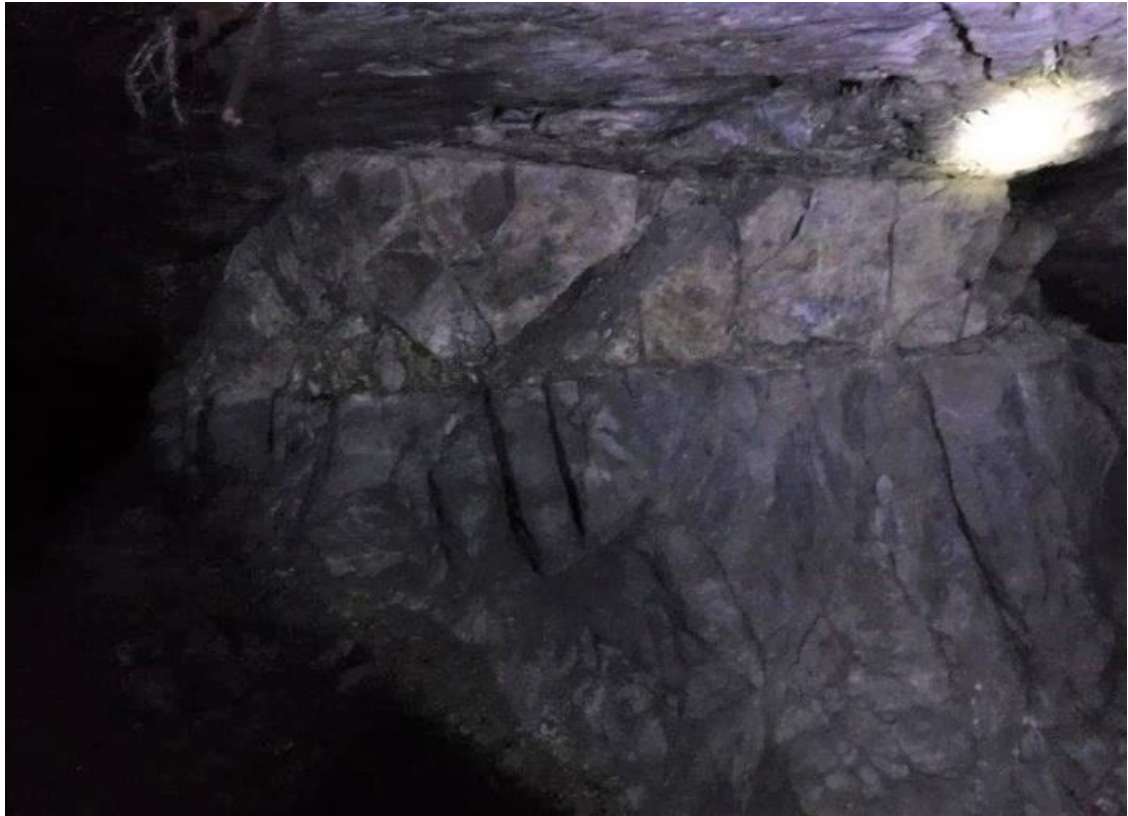
**Figure 4-6.** The typical condition of a pillar in the Level 2 failure zone.

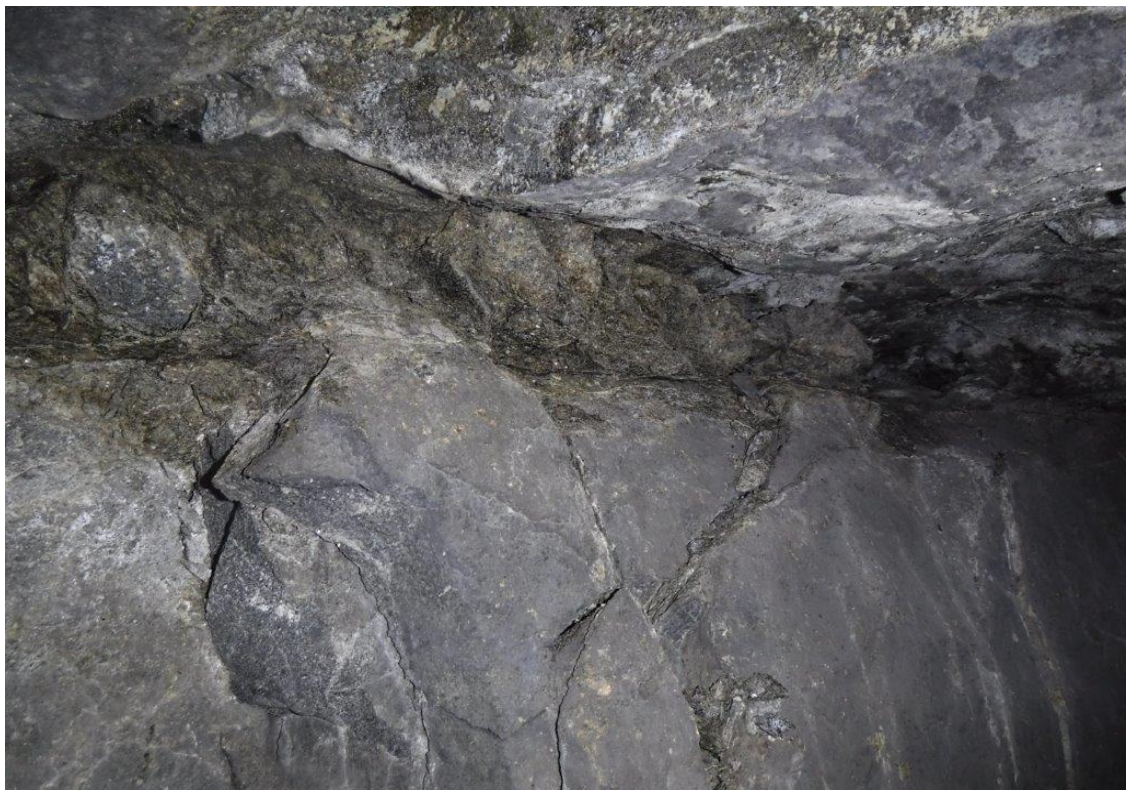
**Figure 4-7.** Position of the alteration zone in a pillar in the Level 3 failure zone. Note the thick alteration zone at the pillar/hangingwall contact.

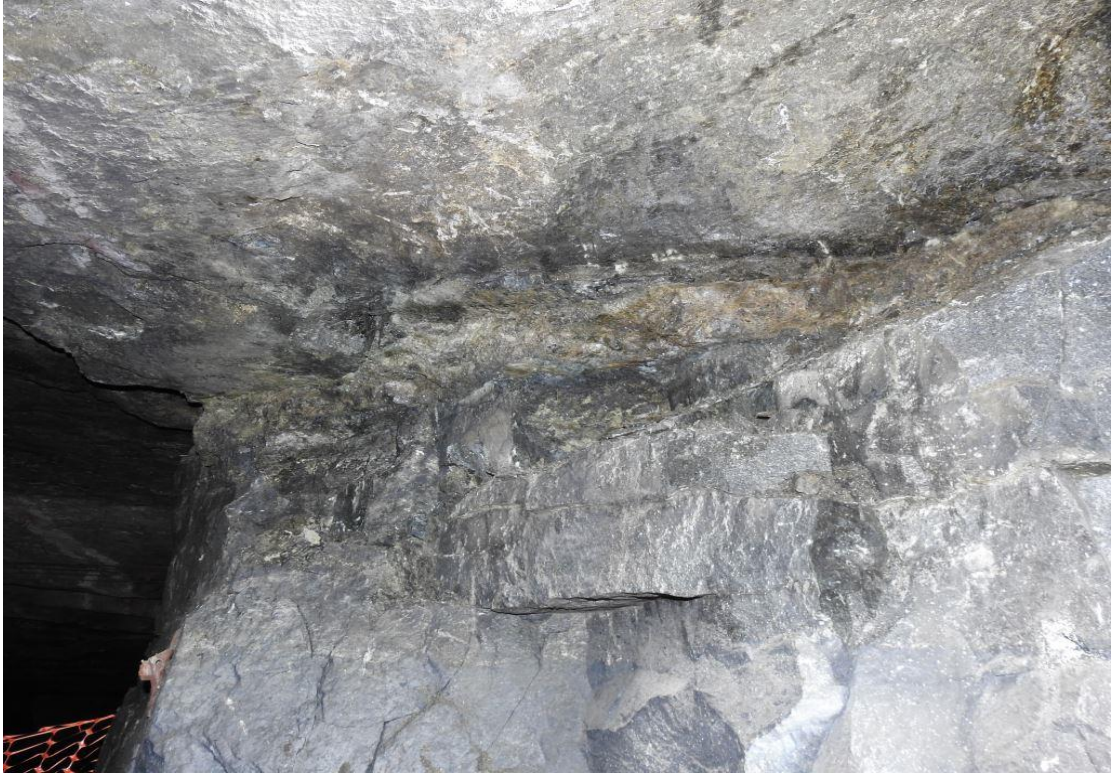
**Figure 4-8.** Another photograph of the nature of the alteration zone at the pillar/hangingwall contact.

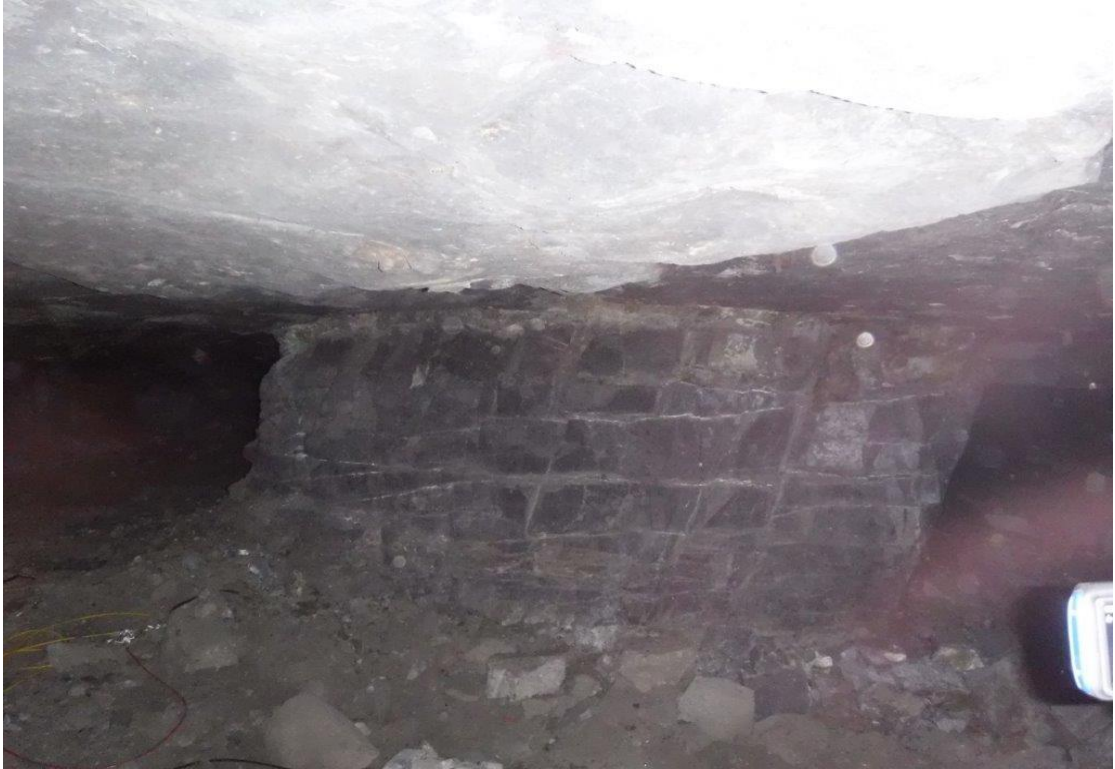
**Figure 4-10.** A pillar in the Level 2 failure zone with joints and fractures visible.

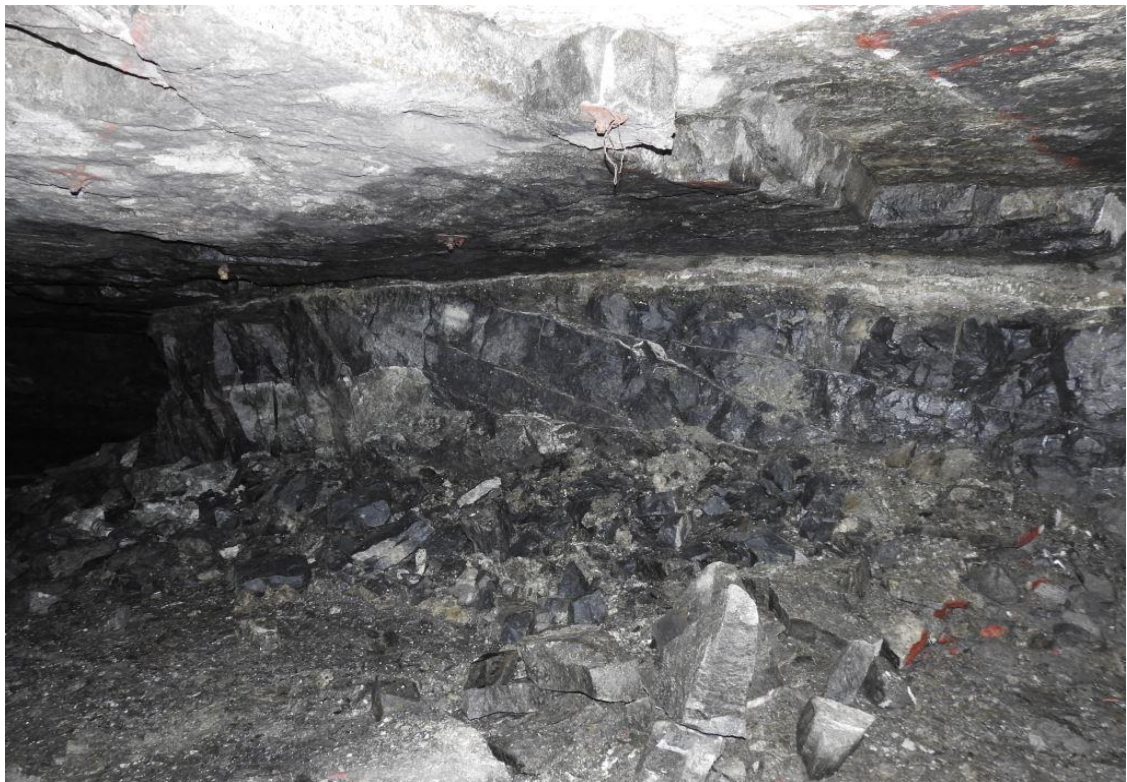
**Figure 4-11.** Failure of a pillar as a result of the presence of jointing in the Level 2 failure zone.

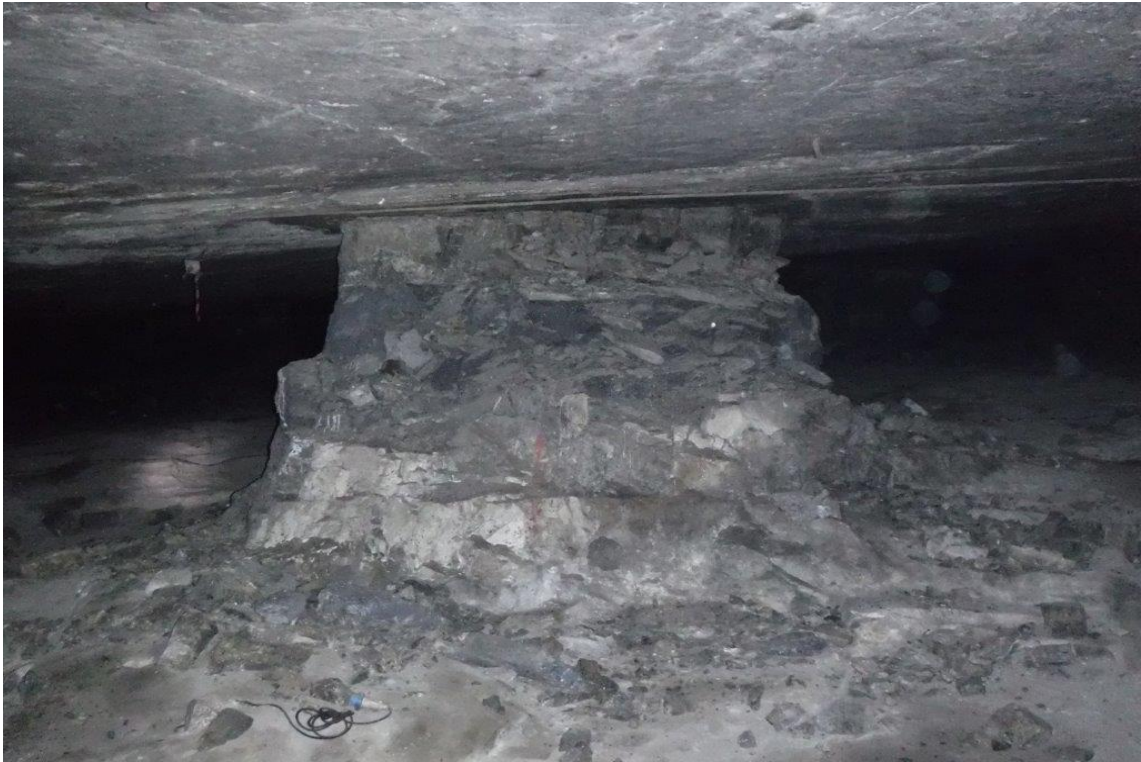
**Figure 4-12.** A pillar in the Level 3 failure zone showing extensive scaling and failure. The core of this pillar is still deemed to be intact.

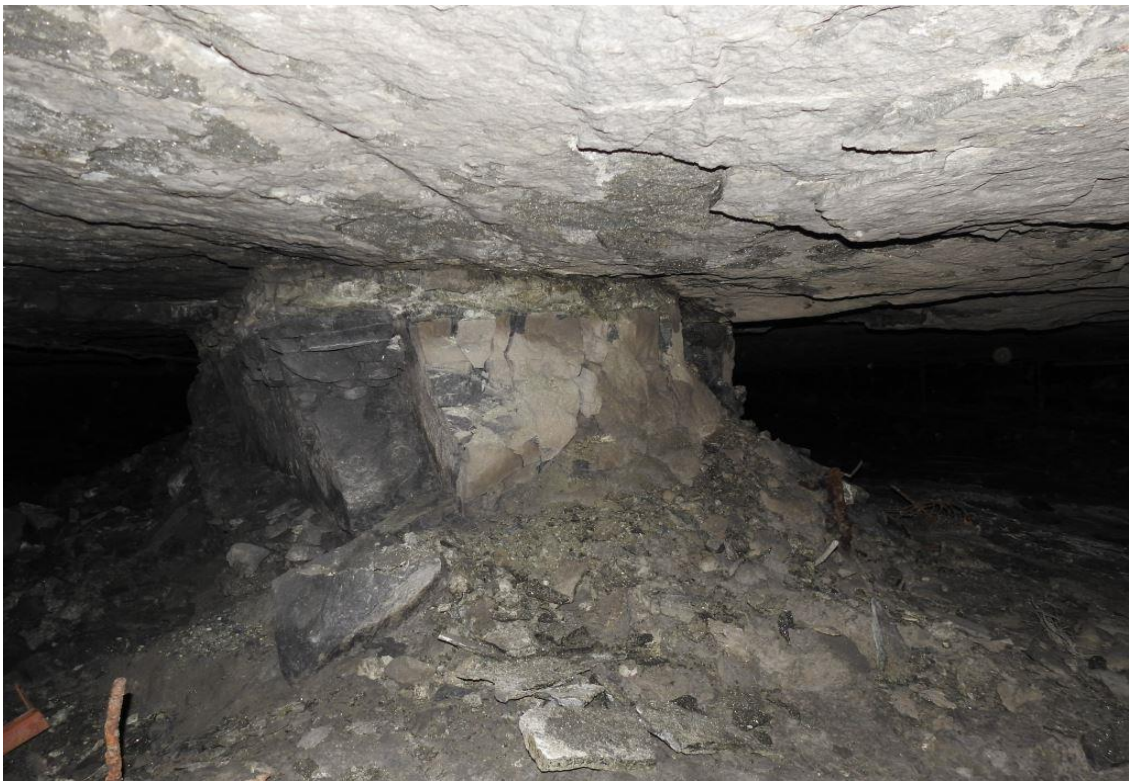
**Figure 4-13.** Extensive scaling of a pillar in the Level 3 failure zone. Note the hangingwall deterioration due to significant closure occurring.

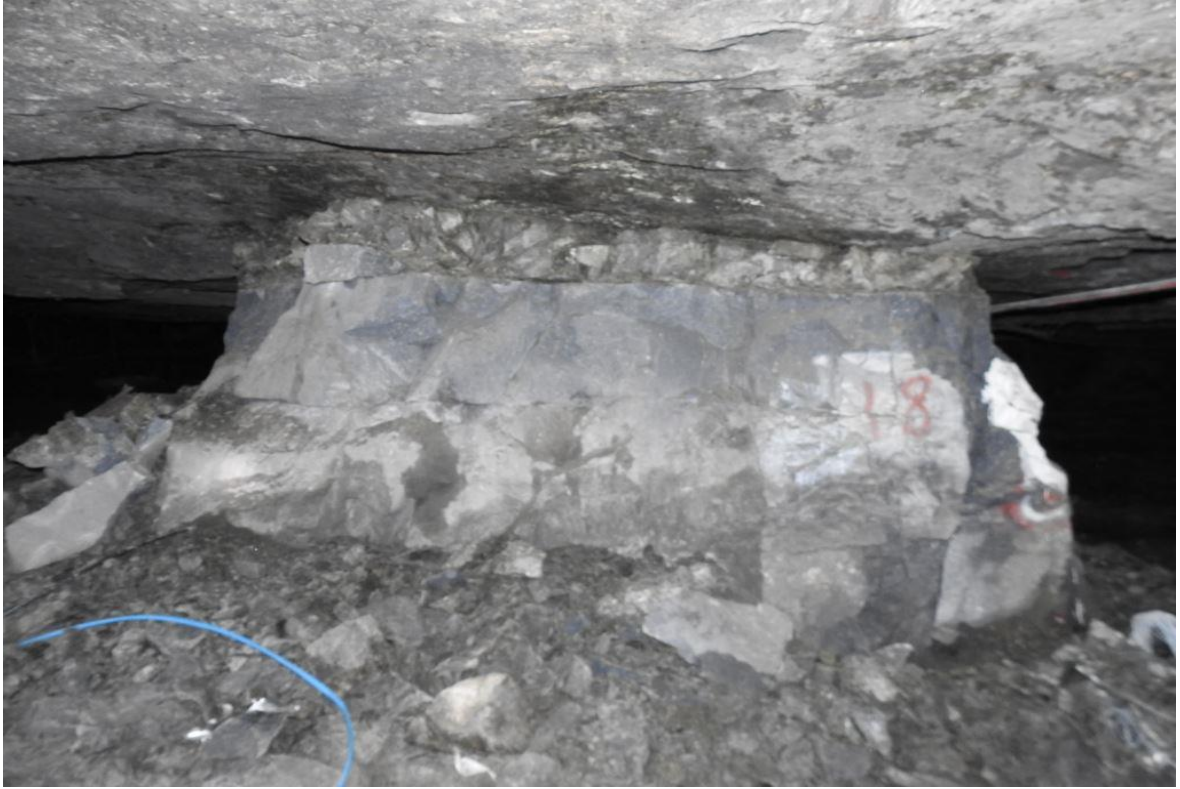
**Figure 4-14.** A pillar in the Level 3 failure zone with the alteration zone clearly visible.

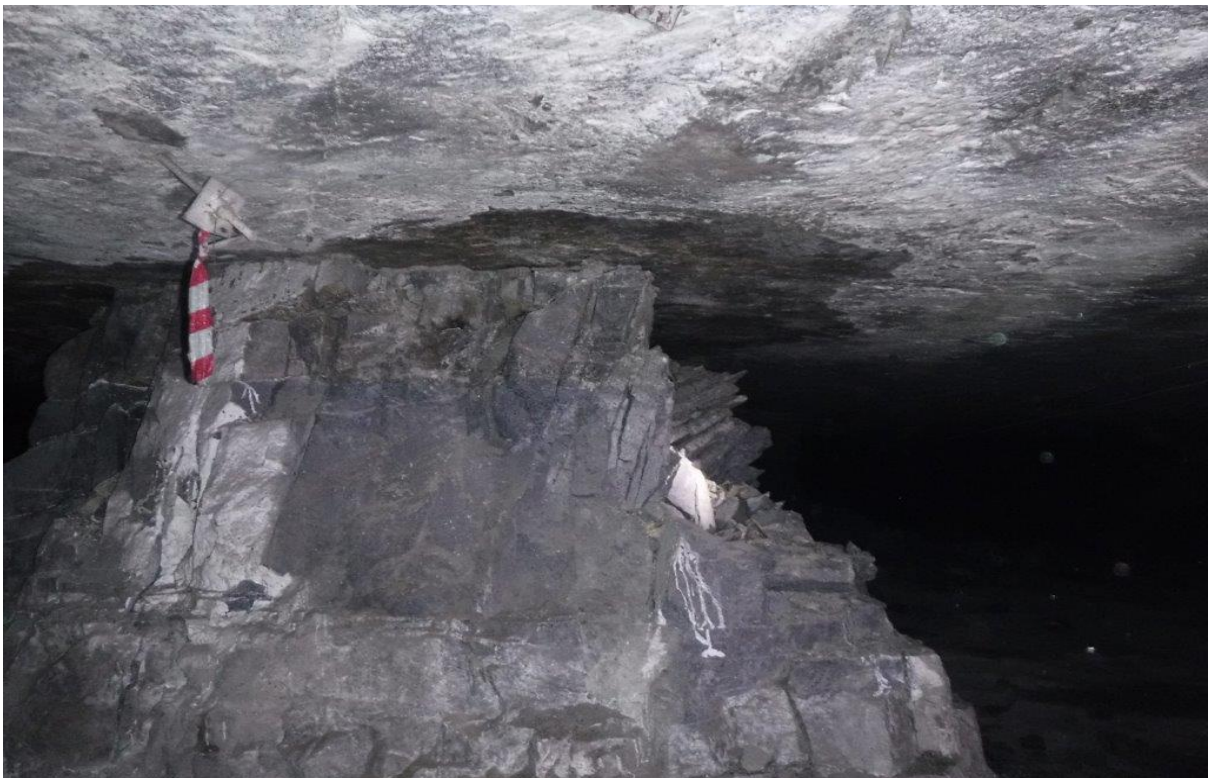
**Figure 4-15.** A pillar in the Level 3 failure zone where the original size of the pillar is clearly visible on the hangingwall owing to the change in colour caused by the white wash.

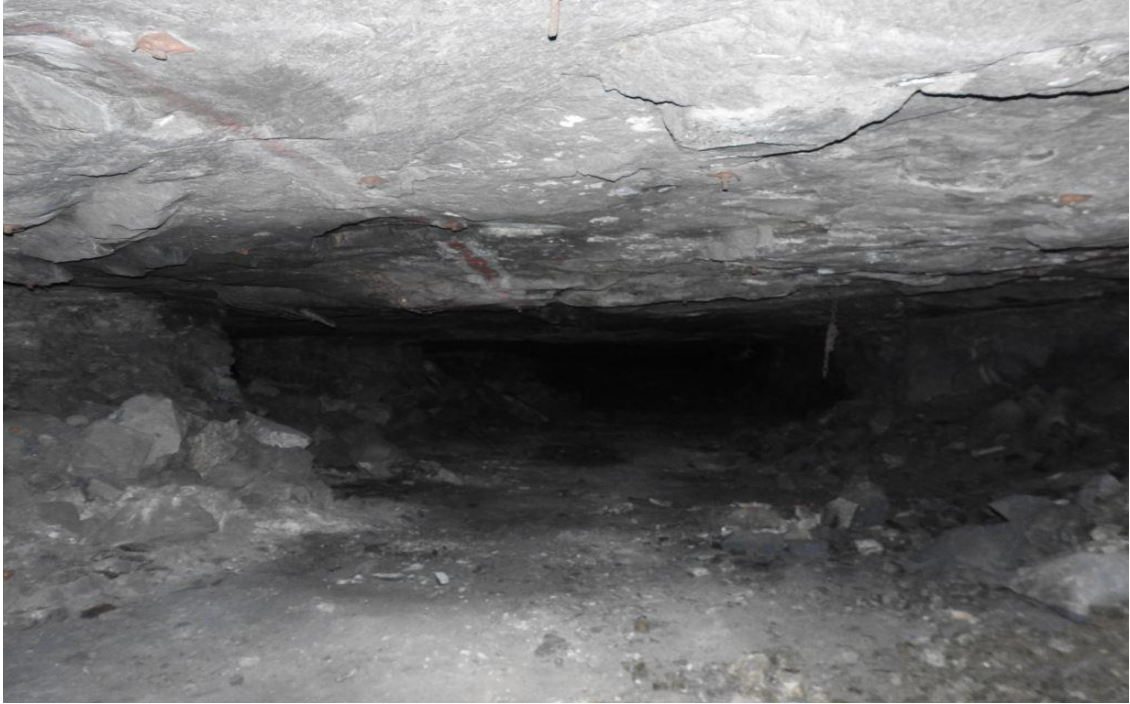
**Figure 4-16.** Pillar condition in the Level 4 failure zone. The pillars are crushed, but some contact with the hangingwall is still maintained. The large spans indicate that the pillars were not cut to the planned design.

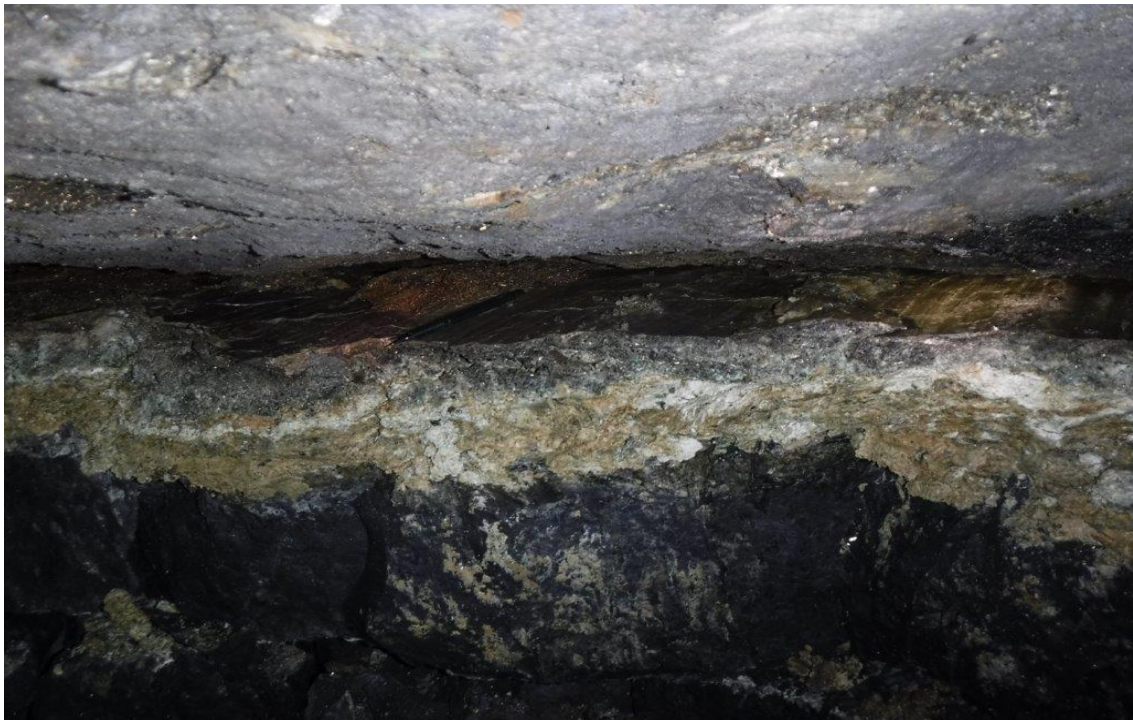
**Figure 4-17.** A close-up photograph of the alteration zone in the Level 4 failure zone. It is wet and it has evidence of slickenside surfaces. There is a gap between the pillar material and the hangingwall in this area.

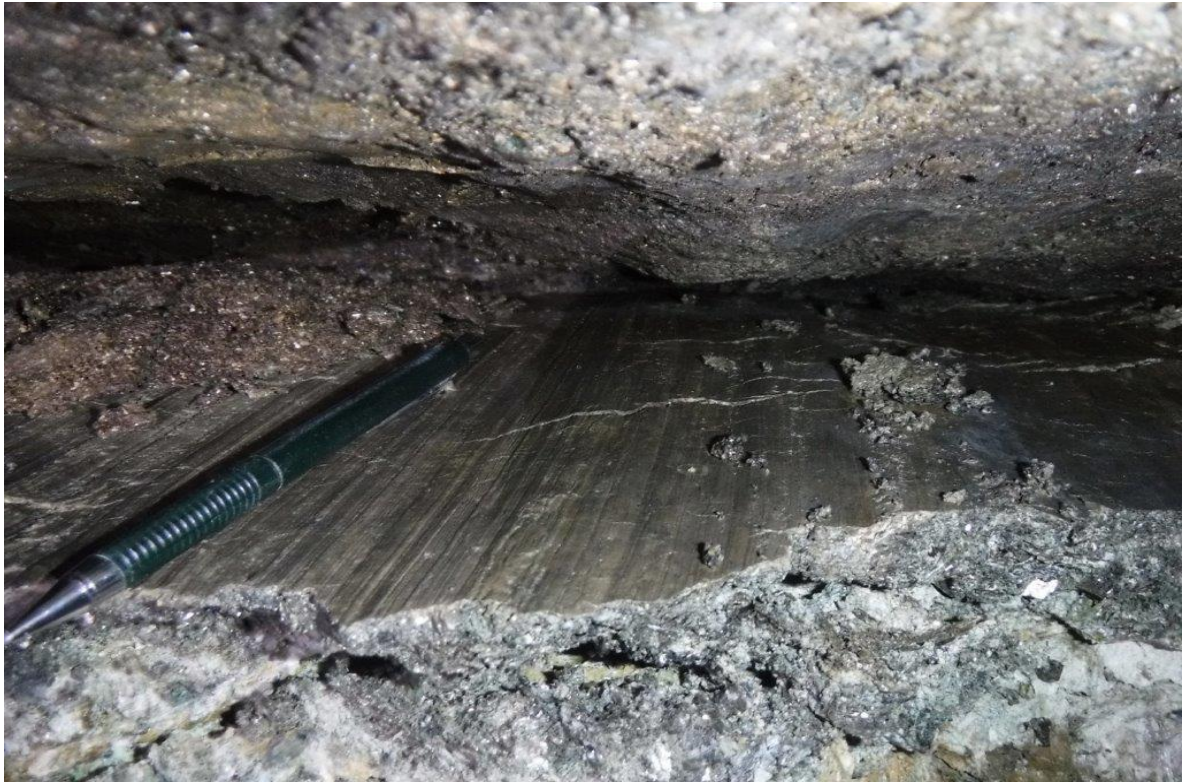
**Figure 4-18.** A slickenside surface between the crushed pillar material and the hangingwall.

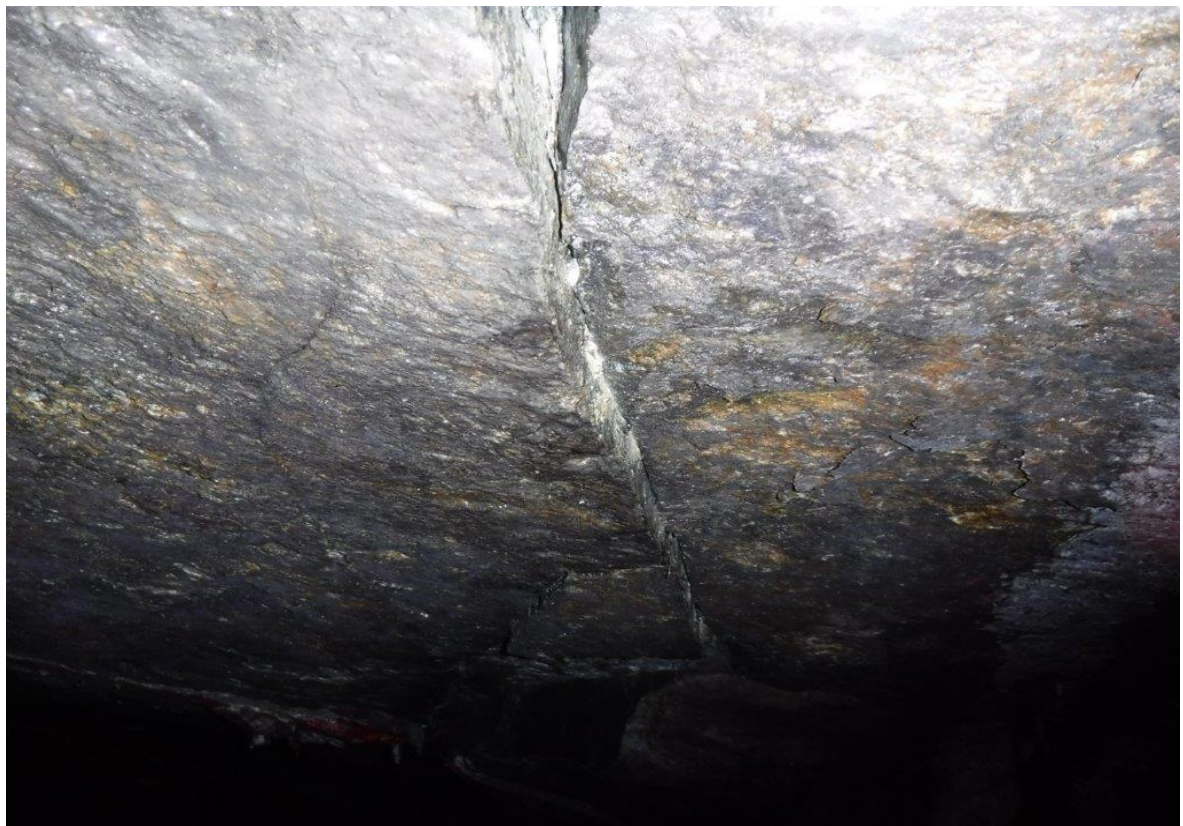
**Figure 4-19.** Tensile cracks in the hangingwall of the Level 5 failure zone.

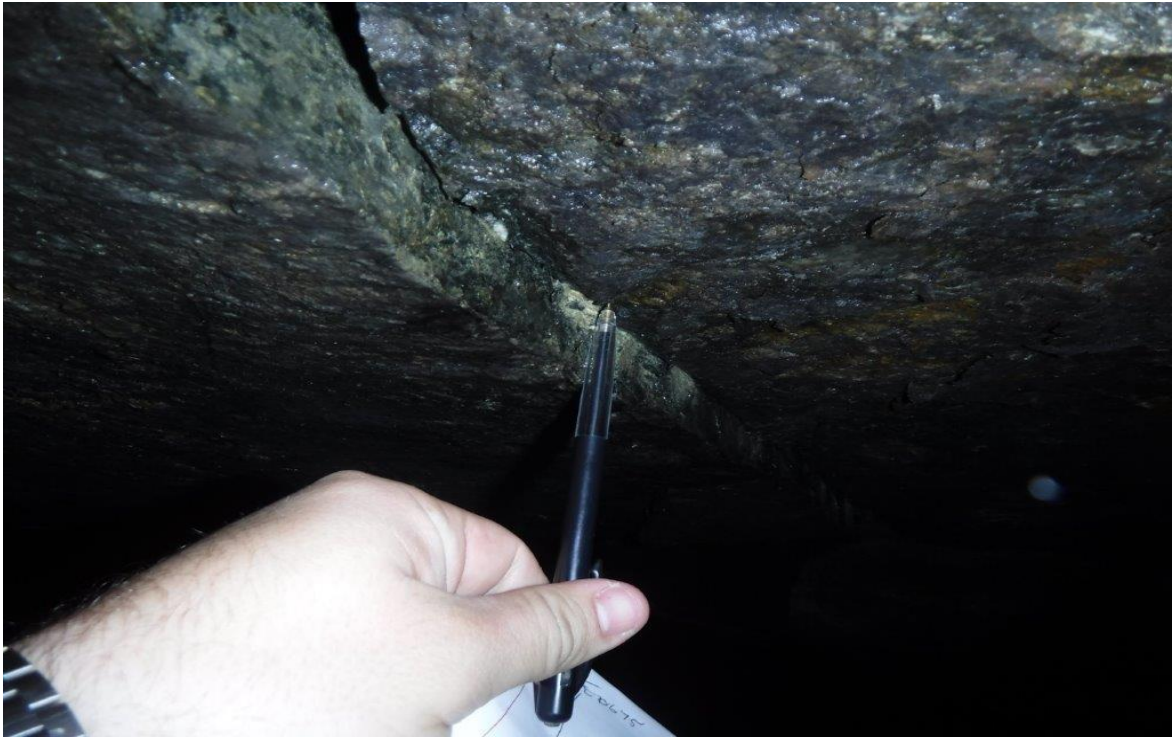
**Figure 4-20.** Relative displacement of a tensile crack in the Level 5 failure zone close to the Decline position.
