# **THE EFFECT OF GEOLOGICAL ALTERATIONS ON PILLAR STRENGTH**

M.Sc. Applied Science (Mining Engineering)

Department of Mining Engineering

21 March 2022

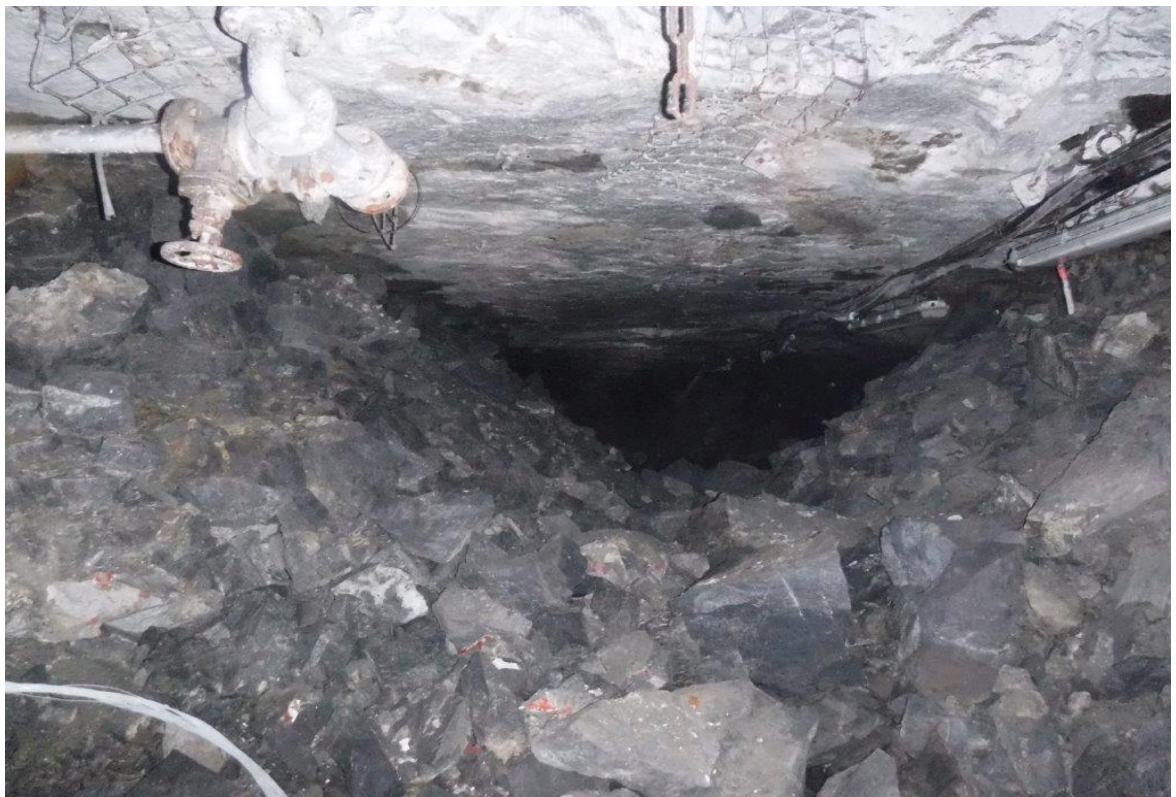
**Figure 4-21.** A view illustrating that the pillars adjacent to the Decline have been completely crushed.

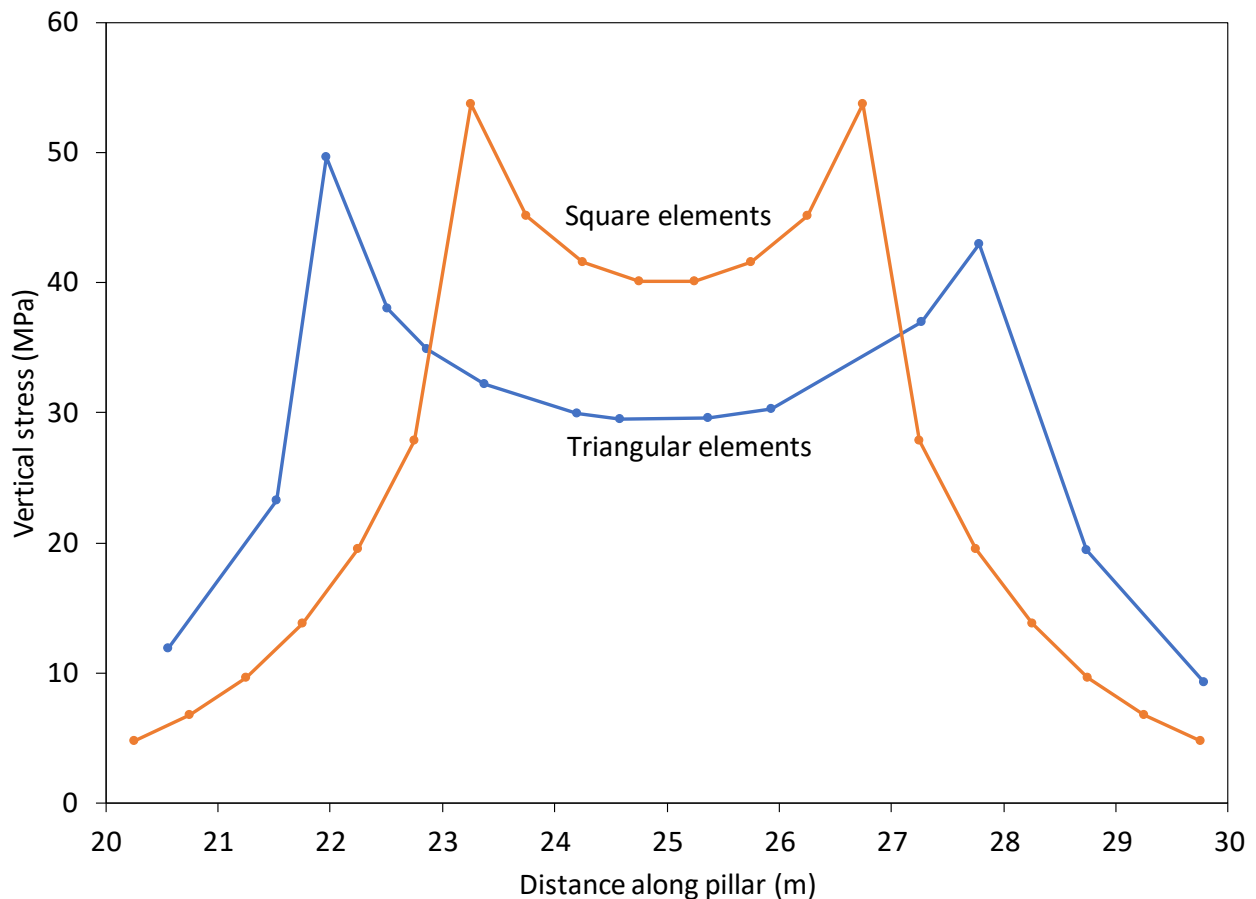
**Figure 5-15.** Vertical stress along section AA' for square and triangular element shapes.
