# **A limit equilibrium model to simulate the large-scale pillar collapse at the Everest Platinum Mine**

P.M. Couto and D.F. Malan

This paper is a case study of a large-scale pillar collapse at the Everest Platinum Mine. A major contributing factor to the collapse was the presence of weak alteration layers in the pillars. These alteration layers are found in the Bushveld Complex in South Africa where the pyroxenite layers have been exposed to hydrothermal fluid flow, serpentinization and layer-parallel shearing. The resulting clay-like material and the weak partings substantially reduce the pillar strength. From the literature survey, it is clear that weak seams in pillars reduce their strength and conventional pillar strength formulas overestimate the strength in these cases. As an alternative, a novel numerical modelling approach is proposed to study the pillar failure and to conduct a back analysis of the mine collapse. This consists of a limit equilibrium constitutive model implemented in a displacement discontinuity code. Two areas of the mine were simulated, namely part of the collapsed area and a second area, with larger pillars that is still stable. This allowed for a pre

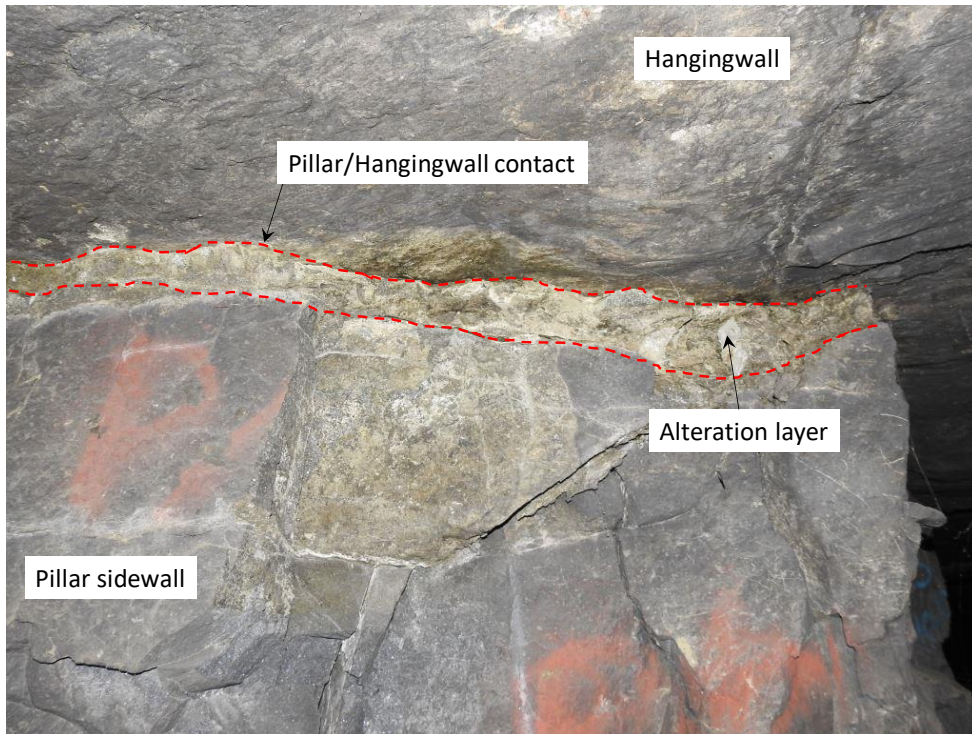
**Fig. 1** A weak alteration layer is present at the contact between the pillar and the hangingwall at the Everest Platinum Mine.

In the South African platinum mines, weak partings with infilling are also referred to as “alteration layers”. In contrast to the angular discontinuities described by Esterhuizen et al. (2019), these alteration layers are typically sub-parallel to the dip of the reef and therefore normal to the axis of the pillars. Hartzenberg et al. (2020) defines alteration layers as follows: “*The hangingwall contact of the UG2 Chromitite Reef at these sites consists of pyroxenite. The pyroxenite layers have been exposed to hydrothermal fluid flow, serpentization and layer-parallel shearing. The resulting clay-like material (weak partings) is defined as the alteration zone.*”. The term “alteration layers” are also adopted in this paper for the partings with the weak infilling. Fig. 1 illustrates this alteration zone at the contact between the pillar and the hangingwall at the Everest Platinum Mine. Note the varying thickness of the layer. Almost no research has been done on the effect of this layer on pillar strength. The low friction angle between the layer and the host rock, as well as the low strength of the alteration layer, seems to reduce the pillar strength substantially and the resulting typical pillar failure is shown in Fig. 2.

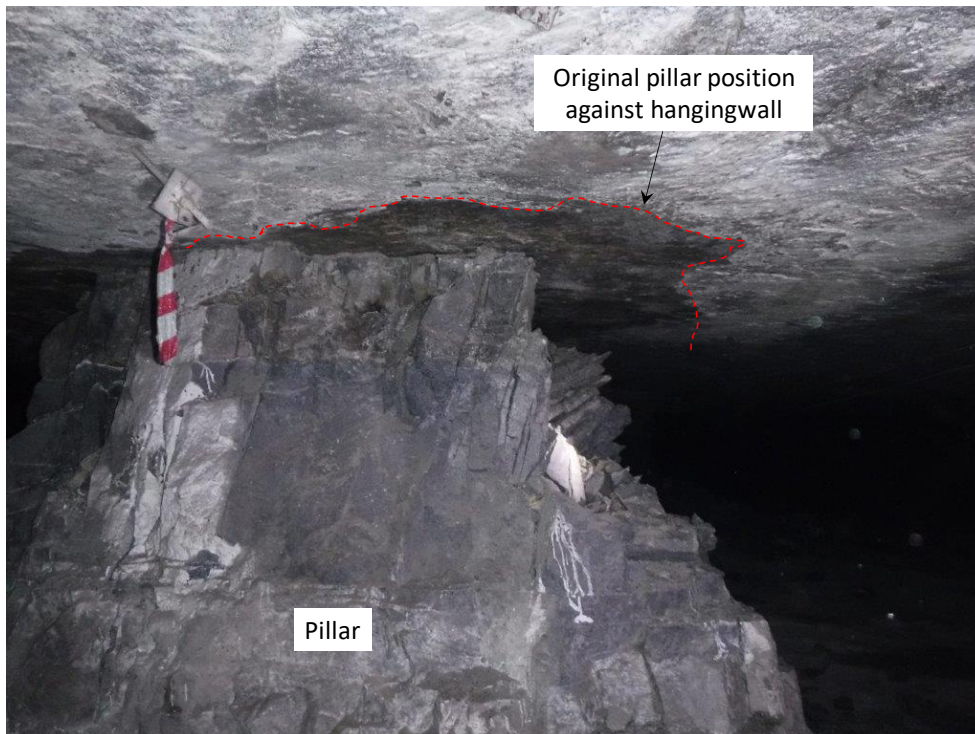
Fig. 2

**Fig. 2** Typical pillar failure in areas where weak alteration zones are present. Note the original size of the pillar against the hangingwall as indicated by the red dotted line.

maintenance strategy have continued. These are limited to the pumping of water and the inspections of escape ways. Unfortunately, the inflow of water was never measured or assessed and the role of water in the possible ongoing deterioration of the pillars cannot be quantified. The initial pillar design, in the area where the collapse occurred, resulted in pillar dimensions ranging from 5 m x 5 m to 6 m x 6 m, depending on depth. It is important to note that many of the pillars that could be measured during the underground visits were smaller than these sizes. The mining plan based on survey offsets done prior to 2008 also indicated that the pillar cutting was done poorly. Many pillars were cut smaller than the design specifications and this is considered an important contributing factor to the collapse. The depth of pillar spalling could be estimated during the underground visits as the original boundaries of many of the pillars were still visible on the hangingwall as a result of the colour contrasts. As an example, the original pillar size can be seen on the hangingwall in Fig. 2.

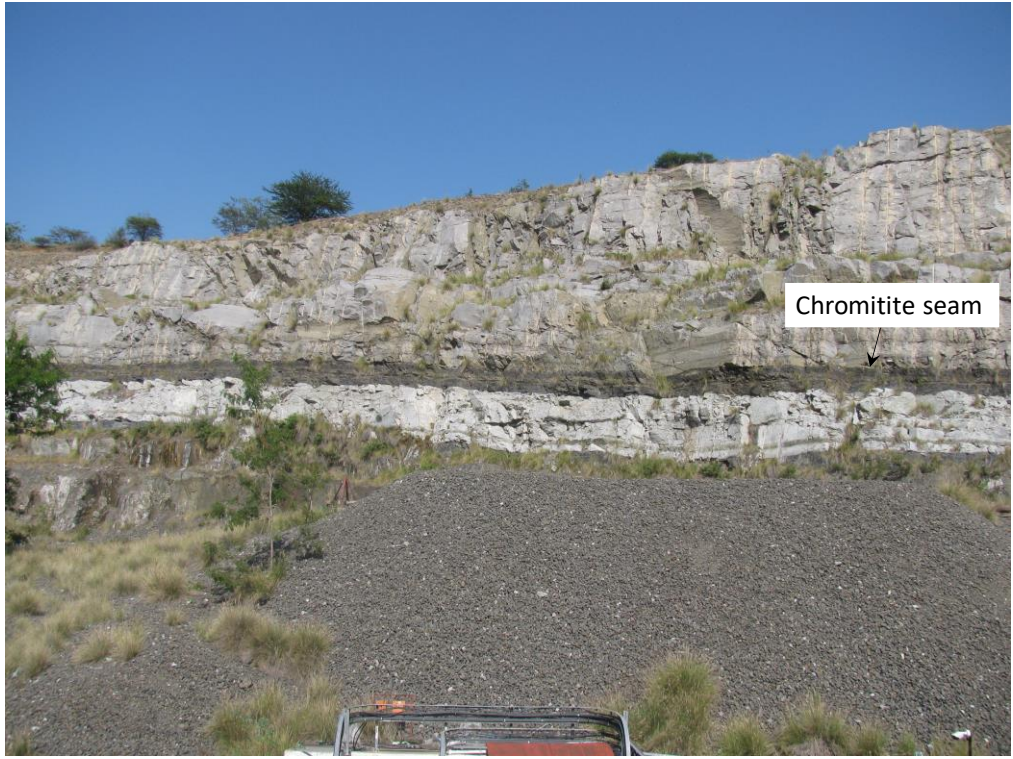
Fig. 3

**Fig. 3** A black chromitite seam visible above the portal of a chrome mine in the Bushveld Complex.

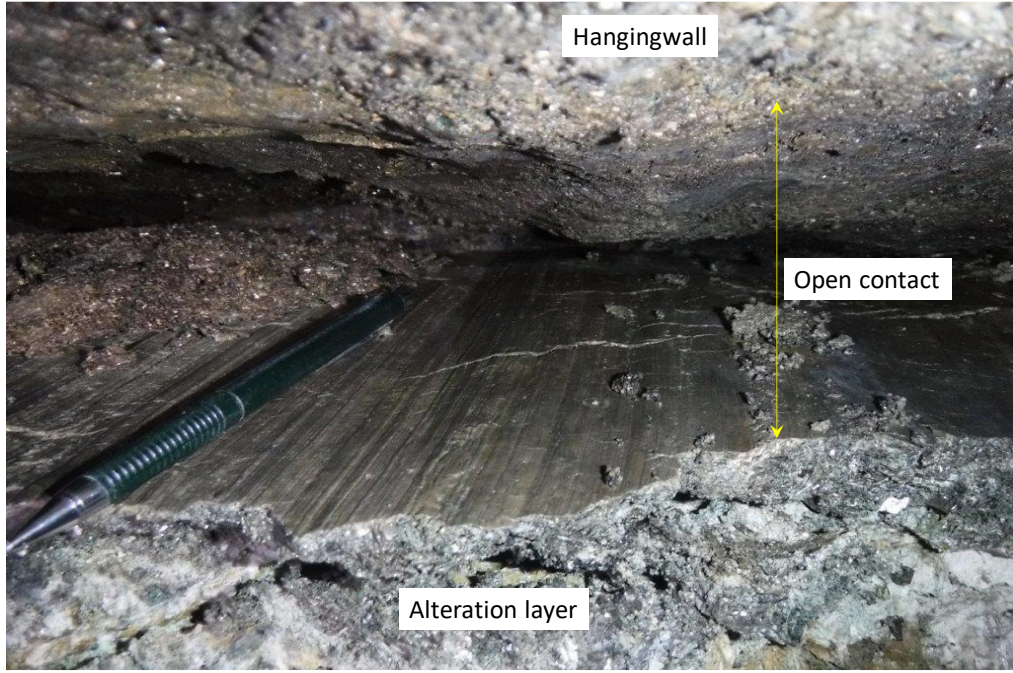
Fig. 4

At Everest Platinum Mine, a reef parallel alteration zone undulates close to the top reef contact. The material of the alteration zone is weathered, clay-like and moist close to surface, but more competent and solid at greater depths. The appearance of this zone at the deeper levels has been shown in Fig. 1. The nature of this material when it is wet and subjected to shear is shown in Fig. 4.

**Fig. 4** The clay-like nature of the alteration layer in the shallower sections of the mine. Note the evidence of shear movement on this contact.

The weathering of the alteration zone in the pillars was evident. The presence of water and high humidity have allowed the alteration to deteriorate into a “muddy” composition that appears to have no cohesive properties and a low friction angle. This material needs to be tested in future to quantify the strength and friction angle. For the purposes of this study, the friction angles were estimated as discussed below. In many areas, the alteration zone “squeezed” out between the reef contact and the hangingwall contact. This has also resulted in slickenside surfaces clearly visible on the up-dip side of the pillars (Fig. 4).

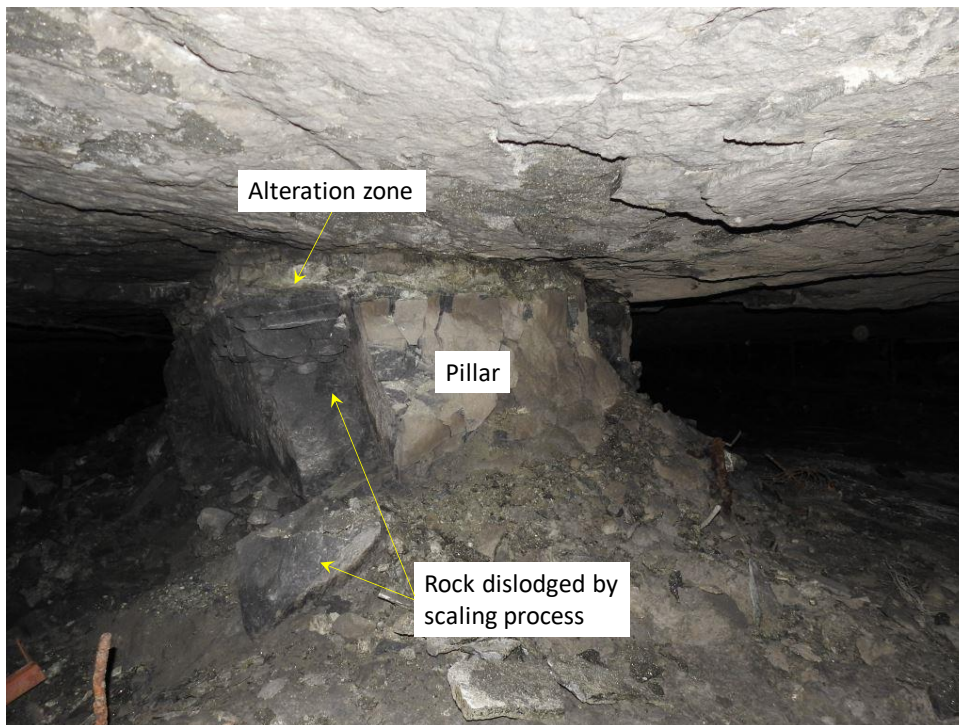
Fig. 6

**Fig. 6** Extensive spalling of a pillar in the Level 3 failure zone.

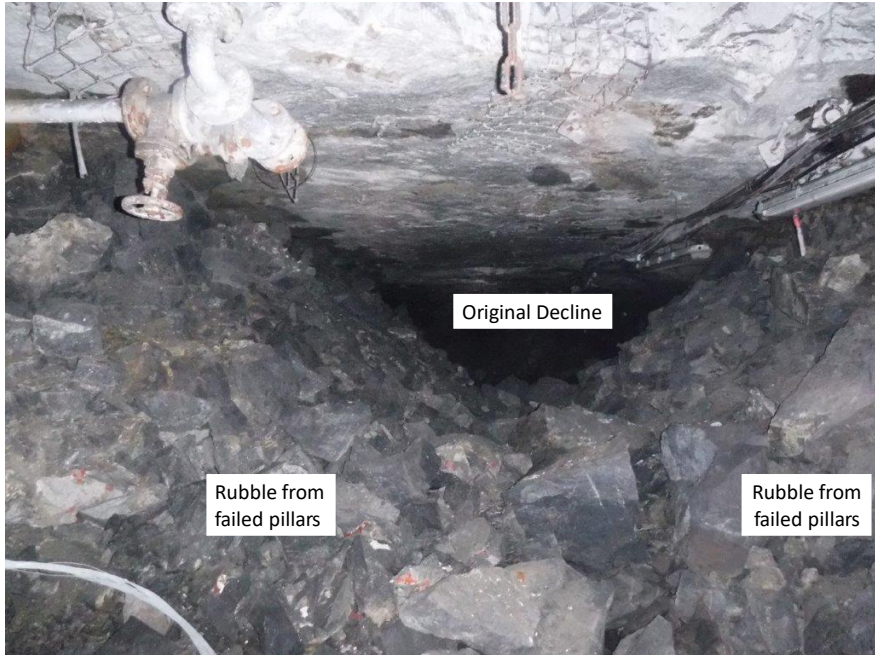
Fig. 7

**Fig. 7** The pillars adjacent to the decline at Everest Platinum Mine were completely crushed during the collapse.

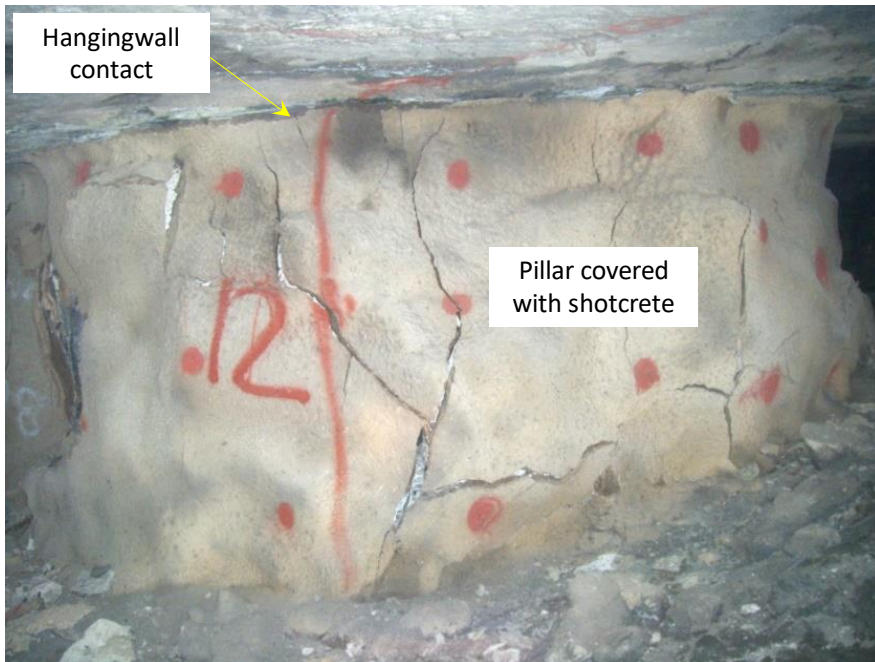
In summary, the pillar rehabilitation measures implemented by the mine was not successful in the shallow areas. Fig. 8 illustrate the cracking of the shotcrete applied to some of the pillars. From the literature (e.g. Alejano et al, 2017), it seems as if pillar support can be beneficial in some cases, but it did not work at Everest Platinum Mine. Many questions also remain with regards to the actual pillar strength and if an alternative layout should have been implemented. The section below describes a modelling approach to obtain additional information about the pillar strength and layout stability.

**Fig. 8** The pillars adjacent to the decline at Everest Platinum Mine were completely crushed during the collapse.

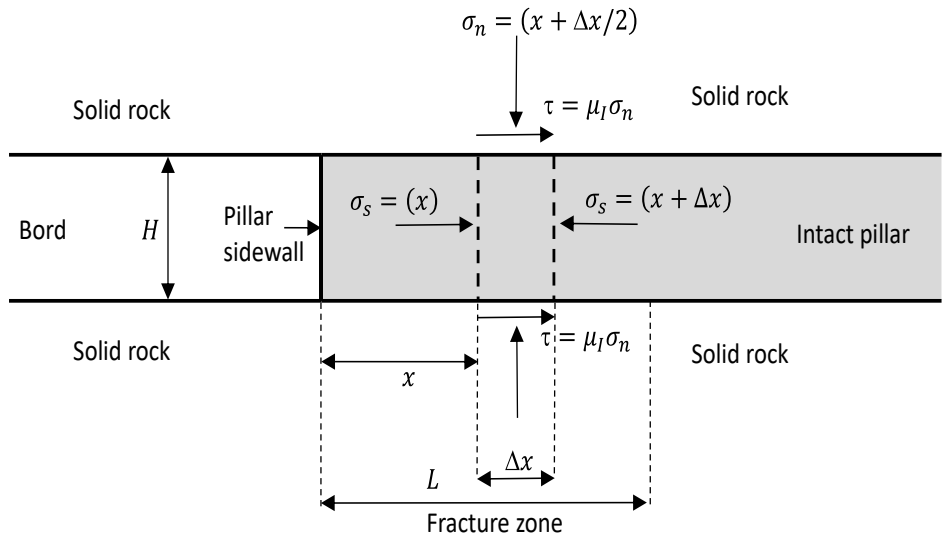
Consider the force equilibrium of a slice of rock in the pillar shown in Fig. 9. This diagram illustrates the mined bord on the left and part of the pillar on the right. This simplistic model assumes the presence of an interface for the pillar contacts at both the hangingwall and footwall. Typically, the edge of the pillar will fail where the stress exceeds the specified strength and the remainder of the pillar will remain intact. For weak material properties and high stress, the entire pillar can fail.

**Fig. 9.** Force equilibrium of a slice of rock in a pillar.

It is assumed that at  $x = 0$ , the edge of the pillar, the material is unconfined and that the seam-parallel stress component  $\sigma_s$  increases as  $x$  increases. The slice of rock indicated by the dotted lines in Fig. 9 is assumed to be in equilibrium. For this to be true, it is required that:

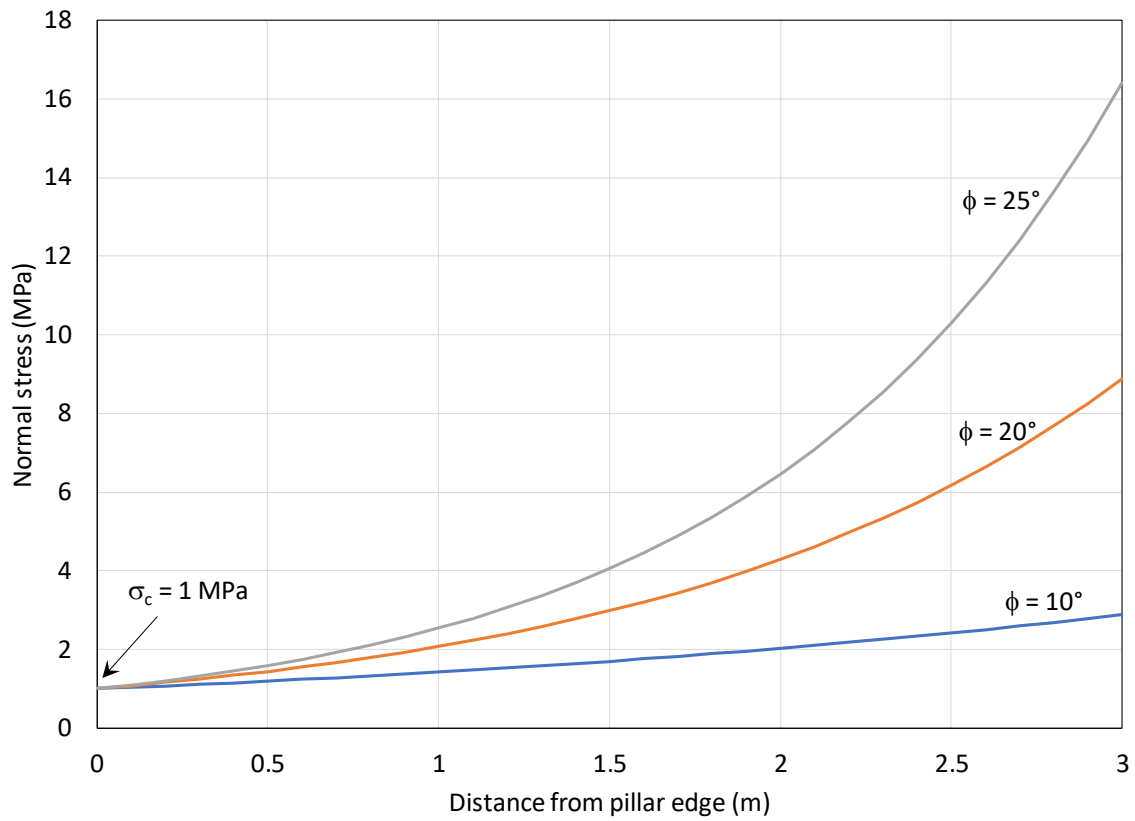
Fig. 10

Equation (19) implies that the normal stress in the failed pillar edge increases exponentially from the edge towards the boundary between the failed and intact rock. This exponential increase in stress is characteristic of the model and it is not clear if this is an appropriate representation of the stress in a failed pillar. Also, important to consider is that it is a requirement that  $\sigma_c > 0$ , even after failure, otherwise the normal stress will be zero in all the failed parts of the pillar.

**Fig. 10.** Increase in normal stress acting on a completely failed pillar when assuming a limit equilibrium model. The pillar is 6 m wide and the centre of the pillar is at 3 m. The graph is plotted using parameters  $m = 2$ ,  $\sigma_c = 1$  MPa and  $H = 2$  m.

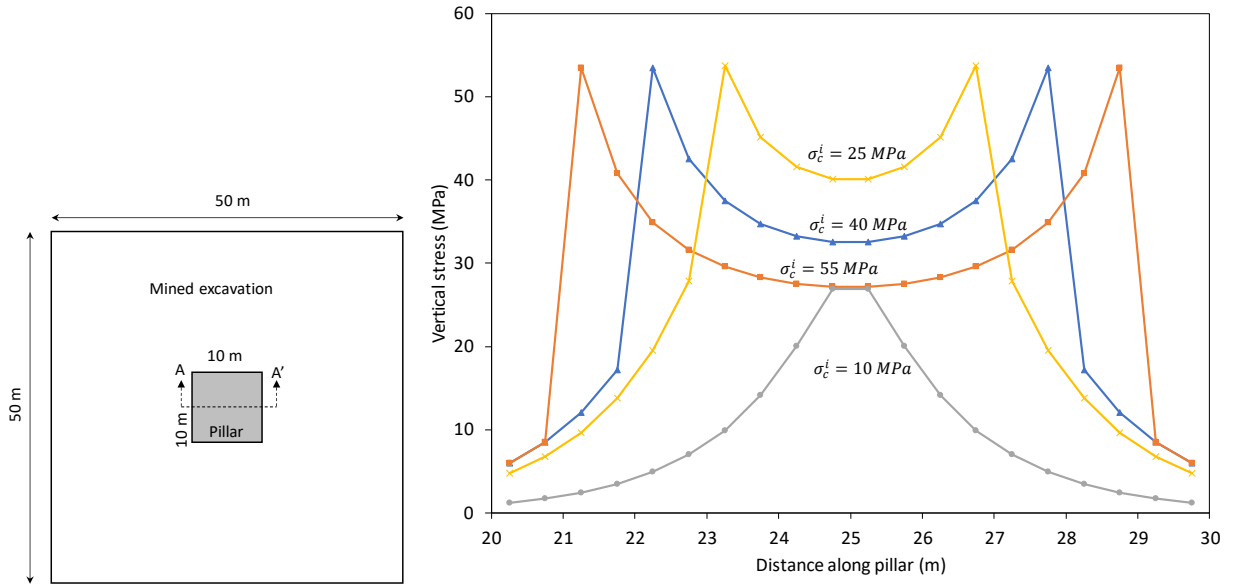
Fig. 11

When specifying these parameters, the requirements of  $m^i \geq m^f$  and  $\sigma_c^i \geq \sigma_c^f$  must be met. As an illustration of the simulated model behaviour, a simple square pillar of 10 m width in the centre of a 50 m  $\times$  50 m excavation was simulated (Fig. 11). The results illustrate the effect of the reducing the intact strength,  $\sigma_c^i$ , from 55 MPa to 10 MPa while keeping the other parameters constant. For a value of 10 MPa, the pillar was completely crushed.

**Fig. 11.** Simulated vertical stress along a 10 m wide pillar (Section AA’) for different values of  $\sigma_c^i$ . High values for this parameter result in a large intact core of the pillar and for low values, the pillar is completely crushed. The other parameters were  $m_i = m_f = 4$ ,  $\sigma_c^f = 4$  MPa,  $\phi = 10^\circ$  and  $H = 2$  m.

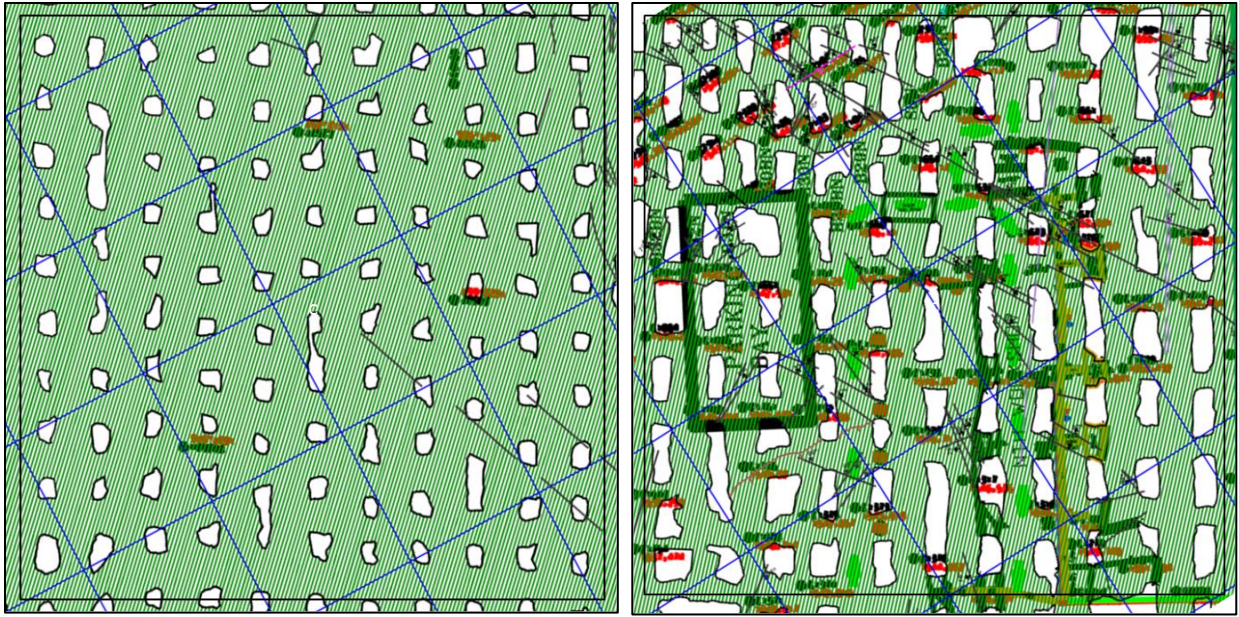
**Fig. 13**

Fig. 13 illustrates enlarged views of the two areas. As the areas were simulated with no dip, they were also rotated to simplify the digitising and meshing process for the models. The pillar shapes shown in Fig. 13 were approximated using straight line polygons. This simplified the digitising and meshing process using triangular elements.

**Fig. 13.** An enlarged view of the two areas selected for detailed modelling. Note the clear difference in pillar sizes. The extraction ratio of the collapsed area was 88% compared to the 67% of the intact area. The sizes of both areas simulated were 160 m x 160 m. The input parameters are given in Table 1. Again, note that on these mine plans the pillars are indicated by the white areas.

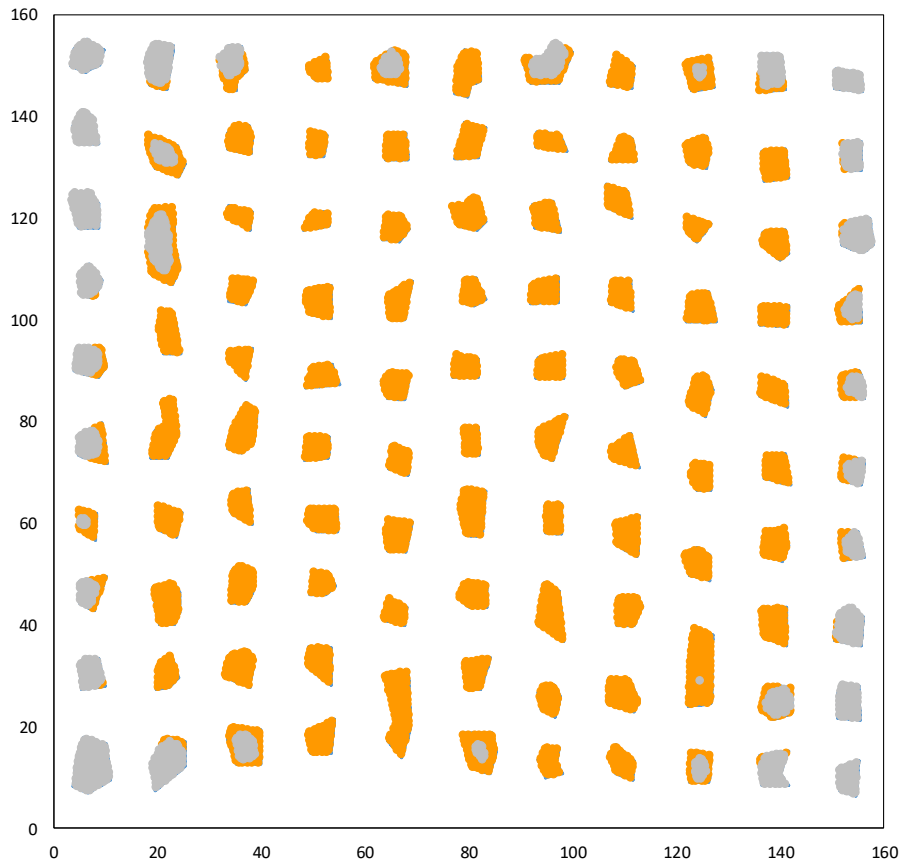
**Fig. 14**

The simulated condition of the pillars in the two areas are shown in Fig. 14 and Fig. 15. These are encouraging results as the pillars in the centre of the collapsed area are completely failed and there is only minor spalling in the centre of the intact area. This agrees with the underground observations for the two areas. The pillars on the edges of the collapsed area are still intact, but this is caused by the modelled abutment next to these pillars and the relatively small size of the model.

**Fig. 14.** Simulation of pillar failure for the **collapsed area** using the “Set 12” calibration parameters. The orange colour denotes failure and the grey denotes intact pillars.

From these results, it seems as if the particular numerical model is able to simulate the observed pillar behaviour. Encouraging was that the same parameters could be used for the stable and intact area except that the friction angle of the interfaces were varied. A challenging aspect is that the calibration of the limit equilibrium model is very difficult. Future work needs to study methods to better calibrate this model. Laboratory testing is required to determine the rock strengths as well as the friction angles of the wet and dry alteration zone material. As the proposed model seems

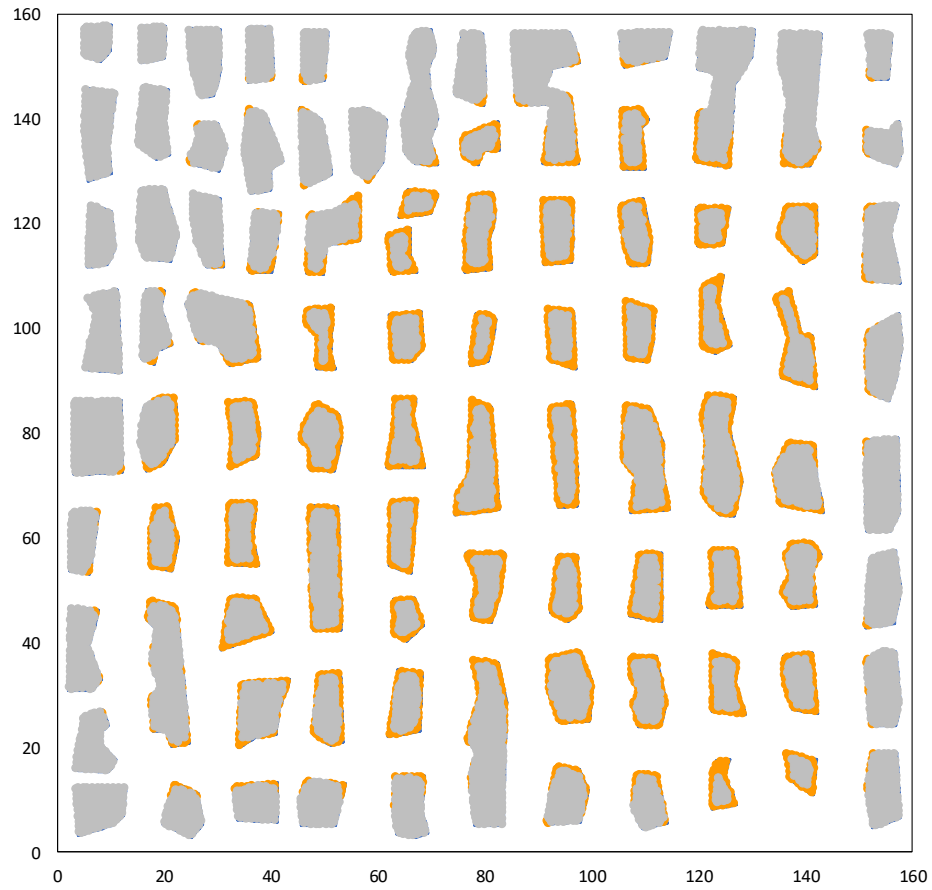
Fig. 15

**Fig. 15.** Simulation of pillar failure for the **intact area** using the “Set 10” calibration parameters. The orange colour denotes failure and the grey denotes intact pillars.
