A case investigation into causes of premature rutting failures in rehabilitated asphalt pavements in Tanzania

ABSTRACT

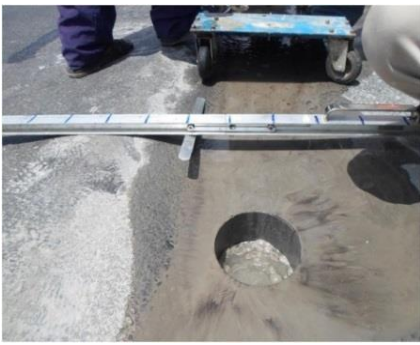
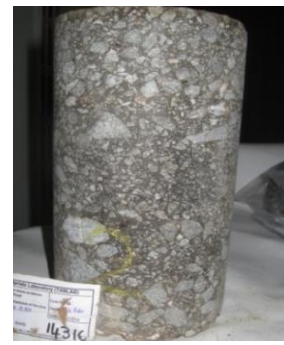
(A) Nelson Mandela road section

Figure 1 shows rut depth measurements for the five rehabilitated road sections (Nelson Mandela, Mlandizi-Chalinze, Chalinze-Morogoro, Mikumi-Iyovi, and Makambako-Mbeya). The

FIGURE 1
Road conditions, rut depths and representative field cores

outer wheel tracks of these sections have experienced a more severe rutting. A common feature for these sections was that after rain, water stays in the wheel tracks, resulting in ponding and hydroplaning. In addition, bitumen bleeding was accompanying rutting on some of these AC sections.

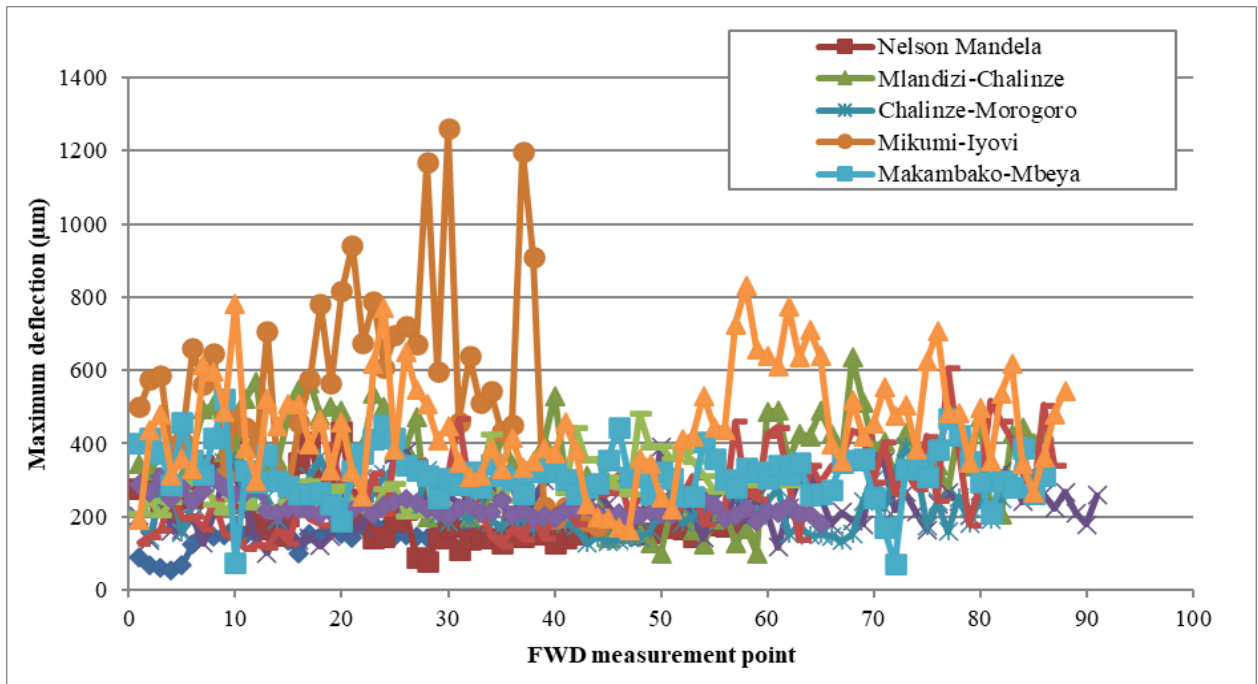
FIGURE 2
Maximum FWD deflections on the road sections

“green”). Figure 2 presents the maximum deflections for the road sections plotted on the same graph for comparison. The deflections are plotted against FWD test points instead of chainage since the tested sections are at different locations. High deflection values were generally reported for the Mikumi-Iyovi and Mlandizi-Chalinze roads sections. This agrees with the deflection bowl parameter results presented in table 3, and akin to low stiffness, and consequently indicating that these two sections had excessive rutting in both outer and inner wheel tracks of the asphalt layer. However, this assertion could only be a speculation based on the empirical data presented in this paper as there is no direct relationship between rutting and FWD deflection bowl parameters. It is worth mentioning that rutting is due to plastic deformation and FWD only measures elastic response, and the two are not linearly related.

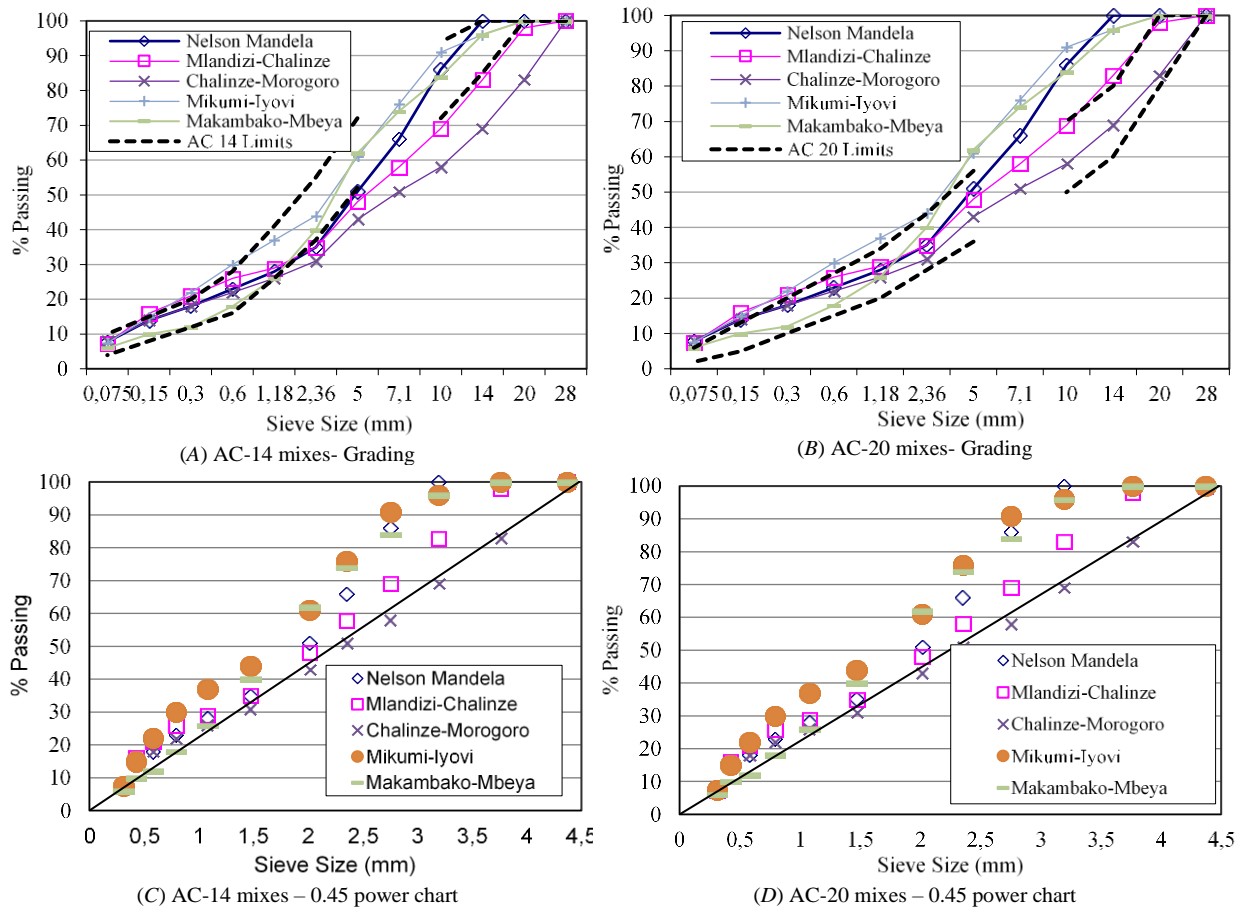
FIGURE 3

Grading analysis results of AC cores compared with specification limits

rutting and bleeding were found to be excessive on this section. The Mlandizi-Chalinze section also plots too close to the maximum density line although this behaviour is found on only the lower sieves.

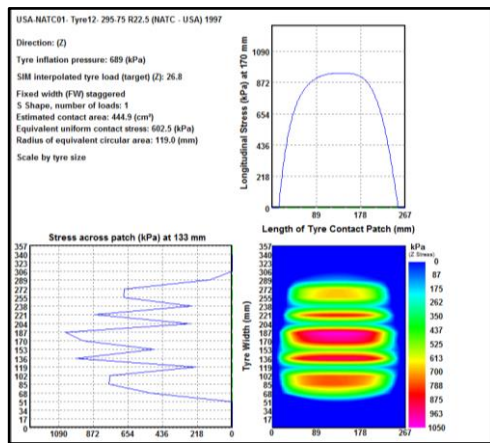
(C) 2D Tyre stress contact pattern- dual tyre 295

(D) 3D Tyre stress contact pattern- dual tyre 295

From table 1, the NCP ratios of the wide-base tyres are generally high compared to the dual tyres, meaning that the asphalt layer of the investigated rehabilitated road sections experiences higher stresses under wide-base tyres than under dual tyres. This could also imply that the wide-base tyres used for this analysis can potentially cause more damage (i.e., rutting) than the dual tyres. The contact stress shapes for the wide-base and dual tyres are illustrated in figure 4 using the TiP of 689 kPa for the three different tyres. Usually, the maximum stresses for dual tyres, depending on the tyre loading, are 1 to 2 times higher than the actual tyre inflation pressures as indicated by a study conducted by De Beer et al.¹⁶ For a rut depth of 12.5 mm, the study found that a wide-base tyre could cause a damage of more than 10 times that of a dual tyre. Ponniah et al.¹⁷ reported that wide-base tyres produce 20 percent higher stress than the dual tyres under the same axle loading and noted a wide-base tyre causing 2 to 3.5 times damage than dual tyres.
