The Oranjemund shipwreck, Namibia. The excavation of sub-Saharan Africa's oldest discovered wreck*

Bruno E.J.S. Werz

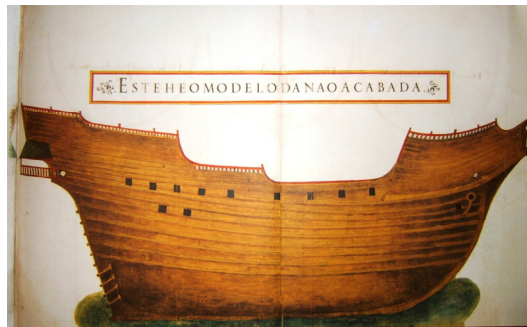
Figure 1: Watercolour of the early seventeenth century Portuguese *nao* 'Acabada'. Although dating to some 80 years after the foundering of the Oranjemund ship, the drawing provides a good impression of the outer hull of merchant vessels of the period. (Manuel Fernandez, *Livro de traças de carpintaria*. S.l. 1616. Facsimile copy produced by the Academia de Marinha, Lisbon 1995: fo. 71).

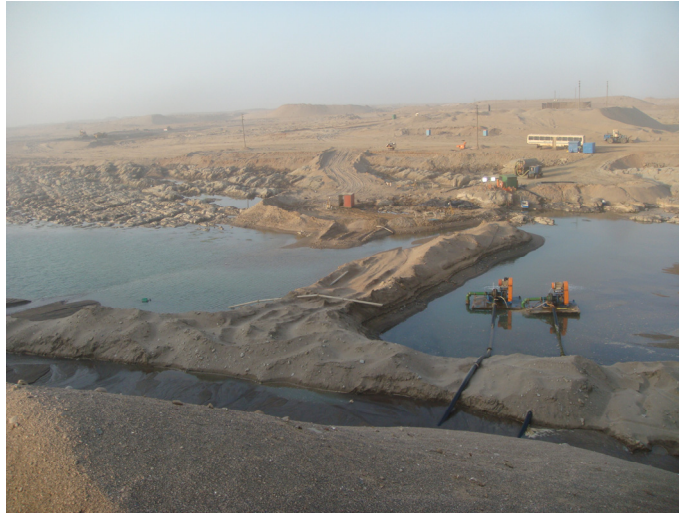
Figure 2: Overview of the site towards the east. The picture was taken from the top of the sand wall that protected the area from the sea. The wreck site is in the centre. In the foreground, two pumps that kept the water out. The bus in the background provided shelter and office space. (Bruno Werz)

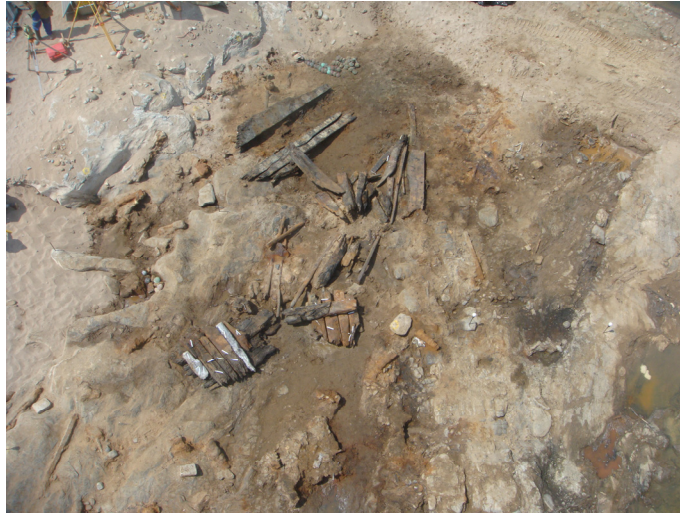
Figure 3: Aerial view of part of the site towards the southeast. The picture was taken on 6 October 2008, towards the end of the excavations. At this stage, most material had been removed. The hull fragments were left *in situ* to allow for a final laser scan survey. Left, bottom is St.1; in the centre St.2; and top, St.3. The structural remains are flanked by the rocky seabed outcrop, to the left, against which the vessel probably foundered. (Bruno Werz)

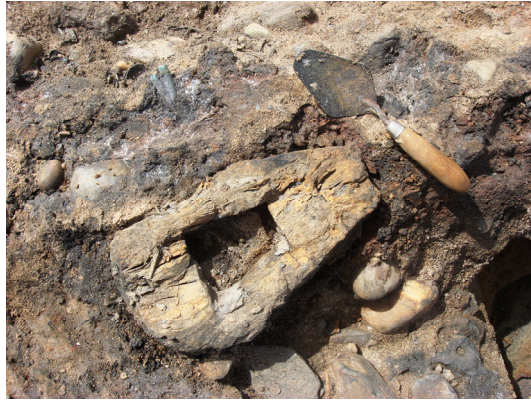
Figure 6: A small wooden block that formed part of the running rigging of the ship (length approx. 290mm). The artefact was found immediately to the west of the wreck remains. When excavated, it was conglomerated onto the bedrock by ferrous oxides. The trowel point indicates north. (Bruno Werz)

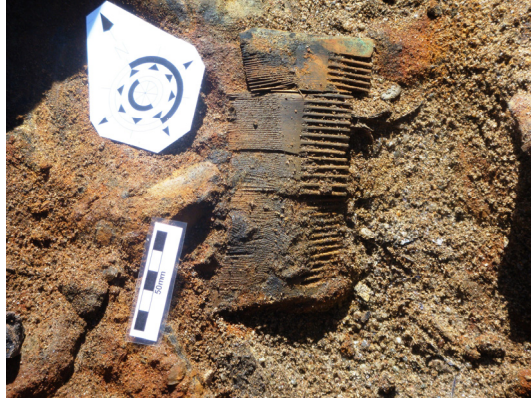
Figure 7: A wooden lice comb, as excavated from the upper layers of St.3, concr. S. Combs like these were personal items of those on board and formed a basic hygienic necessity. (Bruno Werz)

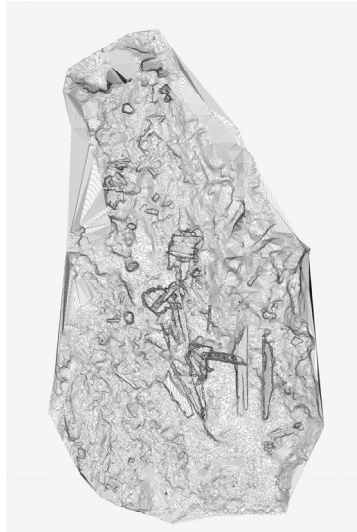
Figure 9: The results of the combined laser scan surveys on the section of the site that contained structural remains. From top to bottom: St. 1, St. 2 and St. 3. The border on the right-hand side of the scan indicates the western perimeter of the seabed outcrop against which the ship struck. (Courtesy Namdeb Survey Section)
