05 SITE ANALYSIS

The purpose of the site analysis is to provide the reader with a clearer understanding of the specific selected salt and soda factory site, illustrating the existing structures. The Burra Charter was employed as guideline to inform design decisions.

5.1 The salt and soda Factory

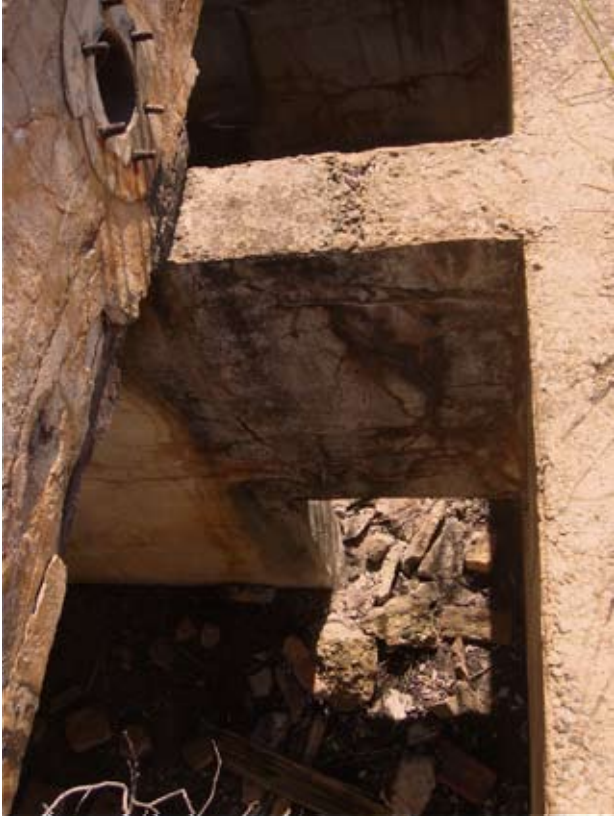
Figure 5.05 Corroded reinforced concrete storage tank structure [March 2009]

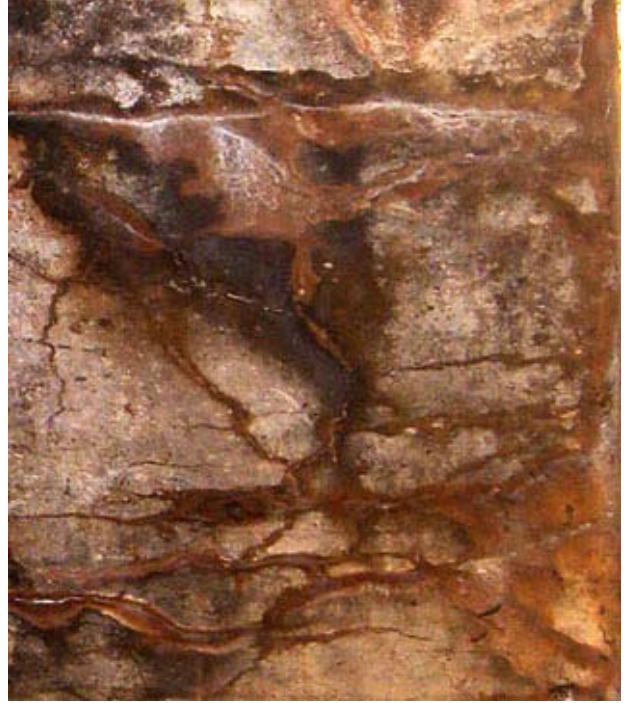
Figure 5.06 Storage tank, filled with dead leaves [August 2009]

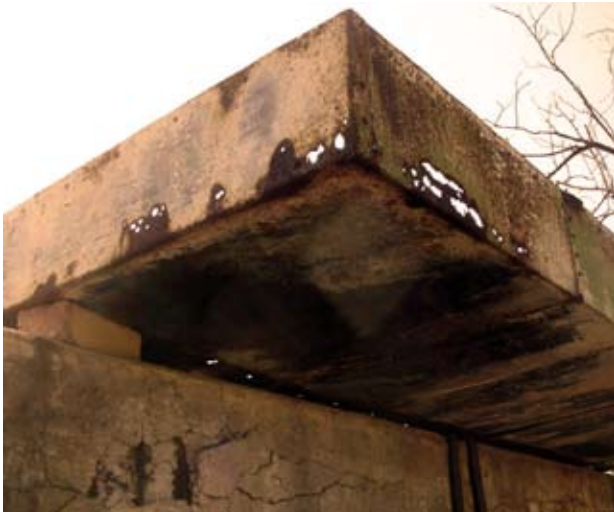
Figure 5.07 Corroded steel element on top of concrete storage tank [June 2009]

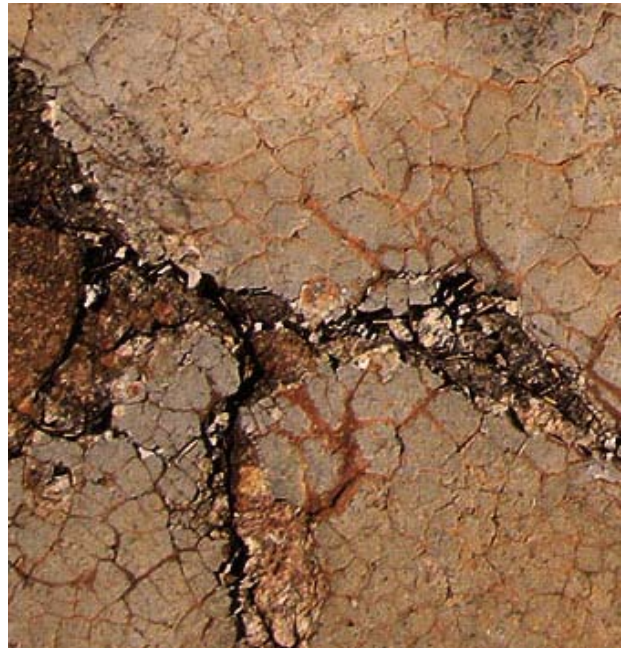
Figure 5.08 Corroded reinforced concrete element [June 2009]

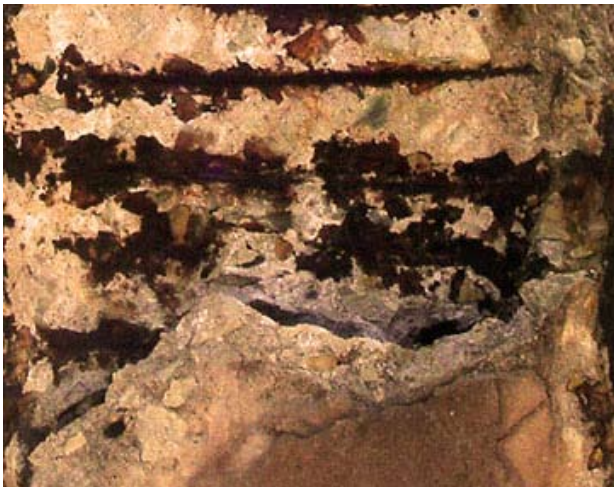
Figure 5.09 Residue of corroded element on concrete surface [June 2009]

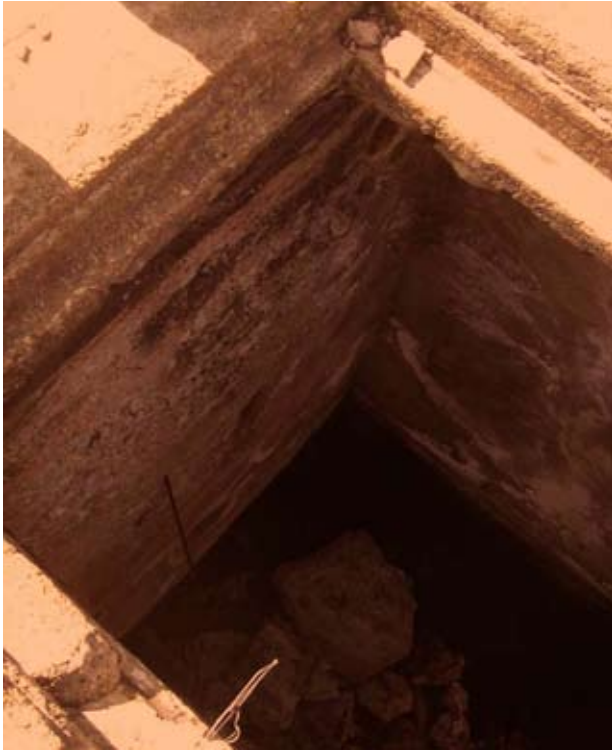
Figure 5.11 Dilapidated reinforced concrete storage tanks filled with rainwater

Remnants of the original storage tanks that are approximately 3m below the natural ground surface have filled with rainwater and other scraps of ruined elements accumulated over time. It is presumed that these tanks were originally used to cool the pumped water down, as the temperatures below ground are much cooler than the outside surface temperatures.

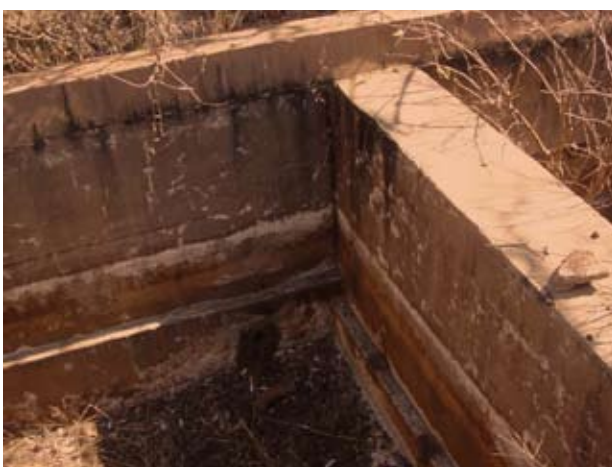
Figure 5.14 Open storage tanks filled with dead leaves [August 2009]

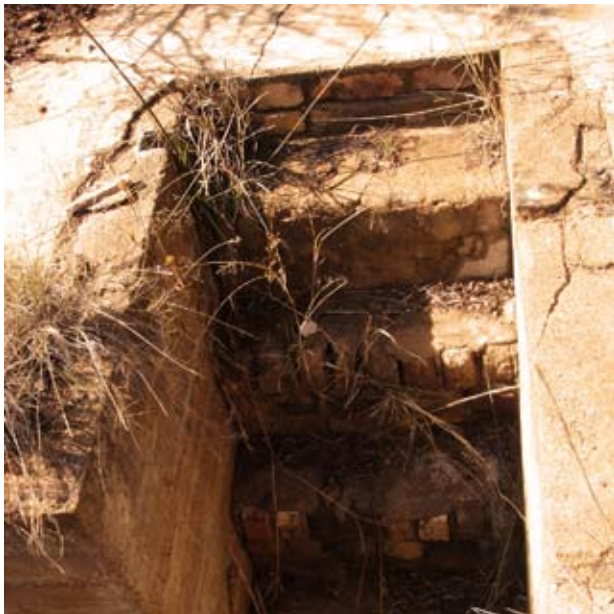
Figure 5.16 Small stairs leading into open storage tank [March 2009]

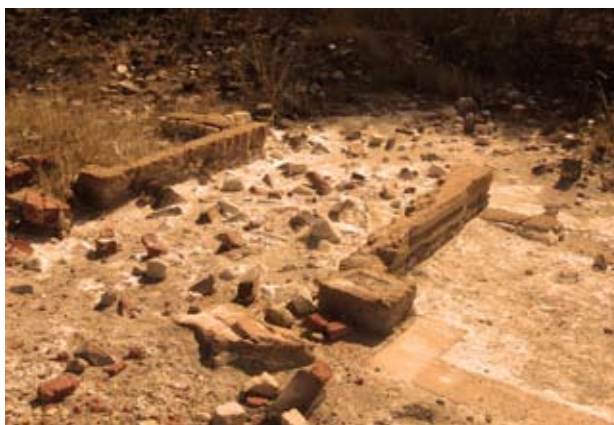
Figure 5.17 Soda ash residue with left over bricks on southern edge of factory structures [August 2009]

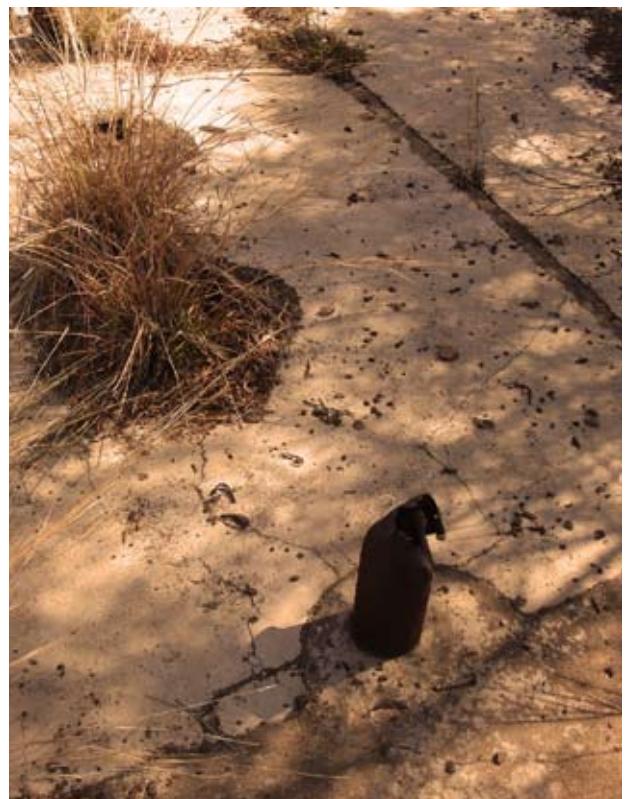
Figure 5.18 Concrete floor with corroded pipe elements protruding [August 2009]

Today, only remnants of the old factory linger in the landscape, marked by a vast expanse of concrete flooring, in which corroded reinforcing, remnants of pipelines and the traces of floor partitions can be found. These have been left to decay and are slowly turning into heaps of rubble over time as nature takes its course and the structures are vulnerably exposed to the elements. Gradually, plants seek out the cracks, bursting through the concrete foundations upon which a profitable industry was formerly founded, the ruins ironically crumbling from the very foundations upon which they were once constructed – salt.

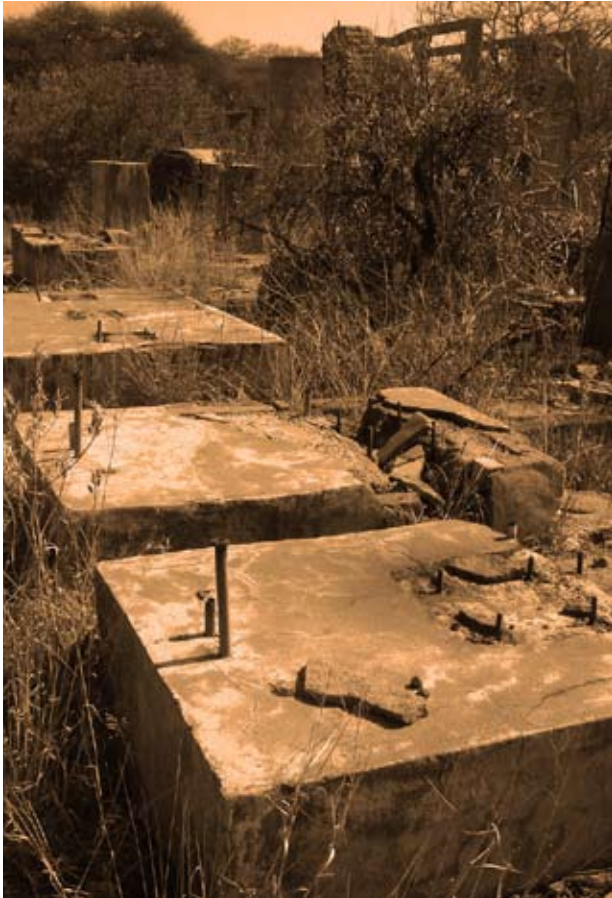
Figure 5.20 Possible foundations of corrugated structures [August 2009]

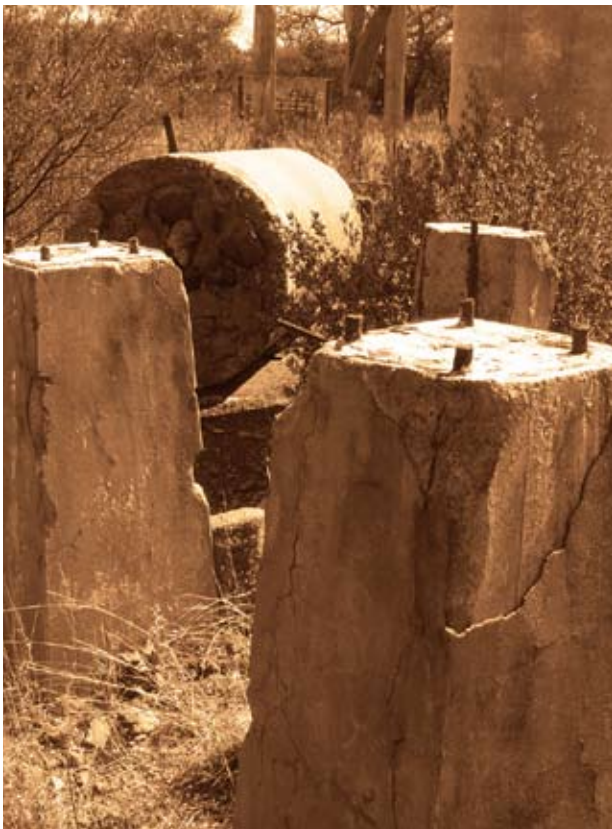
Figure 5.21 Reinforced concrete elements [March 2009]

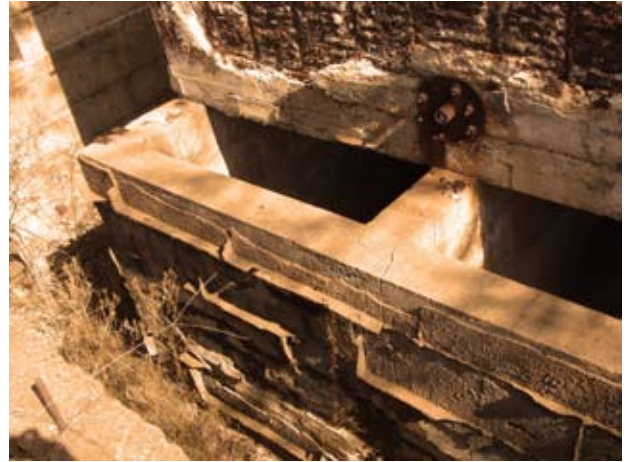
Figure 5.22 Reinforced concrete storage tanks [March 2009]

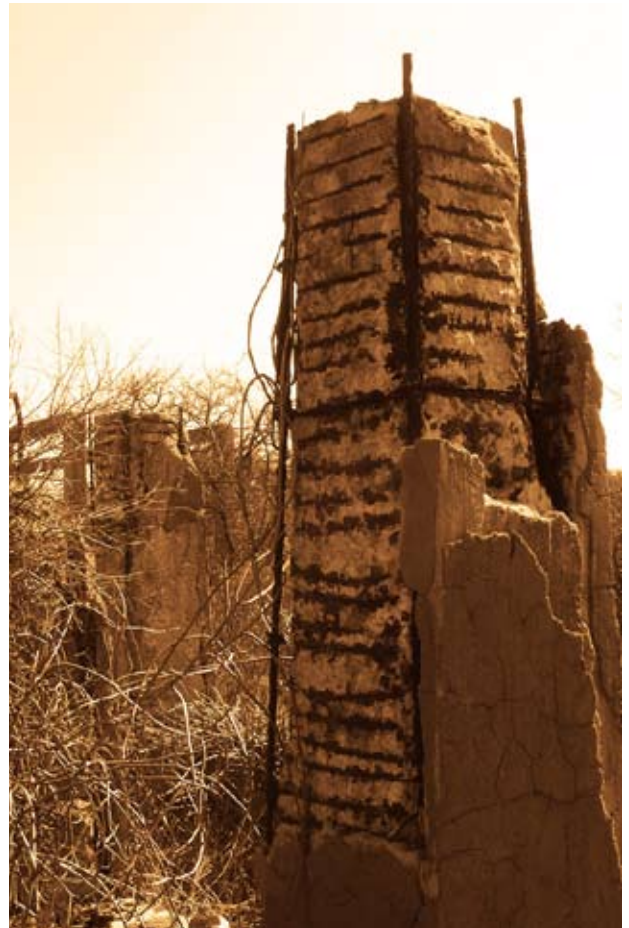
Figure 5.23 Reinforced concrete column structure [March 2009]

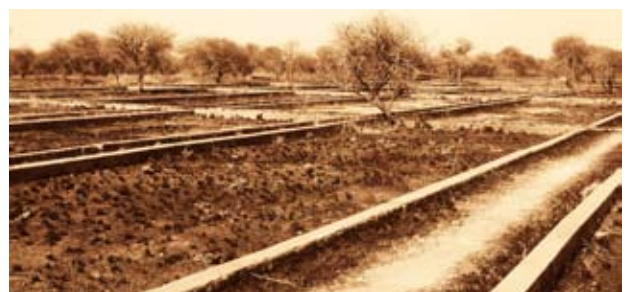
Figure 5.24 Foundations of historic warming ponds [August 2009]
