THE DEVELOPMENT OF A THERMOPLASTIC ROAD MARKING MATERIAL STANDARD

A thesis submitted in partial fulfilment of the requirements for the degree of
MASTER OF SCIENCE (TRANSPORTATION)

In the
FACULTY OF ENGINEERING
UNIVERSITY OF PRETORIA

August 2016

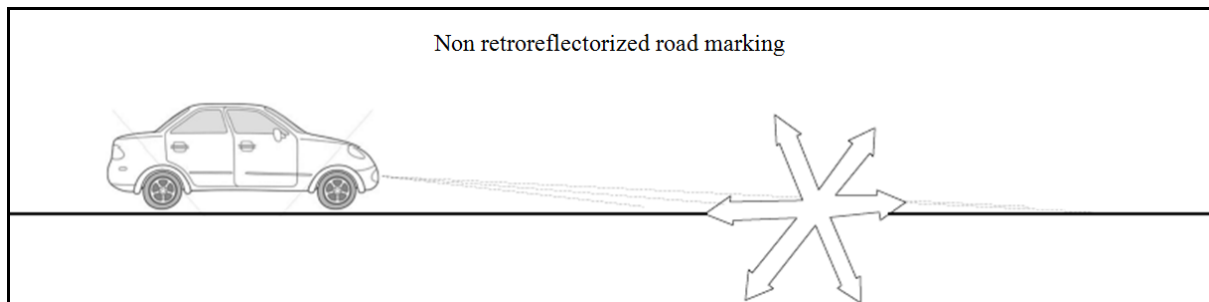
Figure 1.1: Non-retroreflectorized road marking (SARTSM, 1999).

Figure 1.1 illustrates what happens to the light from vehicles' headlights when it strikes onto a road with non-reflective road markings. Instead of being reflected back to the driver, the light is dispersed in all directions, resulting in poor road marking visibility at night. Non-reflective road markings are markings to which glass beads have not been applied or markings which have reached a poor condition in which the glass beads have been worn off by vehicle wheels.

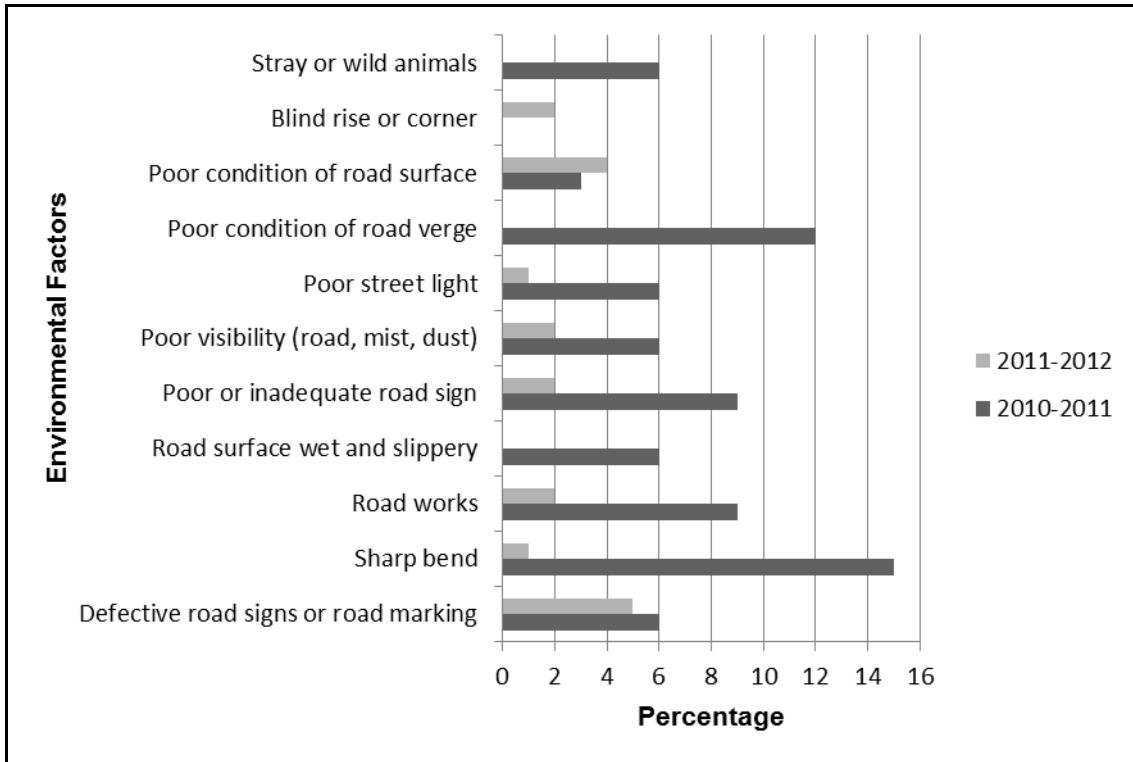
Figure 1.4: Environmental factors contributing to road accidents (Letsoalo, 2012).

According to Figure 1.4 there was a slight reduction in road accidents caused by defective road signs and road markings from 2010 to 2012, but more effort should be placed on these environmental factors in order to reduce road accidents. Road authorities can use rumble road markings on the edge lines at sharp curves, which will alert the driver to being too close to the edge of the road when the wheels of the vehicle pass over the rumble road markings so that an appropriate action can be taken by the driver to prevent an accident from occurring. If there are clearer visible road markings, the driver may be able to see the curve from a distance and appropriate action can be taken to prevent an accident from occurring. At areas under construction, a high retroreflective specification for road markings may be prescribed to ensure that the area is adequately visible to the road user. Traffic signs can be supplemented with relevant road markings so that when the road user cannot see the traffic signs, the continuity of visible road markings can inform the road user of what action needs to be taken. Road accidents cost the SA economy approximately R 307 billion per year (Letsoalo, 2012).

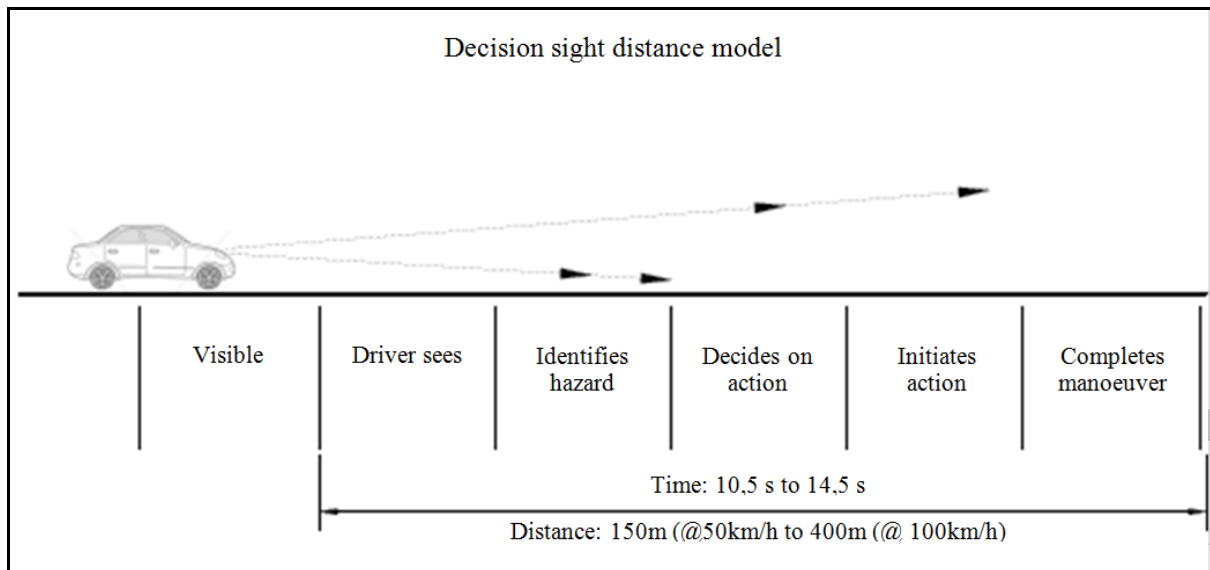
Figure 2.1: Decision sight distance model (Labuschagne and Grosskopff, 2004).

Visual sensory processes are the only pertinent ones in maintaining course, and detecting obstacles and in reading road signs, signals, road markings and other forms of delineation. Drivers do not observe the roadway continuously as they blink, observe objects well off the line of the road, use the rear view mirror, read the vehicle instruments and talk to passengers. The reaction time of a road user is generally low on familiar roads, while reaction times are much higher for road users on unfamiliar roads. The distance at which a driver can detect a hazard in an environment of visual clutter, recognise it as a threat and select an appropriate speed and path in order to perform the required manoeuvre safely and efficiently, is called the "decision sight distance" (Figure 2.1). Drivers must obtain and receive reliable, credible and understandable information to minimise uncertainty in order to make sound decisions timeously (Labuschagne and Grosskopff, 2004).

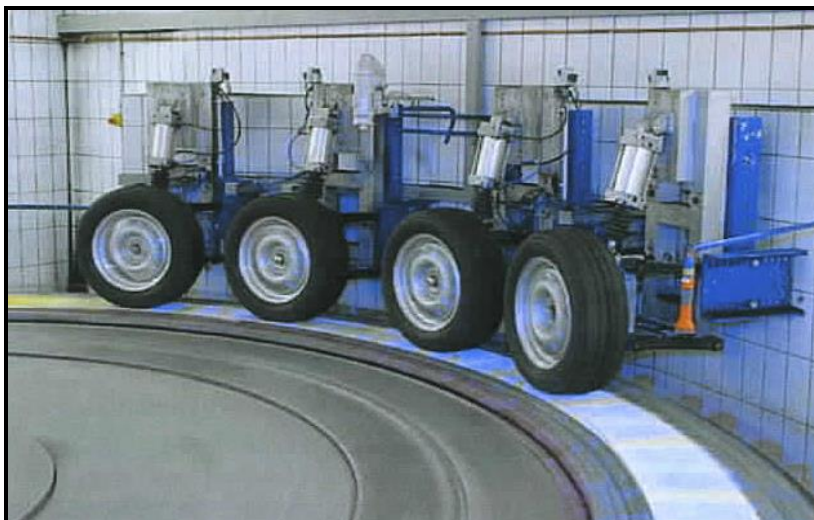
Figure 2.4: Turntable road marking test system (Zedler, 2014).

The BS EN 13197:2011 (2011) standard is used to conduct laboratory measurements of the Q_d , the R_L , colour and skid resistance of the test road markings. This standard is used to measure road marking materials in the wear simulator. Road markings were tested only at road trials in real traffic until 1976 (Zedler, 2014). The field tests had the disadvantage that the results were available only after the real test time. As the number of road users increased, it became difficult to continue with road trials and as such the turntable road marking test system was developed and used extensively. This test system consists of a horizontally arranged turntable with a diameter of 6.40 m to which different road marking samples can be applied at the same time (Figure 2.4). The test samples are subjected to different wheel loads which produce the same degree of wear as real vehicles in traffic. The test markings are applied to special test substrates whose composition and surface correspond to a finely structured roadway surface. The number of wheel passages varies from 50 000 to 4 million depending on the class of traffic to which the test markings will be subjected to in real traffic conditions. The test markings which are subjected to 4 million wheel passages indicate an anticipated service life of the road markings between 4 and 6 years (BS EN 13197:2011, 2011).

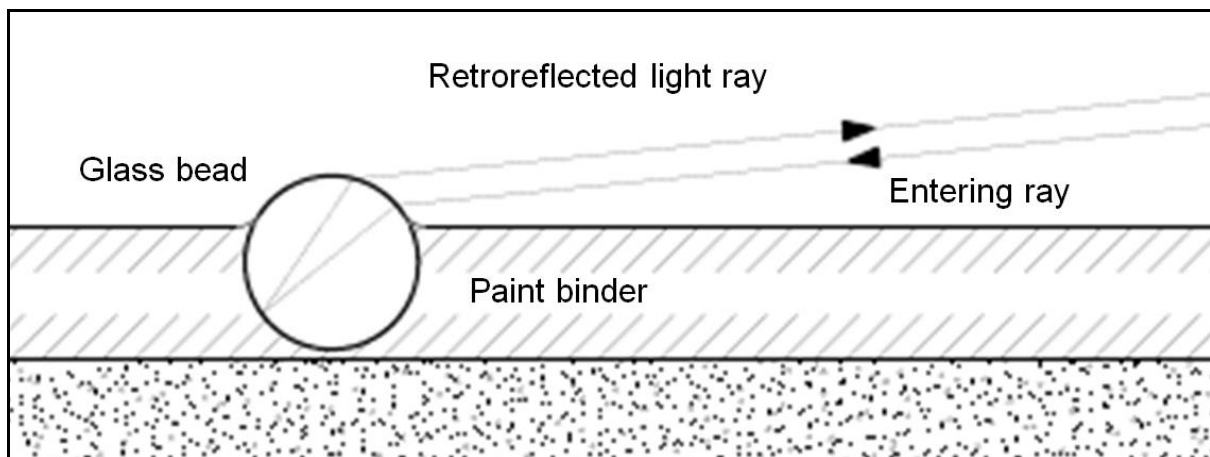
Figure 2.5: Retroreflected light ray (SARTSM, 1999).

The refractive Index (RI) is a measure of the speed of light in a medium and is a function of the chemical makeup of the beads, which is determined by the raw material used to make the beads (Smadi *et al.*, 2013). The RI of road marking beads ranges from 1.5 to 2.4 (Miglets *et al.*, 1994). According to the South African Road Traffic Signs Manual (SARTSM), (1999), the recommended RI ranges from 1.5 to 1.9. Light rays from vehicles' headlights enter the glass beads, which are refracted down towards the binder and then reflected back towards the light source (Figure 2.5). The light which is reflected back is called the retroreflected light which is the critical light that the driver requires to assist him in ensuring that he remains in his path and takes the necessary actions to travel safely on the roads. Figure 2.5 illustrates the path taken by light through a glass bead and back to the driver as well as indicating the importance of proper glass bead embedment (SARTSM, 1999). For best results, approximately 60 per cent of the bead should be embedded in the road marking and 40 per cent of the bead should stand out above the road marking (Austin and Schultz, 2006). The maximum optical efficiency of a pavement marking bead occurs at an RI of approximately 1.9 under dry conditions (Smadi *et al.*, 2013). Glass beads with an RI of 1.5 are made from windowpanes called cullet, while glass beads with an RI of 1.9 are made from virgin glass. The density increases with an increase in the RI of the glass beads and as such the higher the RI of the glass beads the higher the quantity of glass beads that will be required for the same road marking. Glass beads with an RI of 1.5 are usually used on roads while beads with an RI of 1.9 are used at airport markings (Austin and Schultz, 2006).

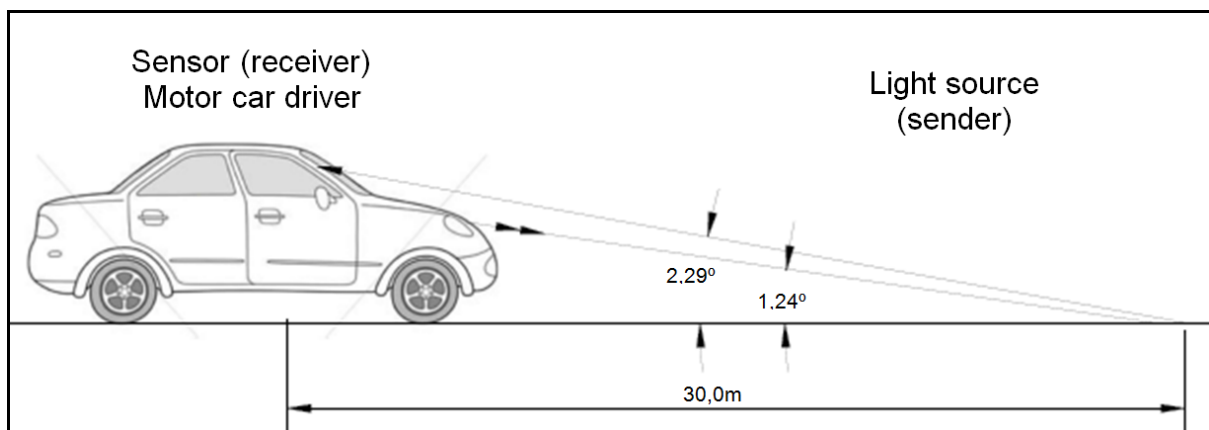
Figure 2.8: Angles defining the 30 m geometry (SANS 6261:2008, 2008).

The observation angle (α) is $2,29^\circ$ and the illumination angle (ϵ) is $1,24^\circ$ (COST 331, 1999). These angles are measured from the horizontal to the directions of observation and illumination respectively (Figure 2.8). This measuring geometry represents the situation obtained for a driver looking 30 m ahead with his eyes at a height of 1,2 m and a headlamp just below the eyes at a height of 0,65 m (COST 331, 1999).

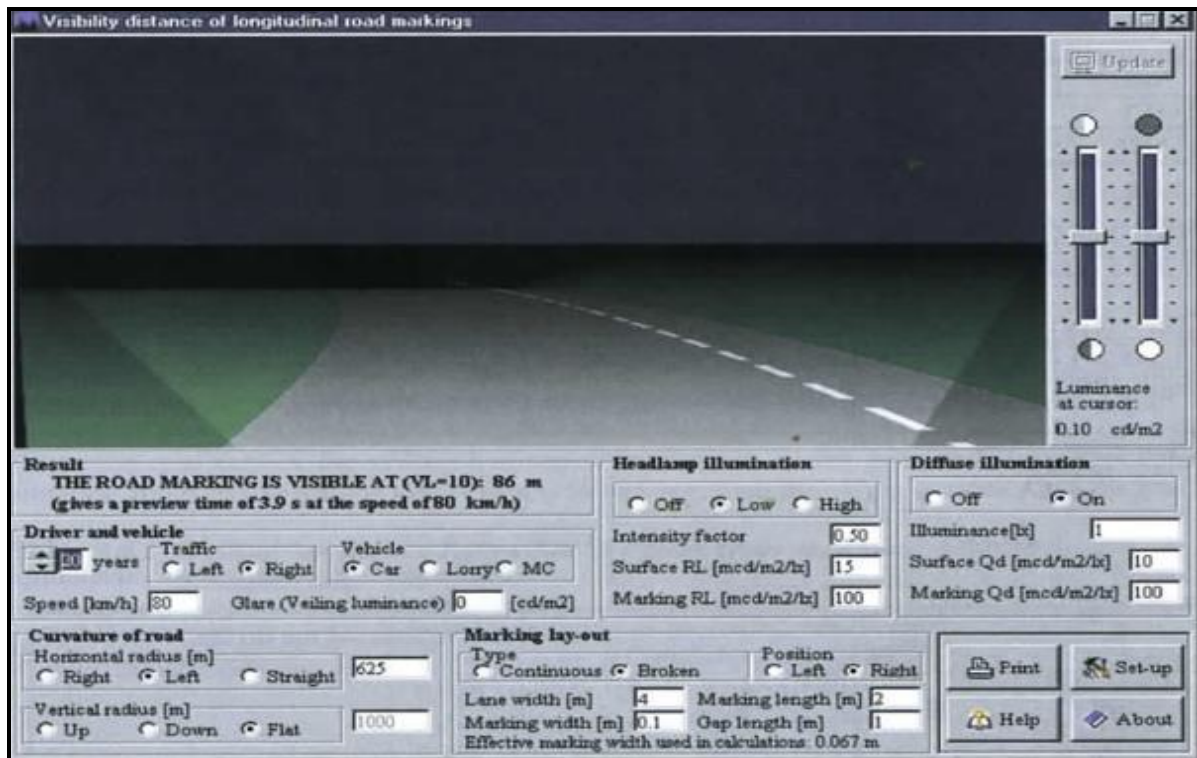
Figure 2.9: Visibility programme (COST 331, 1999).

A programme was developed to calculate the visibility distance of road markings by the European Commission and is illustrated in Figure 2.9 (COST 331, 1999). The various fields in the programme must be populated and the built-in algorithms produce the visible distance of the road markings. With a slight increase in the road marking width while all other fields are constant, the road markings will be visible at a greater distance. Wider road markings cost more than narrower road markings. It should be noted that it is not necessary to produce road markings that are visible at very great distances which may not be necessary as a safe preview distance of 60 m is required when travelling at a speed of 120 km/h (COST 331, 1999).

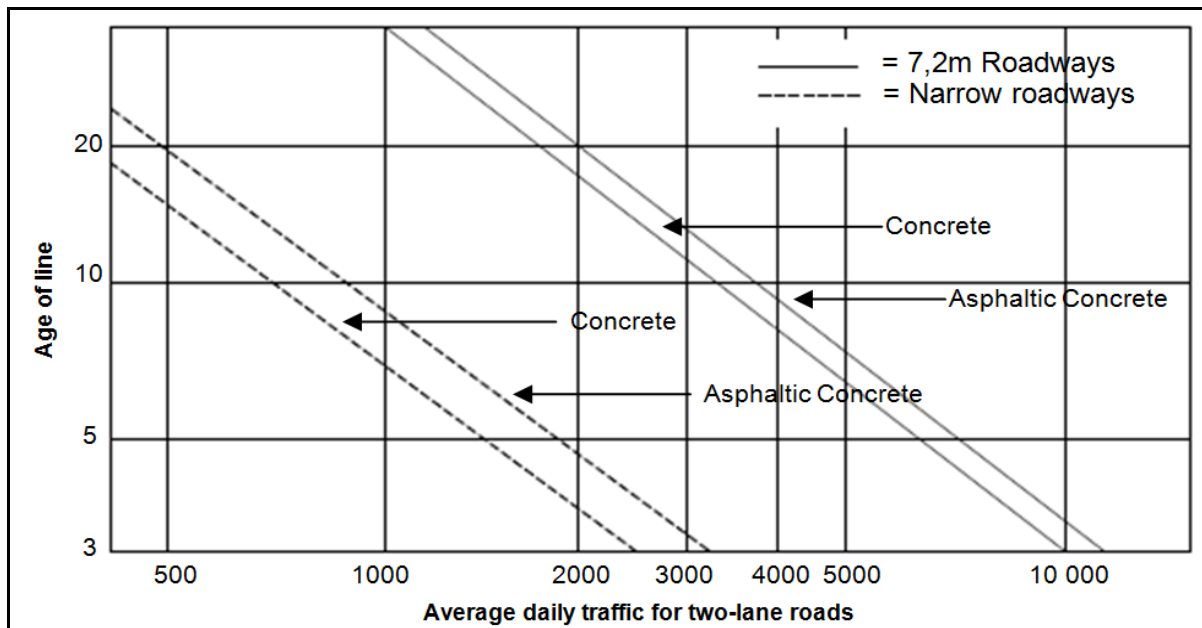
Figure 2.11: Line wear of white traffic paint (SARTSM, 1999).

The SARTSM, (1999) provides an indication of the service life of road marking paint in relation to the AADT whereby higher numbers of vehicles have an adverse effect on the life of the road markings as can be seen in Figures 2.11 and 2.12. The service life of road marking paint on the narrower roads is lower than on the wider roads due to the possibility of the vehicles constantly driving over the road markings as can be seen in Figure 2.11. The service life of road markings on concrete roads is lower than that on asphalt roads as can be seen in Figure 2.11. One of the main reasons is that on concrete roads, applicators fail to apply a primer coat before the road marking is applied (Lopez, 2004).

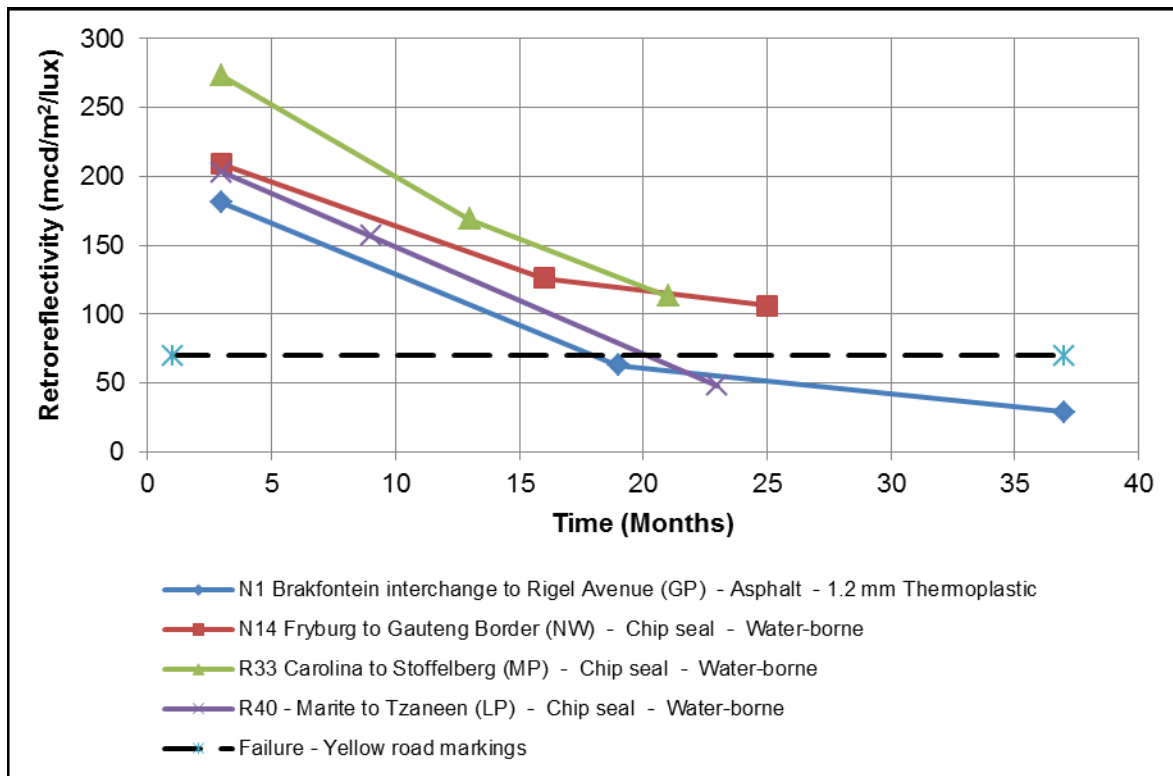
Figure 2.14: Decline in retroreflectivity of yellow markings on SANRAL's road network.

The gradients of each road marking in Figure 2.14 look similar for the first 15 months, but many more vehicles used the N1 where thermoplastic road marking material was applied than the R40, indicating that thermoplastic road marking materials are much more durable than water-borne road marking paints. Only 1.8 million light vehicles and approximately 0.2 million heavy vehicles used the R40 in 20 months, after which the road markings declined to below $70 \text{ mcd/m}^2/\text{lx}$.

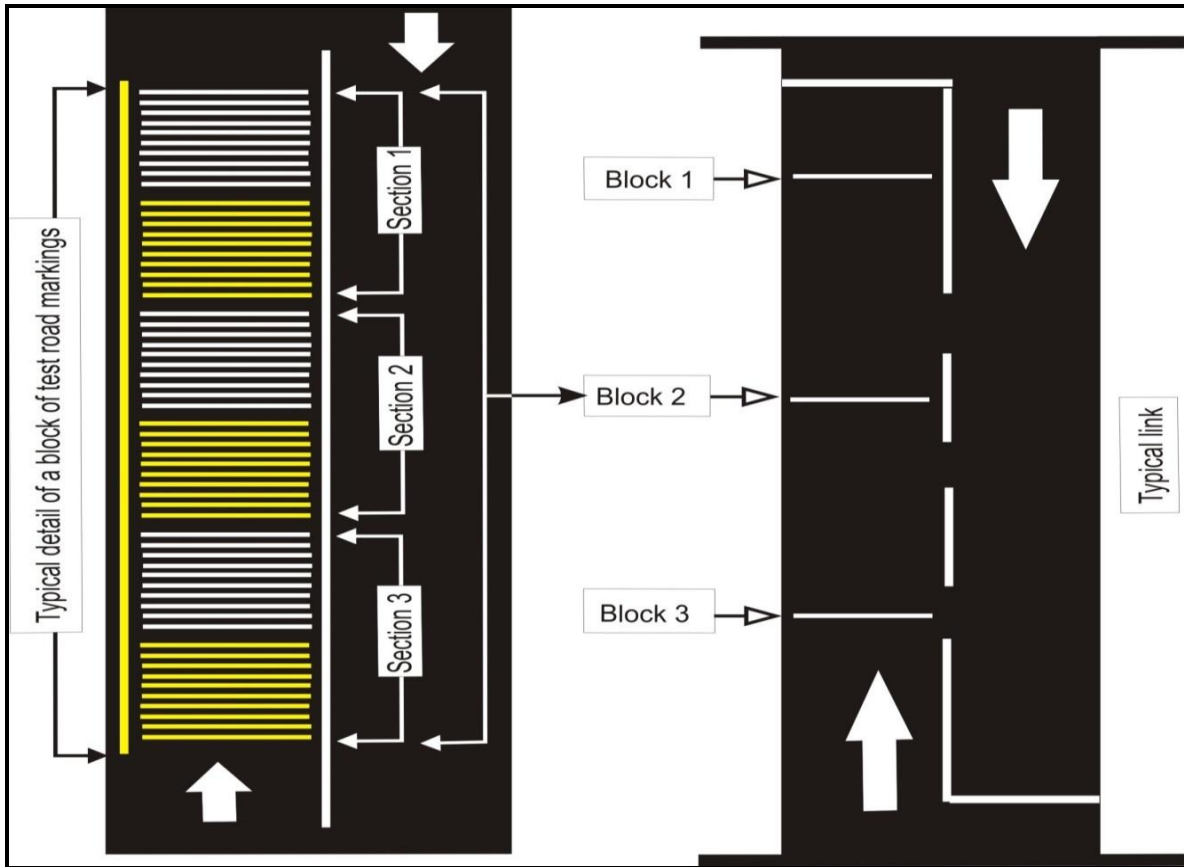
Figure 3.10: Typical layout of the test markings on a link of road.

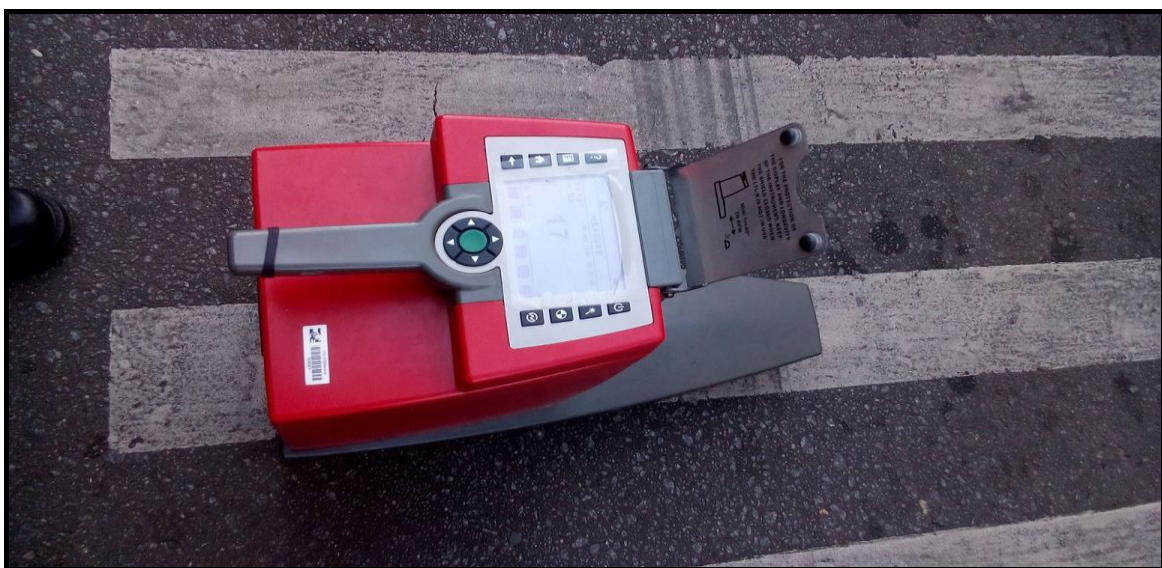
Figure 3.12: LTL-X Retroreflectometer.

Nine measurements were conducted over the length of the white and yellow longitudinal test road markings. The measurement points were distributed more or less evenly over the length of the longitudinally applied test road markings. The longitudinal lines were only measured in the dirty condition as the washing of only the transverse markings was sufficient to identify if there were significant differences of the various parameters in the “dirty” and “washed” condition. It was obvious that, especially on the “dirty roads”, sand and dirt had to be removed before the first set of measurements was conducted.

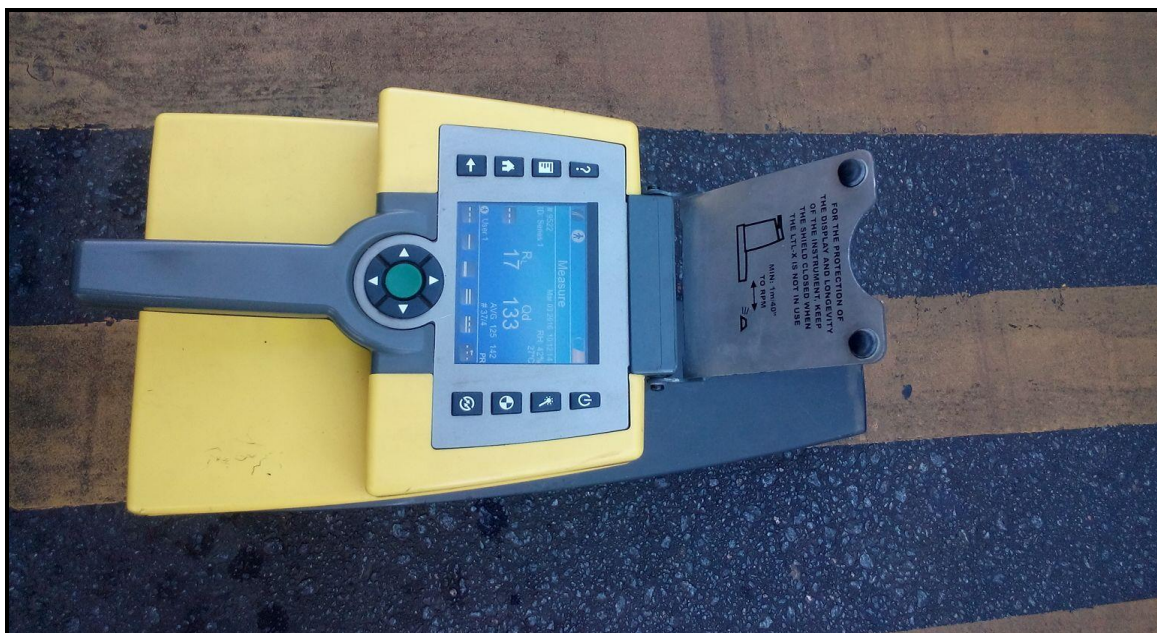
Figure 3.13: LTL-XL Retroreflectometer.

The standard measuring condition is intended to simulate a visual distance of 30 m for the driver of a passenger car with an eye height of 1,2 m and a headlamp mounting height of 0,65 m above the road (BS EN 1436:2007, 2007 and SANS6261:2008). The function to measure the R_L was switched off while measuring the Q_d in order to extend its daily use due to the limitations on the battery power. The LTL-XL retroreflectometer was used randomly, especially on asphalt surfaces, in conjunction with the LTL-X as a check on the R_L measurements. The Q_d value was established as the average of a number of measurements conducted with shifts of the instrument in steps along the marking, in total covering one or more spacing of structures (BS EN 1436:2007, 2007).

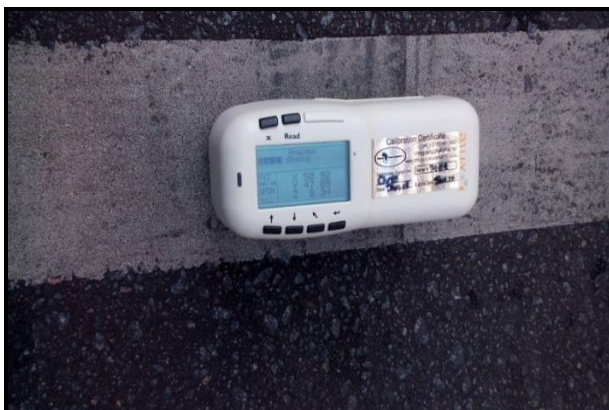
Figure 3.14: X-Rite Model SP60 colour machine.

Two sets of measurements were conducted during the same day on transverse lines, similarly to the R_L and Q_d measurements.

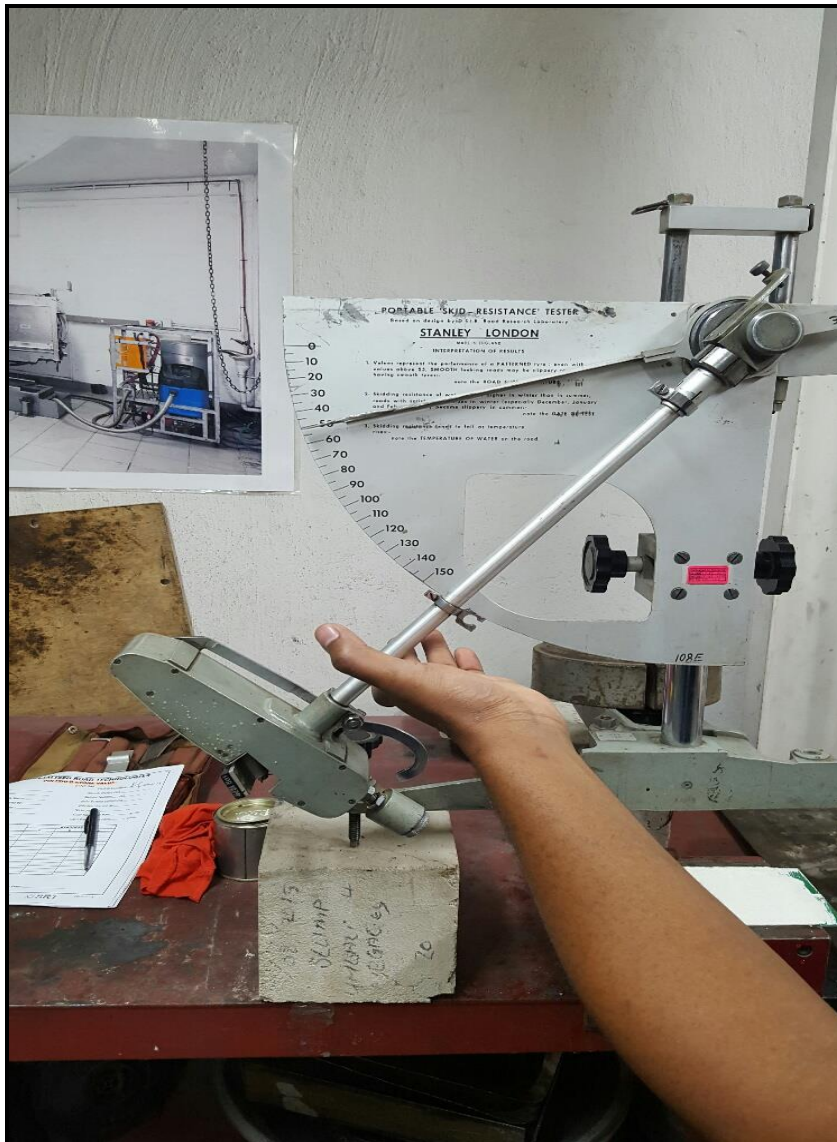
Figure 3.15: Skid resistance tester.

A British Portable Pendulum skid resistance tester as seen in Figure 3.15 was used to measure the skid resistance of the test markings applied on the test plates. A pendulum fitted with a spring loaded slider at its free end was released from a fixed position and the frictional energy loss caused by the dragging motion of the rubber rear edge of the slider over the markings was measured and expressed in Skid Resistance Tester (SRT) units. The test method used was in accordance with SANS 6260:2007 (2007).
