A REVIEW OF THE PILLAR DESIGN METHODOLOGY FOR MANGANESE MINING OPERATIONS IN SOUTH AFRICA

M.Eng (Mining Engineering)

IN THE FACULTY OF ENGINEERING, BUILT ENVIRONMENT AND
INFORMATION TECHNOLOGY
DEPARTMENT OF MINING ENGINEERING
UNIVERSITY OF PRETORIA

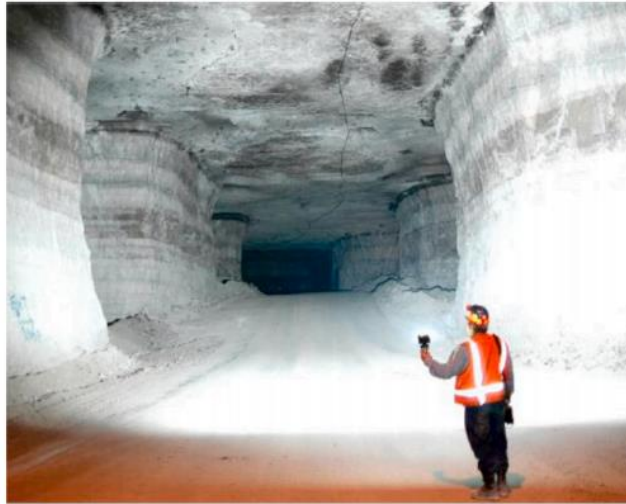
Figure 2-13. A stable limestone mine illustrating concave pillar geometry owing to time-dependent spalling damage (after Wang and Cai, 2021).

Constitutive models have been proposed over the years that are able to simulate time-dependent rock behaviour (Lui and Cai, 2020). This allowed for a better understanding of the long-term strength and time-dependent scaling. (Wang and Cai, 2021). Time-dependent scaling has been observed for pillars that have been stable for many years. Figure 2-13 illustrates an example of a limestone mine. It is clear that the sidewalls gradually changed shape over time.

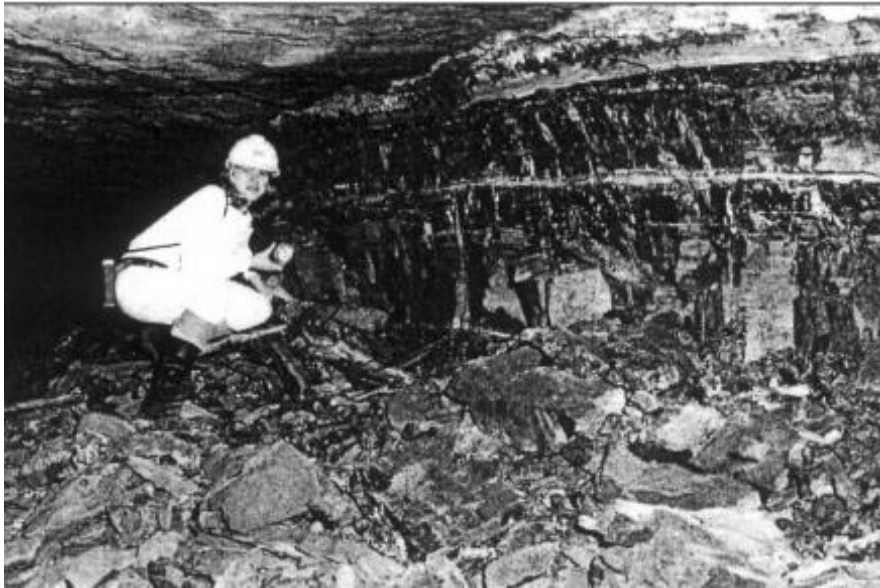
Figure 2-15. Ermelo B seam illustrating pillar scaling in a 90-year-old mining area (after Van der Merwe, 2003).

Several mechanisms can contribute to the failure of coal pillars. This includes fires, which is a special case, foundation failure, and progressive scaling. In South Africa, foundation failure has been observed in isolated cases. It is considered as a minor mechanism in South Africa, while it is seen as the main failure mechanism in the USA in the Illinois mines. It has been suggested over the years that pillars fail owing to progressive scaling (Van der Merwe, 2003). Figure 2-14 and Figure 2-15 indicate the failure of pillars from two different mining areas in South Africa.

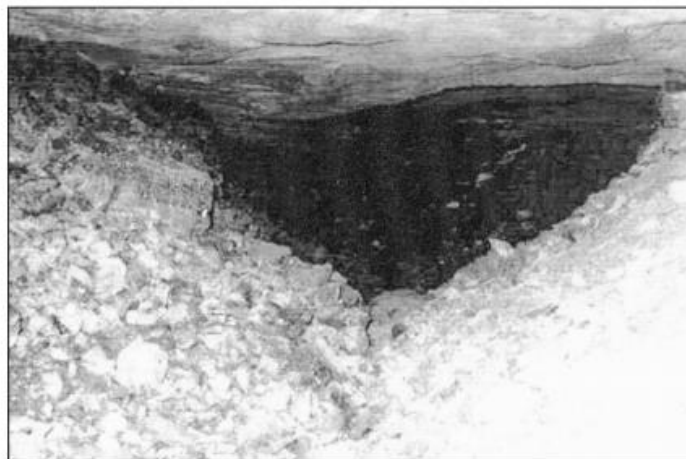
Figure 2-17. An area where scaling debris had built up to the height of the roof and pillar failure still continued (after Van der Merwe, 2003).

As illustrated in Figure 2-17, pillar failure in this case was apparently still observed after debris had indeed built up to the roof. This confirmed the statement made by Salamon et al. (1998), that his expressions should not be applied in practical situations where the failure is stress-driven. Van der Merwe (2003) also noted that it is known that lateral confinement increases the strength of the pillars.

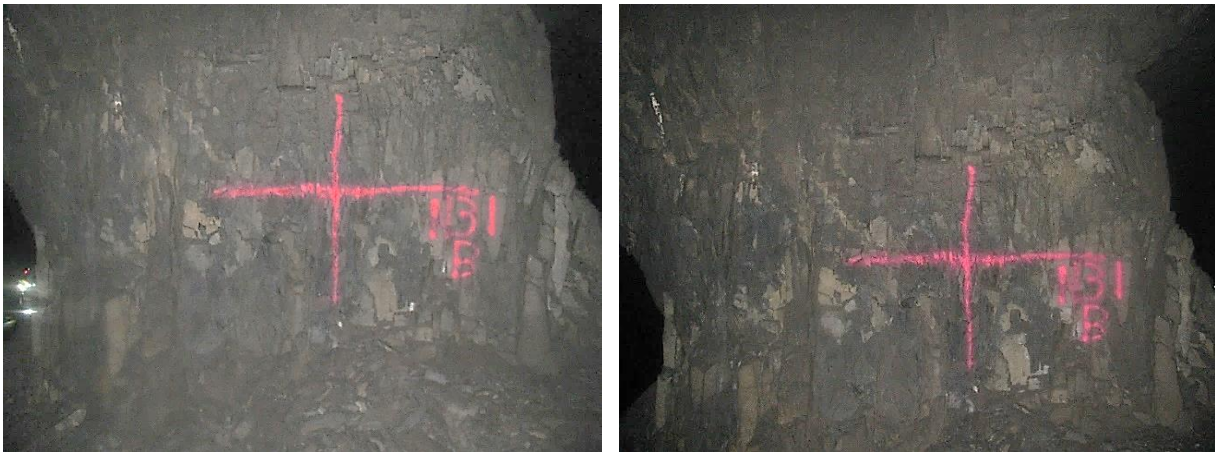
Figure 3-5. Measurement point painted on pillar N3_1 at Nchwaning III shaft. The photograph on the left was taken on 6 May 2021 and the photograph on the right on 18 August 2021. The lines were still pristine on the second date and no scaling occurred during this three-month period.

To study the time-dependent pillar scaling at BRMO, the author established a number of monitoring stations. A problem with any type of “quantitative” monitoring of time-dependent pillar scaling is that stable reference points are required. Distance measurements from these stable reference points to particular points on the pillar sidewalls are required over a period of time. As the pillar sidewalls are subjected to scaling, however, it is difficult to ensure that the measurements are conducted between the same positions on the pillar and the reference points. As a crude attempt to overcome this measurement problem, large crosses were painted on the sidewalls of the pillars, as well as the pillars adjacent to the pillar being monitored (Figure 3-5). The distance between the painted crosses of opposing pillars was then measured using a distomat (Figure 3-6). If parts of a cross are lost owing to scaling, the centre position can still be estimated from the remaining portions of the lines. Although both pillars scale, the scaling distance will then be simply estimated to be half the increase in measured distance. Although rather crude, this method proved useful to indicate that almost no scaling occurred during a three-month monitoring period.

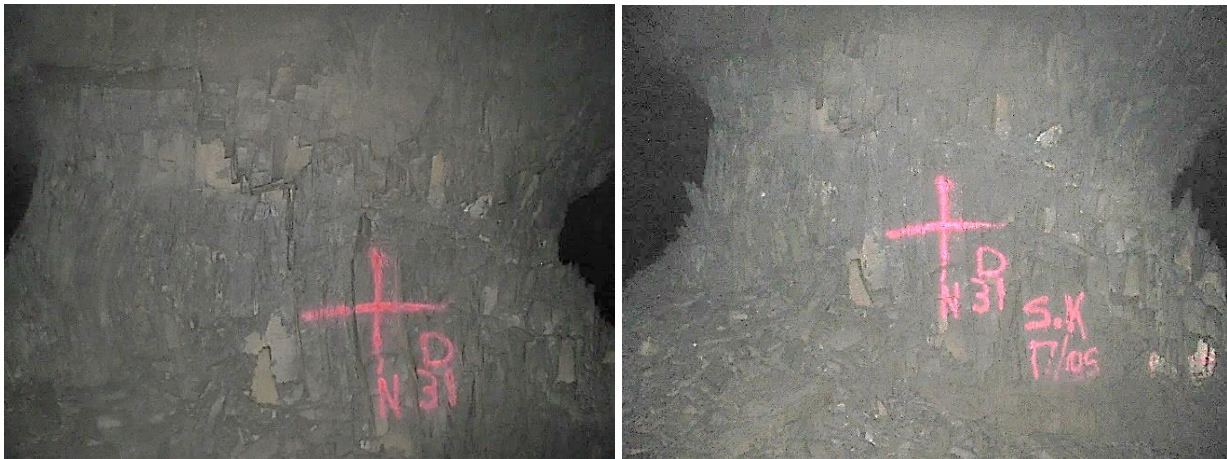
Figure 3-7. Almost no scaling was recorded for most of the pillars over a three-month monitoring period. As an example, this is pillar N3_1 at Nchwaning III Shaft. The photograph on the left was taken on 6 May 2021 and the photograph on the right on 18 August 2021.

Figure 3-7 and Figure 3-8 illustrates additional photographs of particular pillars taken approximately three months apart. Some localised scaling could be seen in some areas of the pillars, but in most cases, no major scaling could be seen during this period. This was even true for pillar N3_1, which has a low rock mass rating. For pillar N3_25 (Figure 3-8) many portions of the white lines have already scaled away before this pillar was selected for monitoring. It therefore appears that there is a rapid rate of scaling soon after the pillar is formed, which gradually decreases with time.

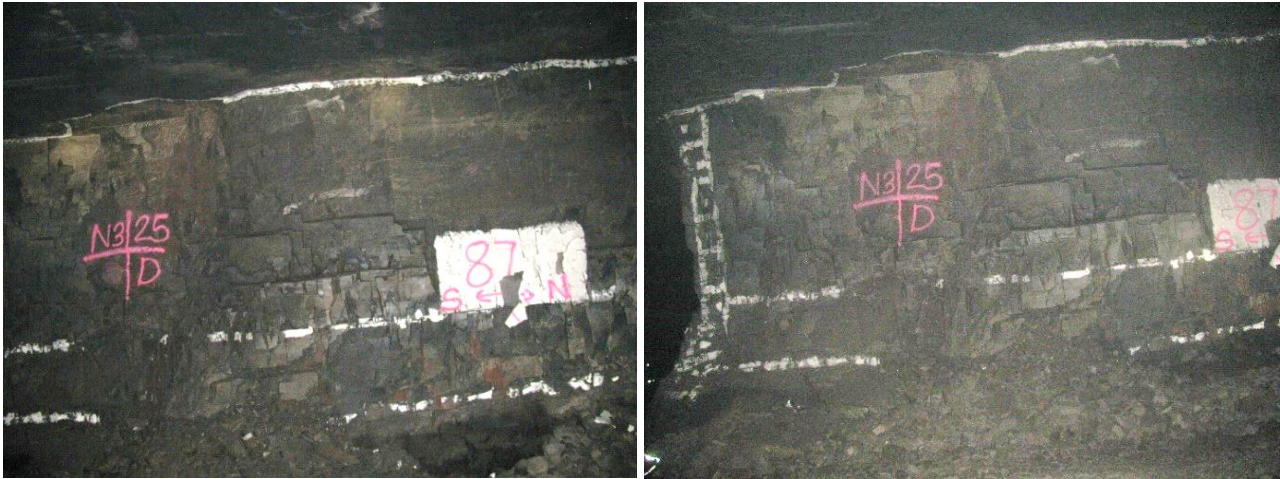
Figure 3-8. Pillar N3_25 at Nchwaning III Shaft. The photograph on the left was taken on 6 May 2021 and the photograph on the right on 18 August 2021. The broken white lines give an indication of a time-dependent scaling process, but this occurred prior to the monitoring done for this study.

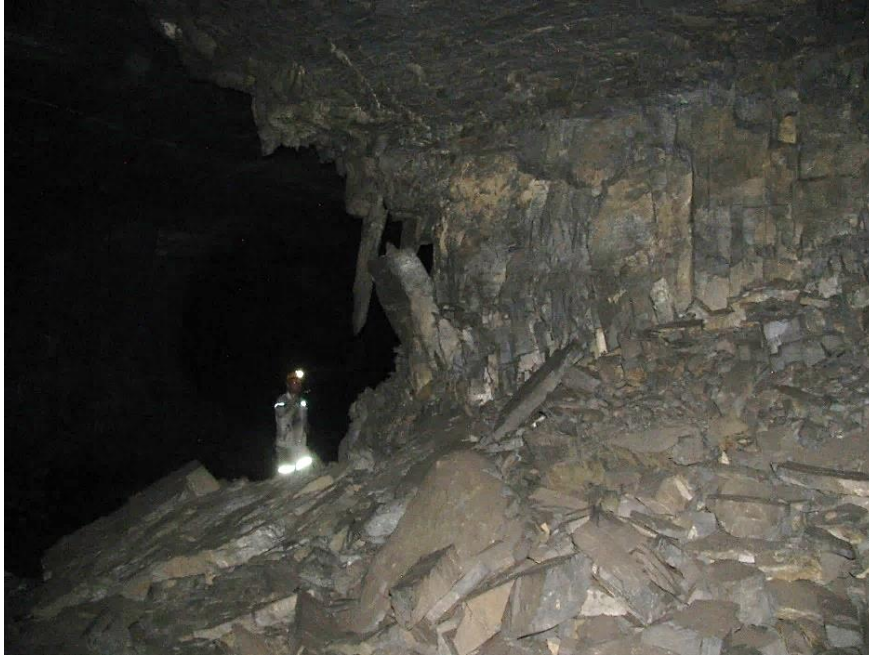
Figure 3-10. Extensive scaling of pillar N3_9.

The extensive scaling of this pillar is shown in Figure 3-10. Note the blocky nature of the scaling owing to the closely spaced, intersecting joint sets. The vertical joints are closely spaced and this spacing ranged from 1 cm to 5 cm in some areas (on N3_9B and N3_9D) to 15 cm to 30 cm on the other two sides. The spacing of the horizontal joints was approximately 30 cm, but also varies across the perimeter of the pillar. The pillar had an hourglass shape and the failed slabs seemed to bulge outwards in some areas. The joints were almost vertical and no shallow dipping joints were observed.

Figure 3-10 in Chapter 3 already illustrated the extensive scaling in this area and it is comparable to the modelling illustrated above. A further example of the scaling is given in Figure 5-4 and this illustrates the condition of pillar N3_1. There seems to be a good agreement between the modelling using the parameters given in Table 5-1 and the underground observations for this area.

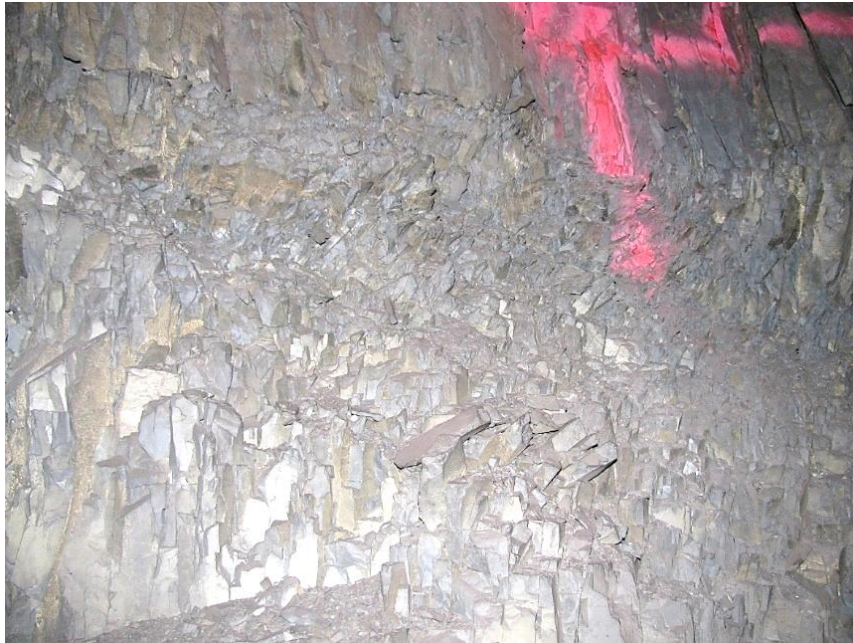
Figure 3-11. Side B of the pillar illustrates the closely spaced joint sets. This creates extensive scaling on the sides of the pillar.

A rock mass rating was very difficult to do as there are significant changes in joint spacing over short distances and the pillars are heavily crushed in many areas. The small vertical joint spacings led to significant scaling and damage. Figure 3-11, Figure 3-12, and Figure 3-13 illustrate the variation of joint spacings. It was therefore difficult to estimate RQD along a horizontal line as it varies from less than 25% to approximately 50%.

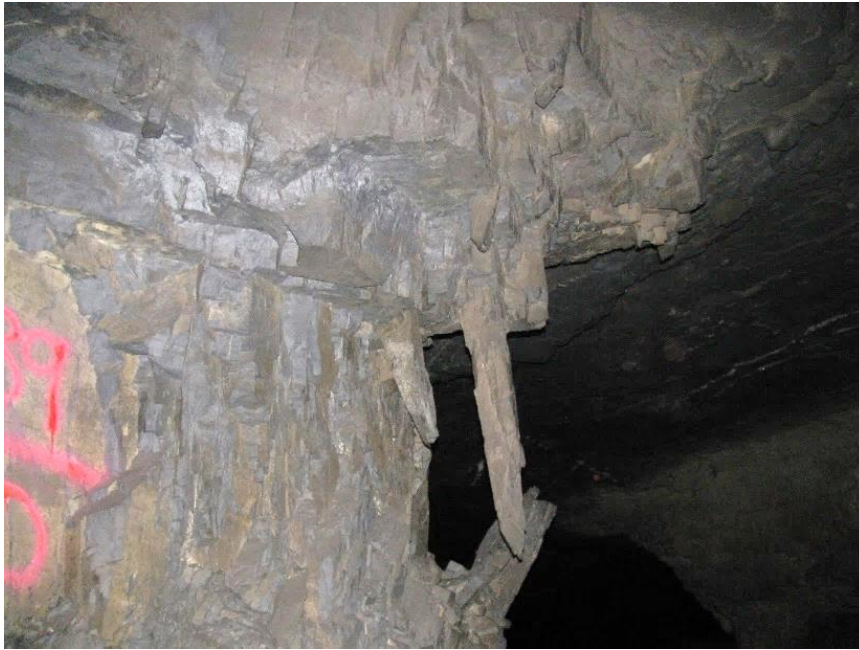
Figure 3-12. Extensive scaling of pillar N3_9. The scaling is facilitated by the intersecting horizontal and vertical joint sets.

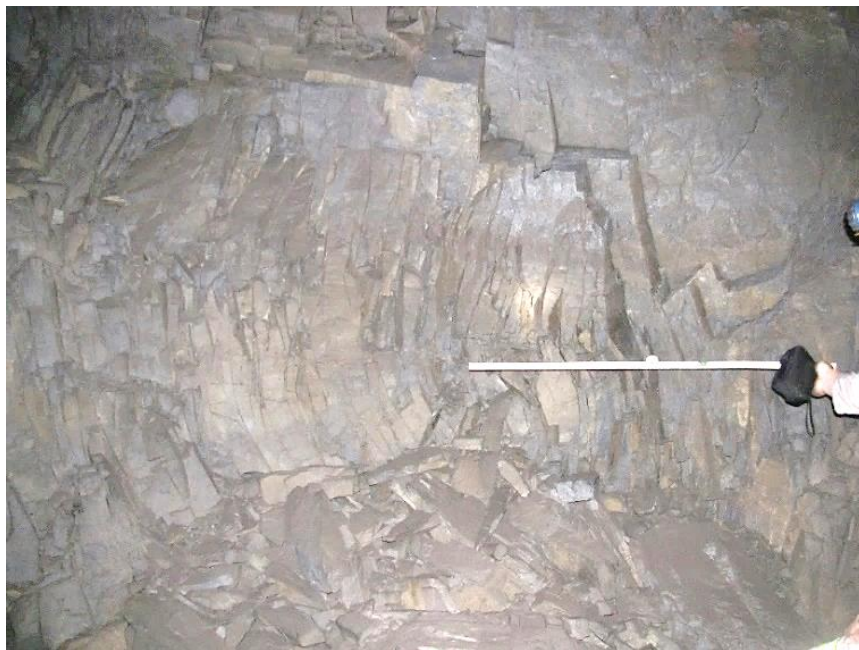
Figure 3-13. Spacing of the joints in pillar N3_9.

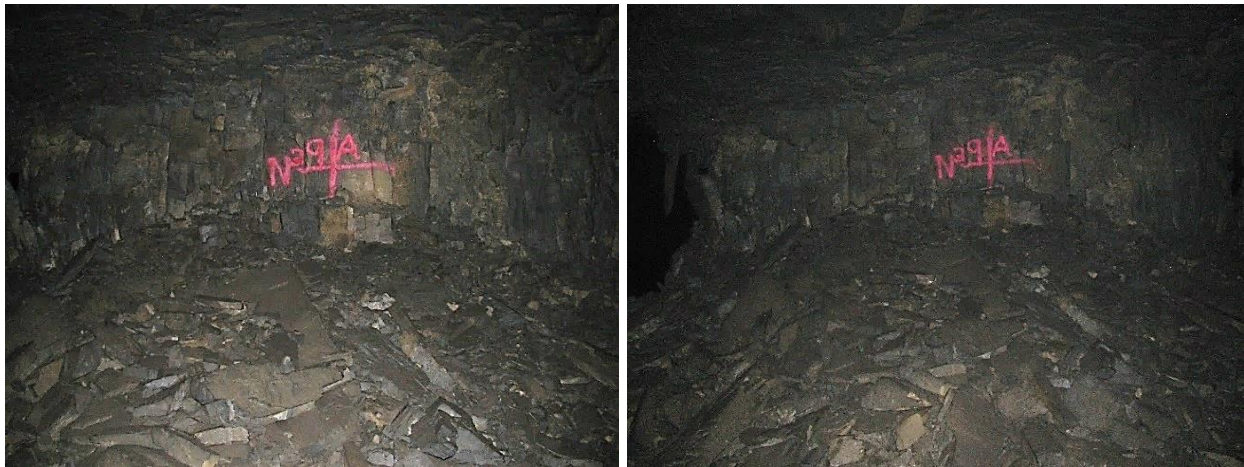
Figure 3-14. Side A of pillar N3_9 at Nchwaning III shaft observed on the 4th of May (left) and on the 18th of August 2021 (right).

Figure 3-14 indicates that no scaling occurred between the time of the first and the second visit. Table 3-1 summarises the measurements recorded for pillar N3_9. This pillar was established between March and June 2018. Some variation of bord spans was recorded, but this was attributed to measurement error as the photographs indicated that the measurement points were still intact.

From the measurements taken and the photographic evidence, it is clear that no measurable scaling of the pillar occurred during the two measurement dates.

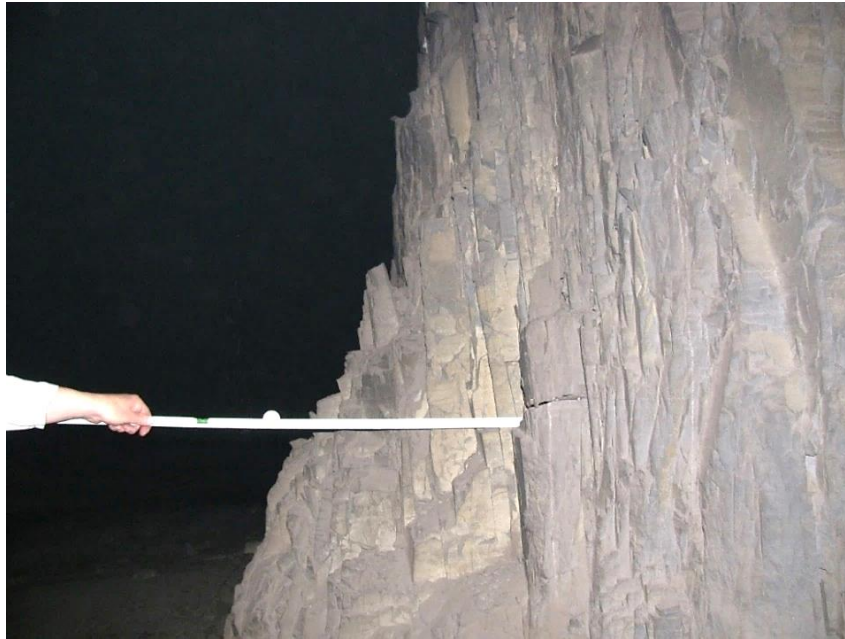
Figure 3-16. The pillar corner at side A illustrates the vertical joints with a spacing of 1 cm to approximately 6 cm.

For this pillar, closely spaced joints were observed and the spacing of the joints varies across the perimeter of the pillar from 1 cm to 5 cm. The horizontal joints were spaced between 15 cm to 80 cm. The pillar had an hourglass shape and was “blocky” owing to the intersection of the vertical and horizontal joints. A total number of three joint sets was observed. Figure 3-16 and Figure 3-17 illustrate the joint spacing on Sides A and C, respectively. Two sides of the pillar (Side B and C) illustrate a vertical joint spacing ranging from 1 cm to 5 cm.

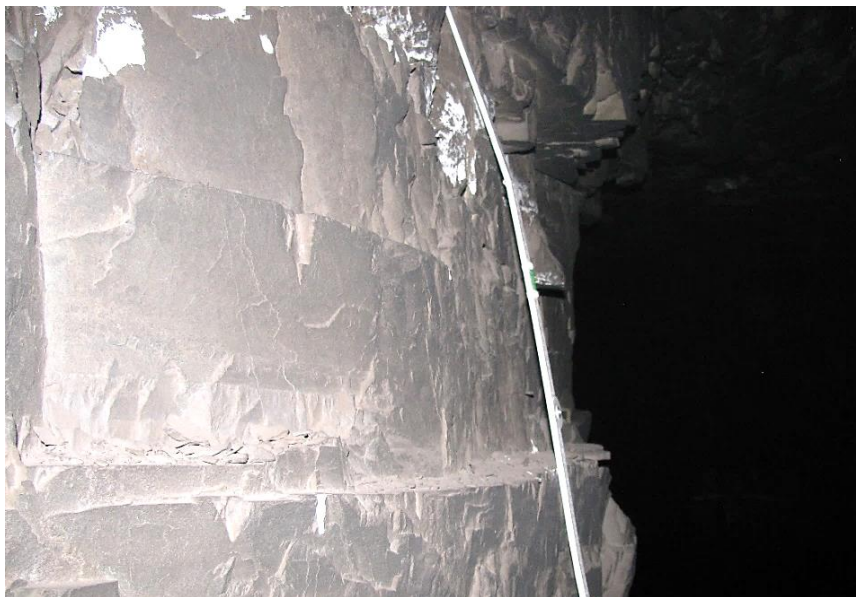
Figure 3-17. The horizontal joint spacing of side C ranges from 15 cm to 25 cm.

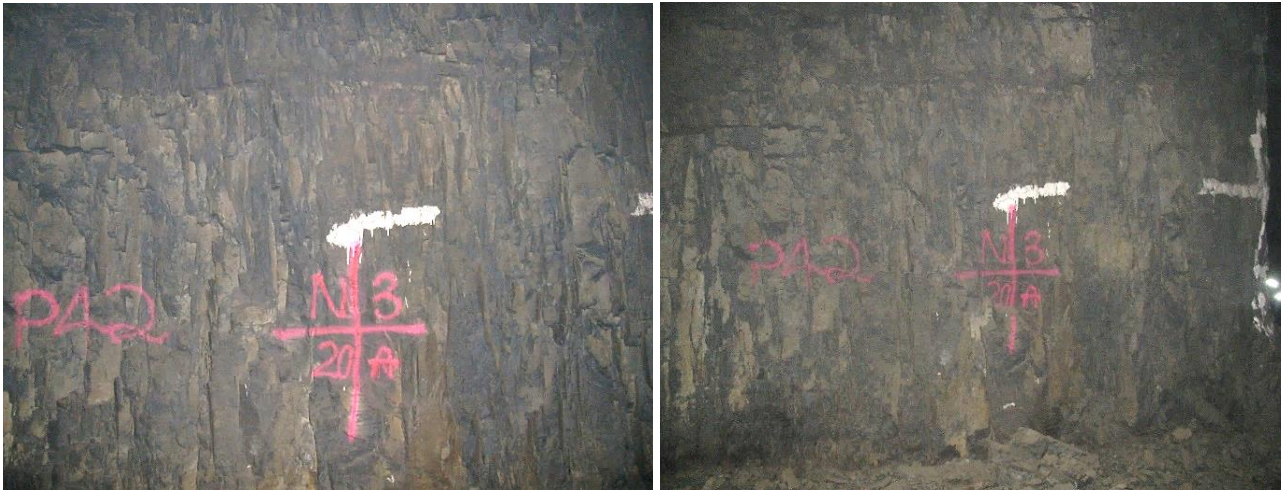
Figure 3-18. Side A of pillar N3_20 at Nchwaning III shaft as photographed on the 6 May 2021 (left) and on 18 August 2021 (right).

Table 3-2 illustrates the measurements recorded for pillar N3_20. This pillar was established in January 2021. The scaling of the pillar did not continue during the three-month monitoring period and this is illustrated in Figure 3-18.

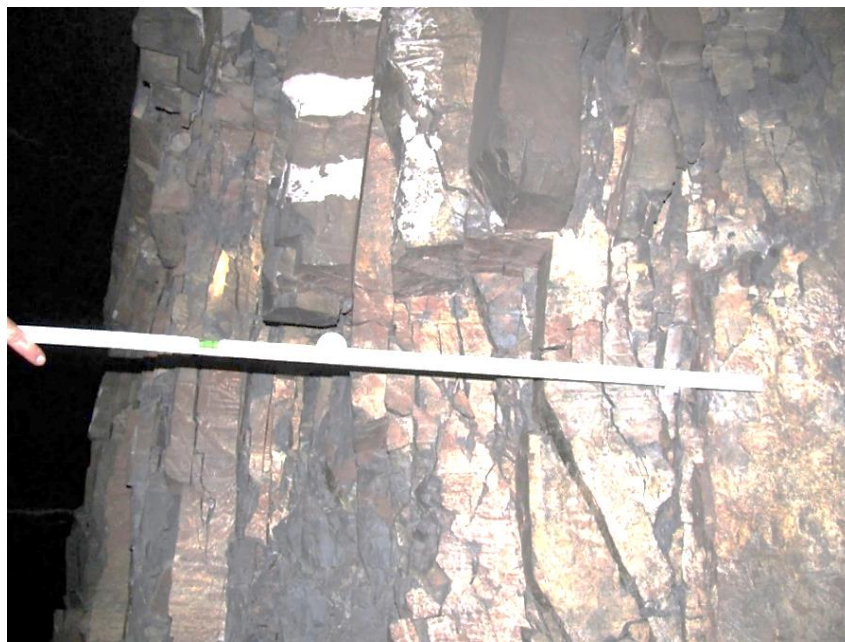
Figure 3-19. Side A of pillar N3_25 illustrates the joint spacing in the vertical direction.

Pillar N3_25 had a lower rock mass rating than pillar N3_20 in Area 2. Views of N3_25 are illustrated in Figure 3-19, Figure 3-20, and Figure 3-21. The closely spaced joints result in the pillar edge breaking into small blocks (Figure 3-22). The rock mass rating of this pillar is comparable to that in Area 1. Overall, the pillar is still in a reasonable condition and the reason is probably that it is not as old as the pillars in Area 1. Area 1 was mined in June 2018, while pillar N3_25, was mined in February 2021. The stress acting on N3_25 and the pillars in Area 1 is approximately similar (refer to the numerical modelling in Chapter 4). It seems as if time-dependent scaling leads to the ongoing deterioration of the pillars.

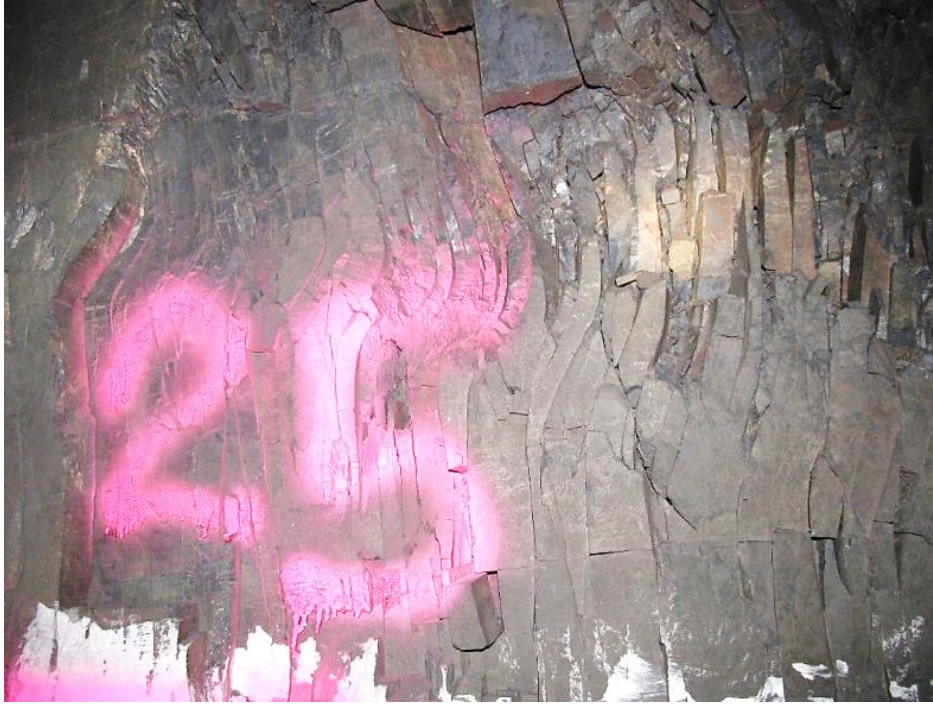
Figure 3-20. Complex jointing observed for pillar N3_25. Note the high density and curvature of the joints.

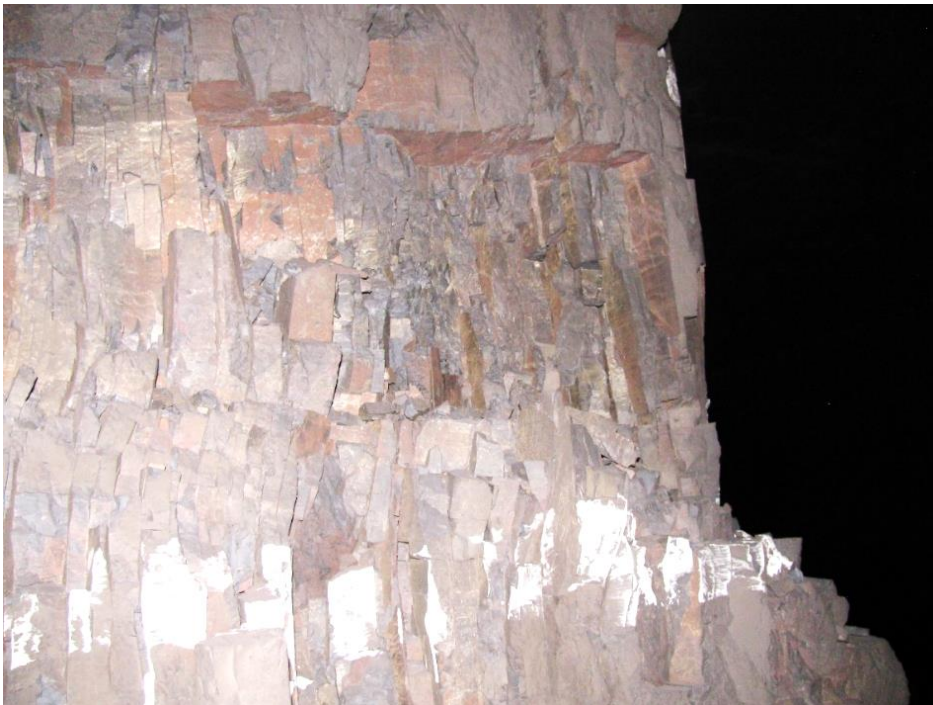
Figure 3-21. The vertical and horizontal joint spacing observed on side C of pillar N3_25. Note the varying joint spacing.

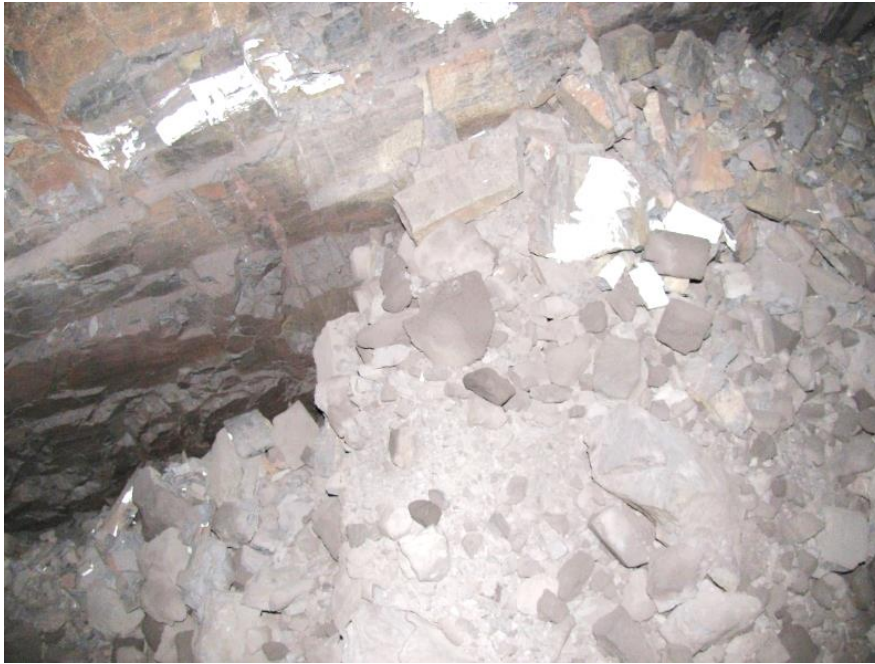
Figure 3-22. Small block sizes were found adjacent to pillar N3_25. These block sizes are controlled by the closely spaced joint sets.

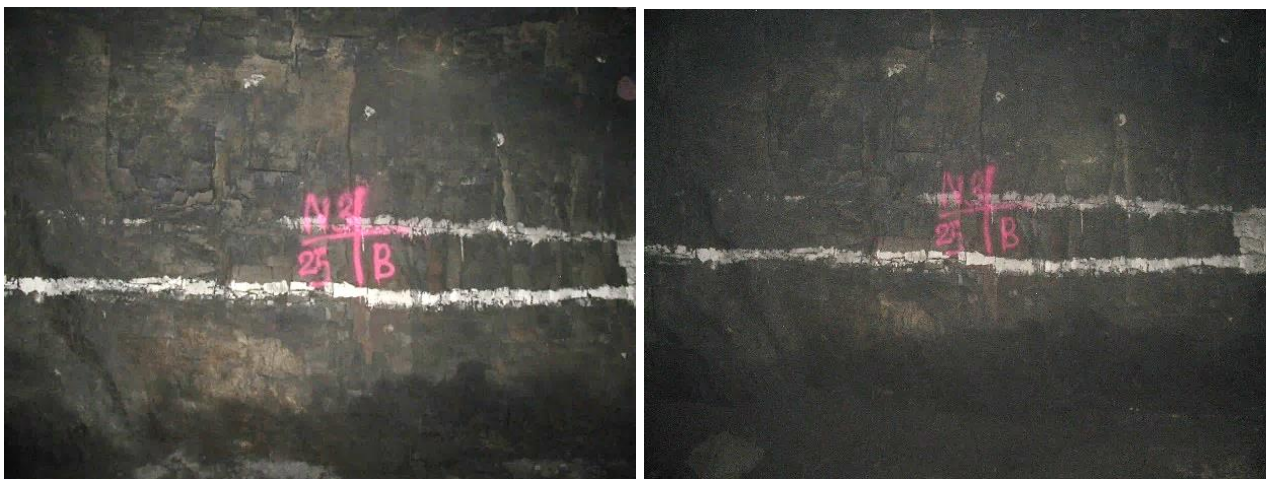
Figure 3-23. Side B of pillar N3_25 at Nchwaning III shaft as photographed on 6 May 2021 (left) and on 18 August 2021 (right).

Table 3-3 summarises the measurements recorded for pillar N3_25. This pillar was established in February 2021. Figure 3-23 confirms that no scaling occurred in the time period between the first and the second visit.

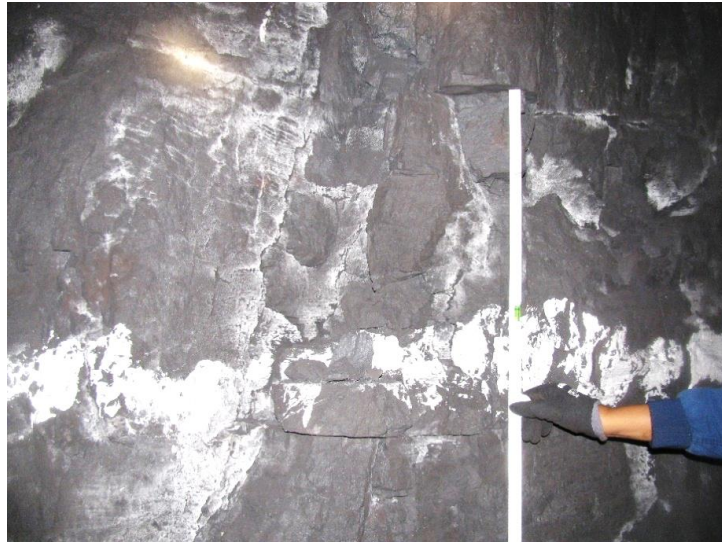
Figure 3-25. Side A of the pillar illustrates the horizontal joints with an approximate spacing of 50 cm.

The pillars in this “+45 grade product” area are in much better condition as compared to the R5 area. The vertical joints in this area are not prominent and almost no signs of scaling were observed. The spacing of the vertical joint sets was difficult to determine as they were only clearly visible on the corners. The vertical joint set on side C was approximately 20 cm and no random joints were present. The horizontal joints seem to be the prominent joint set with the joint spacing varying from 20 cm to greater than 50 cm. The corners of the pillar had an “hourglass” shape. Figure 3-25 and Figure 3-26 illustrate the variation of joint spacing in the pillar.

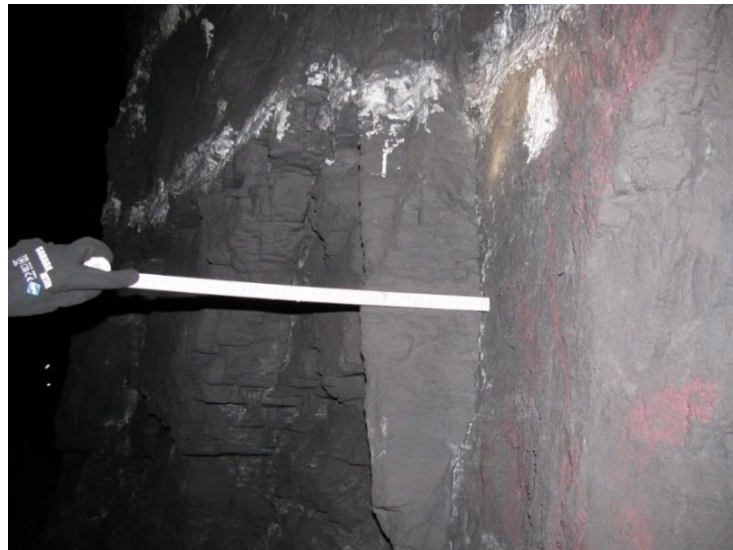
Figure 3-26. The vertical joint spacing is observed on side C of the pillar with a spacing of approximately 20 cm.

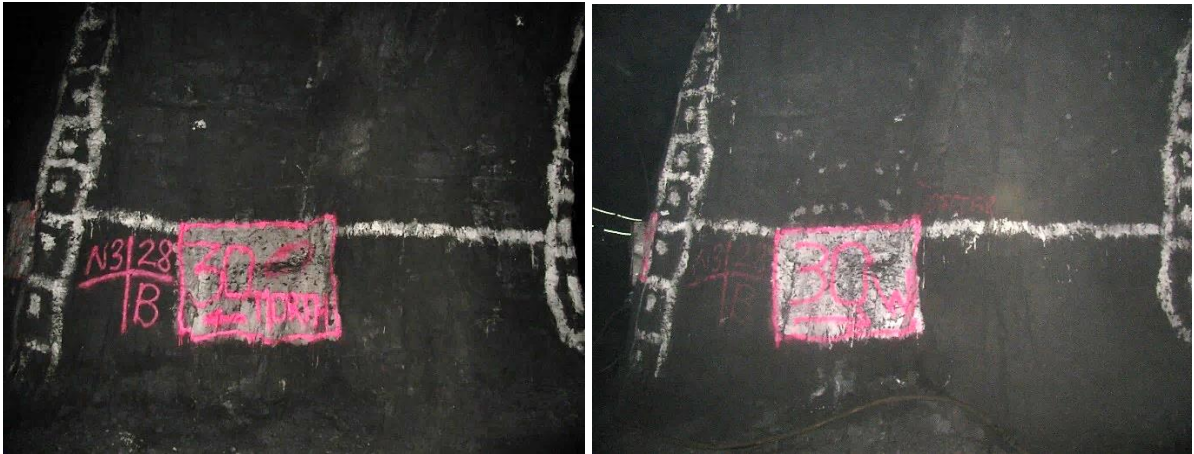
Figure 3-27. Side B of pillar N3_28 at Nchwaning III shaft as observed on 17 May 2021 (left) and on 18 August 2021 (right)

Table 3-4 summarises the measurements recorded for pillar N3_28. This pillar was established between March and December 2020. Figure 3-27 indicates that no scaling occurred in the time period between the first and the second visit.

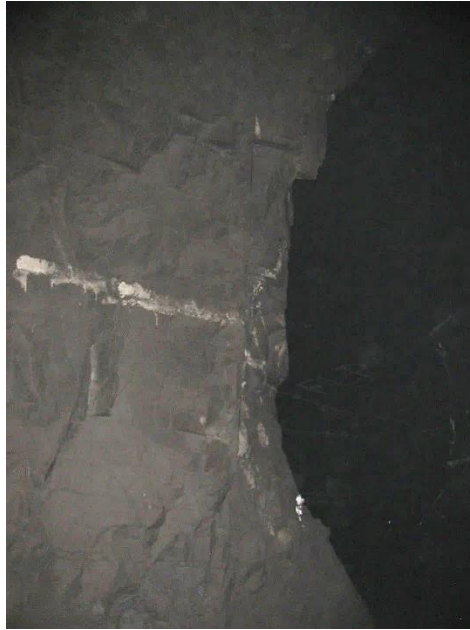
Figure 3-29. The corner of the pillar as viewed from side A. An hourglass shape was observed.

The vertical joints in this area are not prominent and only minor scaling was observed. The horizontal joints seem to be the prominent joint set with the spacing varying from 15 cm to greater than 50 cm. The corners of the pillar had an hourglass shape (Figure 3-29). The pillar shape was irregular, making it difficult to measure its dimensions. The overall condition of the pillar is stable. The spacing of the vertical joint sets varied from approximately 8 cm to 50 cm across the perimeter. Figure 3-30 illustrates one of the prominent vertical joints.

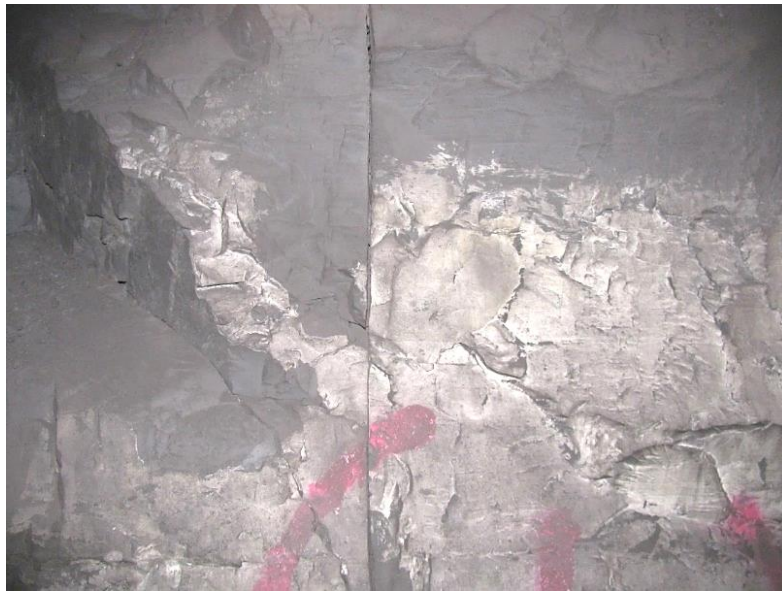
Figure 3-30. An illustration of the prominent vertical joint on sides A.

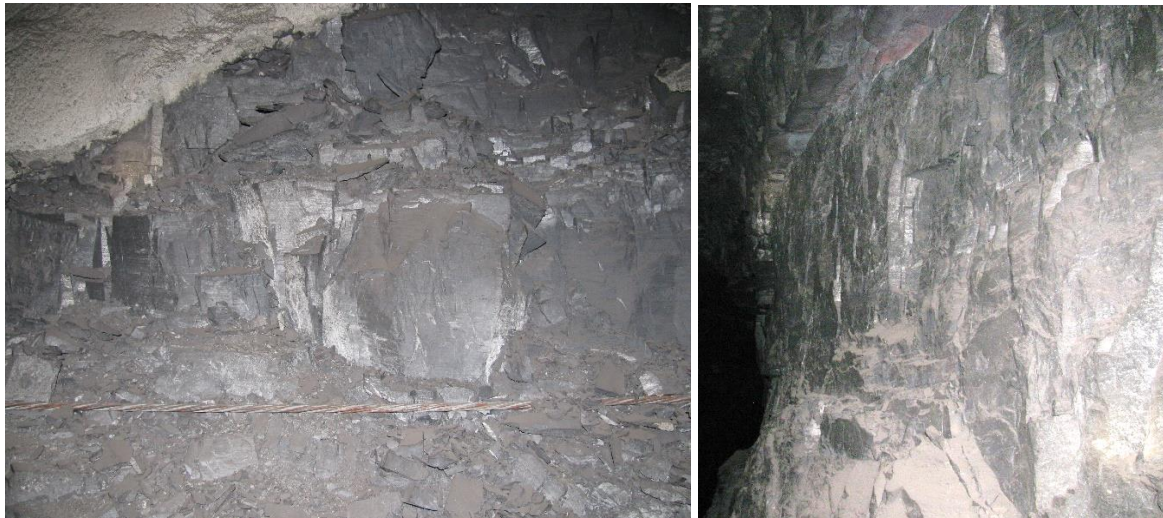
Figure 3-35. An area of pillar 3 where the shotcrete failed (left). Note the high density of jointing and the rock mass characteristics is reminiscent of that observed in Area 1. The small joint spacing is also visible in the photograph of an adjacent pillar (right).

During the author's visit, the pillars were already reinforced using shotcrete and strapping. Pillar 3 is illustrated in Figure 3-34 and Figure 3-35.

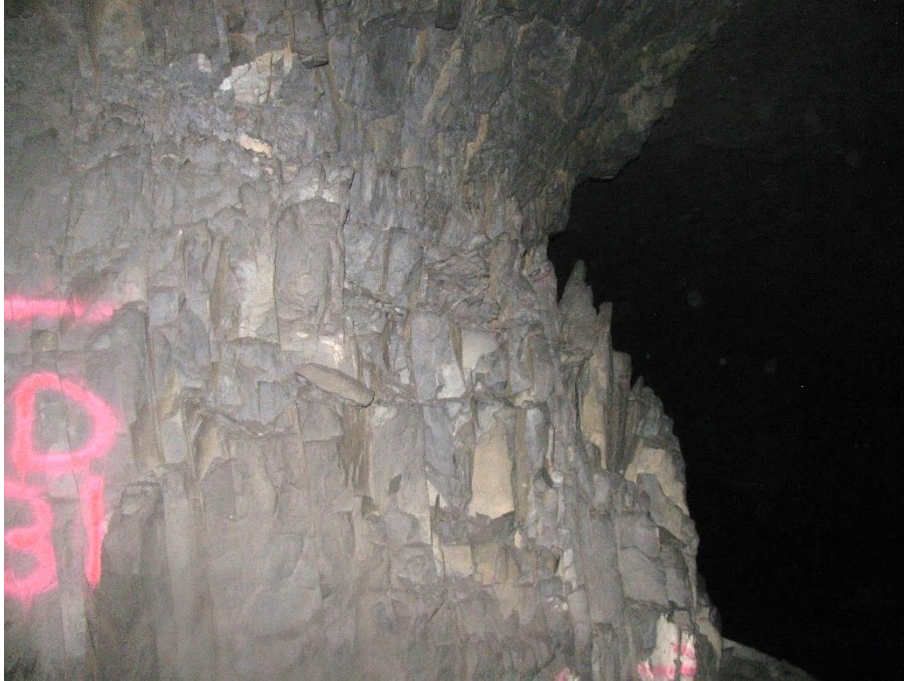
Figure 5-4. The condition of pillar N3_1 in Area 1 illustrating excessive scaling of the pillar.

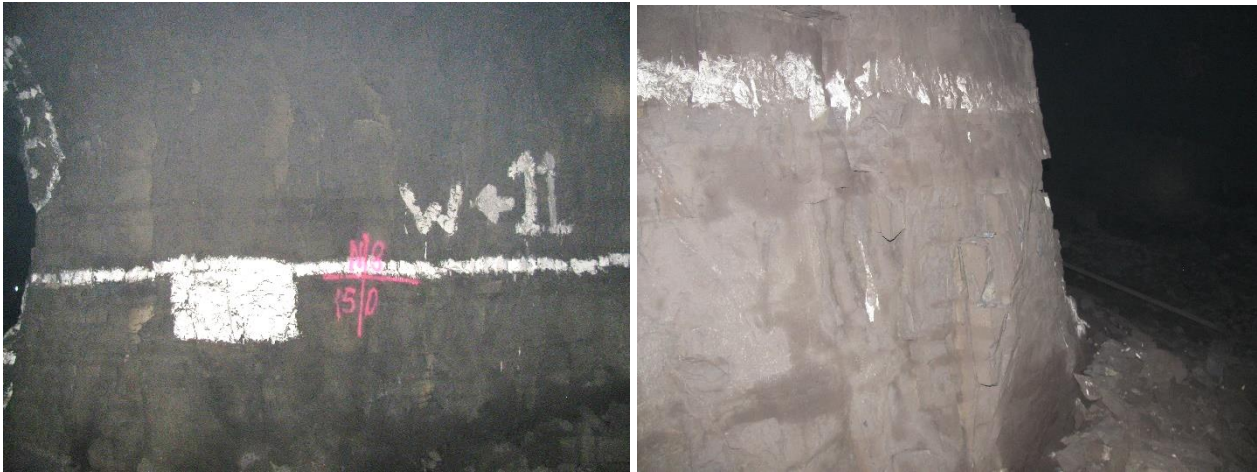
N3_15

An illustration of the condition of the pillars are given in Figure 5-8. There seems to be a qualitative agreement with the modelling, as more scaling is seen for pillar N3_20 compared to N3_15.

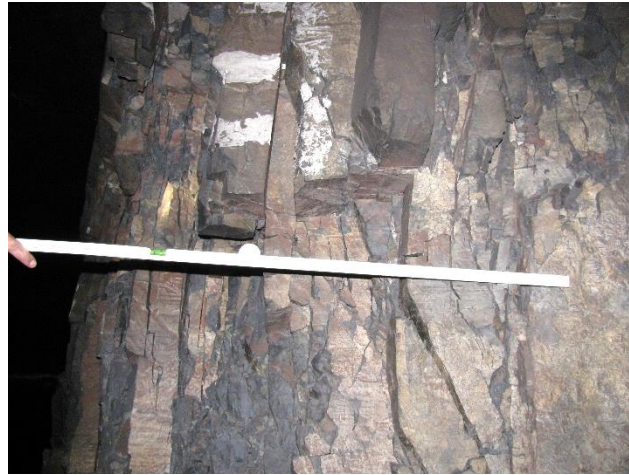
Figure 5-10. Extensive scaling of pillar N3_25.

Figure 5-8 illustrates the simulated scaling of the pillars for Area 3. Extensive scaling is predicted for pillar N3_25. Figure 5-9 illustrates the simulated APS values on the pillars using the limit equilibrium model and for rigid pillars. The simulated stress on pillar N3_25 is relatively high owing to its smaller size and this resulted in extensive scaling similar to that observed underground. This is illustrated in Figure 3-21 and Figure 3-22 in Chapter 3 and a further example is given in Figure 5-10. There also seems to be a good qualitative agreement with the scaling predicted by the modelling and the underground observations for this particular pillar.

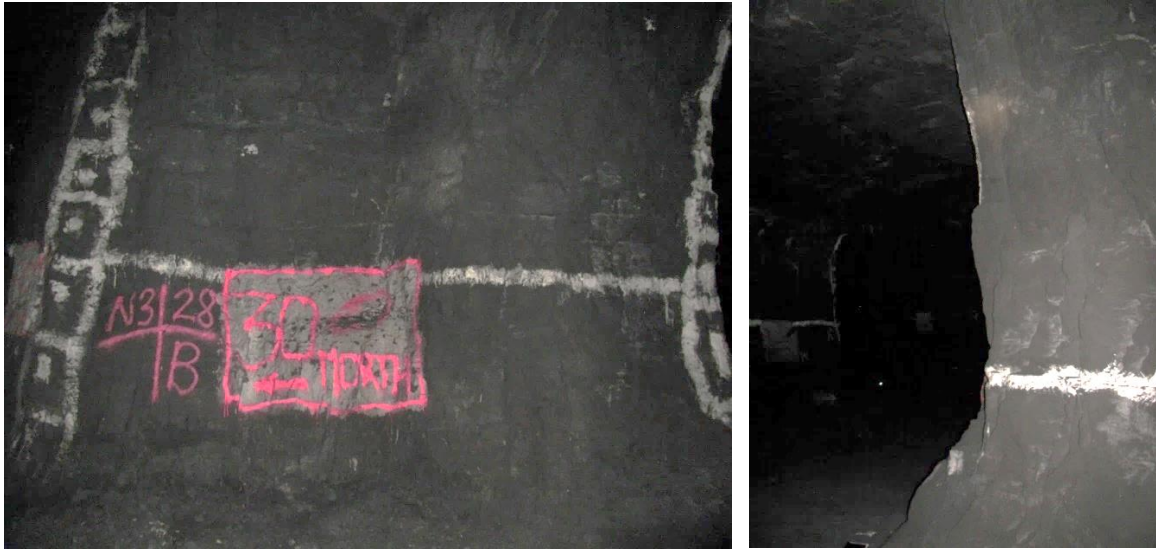
Figure 5-12. Typical condition of the pillars in Area 4. No scaling was observed.

This area is one of the high-grade areas monitored and almost no pillar scaling is observed in this area. This increase in pillar strength was simulated by increasing the intact strength intercept, S_0 , in a trial and error manner until no scaling was simulated for this area. A value of $S_0 = 85$ MPa resulted in the absence of any scaling as shown in Figure 5-11. This is the minimum value that gave no scaling in the modelling and it may in fact be even higher for these pillars. This again emphasises the need for additional work to calibrate the limit equilibrium model. The modelling is nevertheless in agreement with the observations made during the underground visit. The pillar condition is illustrated in Chapter 3 and a further example is given in Figure 5-12.

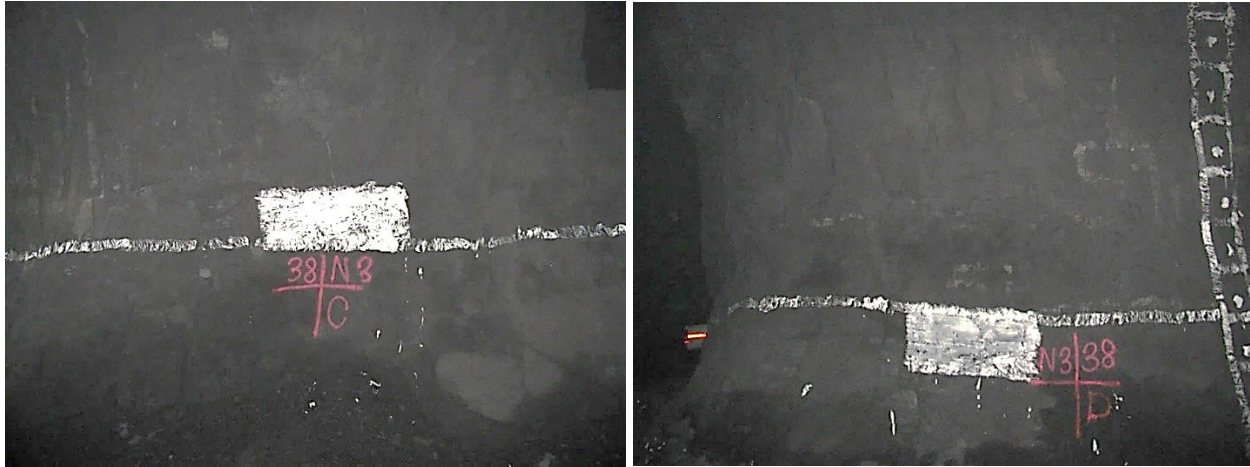
Figure 5-14. Two views of pillar N3_38 at Nchwaning III shaft illustrating the excellent condition of the pillar.

The conditions of the pillars in this area has already been illustrated in Chapter 3. Figure 5-14 illustrates a further example of the condition of pillar N3_38. The pillar is an excellent condition and no scaling is observed. This agrees with the numerical modelling.

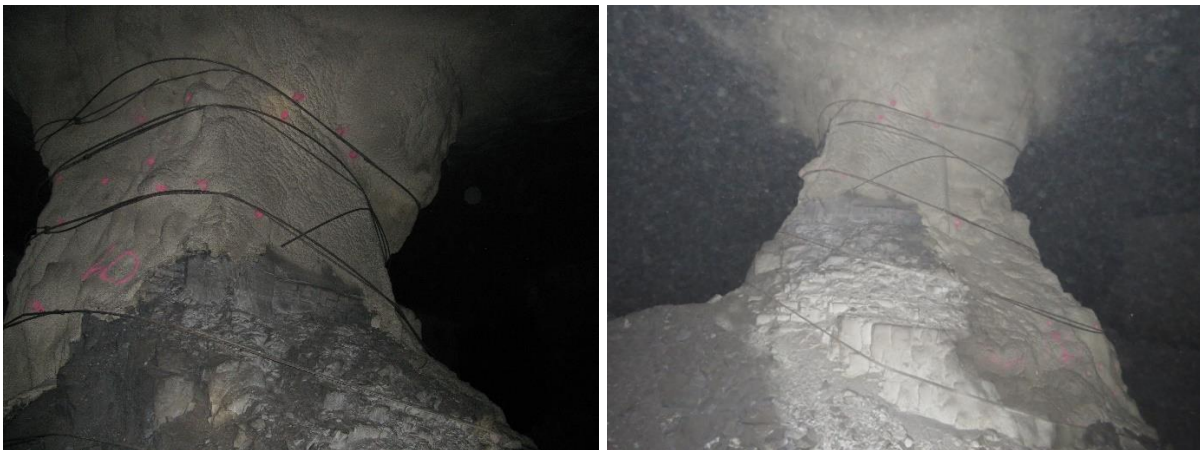
Figure 5-17. Condition of pillar P60.

To compare with the modelling, Figure 5-17 and Figure 5-18 illustrate the condition of pillars P60 and P79 respectively. This highlights the significant scaling that these pillars experienced. These observations also qualitatively similar to the modelling results.

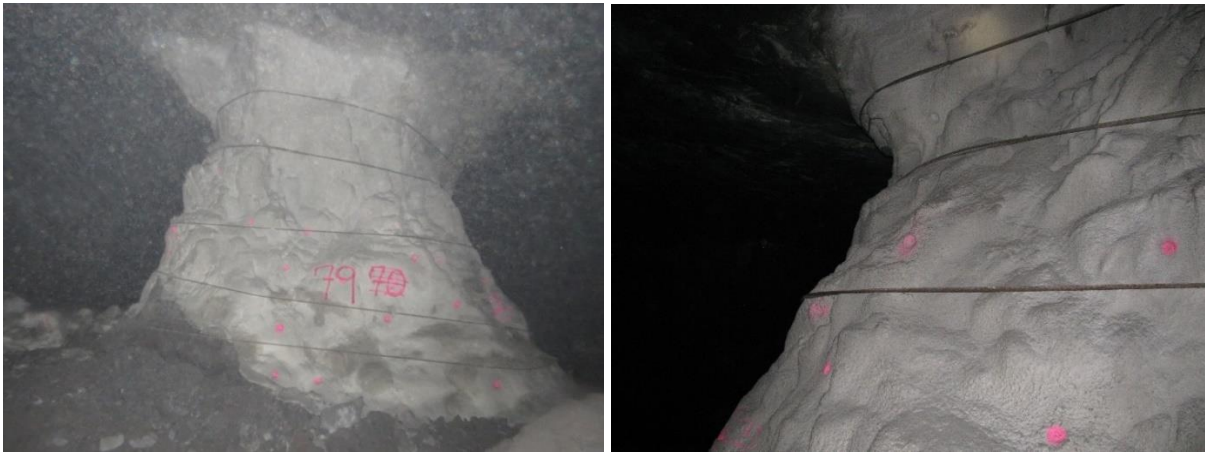
Figure 5-18. Condition of pillar P79.

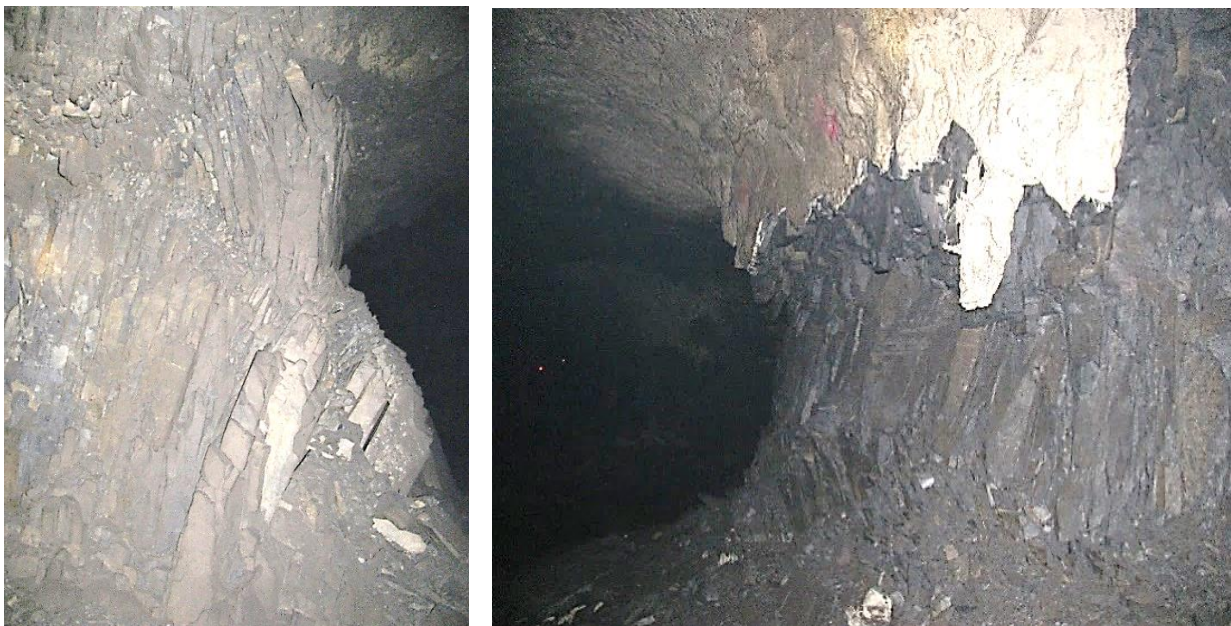
Figure 6-1. Example of pillar scaling at Nchwaning III shaft (left). This failure seems to occur in a time-dependent fashion. For the pillar on the right, a thin spray-on liner was applied to the pillar, but the scaling persisted and the liner failed.

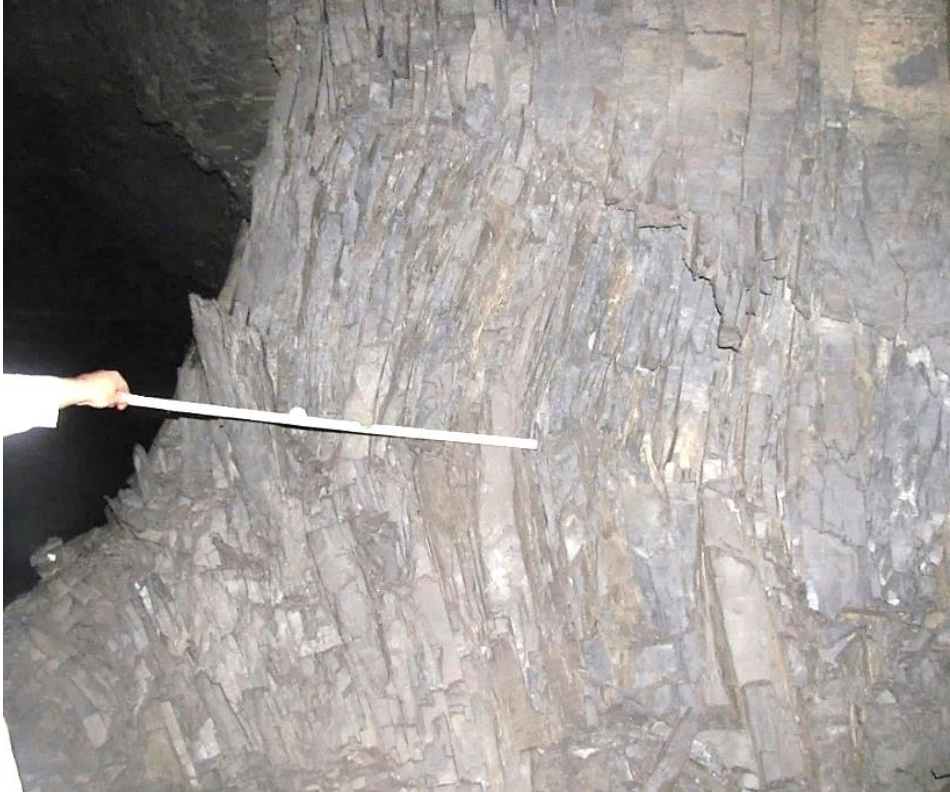
Figure 11-1. Joint spacing on Side D (left corner).
