A REVIEW OF THE PILLAR DESIGN METHODOLOGY FOR MANGANESE MINING OPERATIONS IN SOUTH AFRICA

M.Eng (Mining Engineering)

IN THE FACULTY OF ENGINEERING, BUILT ENVIRONMENT AND
INFORMATION TECHNOLOGY
DEPARTMENT OF MINING ENGINEERING
UNIVERSITY OF PRETORIA

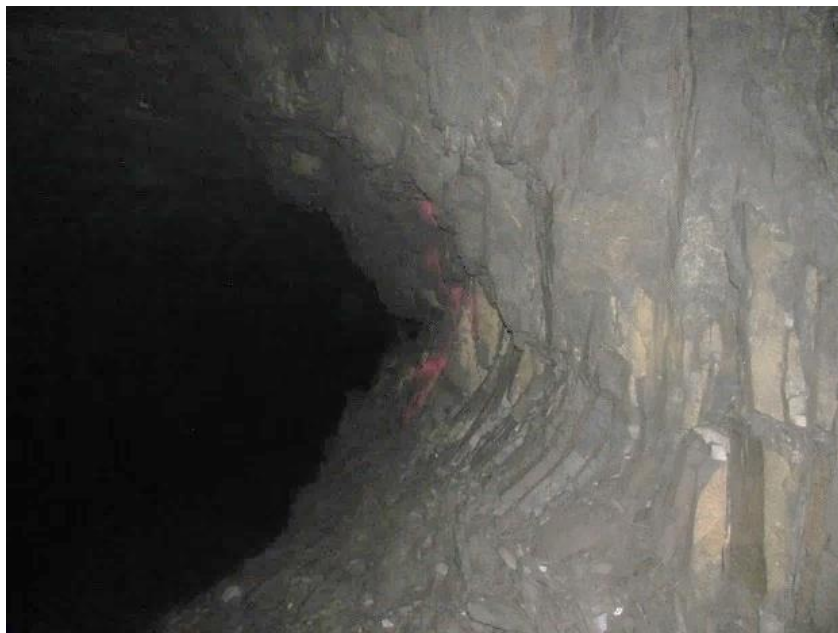
Figure 11-2. Depth of pillar scaling for pillar N3_1. Note the hourglass shape of the pillar.

In summary, the vertical joints are closely spaced with the joint spacing varying over the perimeter of the pillar. Scaling at the corners is prominent. Buckling of the failed slabs on the left side of Side D was observed with an hourglass shape on the righthand side of Side D. The vertical joint spacing varies between 2 cm and 4.5 cm in some places and in other places the joint spacing is 10 cm to 20 cm. The spacing of the joints on Sides A and C was found to be 40 cm and Sides B and D were 10 cm. No random joints were observed and in total, three joint sets were observed. The joint sets are mostly vertical, and no infilling was observed. The joints are smooth and planar with extensive failure on Sides A and C. Figure 11-2 illustrates the typical hourglass shape of the pillar.

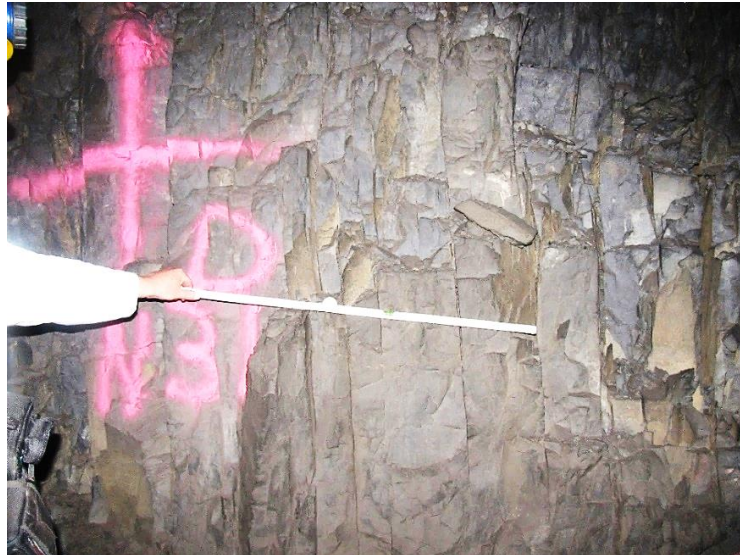
Figure 11-3. Joint spacing on Side D (right corner) of the pillar indicates a vertical joint spacing of approximately 10 cm.

A rock mass rating was very difficult as there are significant changes in joint spacing over short distances and the pillars are heavily crushed in many areas. It is noticeable that the vertical joint spacings of 10 cm led to significant scaling and damage. Figure 11-1 and Figure 11-3 illustrate the variation of joint spacing on the same pillar side (N3_1D). The one side illustrates a joint spacing of 1 cm and the other side approximately 10 cm. Sides A and C had larger joint spacings of 40 cm in some areas. As the edges of the pillar on these sides fail on the closely spaced joints parallel to the plane, it had a smooth appearance in some places.

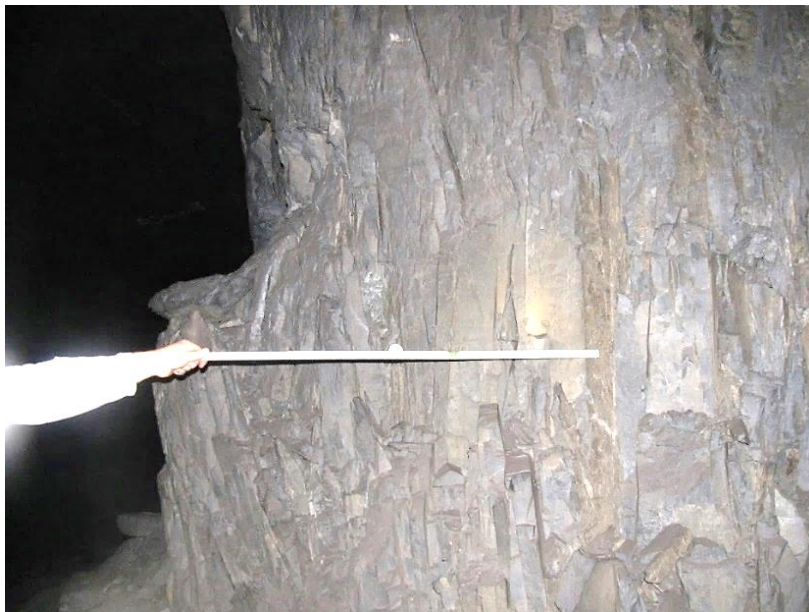
Figure 11-4. Joint spacing on the left-hand corner of Side A. The spacing ranged from 5 cm to 20 cm.

It is noticeable that the vertical joint spacings led to significant scaling and damage. Figure 11-4 and Figure 11-5 illustrate the variation of joint spacing on the same pillar side (N3_2A). The one side illustrates a joint spacing ranging from 1 cm to 5 cm. The vertical joint spacing ranges from 10 cm to 30 cm in different areas making it difficult to determine the RQD as it ranges from less than 25% to approximately 75%.

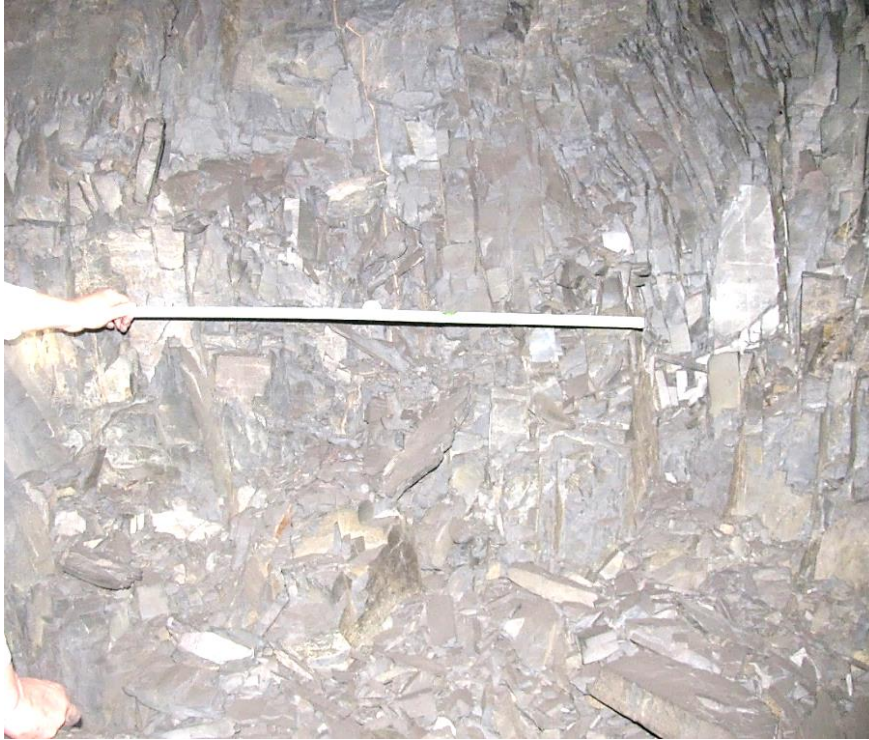
Figure 11-5. The vertical joint spacing on the right-hand side of the pillar. It was difficult to determine as the spacing of the joints as it varies across the perimeter of the pillar.

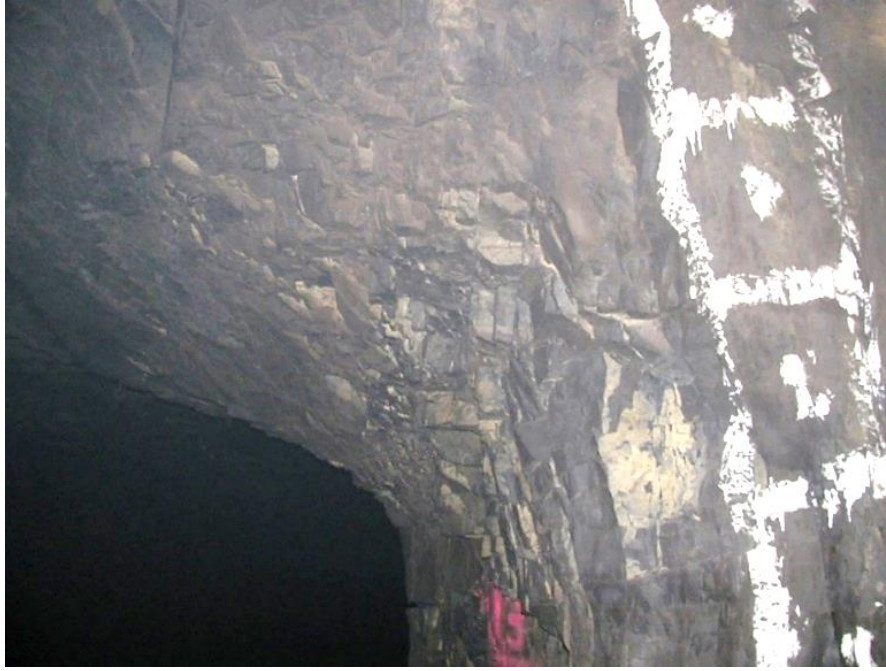
Figure 11-7. Side A illustrates an hourglass shape.

There are three joint sets present and one random joint. The horizontal joint spacing was observed to be greater than 1 m in some places. It varies across the perimeter of the pillar ranging between 30 cm to 50 cm. Some of the horizontal joints are clamped tightly and the spacing varies. Horizontal joints also had a spacing that varied. The vertical joint spacing was observed to be between 3 cm and 10 cm in some places. Sides A and C have a random joint dipping at 45°. The pillar has an hourglass shape. The vertical joints seem to terminate on the horizontal joints, facilitating the scaling. Figure 11-7 illustrates the dip of the random joint set and Figure 11-8 illustrates the joint spacing on Side C. Figure 11-9 illustrates a random joint striking in the direction of Sides B and D.

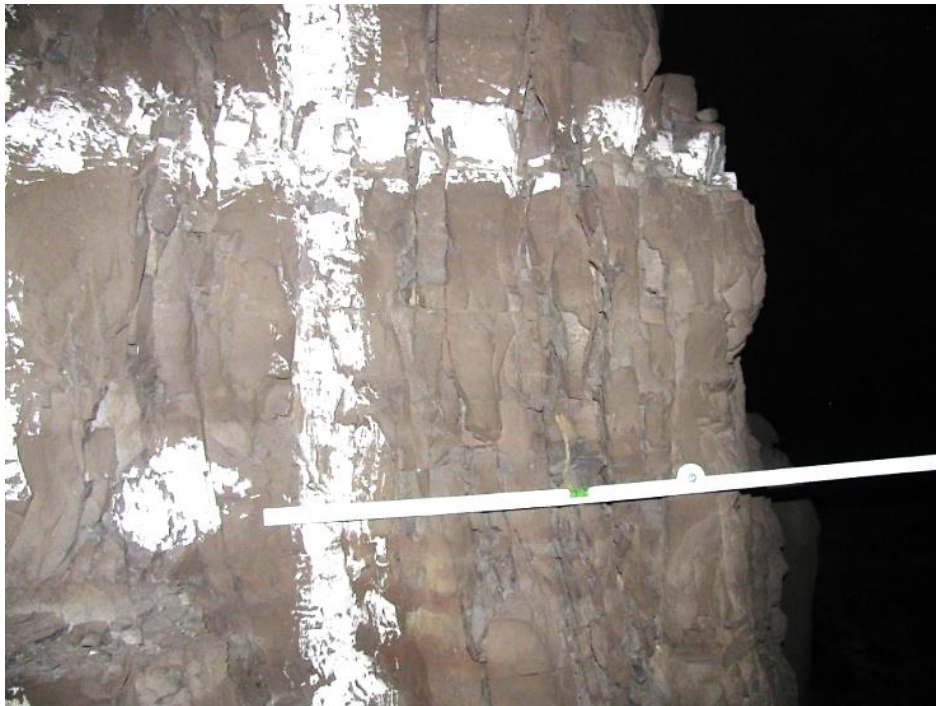
Figure 11-8. Side C illustrates the joint spacing, ranging from 5 cm to 20 cm.

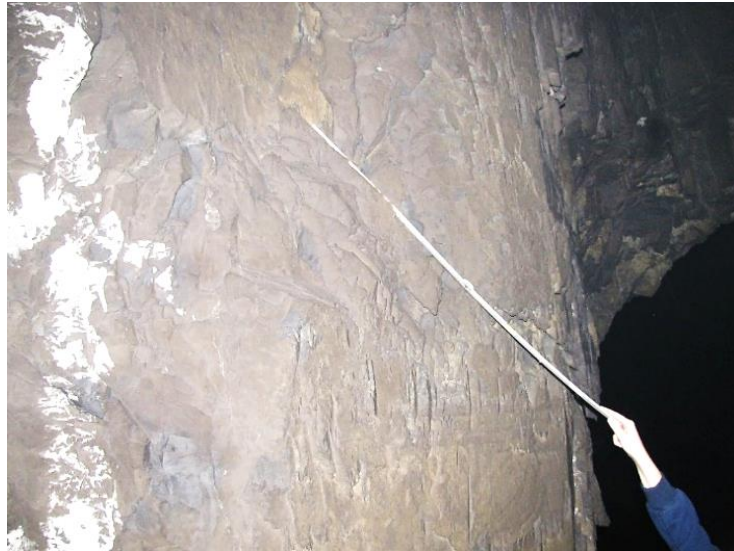
Figure 11-9. Random joint striking in the direction of Sides B and D. Angle of random joint, 45°.

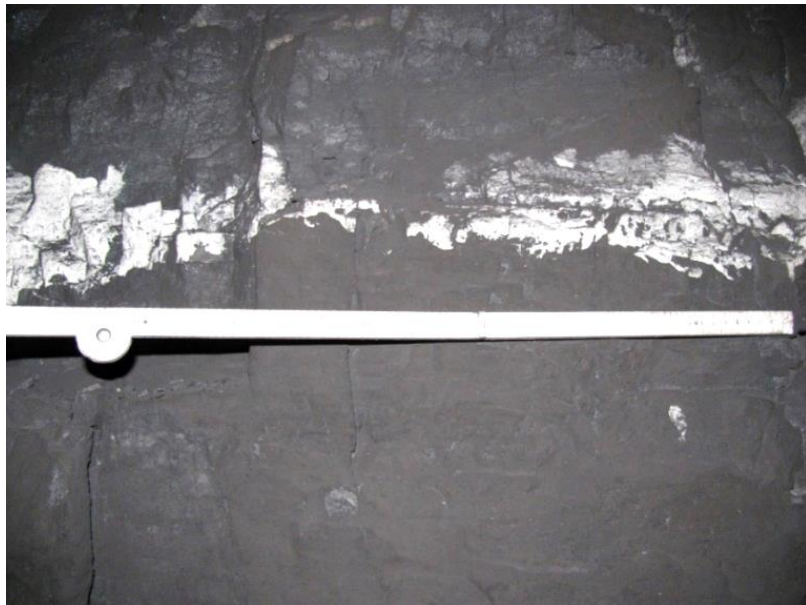
Figure 11-10. Side B illustrates the vertical joint spacing of approximately 40 cm.

The vertical joints in this area are not prominent and almost no signs of scaling were observed. In this particular area, the horizontal joints seem to be the prominent joint set. This joint spacing varies along the perimeter of the pillar, ranging from 30 cm to greater than 50 cm. On the sides of the pillar, the vertical joint spacing was determined to be approximately 20 cm. The corners of the pillars had the shape of an hourglass. The overall condition of the pillar is stable and intact. Only two joint sets were observed, one horizontal and one vertical. Figure 11-10 illustrates the joint spacing across Side B. The vertical joint sets were spaced approximately 40 cm apart. It was difficult to determine the spacing as these joints are not prominent. Figure 11-11 illustrates the hourglass shape of the pillar as observed underground.

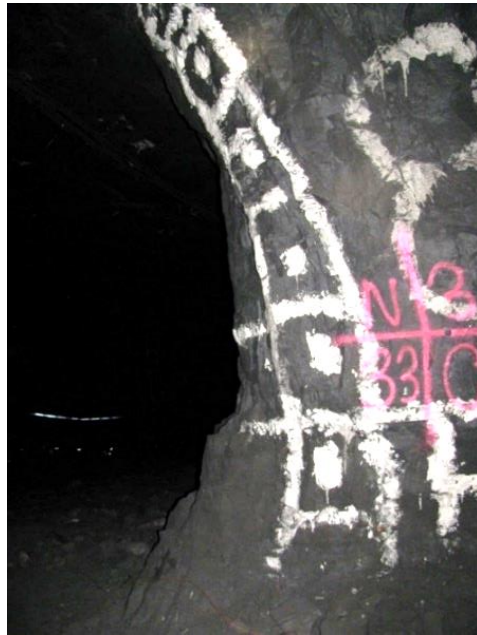
Figure 11-11. Side C illustrates an hourglass shape of the corners of the pillars. The pillar corners are still intact.

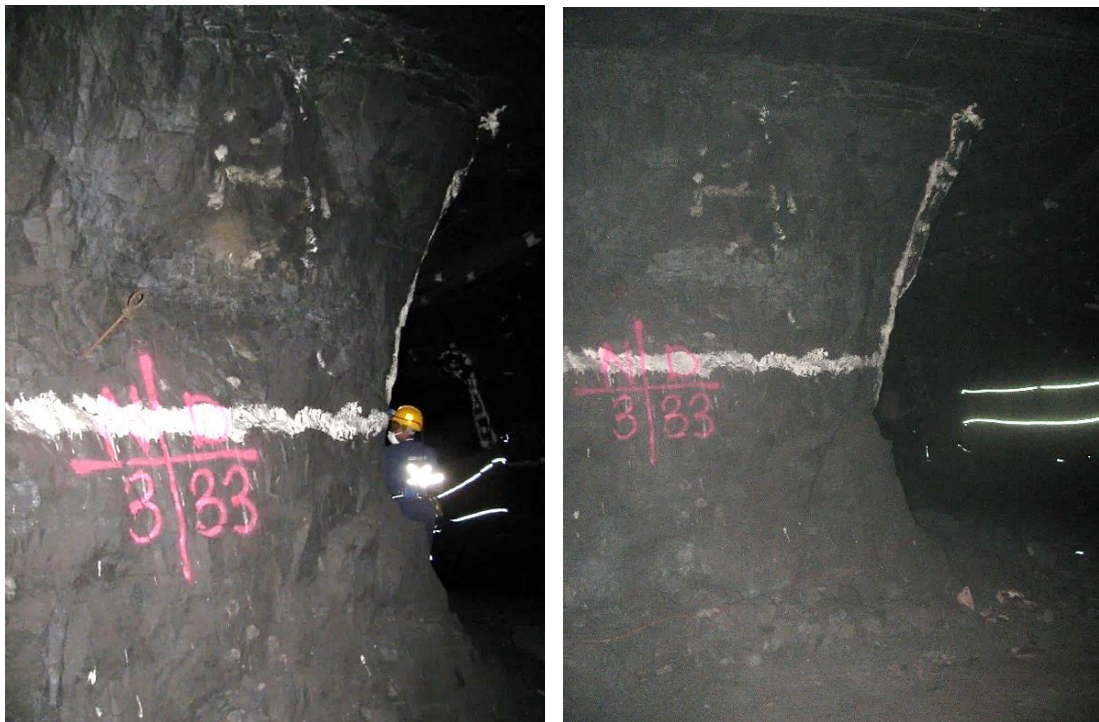
Figure 11-12. Side D of pillar N3_33 at Nchwane III shaft, illustrating the right-hand corner of the pillar observed on the 17th of May and on the 18th of August 2021.

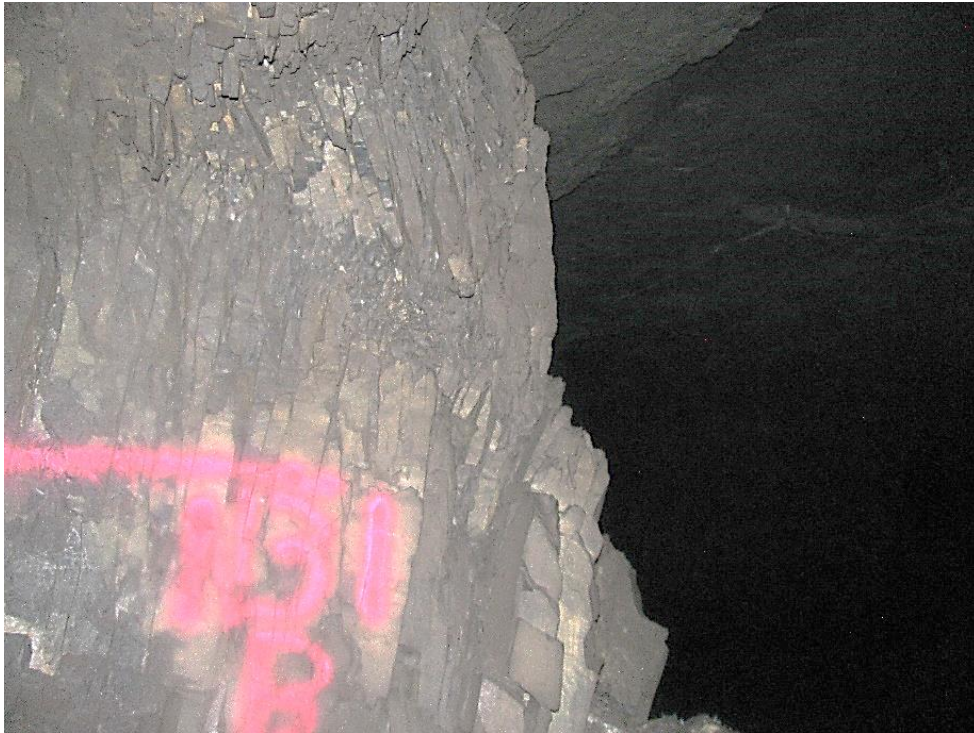
Figure 12-5. Side B of pillar N3_1 at Nchwaning III shaft illustrating buckling of the corner as observed on the 4th of May 2021.

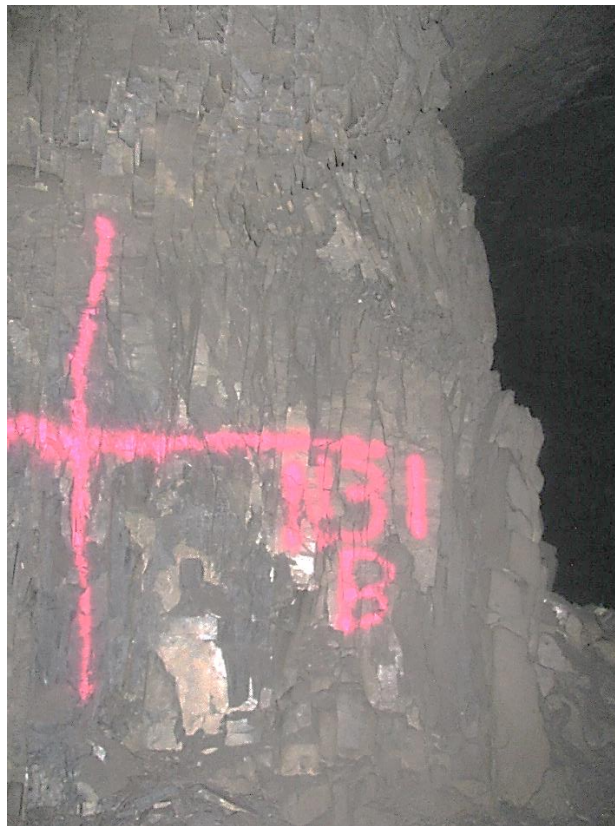
Figure 12-6. Side B of pillar N3_1 at Nchwaning III shaft illustrating buckling of the corner as observed on the 18th of August 2021. No time-dependent scaling took place over this period.

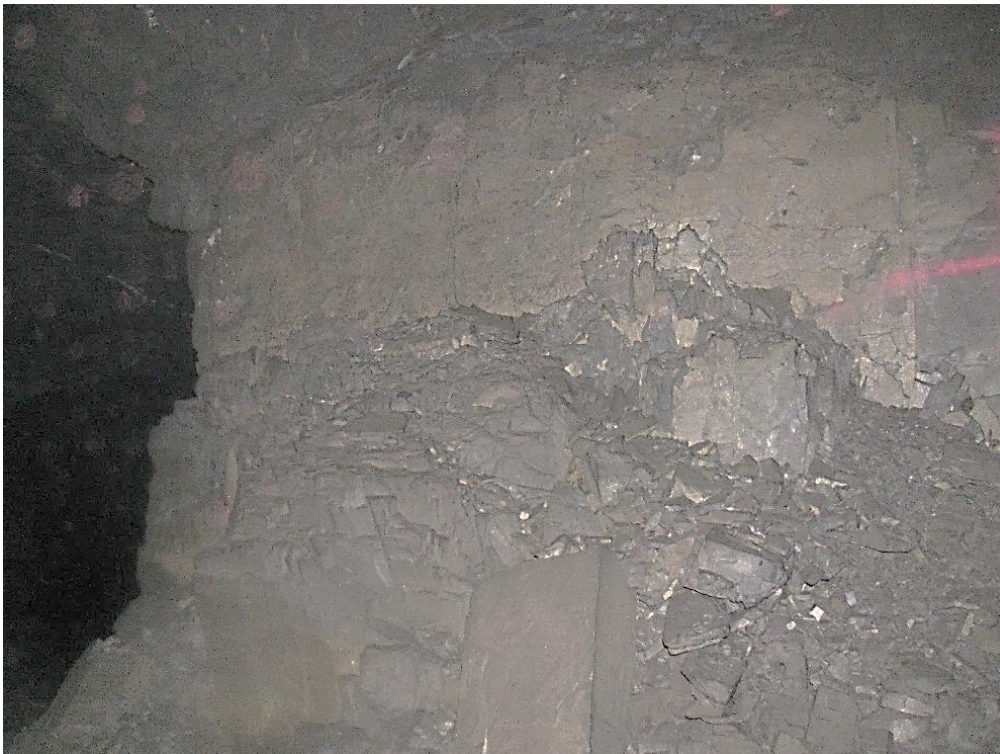
Figure 12-8. Side C of pillar N3_1 at Nchwaning III shaft illustrating the scaling that has taken place since the pillar was cut.

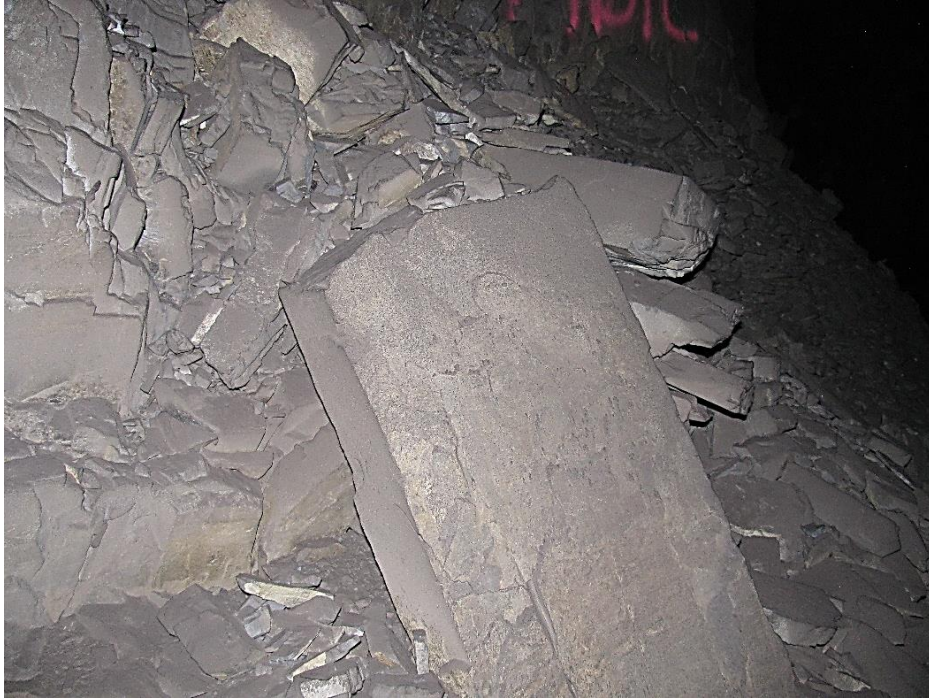
Figure 12-9. Side C of pillar N3_1 illustrating the size of some of the blocks that scaled from the pillar.

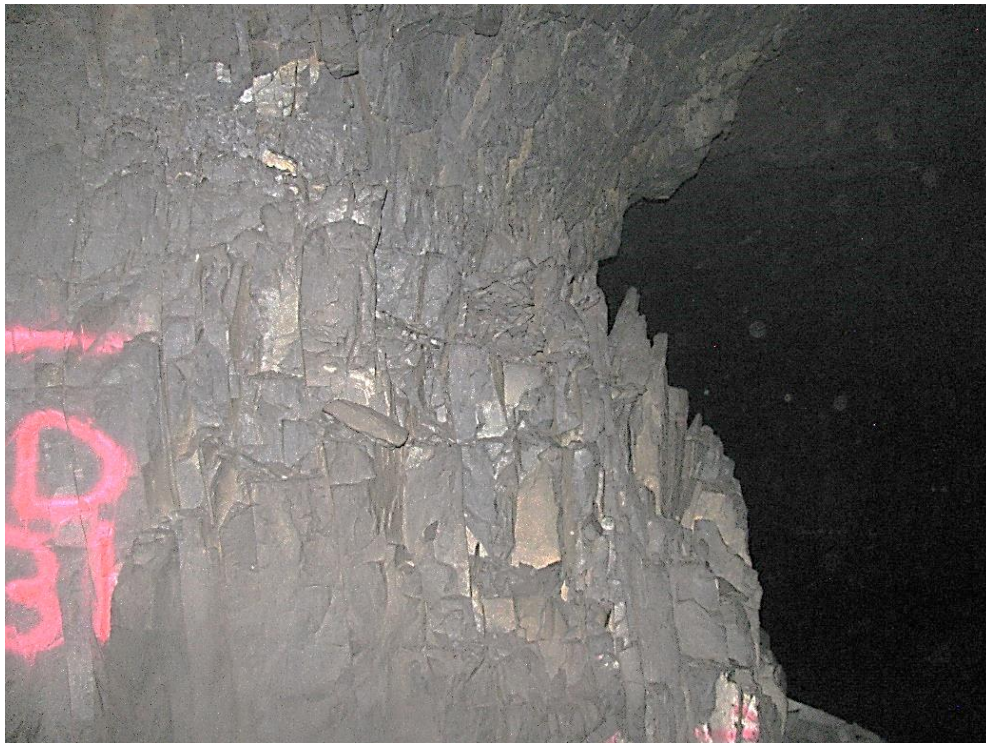
Figure 12-10. Side D of pillar N3_1 at Nchwaning III shaft illustrating the vertical joints on the right-hand corner of the pillar.

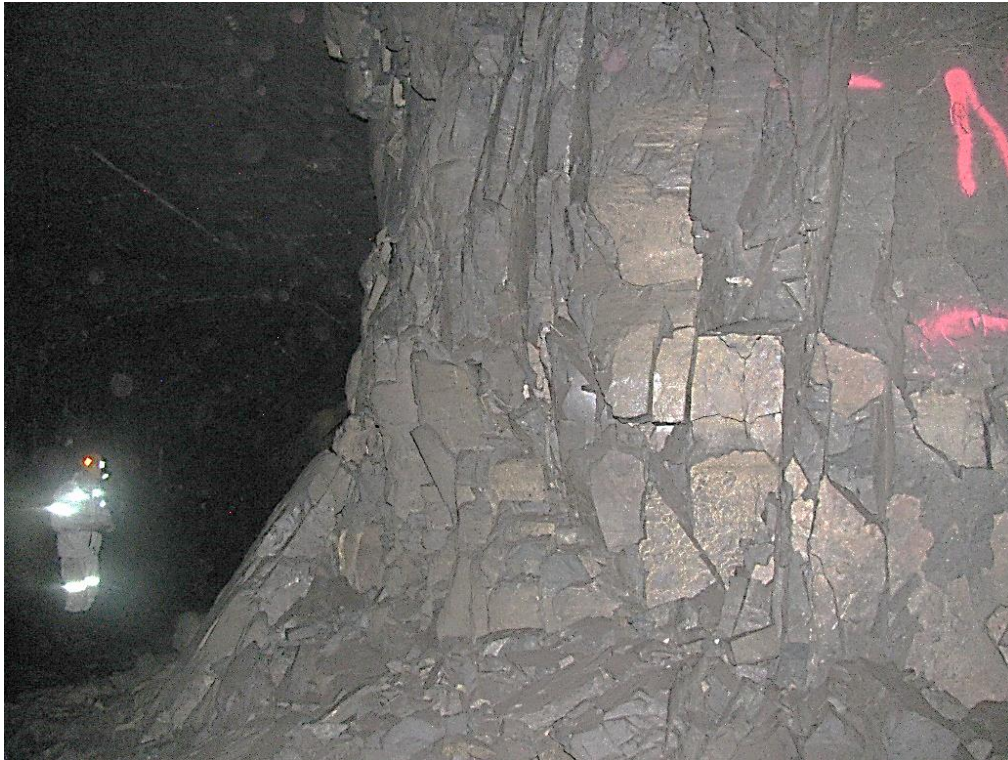
Figure 12-13. Side A of pillar N3_2 at Nchwane III shaft illustrating the vertical joint sets on the left-hand corner of the pillar.

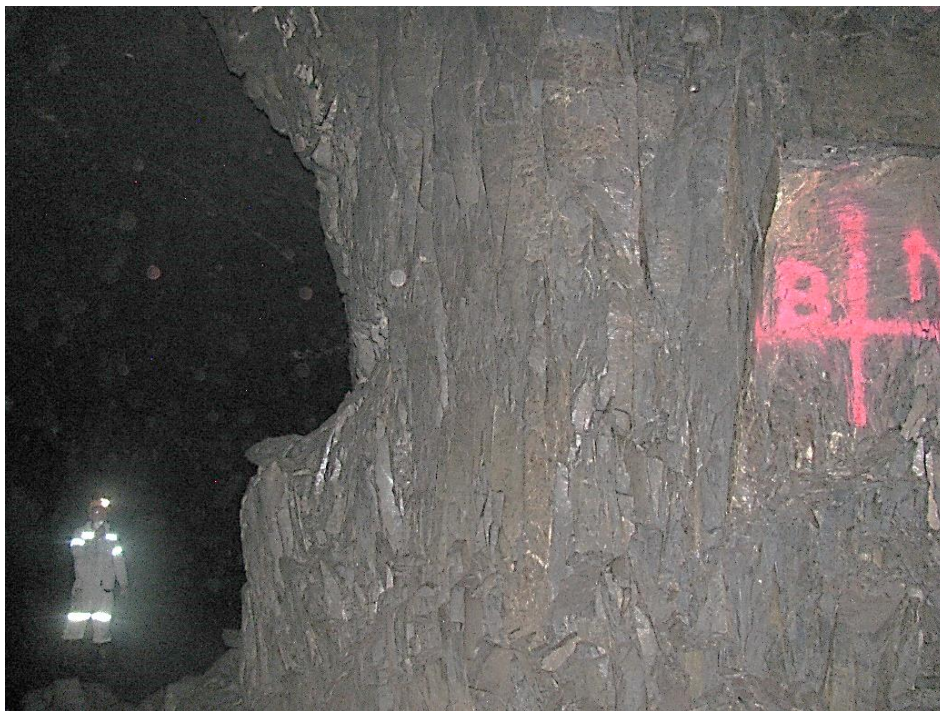
Figure 12-16. Side B of pillar N3_2 at Nchwaning III shaft illustrating the vertical joint sets on the left-hand corner of the pillar.

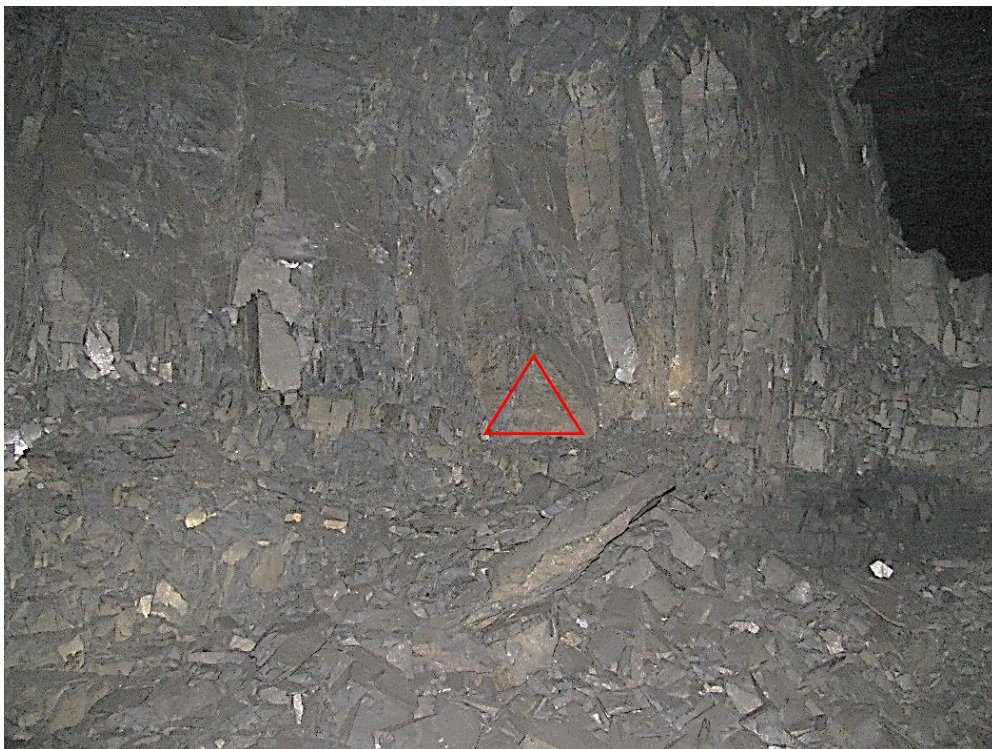
Figure 12-18. Side C of pillar N3_2 at Nchwane III shaft as observed on the 4th of May 2021, the red triangle was used as a reference point to measure the scaling distance as the pillar was too dangerous to mark

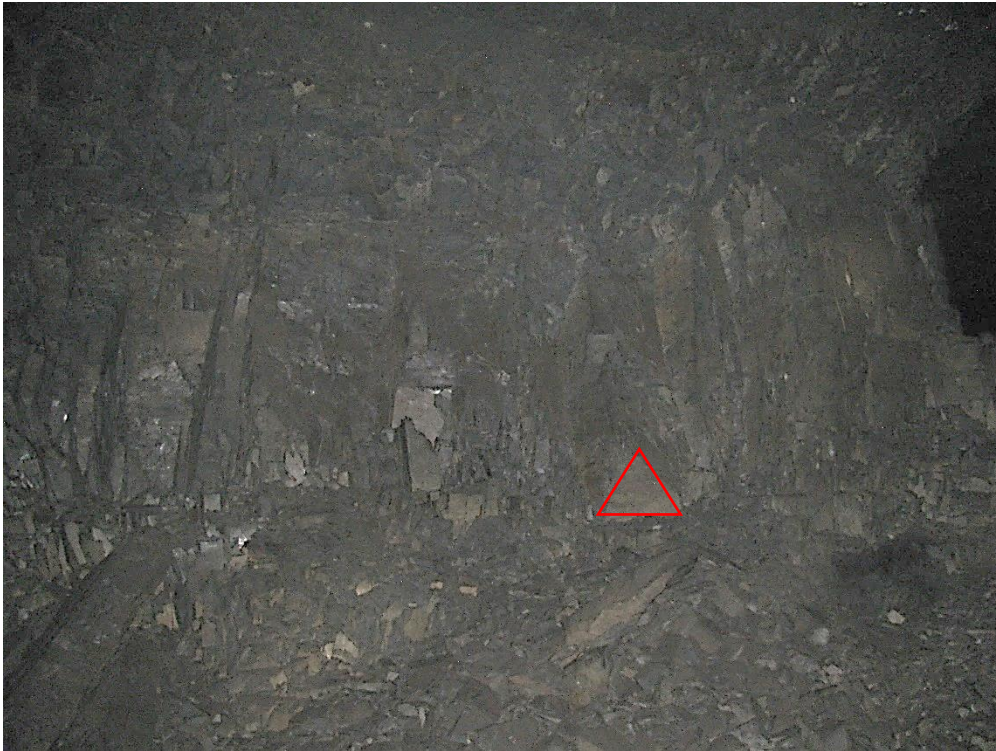
Figure 12-19. Side C of pillar N3_2 at Nchwaneing III shaft, the red triangle was used as a reference point to measure the scaling distance as the pillar was too dangerous to mark. This photograph was taken on the 18th of August 2021.

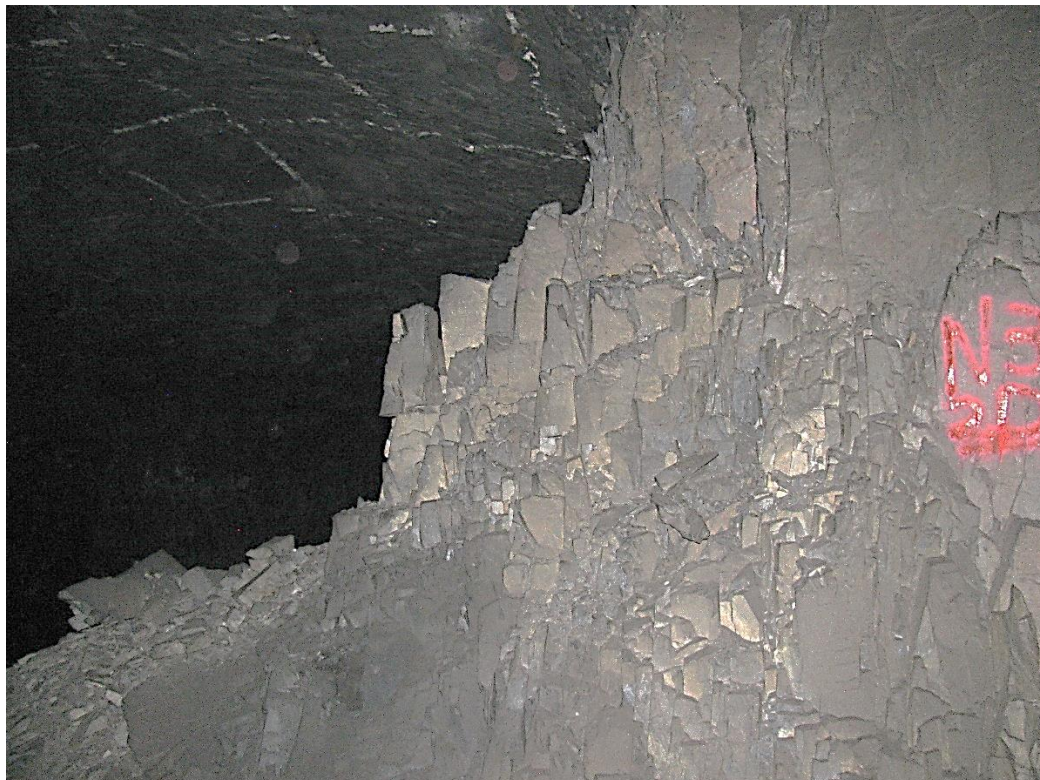
Figure 12-22. Side D of pillar N3_2 at Nchwaning III shaft, illustrating the vertical joint sets on the left-hand corner of the pillar.

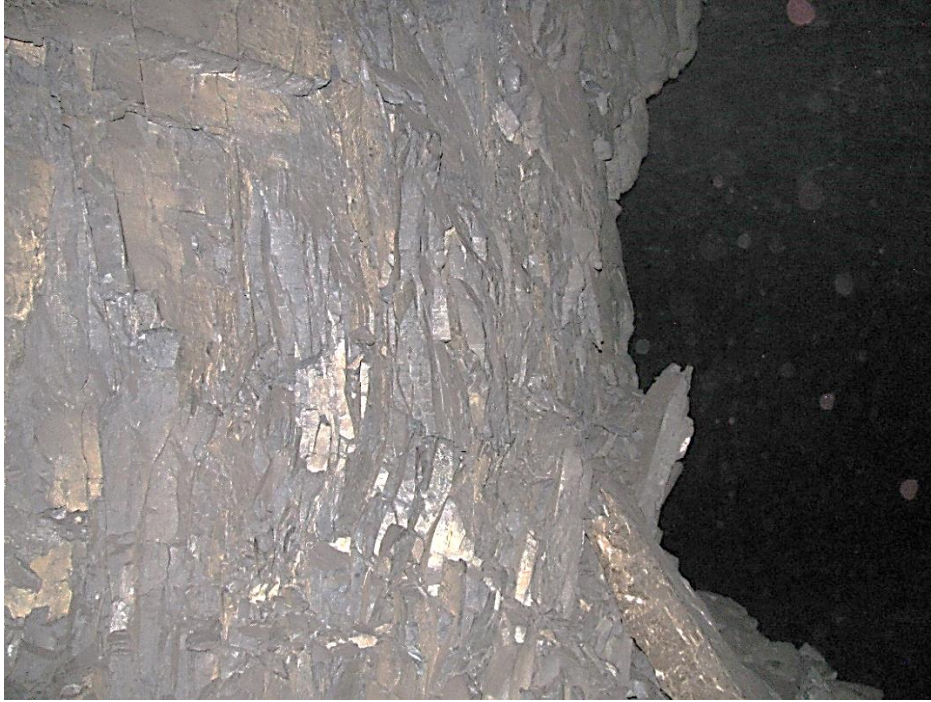
Figure 12-23. Side D of pillar N3_2 at Nchwane III shaft, illustrating the vertical joint sets on the right-hand corner of the pillar as observed on the 4th of May 2021.

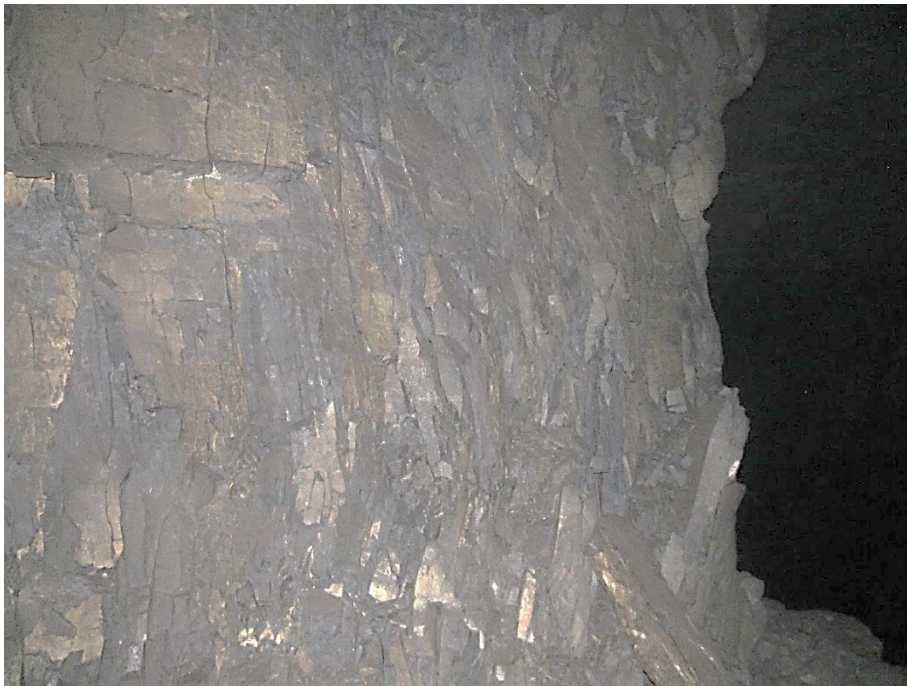
Figure 12-24. Side D of pillar N3_2 at Nchwane III shaft, illustrating the vertical joint sets on the right-hand corner of the pillar as observed on the 18th of August 2021.

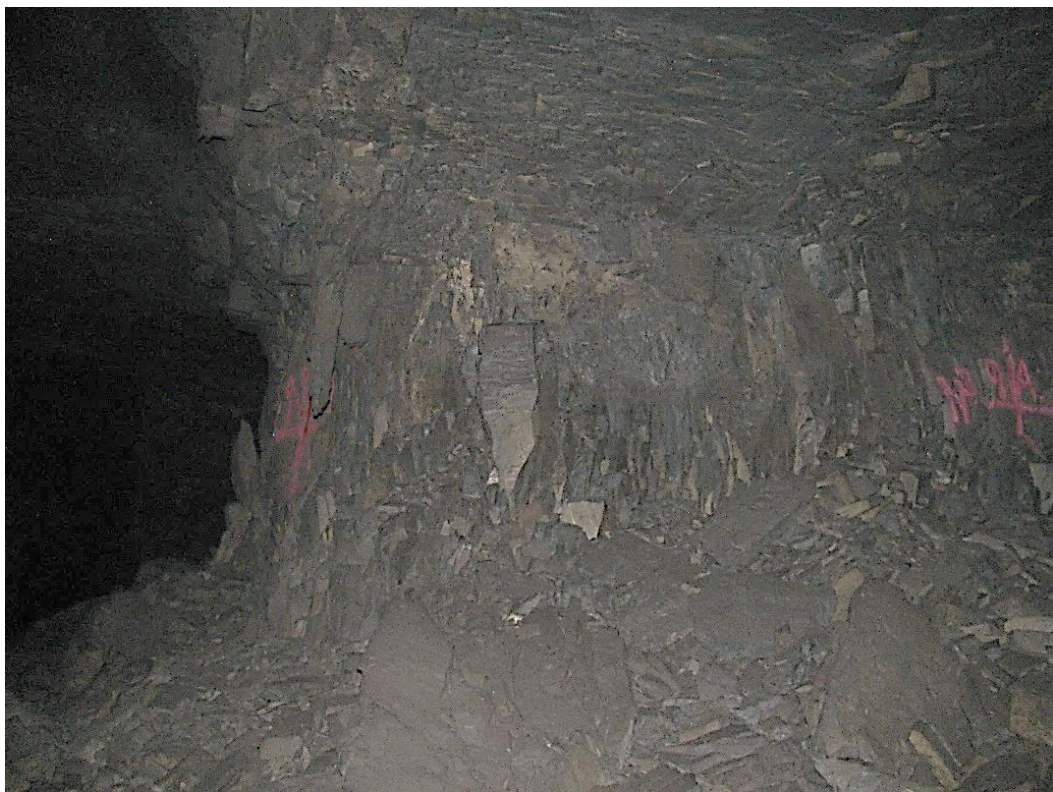
Figure 12-26. Side A of pillar N3_9 at Nchwaneing III shaft, illustrating the vertical joint sets and the size of the block that are scaling off the pillar on the left-hand side.

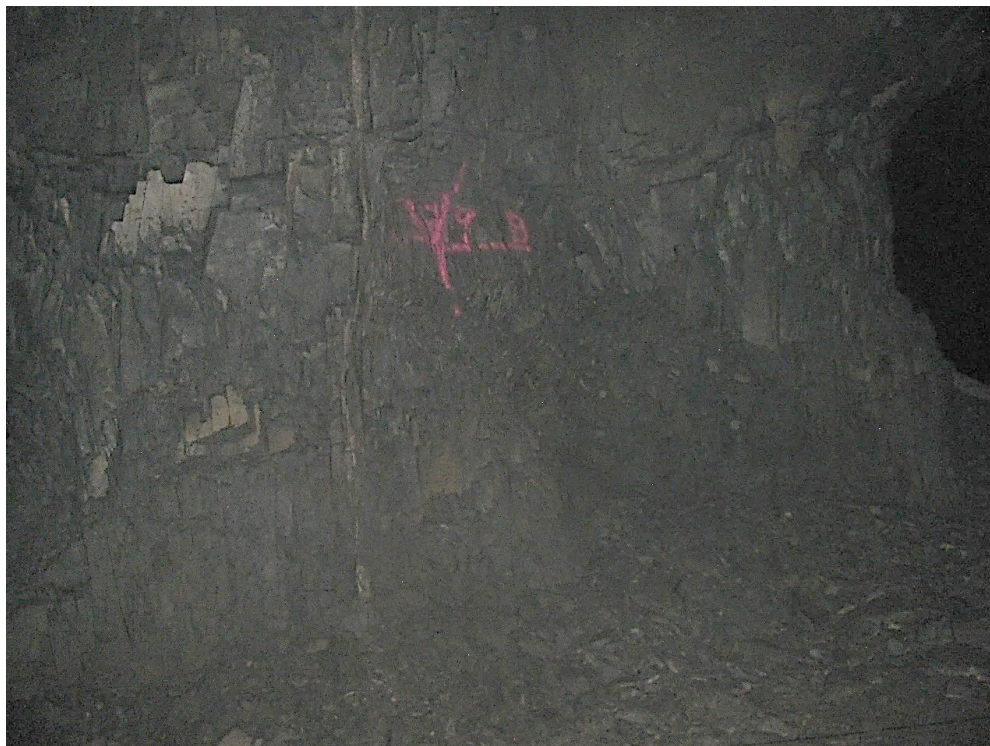
Figure 12-28. Side B of pillar N3_9 at Nchwaning III shaft as observed on the 18th of August 2021. A small amount of scaling took place.

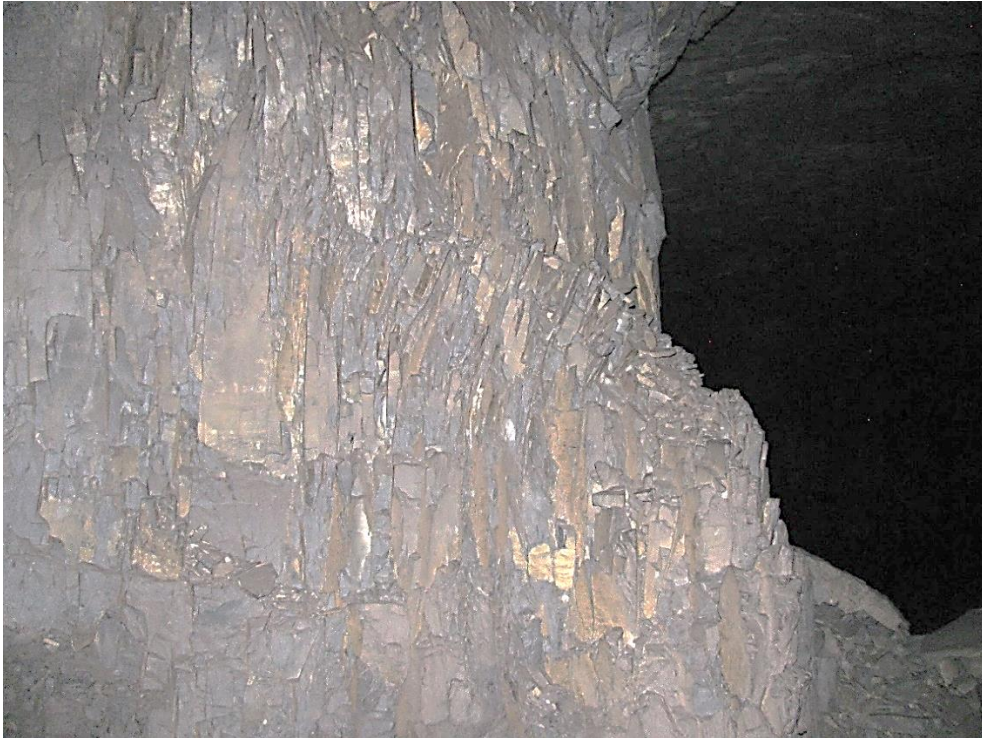
Figure 12-29. Side B of pillar N3_9 at Nchwaning III shaft, illustrating the vertical joint sets as observed on the 4th of May 2021.

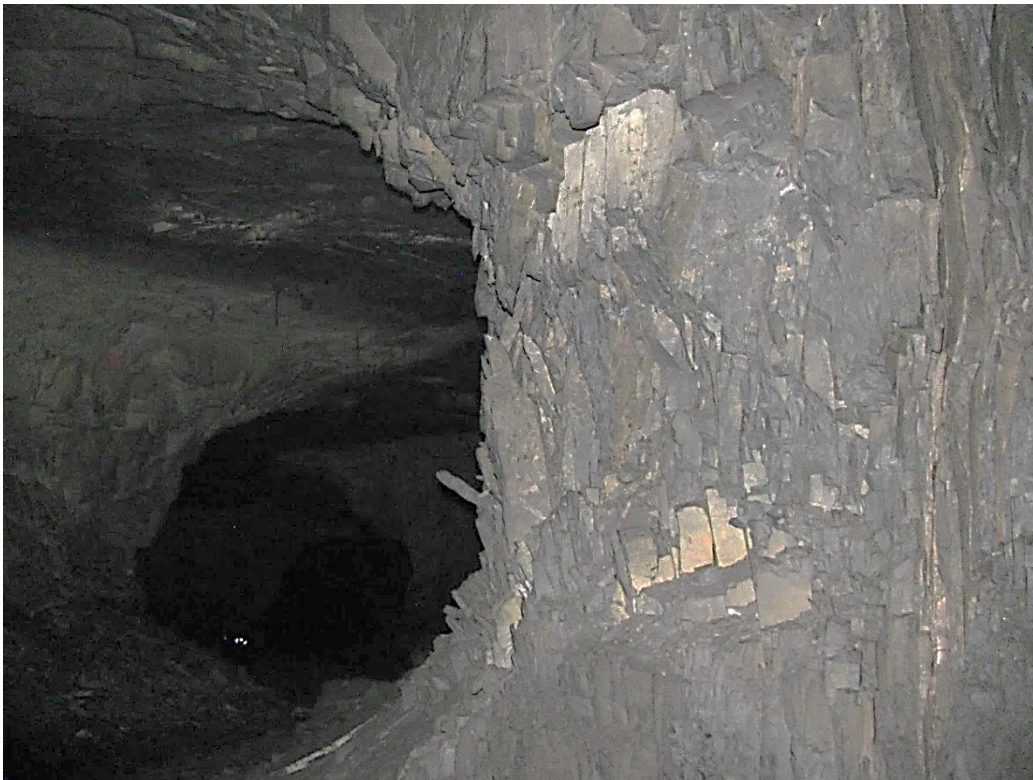
Figure 12-30. Side B of pillar N3_9 at Nchwaning III shaft, illustrating the vertical joint sets on the left-hand corner as observed on the 4th of May 2021.

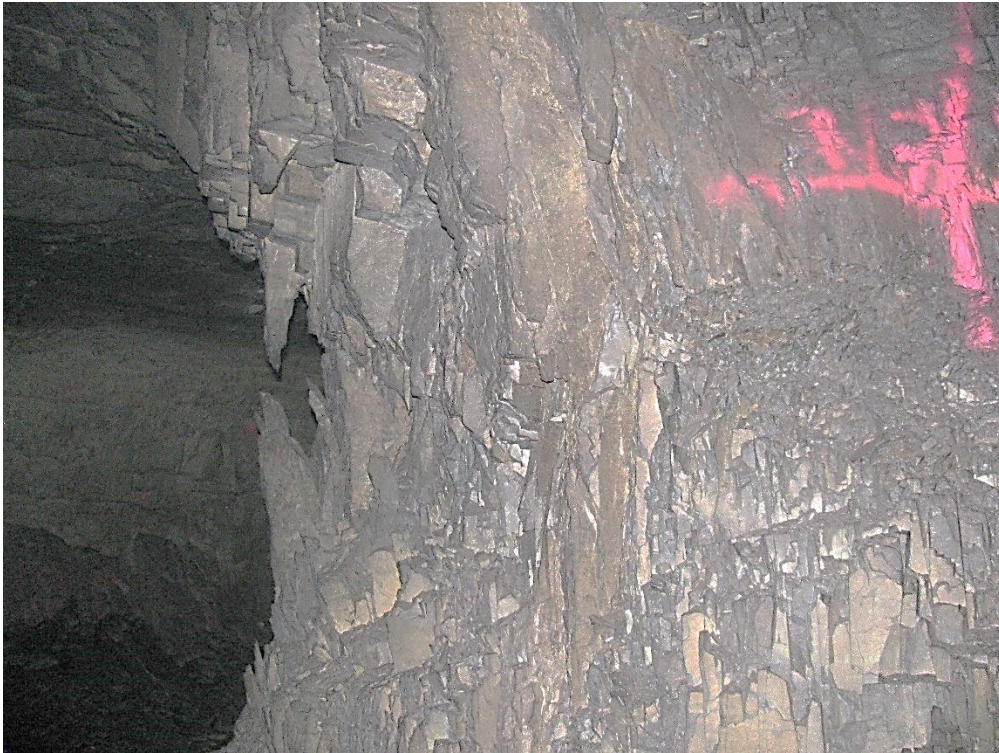
Figure 12-31. Side B of pillar N3_9 at Nchwaning III shaft, illustrating the vertical joint sets on the left-hand corner as observed on the 18th of August 2021.

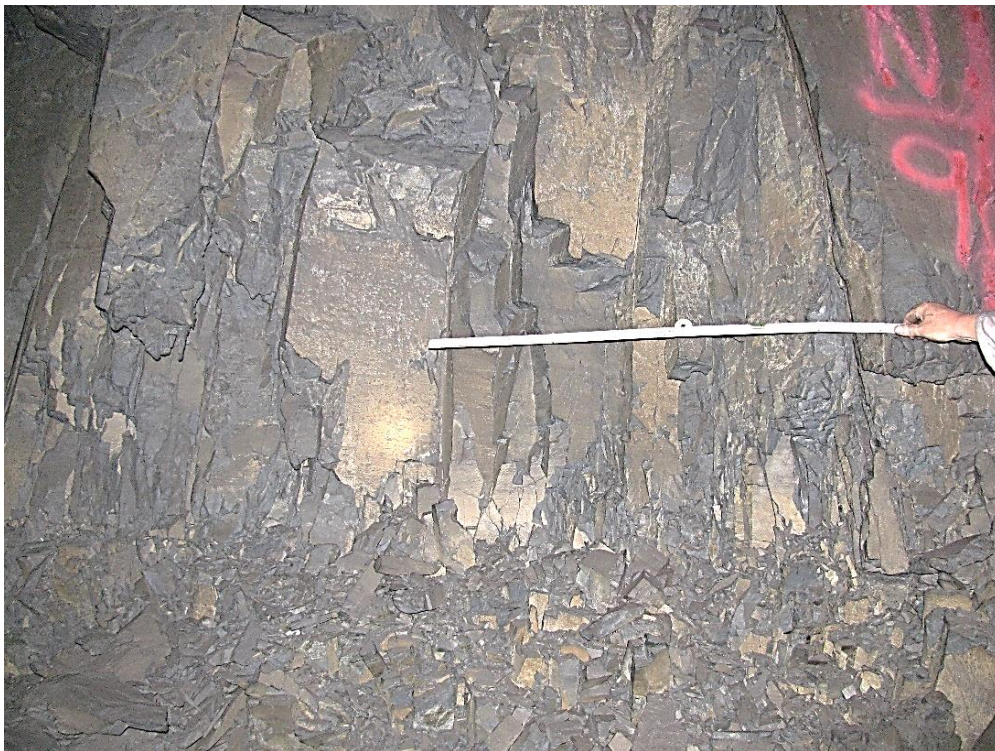
Figure 12-34. Side C of pillar N3_9 at Nchwaning III shaft, illustrating the vertical joint spacing on the left-hand side.

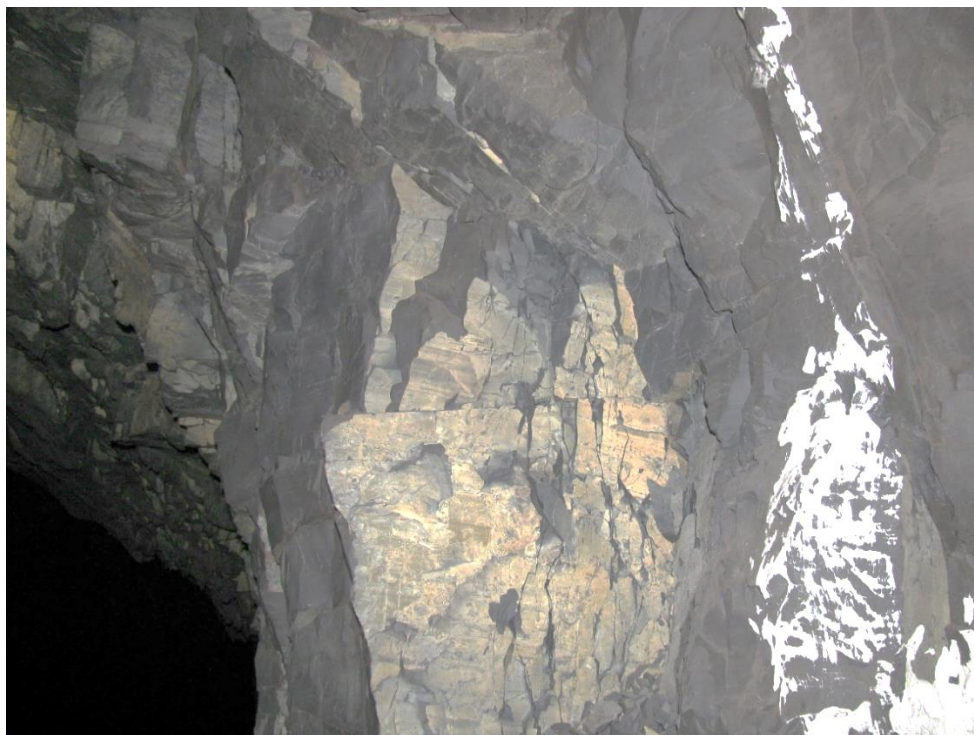
Figure 12-38. Side A of pillar N3_15 at Nchwaning III shaft, illustrating slight weathering on the corner.

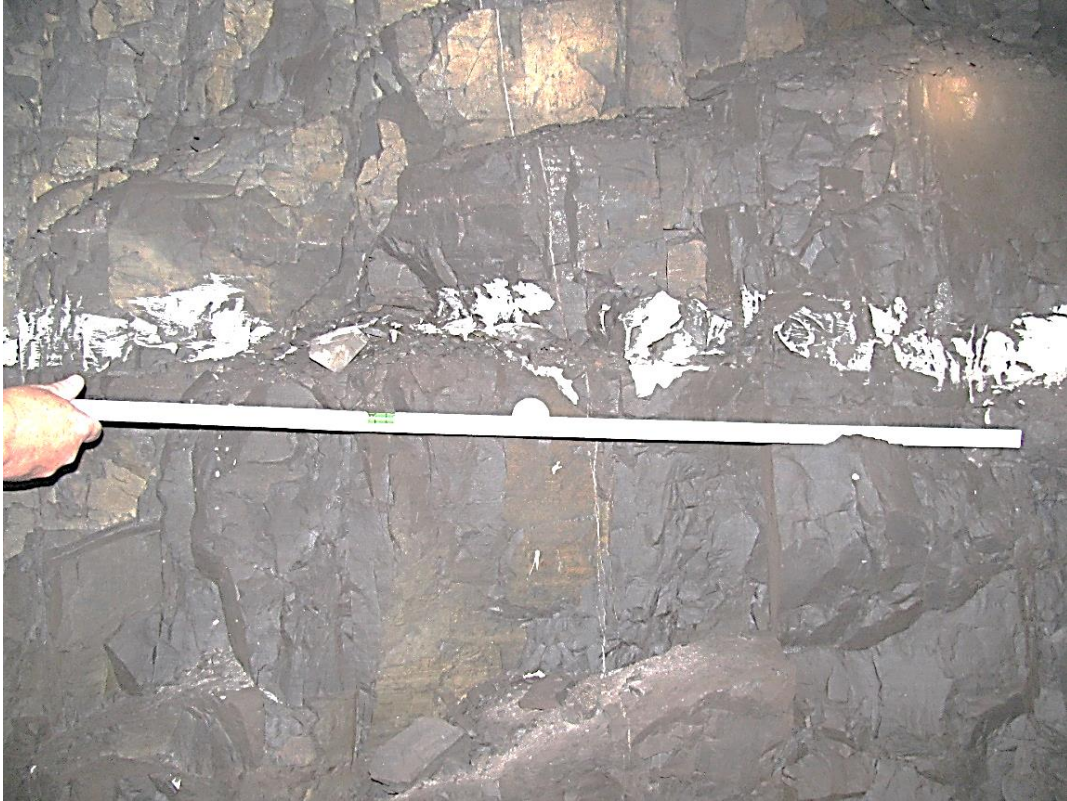
Figure 12-39. Side B of pillar N3_15 at Nchwaneing III shaft, illustrating the vertical joint spacing.

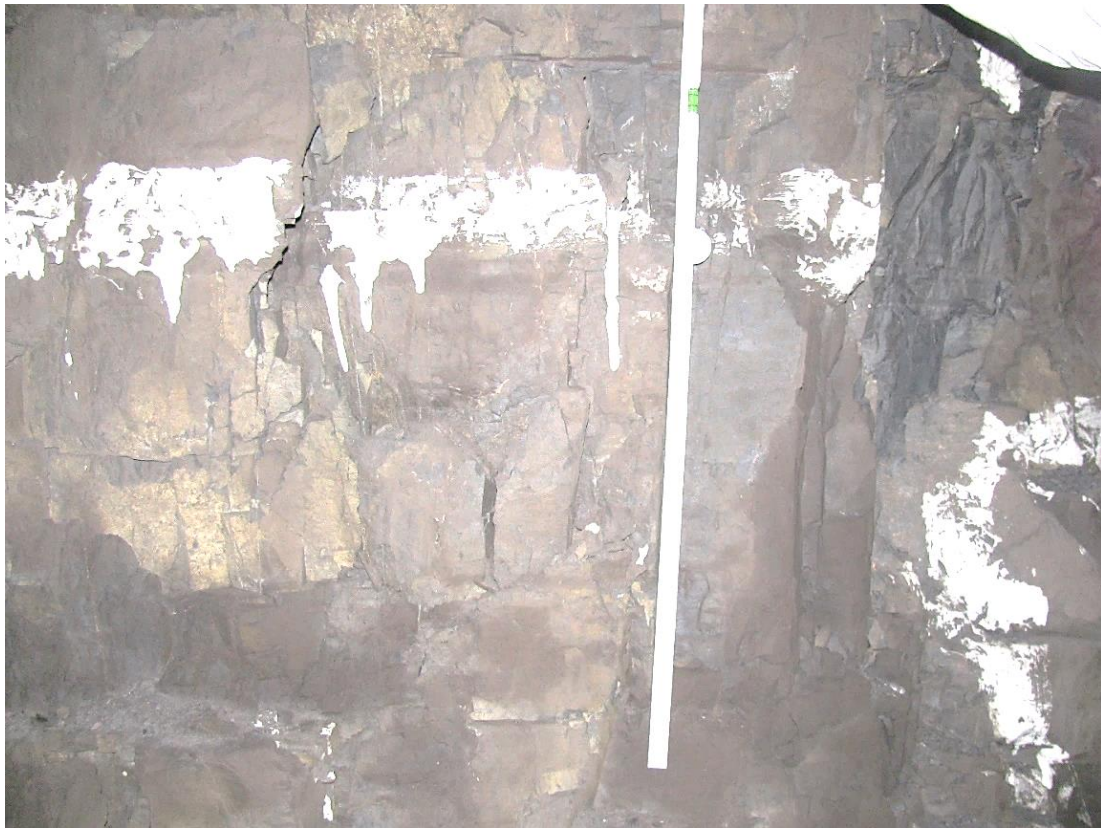
Figure 12-40. Side B of pillar N3_15 at Nchwaneing III shaft, illustrating the horizontal joint spacing.
