A REVIEW OF THE PILLAR DESIGN METHODOLOGY FOR MANGANESE MINING OPERATIONS IN SOUTH AFRICA

M.Eng (Mining Engineering)

IN THE FACULTY OF ENGINEERING, BUILT ENVIRONMENT AND
INFORMATION TECHNOLOGY
DEPARTMENT OF MINING ENGINEERING
UNIVERSITY OF PRETORIA

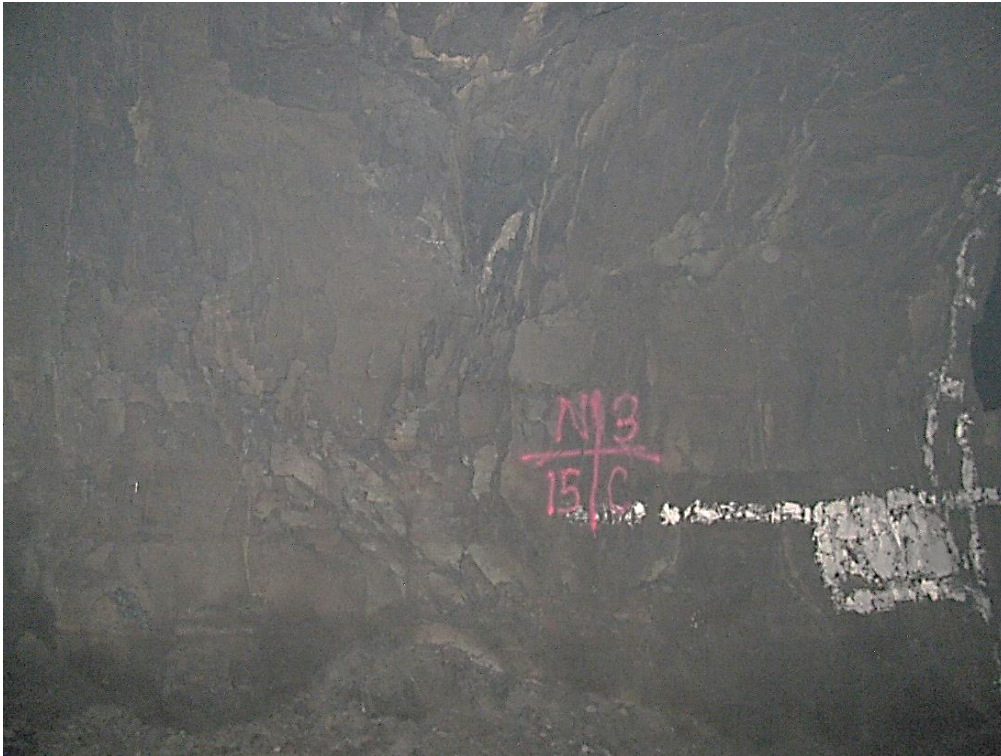
Figure 12-41. Side C of pillar N3_15 at Nchwane III shaft as observed on the 6th of May 2021.

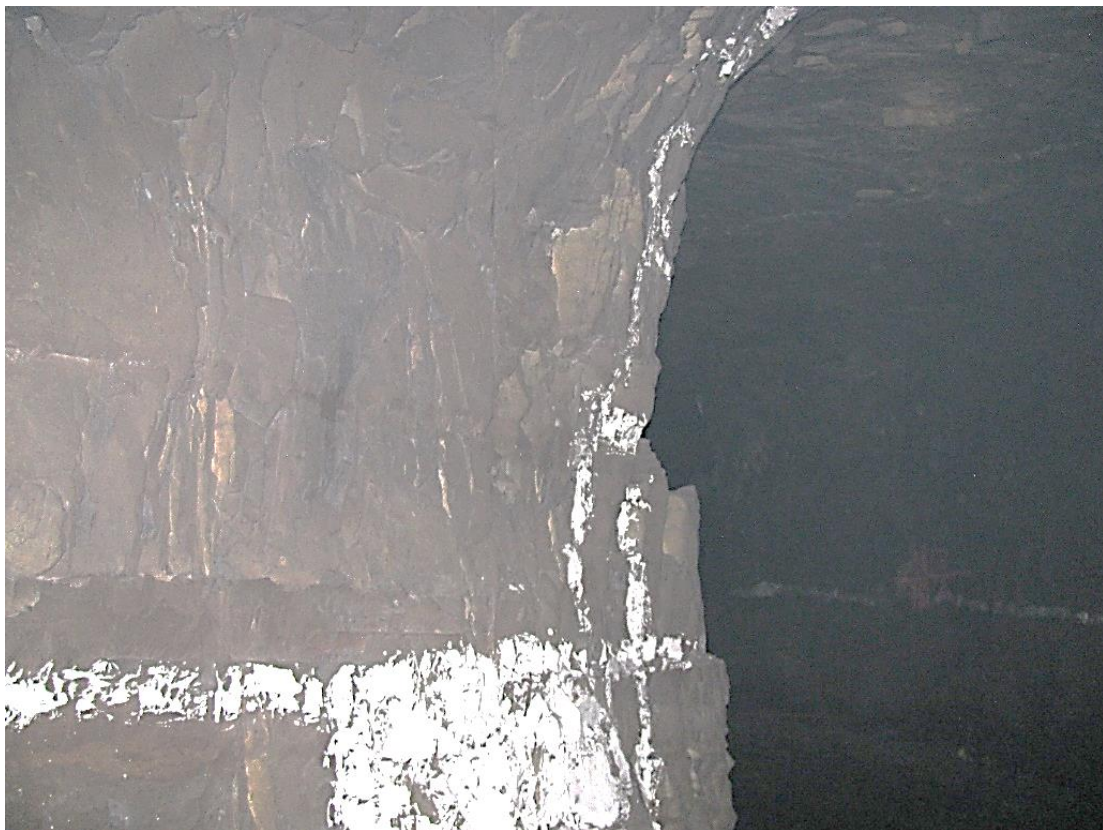
Figure 12-42. Side C of pillar N3_15 at Nchwane III shaft, illustrating the condition of the right-hand corner of the pillar.

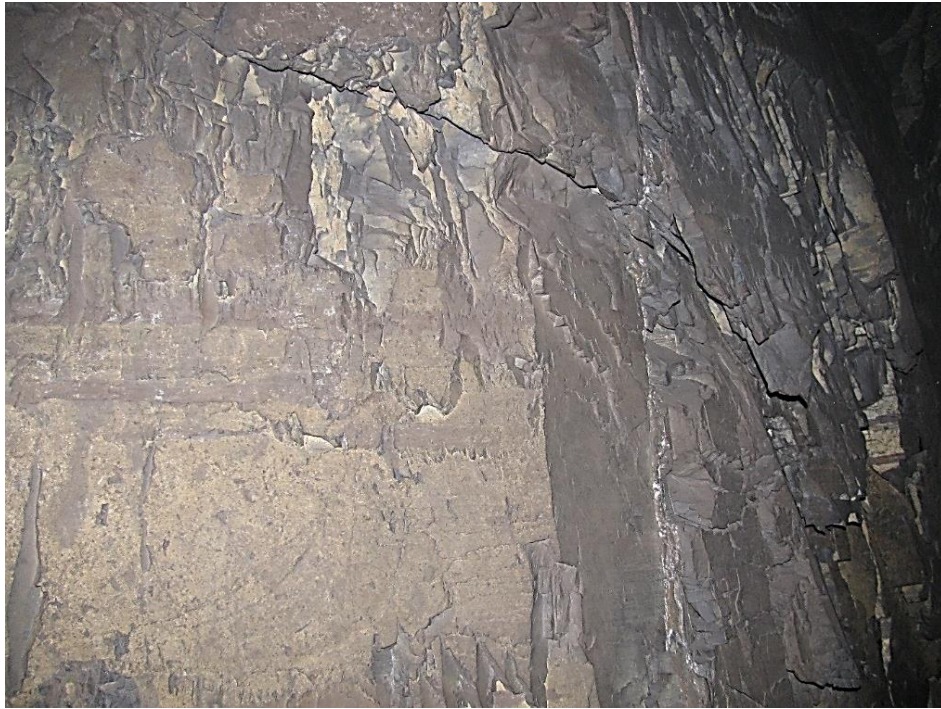
Figure 12-43. Side C of pillar N3_15 at Nchwane III shaft, illustrating the random joint terminating on Side C.

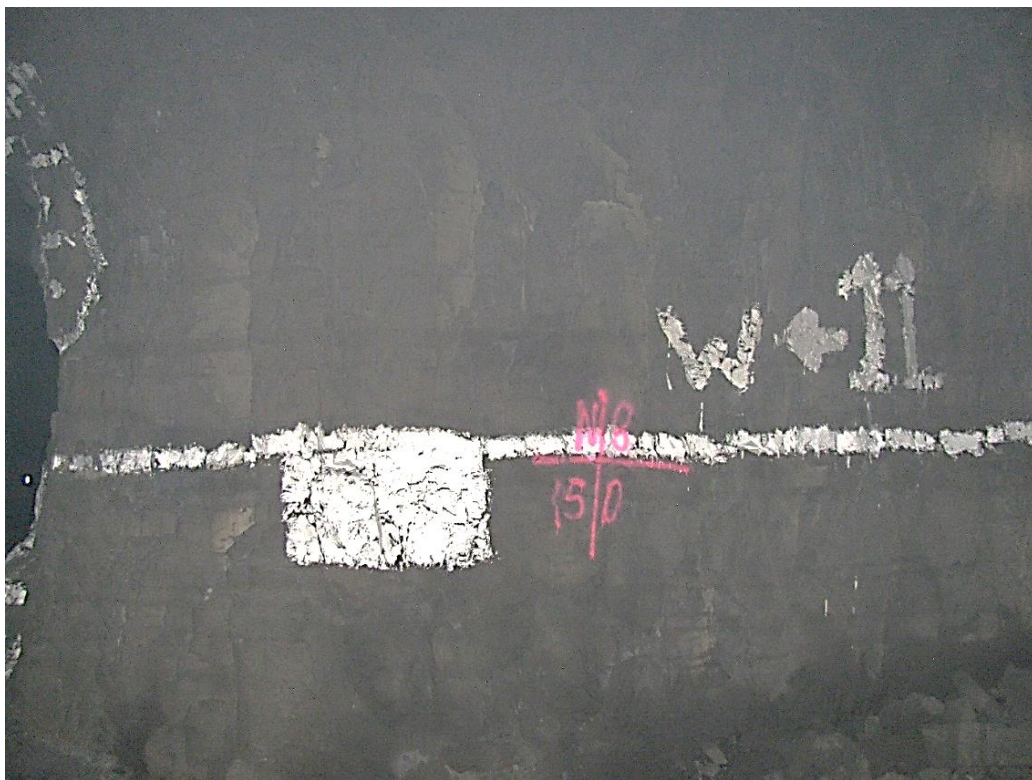
Figure 12-44. Side D of pillar N3_15 at Nchwane III shaft as observed on the 6th of May 2021.

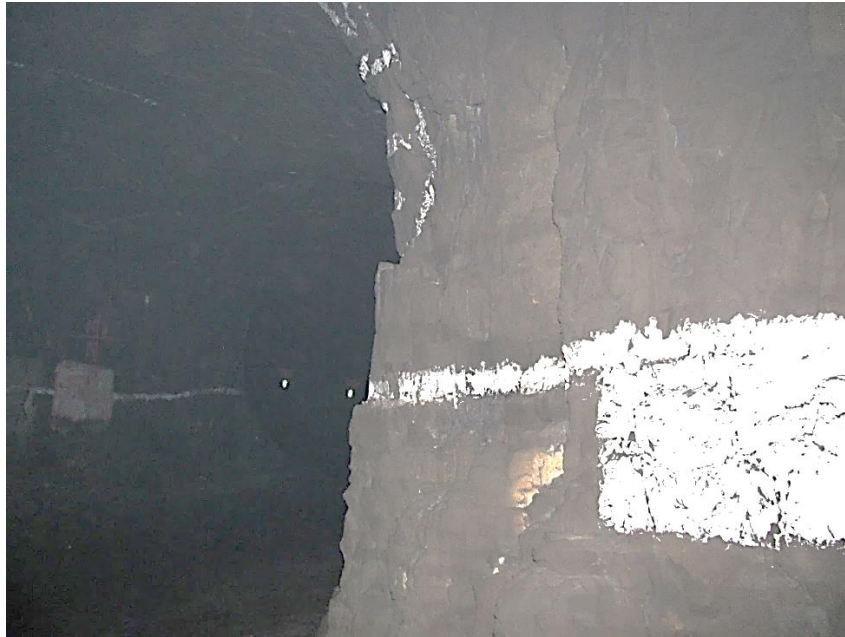
Figure 12-45. Side D of pillar N3_15 at Nchwanning III shaft, illustrating the condition of the left-hand corner of the pillar.

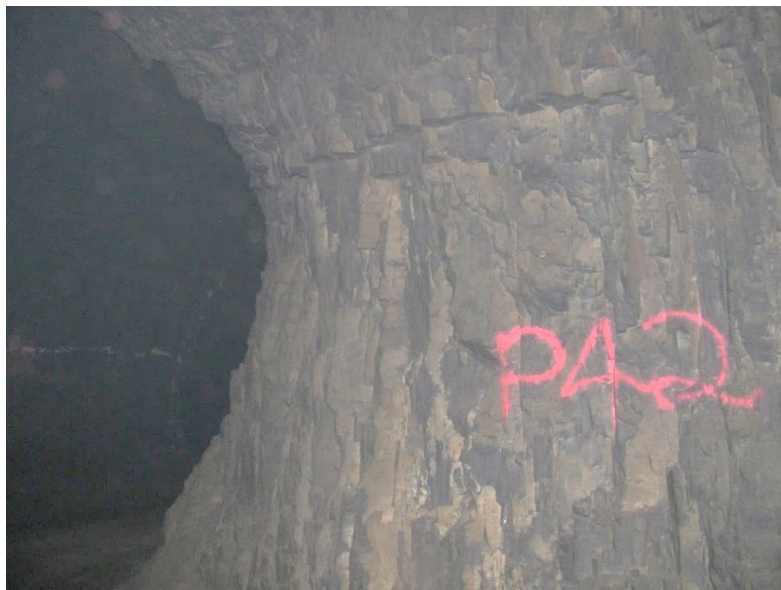
Figure 12-46. Side A of pillar N3_20 at Nchwanning III shaft, illustrating the left-hand corner of the pillar as observed on the 6th of May 2021.

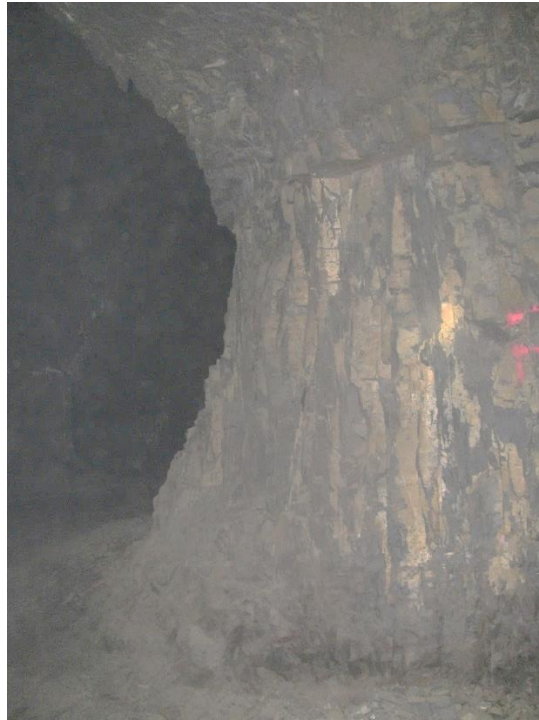
Figure 12-47. Side A of pillar N3_20 at Nchwaning III shaft, illustrating the left-hand corner of the pillar as observed on the 18th of August 2021.

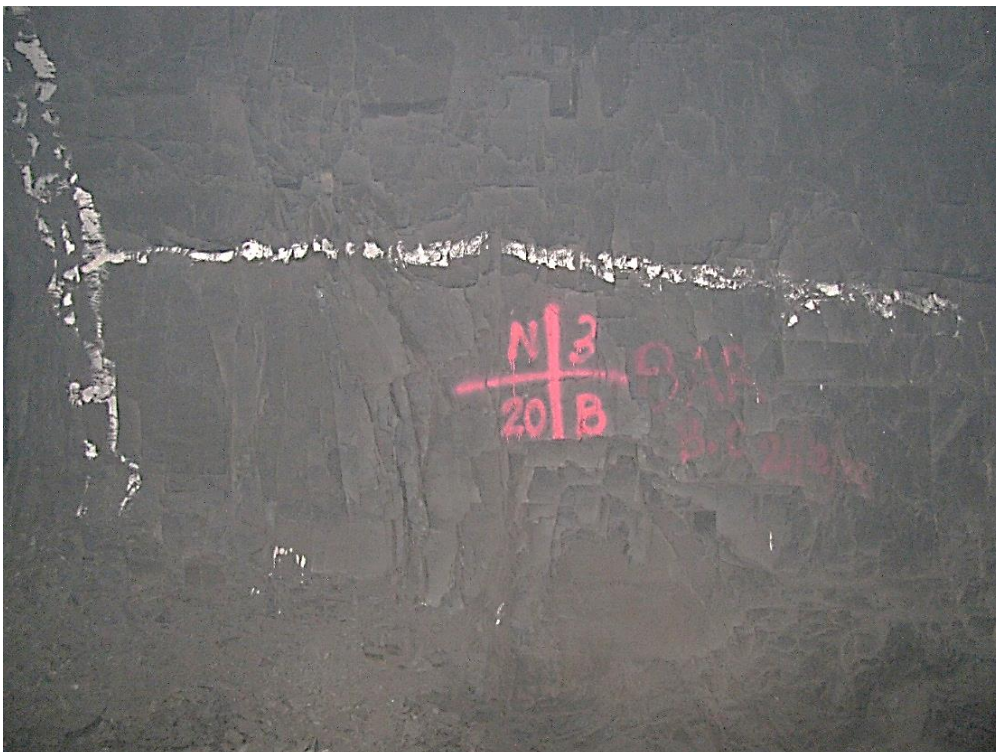
Figure 12-48. Side B of pillar N3_20 at Nchwaning III shaft as observed on the 6th of May 2021.

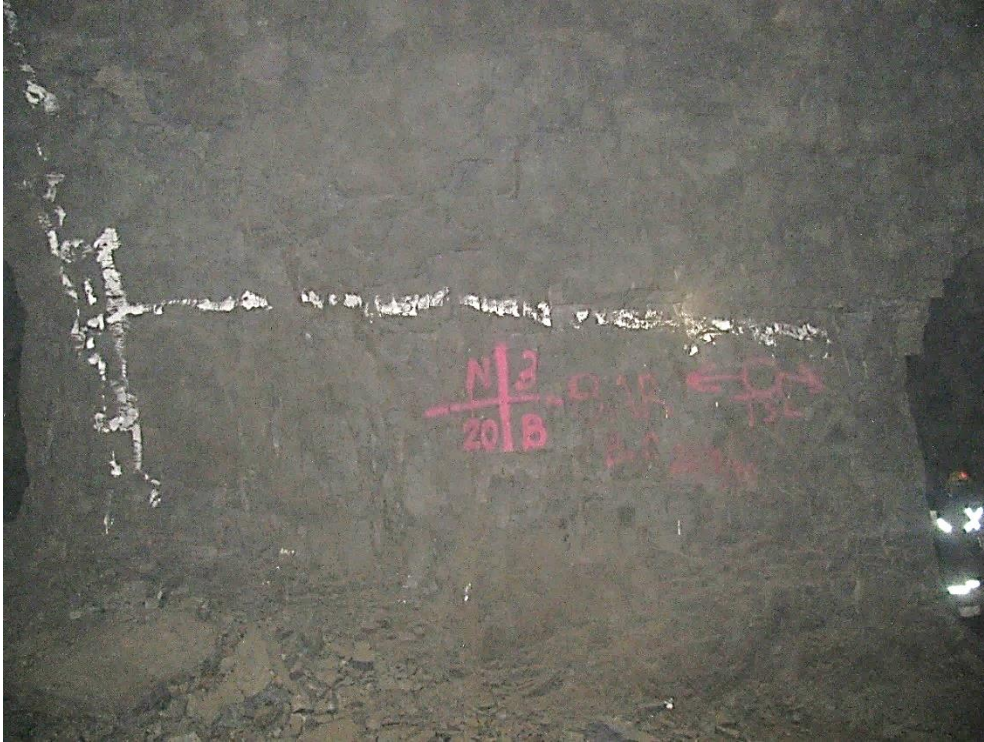
Figure 12-49. Side B of pillar N3_20 at Nchwaning III shaft as observed on the 18th of August 2021.

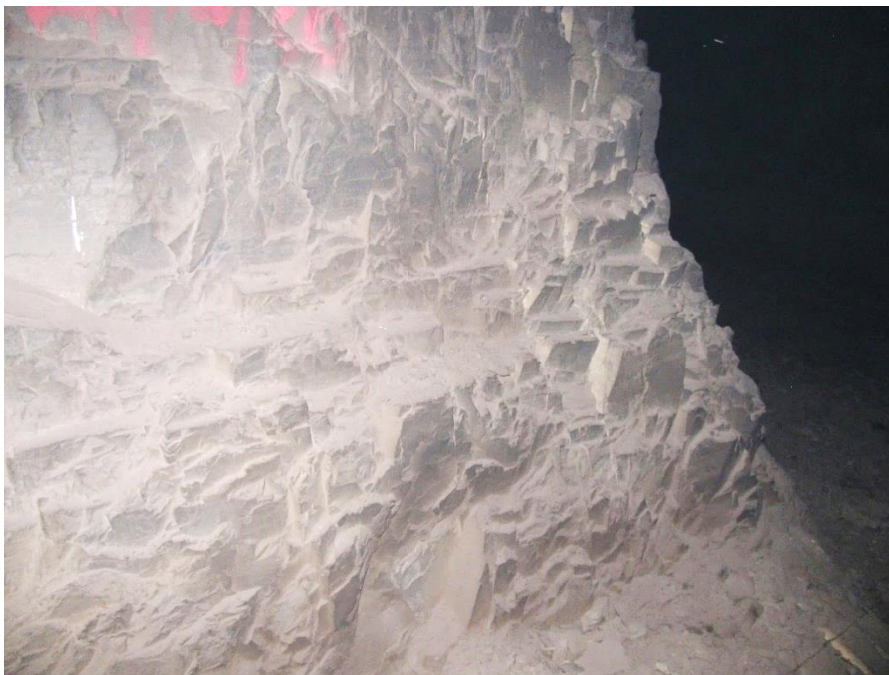
Figure 12-50. Side B of pillar N3_20 at Nchwaning III shaft, illustrating the right-hand corner of the pillar.

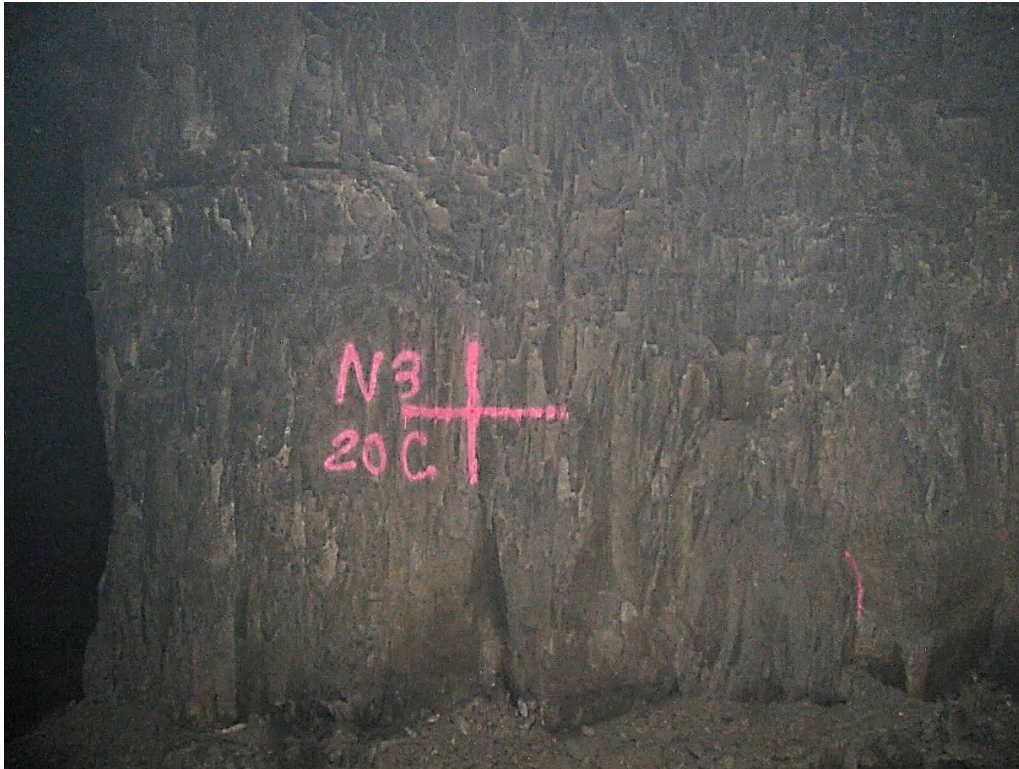
Figure 12-51. Side C of pillar N3_20 at Nchwane III shaft as observed on the 6th of May 2021.

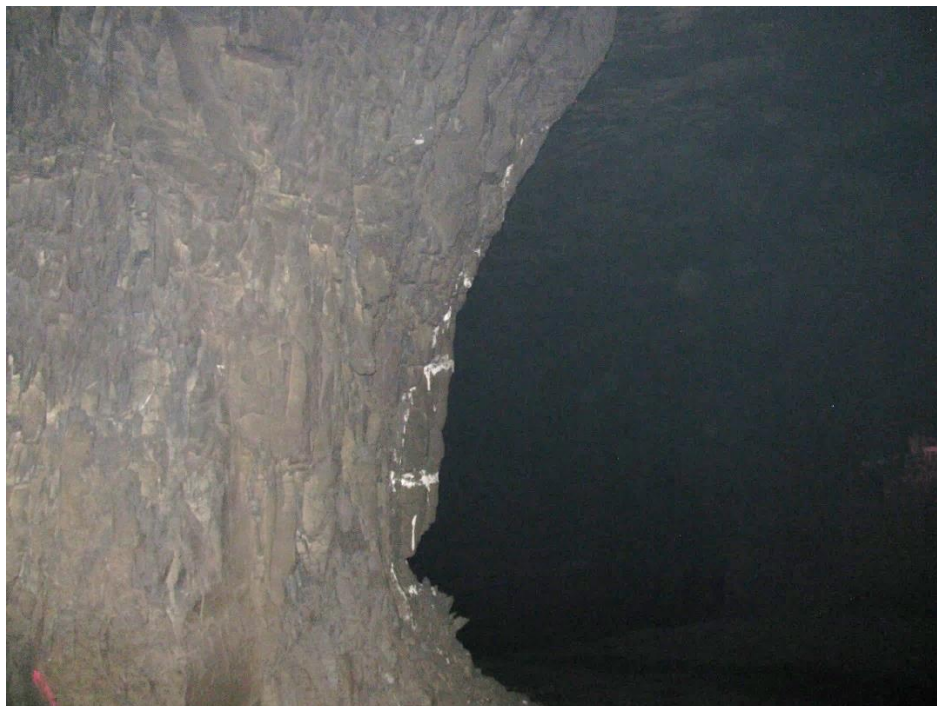
Figure 12-52. Side C of pillar N3_20 at Nchwane III shaft, illustrating the hourglass shape of the corner of the pillar.

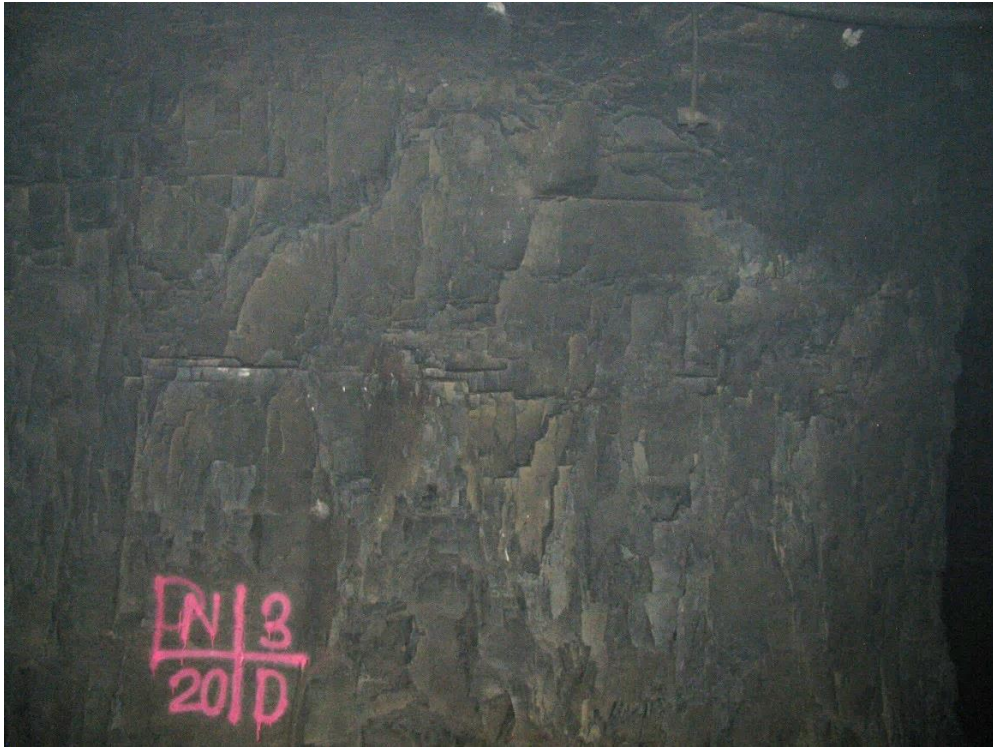
Figure 12-53. Side D of pillar N3_20 at Nchwaning III shaft as observed on the 6th of May 2021.

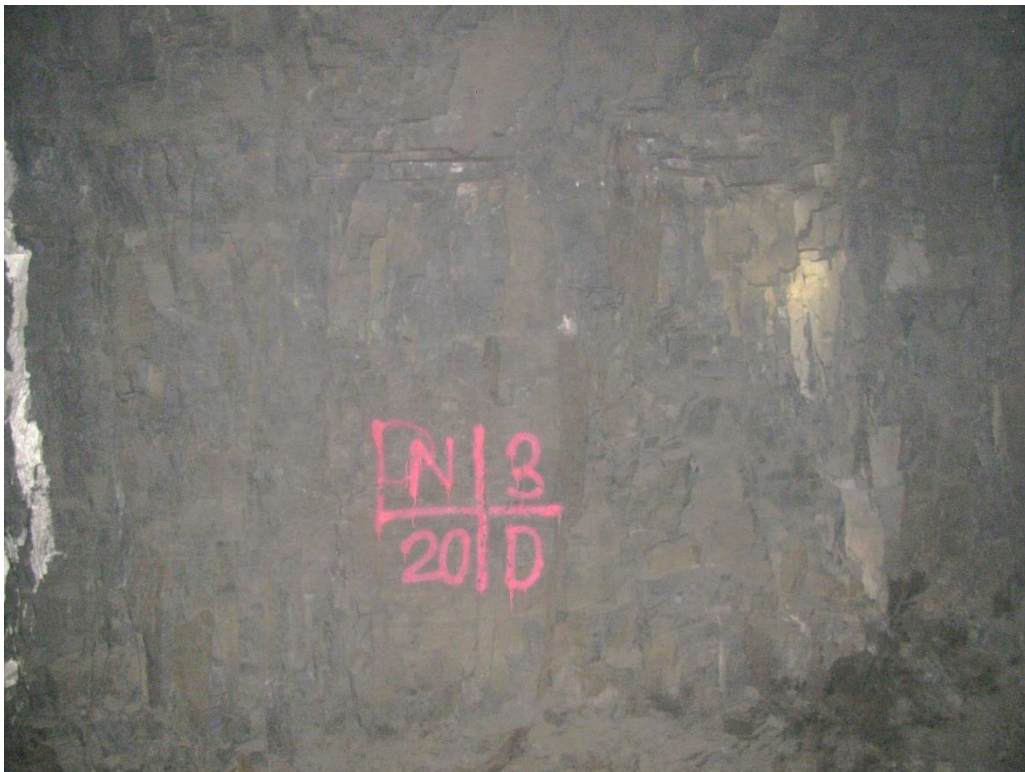
Figure 12-54. Side D of pillar N3_20 at Nchwaning III shaft as observed on the 18th of August 2021.

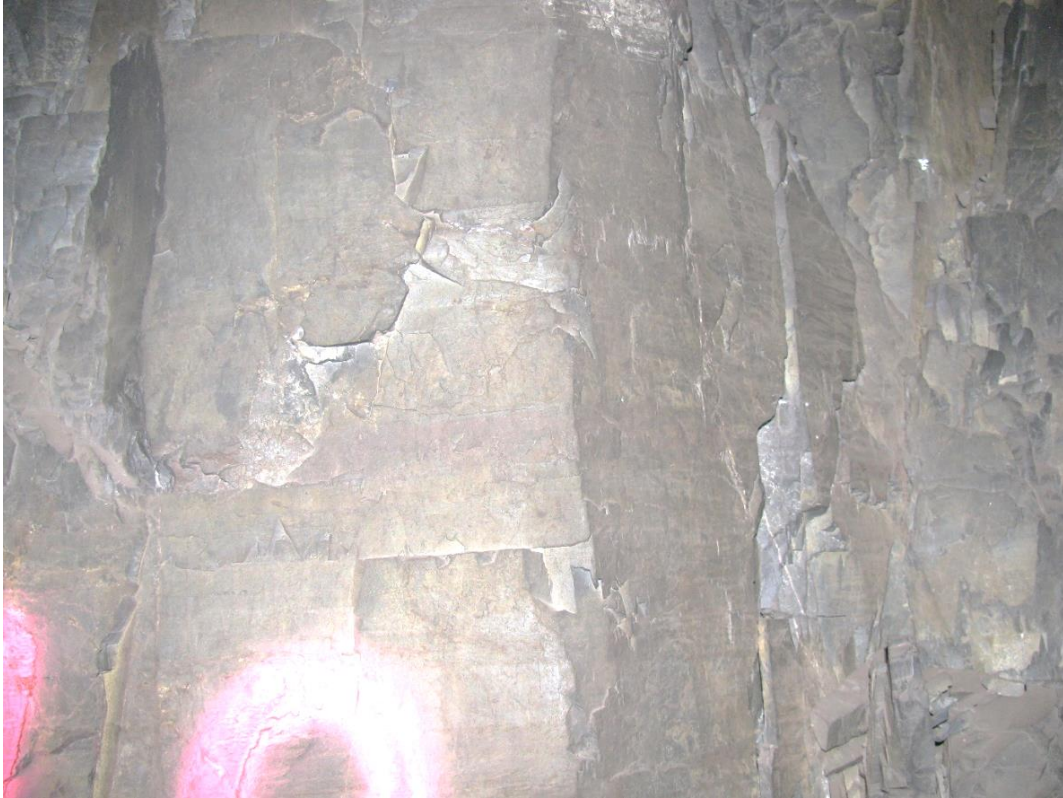
Figure 12-55. Side D of pillar N3_20 at Nchwane III shaft, illustrating the two joint sets.

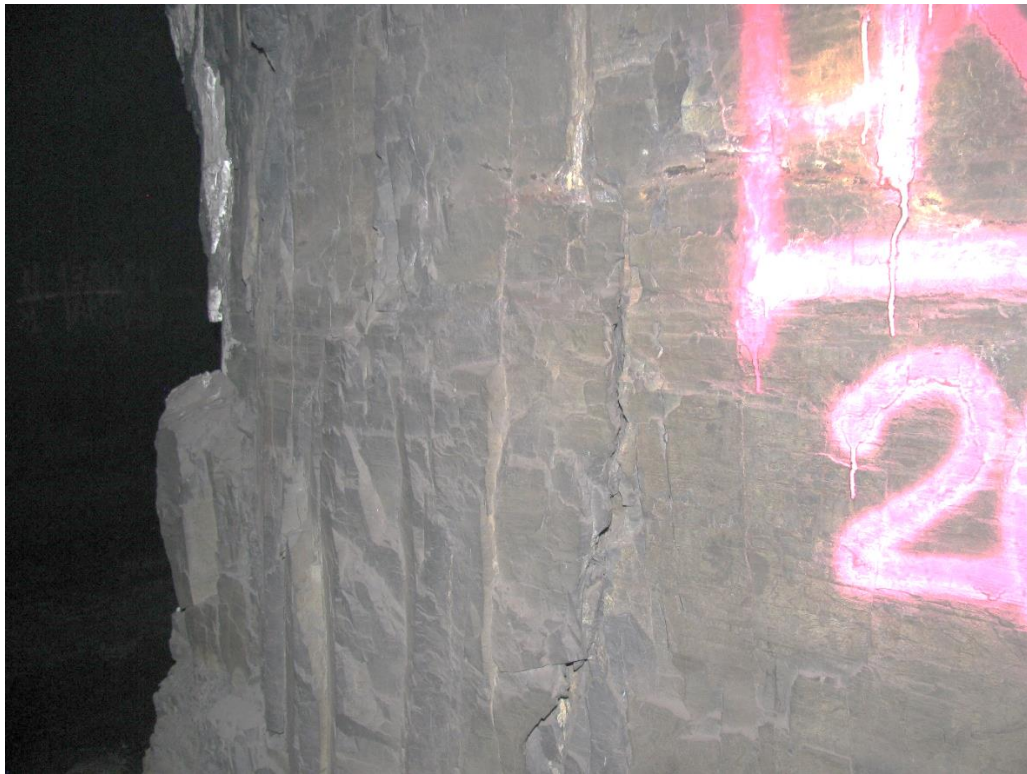
Figure 12-56. Side D of pillar N3_20 at Nchwane III shaft, illustrating the vertical joint opening on the side.

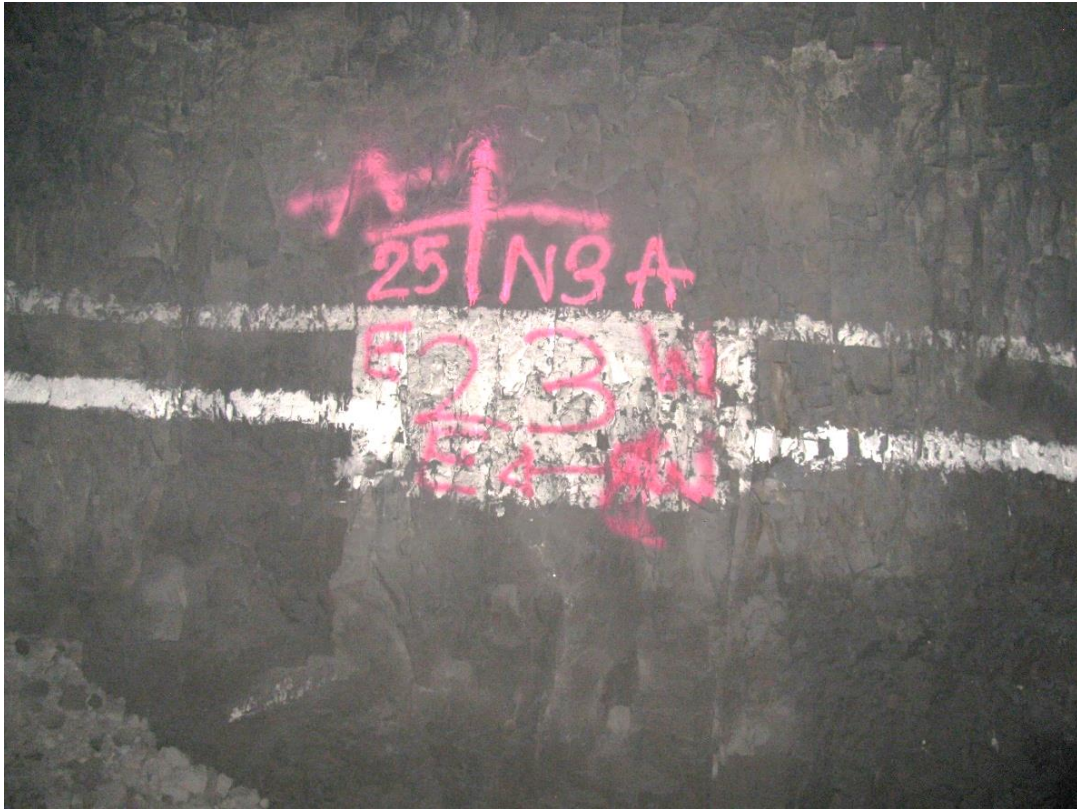
Figure 12-57. Side A of pillar N3_25 at Nchwaning III shaft as observed on the 6th of May 2021.

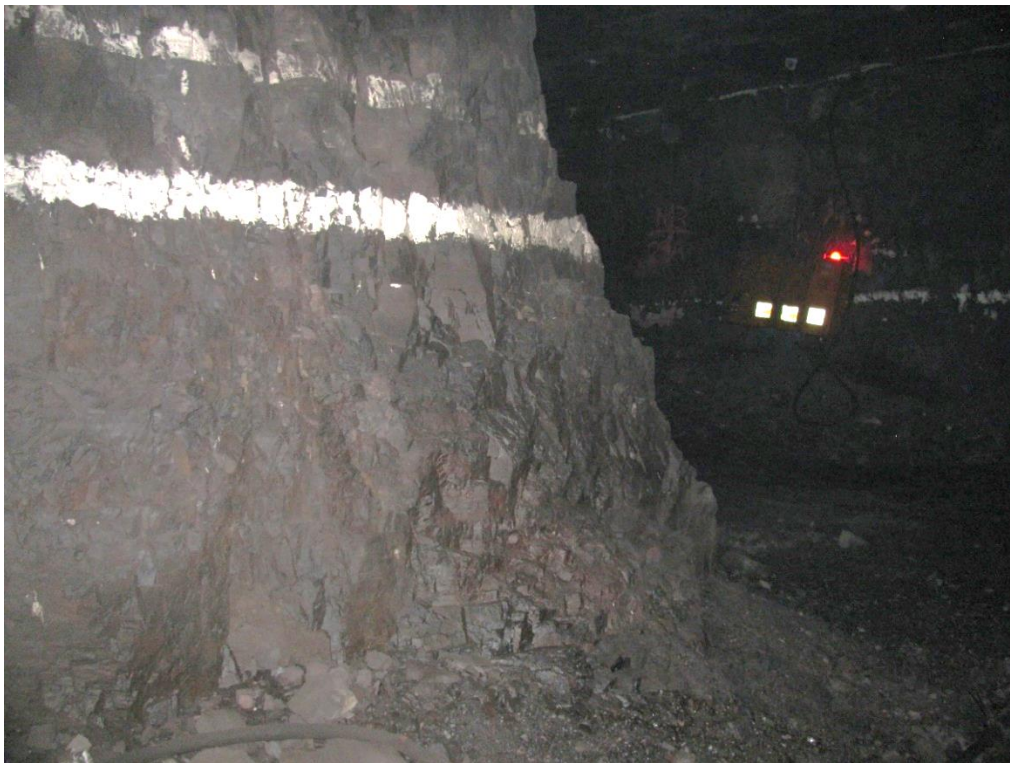
Figure 12-58. Side A of pillar N3_25 at Nchwaning III shaft, illustrating the condition of the right-hand corner of the pillar.

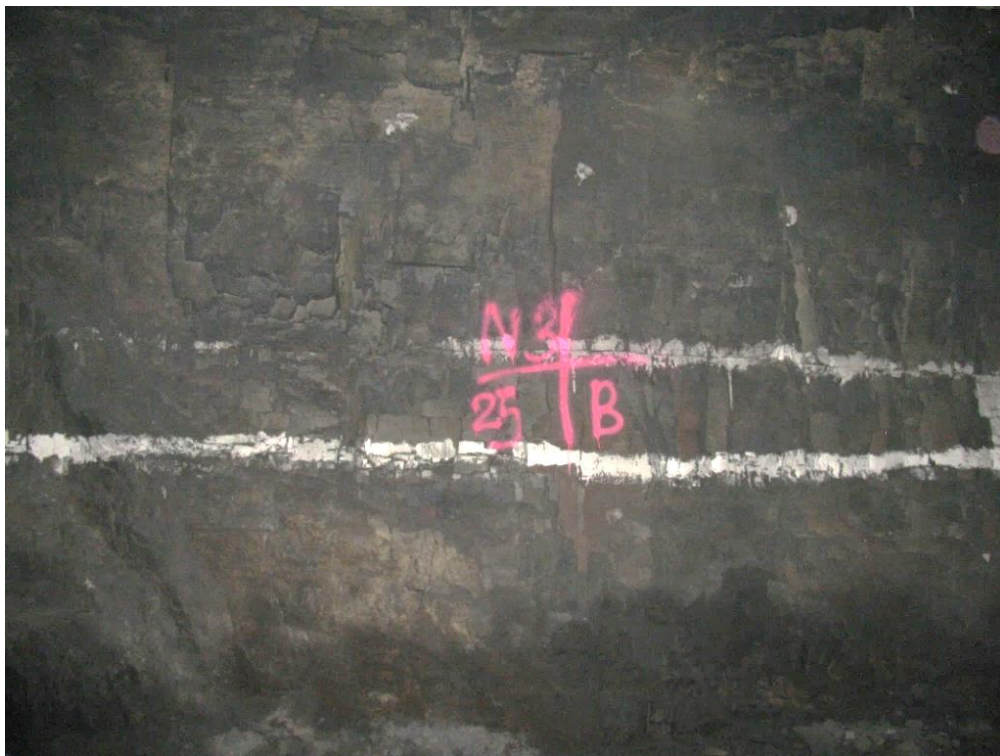
Figure 12-60. Side B of pillar N3_25 at Nchwaning III shaft as observed on the 6th of May 2021.

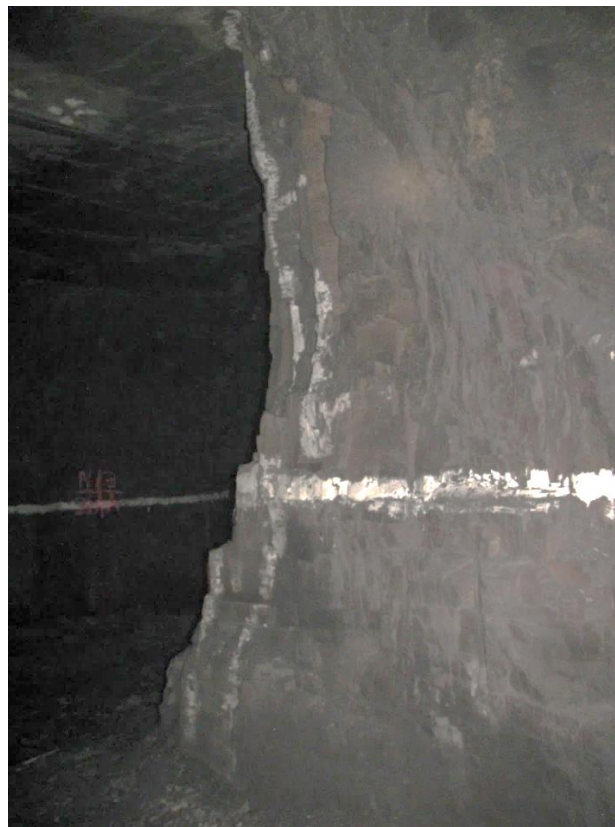
Figure 12-62. Side B of pillar N3_25 at Nchwaning III shaft, illustrating the hourglass shape on the left-hand corner of the pillar.

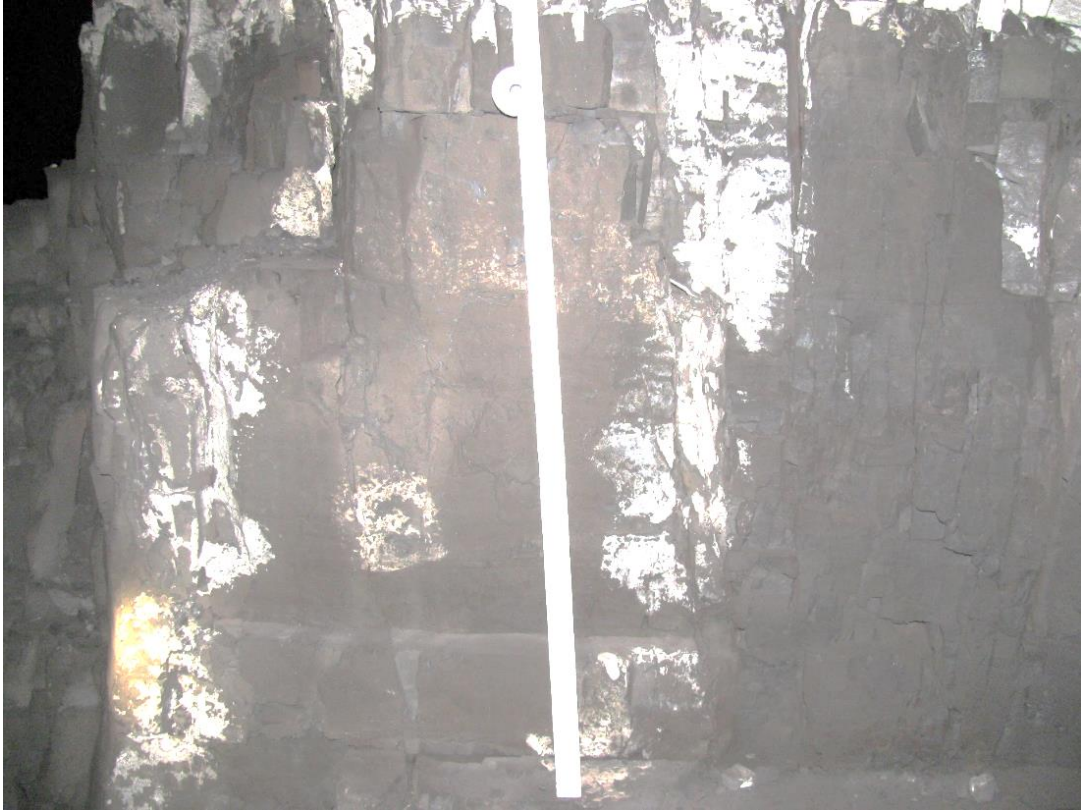
Figure 12-63. Side B of pillar N3_25 at Nchwaning III shaft, illustrating the horizontal joint spacing.

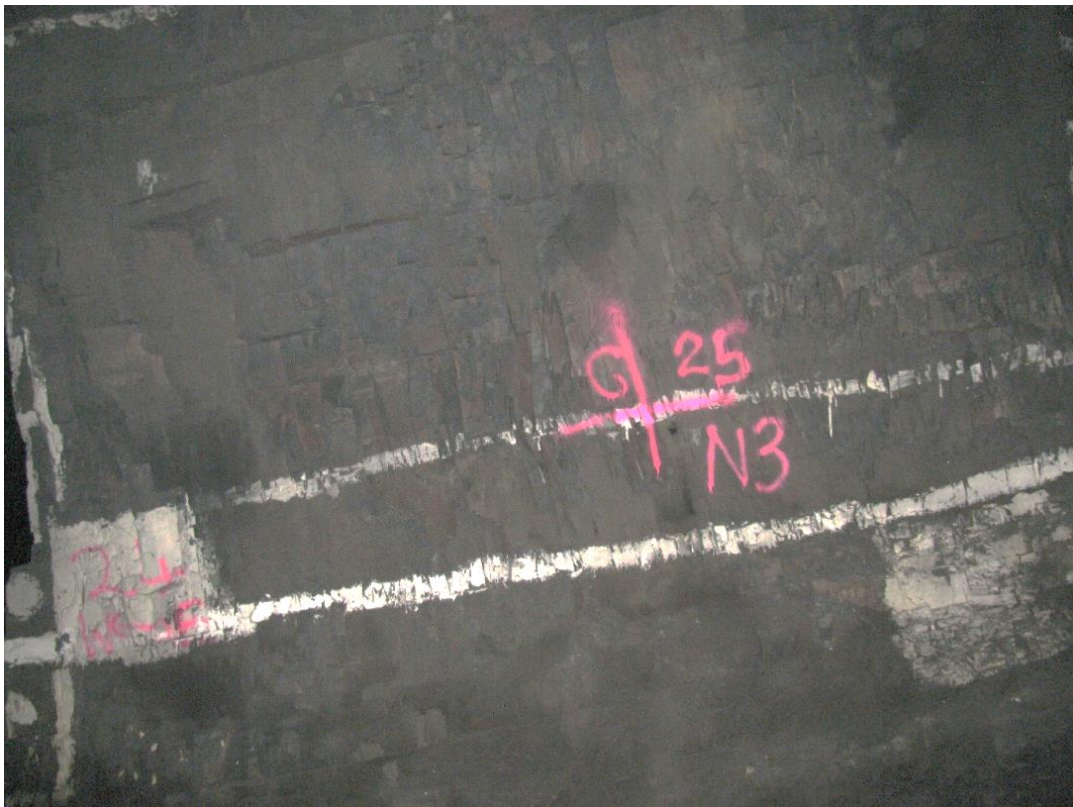
Figure 12-64. Side C of pillar N3_25 at Nchwaning III shaft as observed on the 6th of May 2021.

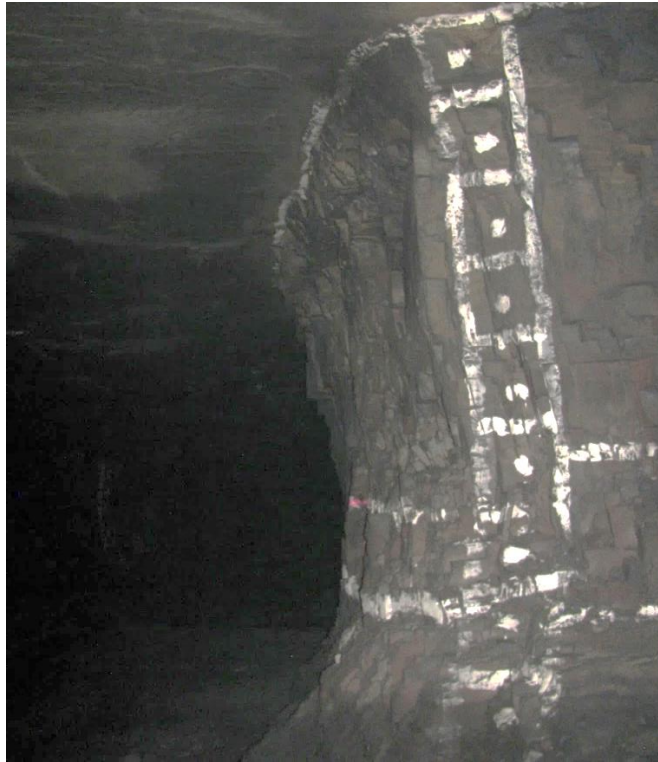
Figure 12-65. Side D of pillar N3_25 at Nchwaning III shaft, illustrating the left-hand corner of the pillar and no additional scaling of the corners was observed.

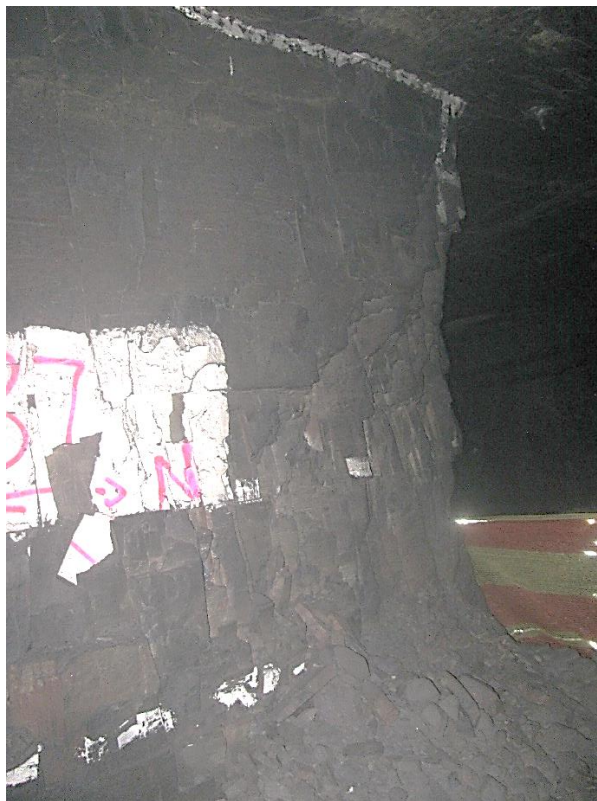
Figure 12-66. Side D of pillar N3_25 at Nchwaning III shaft, illustrating the right-hand corner of the pillar and no additional scaling of the corners was observed on the 18th of August 2021.

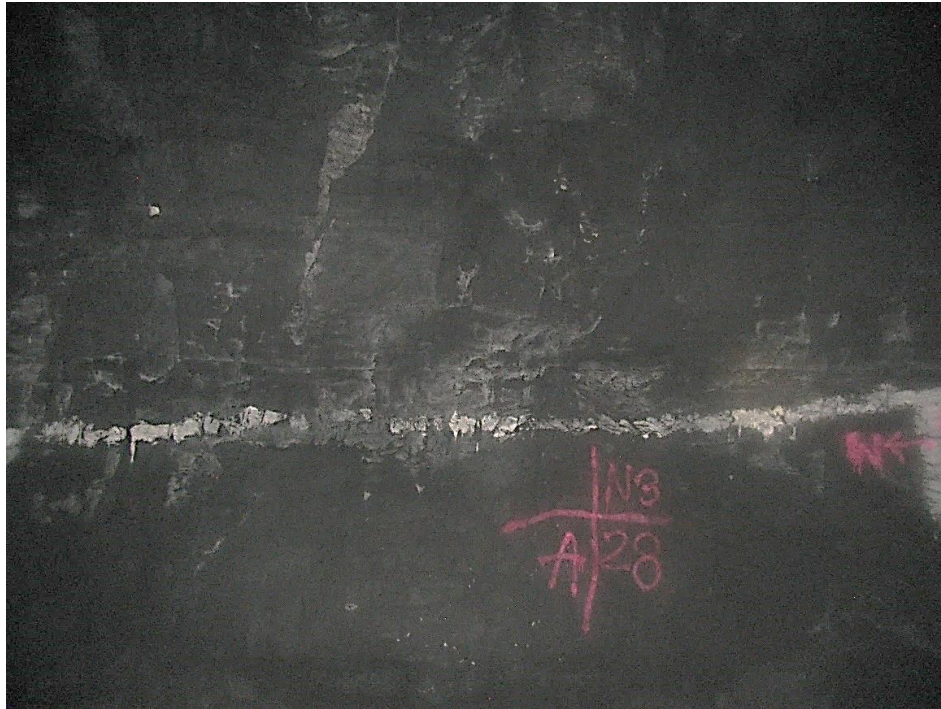
Figure 12-67. Side A of pillar N3_28 at Nchwane III shaft as observed on the 17th of May 2021.

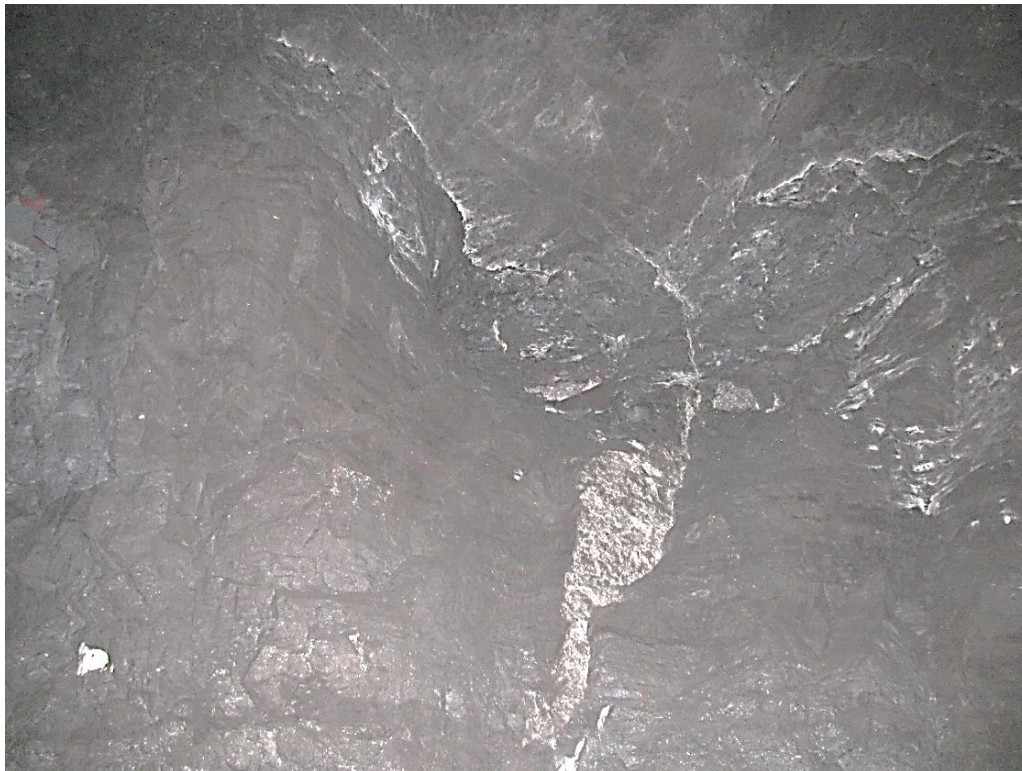
Figure 12-68. Side A of pillar N3_28 at Nchwane III shaft, illustrating the contact between the sidewall and the hanging wall.

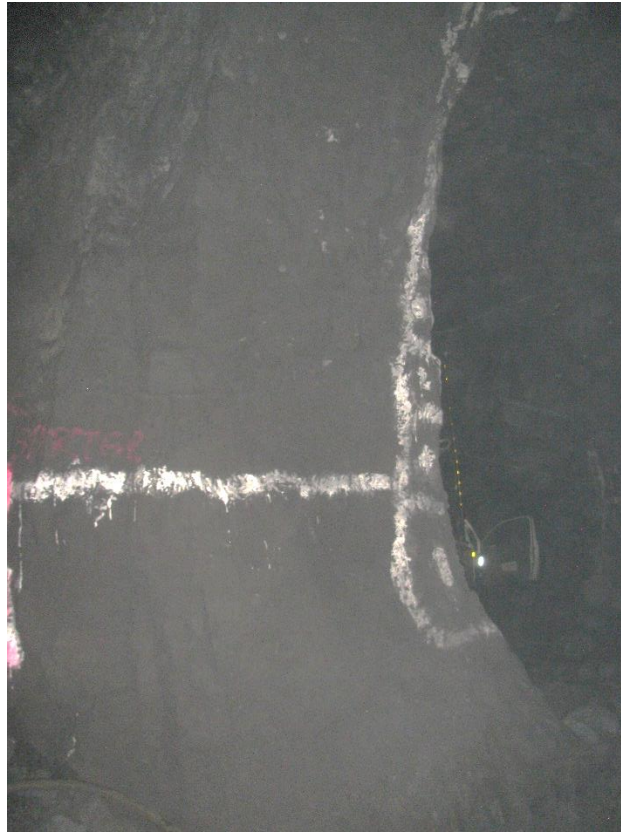
Figure 12-71. Side B of pillar N3_28 at Nchwaning III shaft, illustrating the left-hand side of the pillar as observed on the 18th of August 2021.

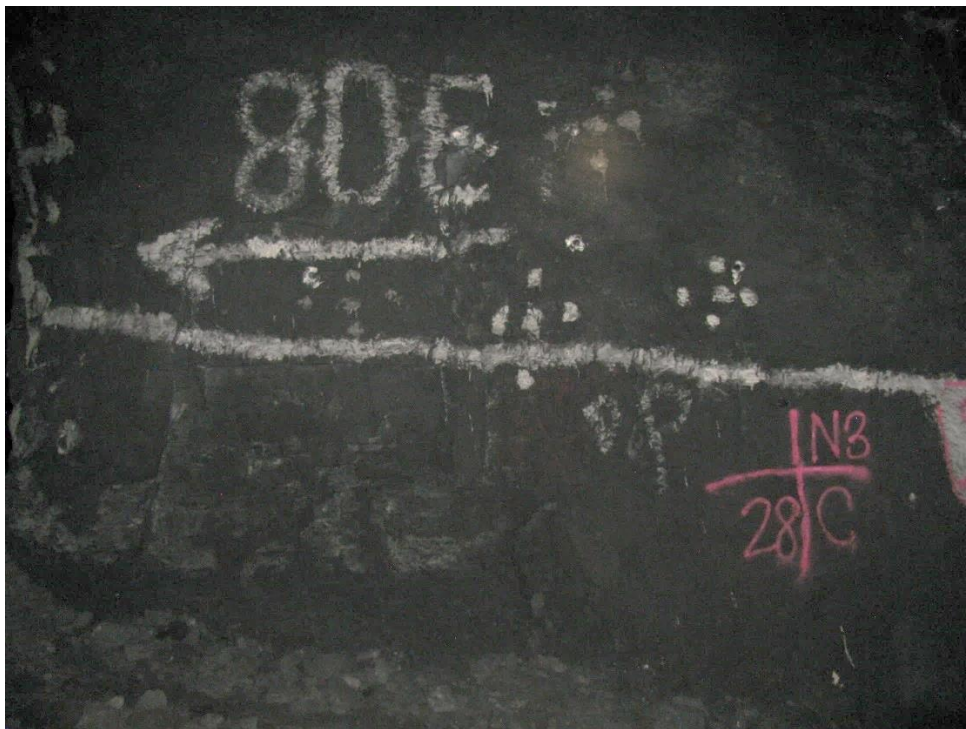
Figure 12-72. Side C of pillar N3_28 at Nchwaning III shaft as observed on the 17th of May 2021.

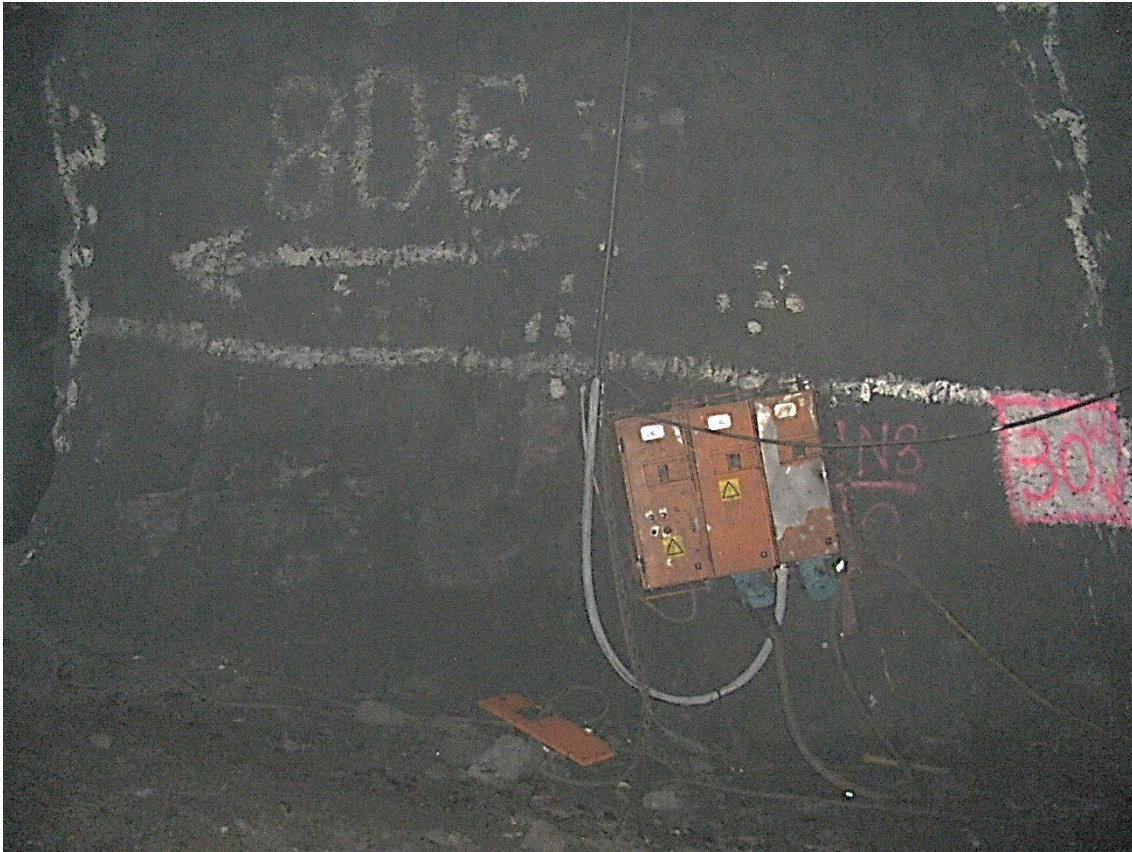
Figure 12-73. Side C of pillar N3_28 at Nchwane III shaft as observed on the 18th of August 2021.

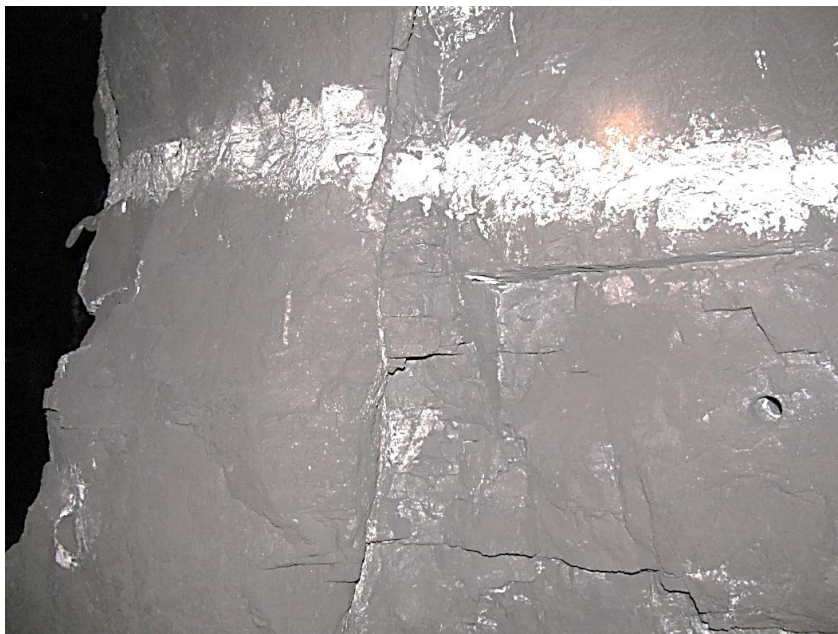
Figure 12-74. Side C of pillar N3_28 at Nchwane III shaft, illustrating the vertical and horizontal joint sets.

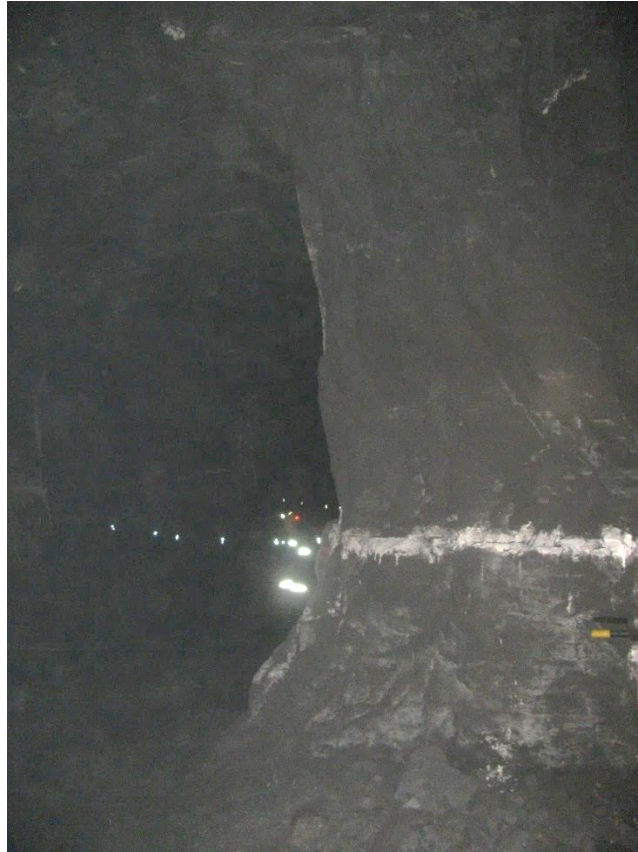
Figure 12-75. Side D of pillar N3_28 at Nchwaning III shaft, illustrating the left-hand corner of the pillar as observed on the 18th of August 2021.

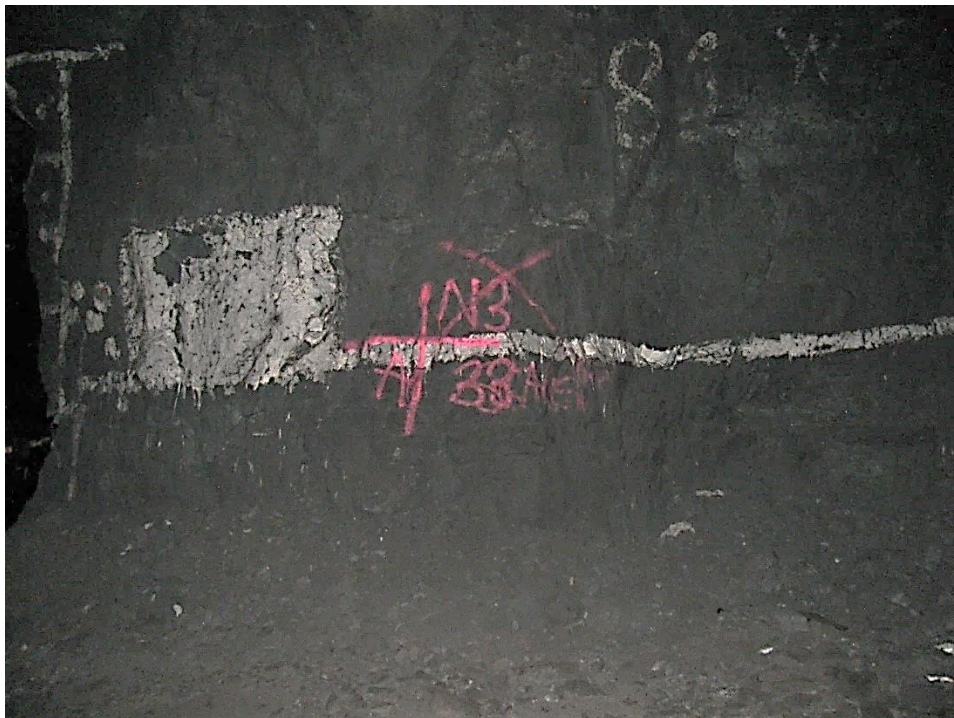
Figure 12-76. Side A of pillar N3_33 at Nchwaning III shaft as observed on the 17th of May 2021.
