A REVIEW OF THE PILLAR DESIGN METHODOLOGY FOR MANGANESE MINING OPERATIONS IN SOUTH AFRICA

M.Eng (Mining Engineering)

IN THE FACULTY OF ENGINEERING, BUILT ENVIRONMENT AND
INFORMATION TECHNOLOGY
DEPARTMENT OF MINING ENGINEERING
UNIVERSITY OF PRETORIA

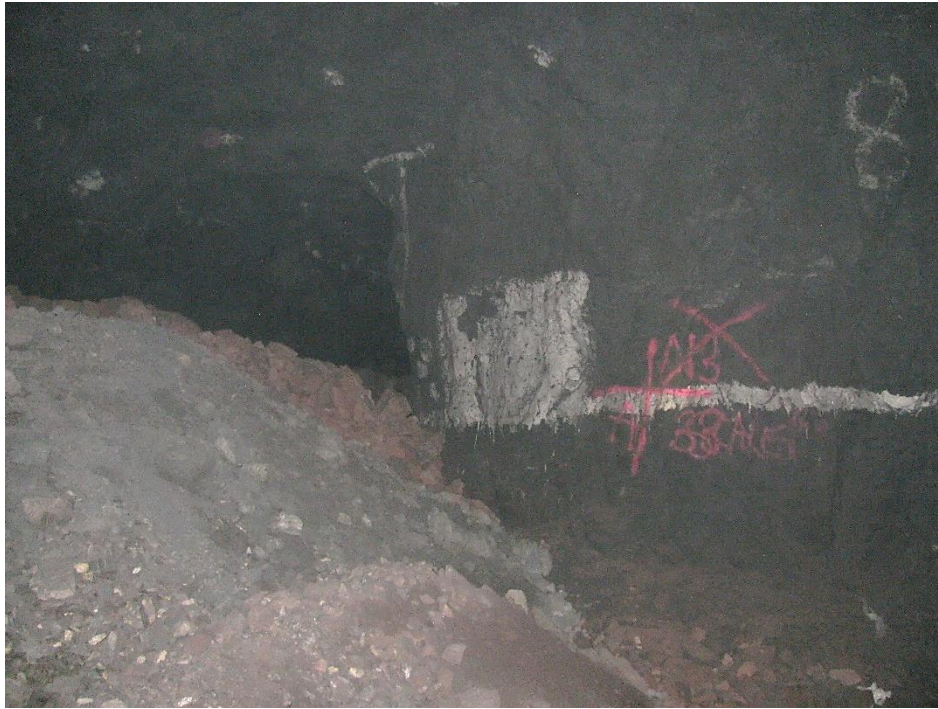
Figure 12-77. Side A of pillar N3_33 at Nchwaning III shaft as observed on the 18th of August 2021.

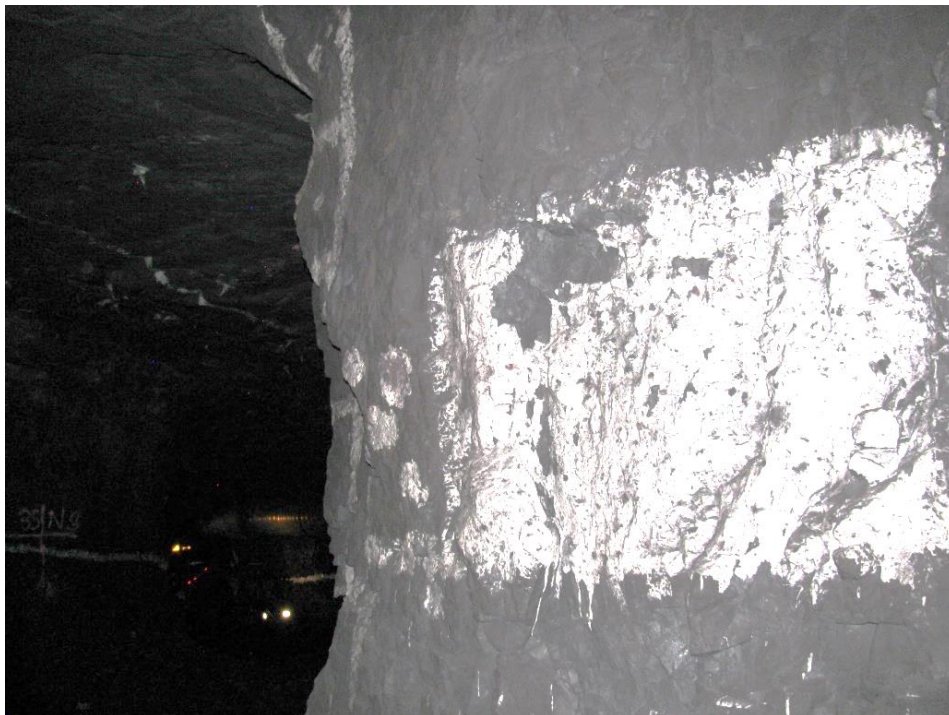
Figure 12-78. Side A of pillar N3_33 at Nchwaning III shaft, illustrating the left-hand corner of the pillar still in very good condition.

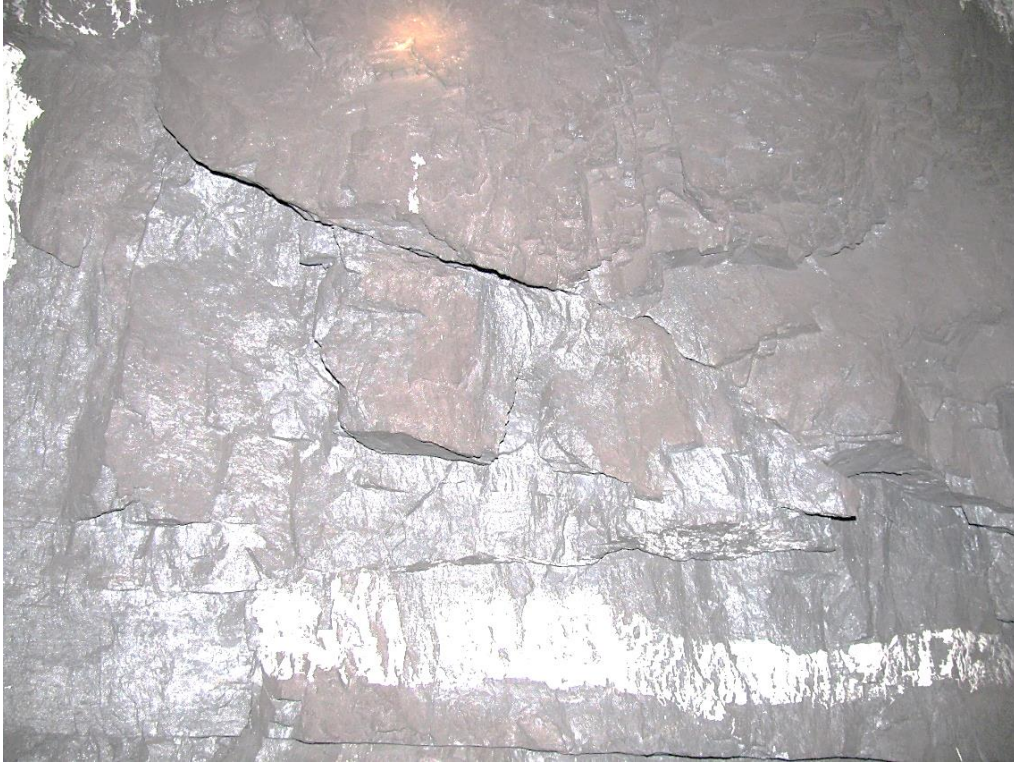
Figure 12-79. Side B of pillar N3_33 at Nchwaning III shaft, illustrating the horizontal joint set.

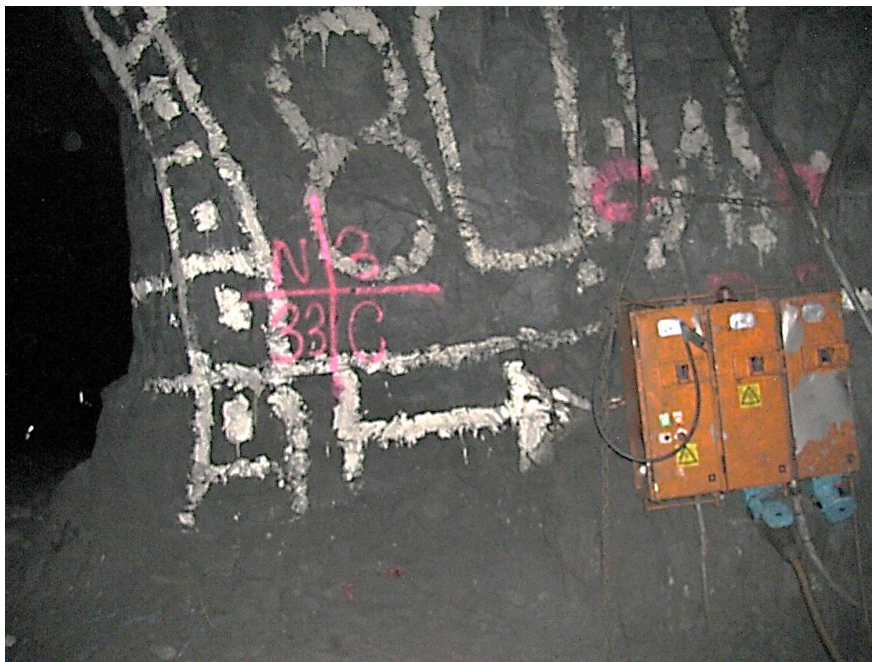
Figure 12-80. Side C of pillar N3_33 at Nchwaning III shaft as observed on the 17th of May 2021.

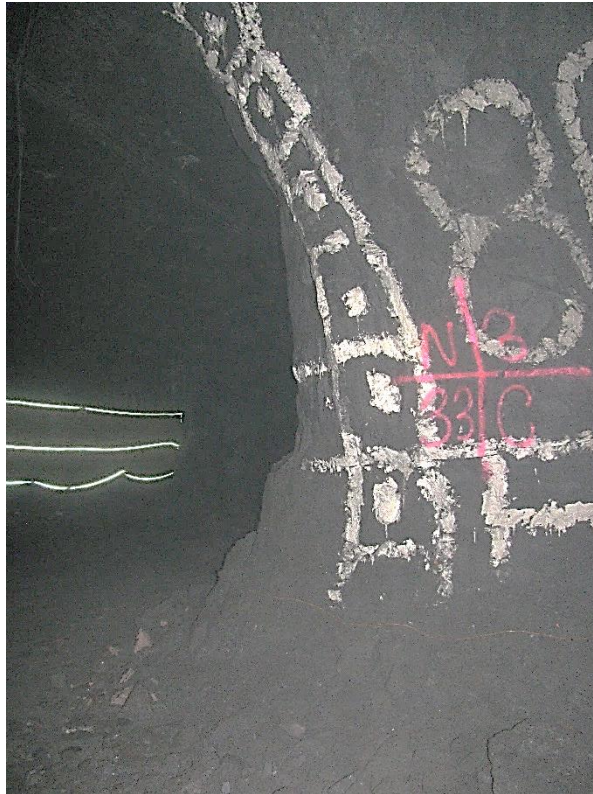
Figure 12-81. Side C of pillar N3_33 at Nchwaning III shaft as observed on the 18th of August 2021.

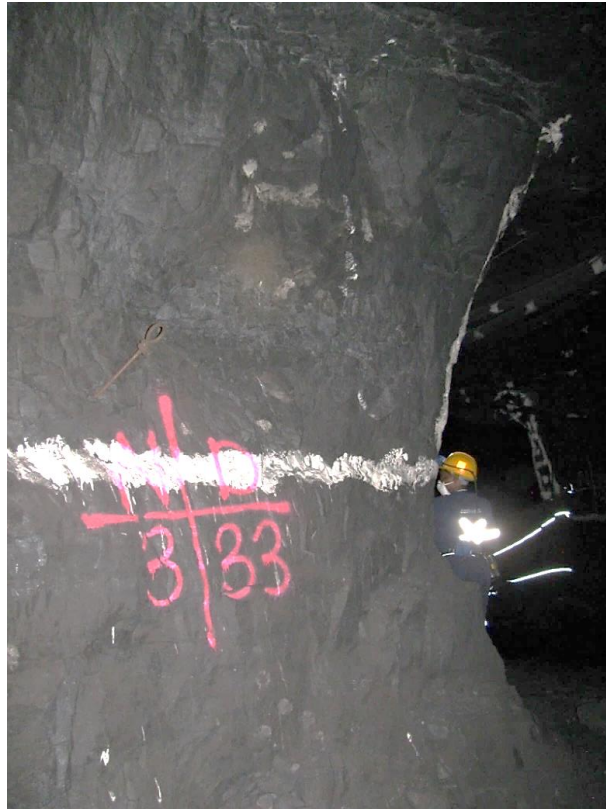
Figure 12-83. Side D of pillar N3_33 at Nchwaneing III shaft, illustrating the right-hand corner of the pillar as observed on the 17th of May 2021.

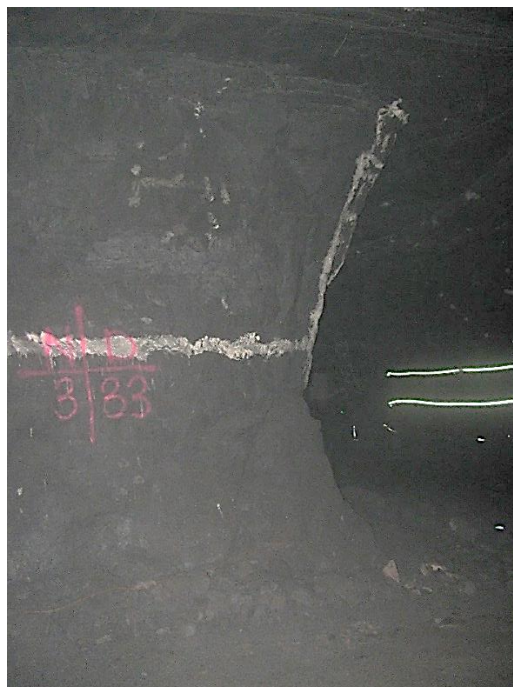
Figure 12-84. Side D of pillar N3_33 at Nchwaneing III shaft, illustrating the right-hand corner of the pillar as observed on the 18th of August 2021.

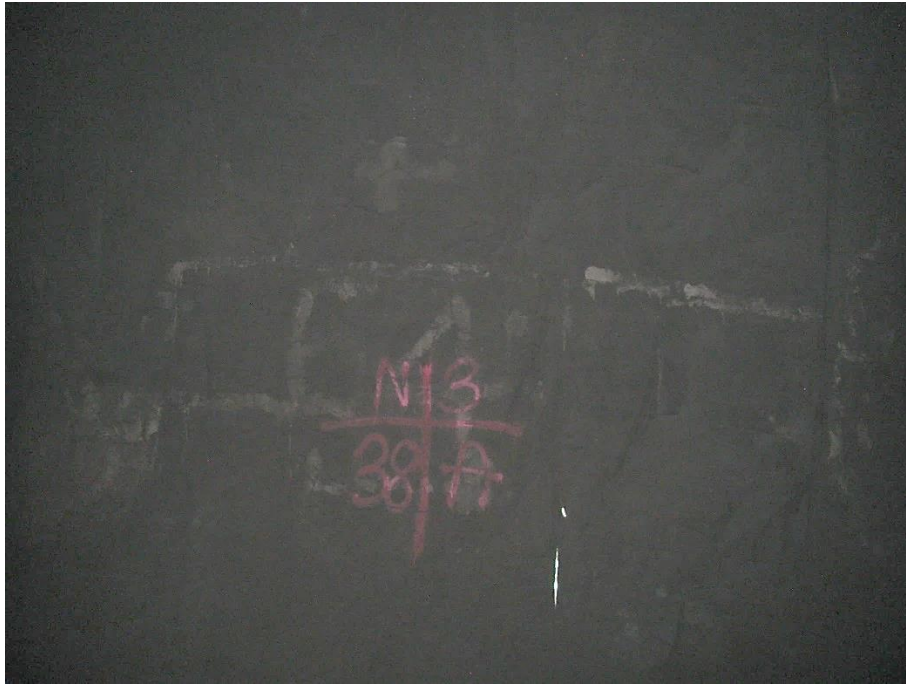
Figure 12-85. Side A of pillar N3_38 at Nchwaning III shaft as observed on the 18th of May 2021.

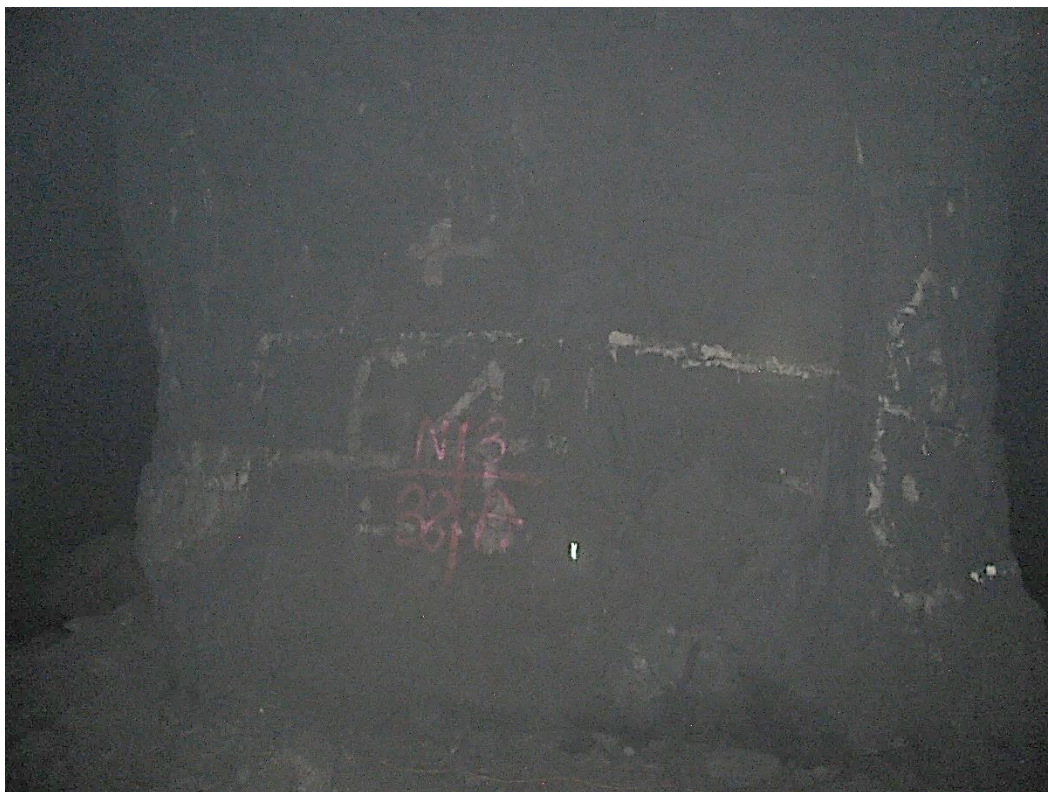
Figure 12-86. Side A of pillar N3_38 at Nchwaning III shaft as observed on the 18th of August 2021.

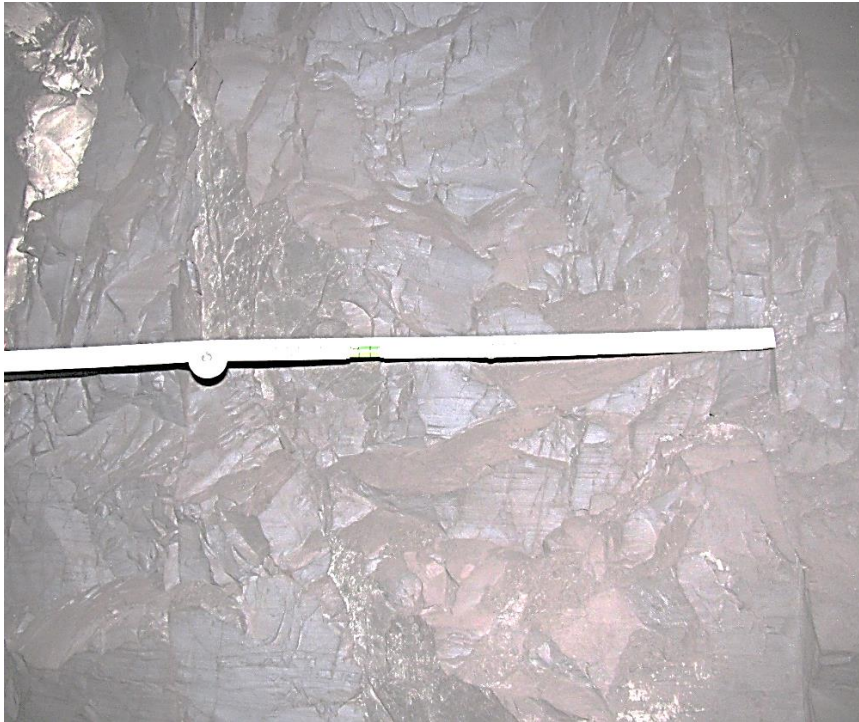
Figure 12-87. Side A of pillar N3_38 at Nchwaning III shaft, illustrating the vertical joint spacing of the pillar.

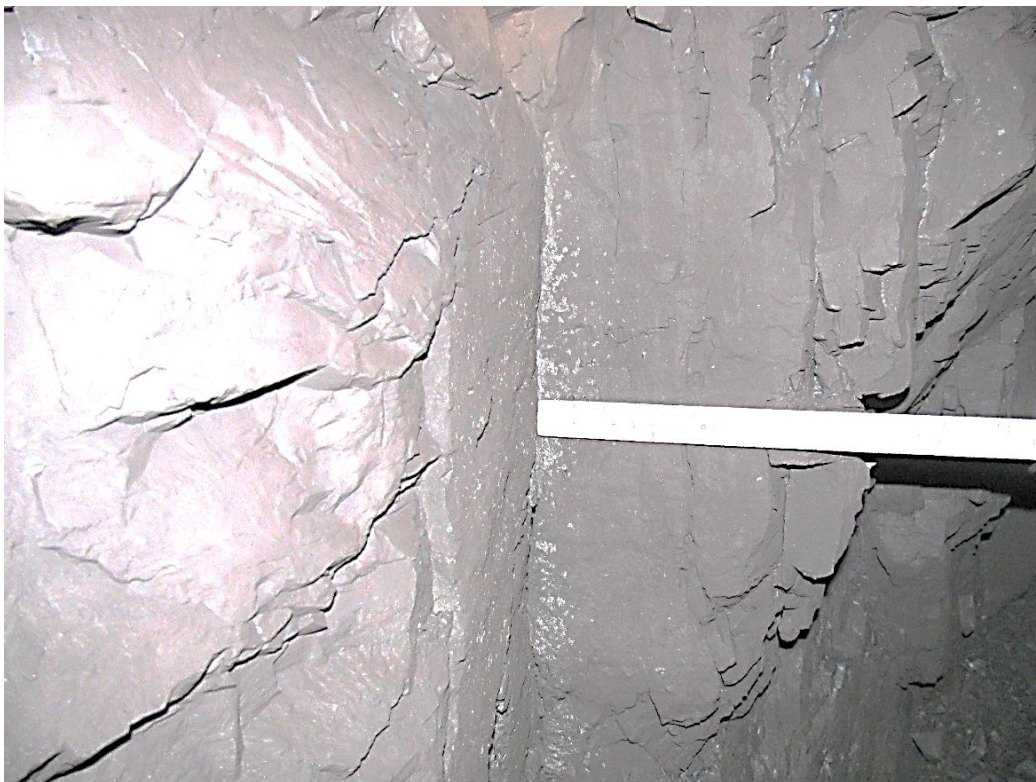
Figure 12-90. Side C of pillar N3_38 at Nchwaning III shaft, illustrating the vertical joint spacing on the edge of the pillar.

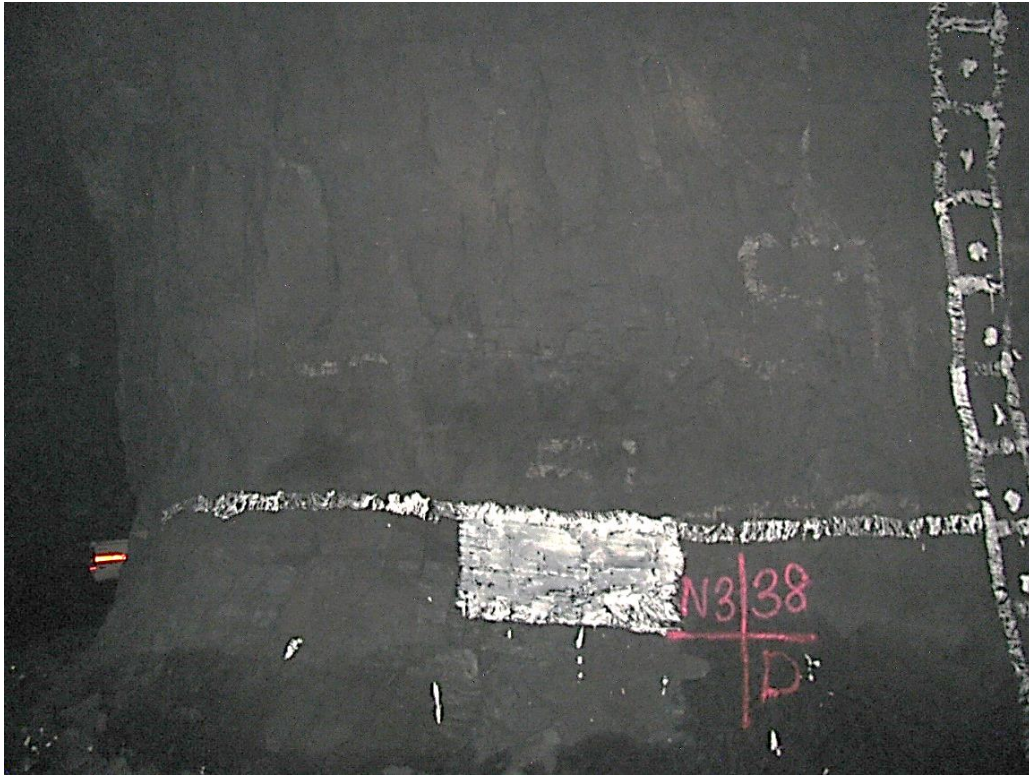
Figure 12-91. Side D of pillar N3_38 at Nchwaning III shaft as observed on the 18th of May 2021.

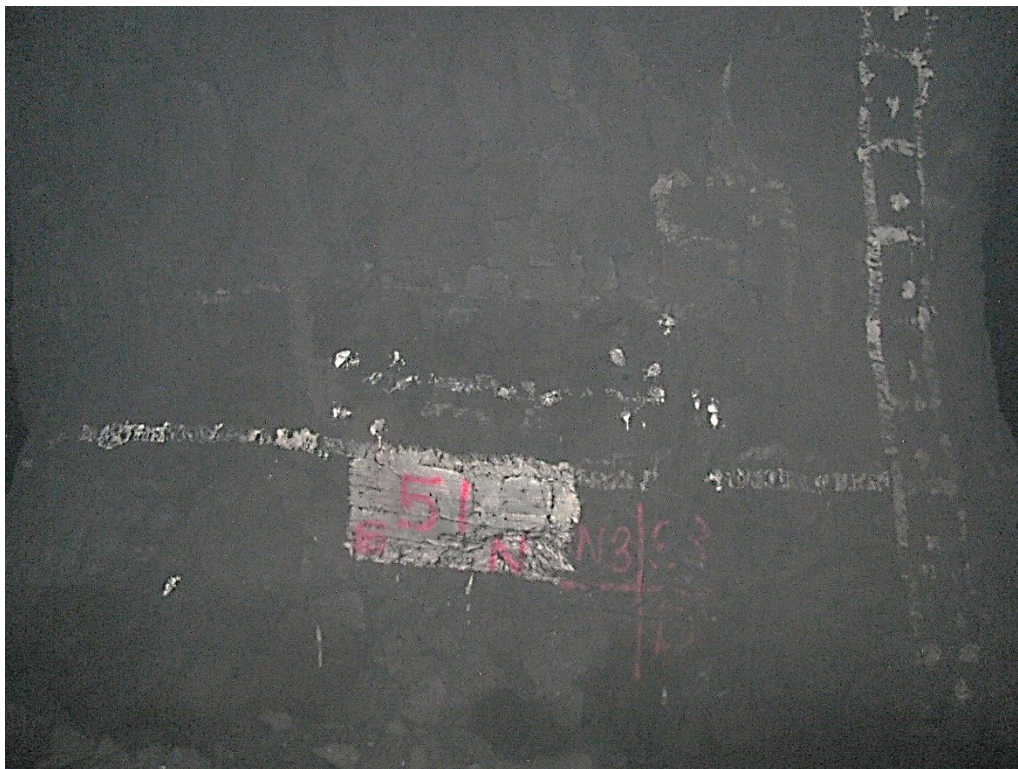
Figure 12-92. Side D of pillar N3_38 at Nchwaning III shaft as observed on the 18th of August 2021.

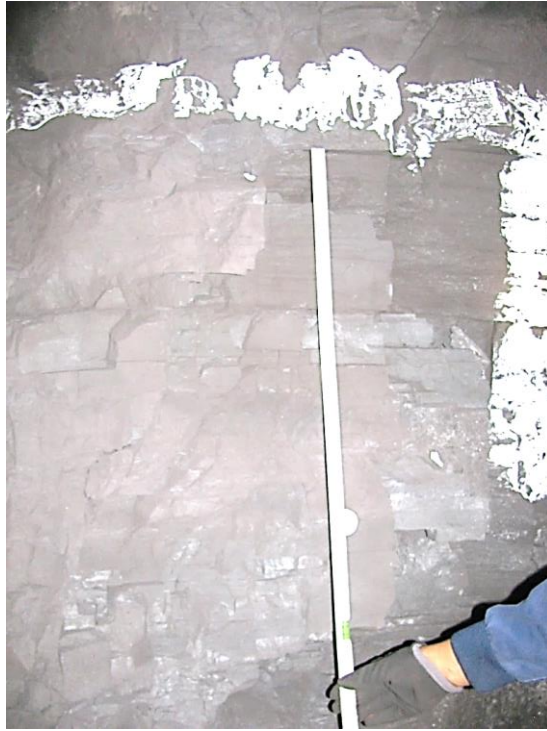
Figure 12-93. Side D of pillar N3_38 at Nchwaning III shaft, illustrating the horizontal joint spacing.
