# **Back-analysis and design review of a failed slope at an open-pit coal mine, Mpumalanga, South Africa**

Submitted in fulfilment of the requirements for the degree

Magister Scientiae: Engineering Geology

University of Pretoria

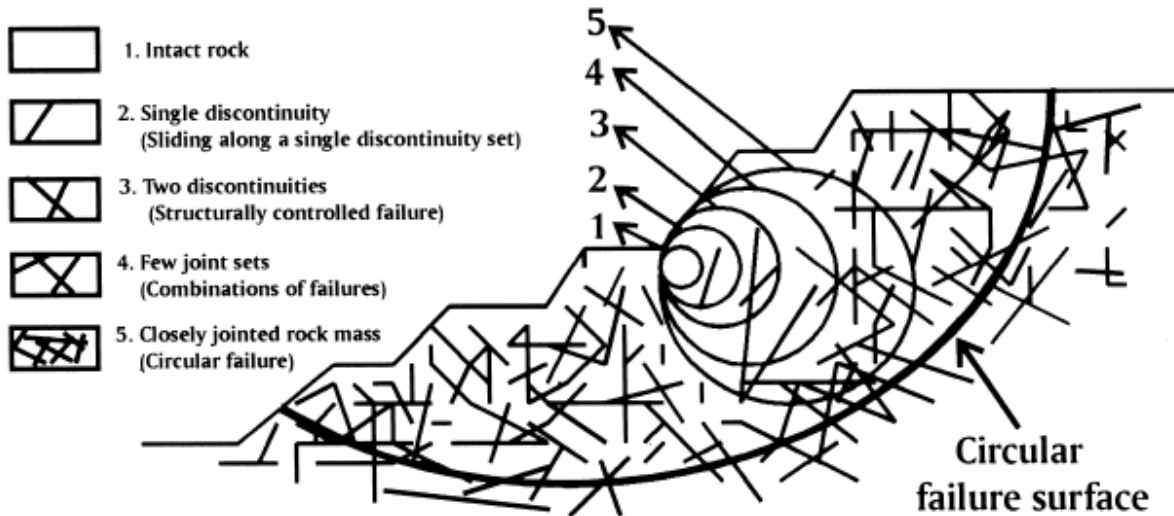
Figure 1: Effect of scale on rock strength and possible mechanisms of failure in rock slopes (Sonmez et al., 1998)

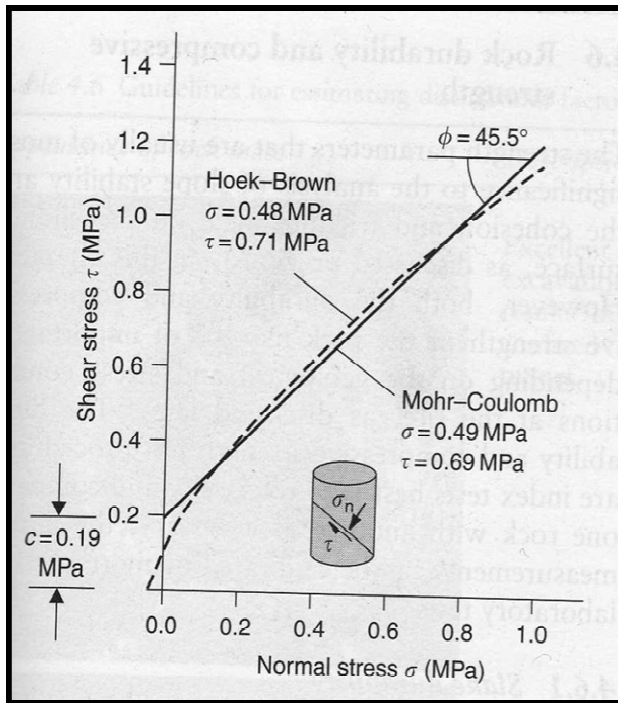
Figure 5: Non-linear Mohr envelope for fractured rock mass defined by equations 5 and 6; best fit line shows cohesion and friction angle for applicable slope height. Rock mass parameters:  $\sigma_c = 30\text{MPa}$ ,  $\text{GSI} = 50$ ,  $m_i = 10$ ,  $D = 0.7$ ,  $H = 20\text{m}$ ,  $\gamma = 0.026\text{MN/m}^3$  (Wyllie and Mah, 2004, based on Hoek et al., 2002)

This results in the following equations for the angle of friction  $\Phi'$  and cohesive strength  $c'$  (Figure 5): (Wyllie and Mah, 2004, based on Hoek et al, 2002)

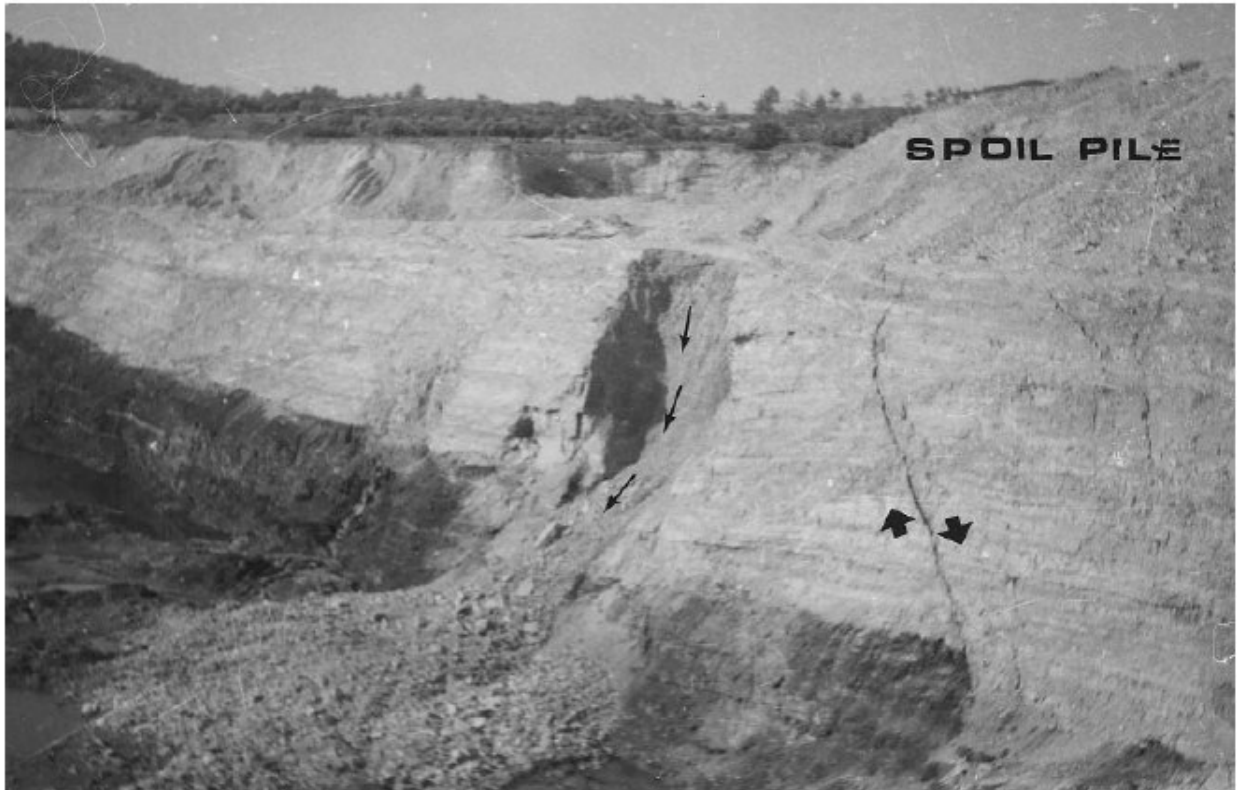
Figure 9: Initiation of the slide in the highwall externally loaded by a spoil (Sonmez et al., 1998)

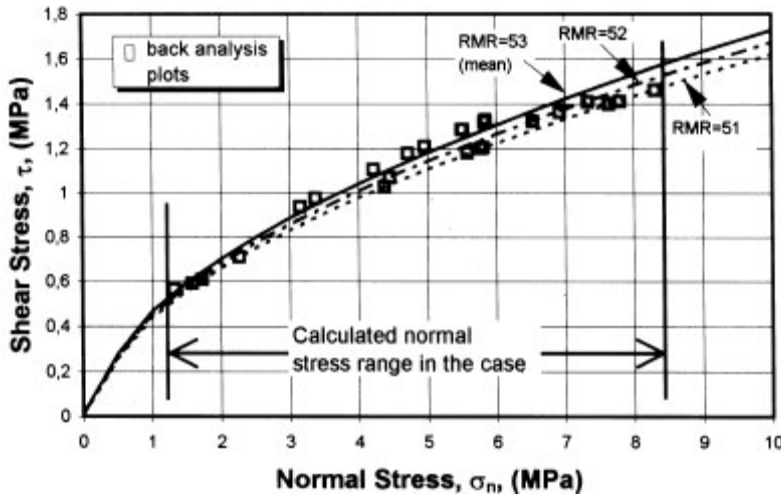
Figure 11: Comparison between the compact marl shear strength obtained from the back-analysis and the failure envelope derived with the Hoek-Brown criterion considering the average RMR value (53) for the rock mass (Sonmez et al., 1998)

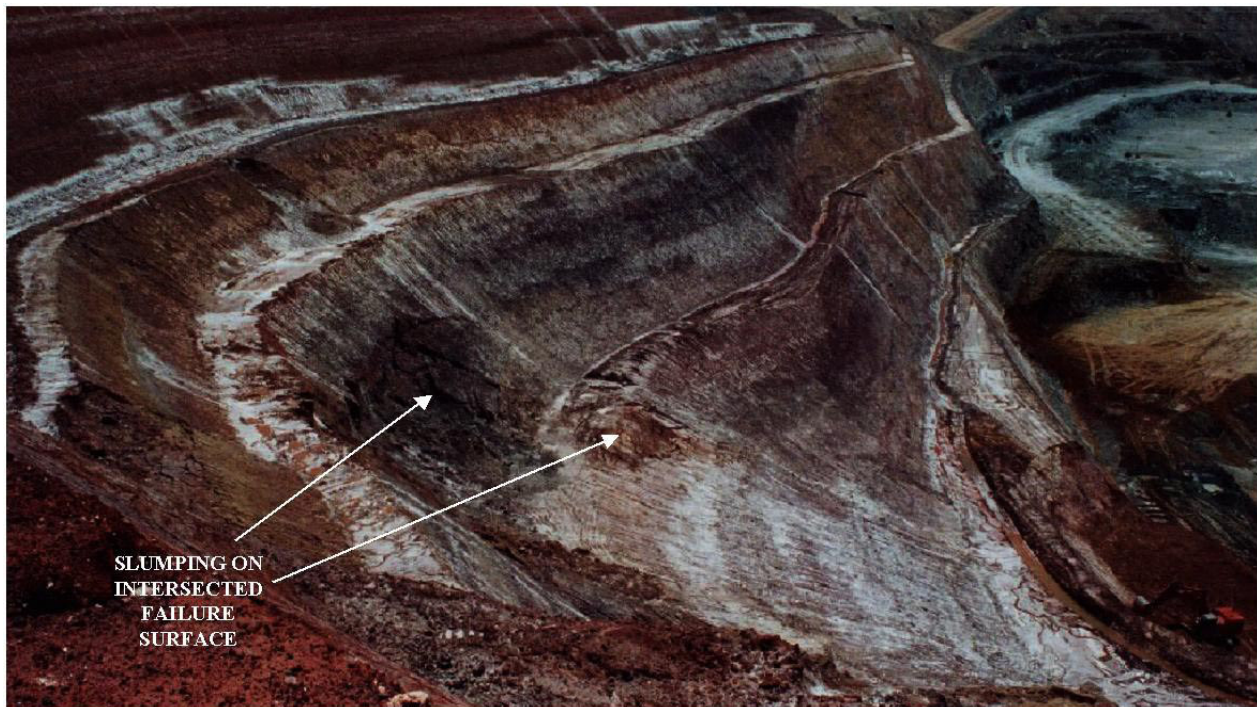
Figure 16: Remedial slope showing isolated slumping on old failure surface (Snowden, 2002)

As the aim of back-analysis in this case study was not to derive material strength properties but to confirm the assumption that the slope failed due to the presence of water, the design recommendations for the remedial slope were based on the geotechnical and hydrogeological models developed from the back-analyses (Snowden, 2002). Therefore, material strength properties and slope angle prior to failure and of the new design were not specified. Figure 16 shows the remediated slope.

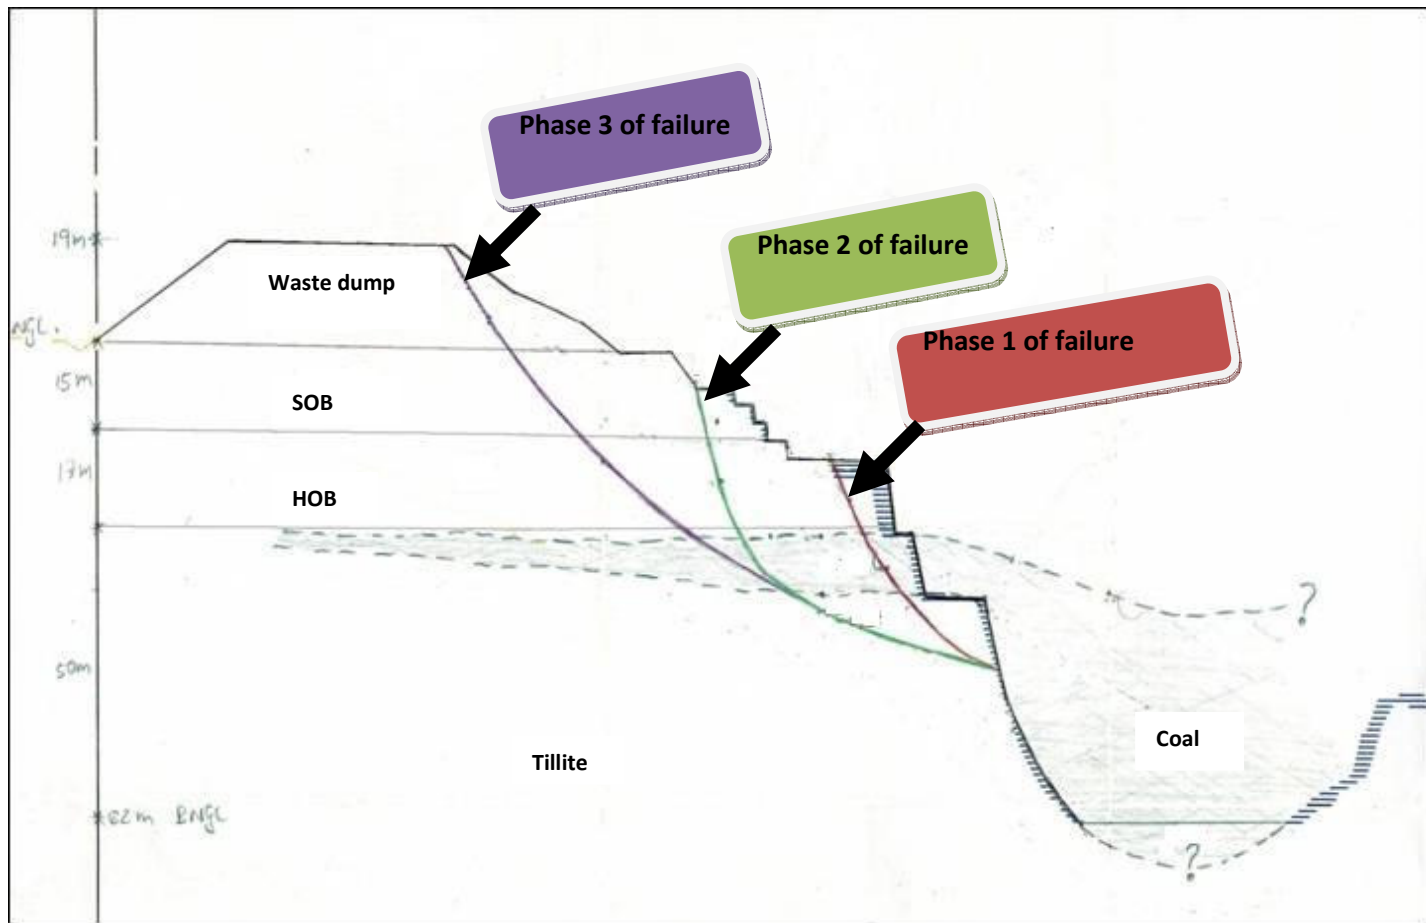
Figure 22: Proposed progressive failure in the slope (failure phases)

As mentioned in the literature review, a sensitivity analysis aims to derive material properties at failure and to determine which property has the greatest effect on the stability of a slope. As failure at the mine was in a progressive manner, the analysis was performed in phases of failure in order to simulate what happened during the actual failure. Figure 22 shows how the slope might have failed (proposed phases of failure).

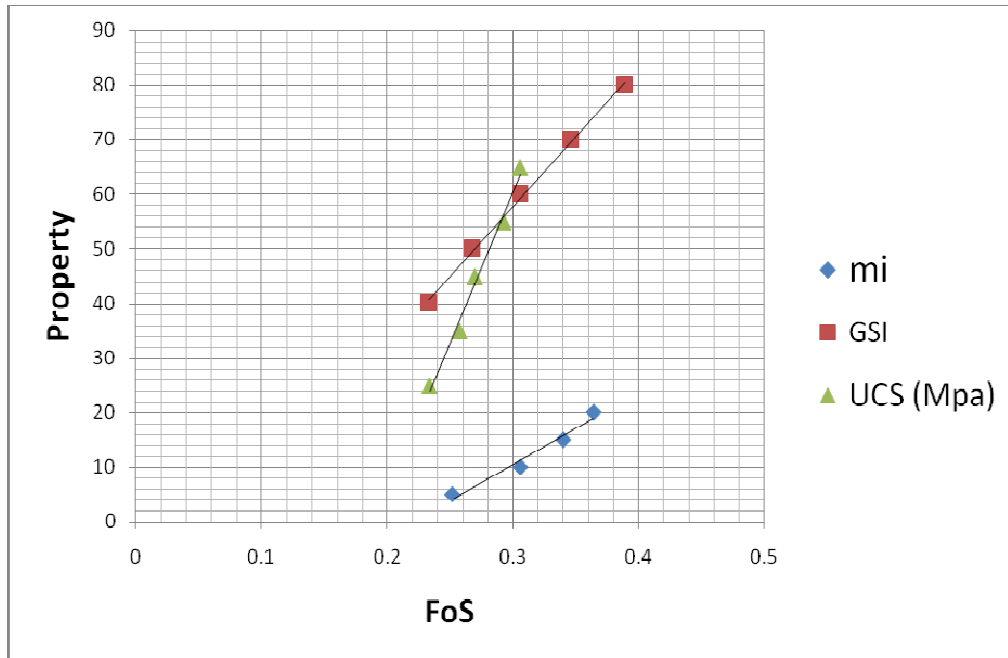
Figure 23:  $m_i$ , GSI and UCS against factor of safety for tillite

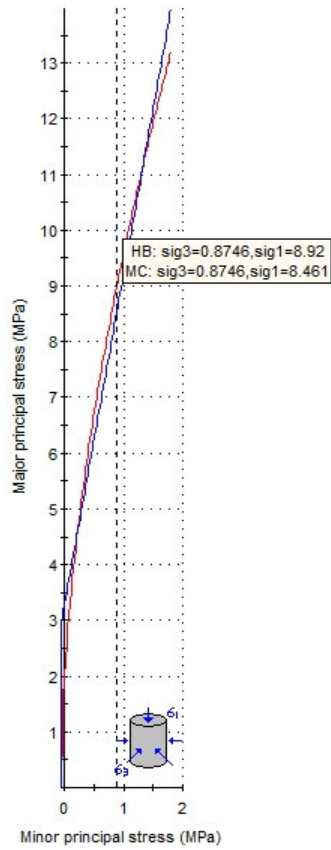
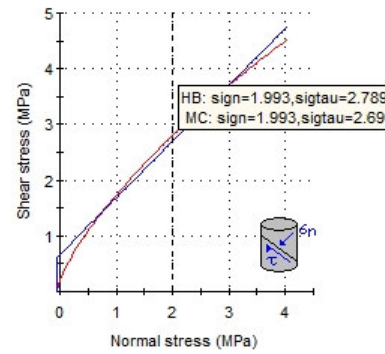
**Hoek-Brown Classification**  
 intact uniaxial comp. strength ( $\sigma_{ci}$ ) = 45 MPa  
 GSI = 53  $m_i$  = 15 Disturbance factor (D) = 0.5  
 intact modulus ( $E_i$ ) = 12375 MPa  
 modulus ratio (MR) = 275

**Rock Mass Parameters**  
 tensile strength = -0.053 MPa  
 uniaxial compressive strength = 1.904 MPa  
 global strength = 7.575 MPa  
 deformation modulus = 2206.97 MPa

Figure 31b: Stress sampling for HOB

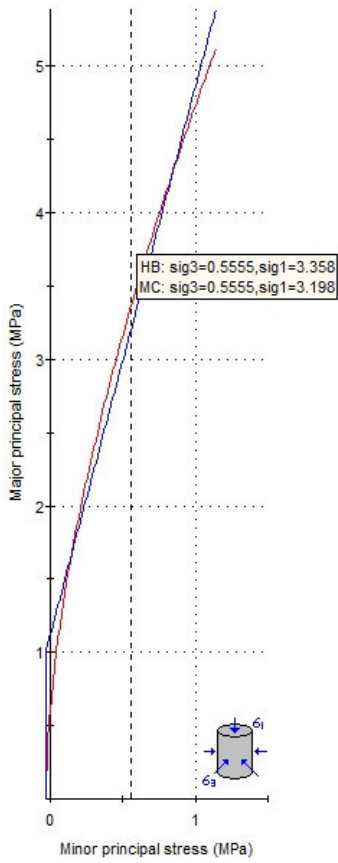
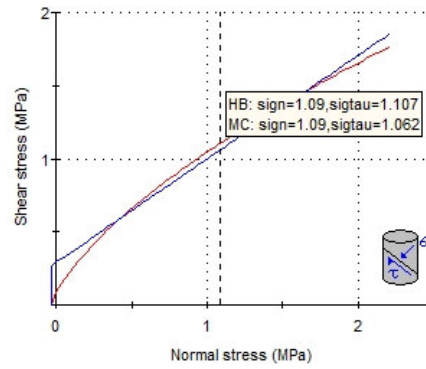
tensile strength = -0.030 MPa  
 uniaxial compressive strength = 0.626 MPa  
 global strength = 2.270 MPa  
 deformation modulus = 744.41 MPa

Figure 32b: Stress sampling for coal

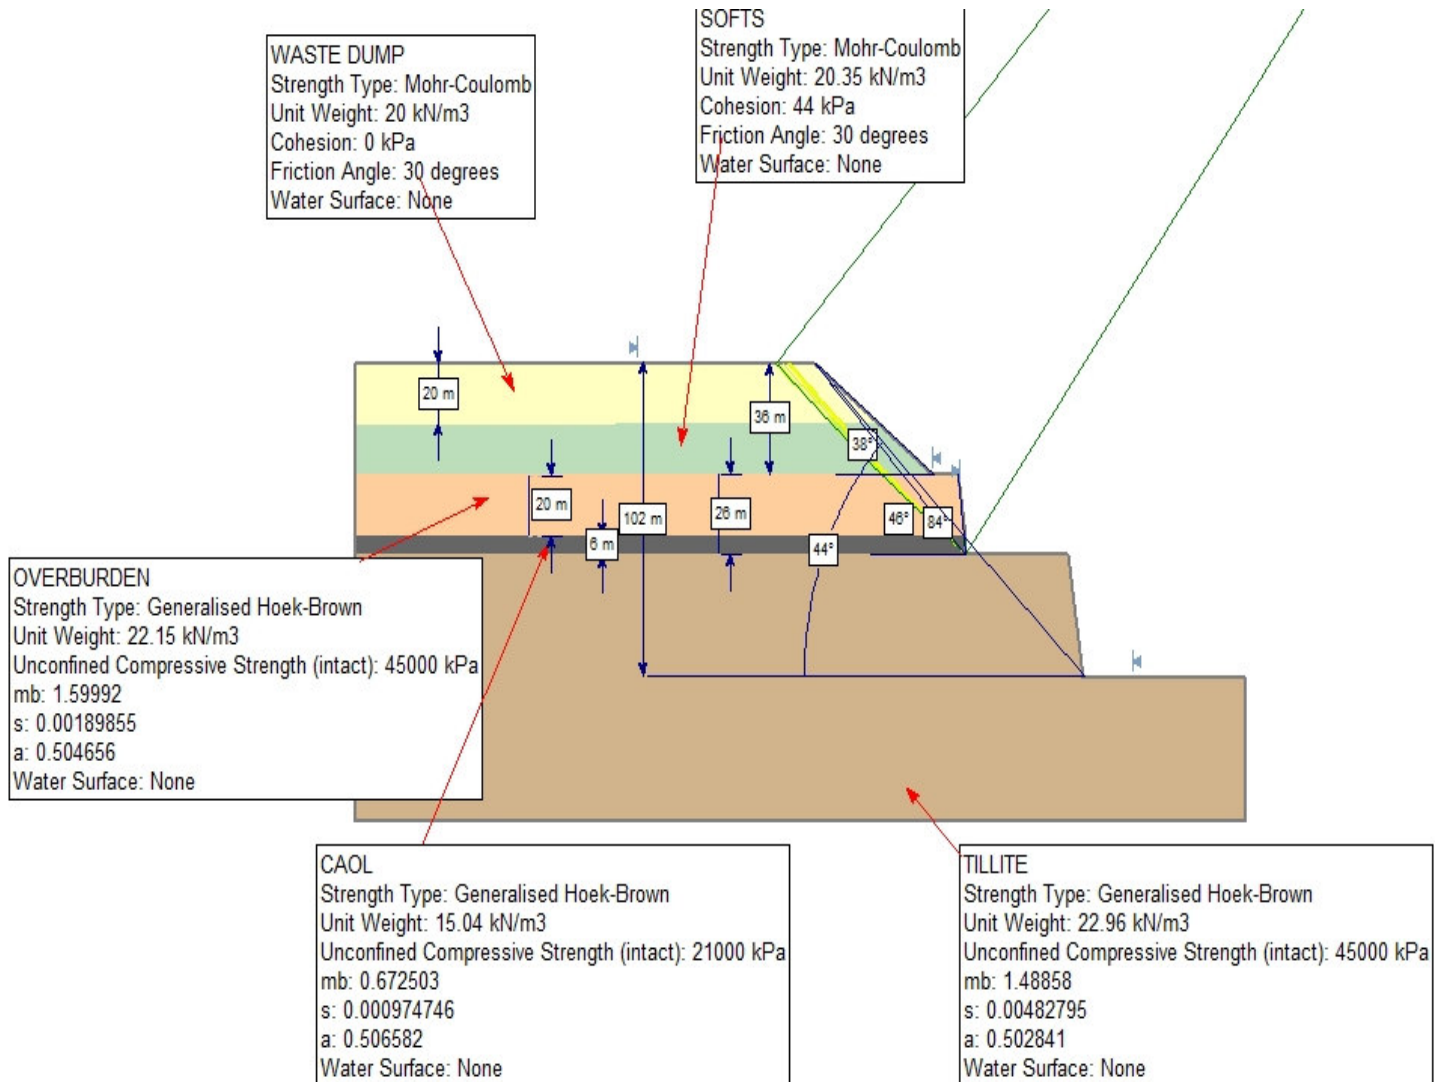
Figure 35: Summary of back-analysis and remedial slope designing results
