3. CONCEPTUAL DESIGN INDICATORS

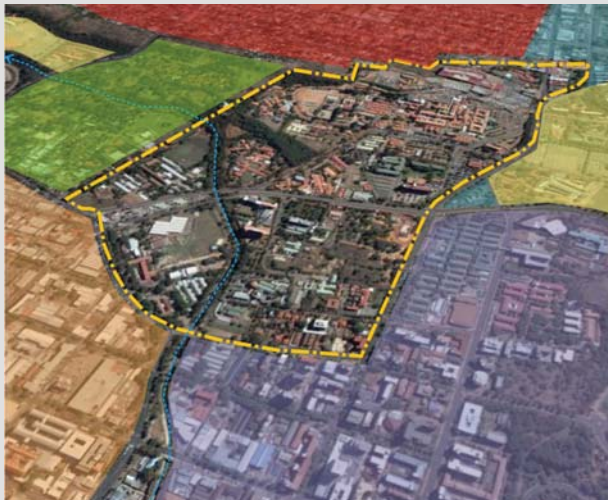
Fig. 3.1: Context of the study area (Google-earth, 2008)

Region. The precinct is located in the transitional area between Prinshof and Riviera in the City of Pretoria, South Africa.

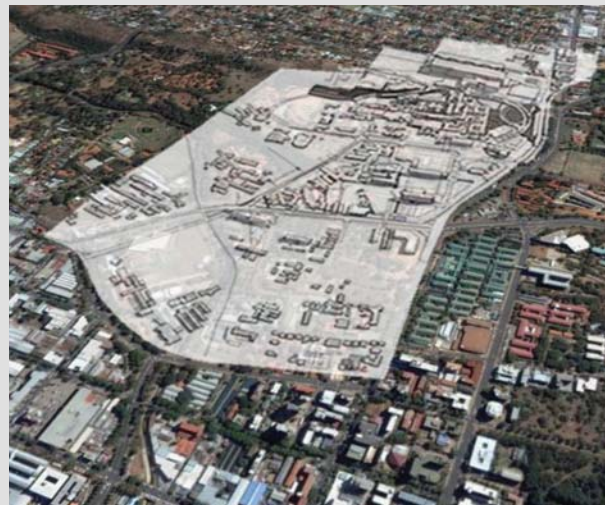
Fig. 3.2: The Hospital Hill Precinct (Author, 2008; Google-earth, 2008)

Precinct: The precinct is characterised by educational and health institutions owned mainly by Government.

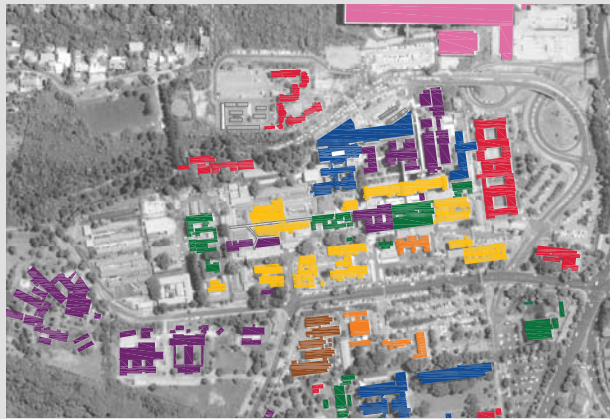
Fig. 3.4: Land-use of the T.R.H.M imposed on an aerial photograph. Unfilled buildings are going to be demolished (Medi-plan Architects, 2007).

Figure 3.4 depicts the land use of the Precinct area. The master plan area is indicated and will now be discussed in further detail.

The aerial photograph in Figure 3.4 depicts buildings on the premises of the Tshwane District Hospital which will be retained during the upgrade to Tshwane Regional Hospital (Medi Plan Architects, 2007). Heritage value (in terms of the National Heritage Resources Act no. 25 of 1999), and potential fire hazard were aspects taken into consideration to determine which buildings should be retained. Furthermore, all the asbestos structures have been demolished, but the foundation walls and floor slabs are still intact. The extension of Bophelo Road to form a ring road system through the area has recently been completed.

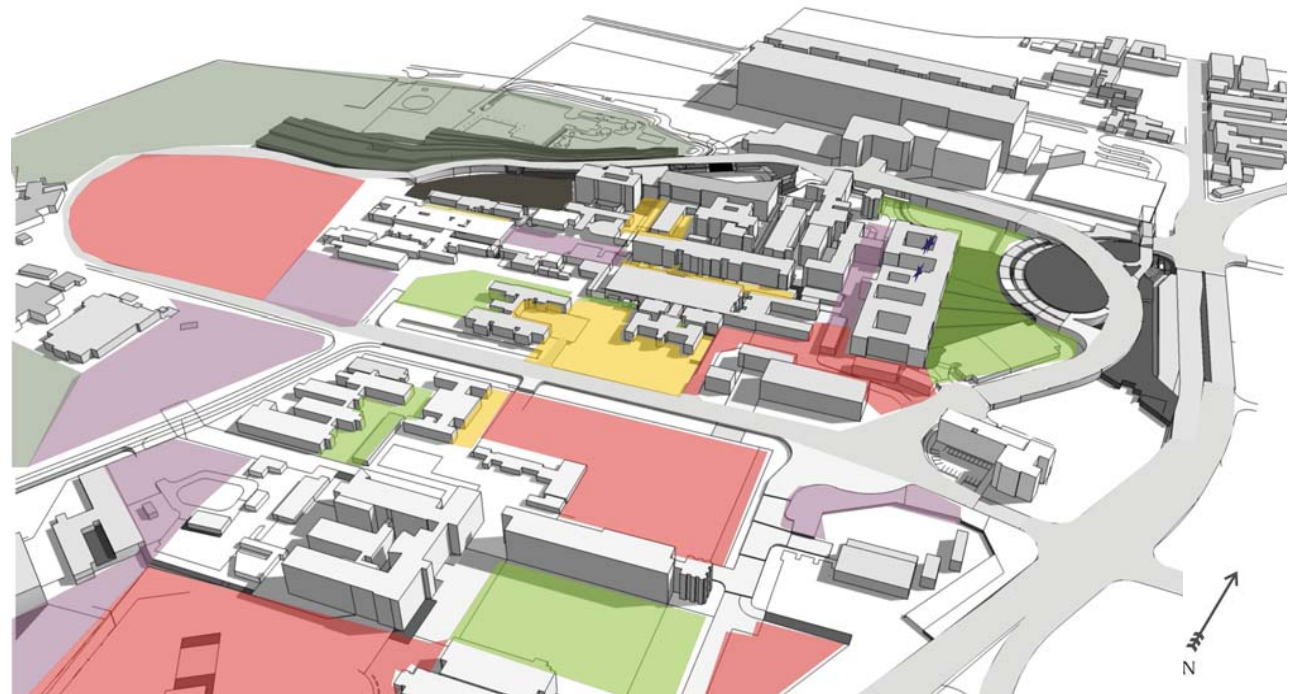
Fig. 3.8: Classification of open spaces. (Author, 2008)

Existing open spaces which are used for resting, observing and gathering are indicated. Examples include the large lawn at the Prinshof Campus of the University of Pretoria, and lawn areas outside the university hostels.

Under-utilised spaces are abundant on the site. For example spaces that have mono-functions, such as parking lots.

Spaces which fell into disrepair and are not being maintained or used for a specific function occur mostly between buildings. The remaining spaces where buildings have been demolished, also fall within this category.

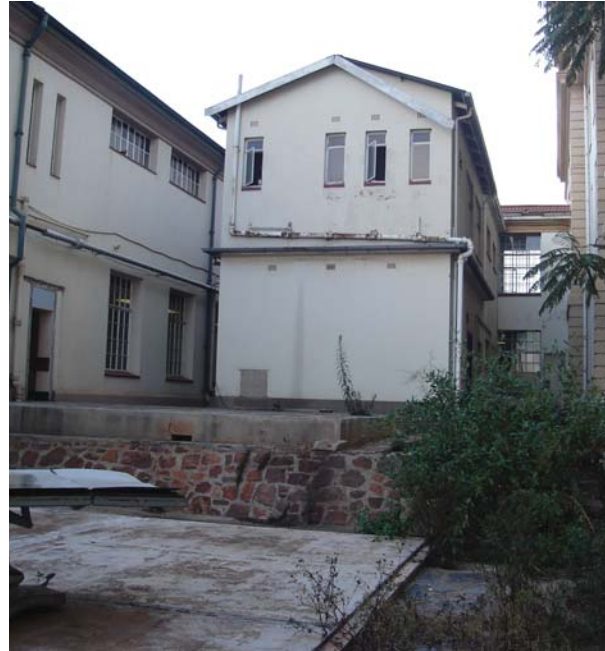
Fig 3.20: Unmaintained internal courtyard (Author, 2008)

A general lack of adequate maintenance is evident throughout the area. This scenario is about to change due to the monetary injection that was budgeted for by the T.R.H. for upgrade from District to Regional hospital. Upgrades, restoration and general maintenance that has, for at least 20 years been left in gloom, are now being attended to. New buildings are being constructed in some areas. The large amount of demolished buildings left open spaces of rubble, overgrown with weeds. These under-utilised spaces provide opportunity for landscape interventions.
