**IRRIGATION OF REHABILITATED MINE LAND WITH CIRCUM-  
NEUTRAL MINE WATER**

**Submitted in partial fulfilment of the requirements for the degree  
MSc(Agric) Soil Science  
In the Faculty of Natural and Agricultural Sciences  
University of Pretoria**

**August 2023**

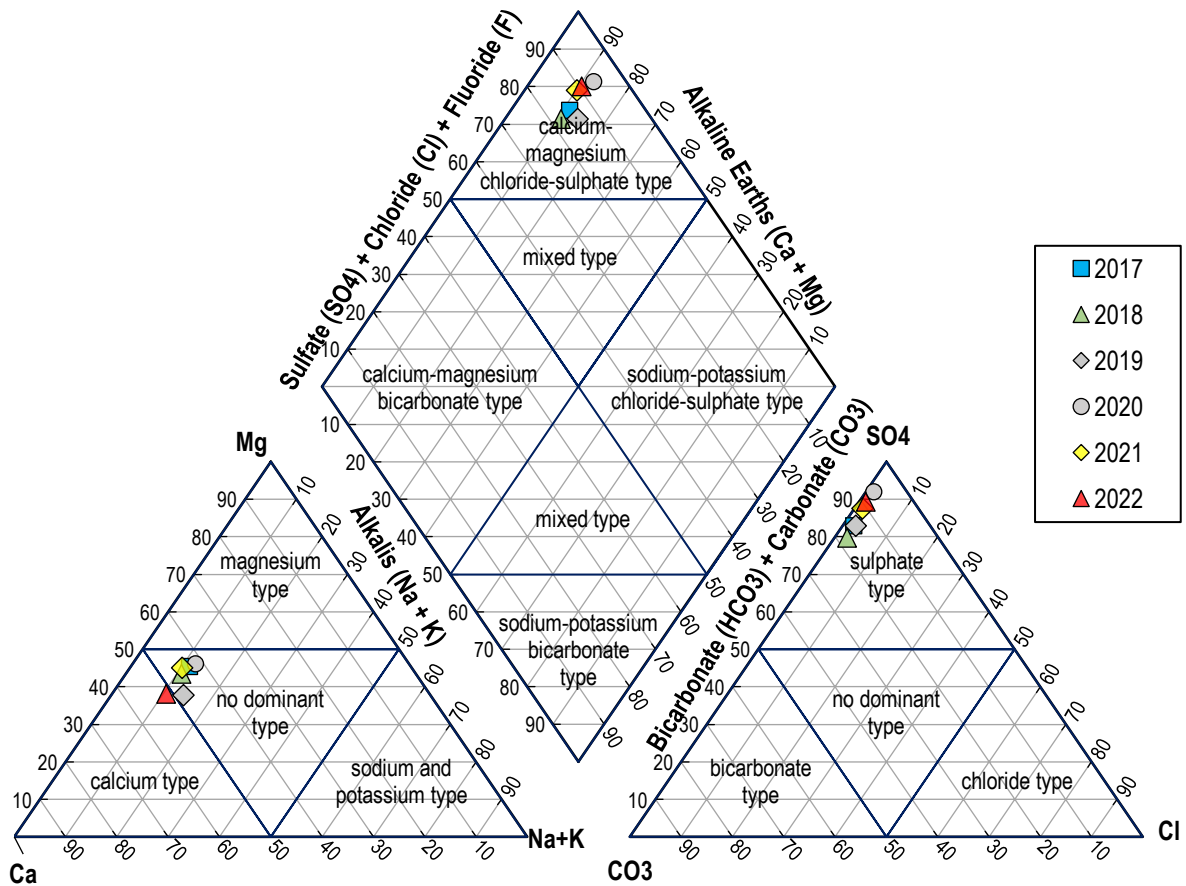
Figure 3.2: Piper diagram representing the water type for Void 3 from 2016- 2022.

Water quality is converted from mg/l to %meq/l, as it is the input required for the piper diagram. As some of the constituents in Table 3.1 vary between years, the piper diagram indicates that these variations have a minimal influence on the nature of the water signature.

As seen in Figure 3.2, the mine water for 2022 was identified as gypsiferous. This section covers the 2022 irrigation season at the rehabilitated pivot. Results presented in this section will serve as the initial data going forward for monitoring the effect of circum-neutral mine water irrigation on rehabilitated land. Figure 3.7 shows the soil sampling locations from 2021 before any irrigation commenced. This will most likely be the reference for future locations for soil samples at the Rehabilitation Pivot.

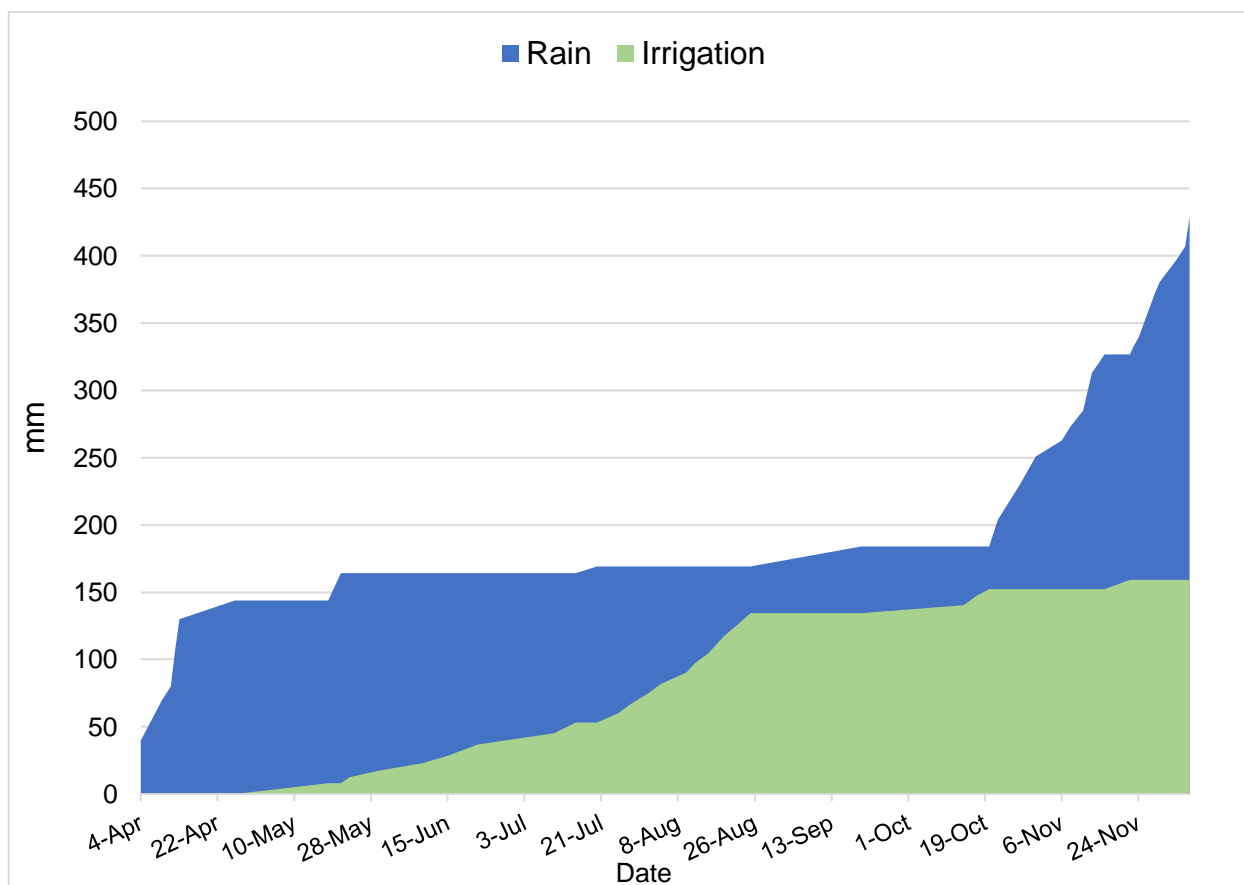
Figure 3.8: Cumulative rainfall and irrigation from April 2022 at the Rehabilitation Field.

Date	Rain	Irrigation
	mm	mm
April	144	0
May	20	17,5
June	0	19,3
July	5	30,2
August	0	67,3
September	15	0
October	67	18
November	130	6,9
December	62	0
<b>Total</b>	<b>443</b>	<b>159,2</b>

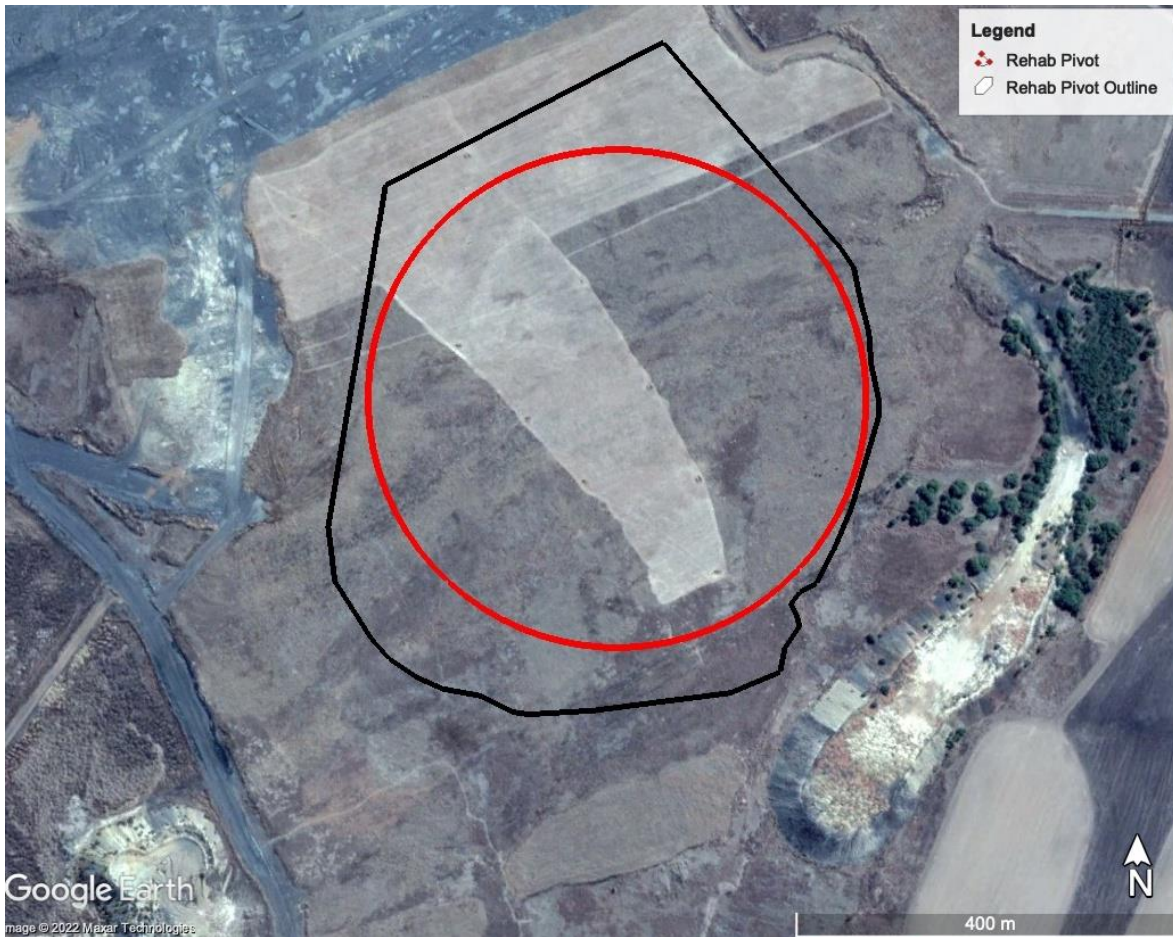
Figure 4.3: Rehabilitation Field in 2016.

By 2016, mining in the area was completed, and the rehabilitation process was in the final stages. Figure 4.3 shows the rehabilitation area in 2016 when the rehabilitation process of soil placement was still underway.

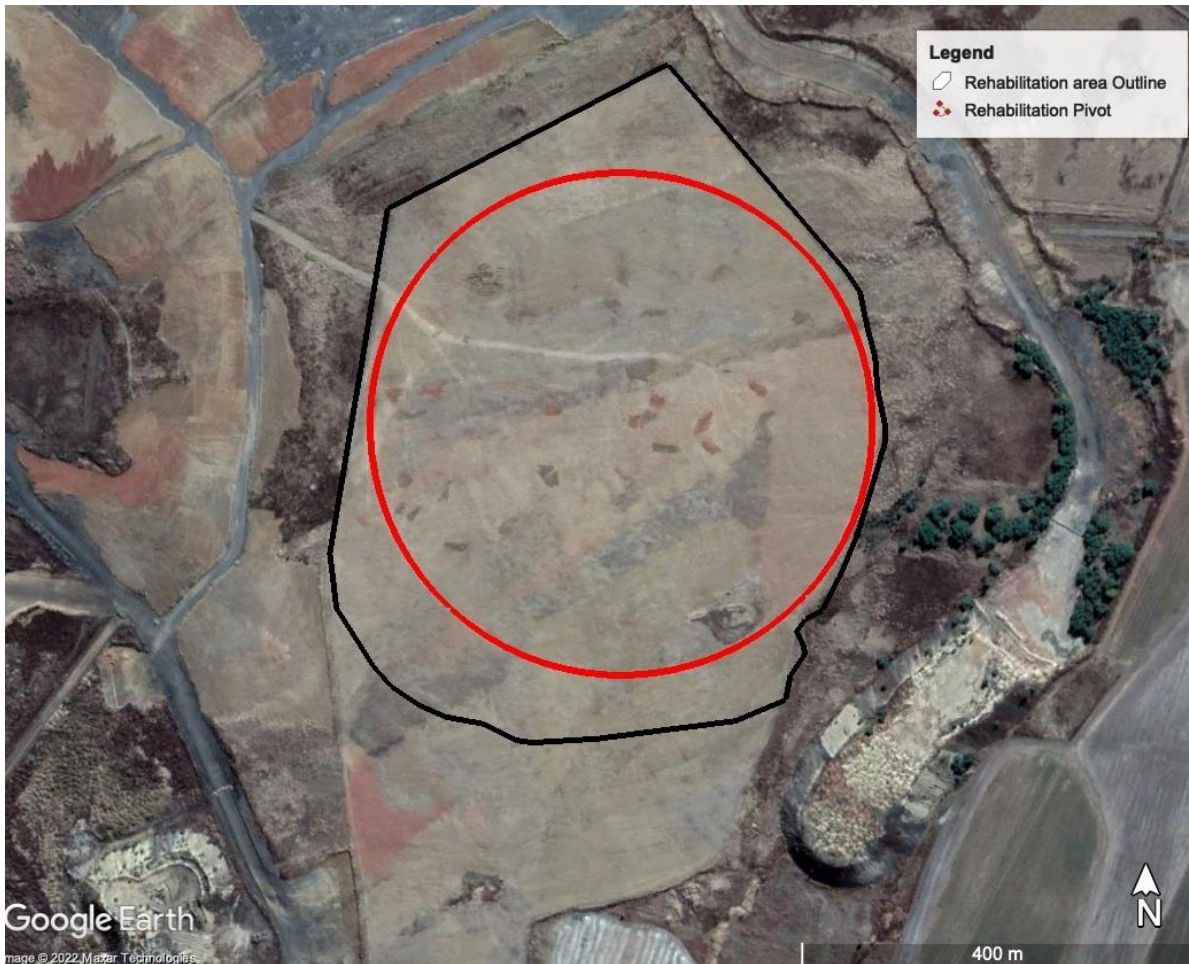
Figure 4.4: Soil heaps visible at the Rehabilitation Field in 2017.

Figure 4.4 shows the Rehabilitation Field in 2017. Some soil heaps that still needed levelling are visible.

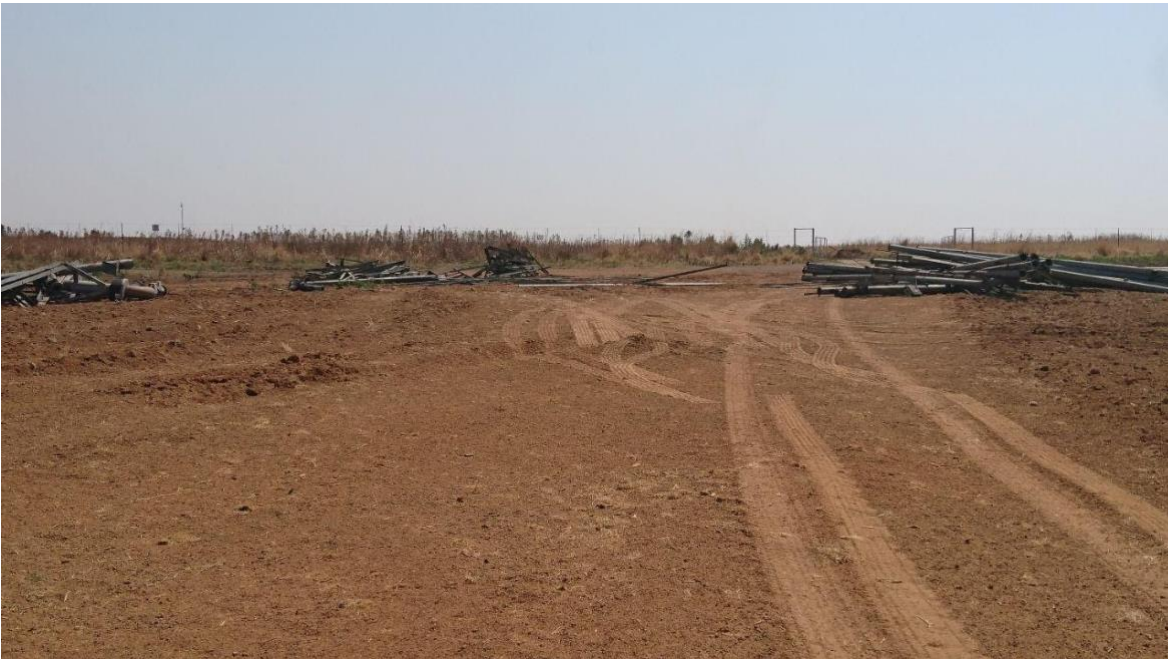
Figure 4.5: Unassembled pivot at the Rehabilitation Field.

After selecting a suitable site to erect a centre-pivot irrigation system, Mafube Colliery proceeded to procure and commission the assembly of the system. South32 collaborated with this endeavour, by donating an old centre pivot that was not in use at one of their mines. Unfortunately, this pivot was not disassembled correctly, with many bolts and stays just being removed with a cutting torch, causing considerable damage. Costs to refurbish this pivot were considerable, with the farmer responsible for this field estimating that it would have been easier and cheaper to just install a new pivot. There were also delays in establishing the central foundation for this pivot and supplying electricity and water to the site. From the outset of this project, there were problems with insufficient water pressure to the pivot. Figure 4.5 shows the unassembled pivot in 2017 at the rehabilitation site.

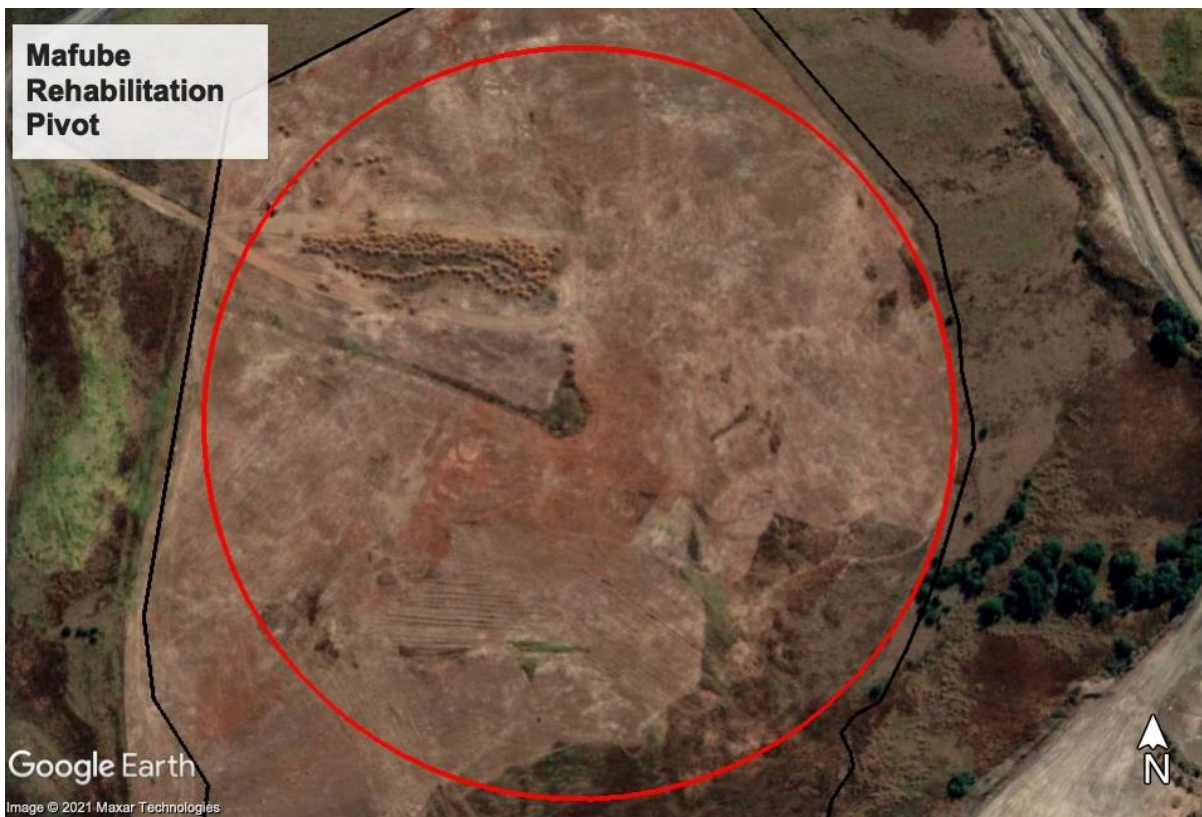
Figure 4.7: Google Earth image from May 2019 showing heaps of soil trucked in to fill additional depressions.

High variability in soil colour is also visible in Figure 4.6, with the red/brown patches in the centre of the pivot indicating soil that had been recently added to the site. Figures 4.7 and 4.8 present rehabilitation site images from May and July 2019. Heaps of soil that were trucked in to fill the depression that caused the water ponding in Figure 4.6, are visible in Figure 4.7.

The heaps of soil shown in Figure 4.7 were levelled, as can be seen in Figure 4.8. Unfortunately, the additional soil that was trucked in was not of the same quality as the stockpiled soil that was originally selected for this task. The effect of this replaced soil variability is apparent and will be discussed in the chapters that follow.

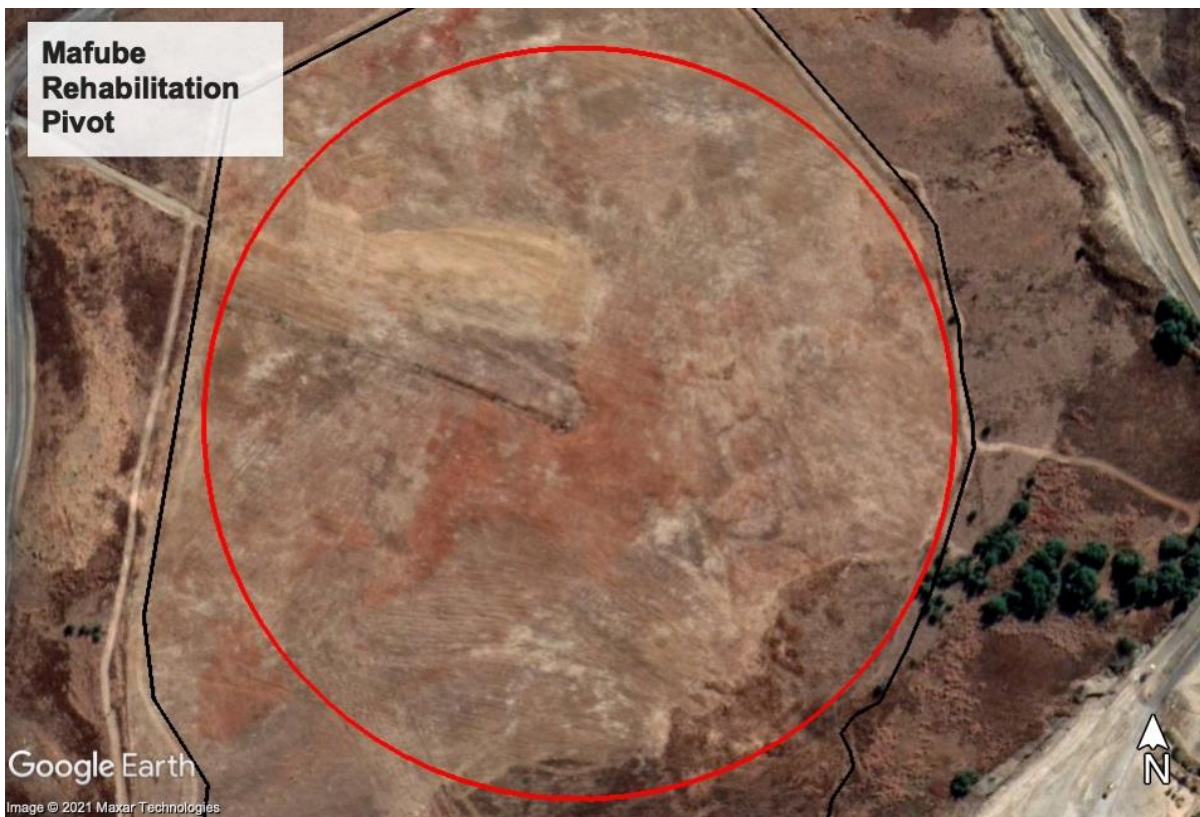
Figure 4.8: Google Earth image from July 2019 showing the levelled heaps of soil.

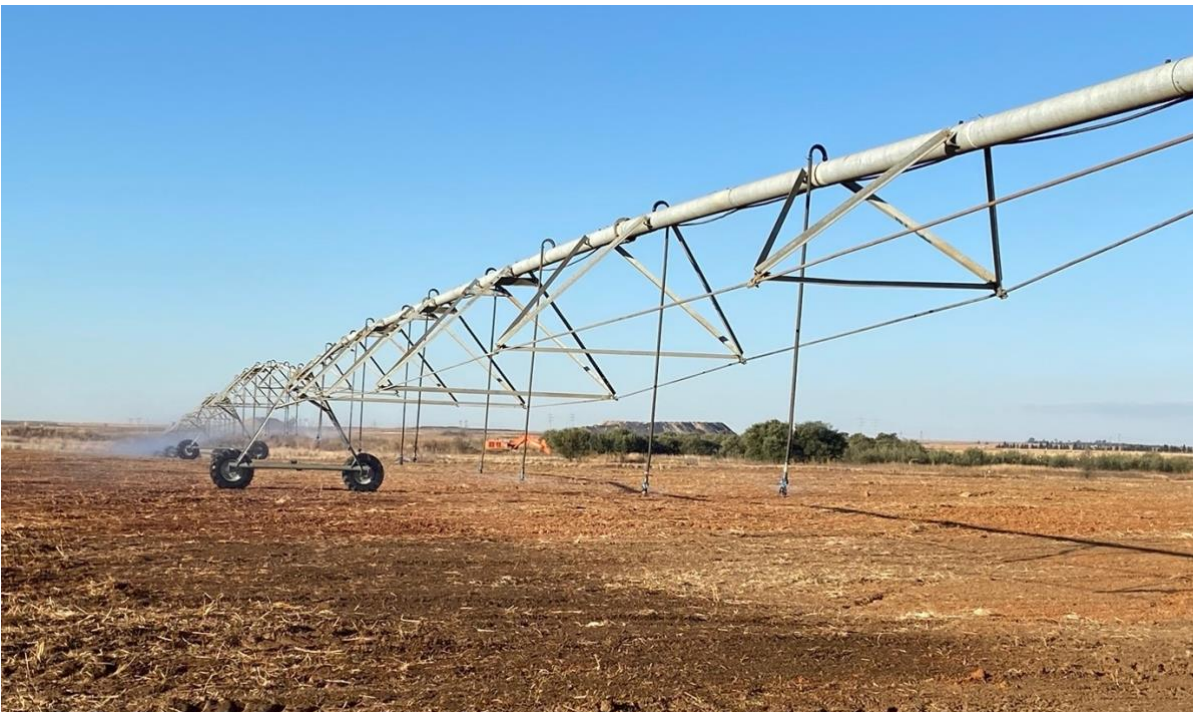
Figure 4.10: Fully functioning pivot irrigating in June 2021.

Figure 4.10 is from June 2021 when the pivot was fully functioning and could make complete revolutions.

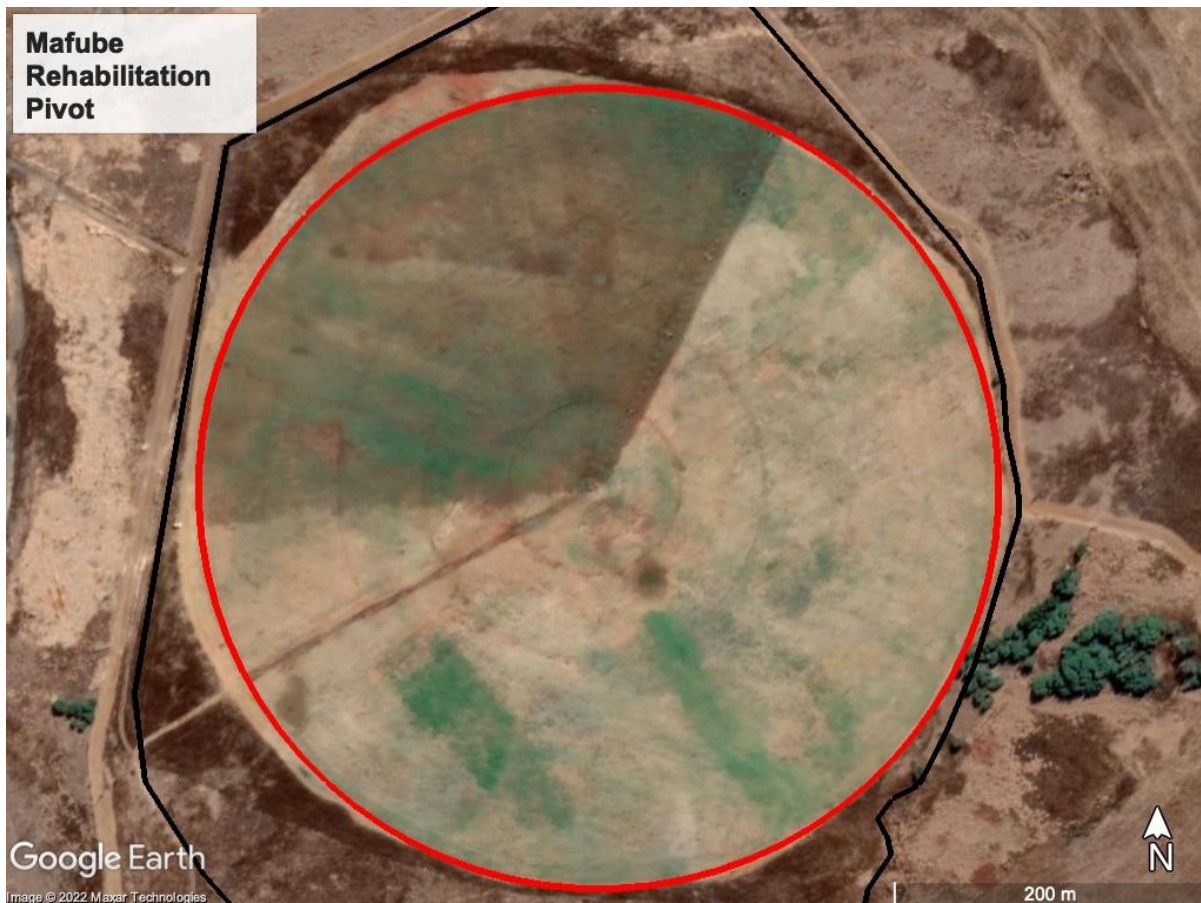
Figure 4.11: Google Earth image from the Rehabilitation Field, June 2022.

Figure 4.11 shows the Rehabilitated Field in June 2022.

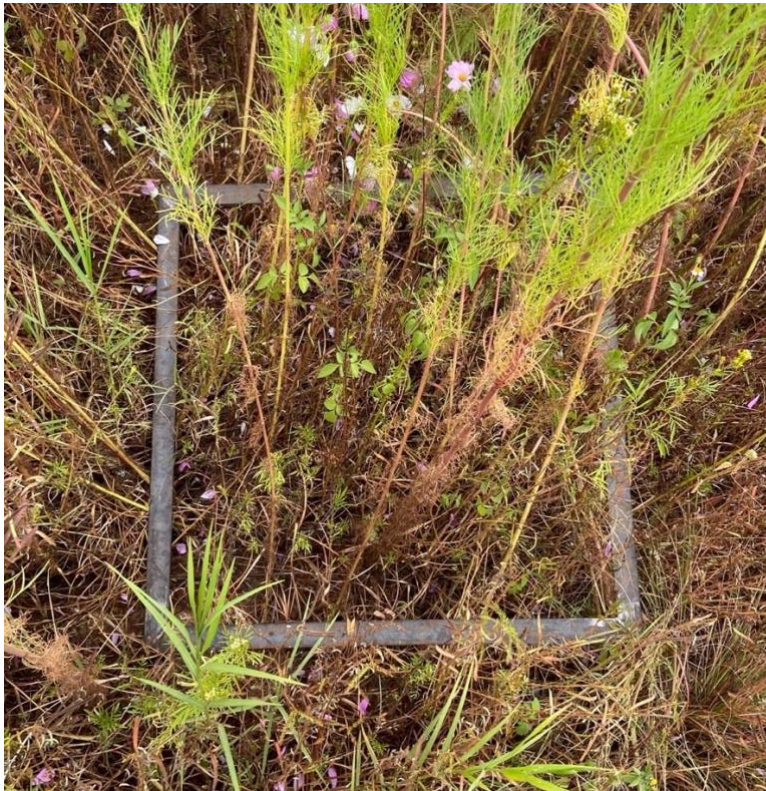
Figure 5.3: Steel square (0.75 m x 0.75 m) within which all plant material was sampled.

Samples were taken in April 2021 when most of the weeds were fully grown and mature. Samples were initially dried at 65 °C for 24 to 27 hours. From 27 hours, weeds were weighed every 4 hours and returned to the oven until a constant mass was obtained. The weights of the samples were converted from g/m<sup>2</sup> to t/ha.

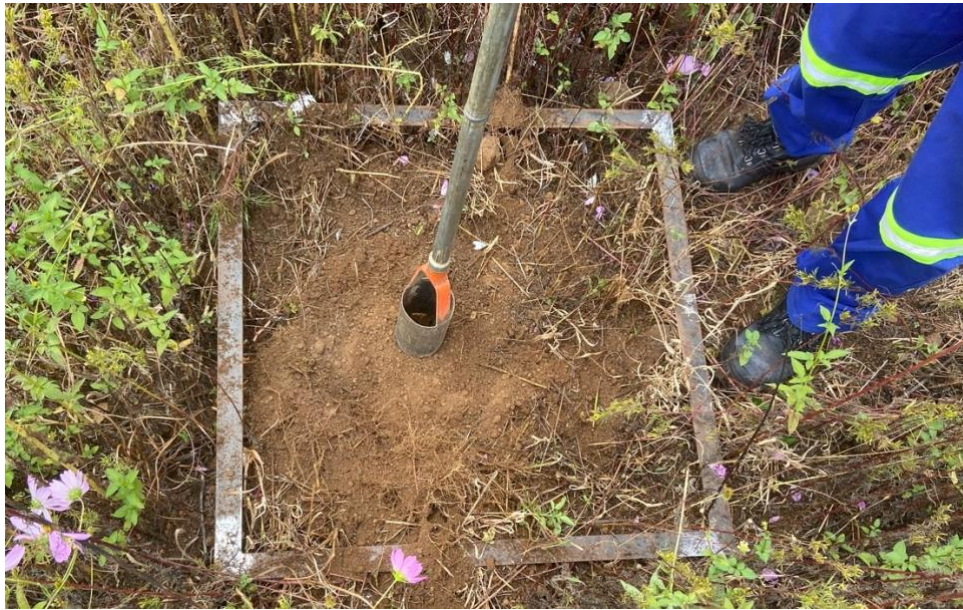
Figure 5.4: Soil sampling in the Rehabilitated Field.

The short-term objective of this section was to determine if weed growth could be related to soil fertility or physical properties. Figure 5.4 shows soil sampling, which was done directly after the weeds had been sampled. Sample R34 was contaminated during lab trials and discarded.

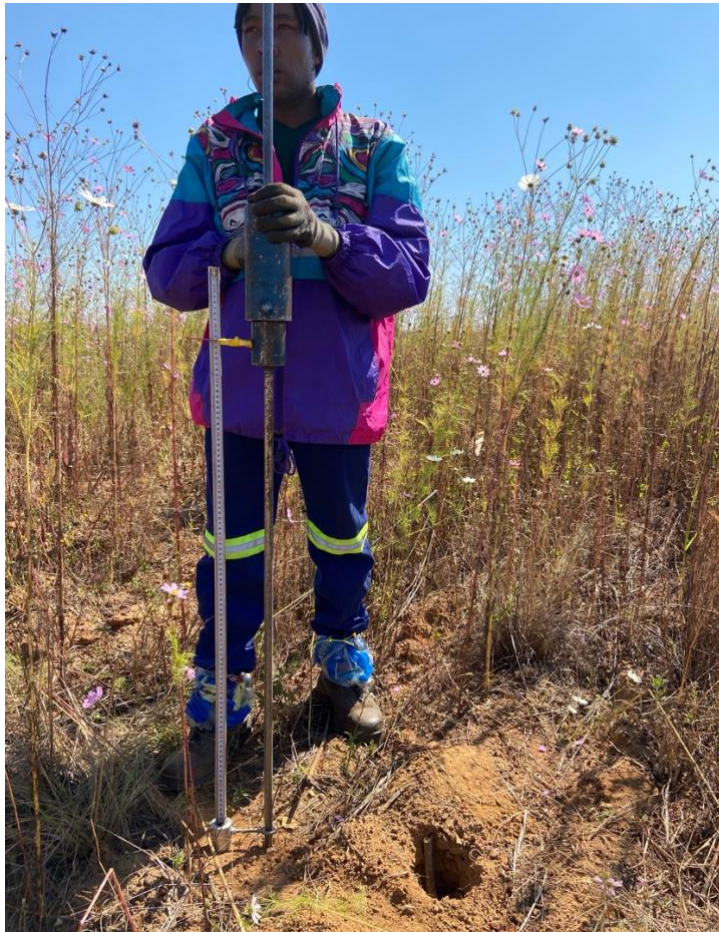
Figure 5.6: Penetrometer measurements in the field.

Figure 5.6 shows a staff member assisting with the penetrometer readings at the Rehabilitated Field.

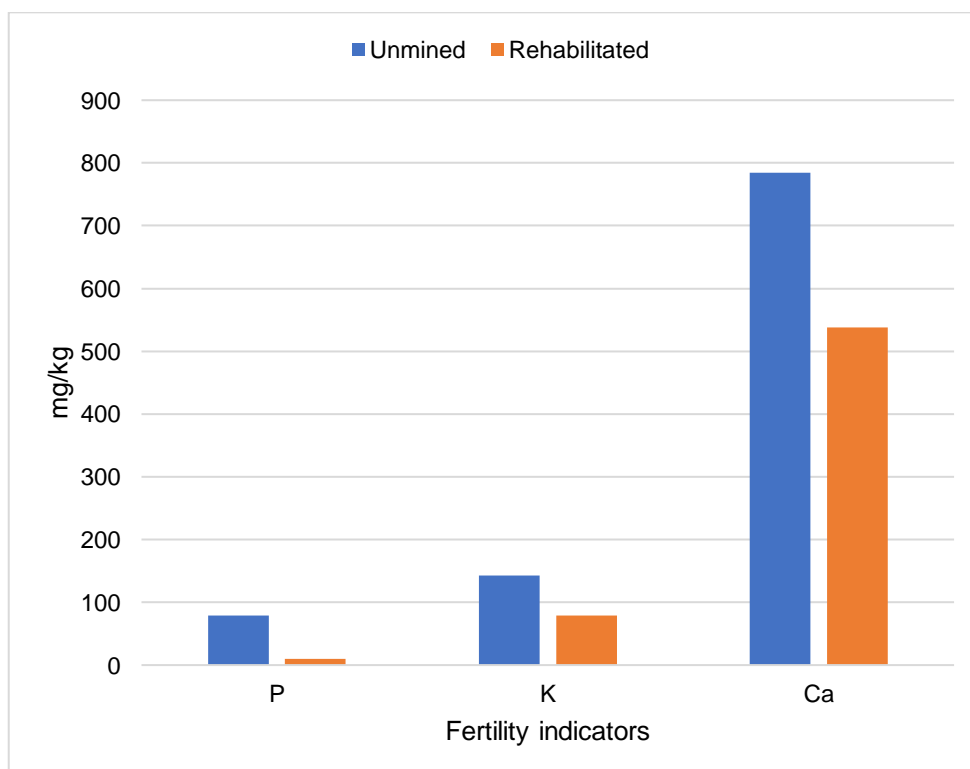
Figure 5.7: Fertility compared between unmined and rehabilitated land

The overall fertility of the Rehabilitated Field was also much lower than that of the unmined and regularly cropped pivot. While pH of the rehabilitated land differs little from that of the unmined land, there are large differences in respect to organic carbon, P, K and Ca. Comparing the averages of some fertility indicators from Tables 5.2 and 5.3, in Figure 5.7, shows there are clear differences between undisturbed (unmined) and rehabilitated mine land.

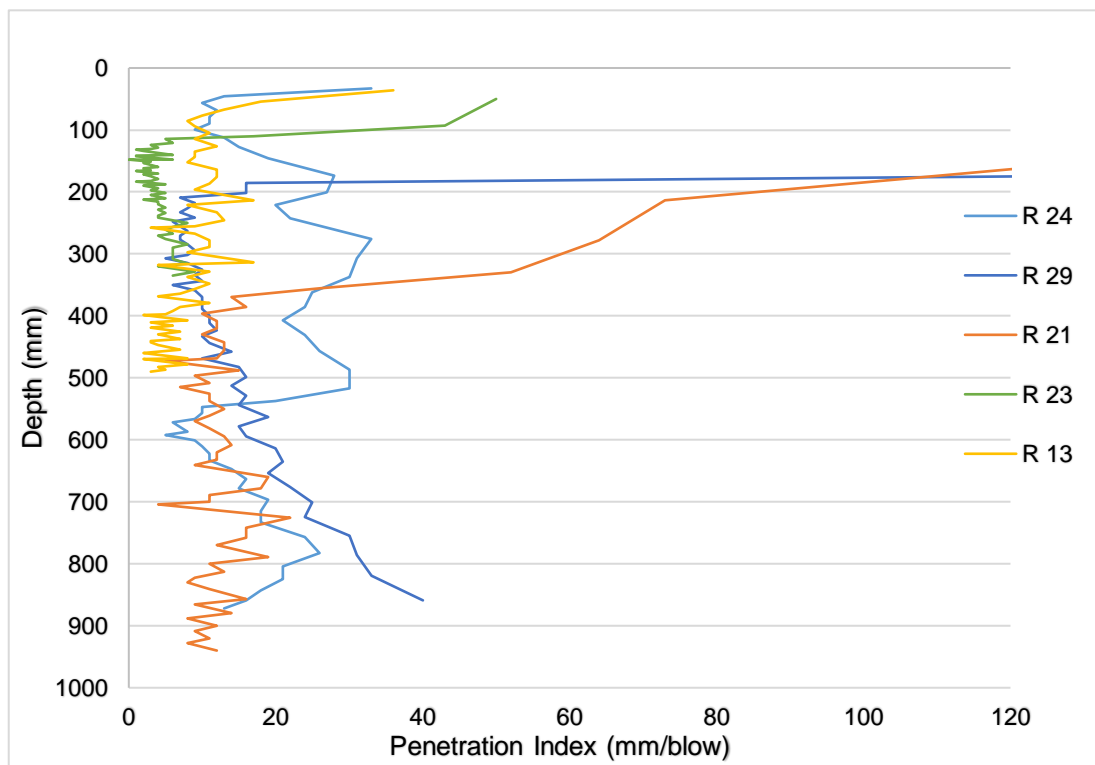
Figure 5.8: Five random penetrometer readings from the Rehabilitated Field.

The soil analysis showed high variability in the chemical properties of the Rehabilitated Field compared to the unmined field. Penetrometer readings presented in graphs assist in identifying and visualising soil resistance through the profile. Small and abrupt changes over a short distance indicate a restricting layer in the profile. High variability in physical properties were expected in the Rehabilitated Field. Figure 5.8 represents penetrometer readings from five random sites in the rehabilitated field and Figure 5.9 from the unmined field.

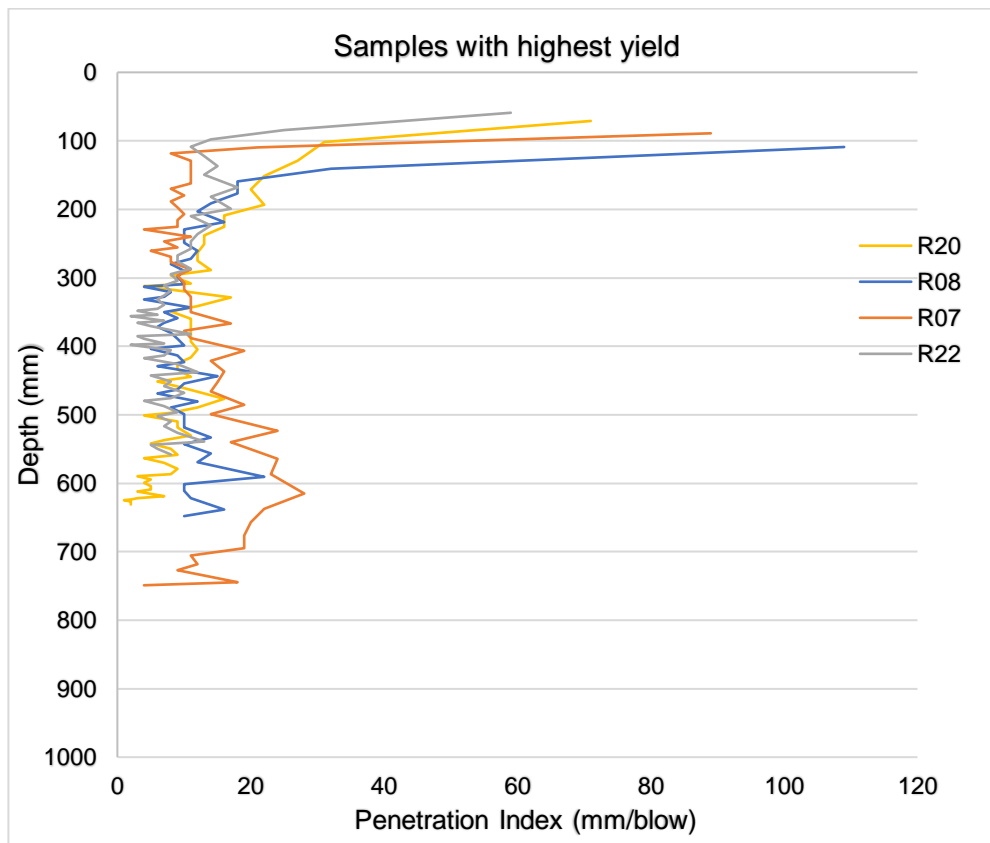
Figure 5.11: Average penetrometer readings of the four samples with the highest yields.

Compaction normally restricts root growth and the downward movement of water and nutrients. Figure 5.10 represents the penetrometer readings of the four locations with the lowest yield and Figure 5.11 the four locations with the highest yields.

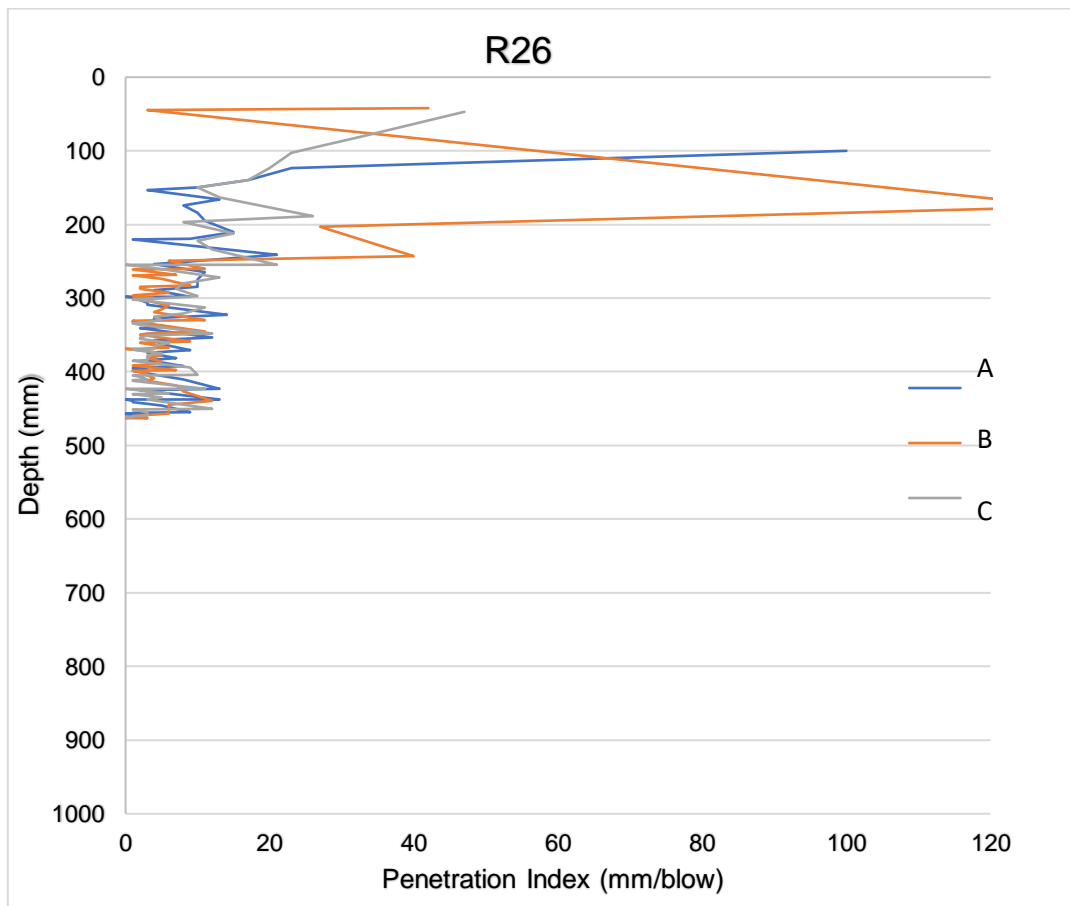
Figure 5.12: Penetrometer measurements at R26 indicating compaction.

It was demonstrated earlier, where the relationship between soil chemical constituents and yield was examined, that there were several low yielding areas that could not be explained by soil chemistry. For example, location R26 had high P and K concentrations compared to other samples, but lower yields. Figure 5.12 represents three average penetrometer samples from R26. Small and abrupt changes over a short depth indicate a boundary layer or compaction (over a longer depth) in the soil. The top 22 cm indicates normal soil with good penetration potential but from 22 cm and deeper, there is a clear boundary layer visible that represents compaction.

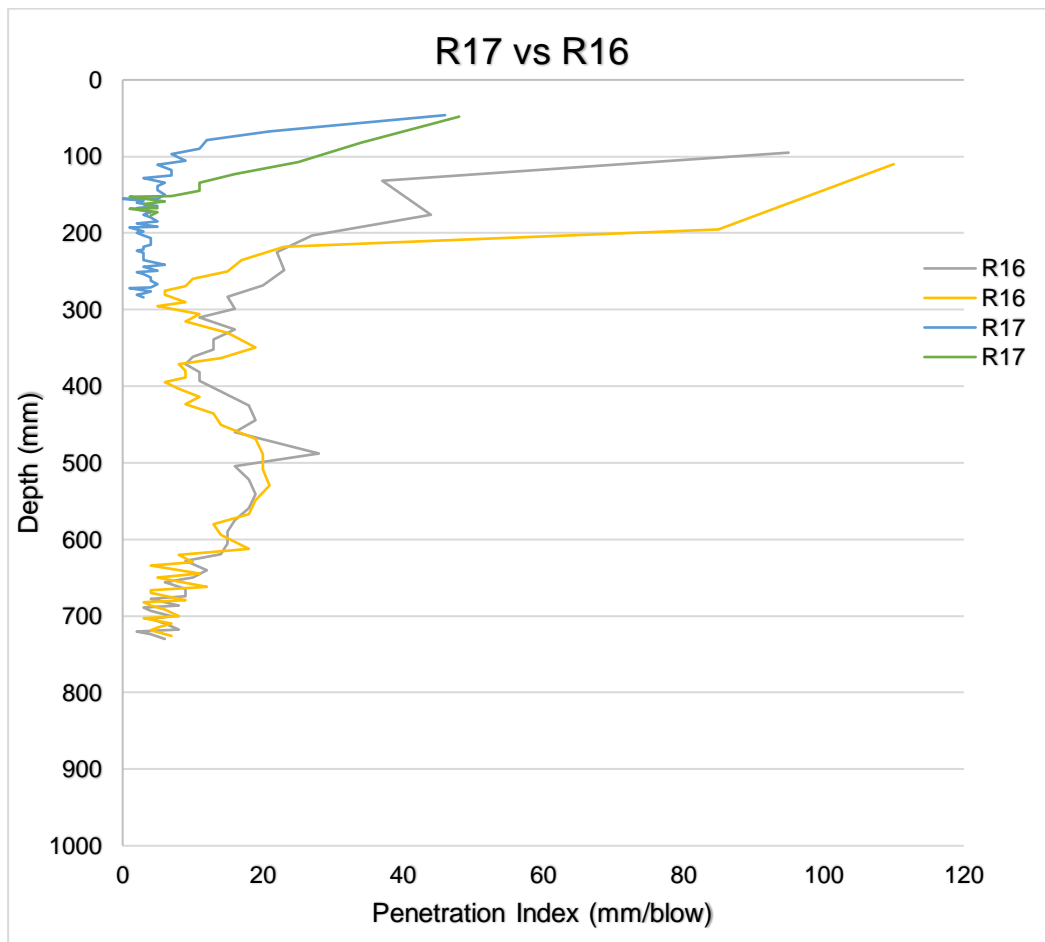
Figure 5.13: R16 and R17 penetrometer measurements compared.

Figure 5.13 illustrates two average penetrometer results from R16 and two from R17 compared to each other. R16 had a yield of 5.5 t/ha and R17 had a yield of 1.3 t/ha. R17 shows a restricting layer that starts from 10 cm and R16 only shows a layer below 60cm. The lower yield of R17 may therefore be a result of compaction.

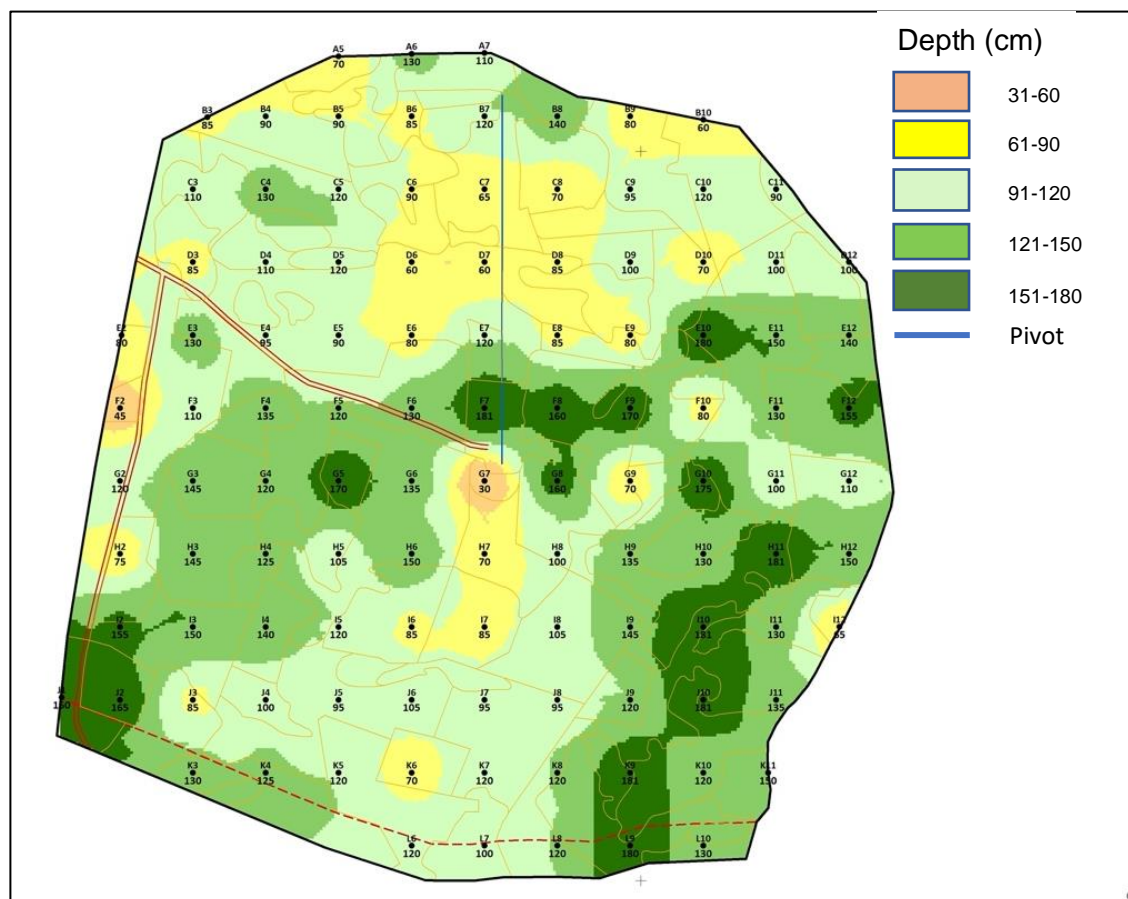
Figure 6.3: Soil to spoil depth at the Rehabilitated Field.

salinization of the root zone. With poorly rehabilitated areas, great variability in soil depth can be expected. The published mine land rehabilitation guidelines state that a soil reserve should be kept for amendments as necessary after rehabilitation. If this is not done, soil depth is very expensive to increase once the rehabilitation process has been completed. Figure 6.3 represents a depth-to-spoil map (soil depth) of the Rehabilitated Field. The blue line in Figure 6.3 represents the irrigation pivot at the time the analysis was done and the double brown line the road to the centre of the pivot.

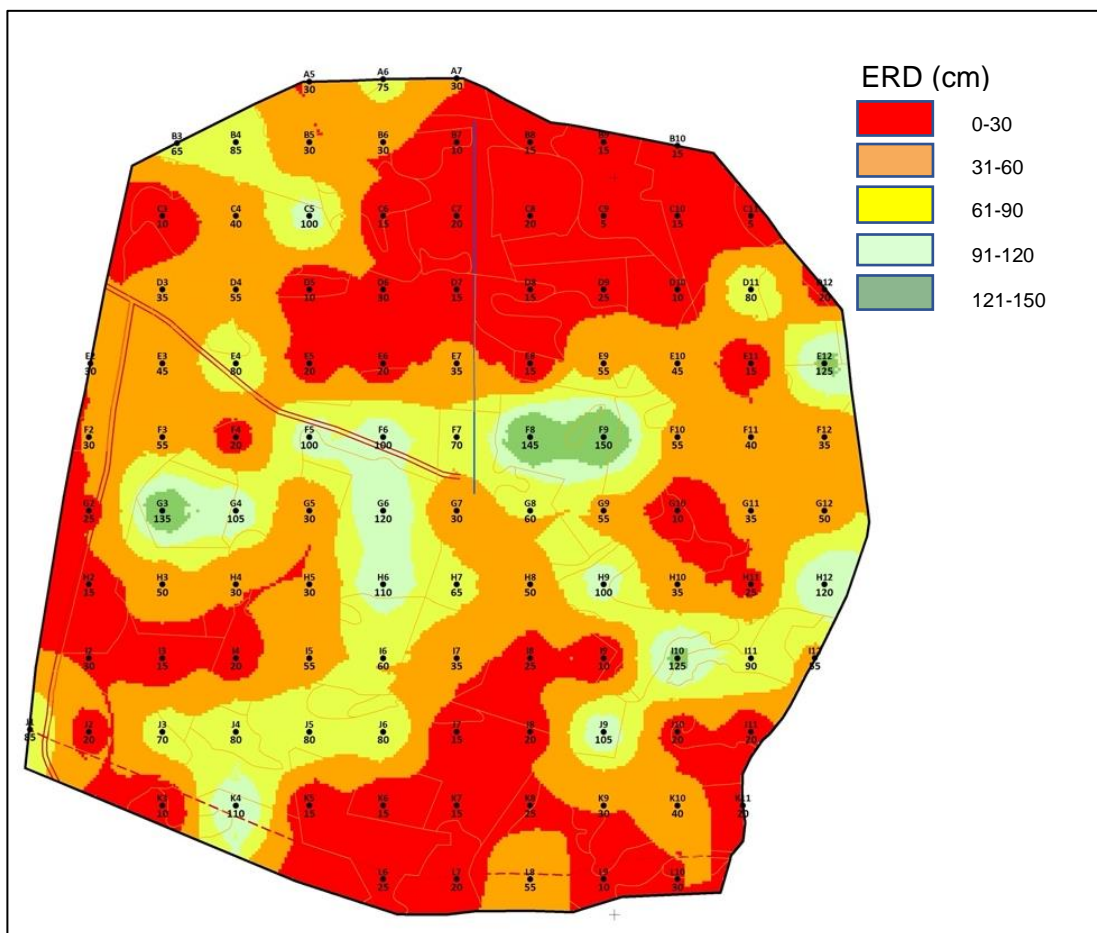
Figure 6.4: Effective rooting depth at the Rehabilitated Field.

Soil texture can determine the root zone water holding capacity. The Rehabilitated Field at Mafube consisted of more coarse material than was found with the unmined soil in close proximity. According to the USCS (unified soil classification system) coarse sand can be defined as particles ranging between 4 mm and 0.074 mm. Coarse material may improve the infiltration of water in the soil, which can be beneficial where restricting layers and compaction are present like in the rehabilitated area, but, too high content of coarse material decreases the water storage potential of the soil. Figure 6.4 indicates the ERD map created for the Rehabilitated Field. The ERD was determined by subtracting the percentage of coarse material from the soil depth of the profile. This map, therefore, rather presents an indication of water storage potential that affects arable potential, and is perhaps not aptly named in the classification system. Irrigable potential is expected to be less affected by the water storage potential, especially if high frequency irrigation is possible, as is the case with centre pivot irrigation.

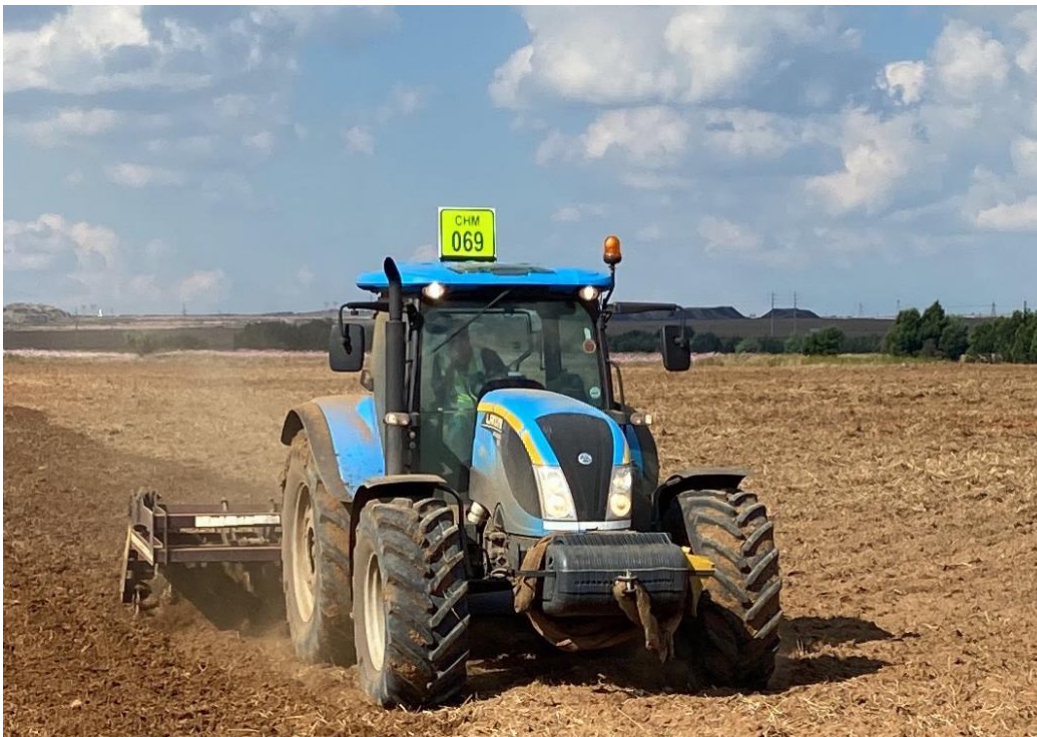
Figure 7.1: Soil preparation at the Rehabilitated Field

Soil was cultivated in March 2022 as shown in Figure 7.1. Seeding occurred directly after cultivation, shown in Figure 7.2. The planting mixture consisted of the following:

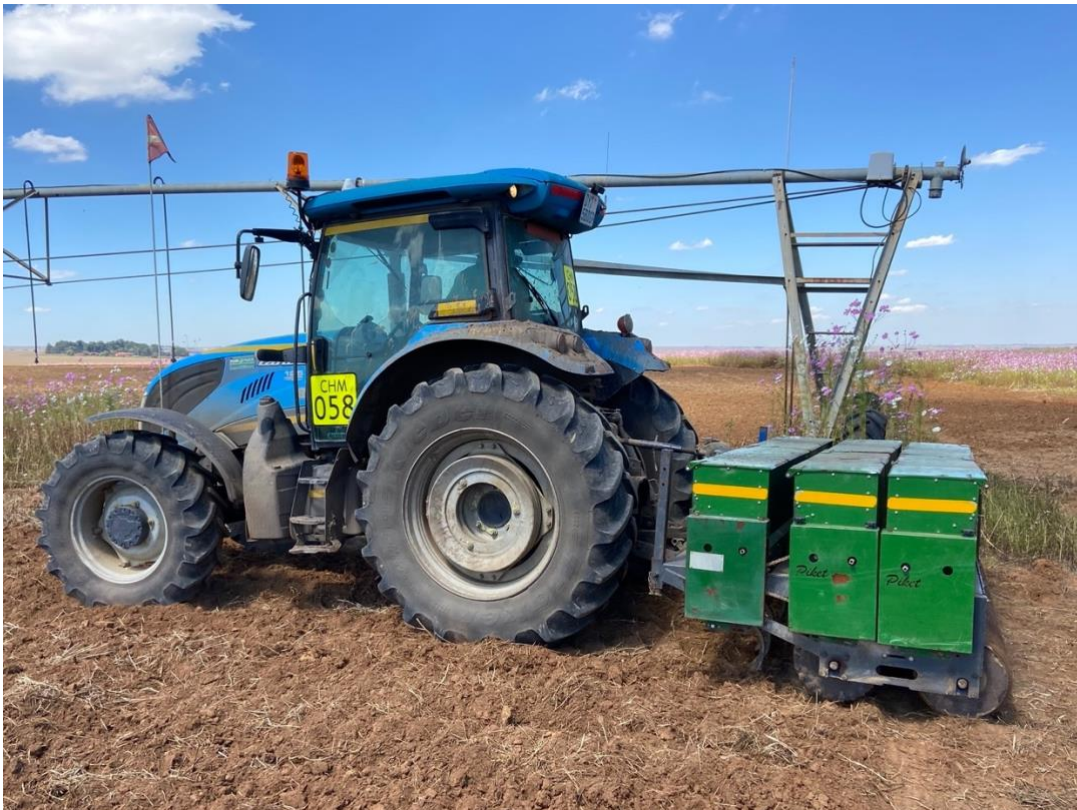
Figure 7.2: Planting of the seed mixture and fertilizer application at the Rehabilitated Field

- Lucerne (*Medicago sativa*): Lima Grain, WL 458 HQ, dormancy 7, 15 kg/ha
- Tall Fescue (*Festuca arundinacea*): Lima Grain, Charlem, 20 kg/ha
- Fertilizer: Kynoch, MAP, 140 kg/ha

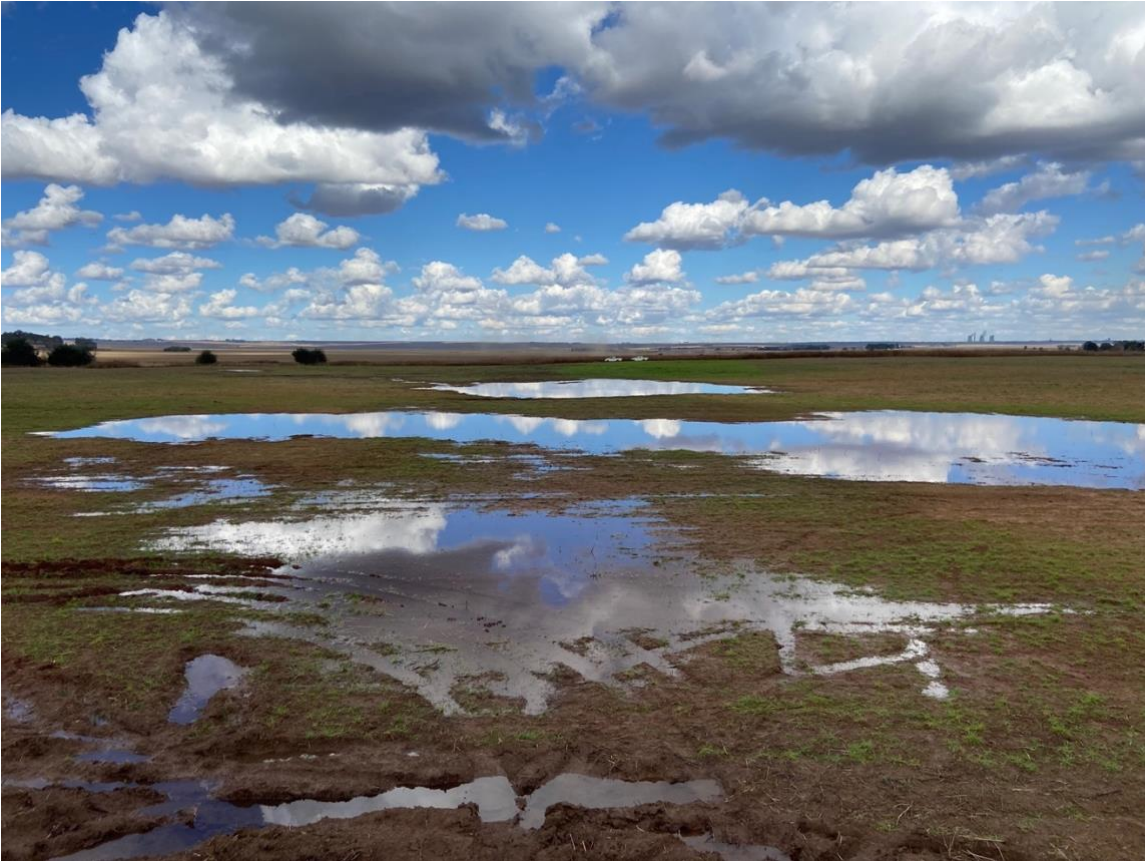
Figure 7.3: Ponding at the Rehabilitation Field

Even with good soil conditions where drainage and infiltration are optimum, a total of 144 mm of rain will not be ideal and will most likely result in ponding or runoff. Figures 7.3 and 7.4 show ponding areas that were still present in the rehabilitated field, long after the heavy rainfall. Germination is also visible in Figure 7.3 around, but not within, the ponded areas.
