**IRRIGATION OF REHABILITATED MINE LAND WITH CIRCUM-  
NEUTRAL MINE WATER**

**Submitted in partial fulfilment of the requirements for the degree  
MSc(Agric) Soil Science  
In the Faculty of Natural and Agricultural Sciences  
University of Pretoria**

**August 2023**

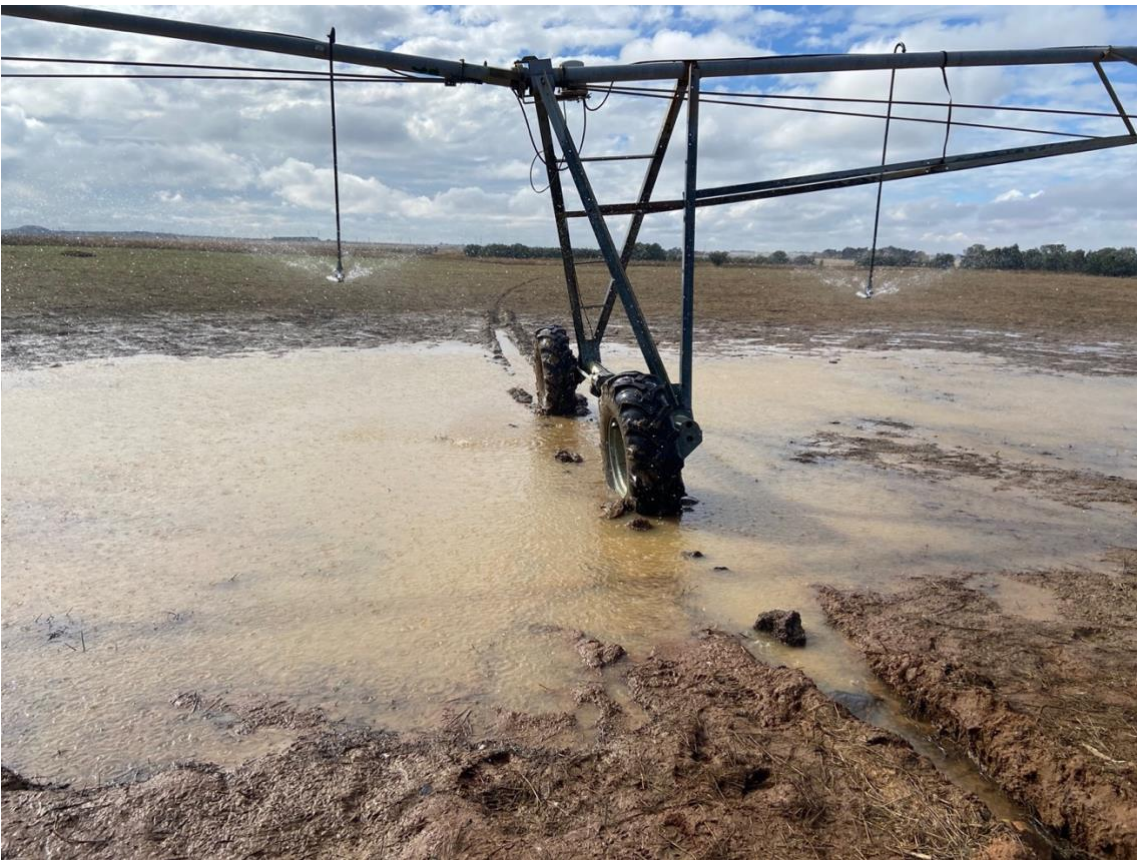
Figure 7.4: Water ponding due to surface subsidence and insufficient filling

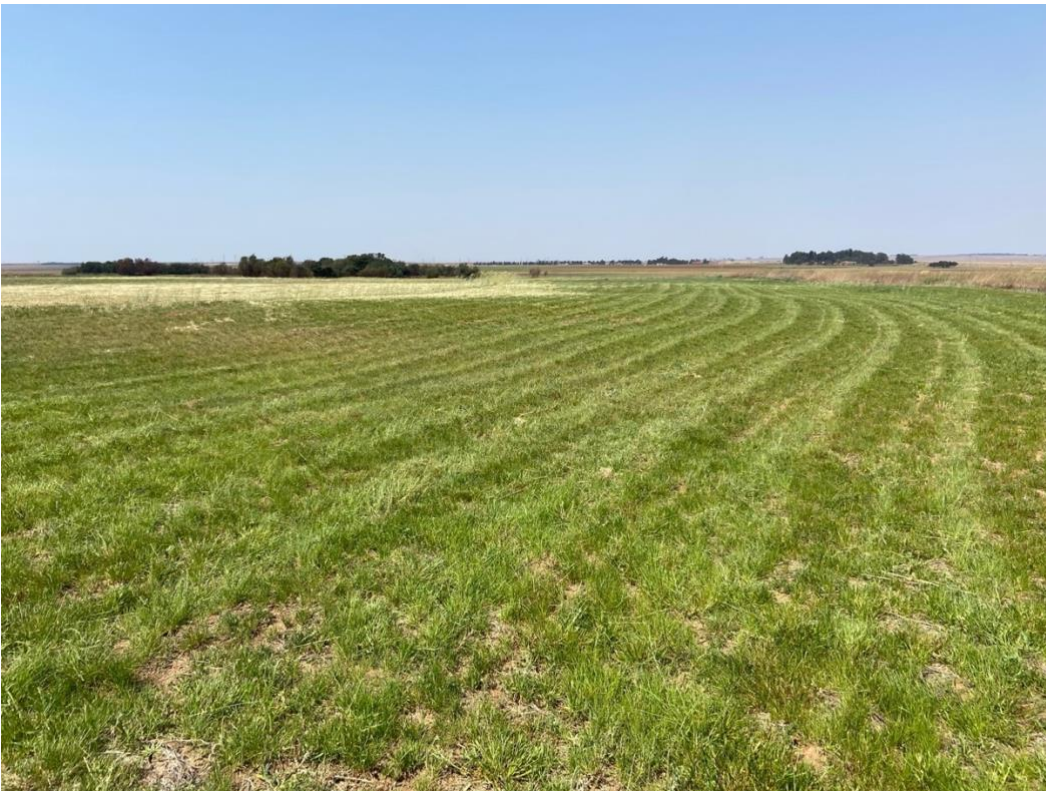
Figure 7.5: Winter cut at the Rehabilitated Field, early October 2022

Since lucerne, which is a perennial crop, requires 6 to 12 months to become well established, and some weeds and volunteer crops establish more rapidly than this, it is normally prudent to reduce weed pressure by mowing the pasture in the early stages of establishment. This is usually done after winter and is referred to as a “winter cut”. This was carried out from 1<sup>st</sup> to 3<sup>rd</sup> October 2022. Figures 7.5 and 7.6 show the winter cut at the Rehabilitated Field.

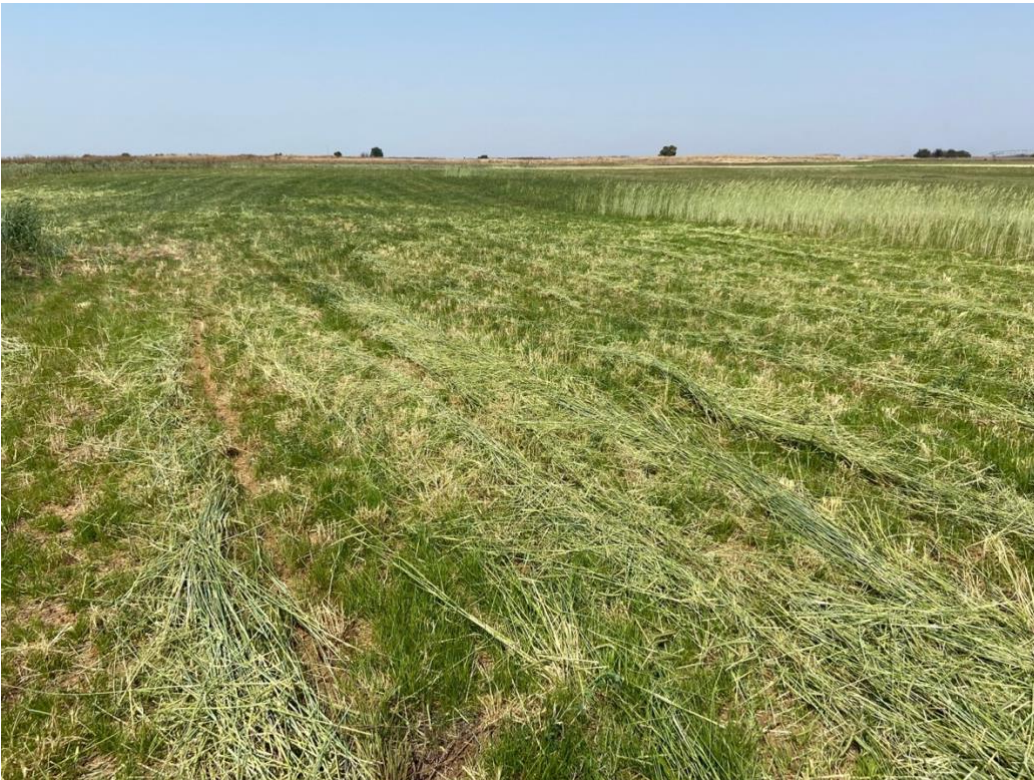
Figure 7.6: Remnants of volunteer small grain regrowth cleared with the winter cut, early October 2022.

Some wheat and other temperate small grain crops germinated from previous failed attempts at establishing crops due to irrigation system challenges, and this was also removed with the winter cut, as can be seen in Figure 7.6. The previous attempt to produce a crop under irrigation on the Rehabilitated Field was eventually aborted after multiple challenges occurred with the irrigation system. These challenges were mainly related to water availability and theft at the pivot. The regrowth of volunteer small grains in the warm season was, as expected, poor, giving the lucerne / fescue mixture an ideal opportunity to establish. With each subsequent hay harvest, the weed population should decrease and the pasture should become more dominant.

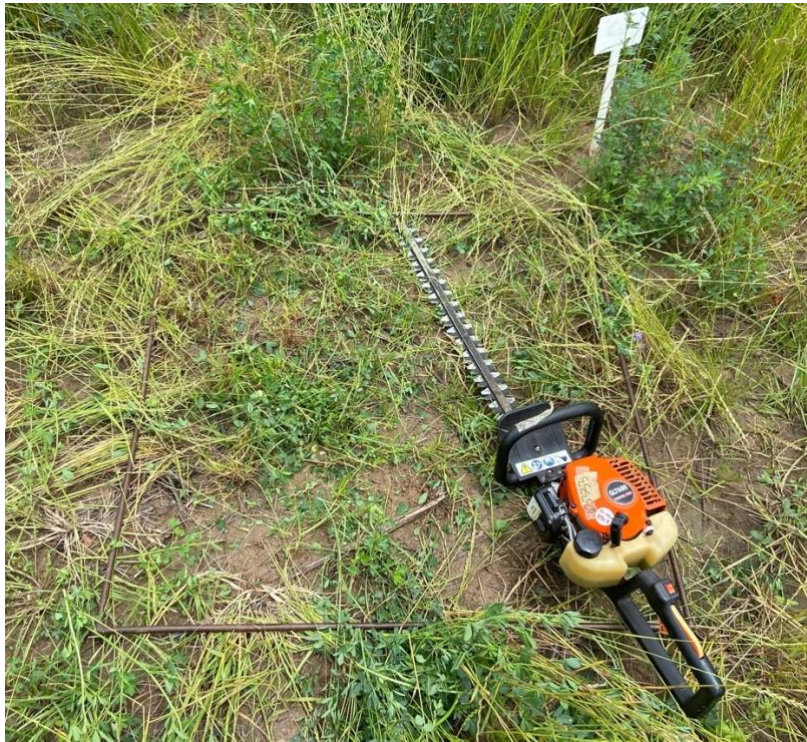
Figure 7.9: Hedge trimmer and sampling square.

The sampling square had a short 7 cm long rod at each corner on which the square could rest to keep it just off the soil surface. This ensured that all samples were harvested 7cm above the soil surface. The material above the square was harvested using a 2-stroke, petrol powered hedge trimmer. Figure 7.9 shows the sampling square where the material still needs to be raked up and collected after being cut. Samples were collected and dried at 65 °C for 72 hours before being weighed.

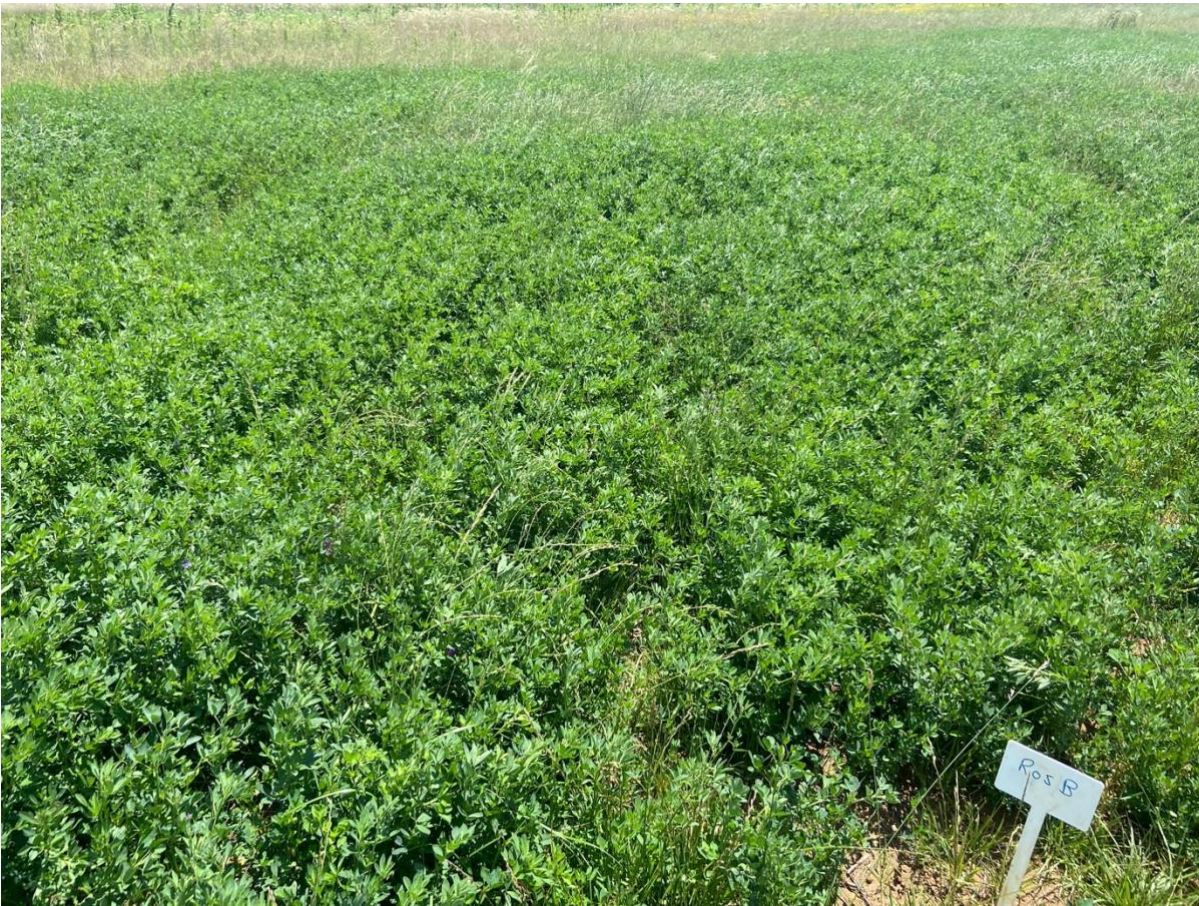
Figure 7.11: Site R 05B (Class C) with a yield of 3.1 t/ha recorded

Class C was classified as areas only having grazing suitability with the dryland classification system, but were deemed suitable for irrigation. Yield and LAI were the highest for class C, with an average of 2.5 t/ha and an average LAI of 2.9 m<sup>2</sup>/m<sup>2</sup>. Good infiltration and drainage were expected because of the greater amounts of coarse material present in the profile for these sites. This seemed to be the case and the reason for the superior growth in these areas. Most of the sampling classified as “grazing” showed more promising results than the areas classified as arable, indicating that soil depth is less important for storing water in the root zone under irrigated than dry land conditions. Figure 7.11 is from site R 05B (Class C) where good growth of the pasture is visible with a yield for the first harvest of 3.1 t/ha.

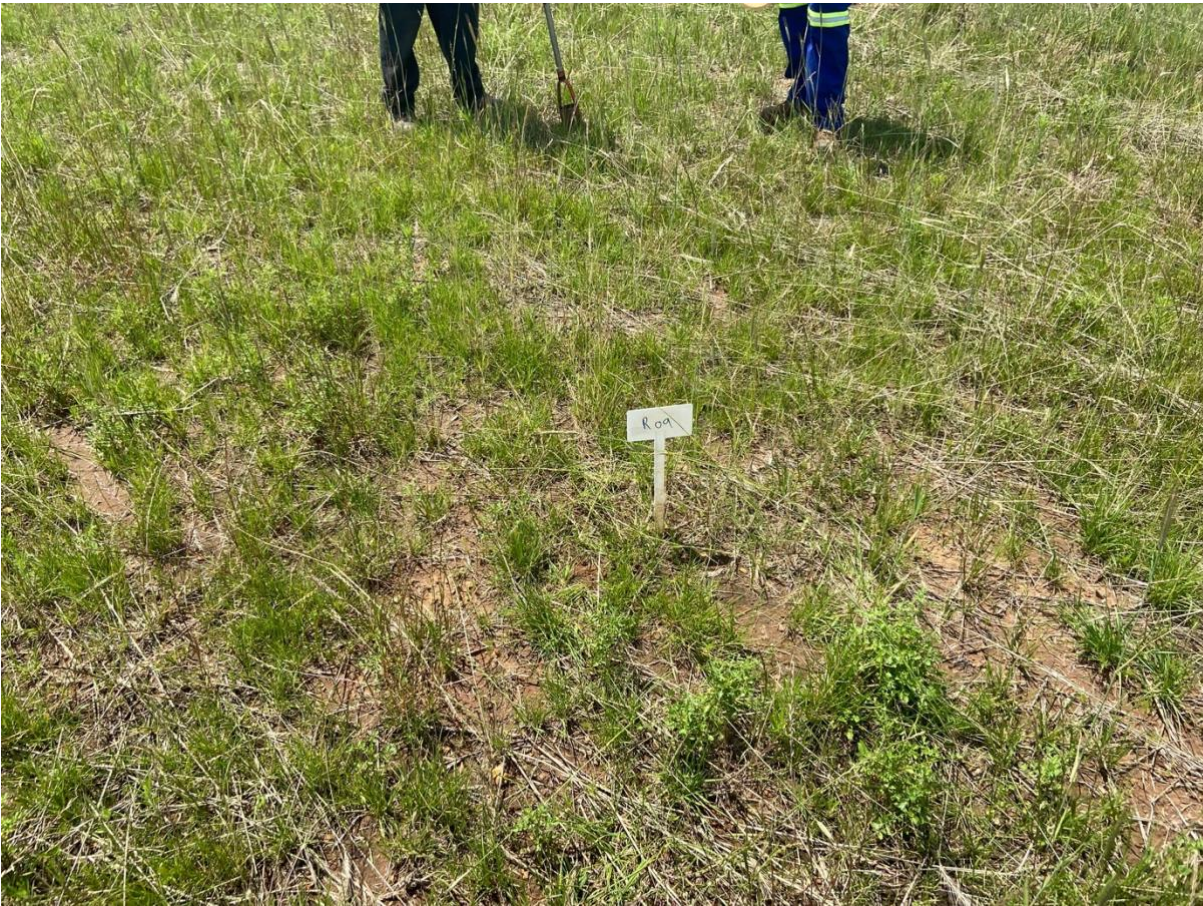
Figure 7.12: Poor growth at R 09.

Class D was classified as wetland areas with poor arable potential according to the dryland system. Unacceptable irrigation suitability was also predicted with the proposed Irrigability Assessment System. R09 and R14 recorded very poor growth and low yields as was expected. The G horizon (very high clay content) formed an almost impenetrable layer, limiting aeration and water infiltration, which resulted in poor establishment and growth. Such areas may improve over time with proper soil cultivation like ripping. Crop germination and establishment may also improve and ease the impact of irrigation and rainfall on the surface, allowing infiltration to take place. Figure 7.12 shows site R 09 (Class D) where only 0.7 t/ha was recorded. This indicates the high variability in the Rehabilitated Field, as the areas depicted in Figures 7.11 and 7.12, are situated less than 30 m from each other.

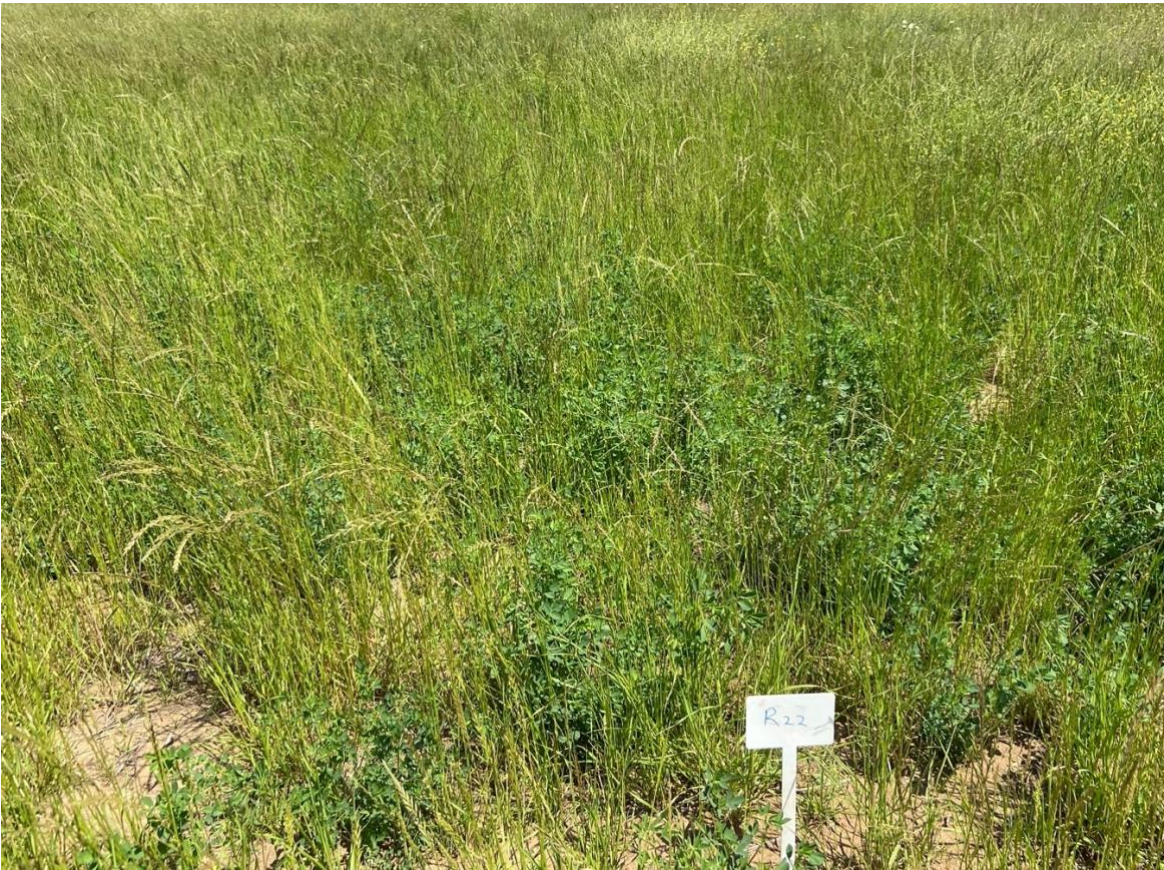
Figure 7.13: Fescue dominated lucerne growth at site R 22 (Class D) (December, 2022)

Site R 22, Class D, produced high yields and good growth which was not expected. Cracks in the clay surface were observed, and different types of clay react differently to water. The cracks in the clay at R 22 are likely the result of the ability of the clay to swell and shrink. These cracks allow better water infiltration and aeration. This was not observed for sites R 09 and R 14, so it appears that R 22 had a different clay type. Figure 7.13 represents site R 22. Fescue dominated lucerne at this site because even though water infiltration and aeration were better than expected, it still remains difficult soil conditions for lucerne growth and establishment.

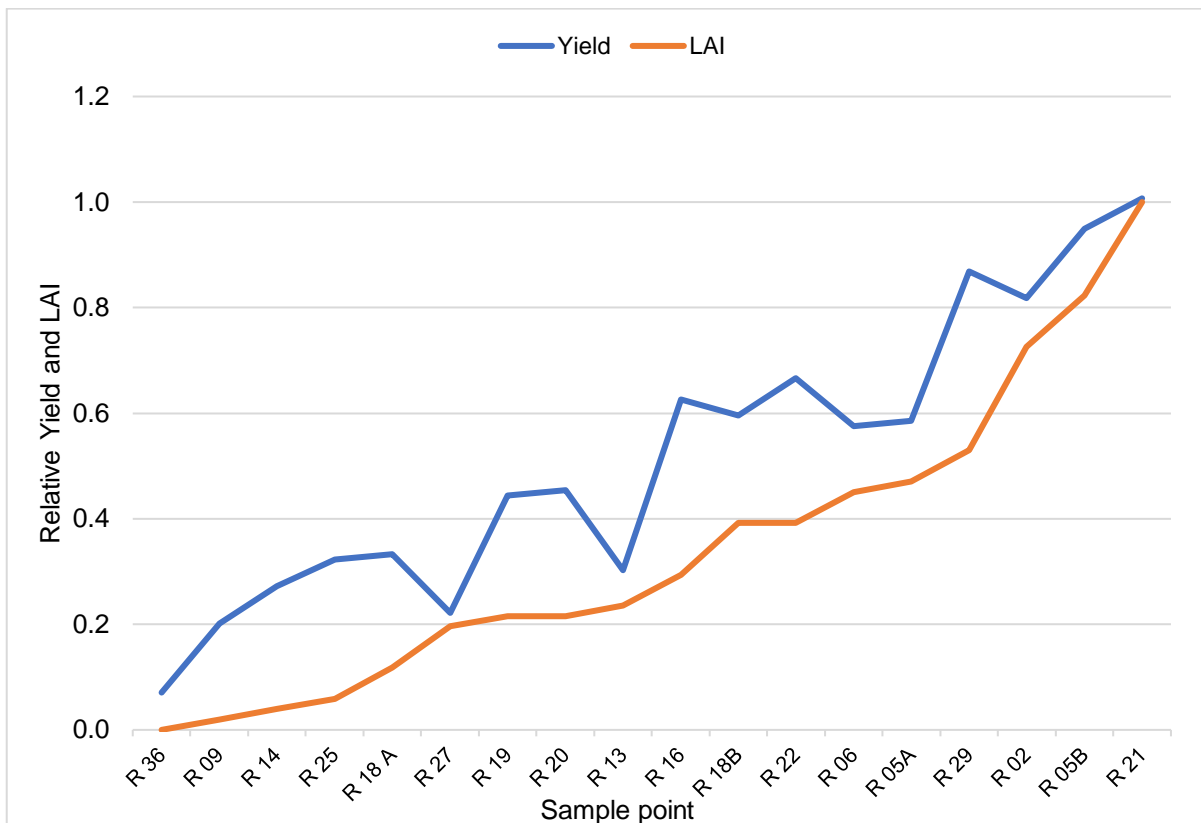
Figure 7.14: Normalised LAI and yields for the sampling points

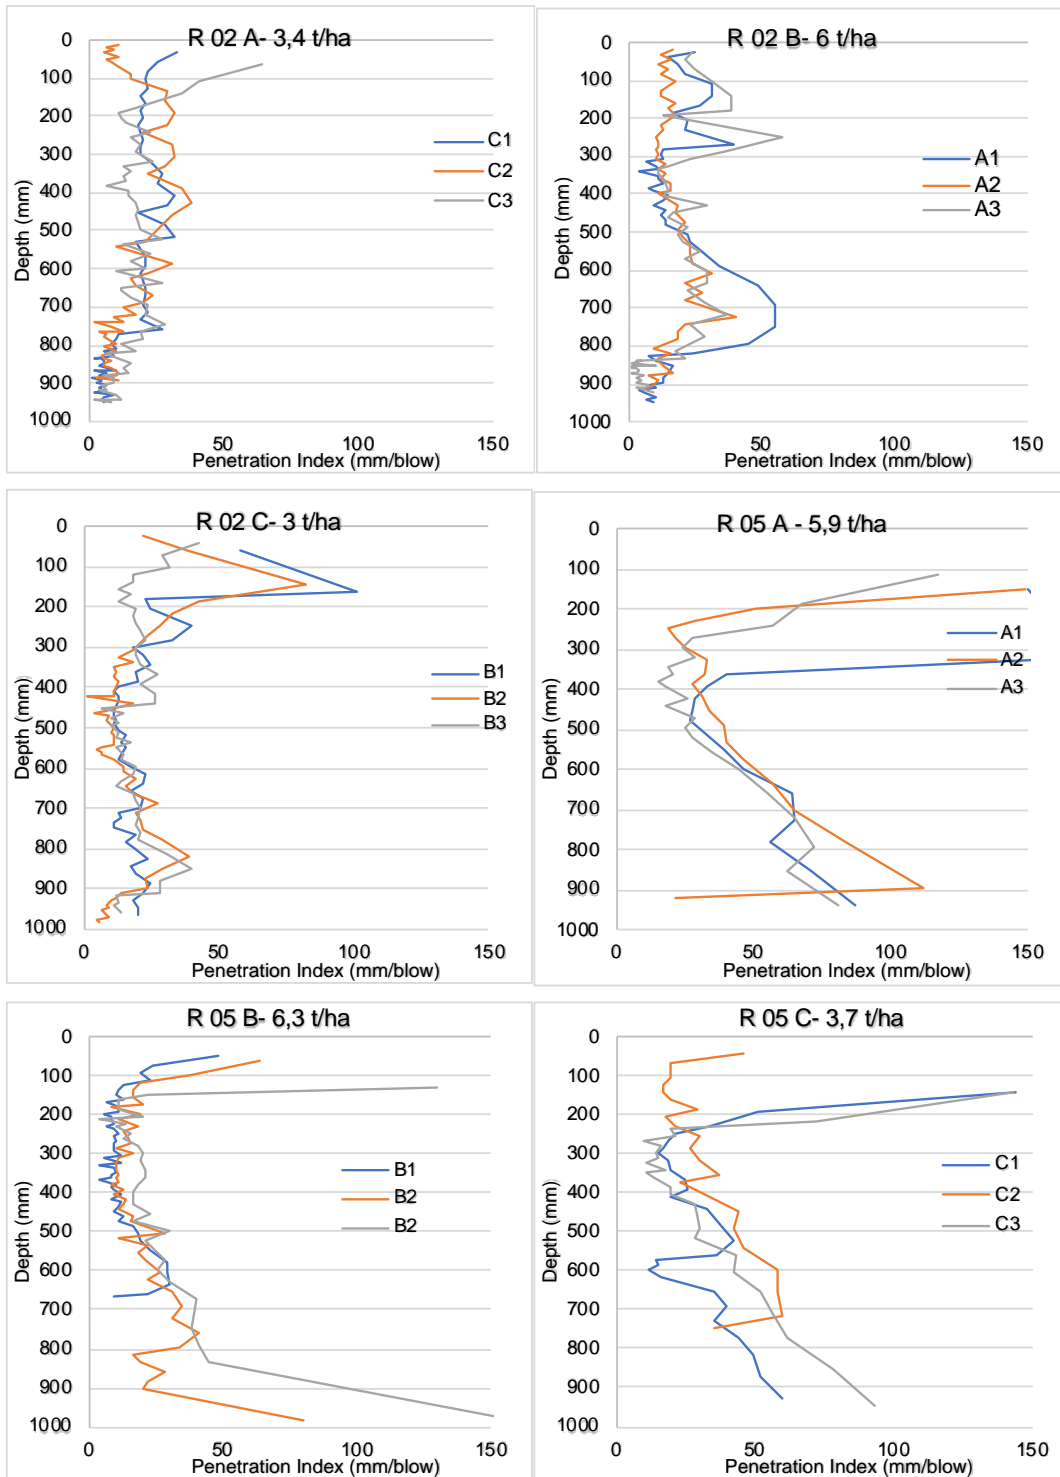
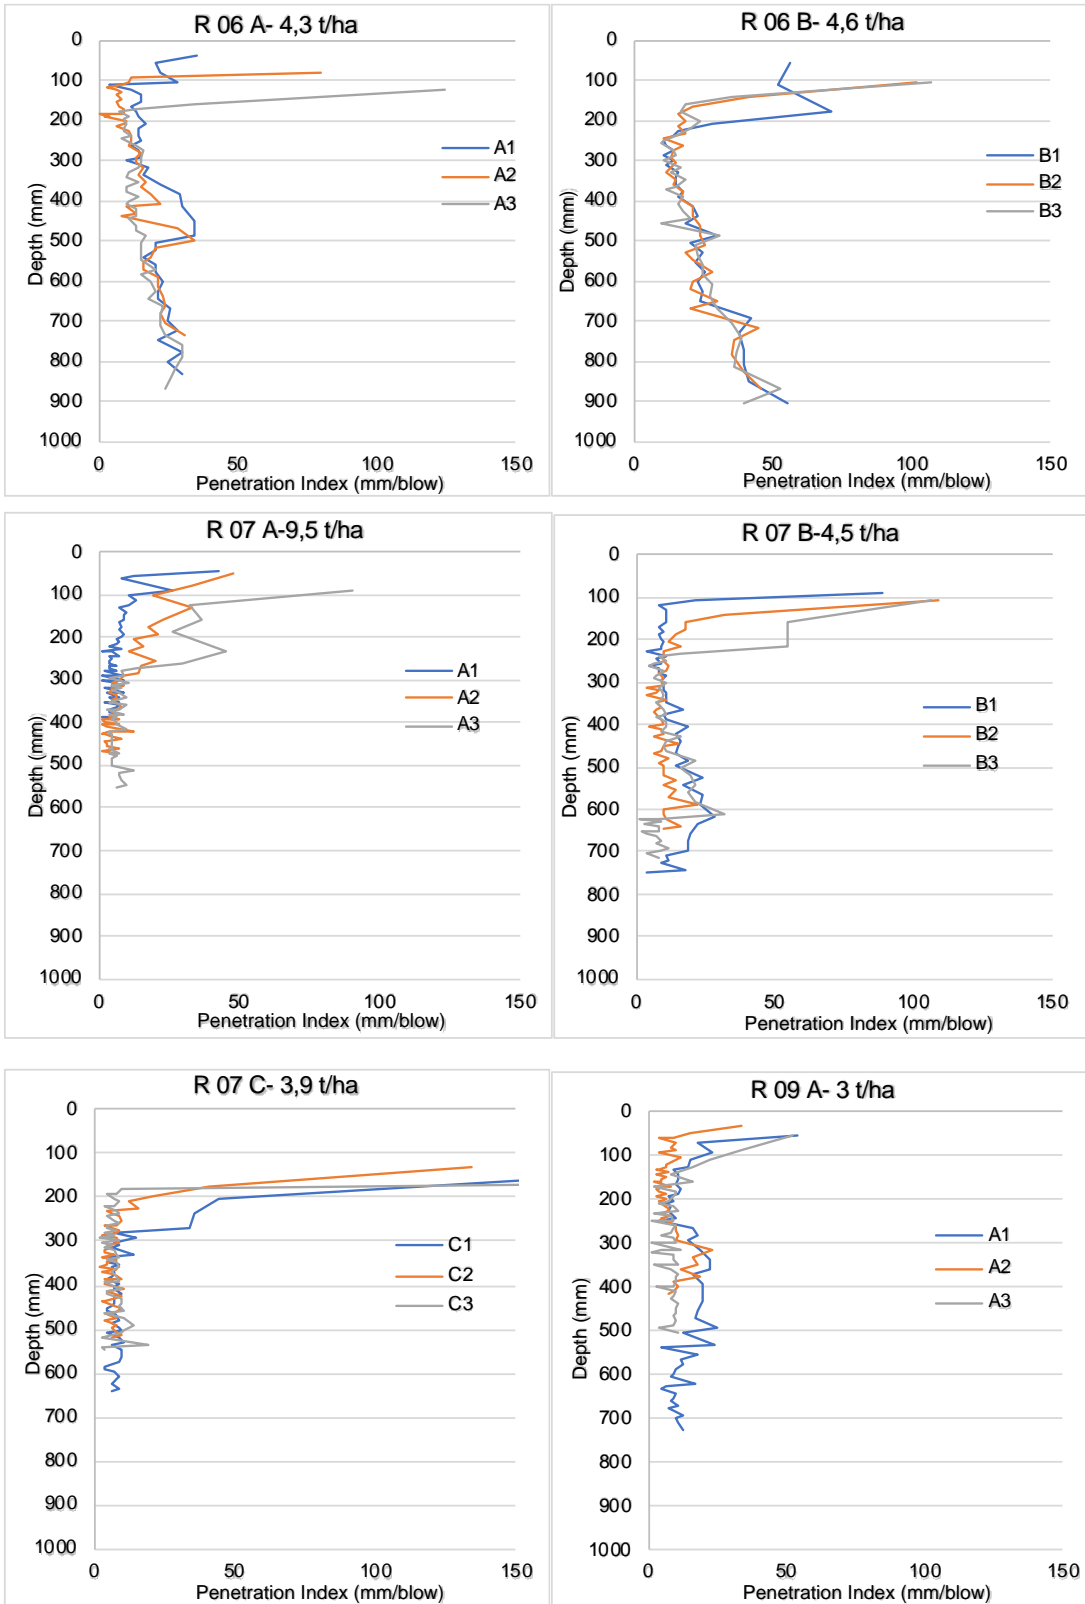
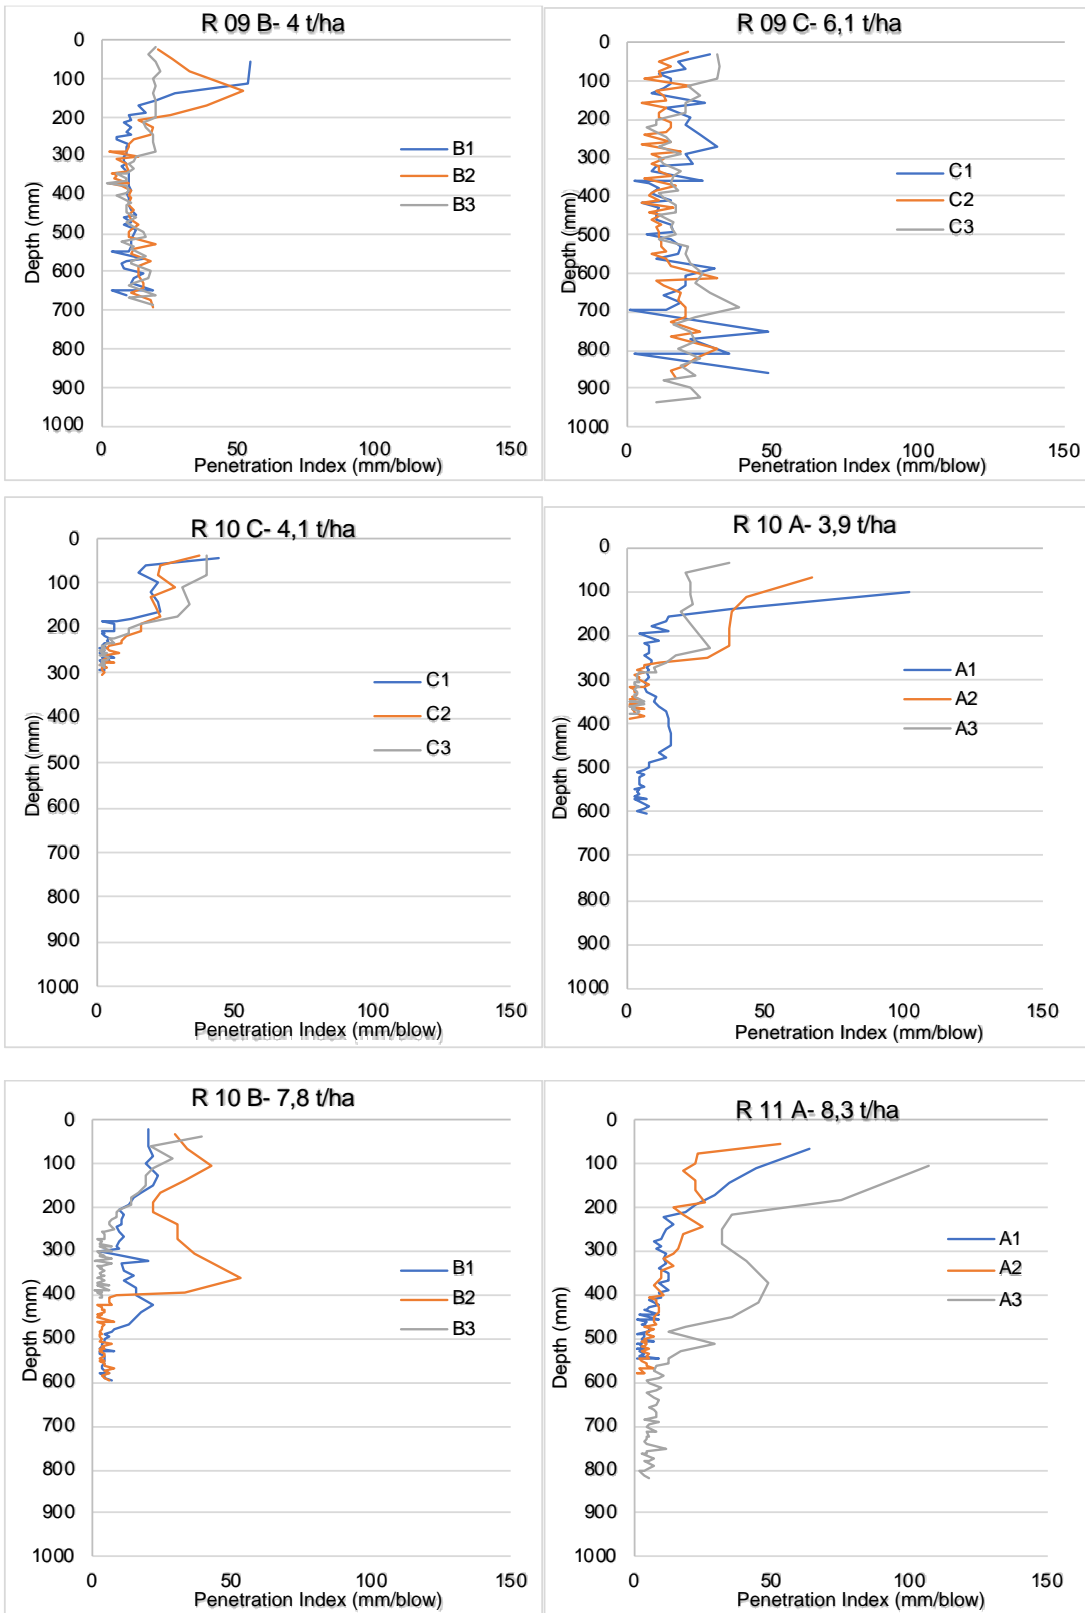
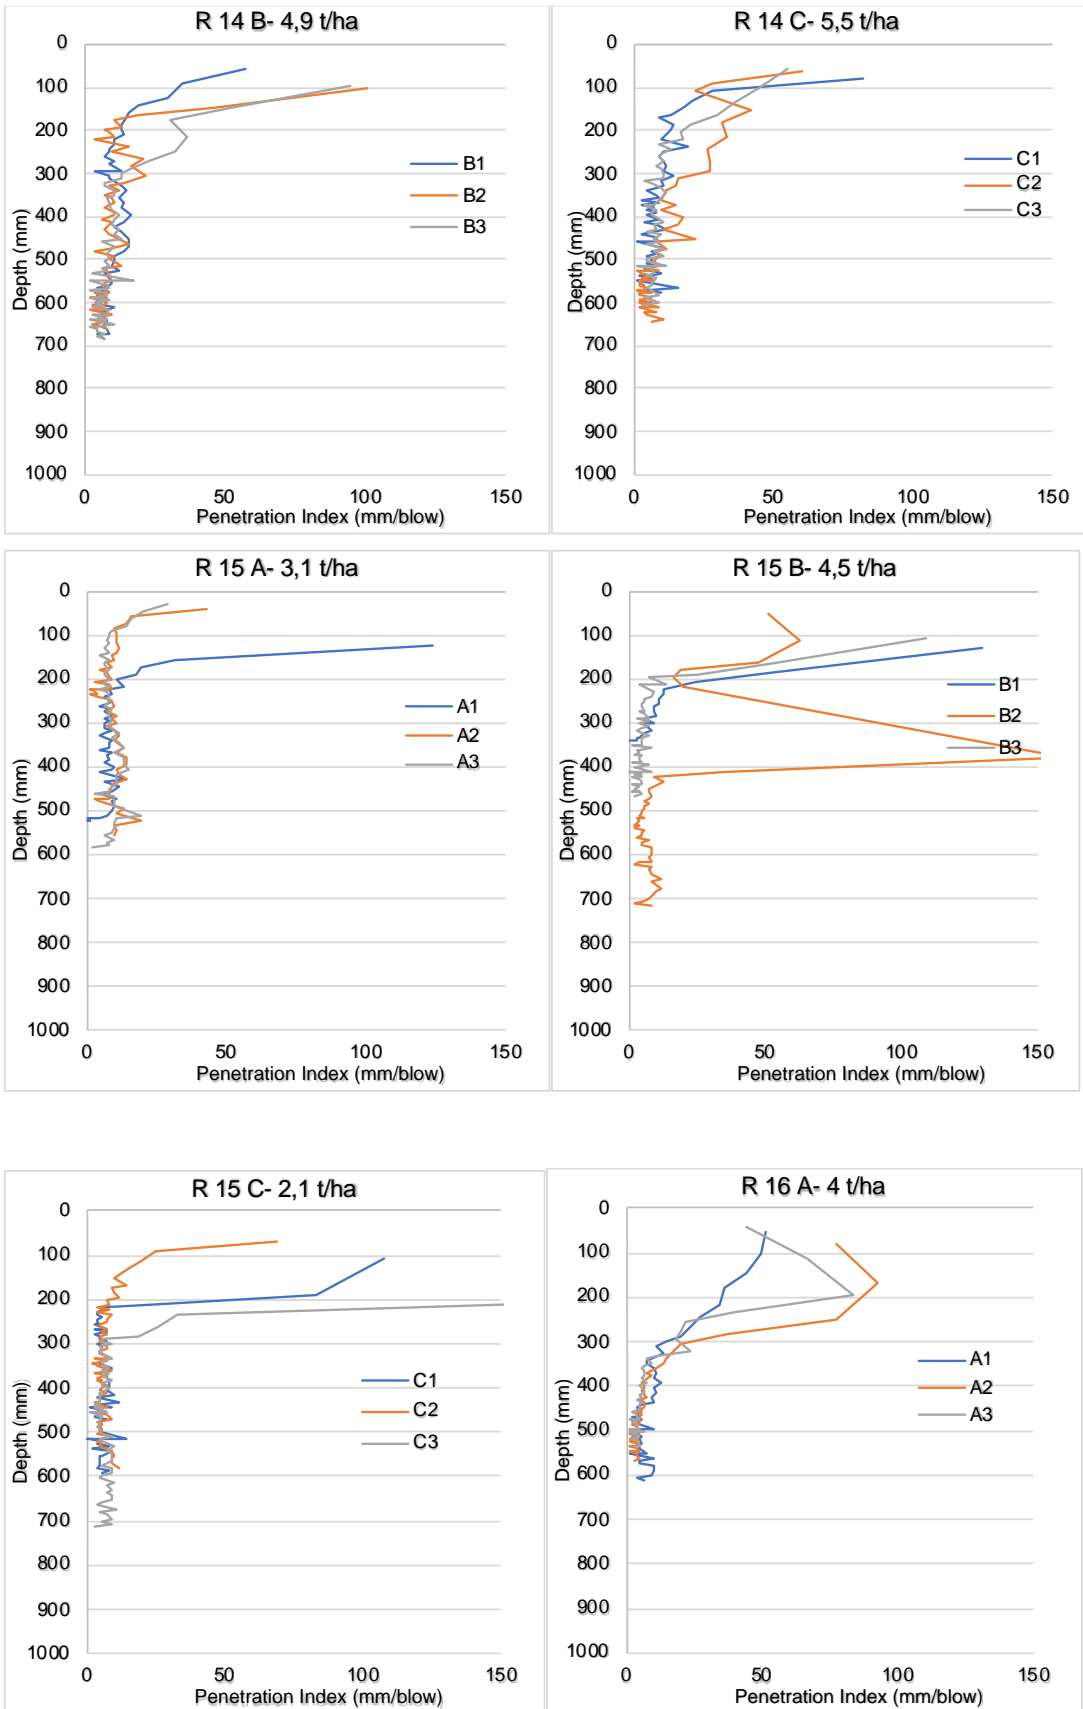
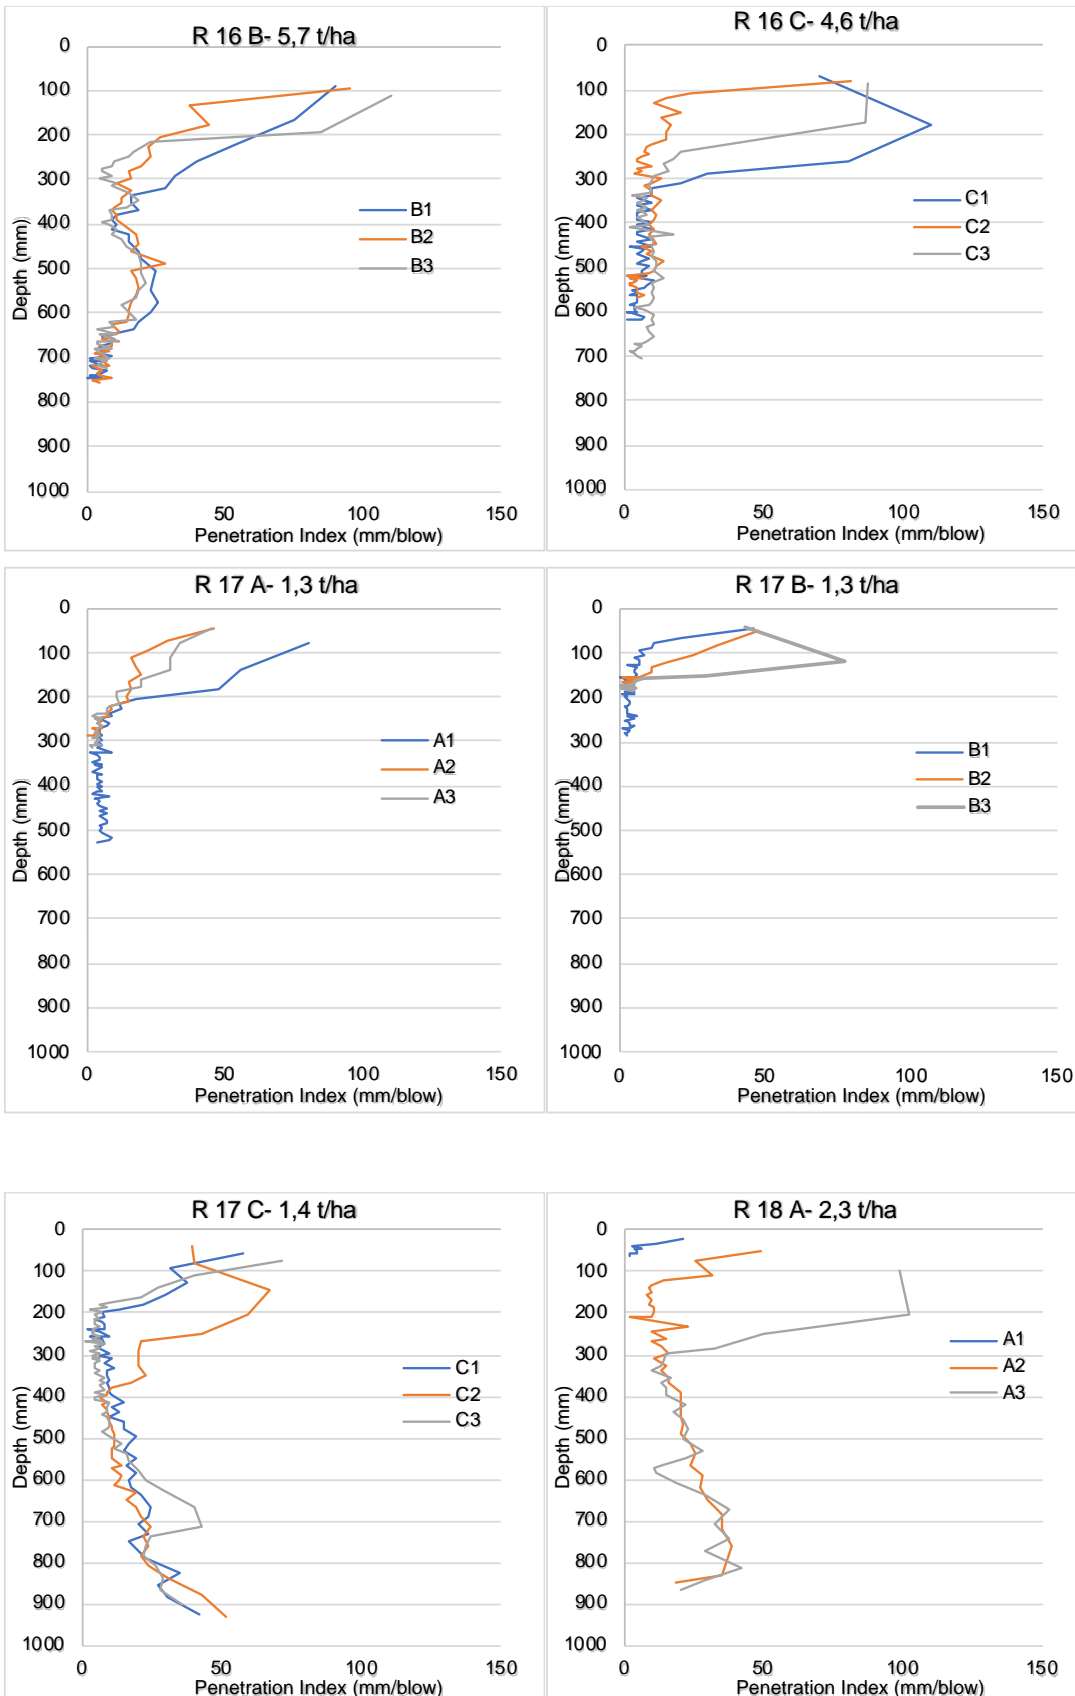
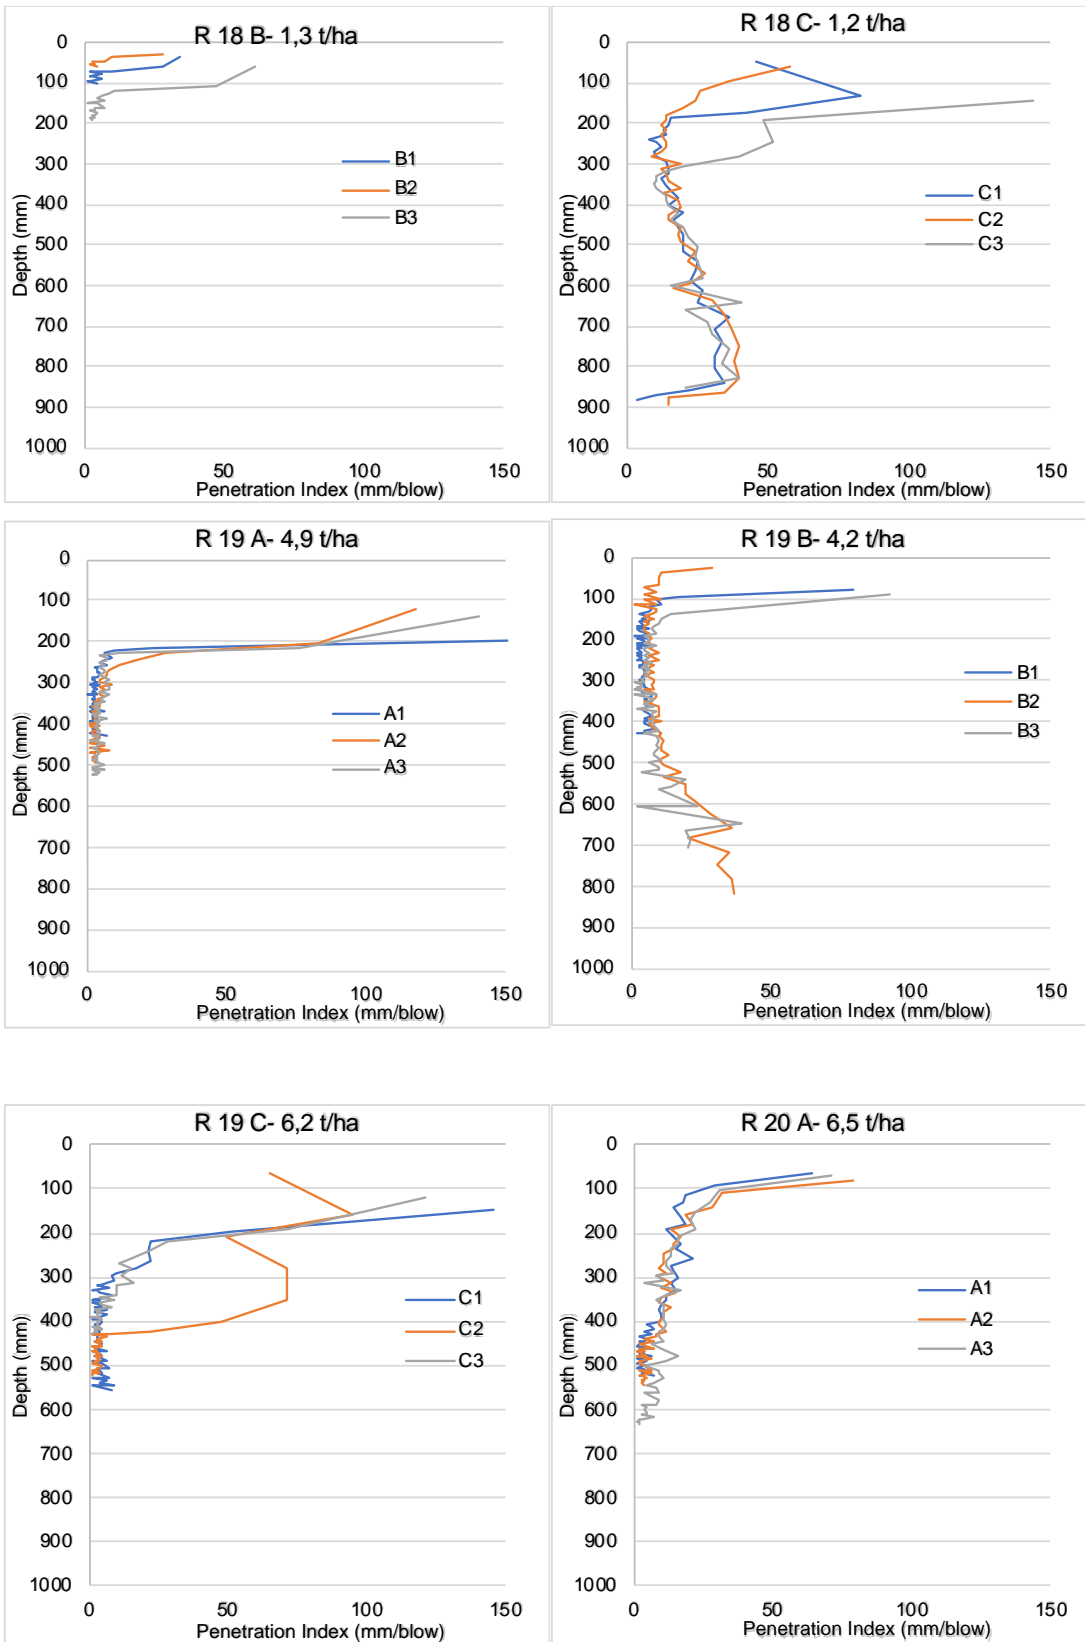
## Appendix B – Penetrometer results from the Rehabilitated Field

yield areas are presented to determine whether the growth can be related to physical conditions. These graphs assisted with determining the depth at which a restricted layer is present, if any. All of the graphs are included in Appendix B.
